# National Transportation Safety Board

ERA24FA096

## **WRECKAGE EXAMINATION**

Location: Weston, FL  
Date: January 23, 2024  
Time: 1844 EST  
2344 UTC  
Airplane: N737VC; Cessna 172-N

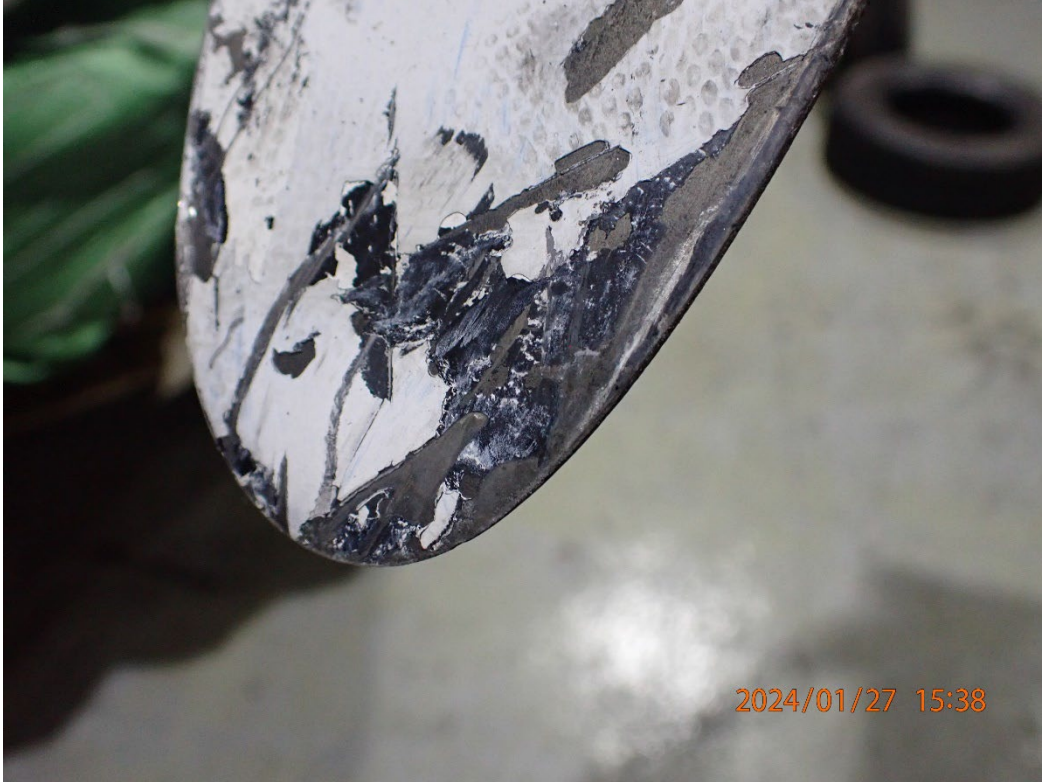
**Photo 55: Tip of blade B.**
