# National Transportation Safety Board

ERA24FA097

## **WRECKAGE EXAMINATION**

Location: Londonderry, NH  
Date: January 26, 2024  
Time: 0726 EST  
Helicopter: N53RP

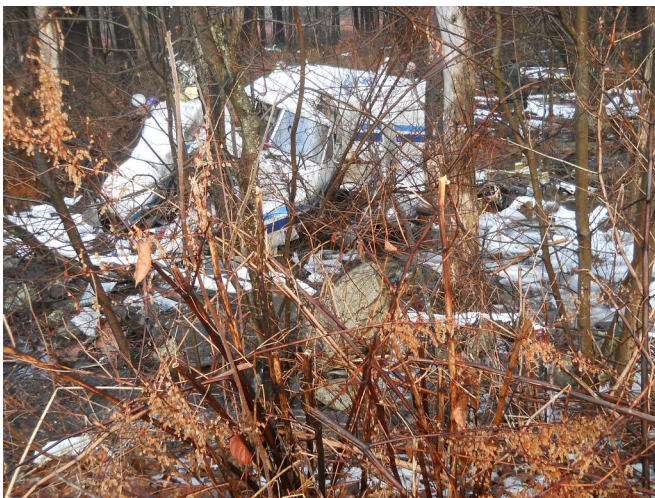
A debris path was observed, beginning with a damage fiber optic line about 75 ft high. The debris path extended on a magnetic course of 140° for about 200 ft through wooded terrain. The right aileron was found near the beginning of the debris path, suspended in a tree. The wreckage came to upright and oriented south at the end of the debris path. The portable ladder for pilot entry was found resting near the left engine nacelle.

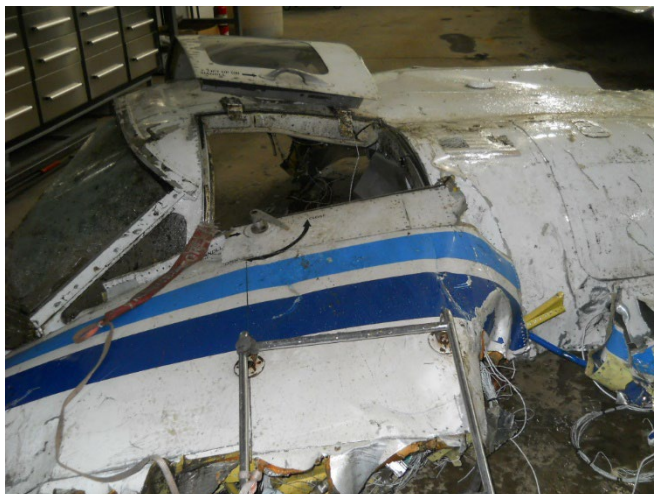
The left side cockpit hatch/door and portable ladder were staged during wreckage examination for orientation purposes. The left side cockpit door/hatch handle (inside and outside handle) operated normally when moved by hand.
