# National Transportation Safety Board

ERA24FA102

## **WRECKAGE EXAMINATION**

Aircraft: Piper PA-24-180

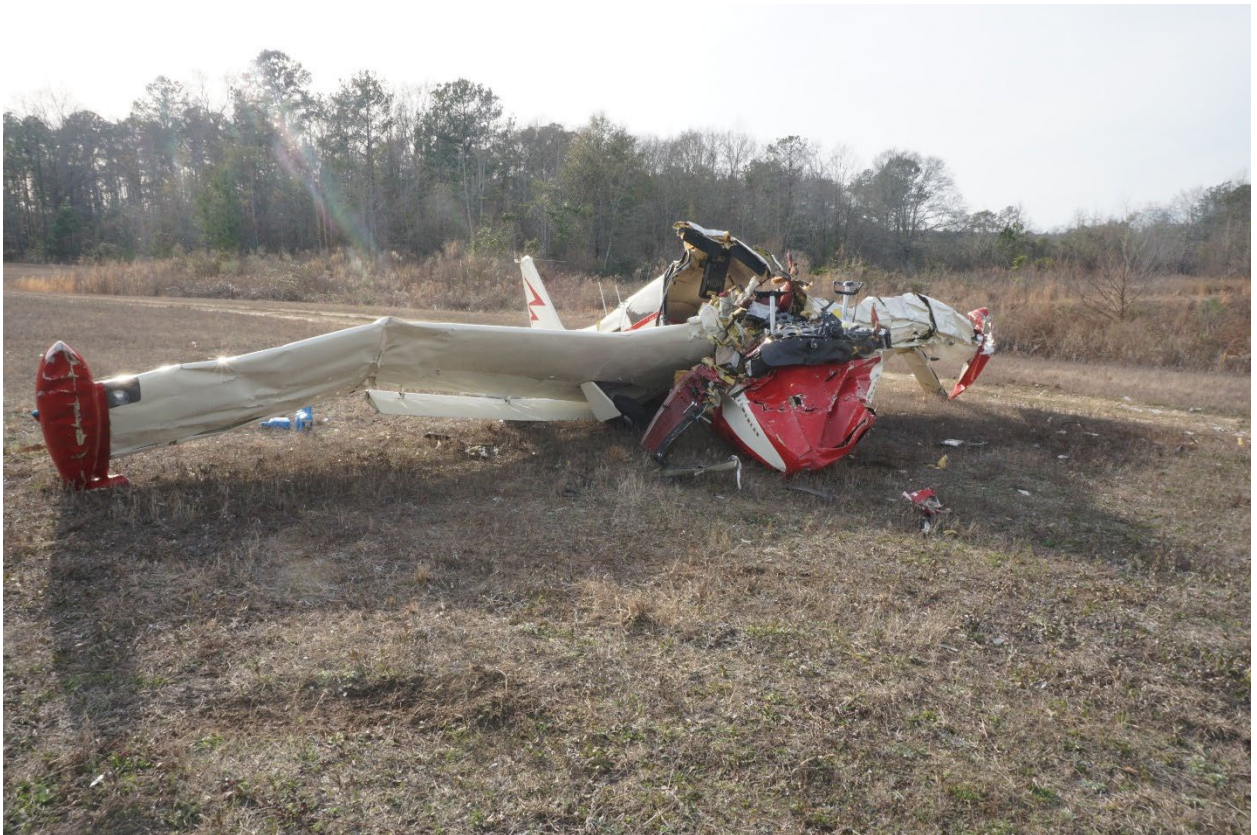
Figure 1 - Wreckage Diagram

The airplane came to rest oriented on a magnetic heading of about 70°. All primary flight control surfaces remained attached to the airplane. The nose of the airplane was crushed aft to the cockpit and partially separated from the fuselage. Flight control continuity was established for all primary flight control surfaces. The engine and avionics instruments were destroyed by impact. The empennage displayed crush damage and remained partially attached. The horizontal and vertical primary control surfaces remained connected to the empennage and were unremarkable. The wings remained attached to the fuselage and exhibited impact damage.

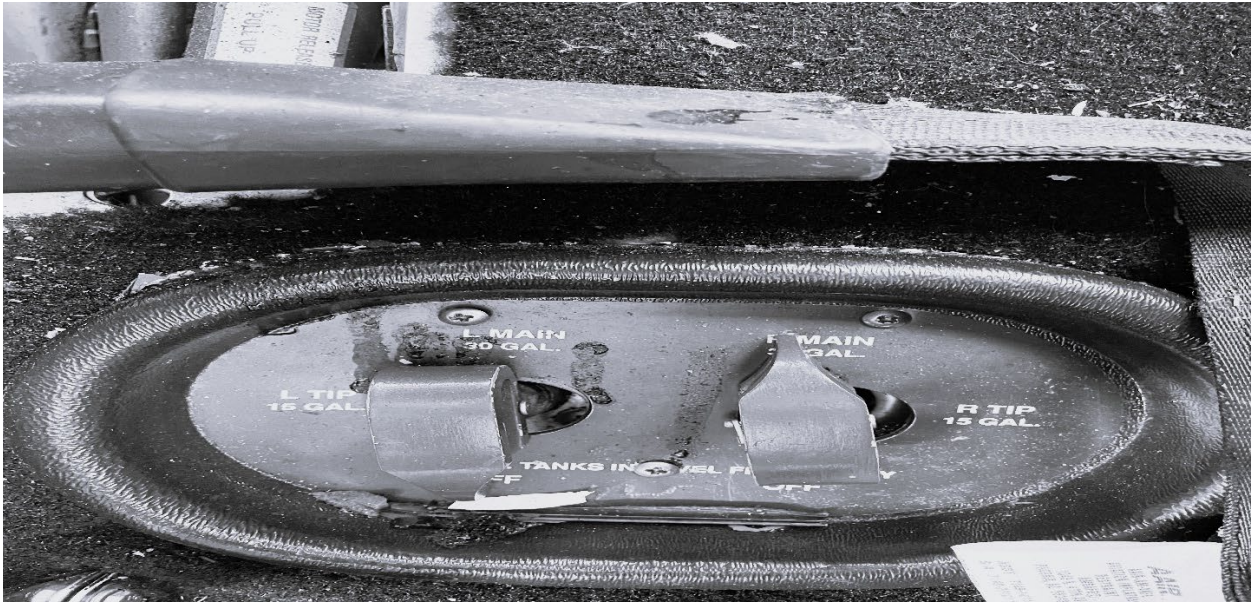
Photo 1-Fuel Selectors

The left fuel selector was positioned to "OFF" and securely in the detent, while the right fuel selector was positioned to the right main tank and also secured in the detent. Using low-pressure air introduced at a breached line forward of the No. 2 pilot seat, approximately 1 ounce of fuel was expelled from the right main tank fuel line at the wing root, and 2-3 ounces from the right tip tank line. Water-detecting paste testing showed no presence of water. Function checks of both fuel selectors using low-pressure air confirmed proper operation. (See Photo 1)
