# National Transportation Safety Board

ERA24FA104

## **VIDEO CAMERA INFORMATION**

Location: Clearwater, Florida  
Date: February 1, 2024  
Time: 1907 Eastern Standard Time  
0007 UTC on UTC Date February 2, 2024  
Airplane: N6659L, Beech V35B

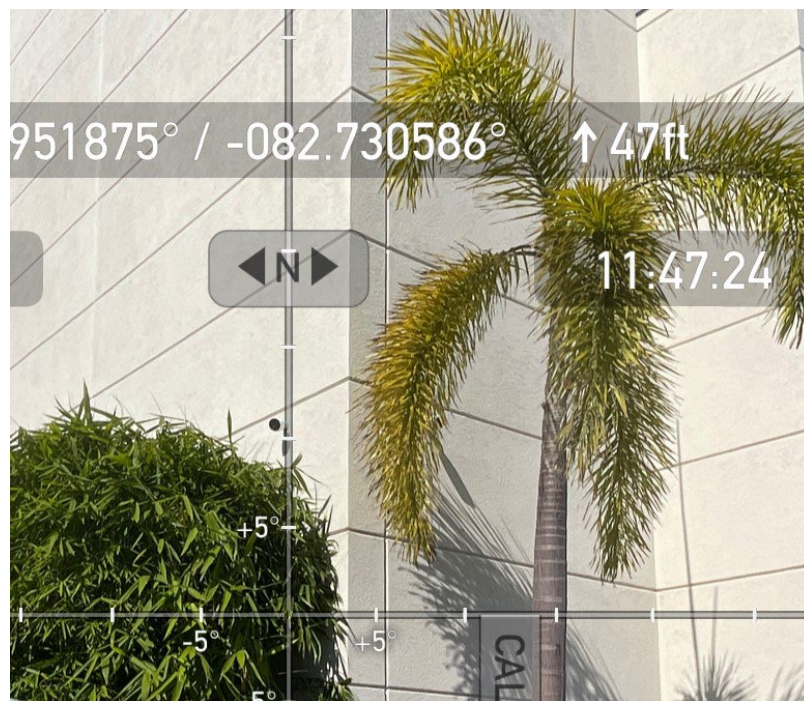
**Figure 1: Camera 1.**

Camera 1, located on southeast corner of Infinity New dealership located 12-15 ft above ground level (agl) at 27.951902° north latitude and -82.730648° west longitude<sup>1</sup>. The camera had a view looking southeast, and the video file name was "G3 Pro 2-1-2024, 19.06.50 EST - 2-1-2024, 19.07.15 EST." The camera was located about 297° and 1,350 ft from the accident site. The 26 seconds long video first recorded sound, then at clock recorded time of 1906:57, a white light came into view moving from right to left. The light continued to the east in a steep descent with what appears to be light trailing the airplane. At 1906:59 recorded camera time, a side of a nearby tall building became visible, followed by seeing a large fireball.

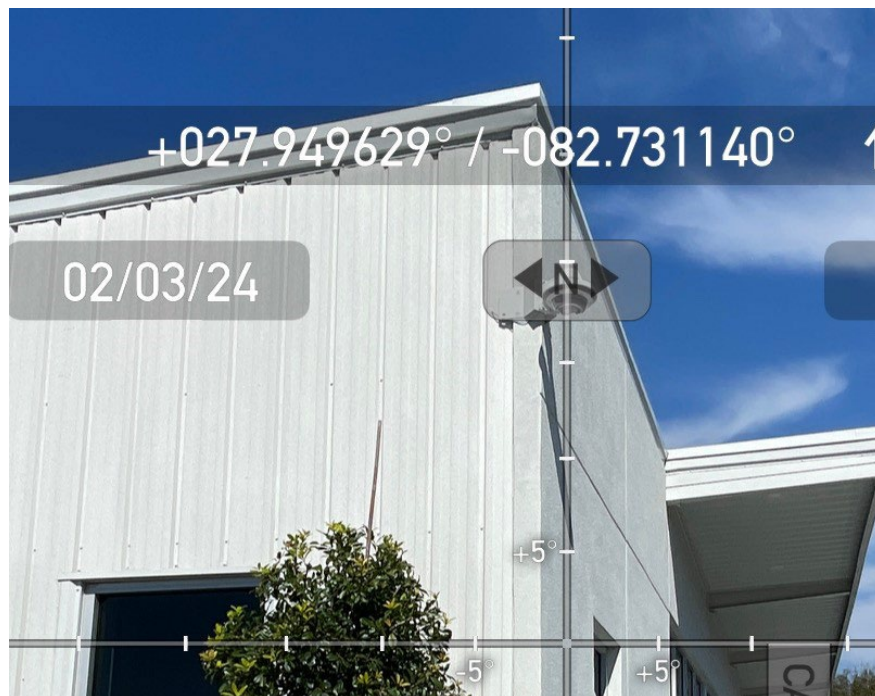
**Figure 2: Camera 2.**

Camera 2, located on southeast corner of Infinity Pre-Owned dealership located about 20 ft agl at 27.949654° north latitude and -082.731165° west longitude<sup>2</sup>. The camera had a view looking northeast, and the video file name was "Timeline-2024-02-02 01.36.30.405 PM." The camera was located about 261° and 1,391 ft from the accident site. The 4 minutes long video depicted the airplane coming in view to the upper right of the frame at 7 seconds elapsed time. The airplane was in a descent and a white light was observed for about 2 seconds, followed by a fireball that occurred about 9 seconds elapsed time. The fire remained to the end of the recording.

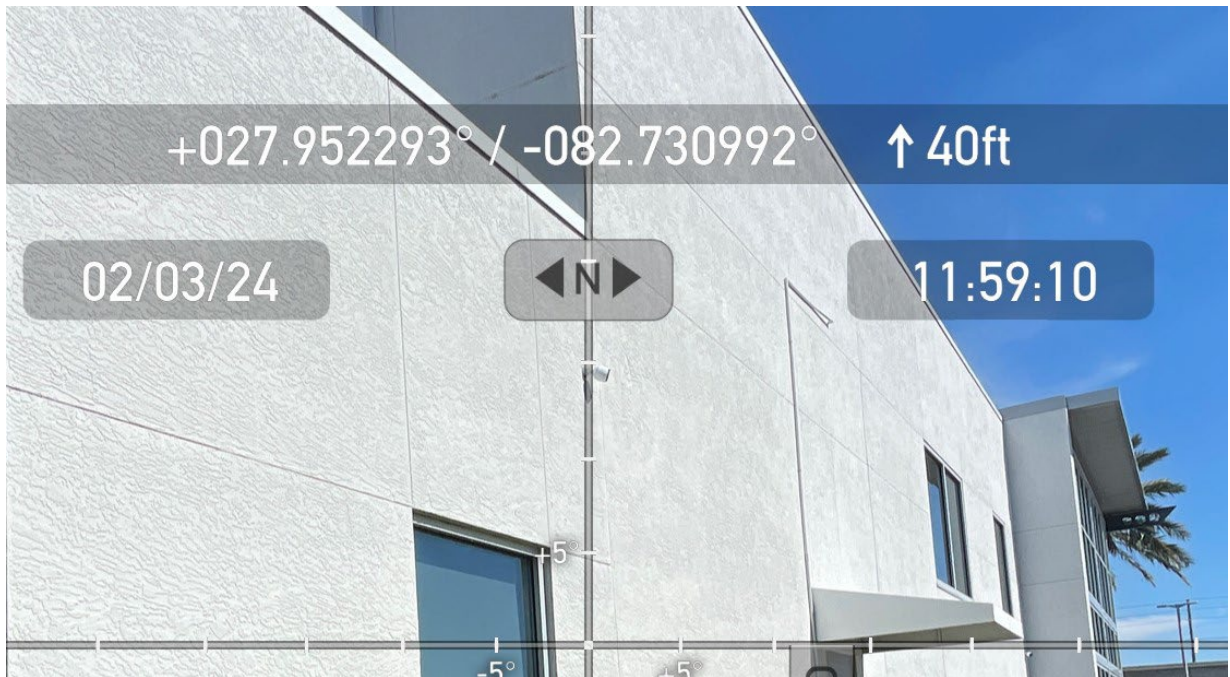
**Figure 3: Camera 3.**

Camera 3, located on southwest corner of Mercedes new dealership located about 12-15 ft agl at 27.952325° north latitude and -82.730954° west longitude<sup>3</sup>. The camera had a view looking southeast, and the video file name was "G3 Pro 2-1-2024, 19.06.50 EST - 2-1-2024, 19.07.15 EST (1)." The camera was located about 1,514 ft and 300° from the accident site. The 26 seconds long video with sound captured the airplane coming into view above the adjacent building in the upper center of the frame at 8 seconds elapsed time. The video depicted the airplane in a descent at about a 30° nose down angle and engine sound which increased

slightly at the end. The airplane went out of view at 9 seconds elapsed time and a fireball was noted at 10 seconds elapsed time. The fireball continues to the end of the recording.
