# National Transportation Safety Board

ERA24FA104

## VIDEO STUDY

Location: Clearwater, Florida  
Date: February 1, 2024  
Time: 1907 eastern standard time  
Aircraft: Beech V35B

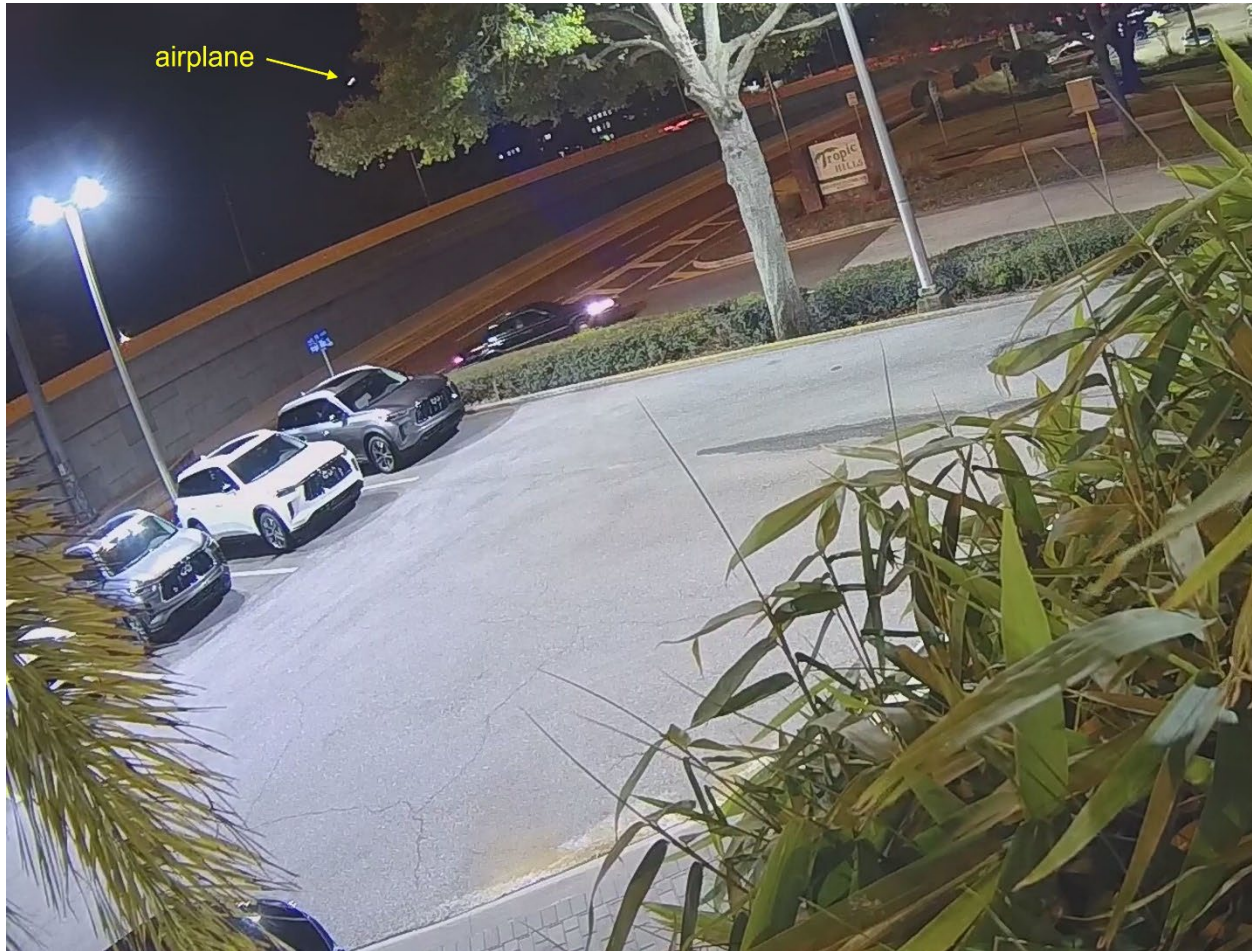
**Figure 1.** Video frame recorded at video time 9.267 seconds

The video had 1920x1080 resolution and frame rate of 30 fps (frames per second). The video lasted about 26.7 seconds and recorded sound at the rate of 48,000 samples/second. The airplane is first seen in the video at video time 9.133 seconds. The last moving image of the airborne airplane is seen at video time 10.233 seconds. At video time 11.2 seconds, the post-crash fire can be seen in the video. Based on these times, the estimated ground impact video time is about 10.6 seconds. Figure 1 is a segment of a video frame recorded at video time 9.267 seconds.

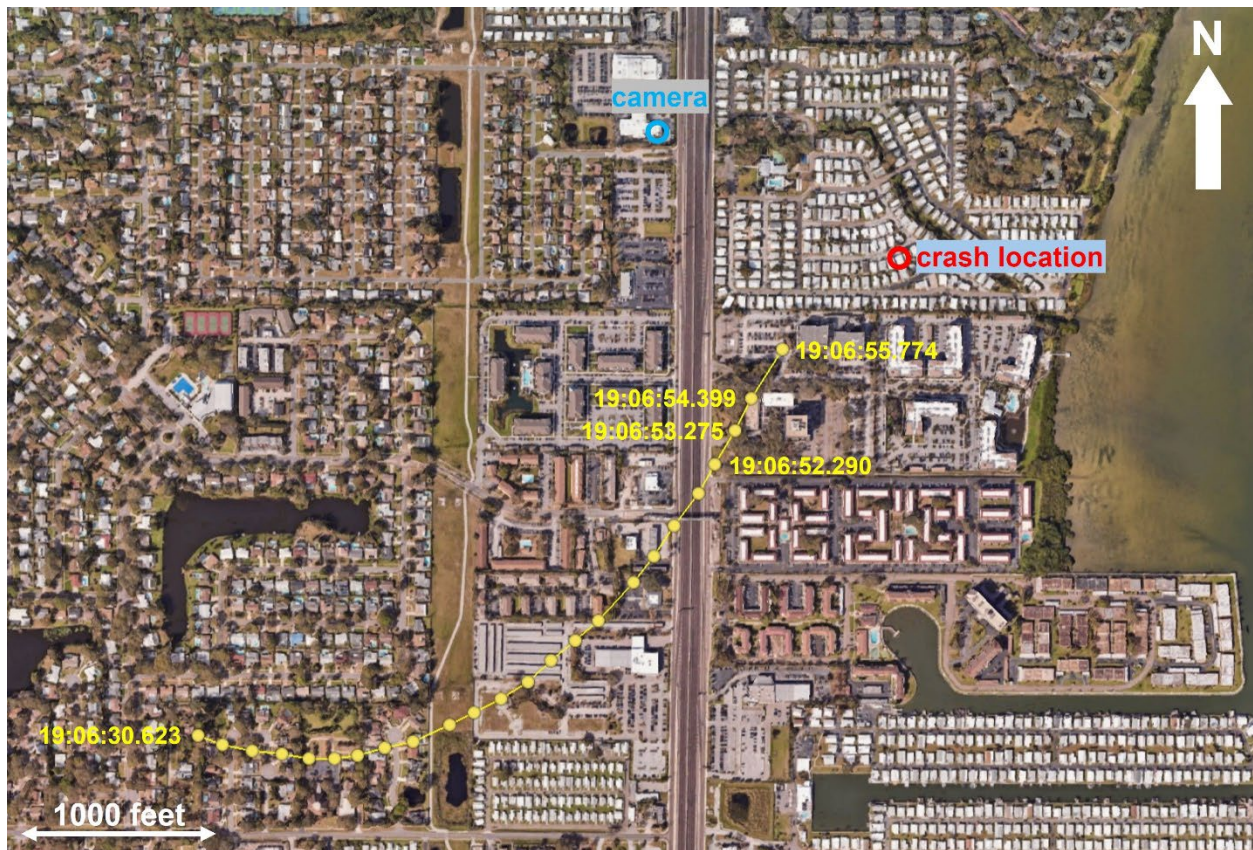
**Figure 2.** Aerial view of the accident area

Figure 2 is an aerial view of the accident area. It shows the location of the camera, the location of ground impact, and 24 airplane ground locations that were

available from ADS-B data. The time when the airplane was at five ADS-B locations is shown in the figure.

Figure 2 shows that the distance that the airplane traveled during the 3.484 seconds between ADS-B times 19:06:52.290 and 19:06:55.774 is about the same as the distance from the 19:06:55.774 location to the crash location. This indicates that the airplane impacted the ground about three seconds past 19:06:55.774.

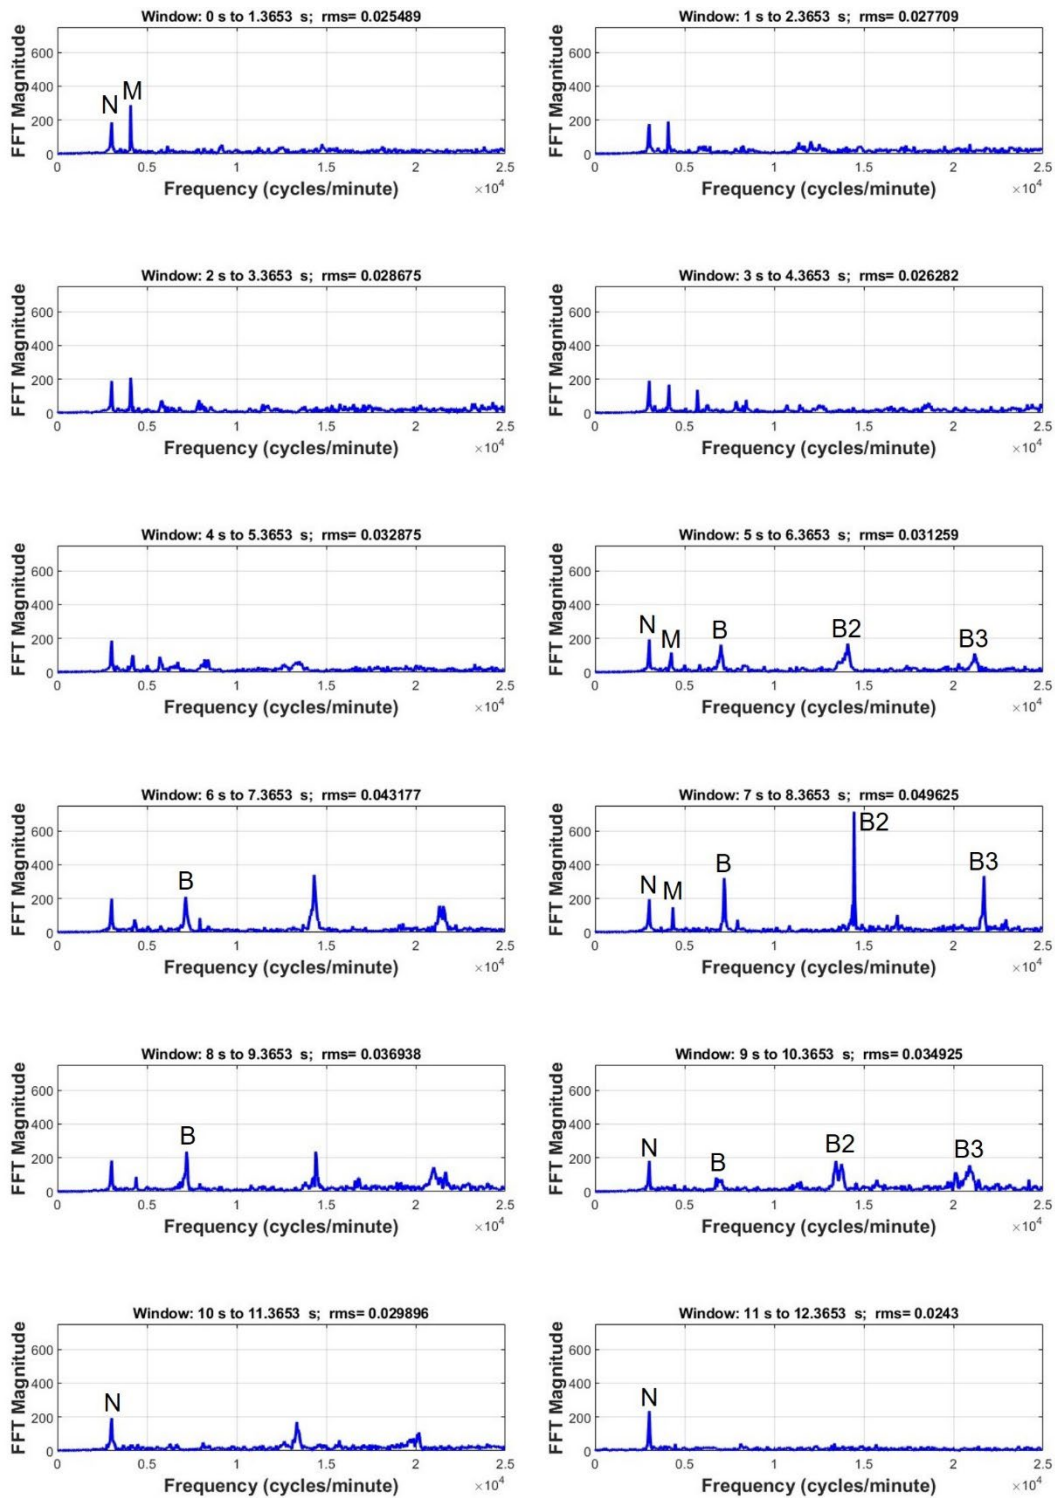
**Figure 3.** Sound spectrum plots

Figure 3 shows twelve spectra computed in processing windows with window starting times from 0 seconds to 11 seconds. Some peaks are marked on the spectra. Spectral peaks N and M are noise due to sources that are not the accident airplane. They are present at time zero, before the sound emitted by the airplane reached a non-negligible level. Peak N is present even after time 11 seconds, past the time of ground impact.

The first processing window that clearly shows peaks due to the airplane starts at video time 5 seconds. The last processing window that clearly shows peaks due to the airplane starts at video time 9 seconds. The spectral peaks due to the sound emitted by the airplane with the highest intensity are in the window starting at time 7 seconds. This spectrum was used for analysis. The spectral peaks B, B2 and B3 were at frequencies 7207 cpm, 14458 cpm and 21709 cpm. These peaks are the BPF (blade passage frequency) of the three-bladed propeller and its second and third harmonics.

Since the propeller has three blades, the recorded propeller frequency and its harmonics were  $7207/3=2402$  cpm,  $14458/3=4819$  cpm and  $21709/3=7236$  cpm. Figure 3 shows that these frequencies stayed unchanged from the window starting at time 5 seconds through the window starting at time 9 seconds and ending at time 10.3653 seconds, i.e., for more than five seconds.

The Doppler effect depends on the component of the 3D speed along the line from the airplane to the camera. At time 19:06:55.774, that speed component was 160 feet/second. Doppler multiplier, defined as the number by which a frequency emitted by the airplane is multiplied when it reaches the camera, was 1.17 at that time. Consequently, the estimated engine speed after correcting for the Doppler effect is  $2402/1.17=2053$  rpm.

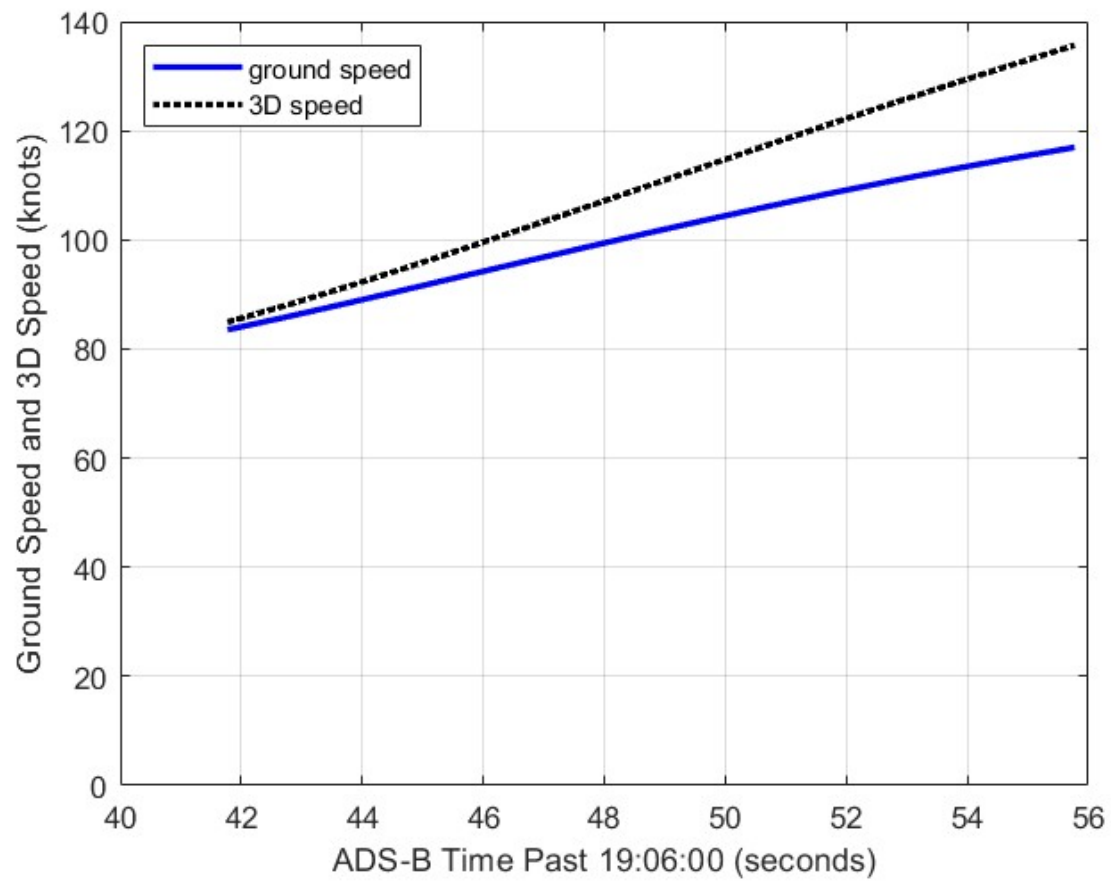
**Figure 4.** Estimated ground speed and 3D speed of the airplane

smoothed via 3<sup>rd</sup> order polynomial fits to the raw data. Figure 4 shows the estimated smoothed ground speed and the smoothed 3D speed of the airplane. The plotted 3D speed is the vector sum of the ground speed and the vertical descent speed. The speed plots in the figure end at ADS-B time 19:06:55.774, the time of the last ground track location in Figure 2. At that time, the ground speed was 117 knots and the 3D speed was 136 knots.
