# National Transportation Safety Board

ERA24FA104

## **MATERIALS LABORATORY**

Factual Report 24-058

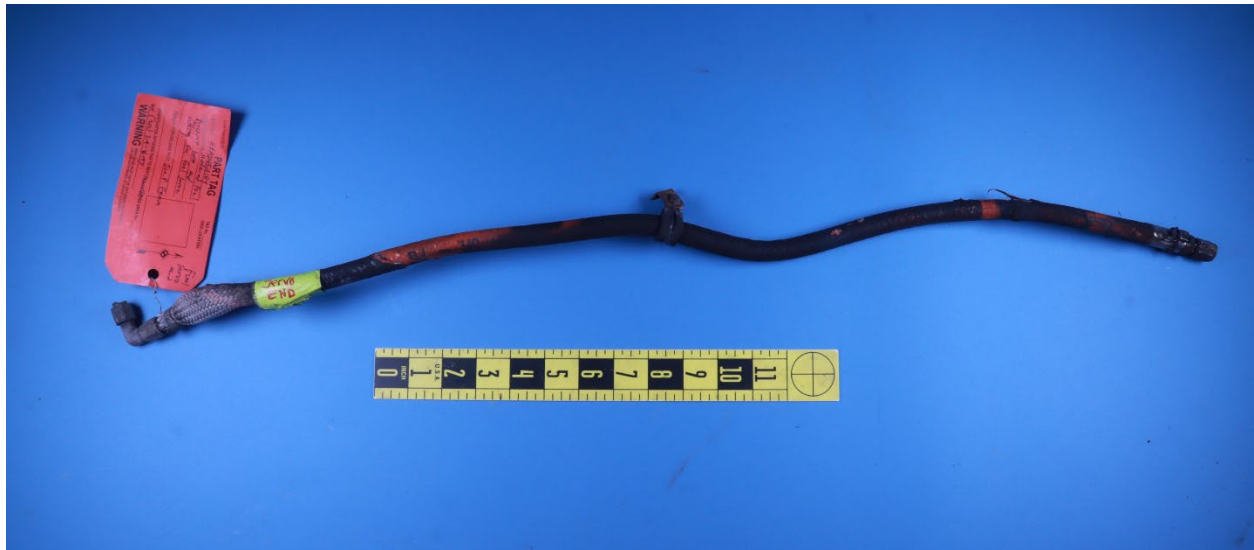
Flexible metered fuel hose and associated 90-degree fitting (Figure 1)

**Figure 1.** Metered fuel hose and fittings as received.

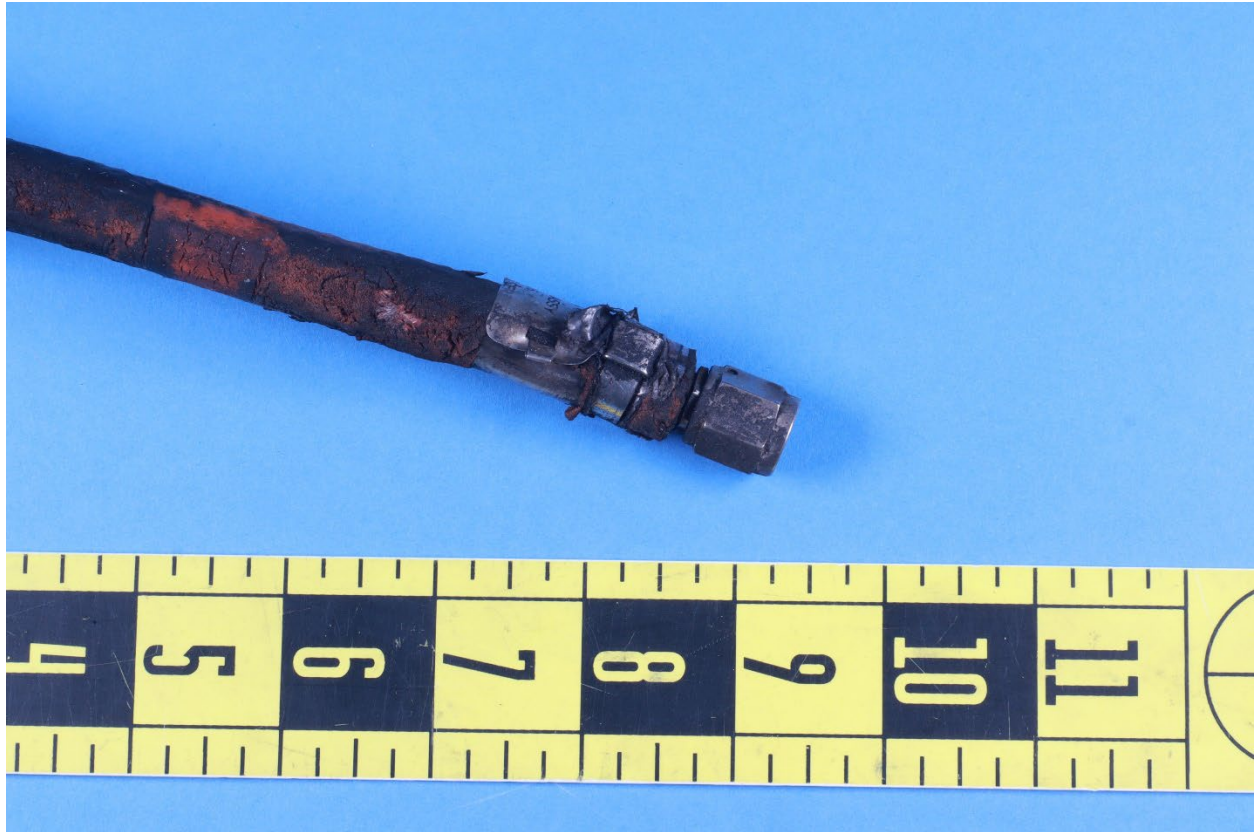
**Figure 2.** Fuel manifold end of the flexible fuel hose.

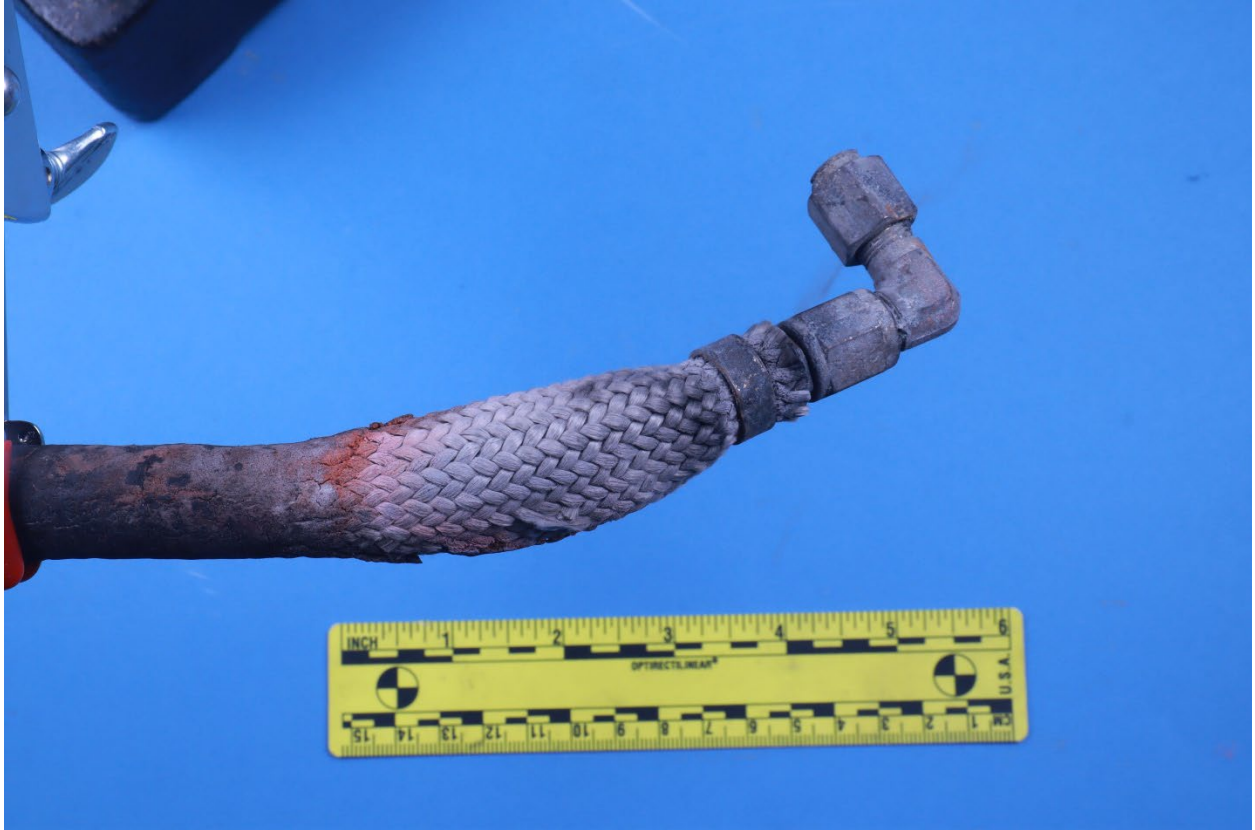
The flexible metered fuel hose was approximately 33 inches long and had captive b-nuts on both ends. One end of the hose had been attached to the fuel manifold (Figure 2). The other end was attached to a 90-degree fitting (Figure 3) which would have been connected to the outlet of the fuel metering valve. The flexible fuel hose was covered with an orange/red colored fire sleeve that exhibited varying levels of soot adhering to its surface. On the fuel manifold end there were non sooted areas consistent with areas protected by clamps. Approximately the last 3 inches of fire sleeve on the fuel metering valve end of the hose exhibited thermal damage that consumed the rubberized coating of the fire sleeve (Figure 3).

**Figure 3.** Fuel metering valve end of the flexible fuel hose. Localized thermal damage to the fire sleeve.

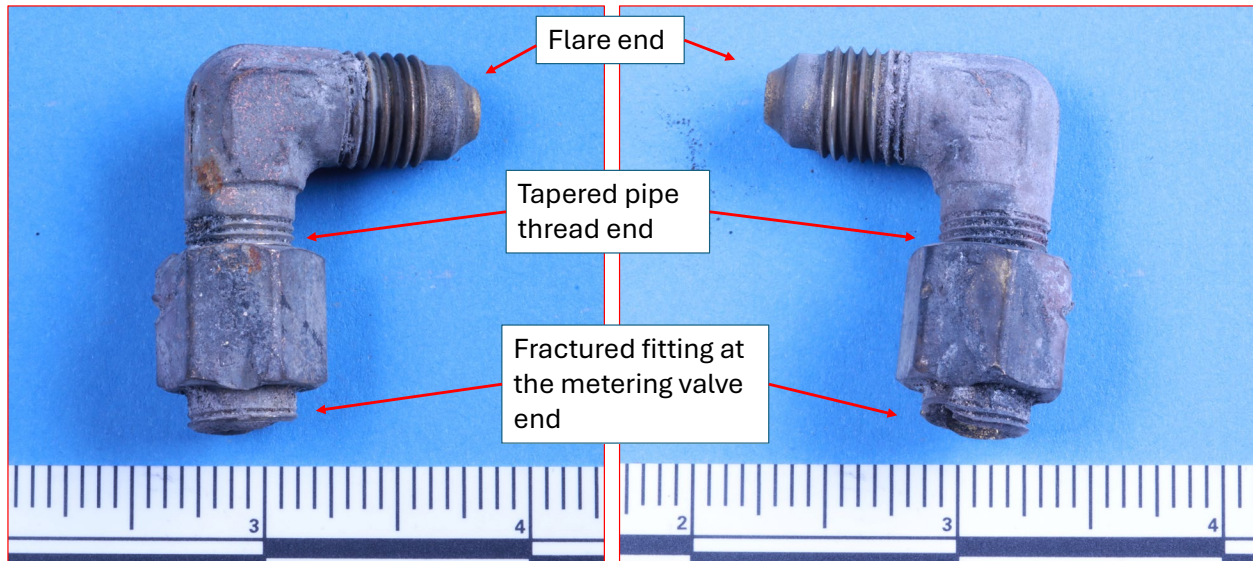
The threads on the flare end of the 90-degree fitting and the corresponding threads in the b-nut of the flexible fuel hose did not exhibit any evidence of cross threading or other anomalies. The mating surfaces of the flared connection also did not exhibit any anomalies. The b-nut and flared end of the 90-degree fitting could be

assembled and torqued to 136 in-lbs. After torquing the connection appeared solid and fully seated.

**Figure 4.** 90-degree elbow and portion of the fitting that would attach it to the fuel metering valve.

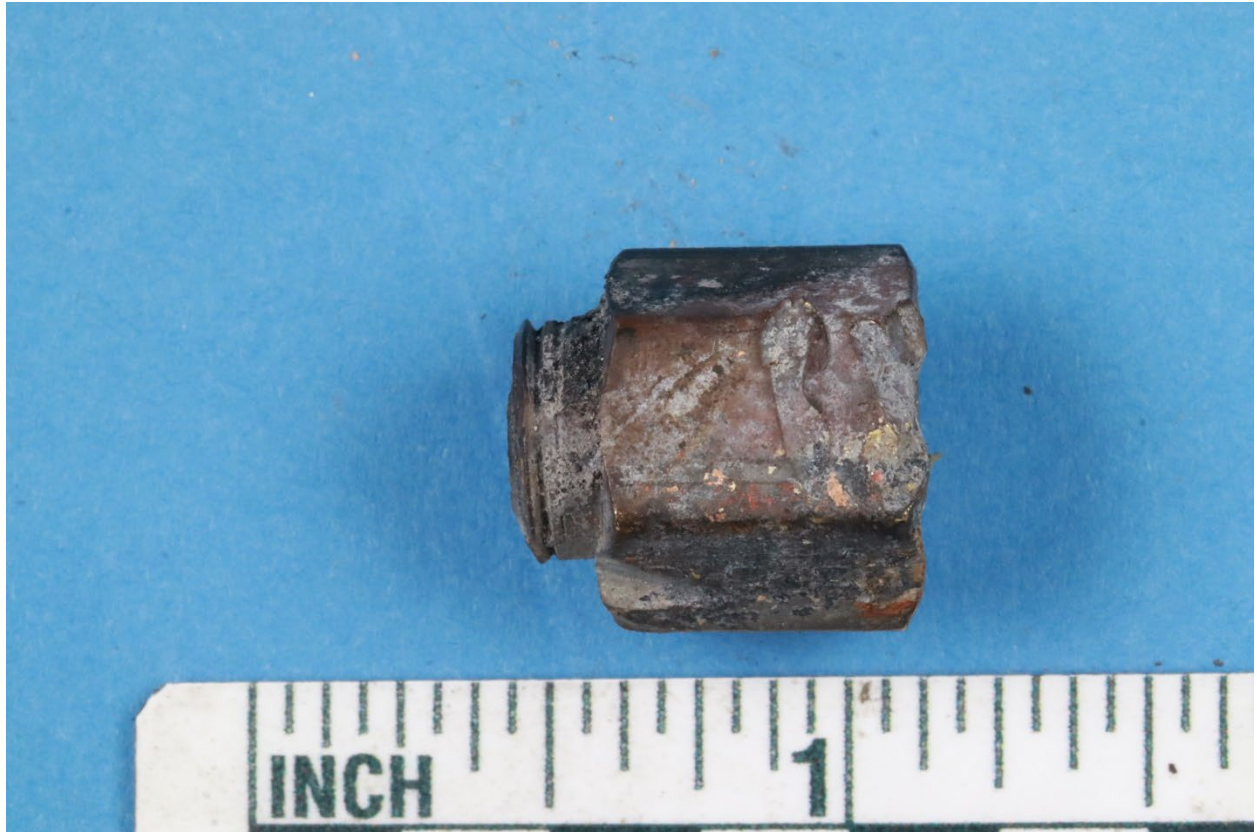
**Figure 5.** Deformation of female threaded nut consistent with impact forces.

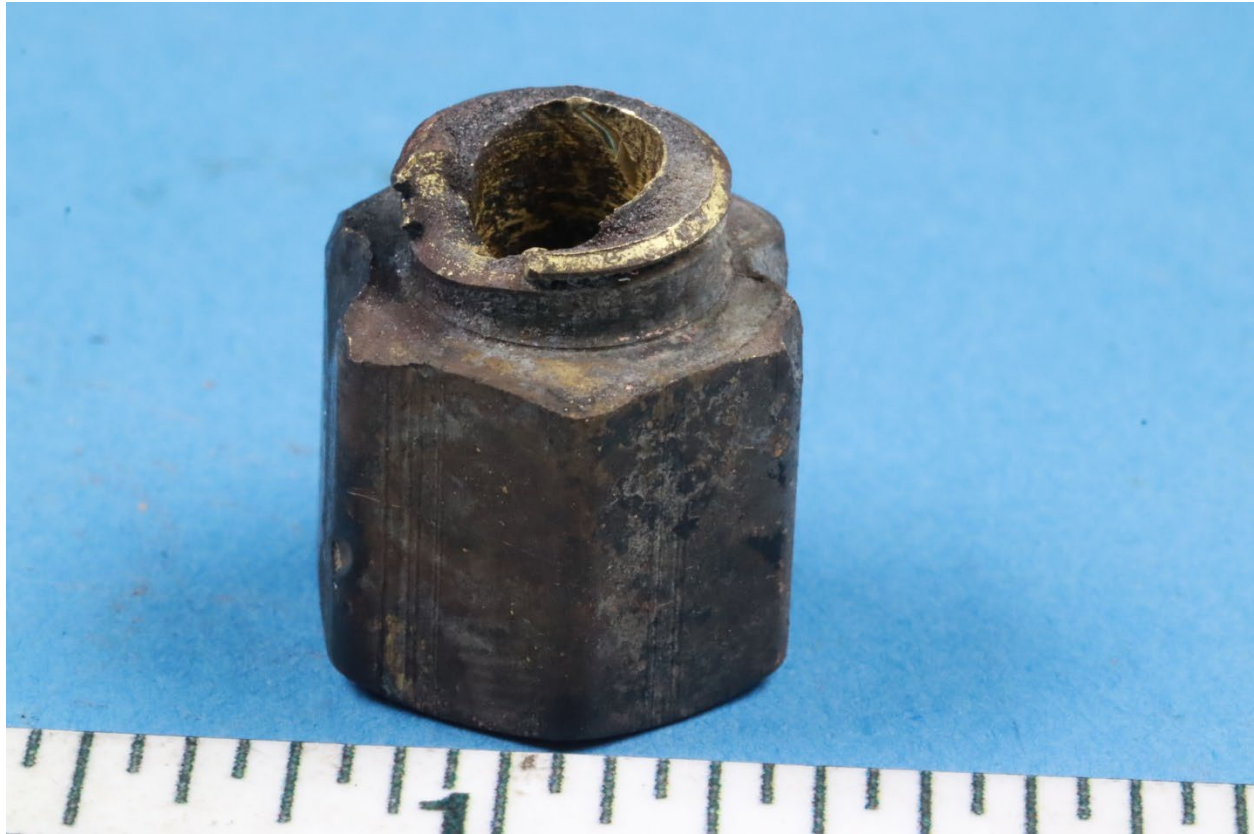
The 90-degree fitting had a flare type end on the side that was attached to the b-nut on the fuel hose and a tapered pipe thread end on the side that was attached to the metering valve end (Figure 4). The attachment to the metering valve utilized a fitting that had a female pipe thread nut on the end attached to the 90-degree elbow and a male pipe thread end that had been threaded into the metering valve body. The male pipe thread end that had been threaded into the metering valve exhibited a fracture as indicated in figure 4. The female pipe thread nut on the fractured fitting exhibited deformations consistent with impact forces (Figure 5). The fracture surface on the male pipe thread portion of the fitting exhibited deformation and slant fractures consistent with bending overstress (Figure 6).

**Figure 6.** Fracture surface on male threaded portion of the fitting.
