# National Transportation Safety Board

ERA24FA104

## **MATERIALS LABORATORY**

Factual Report 24-057

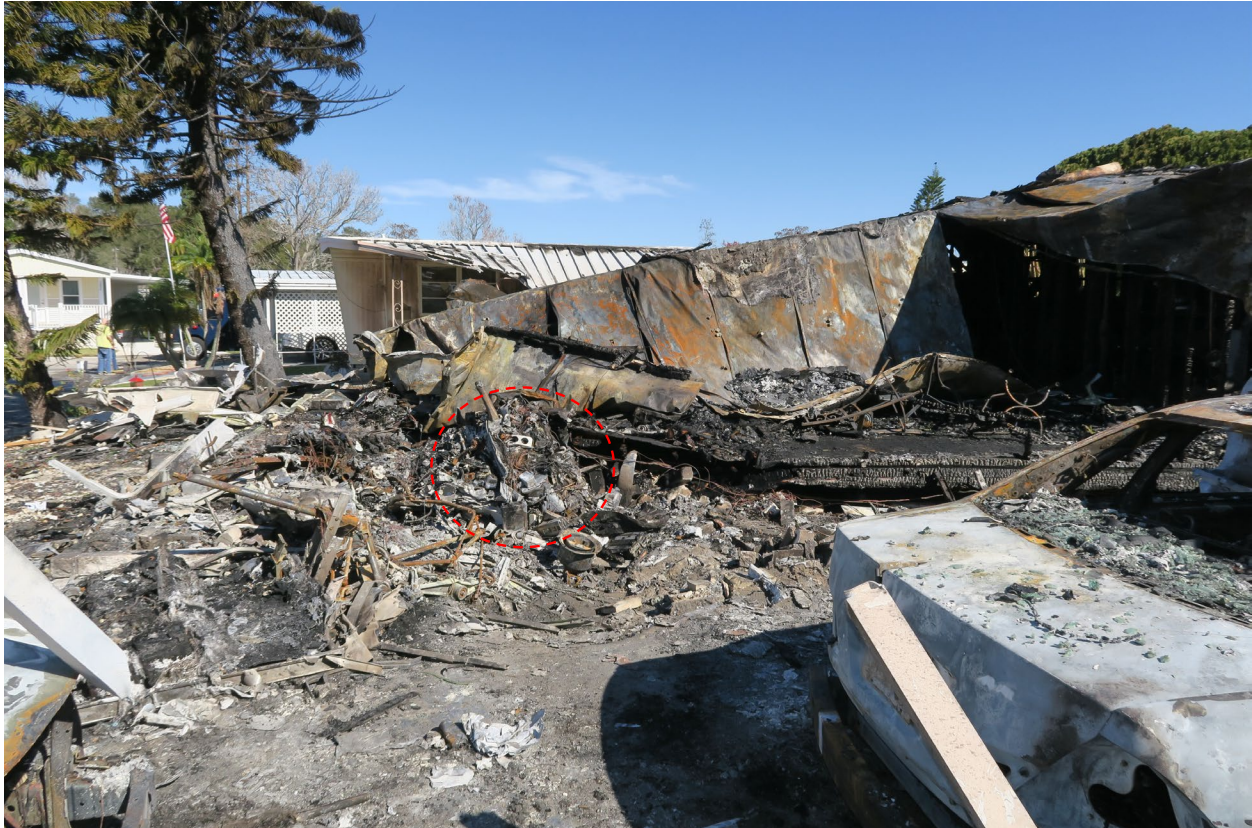
The accident aircraft impacted the roof of a manufactured home and then impacted a second manufactured home hitting it broadside near the foundation. The impact resulted in the latter manufactured home being displaced off its foundation. The main portion of the aircraft's wreckage, which included the engine, came to rest within the home (Figures 1, 2). A post-crash fire ensued which involved both the aircraft and the portions of the home that had collapsed on top of and around the aircraft.

**Figure 1.** Aircraft wreckage location. Red dashed circle denotes the location of the engine.

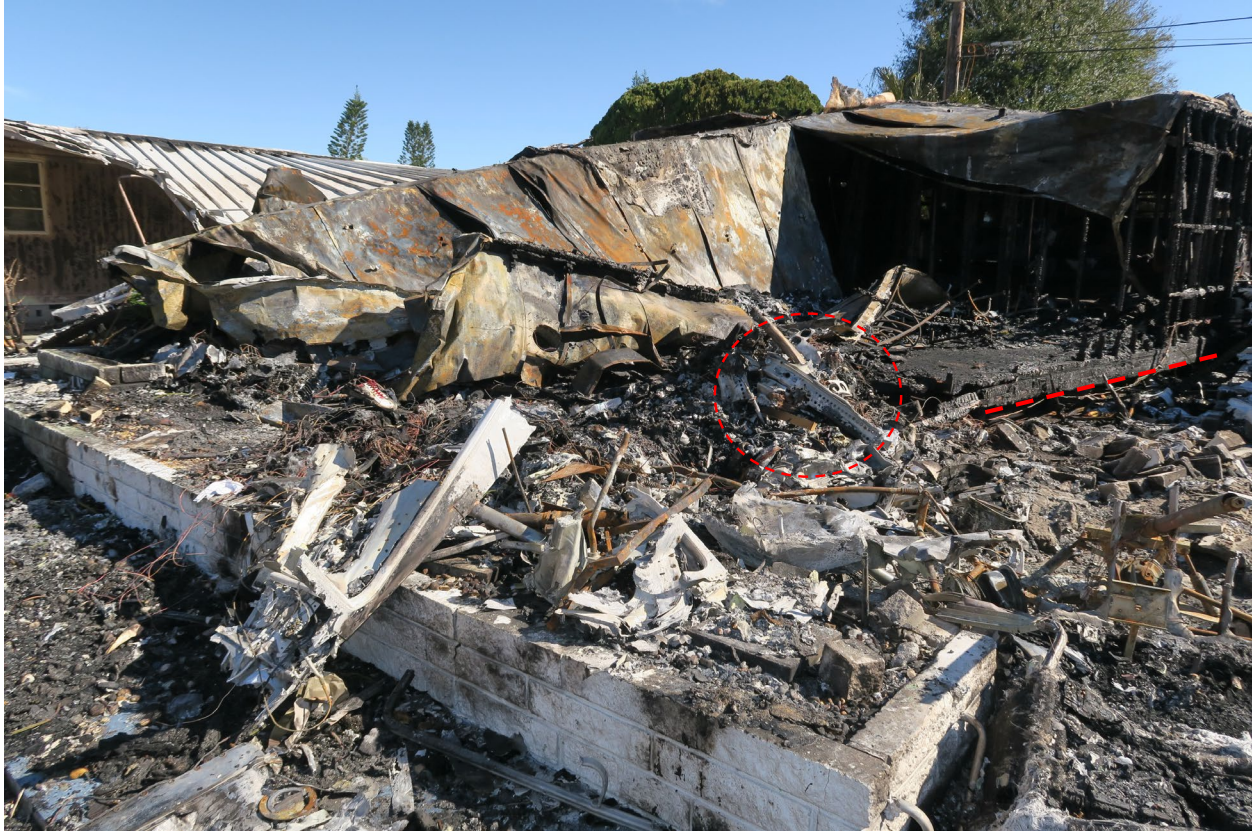
**Figure 2.** Aircraft wreckage location. Red dashed circle denotes the location of the engine. Red dashed line runs parallel to the rim joist of the manufactured home showing its displacement with respect to the brick foundation.

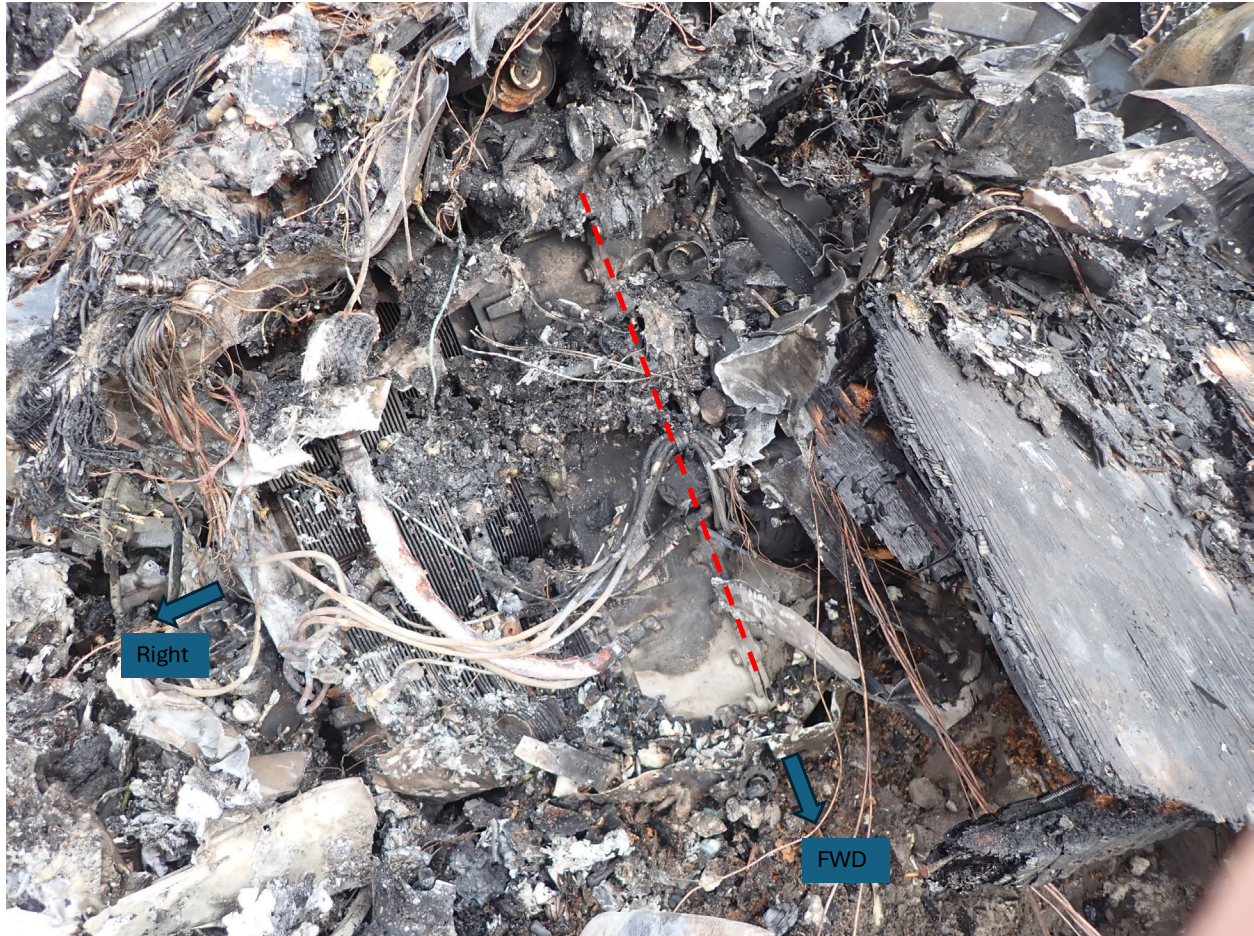
Recovery of the engine from the accident site involved the removal of portions of the home's structure that had collapsed on top of the aircraft's wreckage. A portion of roof sheathing had been laying on top of the engine's left bank of cylinders (Figure 3). This portion of roof sheathing exhibited more charring and thermal damage on the upward facing surface than on the downward facing surface which had been covering part of the engine (Figure 4).

**Figure 3.** Aircraft engine as found among the building debris. A portion of sheathing is covering the left bank cylinders. The dashed red line denotes the engine's centerline.

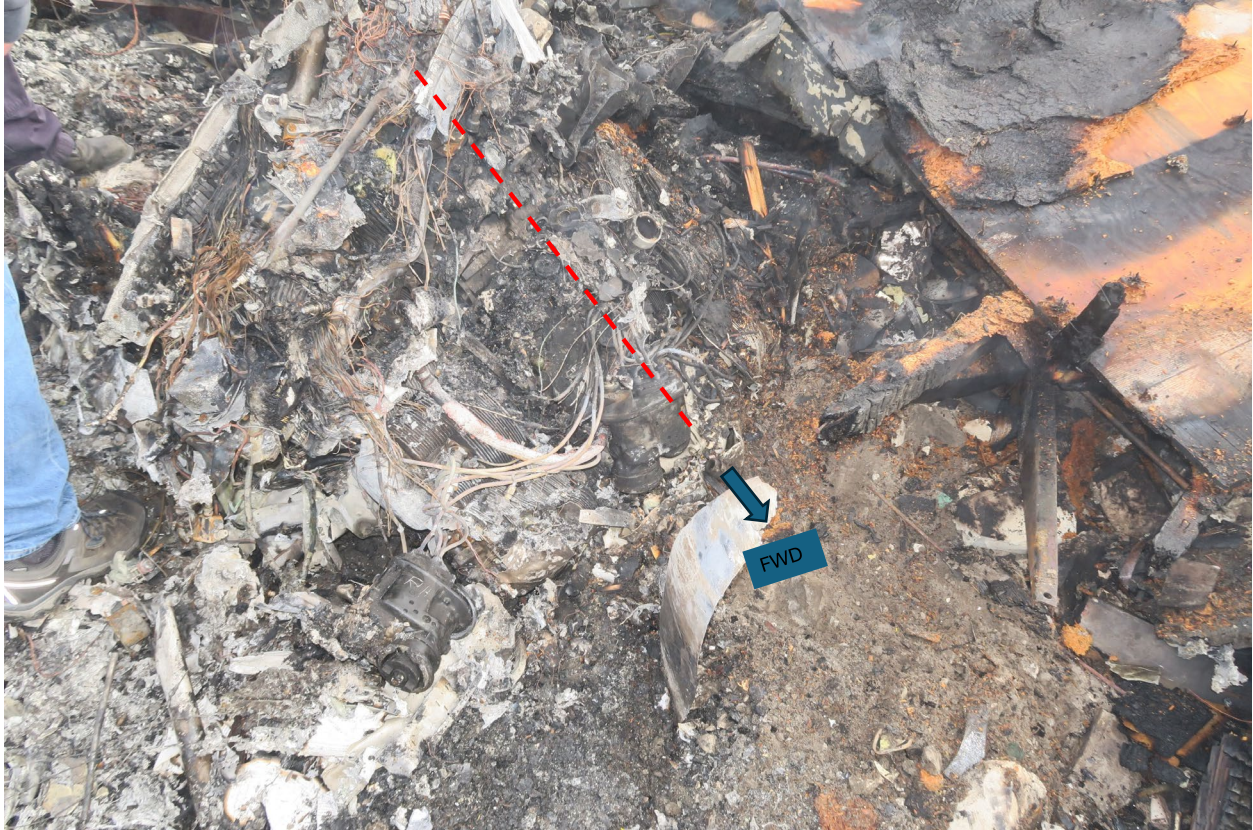
**Figure 4.** Aircraft engine after some of the building debris was removed. The underside of the sheathing that had been on top of the right side of the engine is visible in the top right of the photo. Engine centerline denoted by dashed red line.

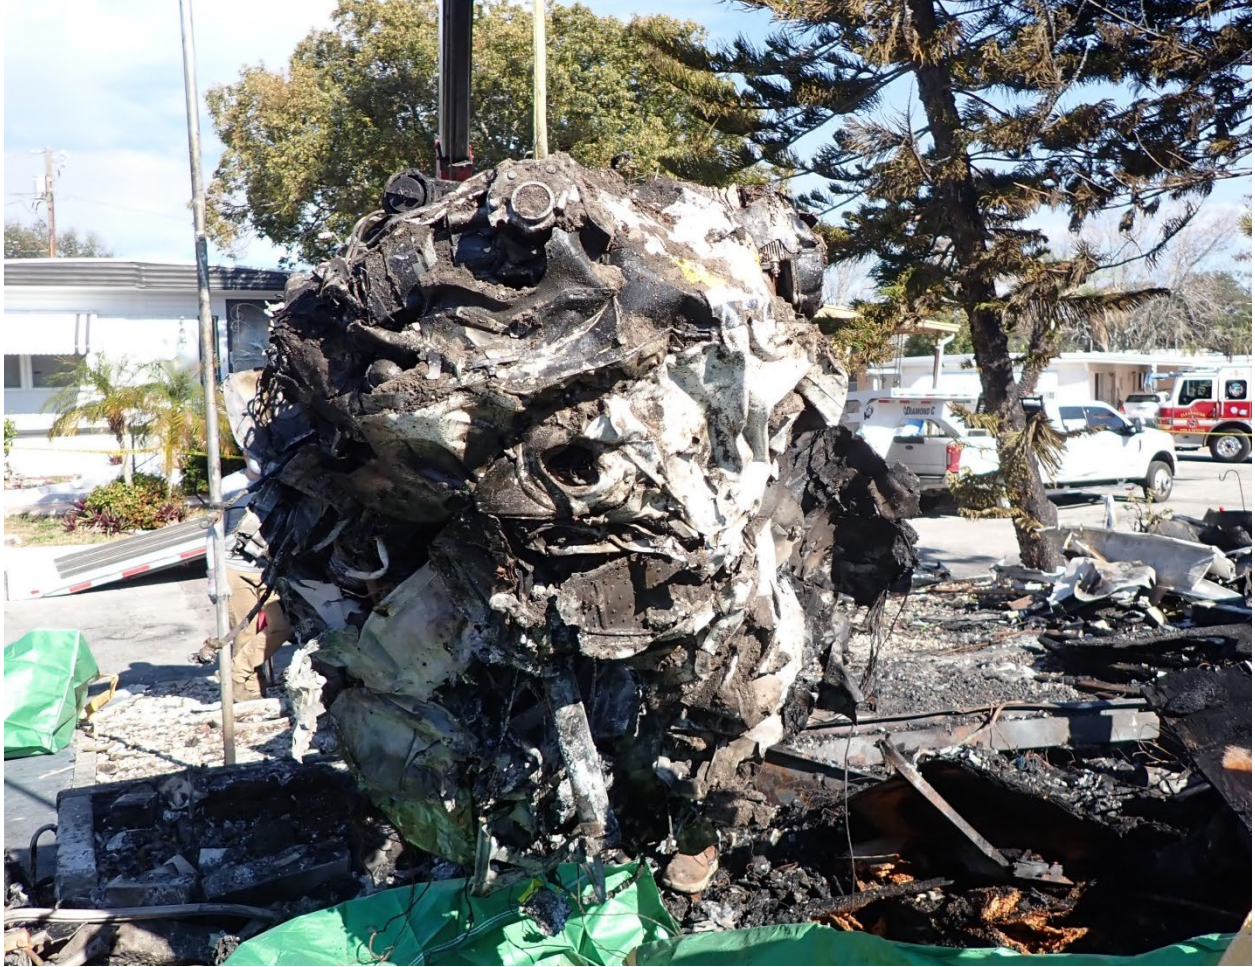
When the engine was hoisted up during the recovery (Figure 5) the left and right-side lower engine cowlings were found to have been pressed against the engine from the impact forces. This caused the cowling to be stuck against and tightly conforming to the engine. On the left side of the engine the cowling exhibited a

**Figure 5.** Aircraft engine being hoisted up during wreckage recovery. Lower engine cowlings are pressed against the engine.

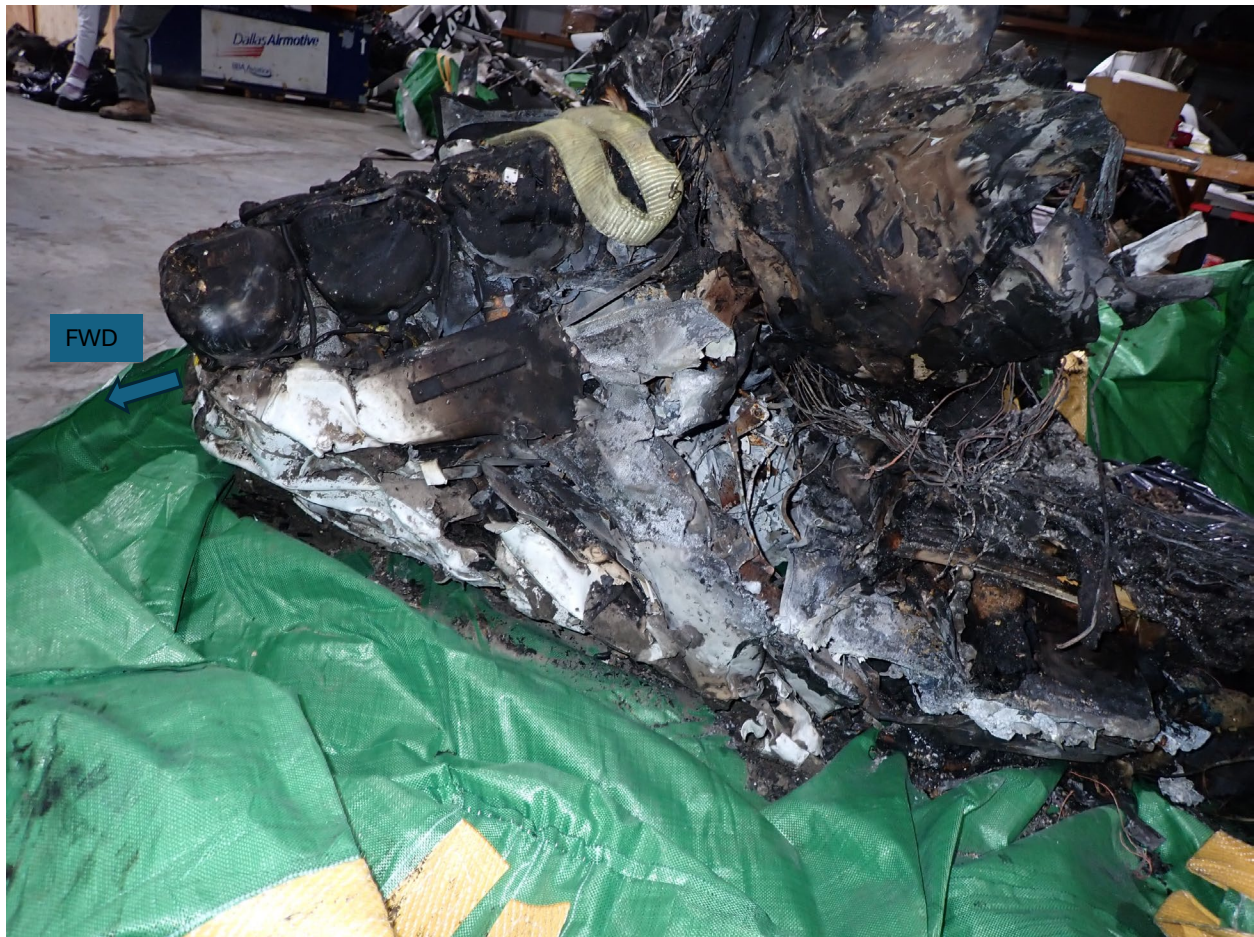
sharp demarcation in thermal damage in the vicinity of the third cylinder from the front and extending downward (Figure 6). This thermal damage had the appearance of clean burn<sup>1</sup> and exhibited melting of the aluminum skin. Further forward of this area exhibiting clean burn was an area with a sooted appearance (where the cowling latch is visible). Further forward of the sooted area was cowling skin exhibiting no thermal damage.

**Figure 6.** View of the left side of the engine and lower cowling. There is a sharp demarcation between the areas exhibiting clean burn, sooting and undamaged cowl.

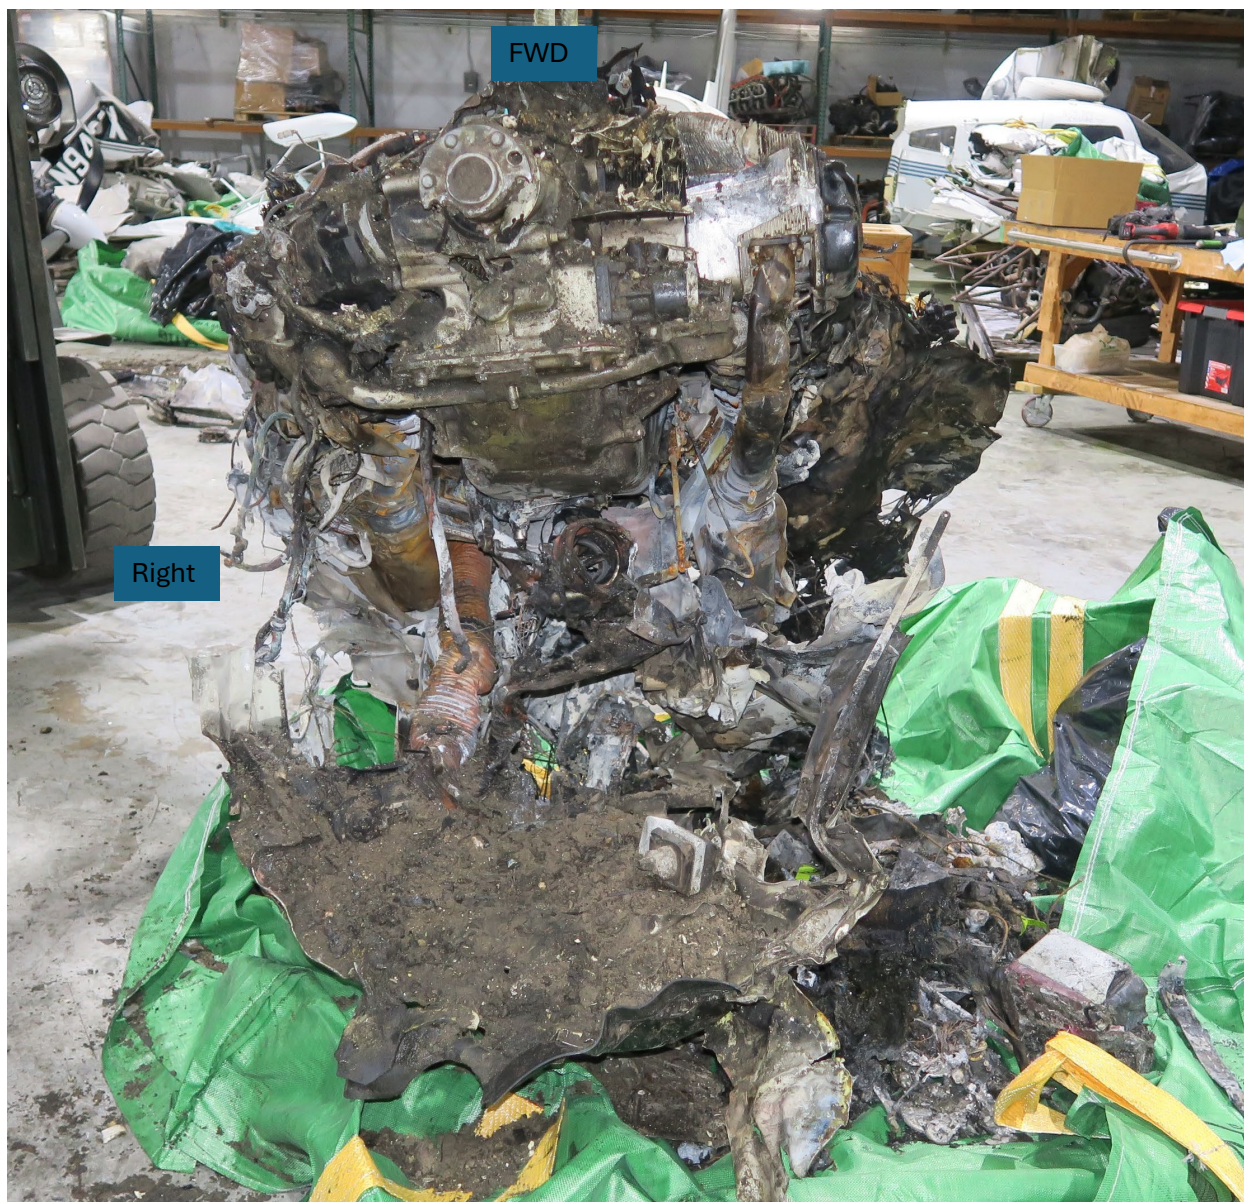
At the wreckage storage facility, the lower engine cowling was separated from the engine to examine the lower portion of the engine (Figure 7). The cowling was found to have a layer of soil on the interior surface consistent with the impact forces having driven the forward portion of the aircraft through the manufactured home and into the ground beneath it. With the lower cowling removed and the engine elevated an area exhibiting the appearance of clean burn can be seen around the aft lower portions of the engine (Figure 8).

**Figure 7.** Forward/underside view of the engine with the cowling separated. The interior surface of the cowling contained dirt.

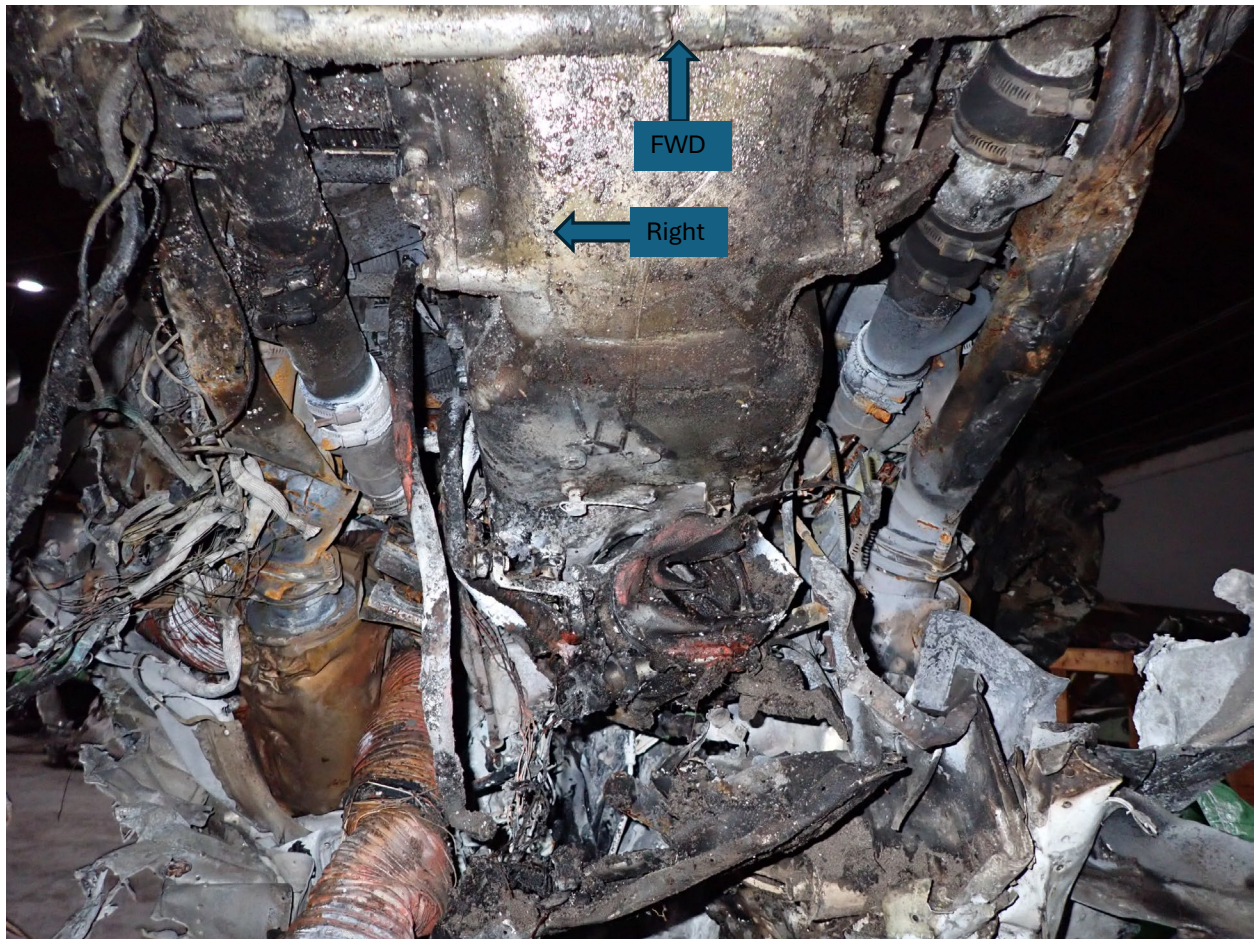
**Figure 8.** Underside of the engine looking from the front. An area of clean burn encompasses the aft portion of the oil sump cover, exhaust components on both sides and the throttle body and metering valve in the center.

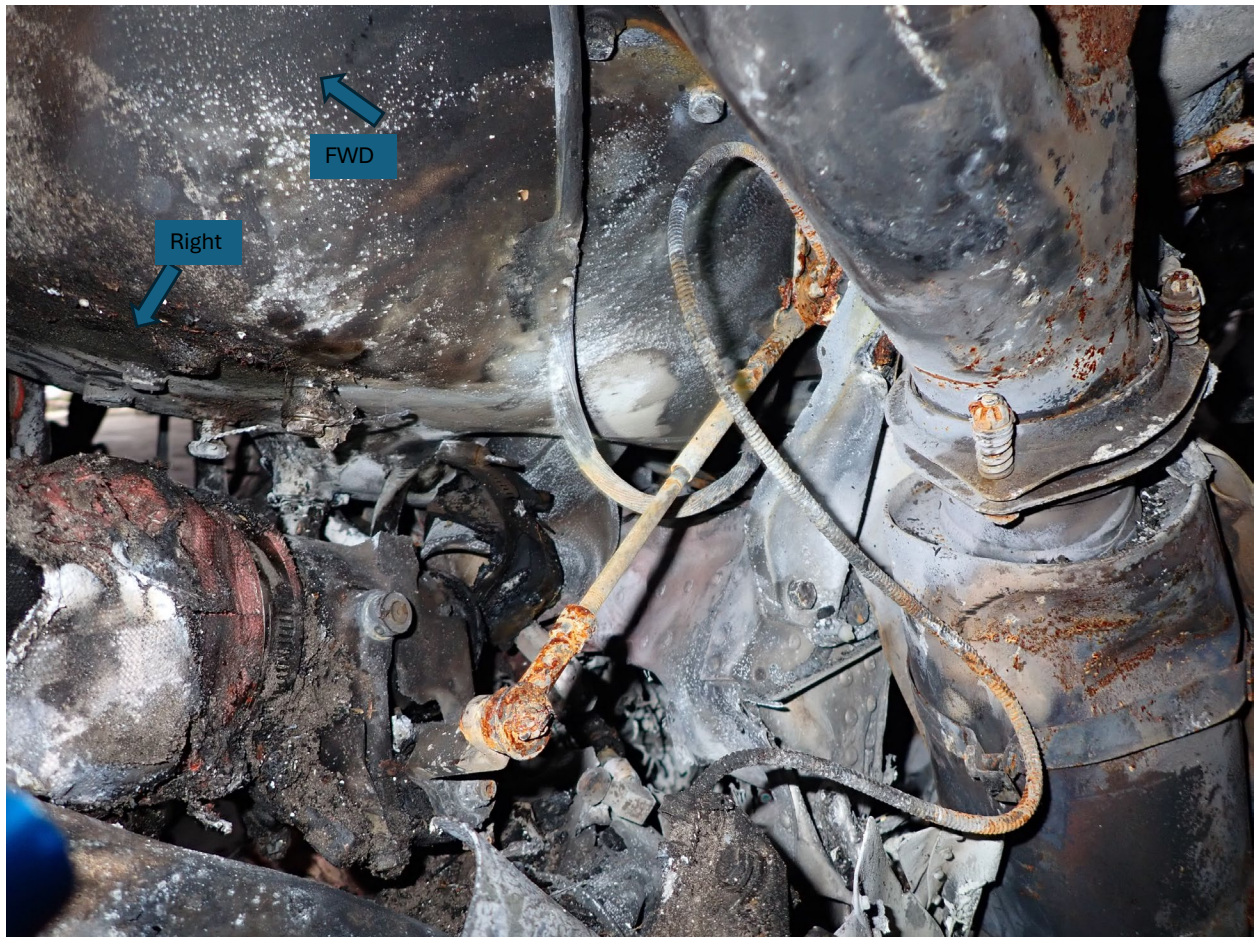
The lower portion of the engine exhibited regions on both the left and right sides with a clean burn appearance. These regions appeared to extend from mid-way along the oil sump and aft. The area where the clean burn region begins is coincident with the location of the fuel metering valve which sits below the engine oil sump cover (Figure 9). With the oil sump cover removed the gasket between the sump cover and the crankcase could be examined. The gasket exhibited thermal degradation and charring along the rear portion of its periphery (Figure 10).

Investigators conducting the wreckage examination discovered that the b-nuts of the fuel supply system hoses were all tight at their respective fittings except for the b-nut at the outlet of the fuel metering valve. That b-nut was determined to be approximately 1.25 flats<sup>2</sup> loose.

**Figure 9.** Close up view of the throttle body and metering valve below the oil sump cover.

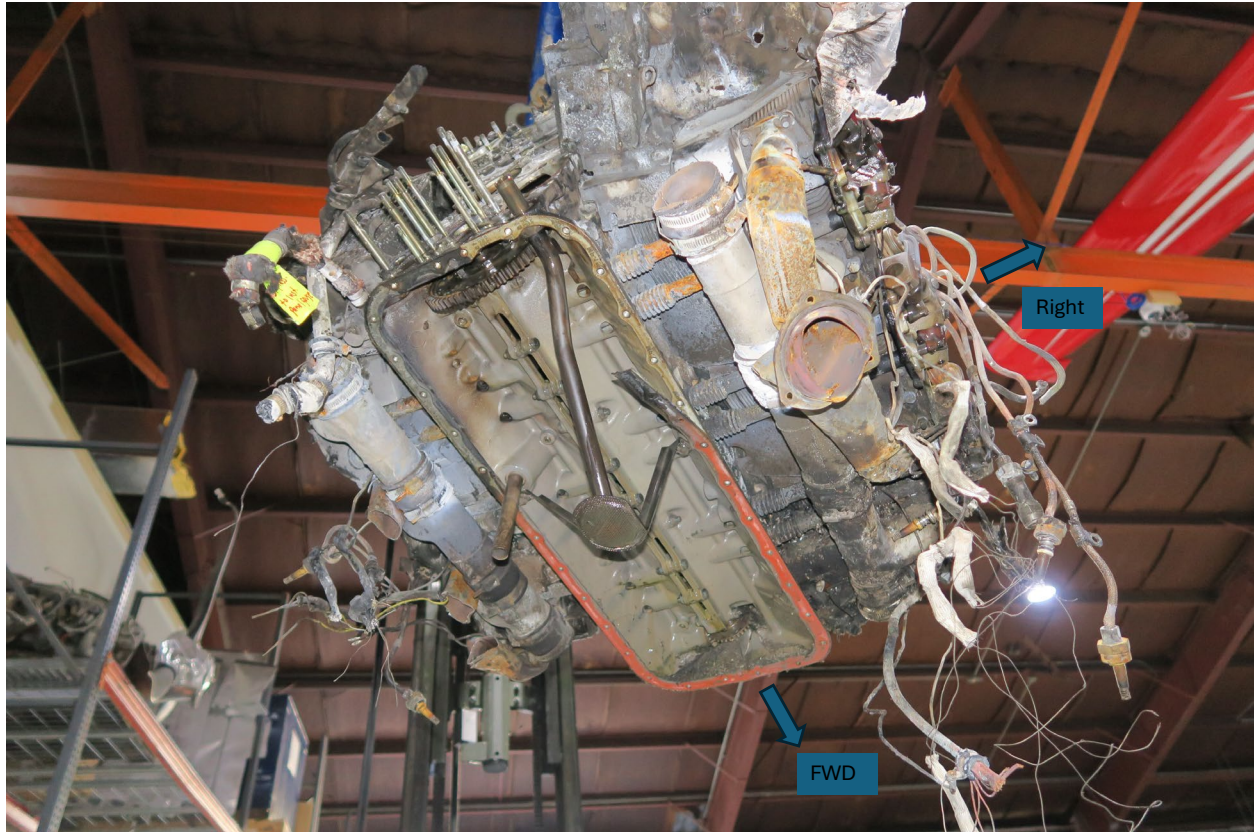
**Figure 10.** Underside of the crankcase with the oil sump cover removed. Sealing gasket thermally damaged and or consumed along the aft left and right areas.
