# National Transportation Safety Board

ERA24FA104

## **AIRCRAFT INFORMATION AND WRECKAGE EXAMINATION SUMMARY**

Location: Clearwater, Florida  
Date: February 1, 2024  
Time: 1907 EST  
0007 coordinated universal time (UTC), UTC Date February 2, 2024  
Airplane: N6659L, Beech V35B

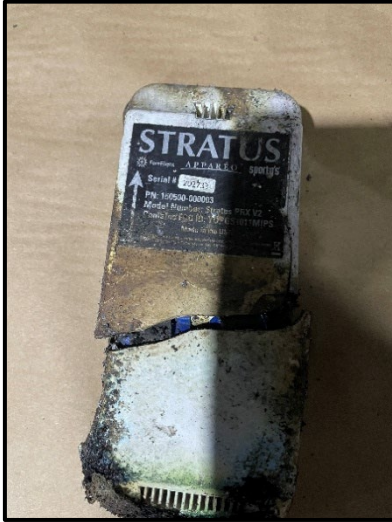
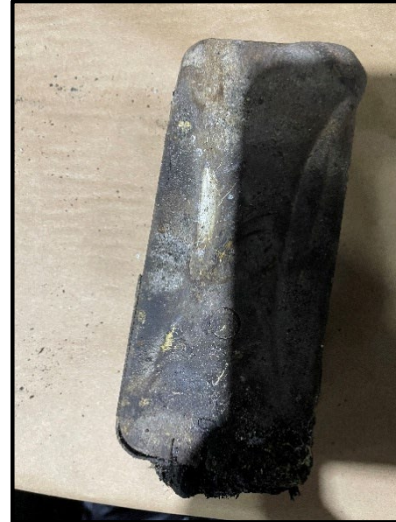
An Appareo Stratus PRX V2, part number 150500-000003, serial number 202733 which was heavily heat damaged was recovered from the wreckage and retained (Figures 7 and 8)<sup>3</sup>.

**Figure 7 View of Appareo Stratus**

**Figure 8 View of Opposite Side of Appareo Stratus**

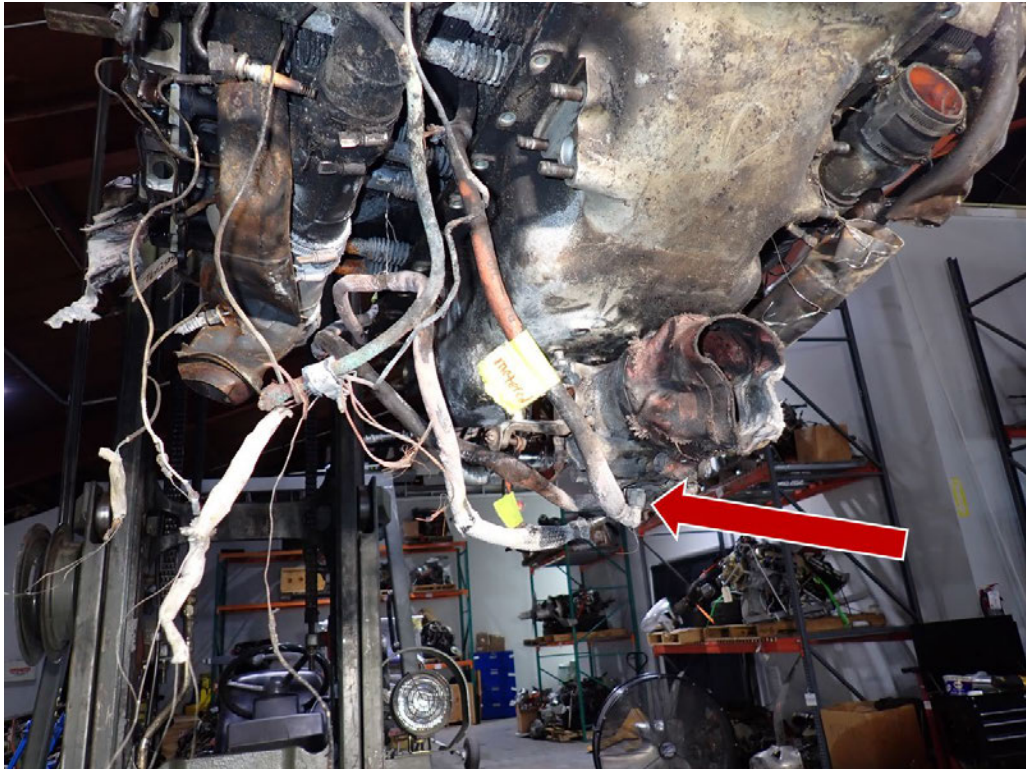
Examination of the throttle body and metering valve revealed it was impact separated, sustained heat damage, but remained attached by the throttle and mixture control cables, and flexible fuel hose. The throttle control was wide open, while the mixture control was 1/8 inch from the full rich stop. Fuel supply hoses were continuous from the firewall fitting to the inlet fitting of the engine-driven fuel pump, fuel metering valve, then to the inlet fitting of the manifold valve. Impact fractures of fuel supply fittings were noted at the inlet of the engine-driven fuel pump, the inlet fitting at the fuel metering valve, and the metered outlet fitting at the fuel metering valve (Figure 9). The b-nut of the fuel supply hose at the outlet of the fuel metering valve was 1.25 flats loose from being finger tight<sup>45</sup>. All remaining b-nuts of fuel supply hoses were tight at their respective fittings included fittings that were fractured.

**Figure 9 Arrow Points to Fractured Outlet Fitting of the Metering Valve and the Attached Flexible Metered Fuel Hose**
