ERA24FA110

Group Chair's Factual Report – Attachment 5

GE Research CF34 Filter Analysis 051624

# — GE Aerospace Research CF34 Filter Analysis

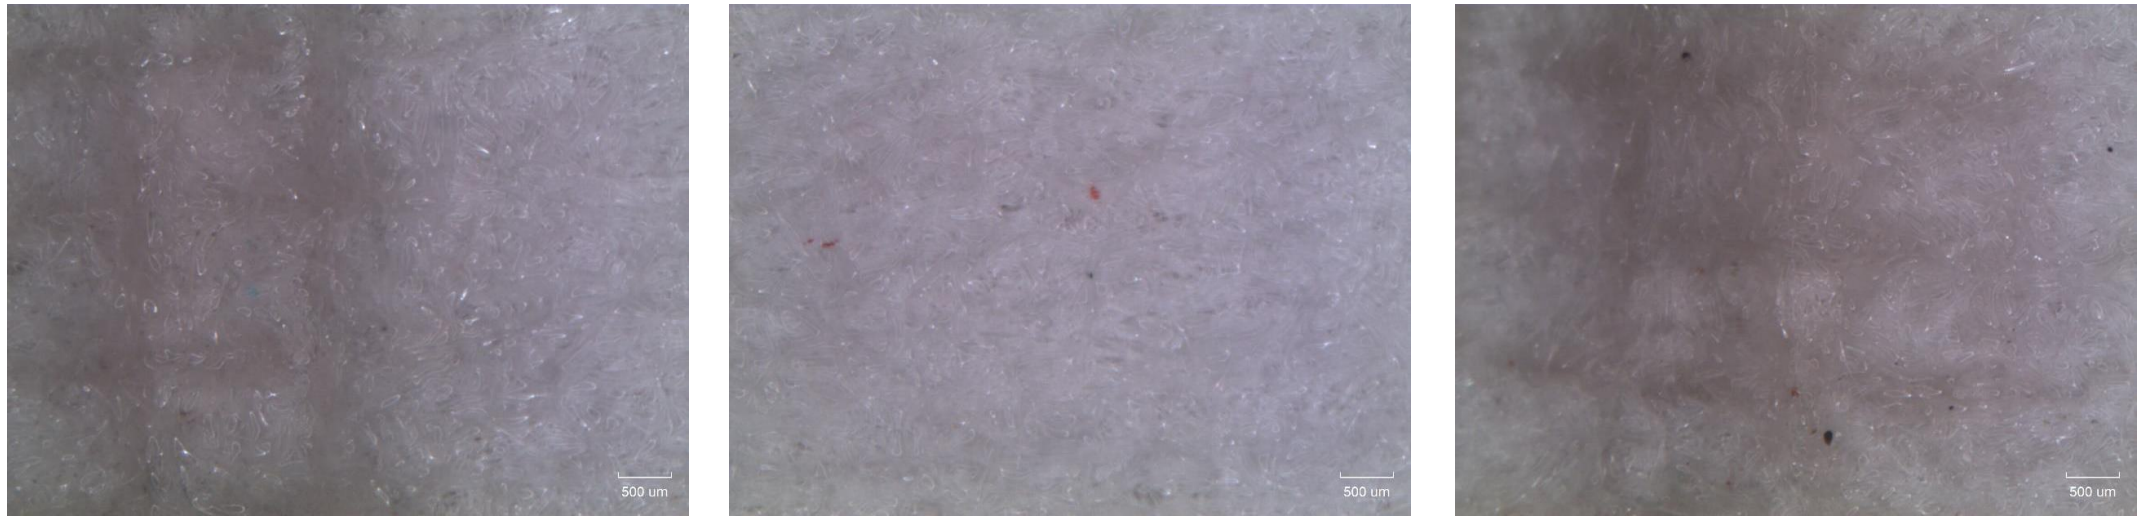
## Optical microscope images of 336047 Engine 1 fuel filter after staining with copper sulfate

No SAP particles or other water adsorbing gels were observed on the filter

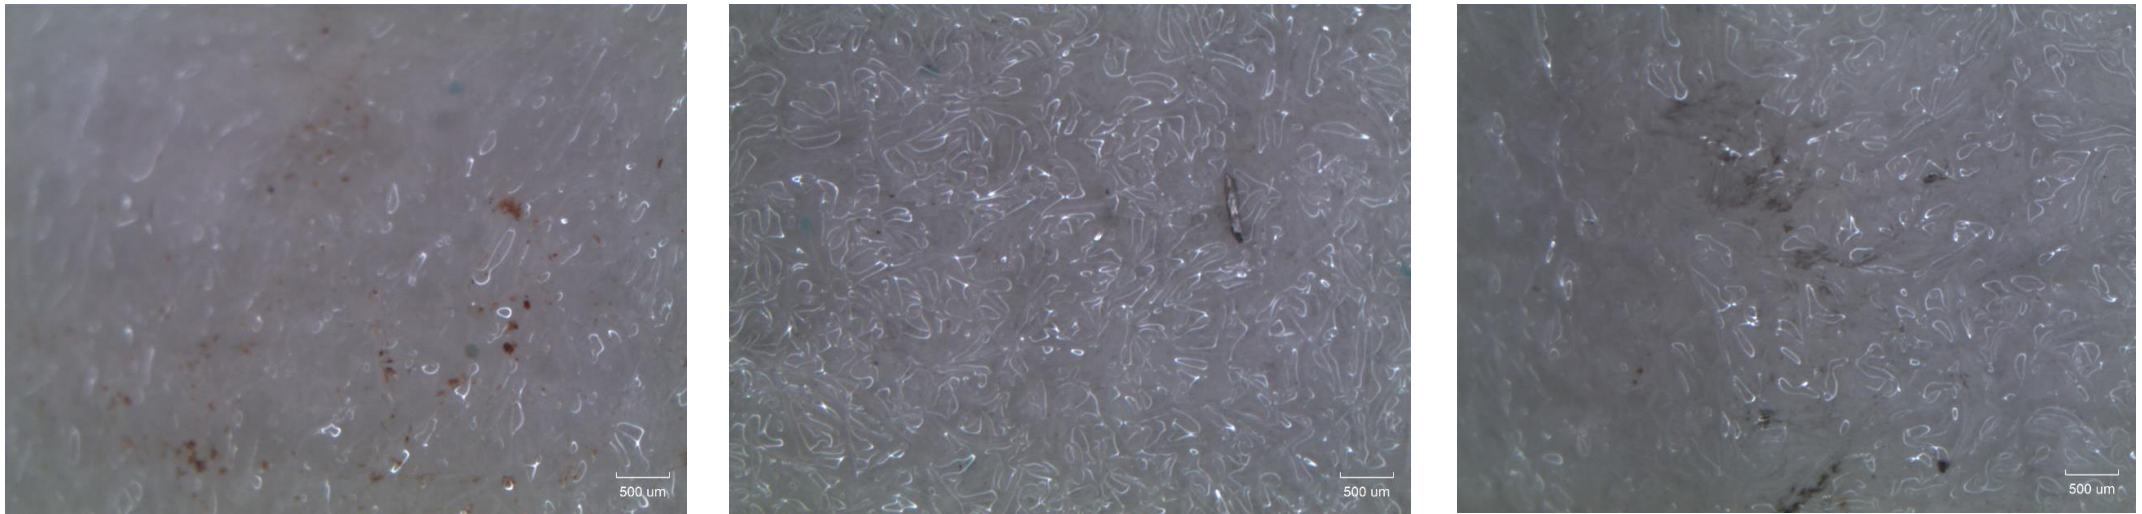
## Optical microscope images of 336048 Engine 2 fuel filter after staining with copper sulfate

No SAP particles or other water adsorbing gels were observed on the filter

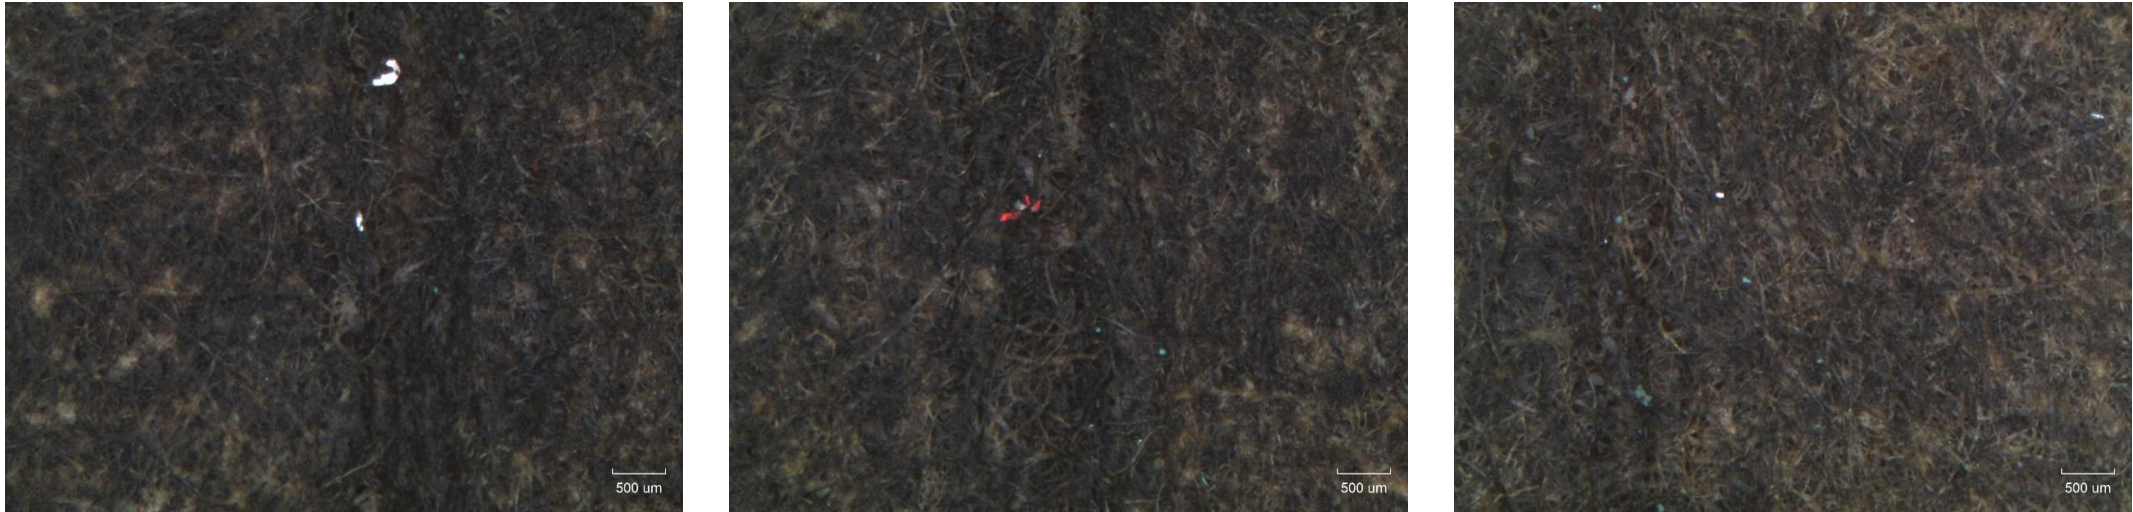
## Optical microscope images of 336049 APU filter after staining with copper sulfate

No SAP particles or other water adsorbing gels were observed on the filter

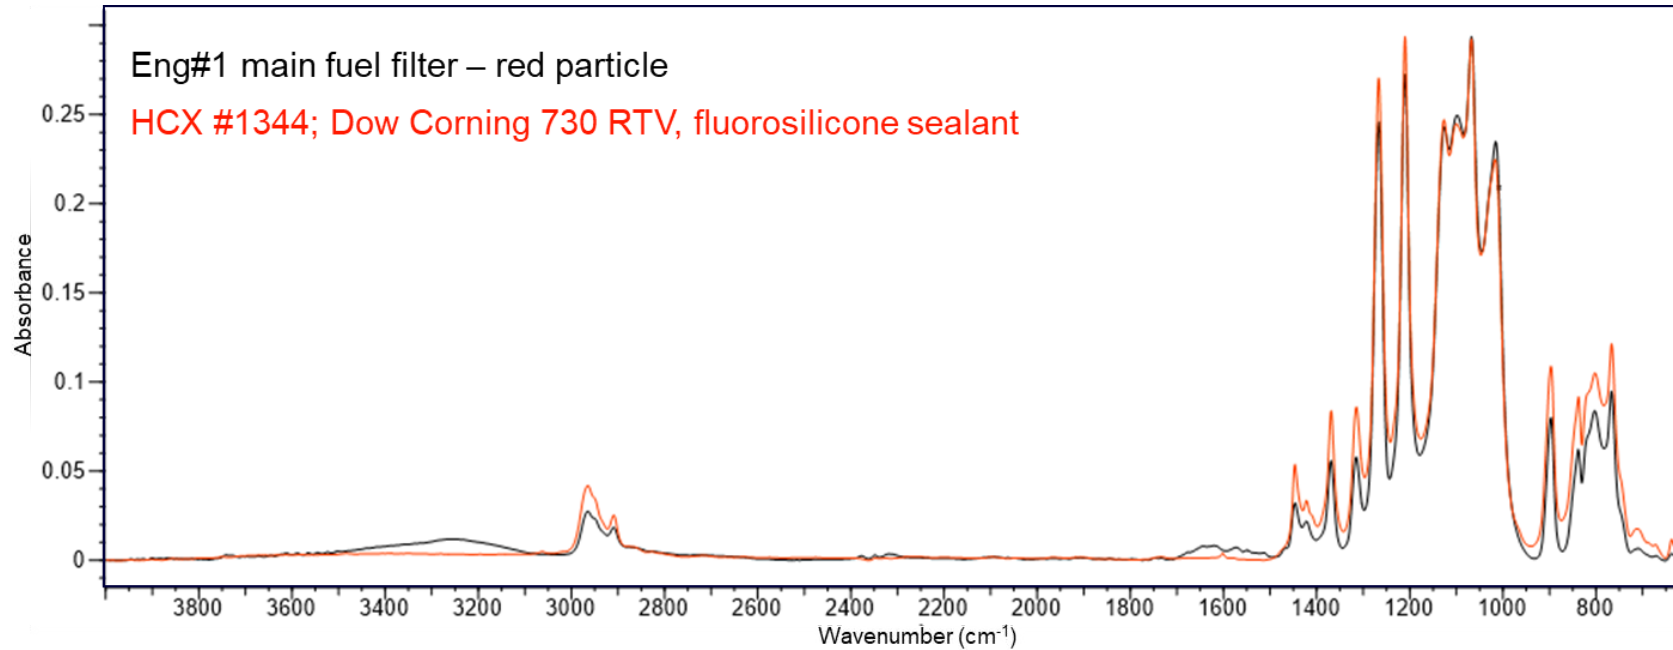
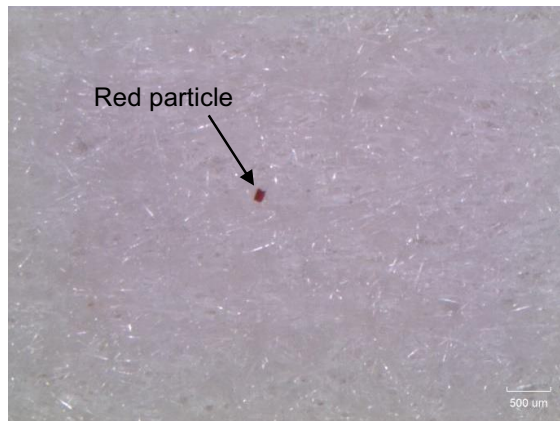
# IR Spectroscopy of Particles from 336047 Engine1 Fuel Filter

Red chunks of pliable, soft material were found on the surface of the 336047 Engine1 fuel filter. These red particles are an excellent match to the IR fingerprint of a **fluorosilicone sealant**.

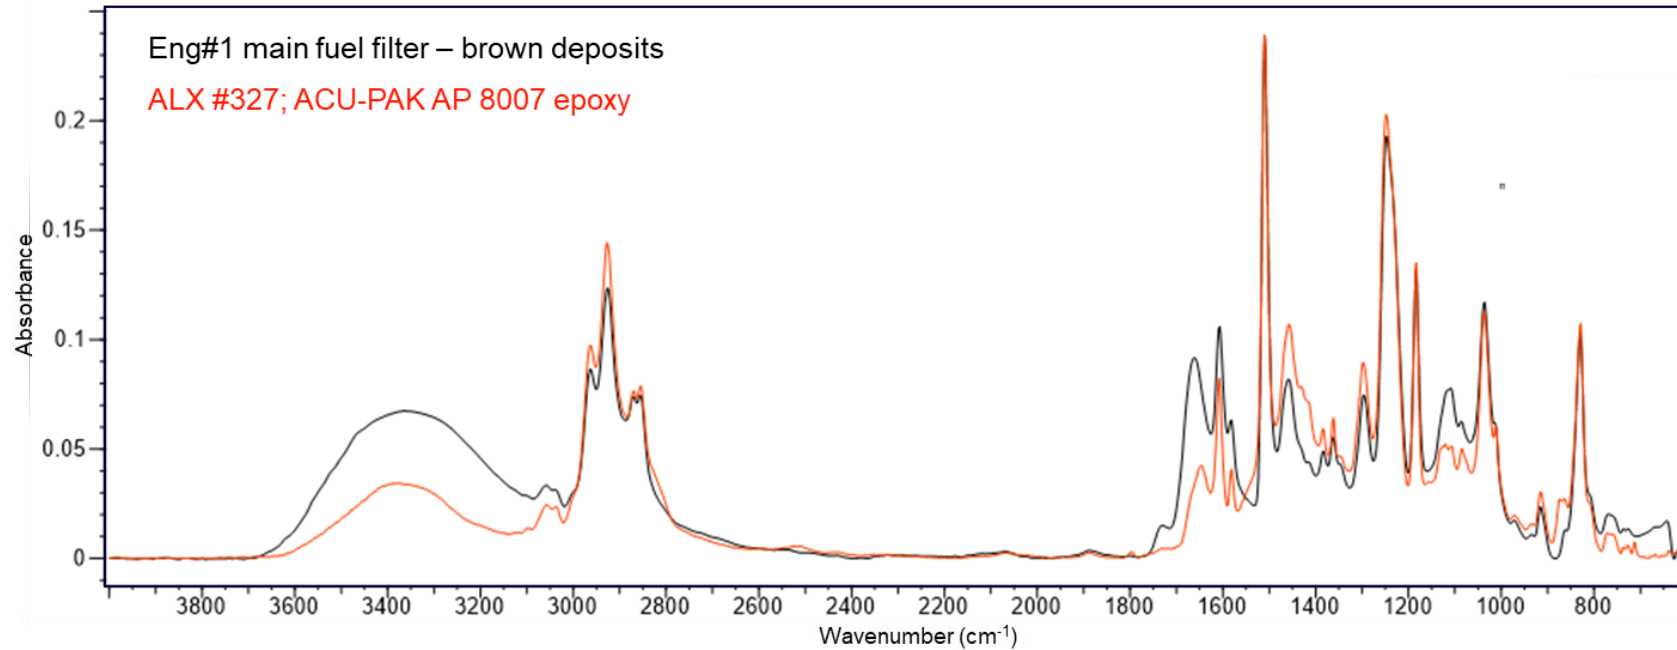
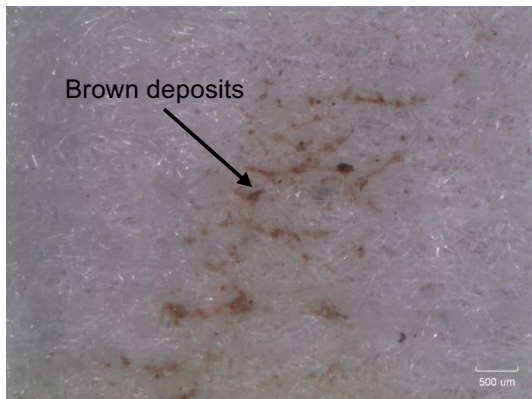
# IR Spectroscopy of Particles from 336047 Engine1 Fuel Filter

Pieces of brown material were found on the surface of the 336047 Engine1 fuel filter. These brown deposits are an excellent match to the IR fingerprint of an **epoxy resin based on DGEBA/polyamide**.

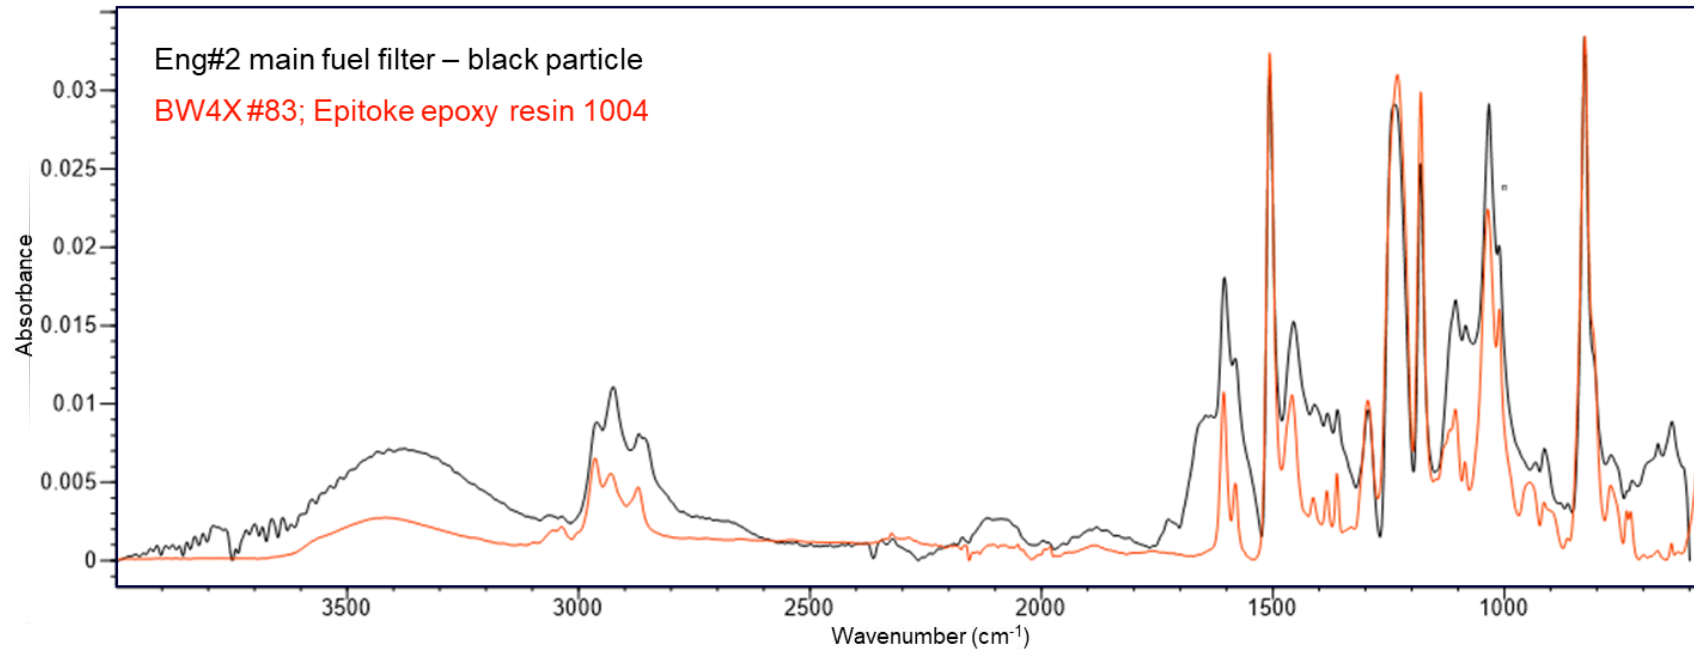
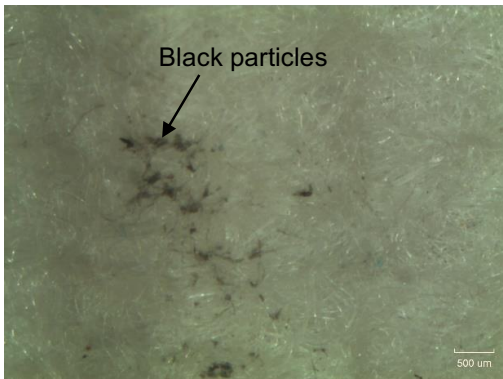
# IR Spectroscopy of Solid Particles from 336048 Engine2 fuel filter

Black particles were found on the surface of the 336048 Engine2 fuel filter. These black particles are a good match to the IR fingerprint of an **epoxy resin based on bisphenol A and epichlorohydrin**

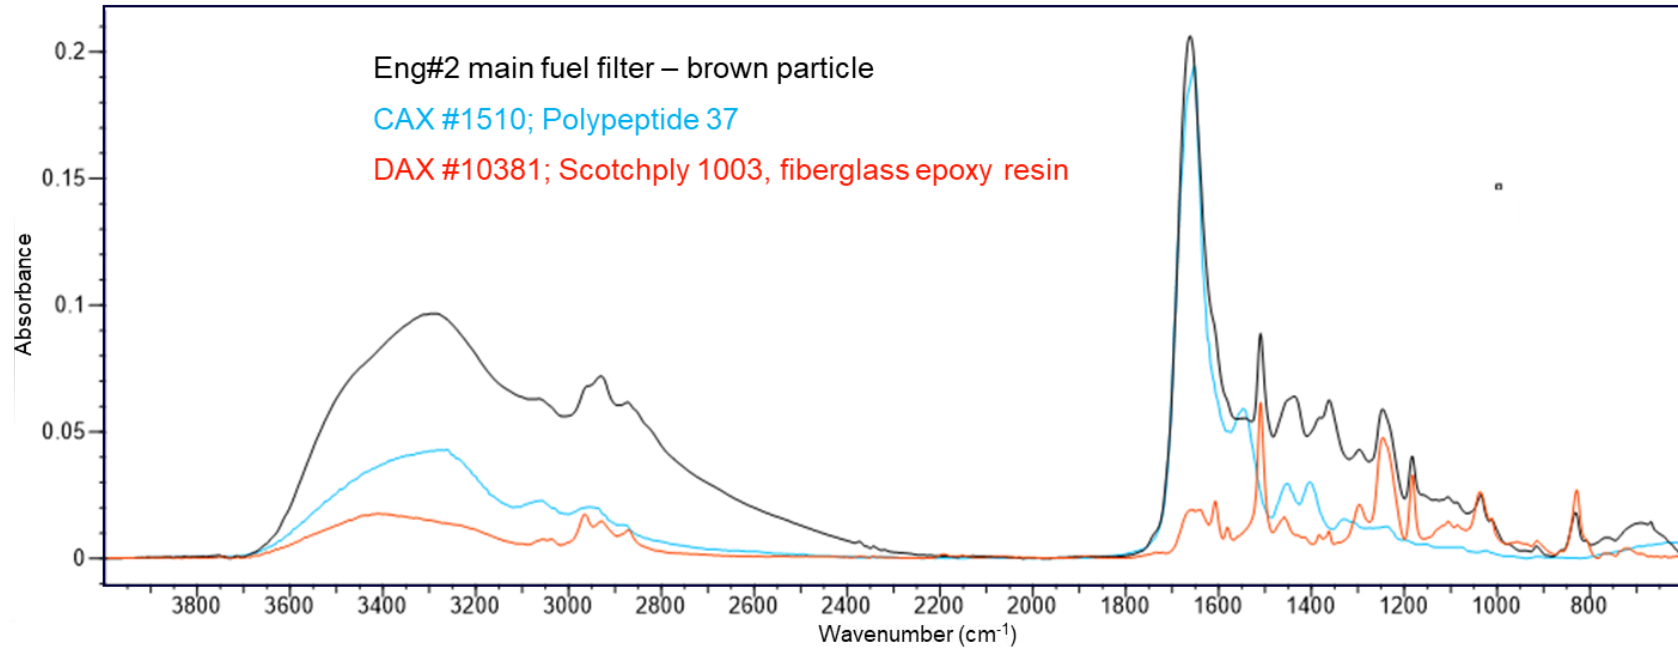
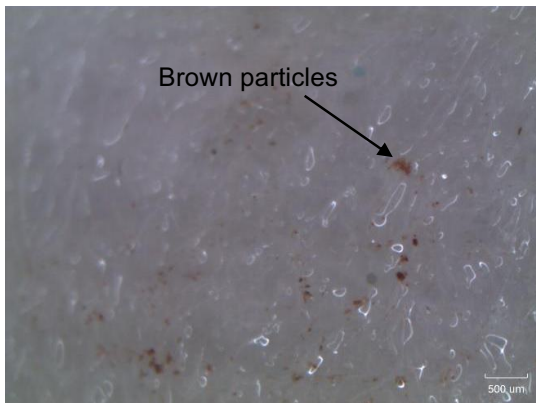
# IR Spectroscopy of Solid Particles from 336048 Engine2 fuel filter

Brown material on 336048 Engine2 fuel filter is a good match to the IR spectral features of **a mixture of a fiber glass epoxy resin and proteins**, likely from biological contamination.

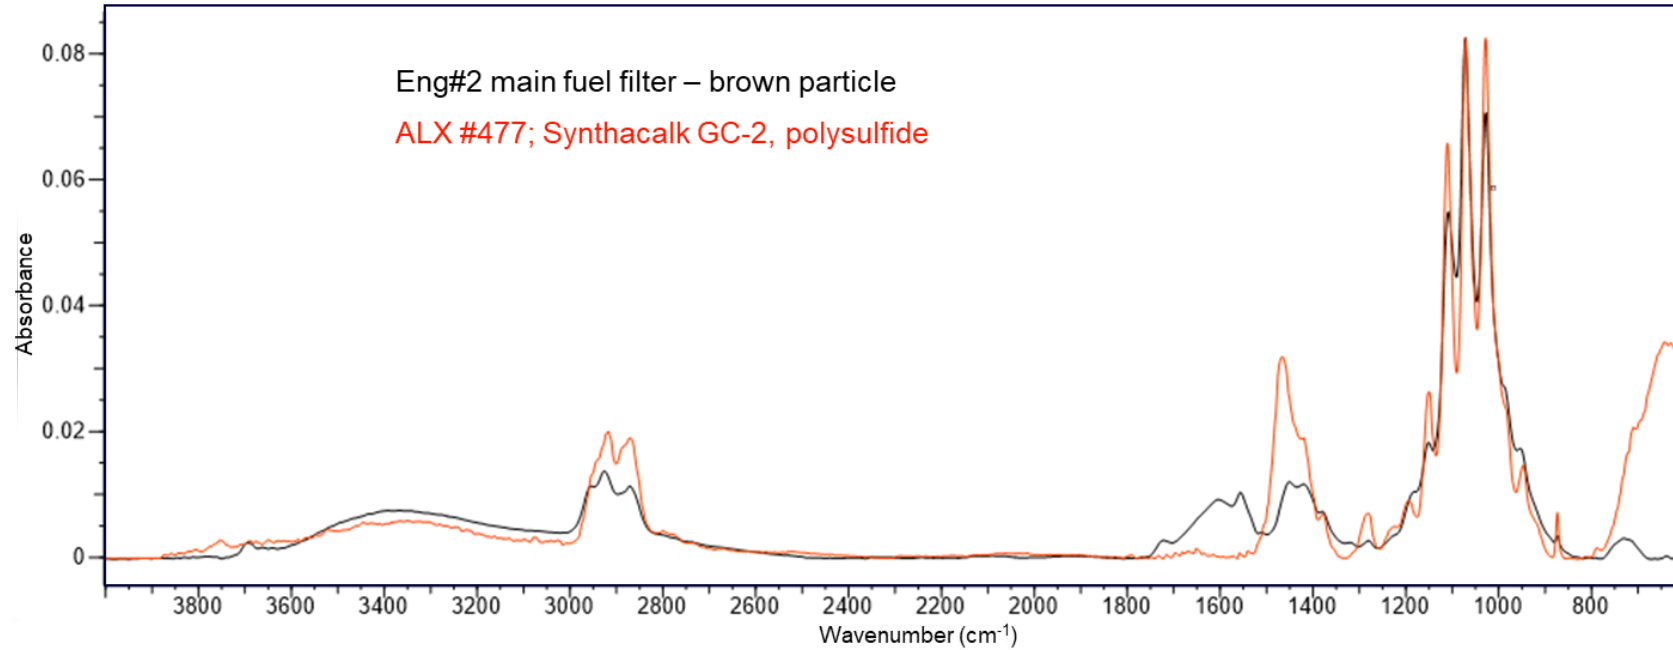
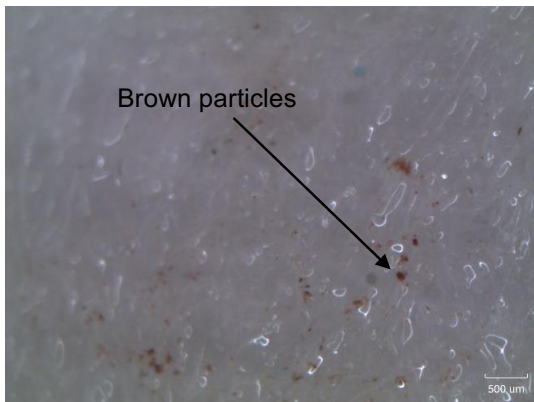
# IR Spectroscopy of Solid Particles from 336048 Engine2 fuel filter

Small brown particles on 336048 Engine2 fuel filter are a good match to the IR spectral features of a **polysulfide sealant**. Polysulfide sealant is often used in the fuel tank and pieces are commonly seen on the main fuel filter.

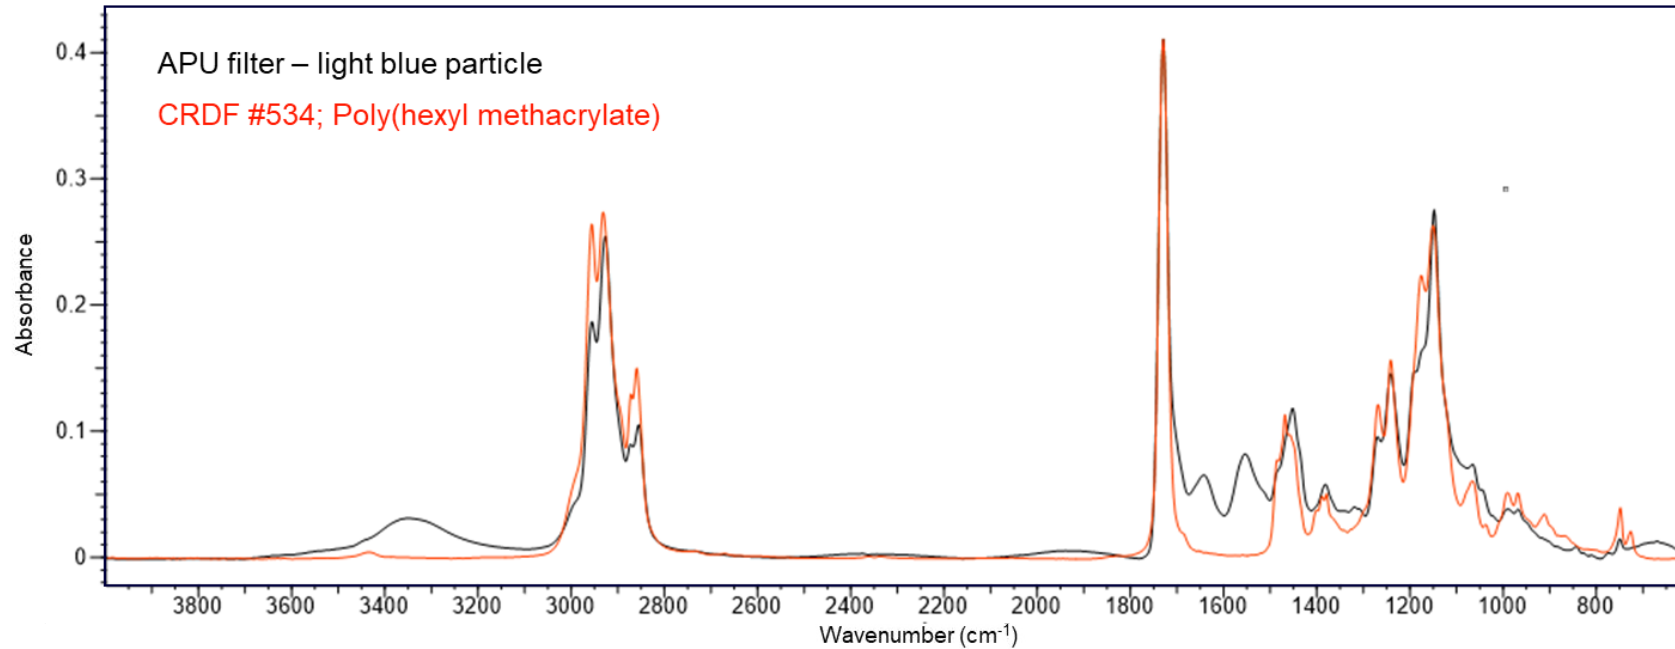
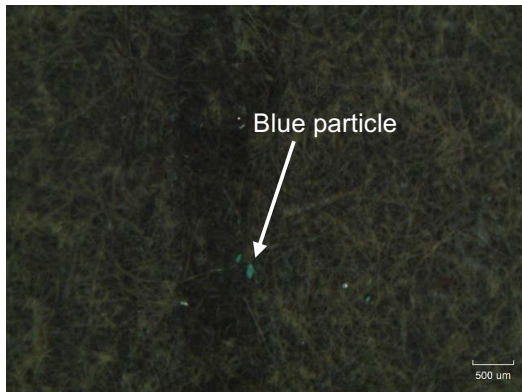
# IR Spectroscopy of Particles from 336049 APU Filter

Pieces of blue material were numerous on the surface of the 336049 APU filter. These blue particles deposits are an excellent match to the IR fingerprint of a **poly(hexyl methacrylate)**

These light blue particles were the most common type of particles observed on the APU filter

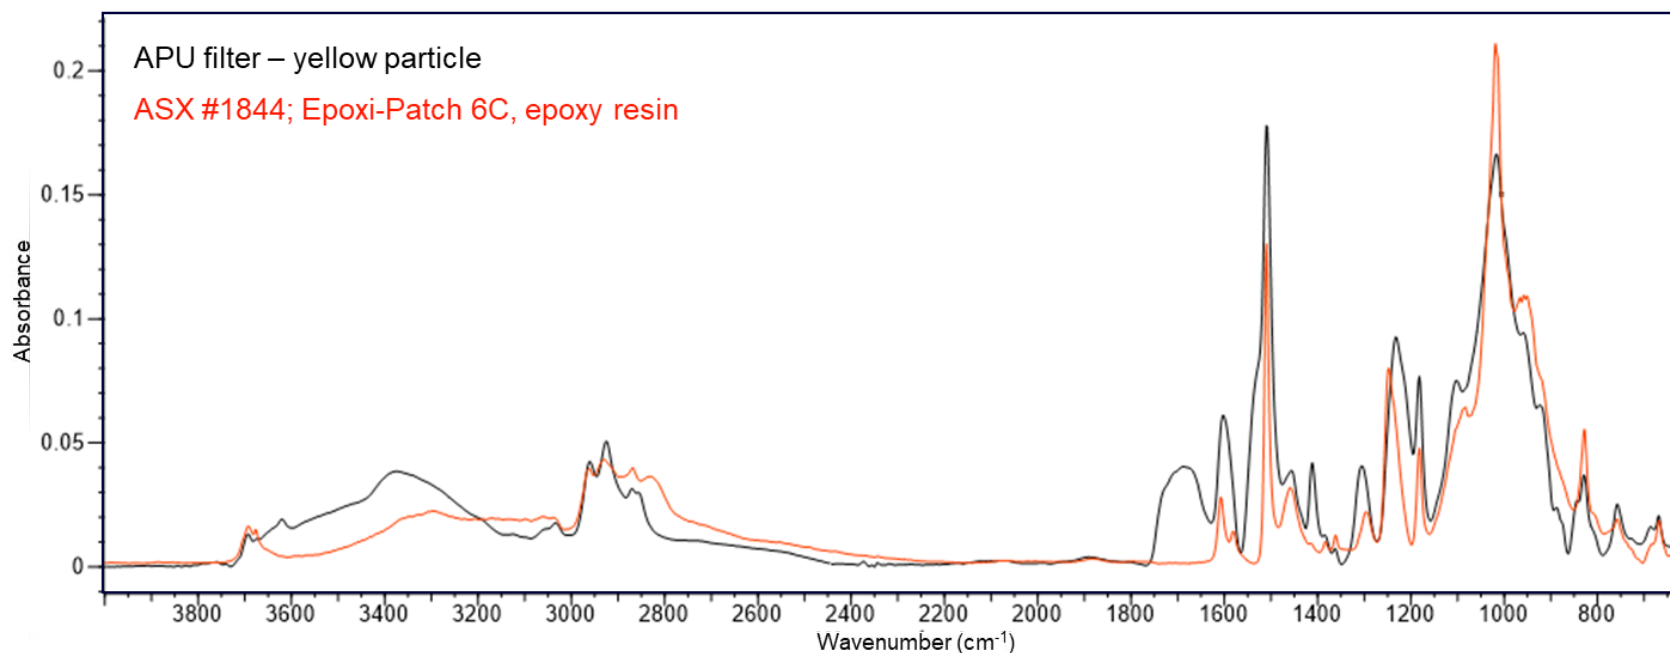
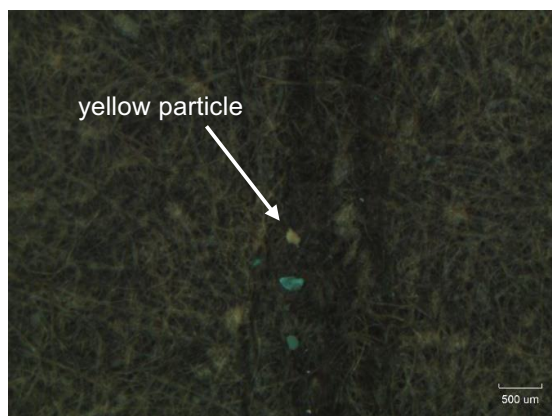
# IR Spectroscopy of Particles from 336049 APU Filter

Pieces of yellow material were found on the surface of the 336049 APU filter. These yellow particles are an excellent match to the IR fingerprint of an **epoxy resin** using an alkylamine linker.

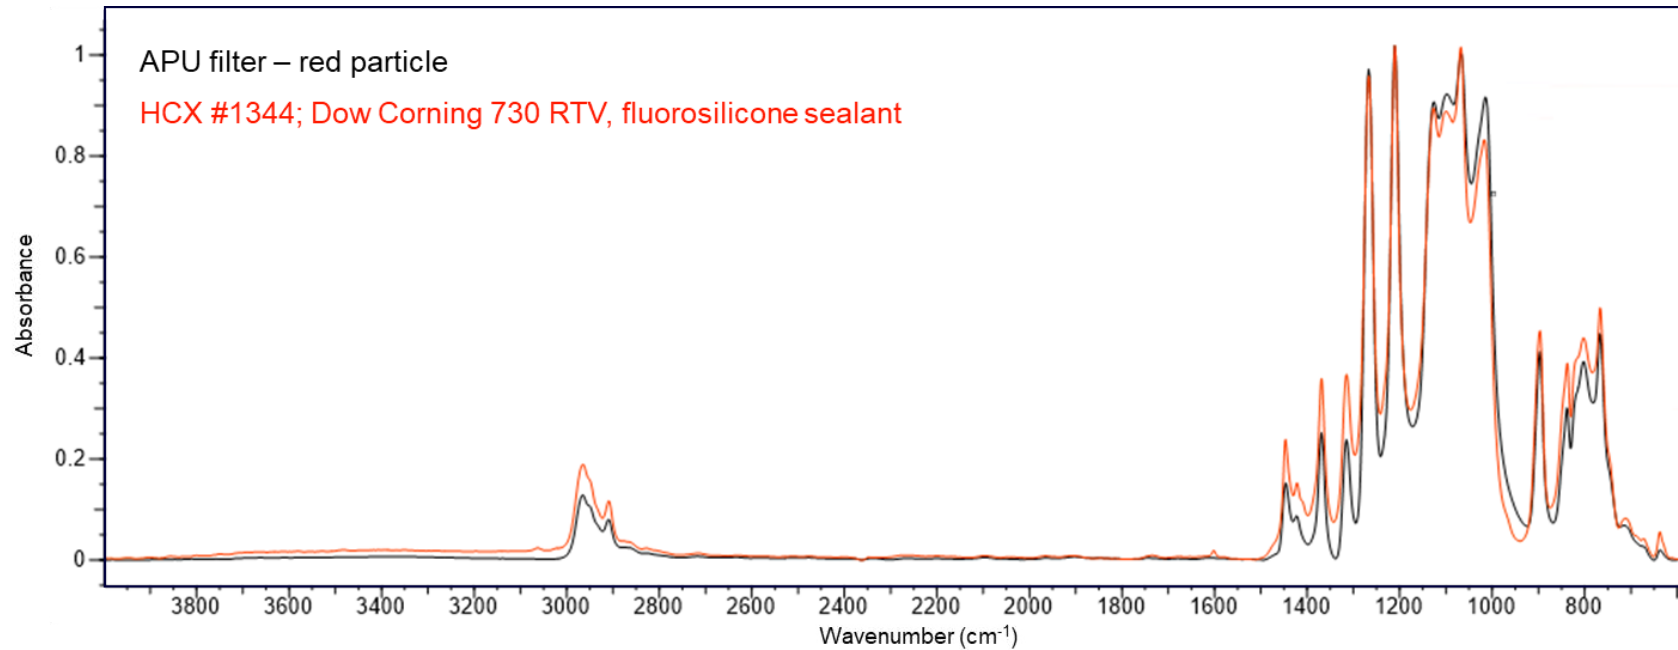
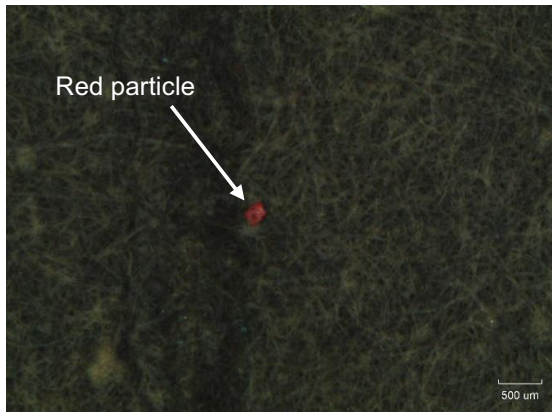
# IR Spectroscopy of Particles from 336049 APU Filter

Red chunks of pliable, soft material were found on the surface of the 336049 APU filter media. These red particles are an excellent match to the IR fingerprint of a **fluorosilicone sealant**. The same fluorosilicone particles were found on the main fuel filters.

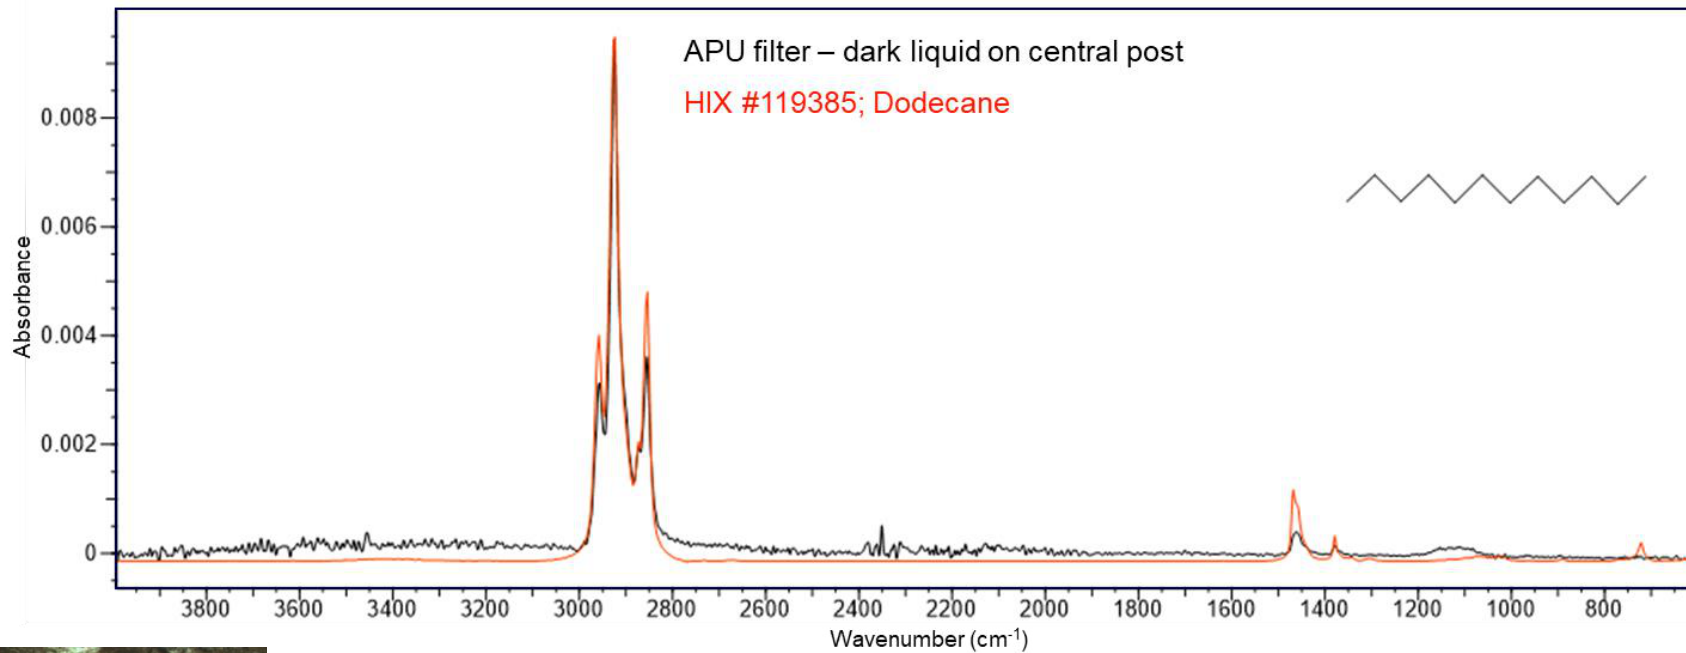
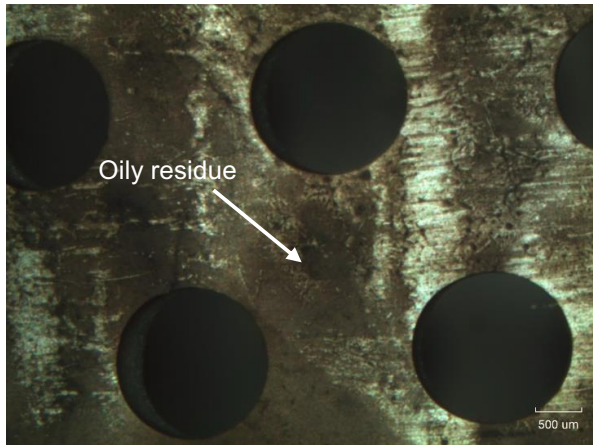
# IR Spectroscopy of Liquid on 336049 APU Filter

The center post of the 336049 APU filter was coated with a dark liquid. This dark liquid was sampled and analyzed and shown to be **largely hydrocarbons**, a typical oil residue.
