# National Transportation Safety Board

ERA24FA127

## **SOUND SPECTRUM**

Location: Nashville, Tennessee  
Date: March 4, 2024  
Time: 19:43 central standard time (CST)  
Aircraft: Piper Aircraft PA32RT-300T, C-FBWH

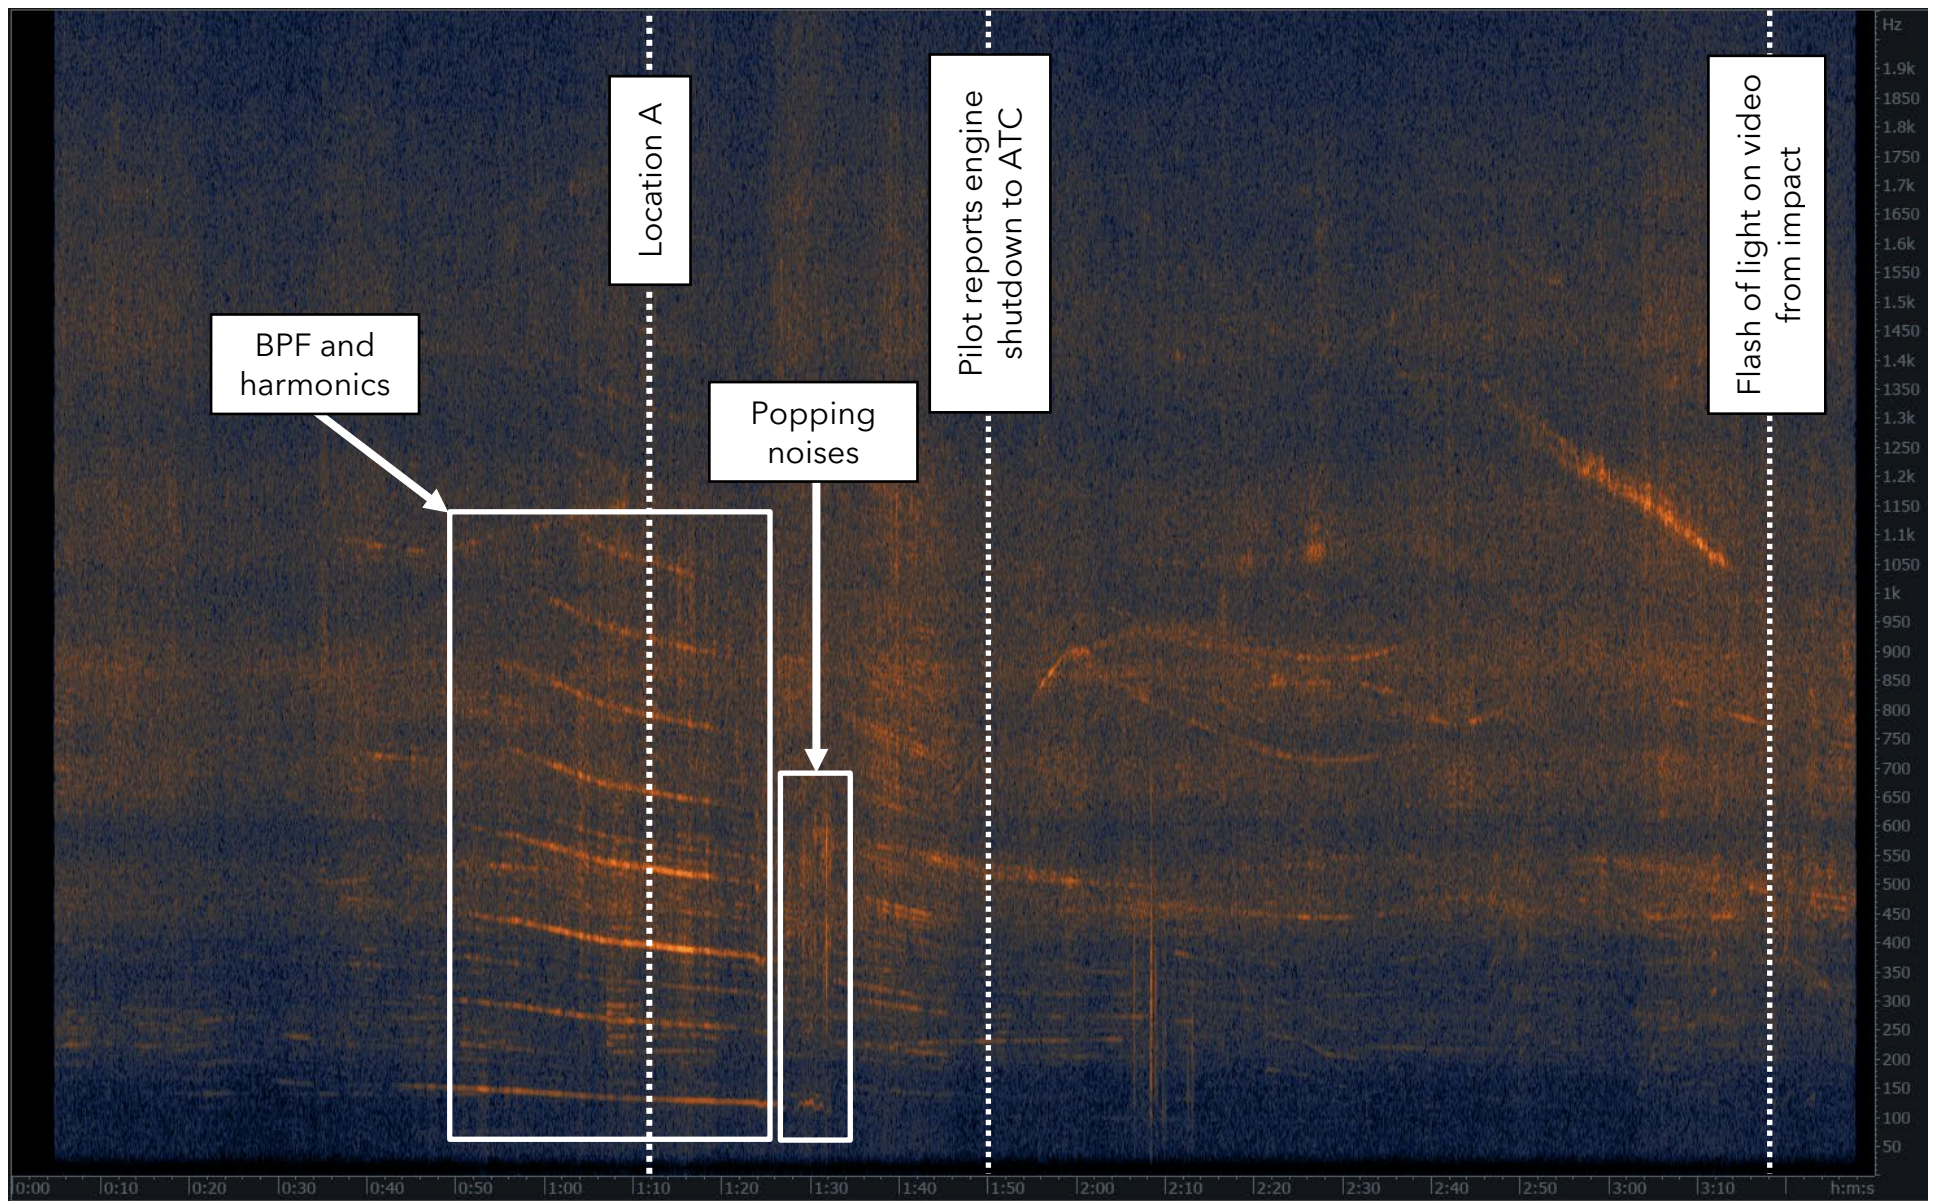
A spectrogram (Figure 2) was generated to illustrate the frequency content of the audio captured by the camera, spanning 19:40:11 CST to 19:43:36 CST. The x-axis represents time in elapsed seconds of the video and the y-axis represents sound frequency in Hertz (Hz). The color represents sound intensity, with black being the lowest intensity sound and orange being the highest intensity. Although the signal-to-noise ratio was low due to the camera's distance from the flight path and its design which prioritized nearby audio, distinct BPF lines were visible until about 19:41:37. From 19:41:37 to 19:41:43, popping noises were audible and visible in the spectrogram. From 19:41:43 to the end of the recording, no BPF could be identified.

The spectrogram reveals a downward slope in the BPF lines and their harmonics over time, indicating the influence of the Doppler effect. The Doppler effect causes sound frequencies to appear higher when the source moves toward an observer, equal as the source passes the observer, and lower when the source moves away.

About 16 seconds later, at 19:41:37, popping noises were visible in the spectrogram, as annotated in Figure 2.

Following the popping noises, no BPF lines were visible in the spectrogram for the remainder of the recording, indicating that the engine had likely stopped operating. This was corroborated by a transmission from the aircraft to air traffic control at about 19:41:56, during which the pilot reported an engine shutdown.

**Figure 2.** Spectrogram of audio from 19:40:11 CST to 19:43:36 CST, the full duration of video. (Source: iZotope RX 7, annotated by NTSB)

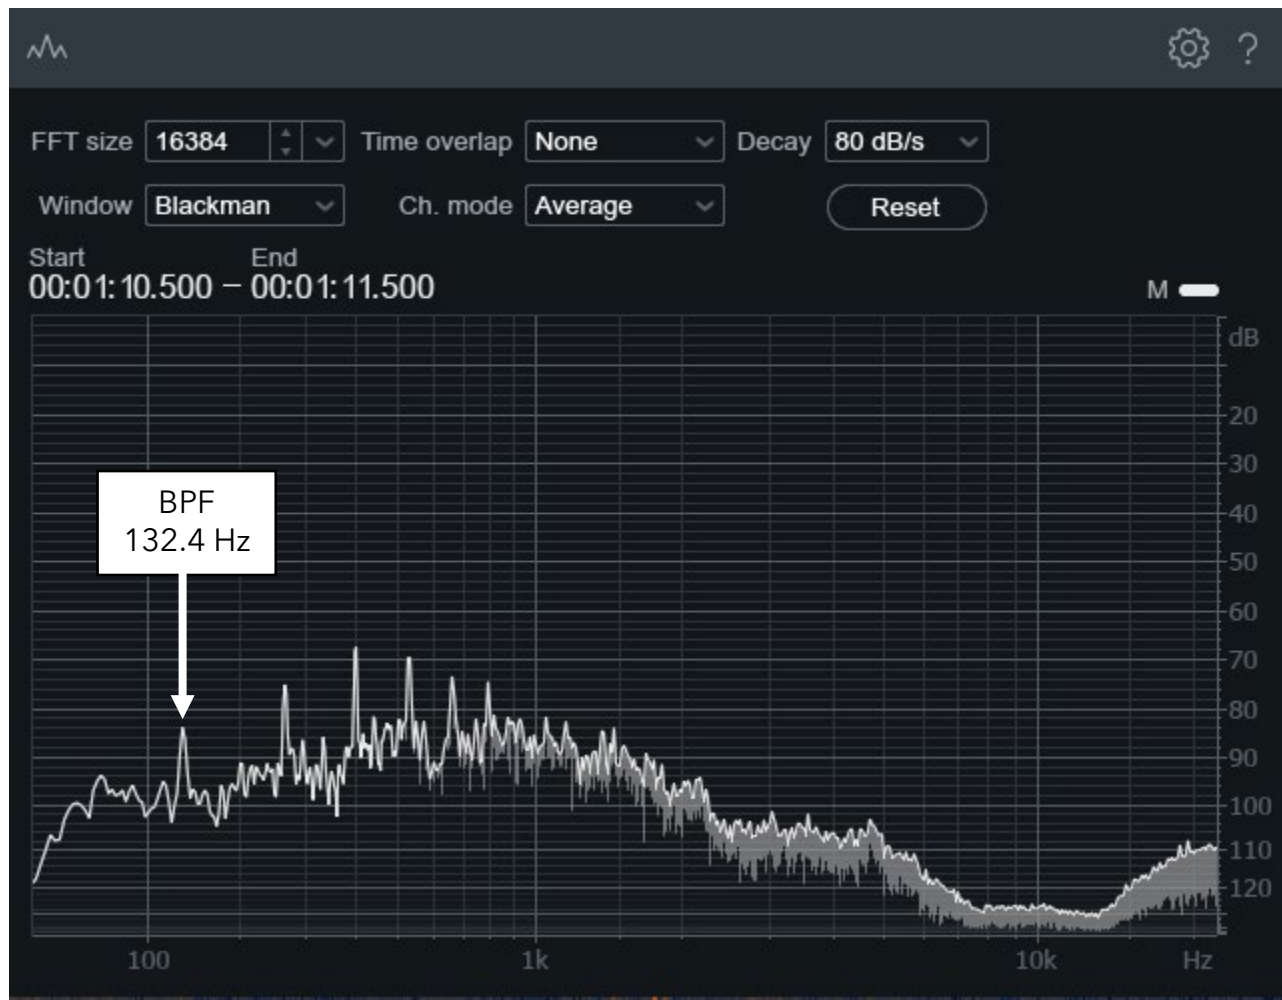
At Location A, the airplane was about 5,000 feet from the camera. Given the air temperature of 66.2°F, the speed of sound was calculated to be 1,124 feet per second.<sup>4</sup> This means the sound emitted by the airplane at 19:41:17 reached the camera around 19:41:21.

Figure 3 is a Fast Fourier Transform (FFT) of the audio signal from 19:41:20.5 to 19:41:21.5.<sup>5</sup> The fundamental BPF at this time was measured as 132.4Hz, corresponding to an estimated engine speed of approximately 2,650 RPM. This is close to the engine's normal rated continuous power setting.

**Figure 3.** FFT of the audio signal from 19:41:20.5 to 19:41:21.5 CST. (Source: iZotope RX 7, annotated by NTSB)
