# National Transportation Safety Board

ERA24FA127

## **AIRFRAME AND ENGINE EXAM**

Location: Nashville, TN  
Date: March 4, 2024  
Time: 1945  
0145 (UTC)  
Airplane: PA-32RT-300T Common Name: Piper Lance II  
Reg Number: C-FBWH

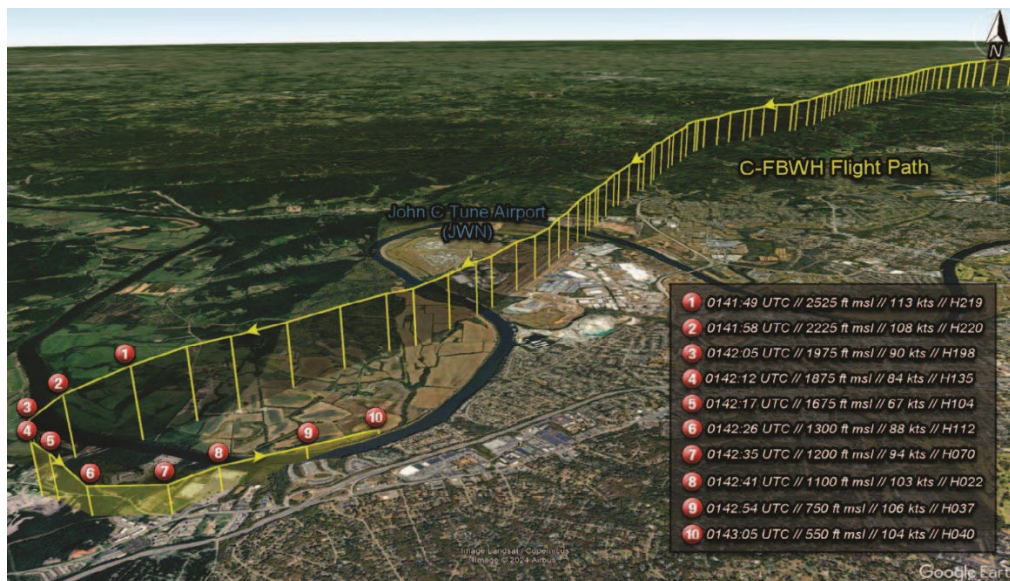
The flight track of the airplane showed that it was at cruising altitude of 10,500 ft for the majority of the flight from IOB until it began a gradual (normal) descent into the JWN airport area. For reasons unknown, the airplane overflew JWN at an altitude of 2,500 mean sea level (MSL) and passed over the airport towards the south southwest; subsequently, the pilot reported engine issues. ATC declared an emergency and cleared the pilot to land on runway 2.

Figure 1 Prelim ADS-B flight track data.

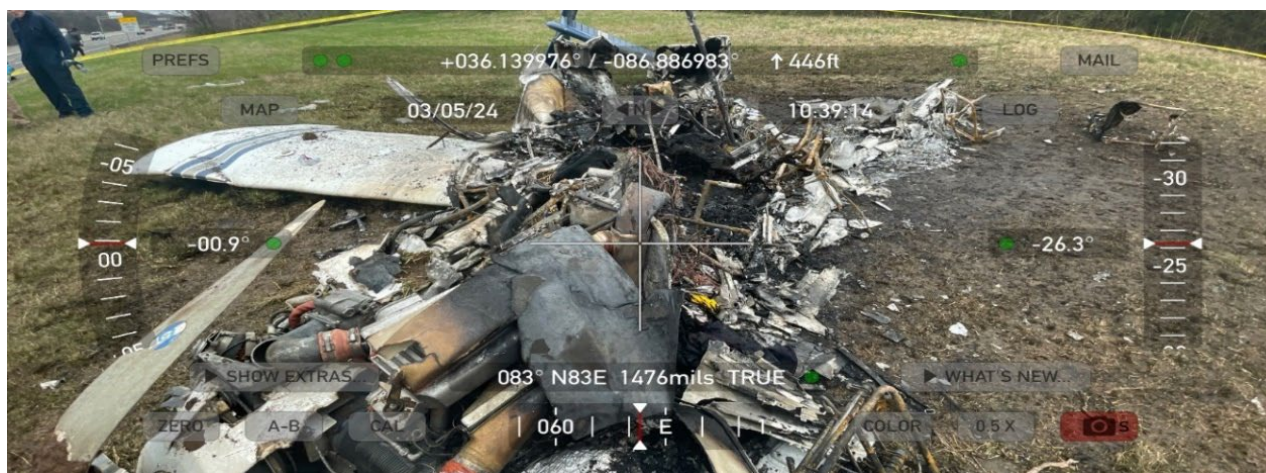
The airplane impacted the grass shoulder immediately adjacent to Nashville, TN Interstate I-40 East, striking a 30 degree incline hill and coming to rest about 60 ft from the roadway on slightly inclined terrain. The accident site was compact with a ground impact gouge about 40 feet from the main wreckage. Initial ground impact contained red position light glass, and the left fiberglass wingtip separated and was discovered in the ditch next to the roadway. The engine compartment struck the ground creating a 5-inch deep and 6-foot wide crater before the airframe came to rest.

The left wing separated aft. The left fuel tank breached during impact, resulting in the post impact fire, which consumed the left wing, instrument panel, cockpit, and cabin. The ground scars were oriented on a heading of 083° magnetic and the nose of the airplane was oriented on a magnetic heading of about 309°. The elevation was 446 feet. Lat/long 36.139976° / -86.886983° (figure 2/3)

**Figure 2 Accident Site Overview**

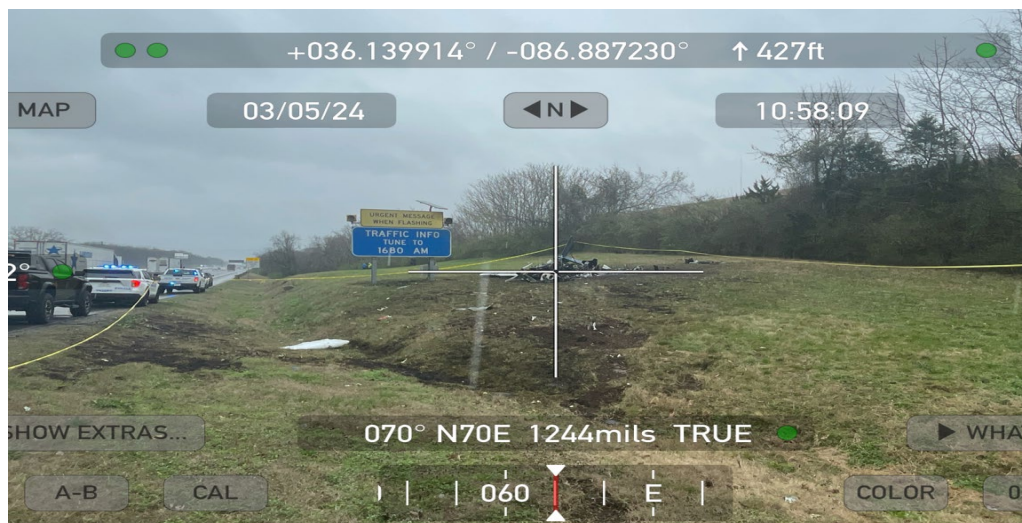
**Figure 3 Accident Site Overview and Ground Scars**

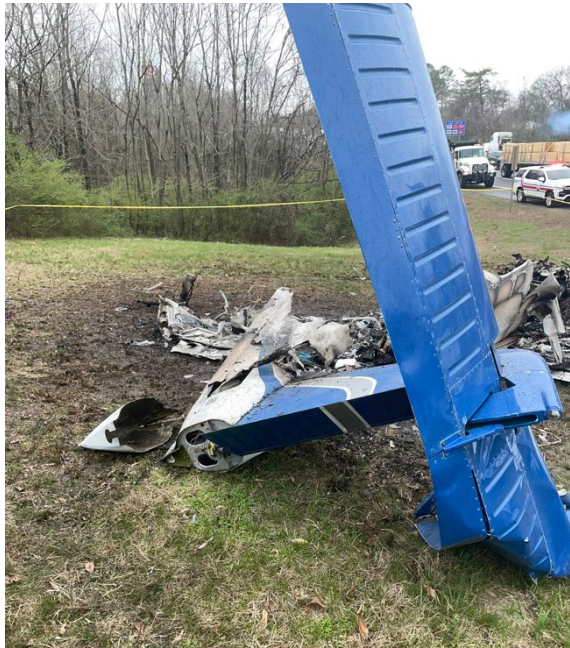
The empennage remained partially attached to the fuselage (Figure 4) The rudder and stabilator remained attached to the empennage at their respective hinges. The right side of the stabilator was bent down by impact forces. The stabilator trim control surface remained attached. The rudder and stabilator control cables remained intact and continuous from the control column to their respective control attachments. The rudder and stab cables were cut by emergency personnel about 1-foot from their attachments at the control column. The rudder cables remained attached to the rudder bar. The stabilator control cables remained attached to the base of the control column. The trim actuator was found with 0 threads exposed at

the front of the actuator drum which equates to a full nose down trim condition. Rudder, stabilator and stabilator trim continuity was confirmed.

**Figure 4 View of empennage looking forward.**

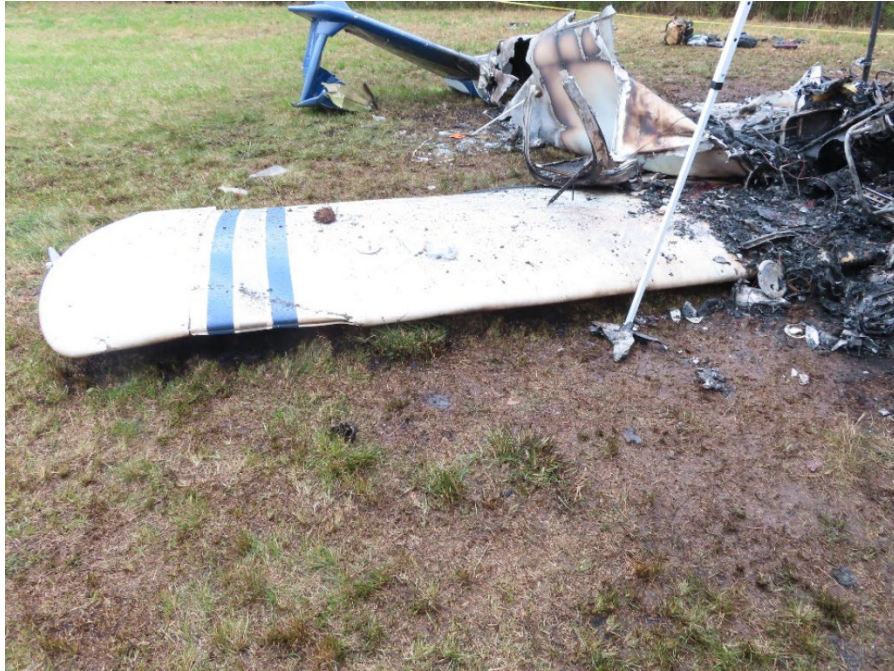
The right wing (Figure 5) came to rest on the right side of the fuselage with the root end underneath the fuselage. The right flap and aileron remained attached to the wing at their hinges. The right flap appeared to be approximately in the 10 degree position. The right flap control rod was broken from the flap torque tube and remained attached to the flap. The right aileron was manually manipulated with the control cables and operated normally through its up/down stops.

**Figure 5 Right wing on site.**

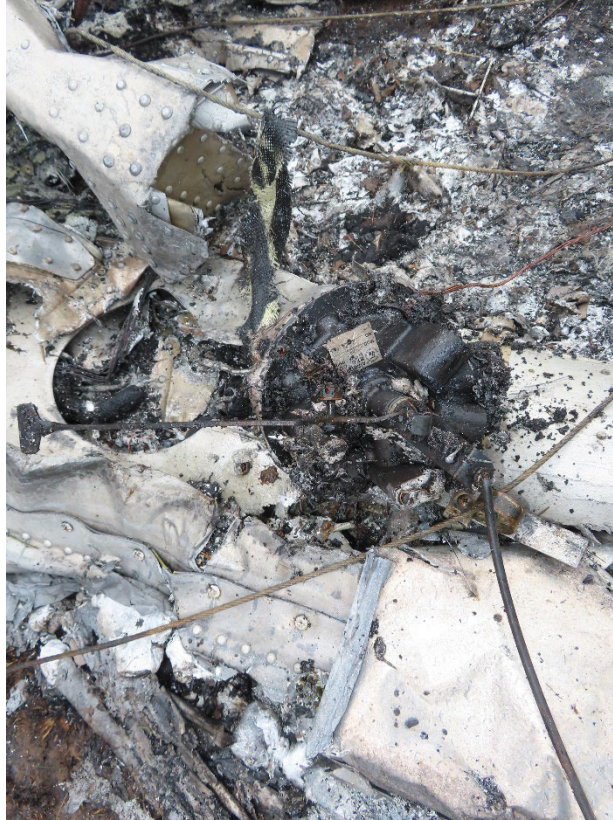
The fuel selector, fuel selector valve/fuel strainer were damaged and deformed by impact forces and heat as observed on site. Care was taken not to manipulate or move the selector until it was removed from the wreckage. The unit had separated from the fuselage. The unit was secured for additional examination and testing. The fuel selector valve was found selected to a position between off and left main tank, slightly favoring the left tank position but still in between the 2 ports. (Figure 6/7)

**Figure 6 Fuel selector on site.**

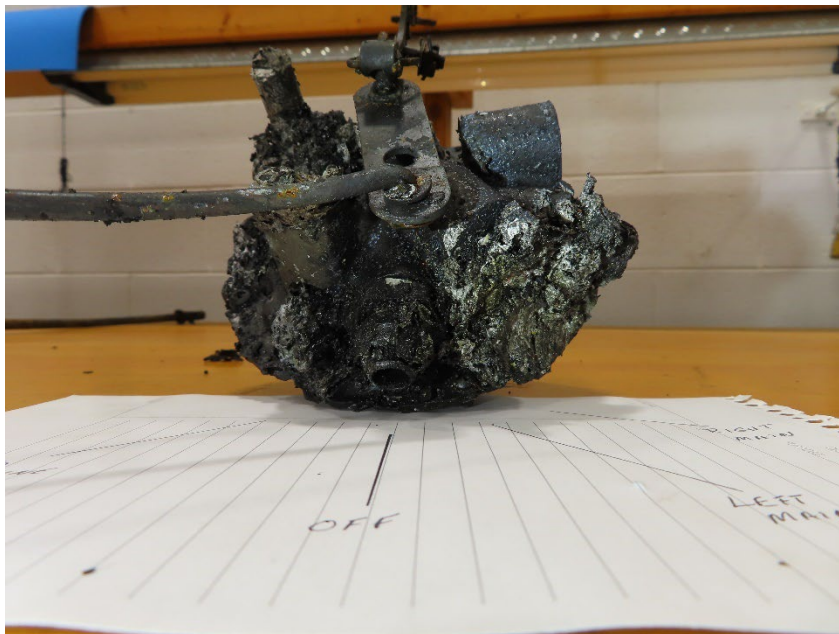
The unit was opened for examination during the hanger exam; the fuel selector valve/fuel strainer fuel screen was burned away. The ports inside the fuel selector valve were not open.

**Figure 7 Fuel selector during examination.**

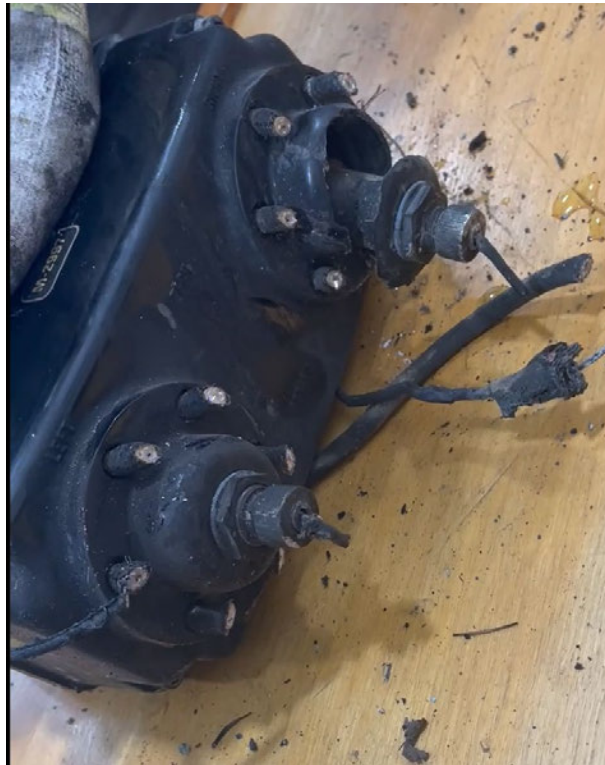
At the secured facility, both left and right magnetos which are dual self-contained Hartzell units were removed and manually operated with a drill at low a RMP setting for several seconds through a high RPM. (Figure 8) Video recording was taken of the test. Both magnetos produced healthy blue/purple spark at all of the posts and at every RPM.

**Figure 8 Dual magneto during operational test.**

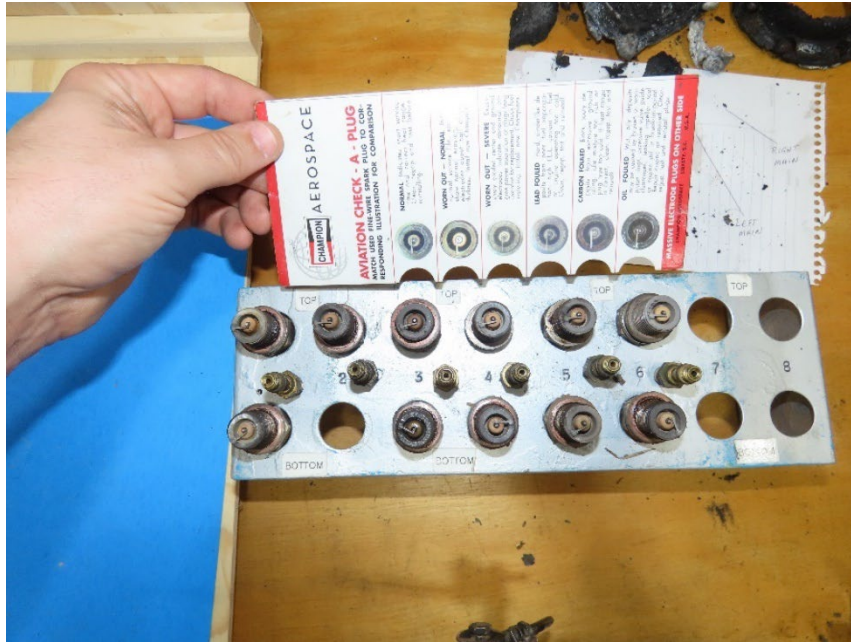
All the spark plugs displayed normal coloration and normal electrodes as compared to the Champion Aerospace AV-27 Check-A-Plug chart. (Figure 9)

**Figure 9 Spark plugs.**

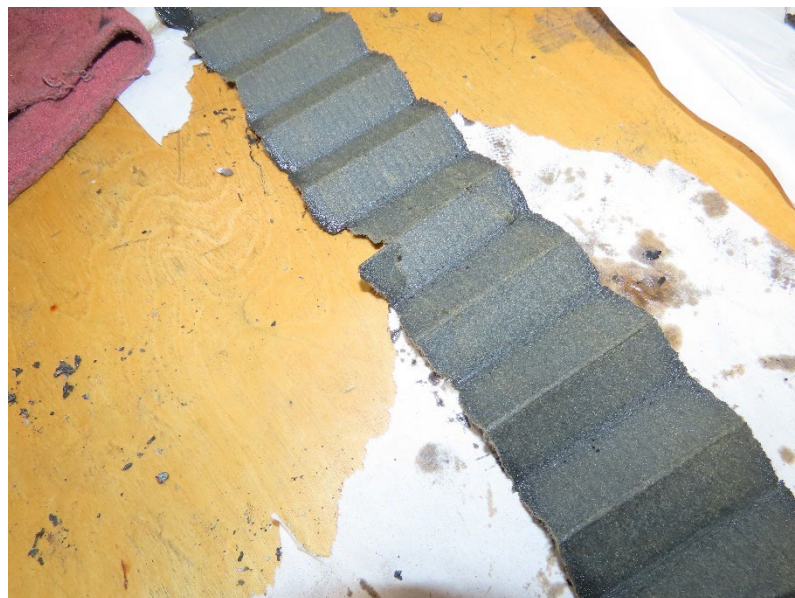
The oil filter was opened, and the pleats contained no foreign debris or ferrous material but several pieces of carbon from the burned pleats. The oil appeared dark brown in color and all lubricated components appeared to be well lubricated. (Figure 10)

**Figure 10 Oil pleats.**

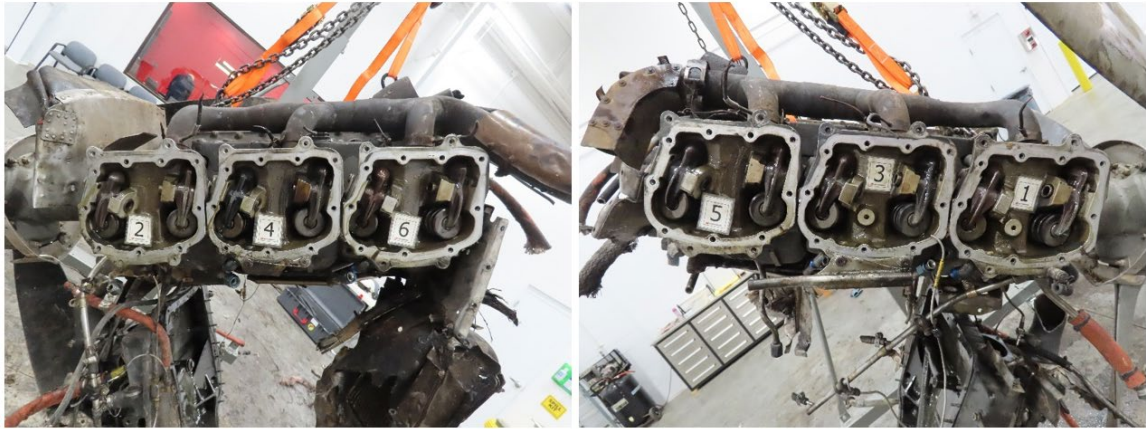
The engine crankcase was manually rotated 720° degrees of rotation several time to check for crankshaft continuity and compression and suction. Continuity was confirmed and all pistons, valves, springs, and pushrods operated as designed. There was adequate suction and compression on each of the six cylinders. (Figure 11)

**Figure 11 Both sides of engine with valve covers removed.**

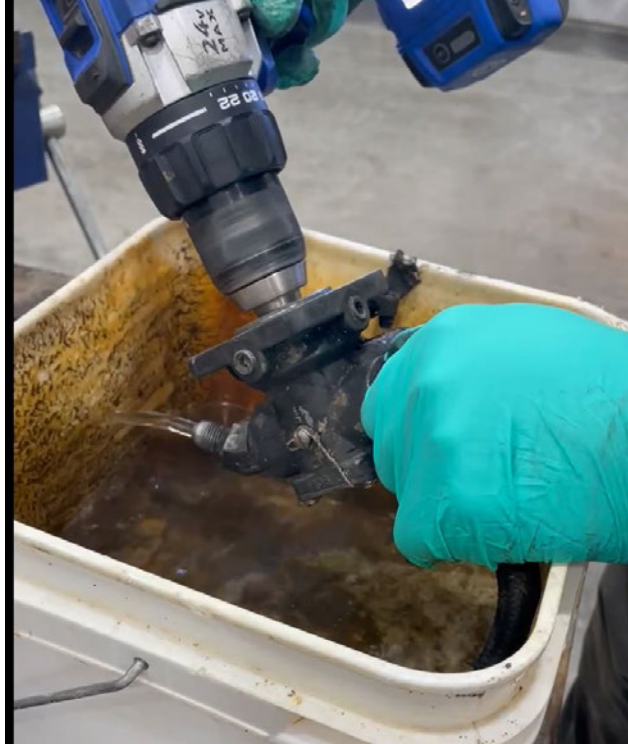
The engine driven fuel pump (Figure 12) was actuated by hand and produced fuel when rotated by hand. Suction and compression were confirmed on the pump. An electric drill test was conducted and resulted in significant pump pressure; it pumped water successfully.

**Figure 12 Fuel pump operational test.**

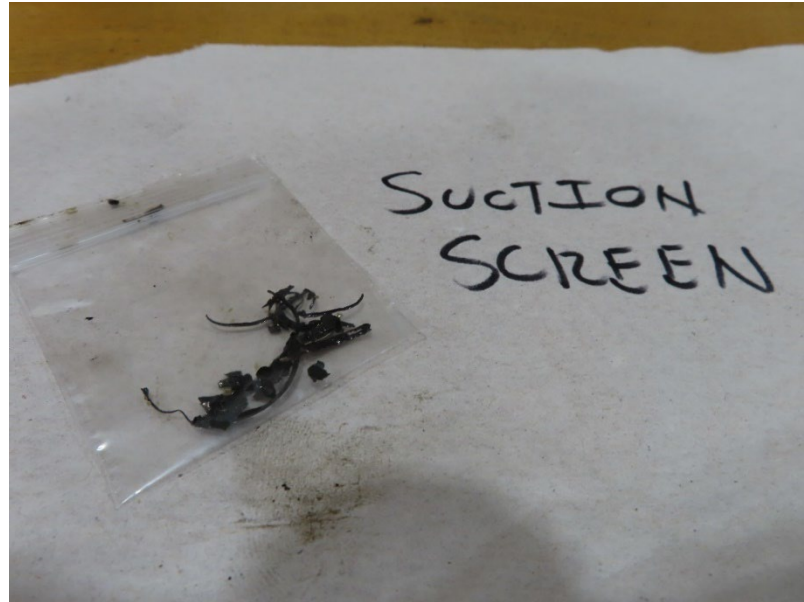
The engine oil suction screen was removed and examined. It contained some unknown debris that had the consistency of plastic fibers (Figure 13). This debris was retained by the NTSB for further analysis. The engine oil filter was opened. The filter medium appeared clean with a few small shiny flecks present. The engine oil pan appeared free of debris. Magnet testing of oil pan revealed no metallic particles.

**Figure 13 Debris in oil suction screen.**

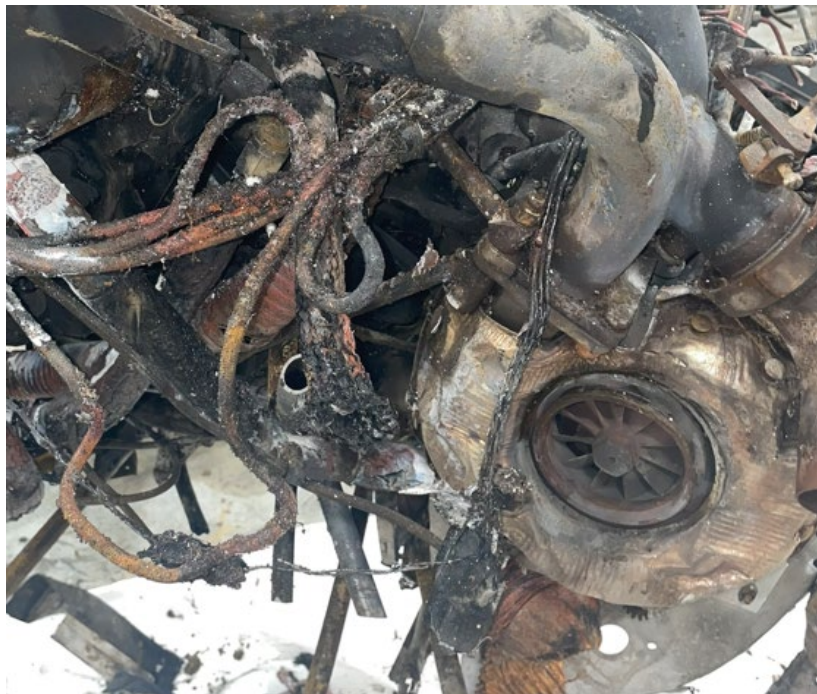
The turbocharger (Figure 14) rotated freely and was connected from the compressor side to the turbine side. No oil leaks noted and the system intact and outflow exhibited no anomalies.

**Figure 14 View of turbo prior to removal.**

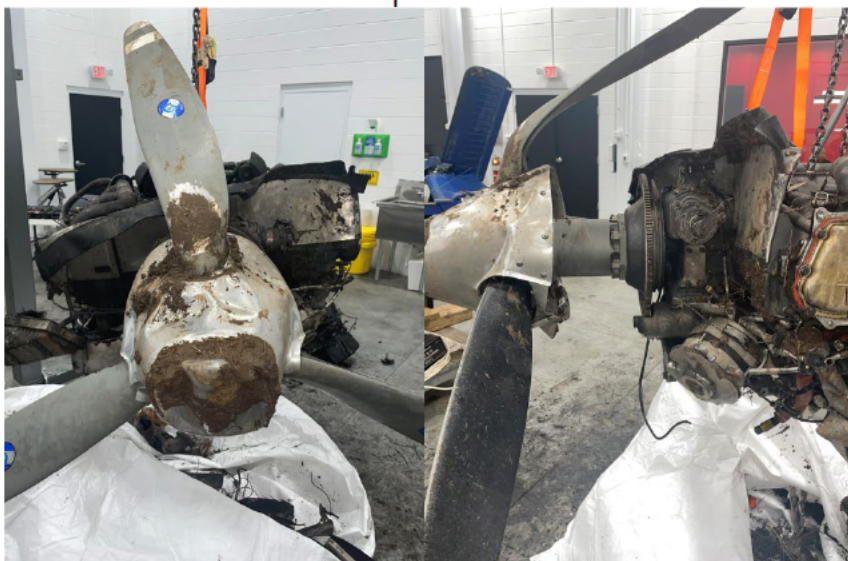
The propeller (Hartzell) hub remained attached to the flange. The blades are designated as A, B, C. The A blade had a slight/minimal forward bend barely noticeable and did not have leading edge gouges or chordwise scraping. The B blade appeared normal and there was no chordwise scrapes or gouges. The C blade was bent significantly aft in a uniform manner. The bend in the blade was about 60 degrees. The spinner was crushed inwards with little rotational damage. The bends were uniform and did not have the "folded over" wave feature as normally found with propellers under power. The blades appeared in a normal range. Hartzell will come and examine the propeller assembly at a later date. The propeller governor and control linkage remained attached to its respective mount and was not damaged.

**Figure 15 Propeller Assy.**
