# National Transportation Safety Board

ERA24FA154

## **WRECKAGE EXAMINATION REPORT**

Location: St. Augustine, Florida  
Date: March 25, 2024  
Time: 1154 EDT  
1554 UTC  
Airplane: Mooney M20K

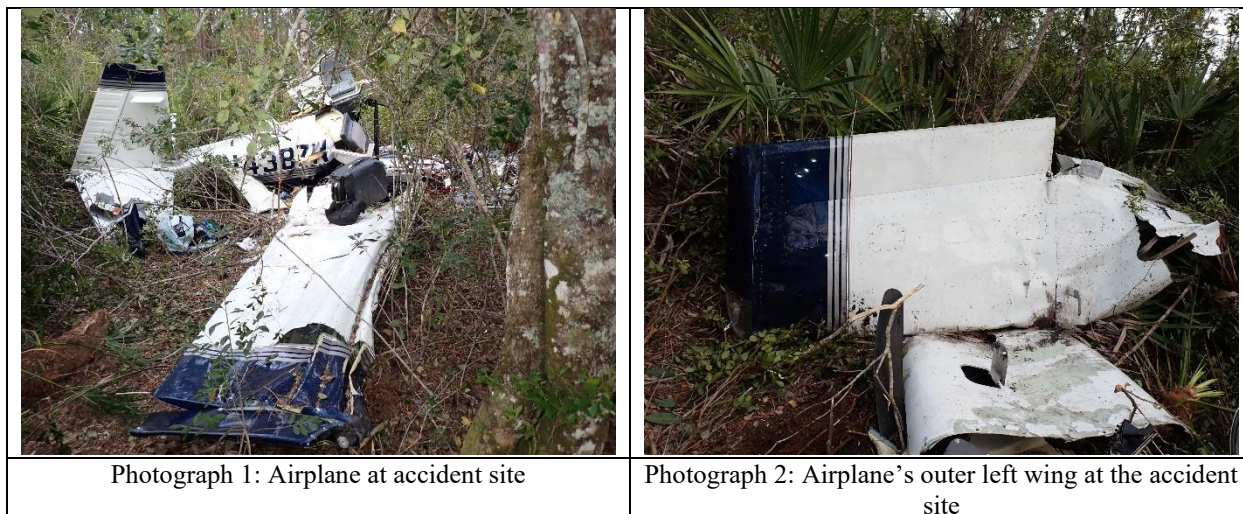
The airframe sustained substantial damage to the fuselage and to both wings. The outboard 4 ft of the left wing had separated from the rest of the wing and was

located at the accident site. The right wing displayed aft crushing damage. The empennage had partially separated from the rest of the fuselage.

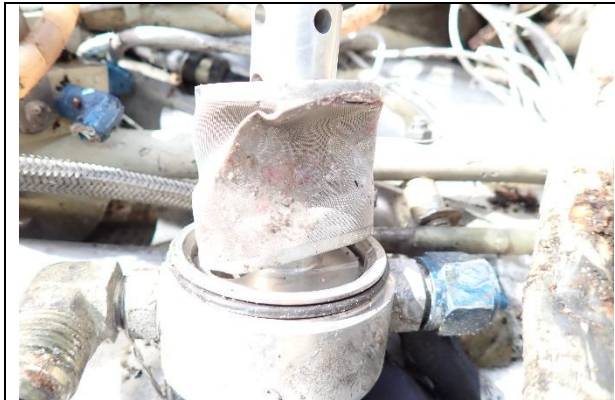
The airplane was equipped with four fuel tanks, two fuel tanks in each wing. All four fuel tanks were breached and were devoid of fuel. All four fuel caps remained secured to their respective filler ports. The fuel caps were removed and examined; they displayed normal operating signatures. The fuel strainer bowl was disassembled and visually examined. The fuel strainer screen contained debris; however, it was not obstructed. The fuel selector valve was not observed.

Photograph 4: Fuel strainer screen

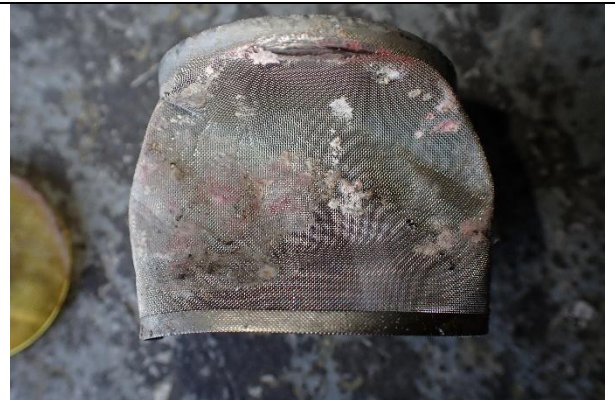
Photograph 5: Fuel strainer screen

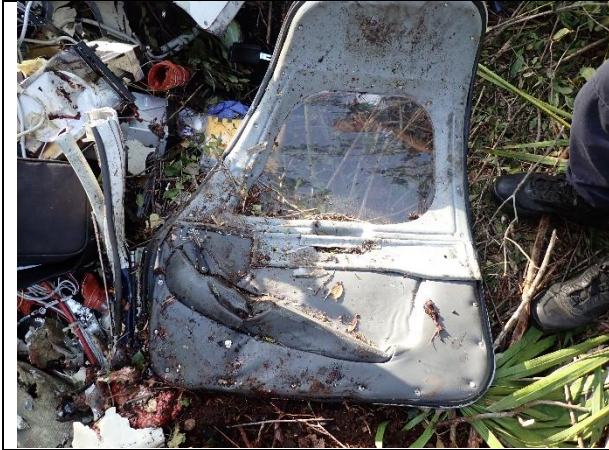
Access to the cabin was provided by the main cabin door located on the right side of the fuselage. The door had inside and outside operating handles. The door had two latching mechanisms, one located on top of the door, and one at the aft, center of the door. The main cabin door remained attached to the fuselage by the forward hinge; the cabin door hold open arm had separated from the door. The upper door cam latch and cabin door pin were found in the retracted position. The door trim was removed, and the door latch assembly was examined. The aft door pin actuating rod was bent, and the door latch handle assembly was fractured which was consistent with impact damage to the door. The upper door latch assembly was undamaged and operated normally. The aft door latch pin was capable of normal movement when operated manually. The aft door latch pin was found with the beveled side toward the outside of the door. The upper door latch pin remained attached to the fuselage and was undamaged, there were no signs of tearing or gouging of the latch pin. The aft door latch striker plate remained attached to the fuselage and was undamaged. There were no signs of the aft door pin being forced past the door pin striker plate hole.

Photograph 6: Main cabin door at accident site

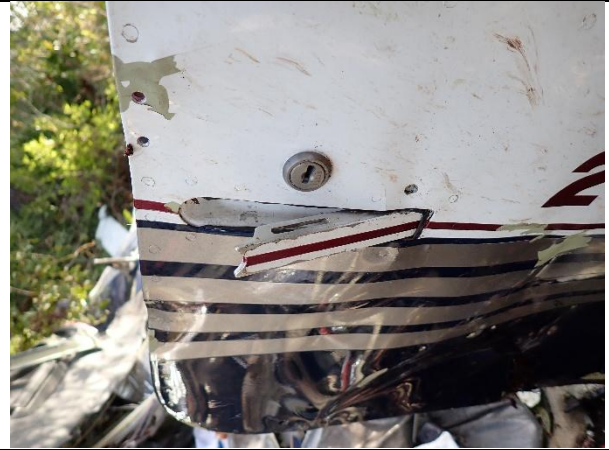
Photograph 7: Main cabin door outer latch handle

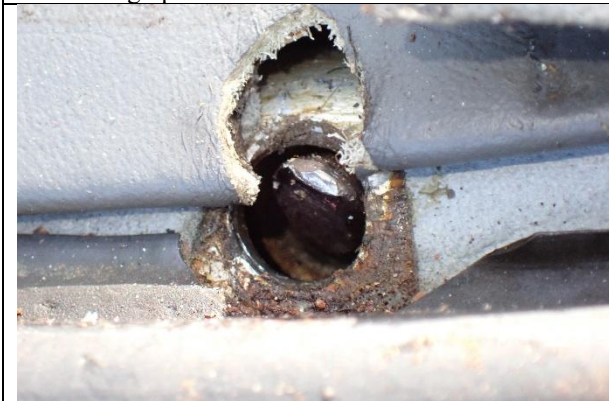
Photograph 8: Main cabin door aft latch pin

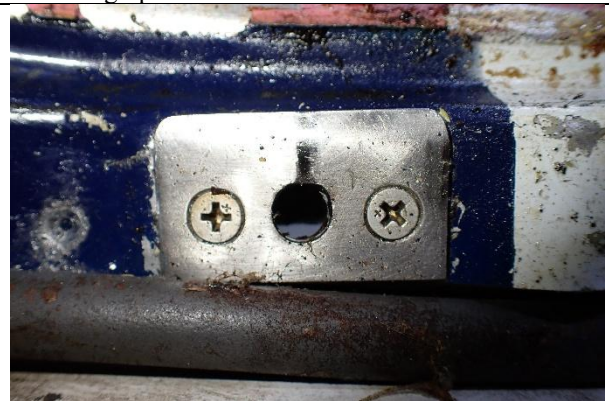
Photograph 9: Main cabin door aft striker plate

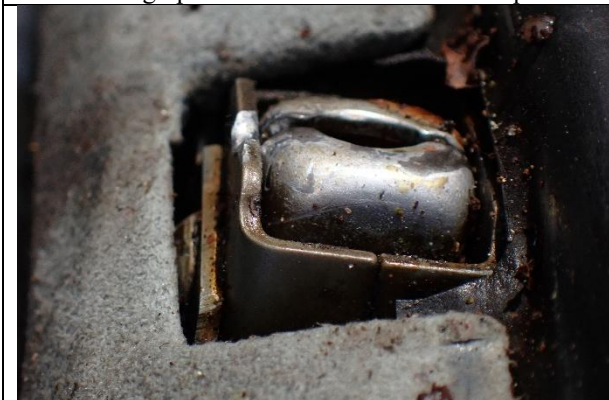
Photograph 10: Main cabin door upper door latch

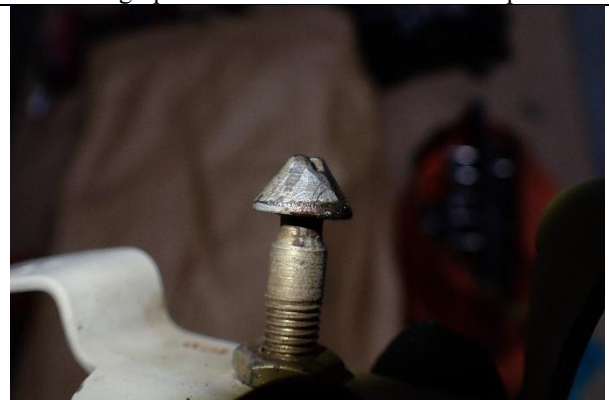
Photograph 11: Main cabin door upper door latch pin

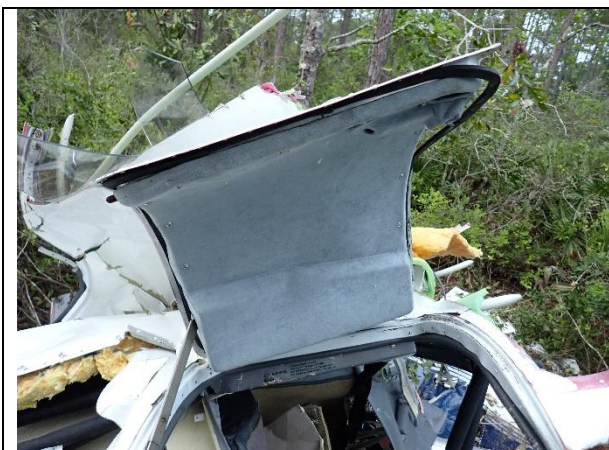
The baggage door was found in the open position and remained attached to the fuselage by its door hinge and hold open arm. The door latch was found in the latched position and the door lock was in the locked position. Both baggage door latch pins were in the extended position. Both baggage door latch striker plates remained attached to the fuselage and both striker plates displayed gouging in the direction of the baggage door opening position. The baggage door was placed in the closed position, and it was observed that a crease in the fuselage skin continued into baggage door when the door was in the closed position.

Photograph 18: Baggage door as found at accident site

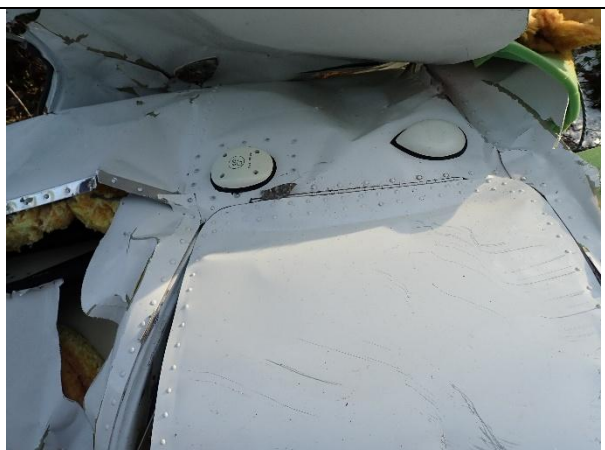
Photograph 19: Baggage door in the closed position

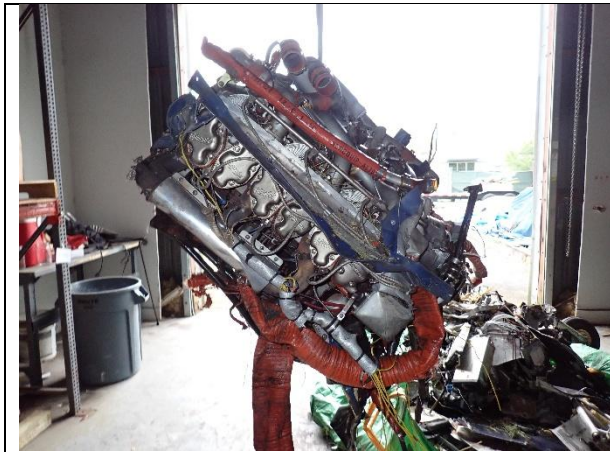
The engine remained partially attached to the airframe through one engine mount, cables, wires, and hoses. The engine and all the engine components displayed impact damage. The propeller flange had separated from the rest of the crankshaft, and multiple 45-degree cracks were noted along the remaining portion of the crankshaft; the fracture surface was about a 45-degree angle. Most of the

Photograph 24: Engine overview (left side view)

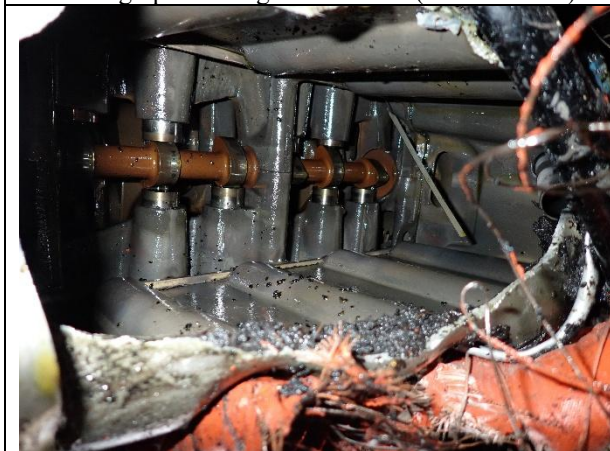
crankshaft and camshaft were visible through the broken oil sump. The visible portions of the crankshaft, camshaft, connecting rods, and lifters displayed normal operating and lubrication signatures. The cylinders were inspected using a lighted borescope. The pistons, exhaust valves, intake valves, and cylinder walls displayed normal operating and combustion signatures. All the rocker arms, valve springs, and valve stems displayed normal operating and lubrication signatures. The oil filter was cut open and there was no metallic debris noted inside the filter pleats.

Photograph 26: View from broken oil sump (camshaft visible)

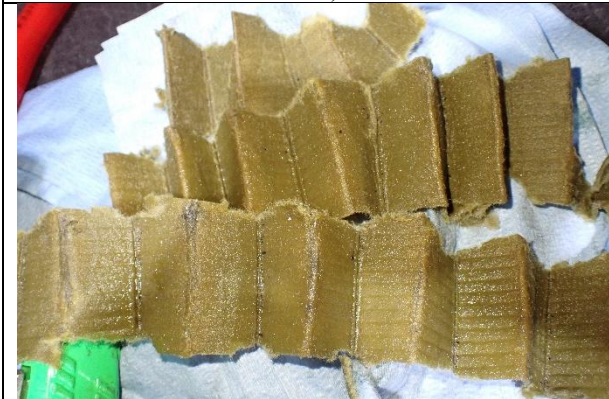
Photograph 30: Oil filter pleats

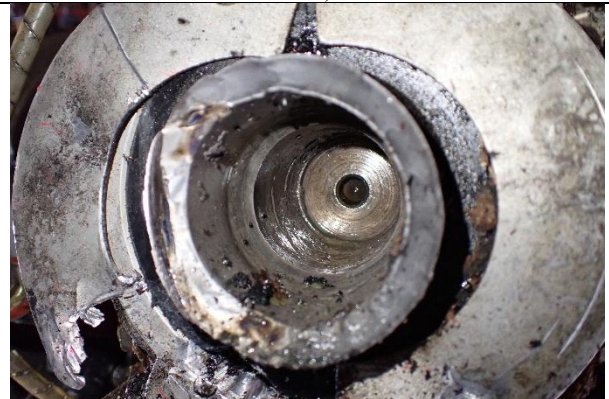
Photograph 31: Crankshaft

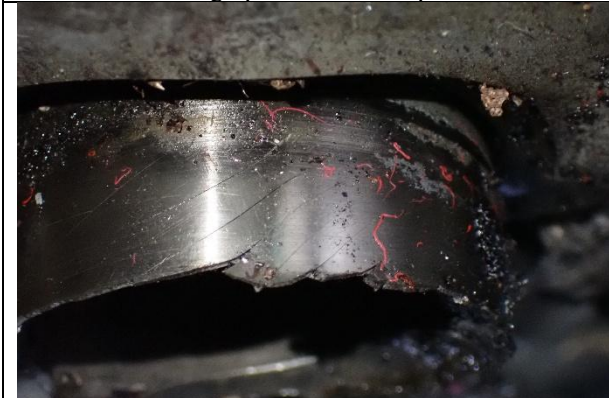
Photograph 32: Cracks in crankshaft

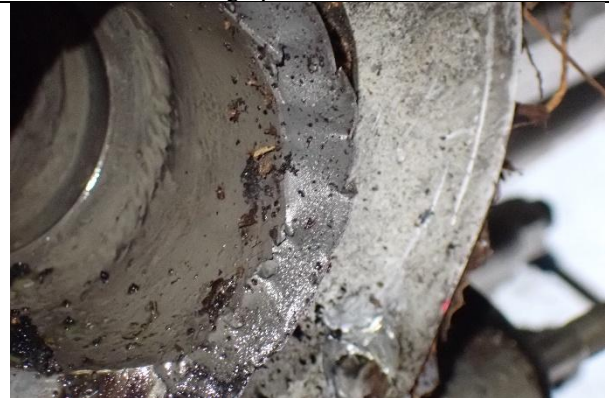
Photograph 33: Crankshaft fracture surface

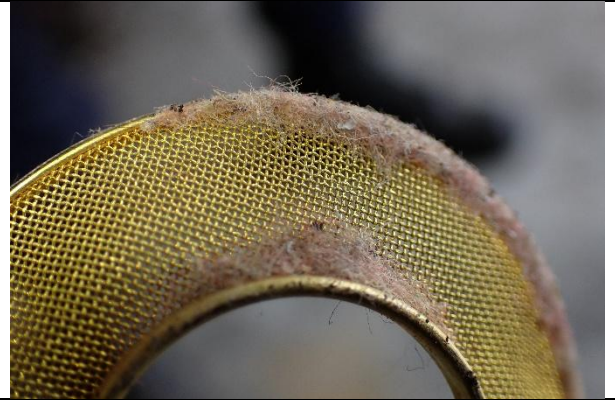
The fuel pump was removed, and the drive shaft coupling was noted to be intact. The fuel pump was disassembled, and the internal components displayed normal operating signatures. The throttle and fuel metering assembly was disassembled and the internal components displayed normal operating signatures. The fuel manifold valve was disassembled and examined. A small amount of fuel, consistent with 100LL, was found in the fuel manifold valve. The fuel was tested using water finding paste, there was no water detected in the fuel sample. The manifold valve screen contained fibrous debris in the screen; however, the screen was not

blocked. The rest of the components displayed normal operating signatures. All the fuel nozzles were removed and were noted to be clear of obstructions.

Photograph 41: Fuel manifold screen

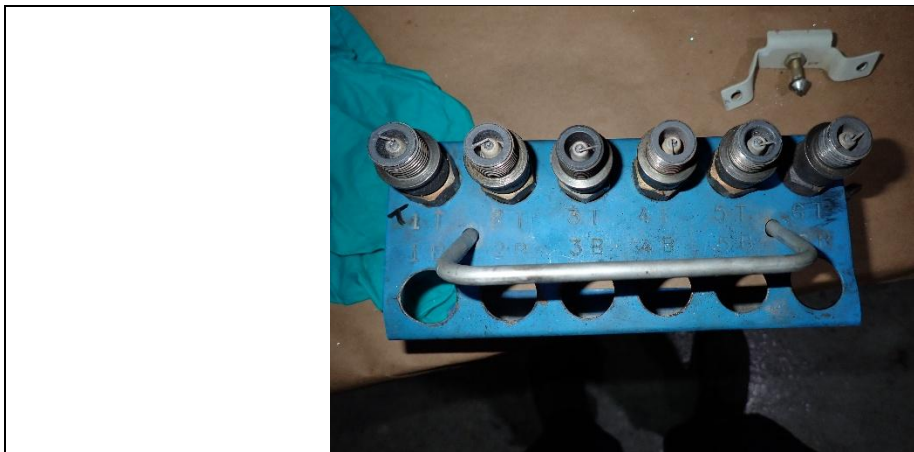
Both magnetos were removed from the engine and the drive shafts were noted to be capable of rotation. Both magnetos were capable of producing a spark on all of their posts in the correct firing order. The top spark plugs were removed for examination, and the bottom spark plugs were examined using a lighted borescope. All spark plug electrodes displayed normal wear and operating signatures when compared with the Champion Aviation Service Manual AV6-R.

Photograph 42: Top spark plugs

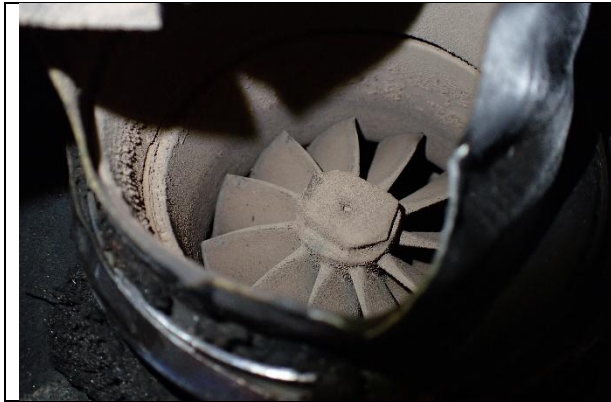
Photograph 43: Turbocharger turbine section

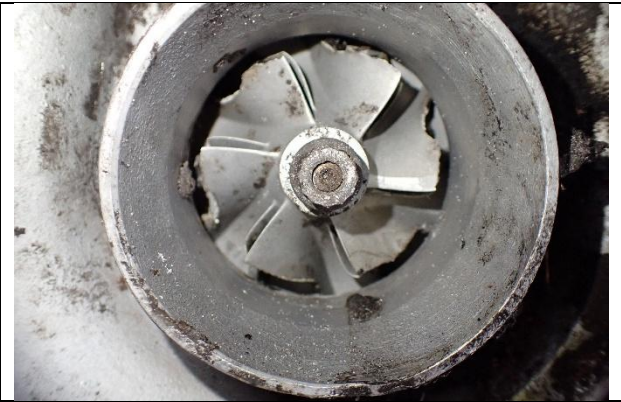
The turbocharger remained attached to the exhaust and intake system. There was a significant amount of impacted dirt in the turbocharger compressor section. The dirt was removed, and it was observed that most of the compressor blades were broken, and the compressor nut was found loose. The turbine displayed normal operating signatures and was capable of normal rotation. The wastegate displayed impact damage signatures, and the wastegate actuator had broken free and was not observed. The wastegate valve was found in the closed position and the wastegate actuating arm displayed impact damage. The turbocharger controller displayed impact damage signatures, and the oil lines were secured to the controller.

Photograph 44: Turbocharger compressor

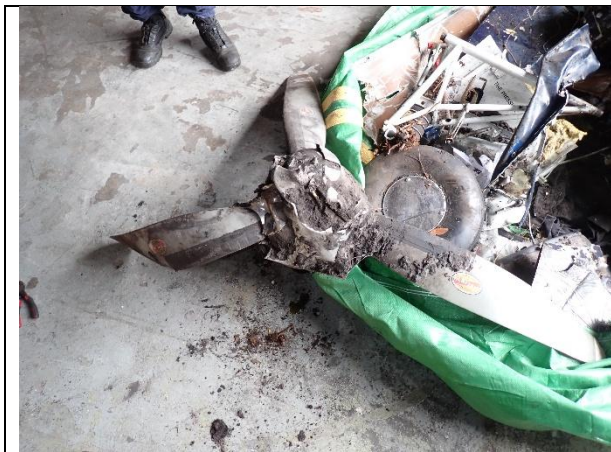
The three-blade, constant-speed propeller remained attached to the crankshaft propeller flange; however, the propeller flange had separated from the rest of the crankshaft. All three of the propeller blades remained secured in the hub, and the blades displayed impact damage. One propeller blade displayed aft bending and twisting deformation, and the cambered side displayed polishing and chordwise scratches. Another propeller blade displayed minor aft bending deformation and polishing of the leading edge and cambered side of the propeller blade. The third propeller blade displayed aft bending deformation and some chordwise scratches.

Photograph 45: Propeller overview (cambered side view)

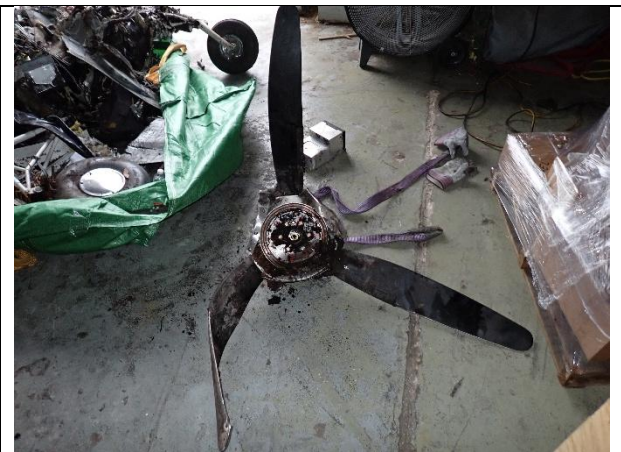
Photograph 46: Propeller overview (back side view)

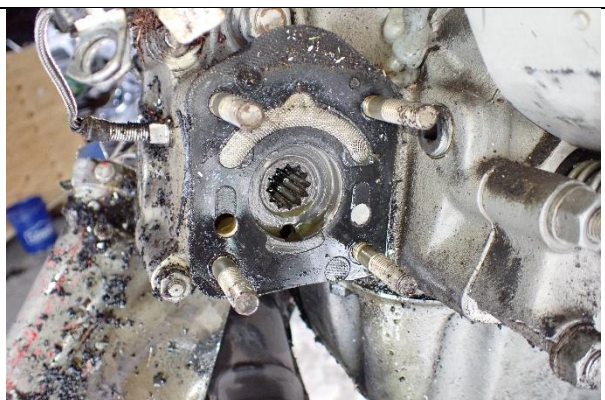
The propeller governor remained attached to the engine and displayed impact damage signatures. The governor was removed, and the oil screen gasket was noted to be clear of debris.

Photograph 48: Propeller governor gasket and screen
