ERA24FA154

## INVESTIGATION PHOTOGRAPHS

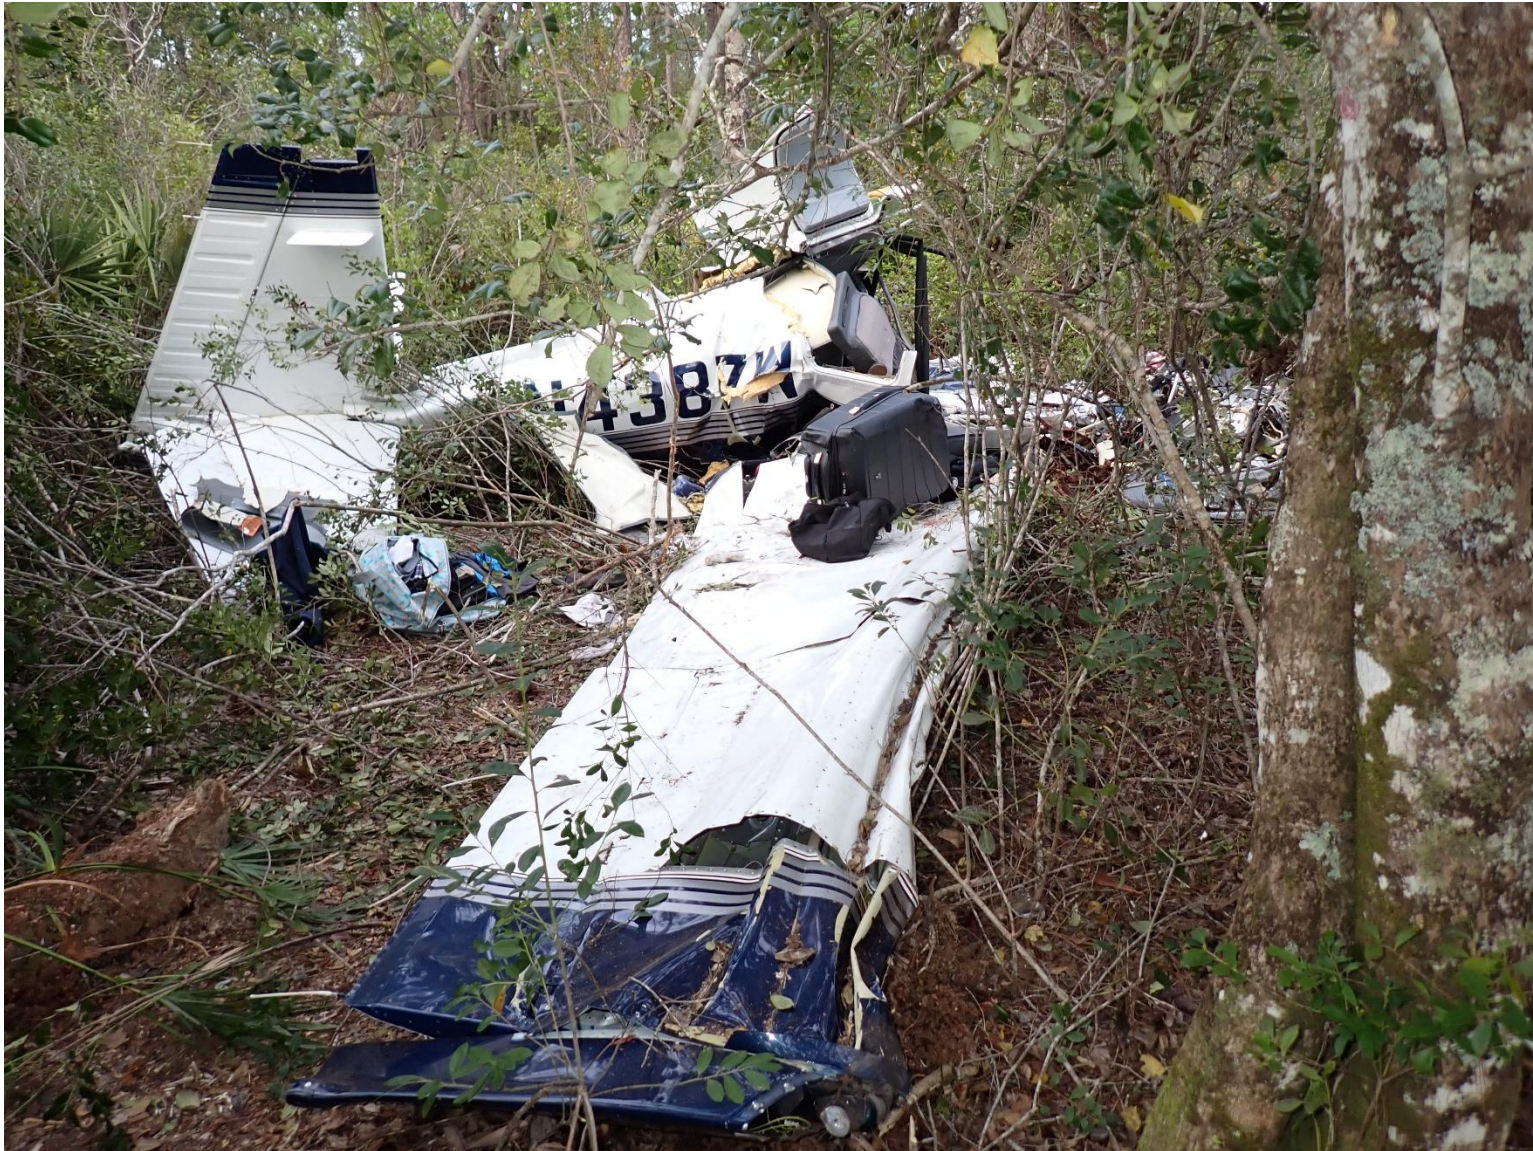
**Photograph 1 - Airplane overview at accident site**

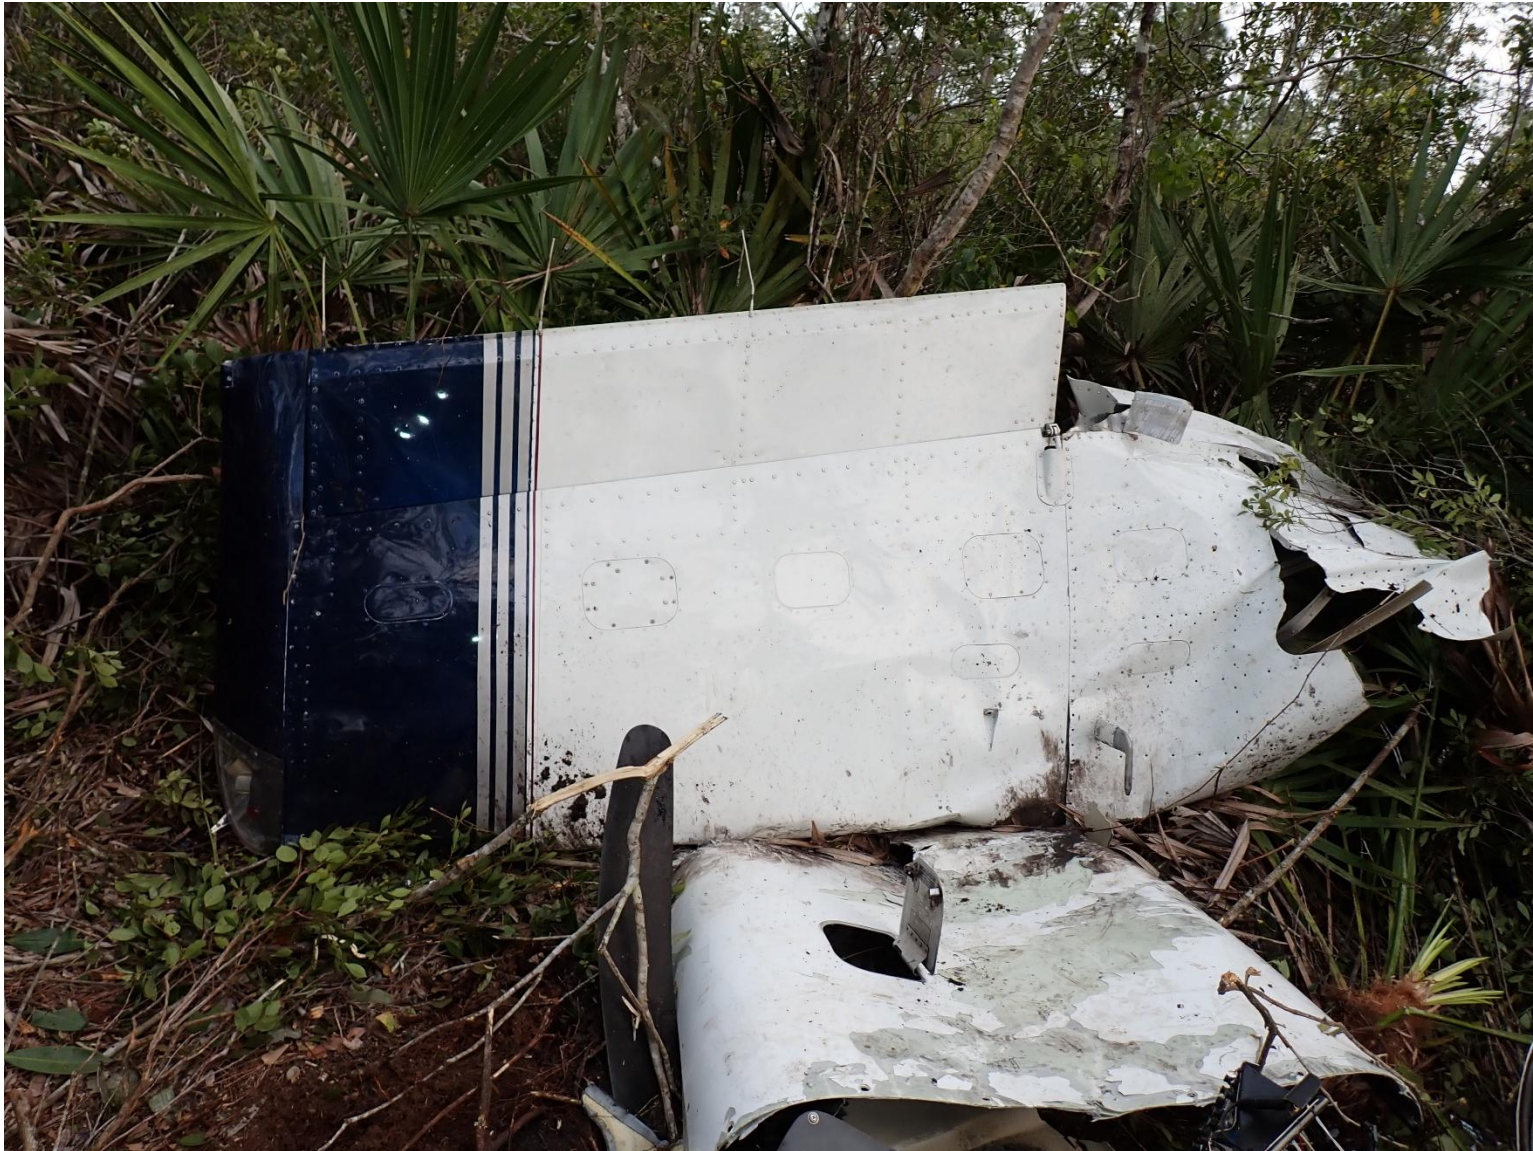
**Photograph 2 - Part of the airplane's left wing outboard section**

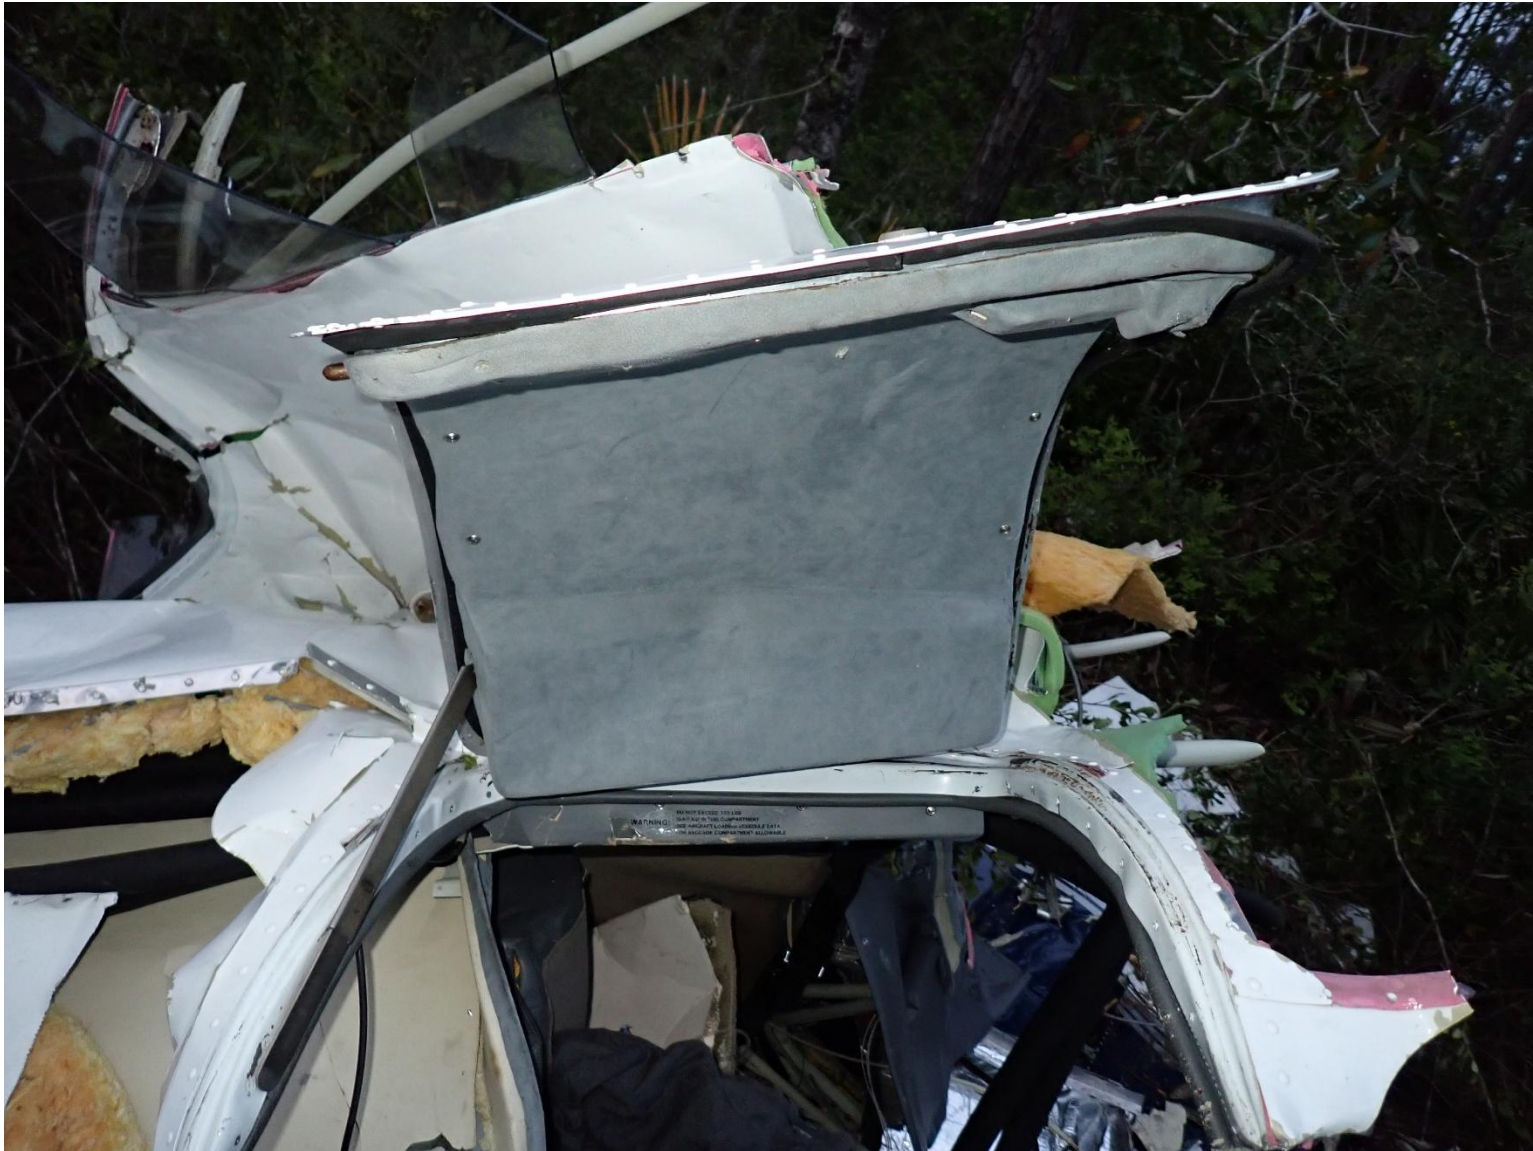
**Photograph 3 - Baggage door in the open position**

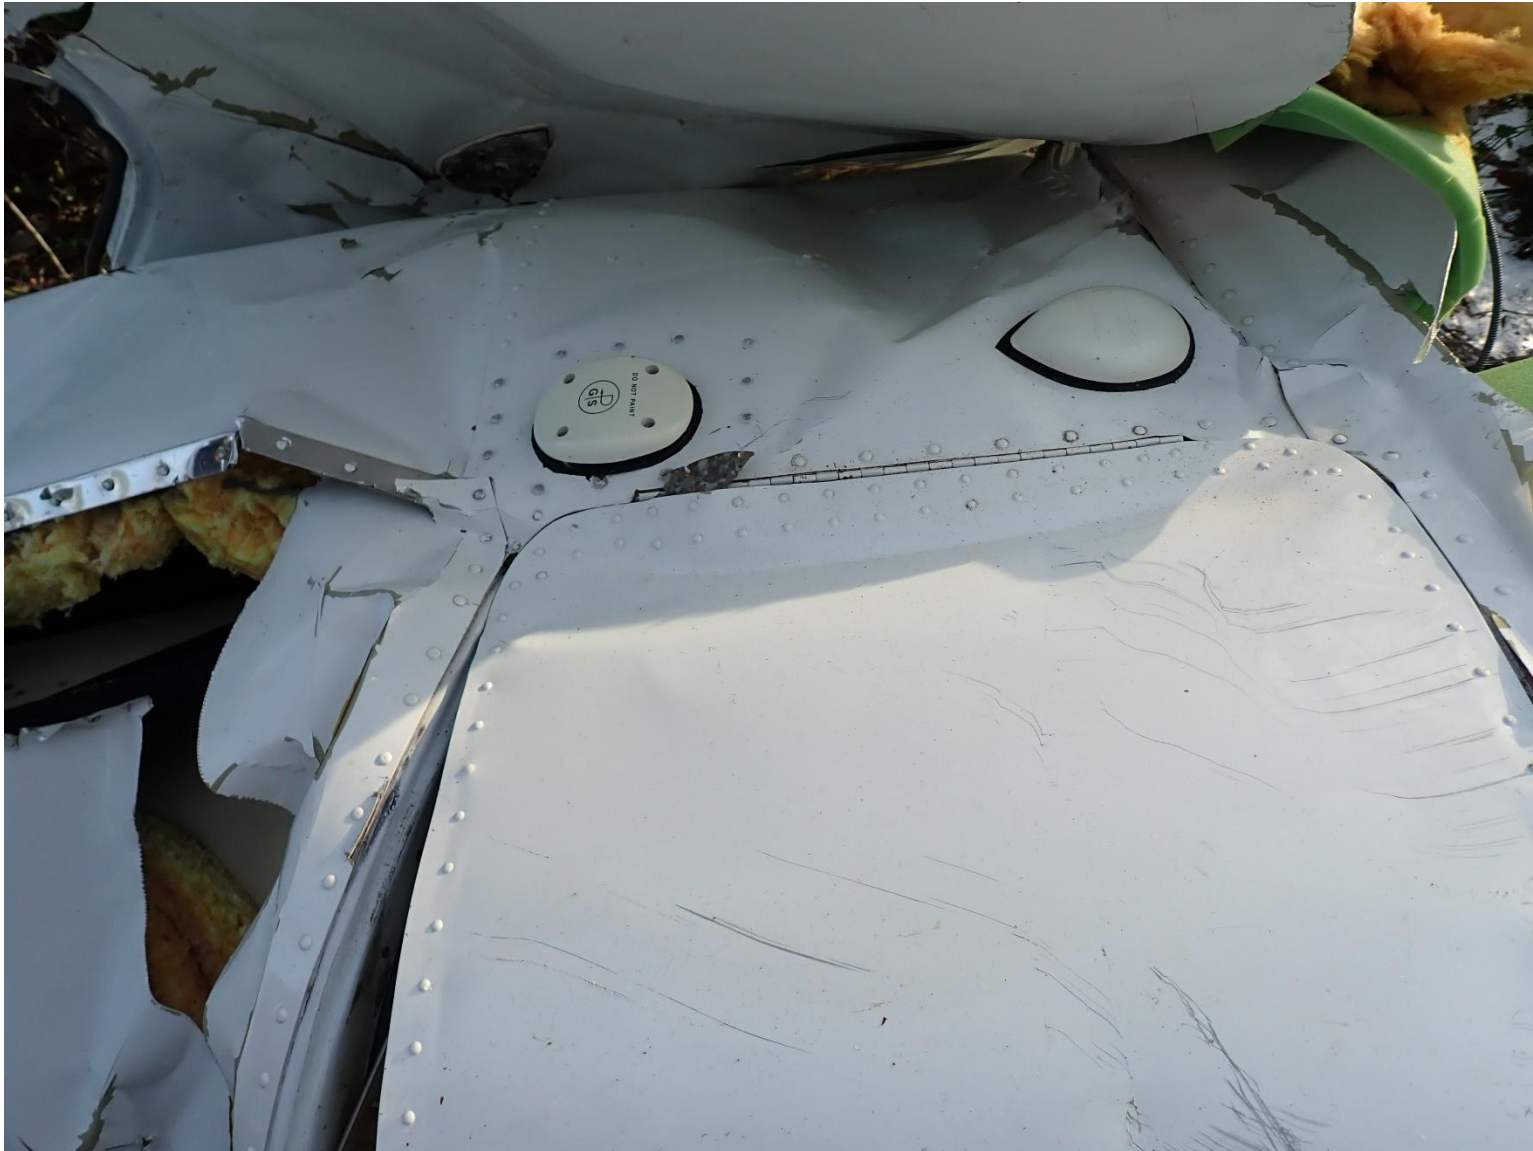
**Photograph 4 - Baggage door in the closed position**

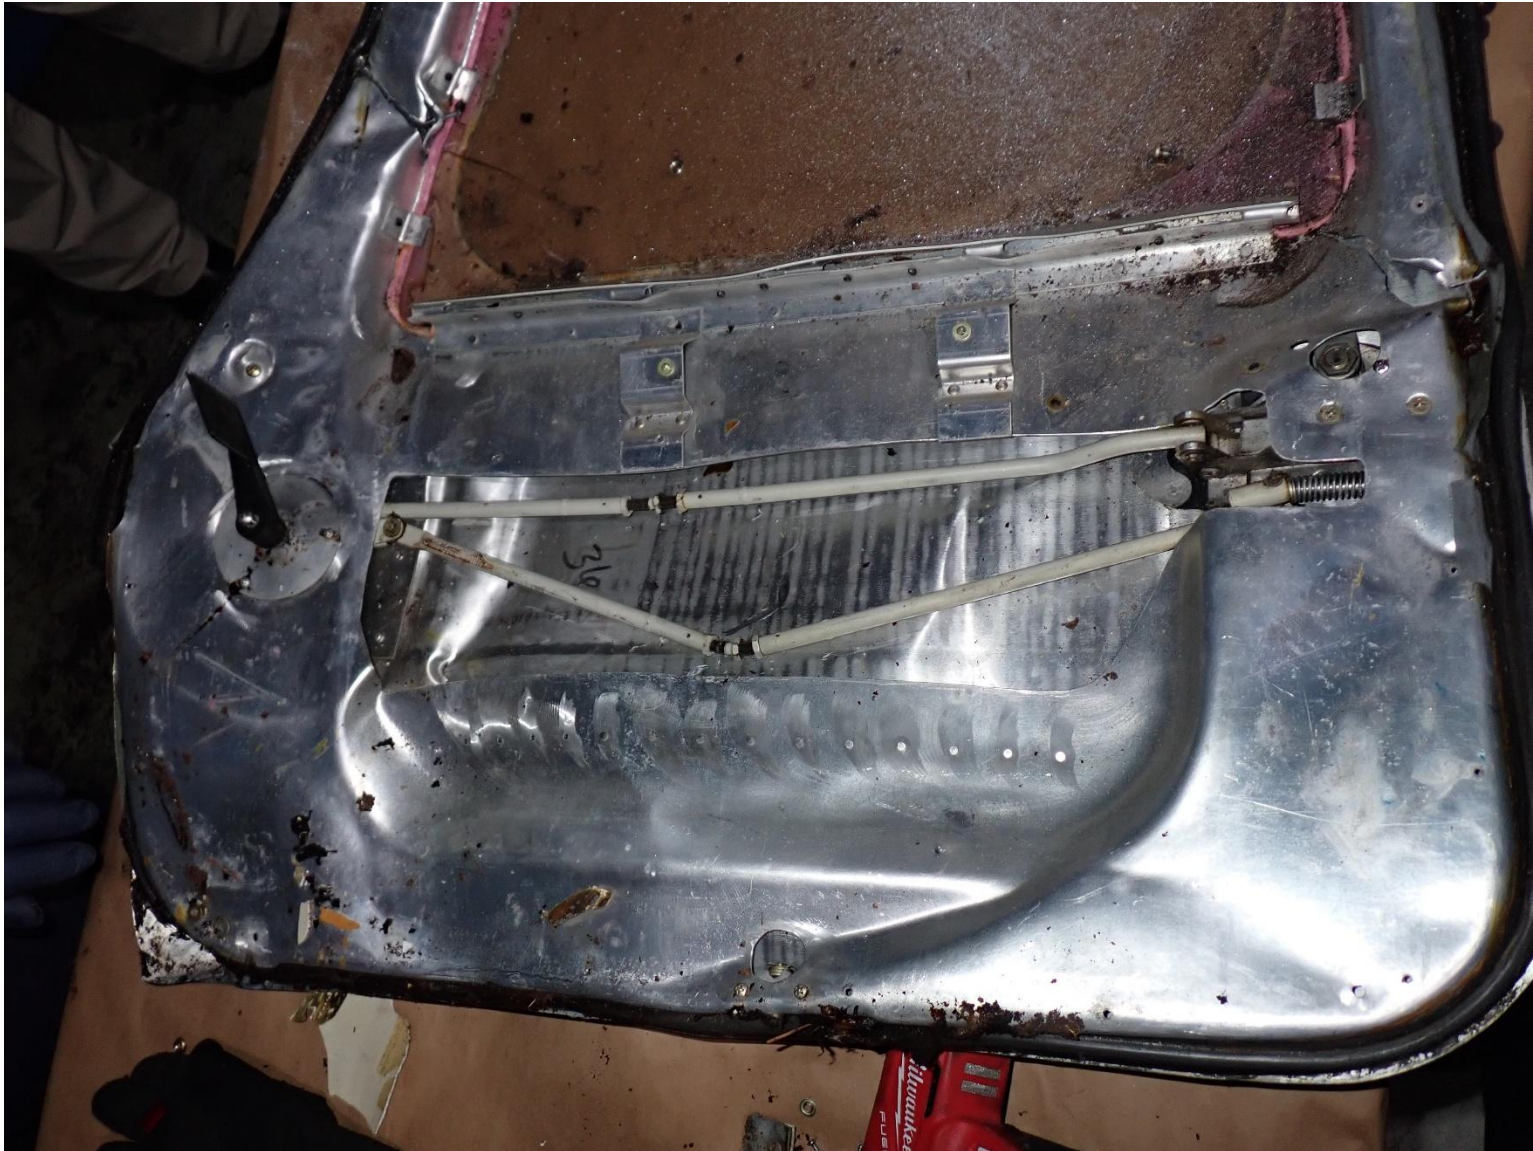
**Photograph 5 - Main cabin door after partial disassembly**

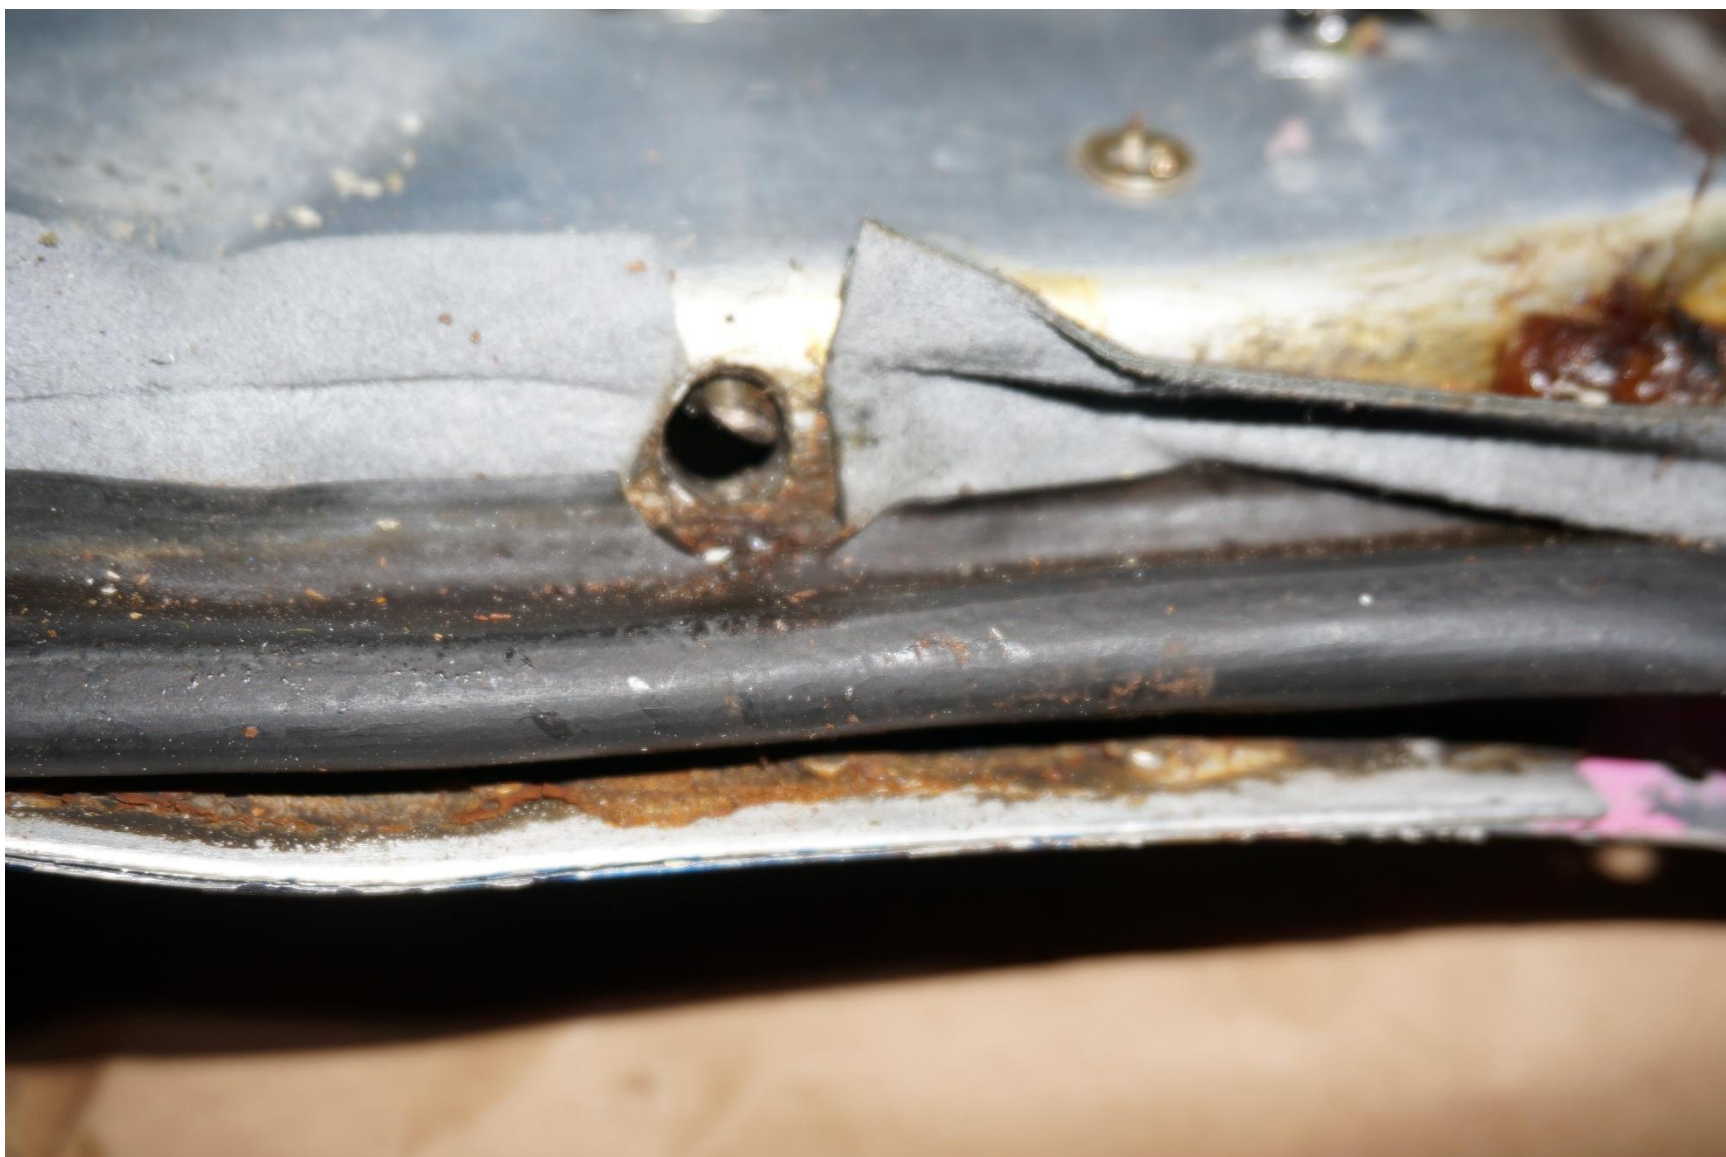
**Photograph 6 - Main cabin door aft latch pin**

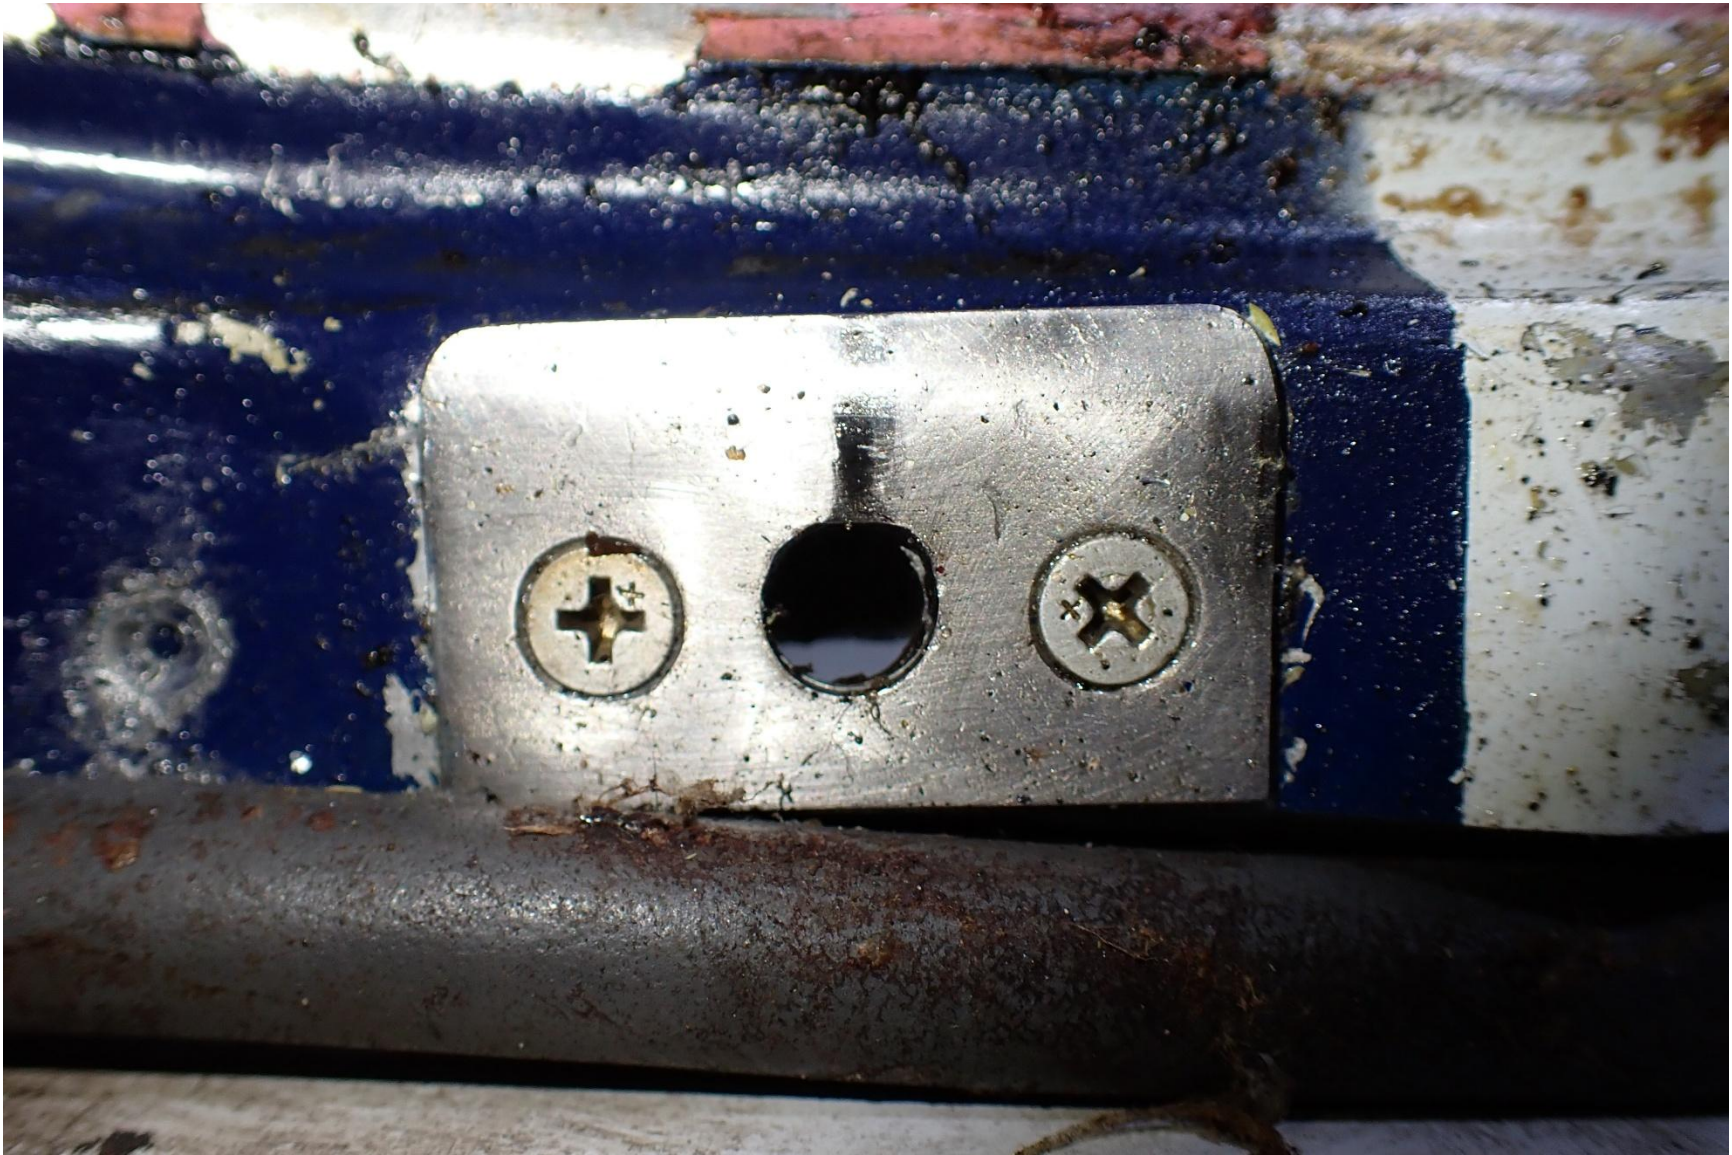
**Photograph 7 - Main cabin door aft striker plate**

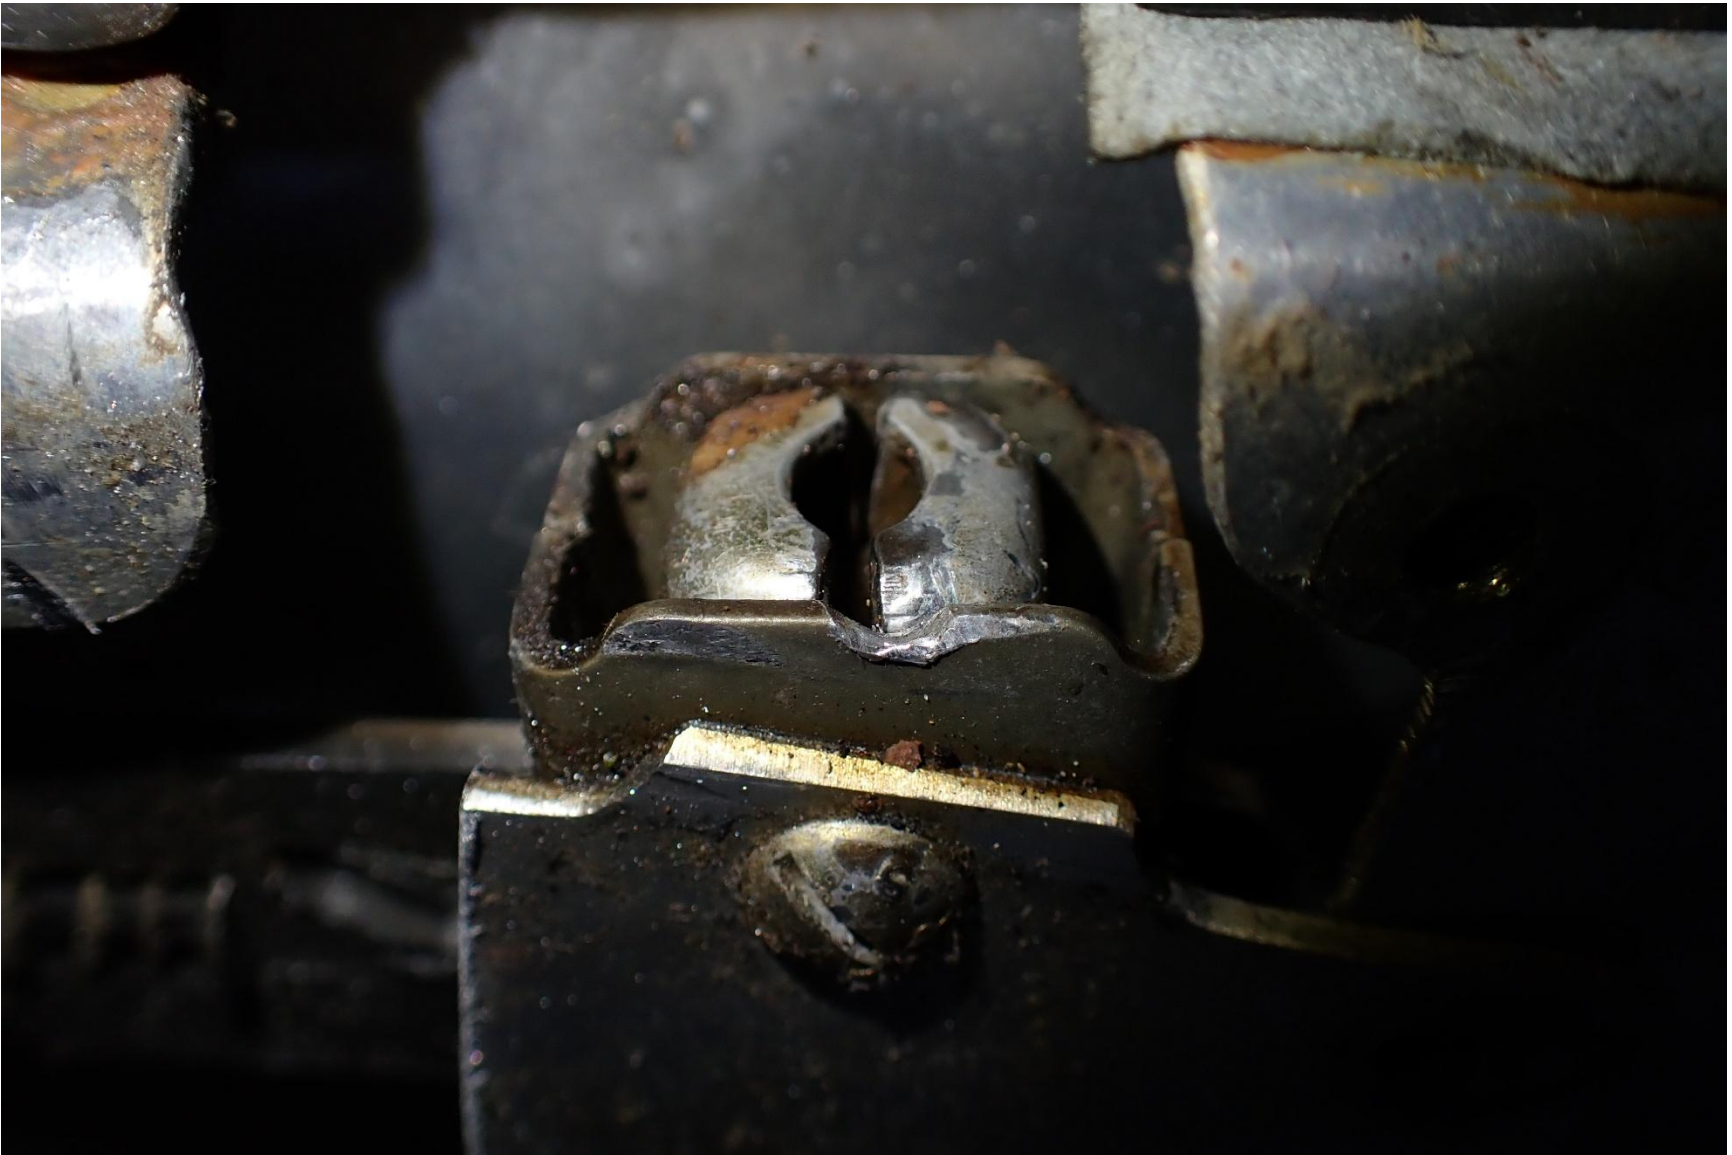
**Photograph 8 - Main cabin door upper latch**

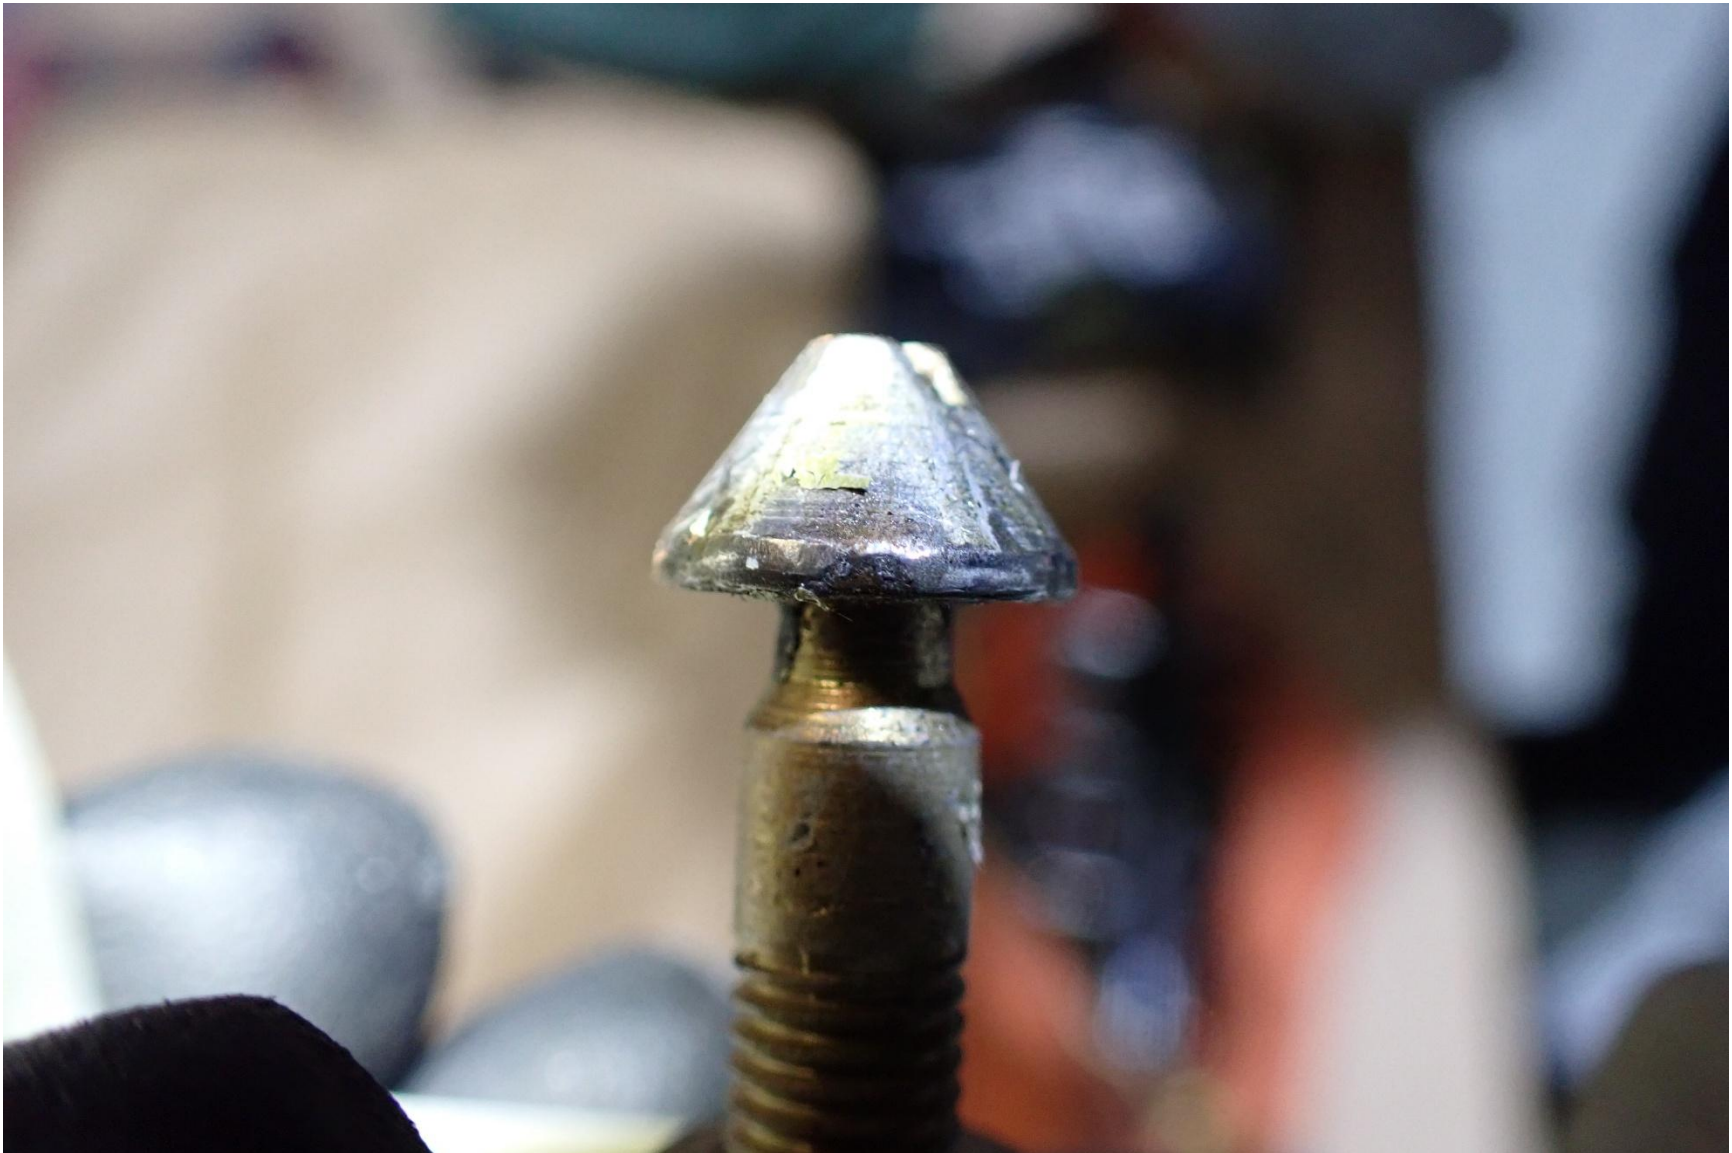
**Photograph 9 - Main cabin door upper latch pin**
