# National Transportation Safety Board

ERA24FA157

## **MATERIALS LABORATORY**

Factual Report 24-084

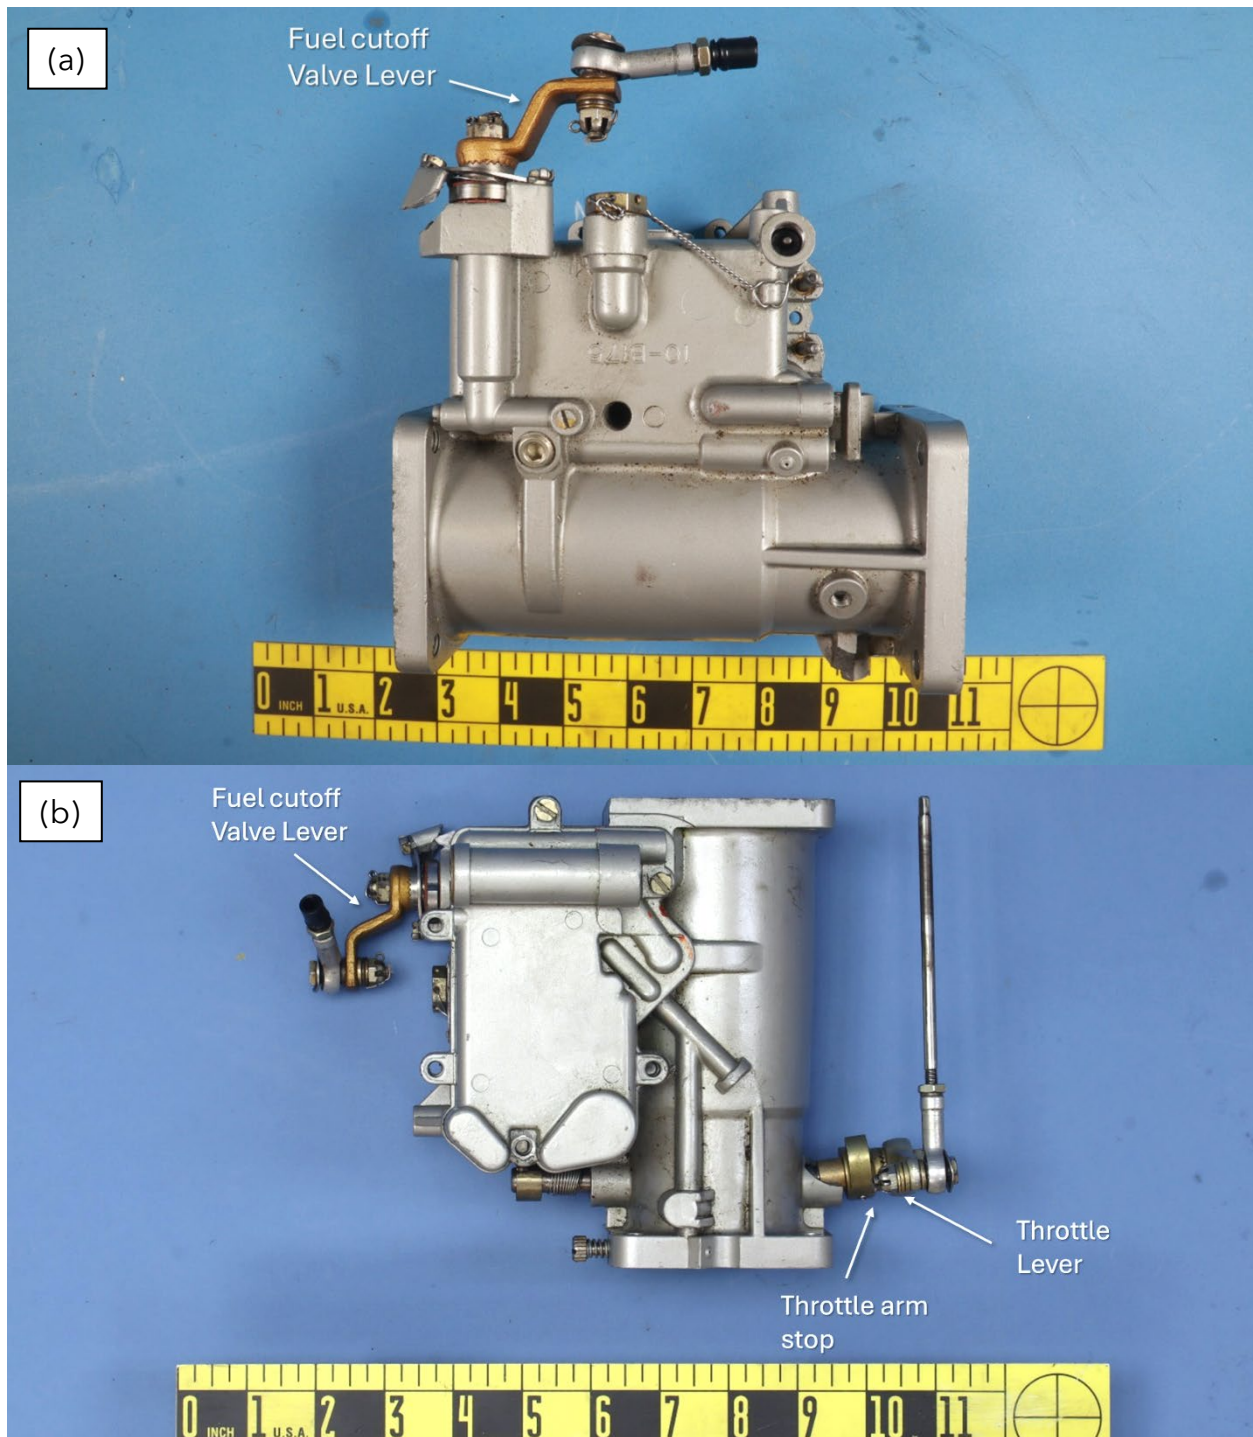
Figure 1 shows the carburetor assembly, as received. There were two areas of the housing that had fractured located at hollow bosses, as identified in Figure 1. These were near the fuel cut off assembly lever and the throttle shaft and lever arm assembly. Highlighted in Figure 1b, the levers at these fractured bosses also exhibited bending deformation. On the left side, the mixture control lever had been bent away from the housing, whereas the throttle lever and stop assembly on the right side had been bent back toward the carburetor.

Figure 1. Rotated views of the carburetor from the housing, annotated to show some of the fractured locations.

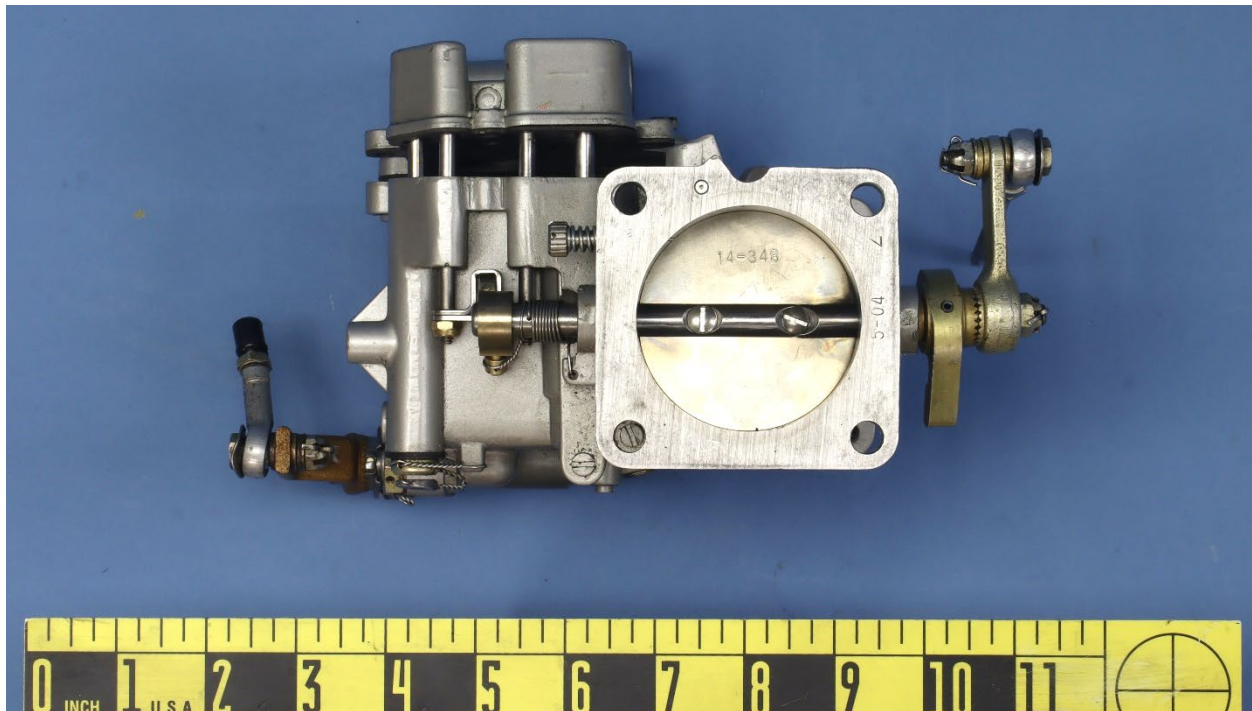
Figure 2 shows the throttle side of the carburetor, showing the throttle arm and stop assembly attached to the circular valve (or plate) and the throttle lever arm on the right. Figure 3 shows a closer view of the interior of the carburetor, displaying the lever arm attached to the throttle valve with two screws. The screws were not oriented parallel to each other. The area of the arm surrounding the right screw had fractured (see Figure 4).

Figure 2. View of the carburetor, rotated to show the fuel cutoff valve assembly on the left, and the throttle lever and throttle arm assembly on the right.

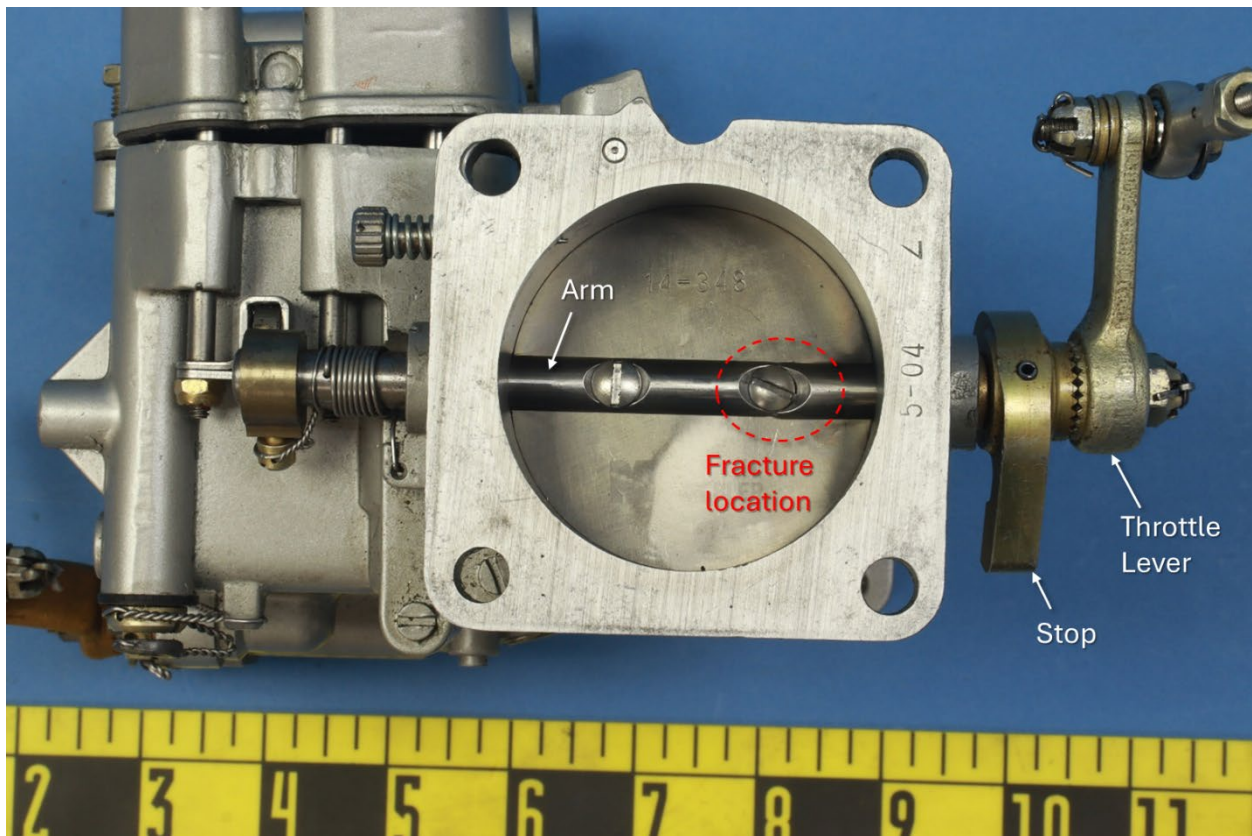
Figure 3. Closer view of Figure 2, showing the fractured throttle shaft and the disengaged teeth from the throttle lever (right).

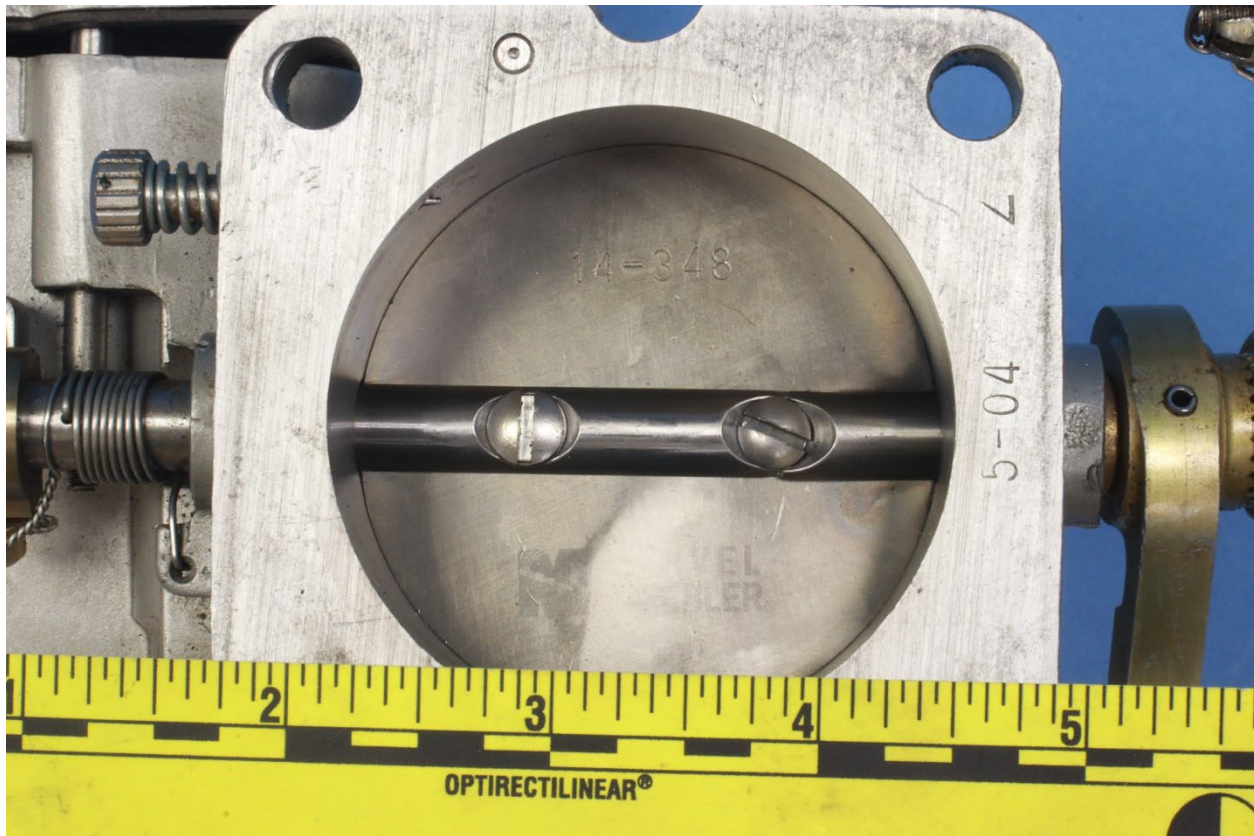
Figure 4. Closer view of the valve and throttle arm assembly in the body assembly interior.

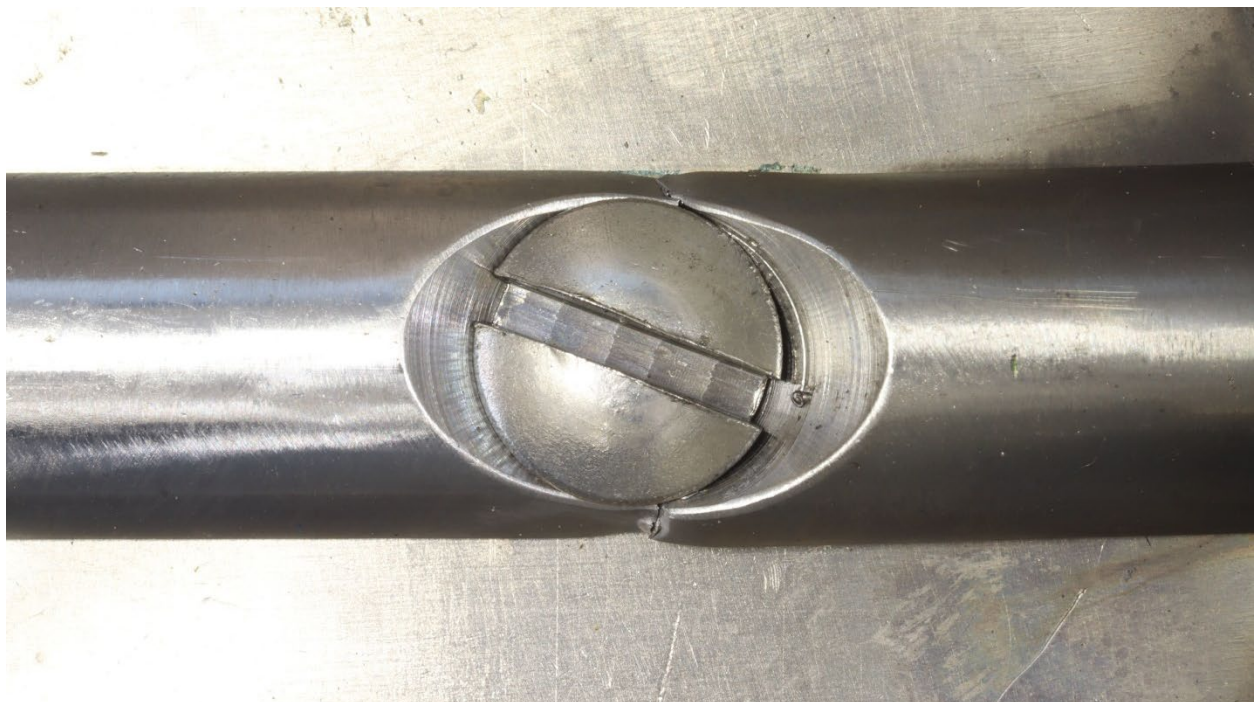
As illustrated in Figure 5, the arm around the right screw hole exhibited localized necking, or plastic thinning deformation around the hole. The arm had also fractured at this hole location, indicated by the vertical dark lines. Figure 6 shows a closer view of the arm as affixed to the throttle valve, via two screws. Figure 7 shows the right screw and the arm around it. The arm exhibited localized thinning deformation, or necking, adjacent to the screw.

Figure 5. View of the fractured shaft and position of the screw, as received.

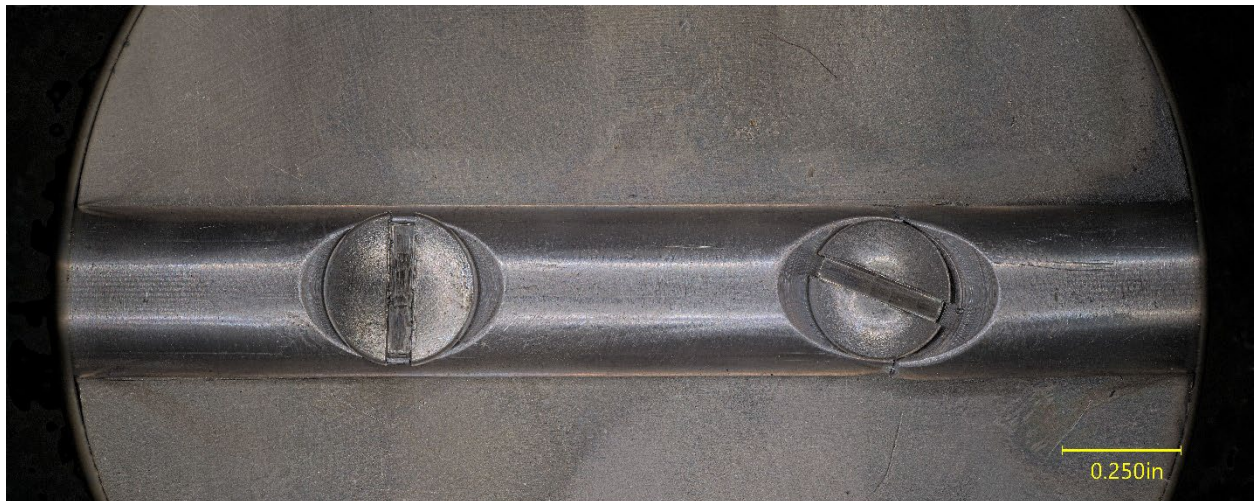
Figure 6. View of the throttle arm, as received when still attached to the valve plate.

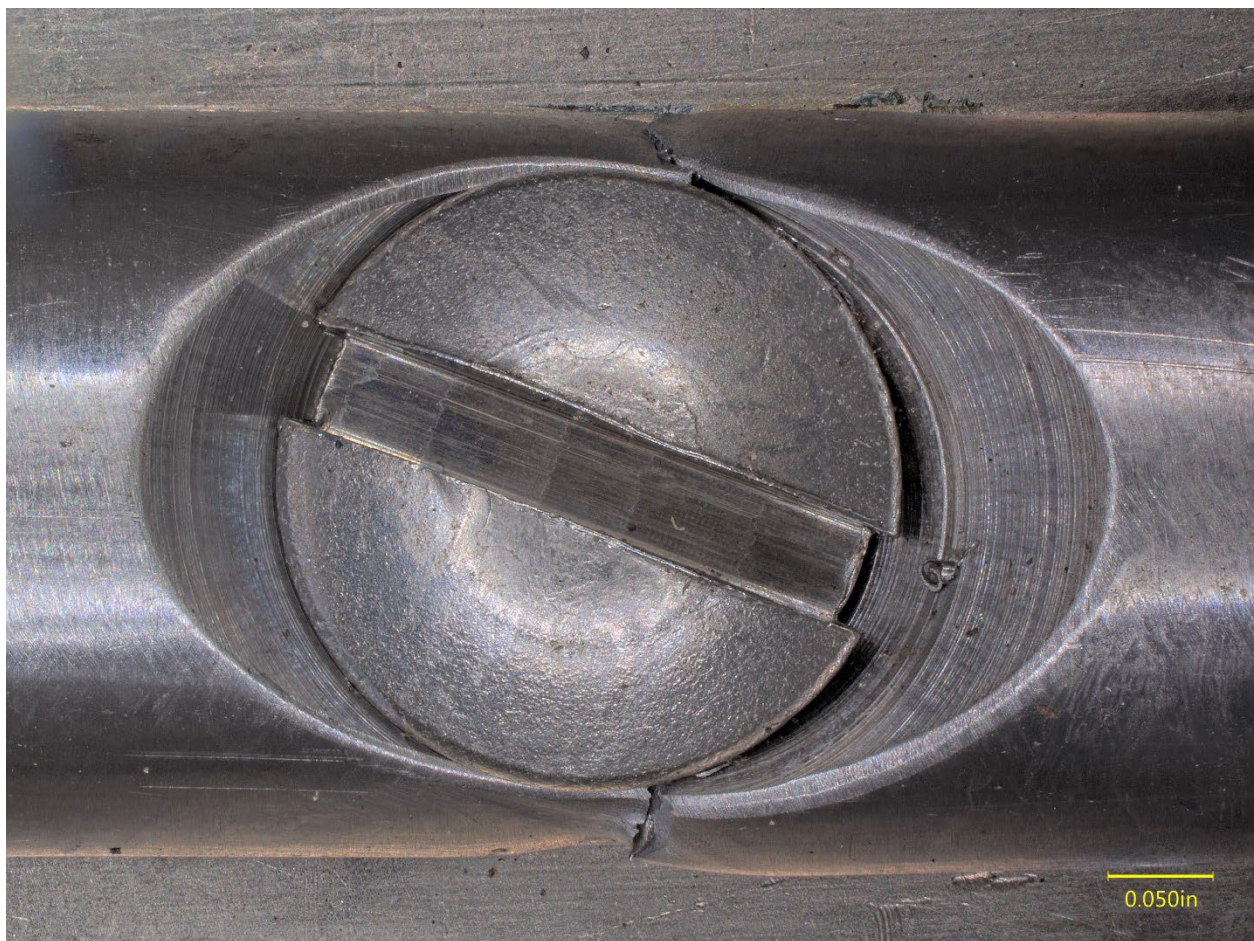
Figure 7. View of the fractured arm around the right throttle valve screw in Figure 10.

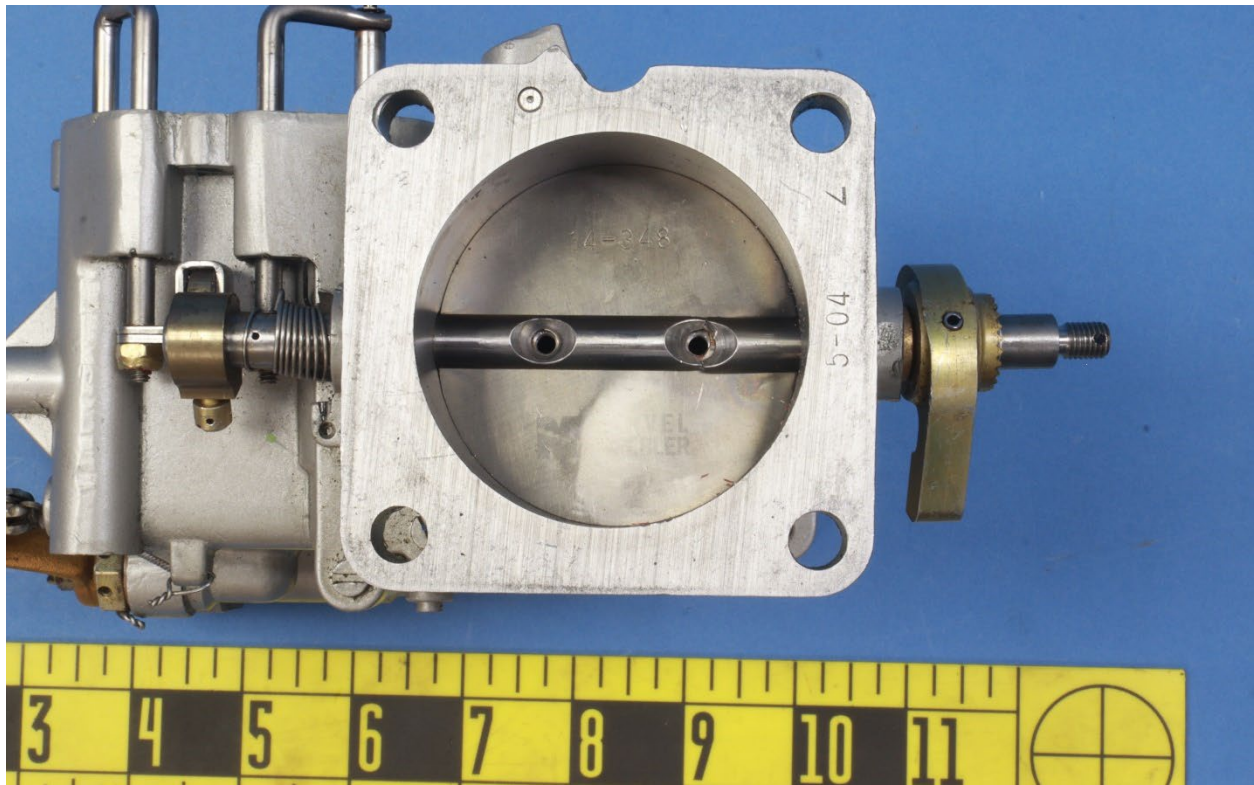
The throttle arm was disassembled from the valve sequentially. Figure 8 shows the valve and arm after removal of the screws. This view demonstrates that the arm had fractured around the right screw hole, but was still intact on the left hole. The throttle valve plate was jammed into the position as received, and when removed, the inner surface of the housing revealed a black crescent witness mark, shown in Figure 9.

Figure 8. View of the throttle arm assembly inside the carburetor, after removal of the screws.

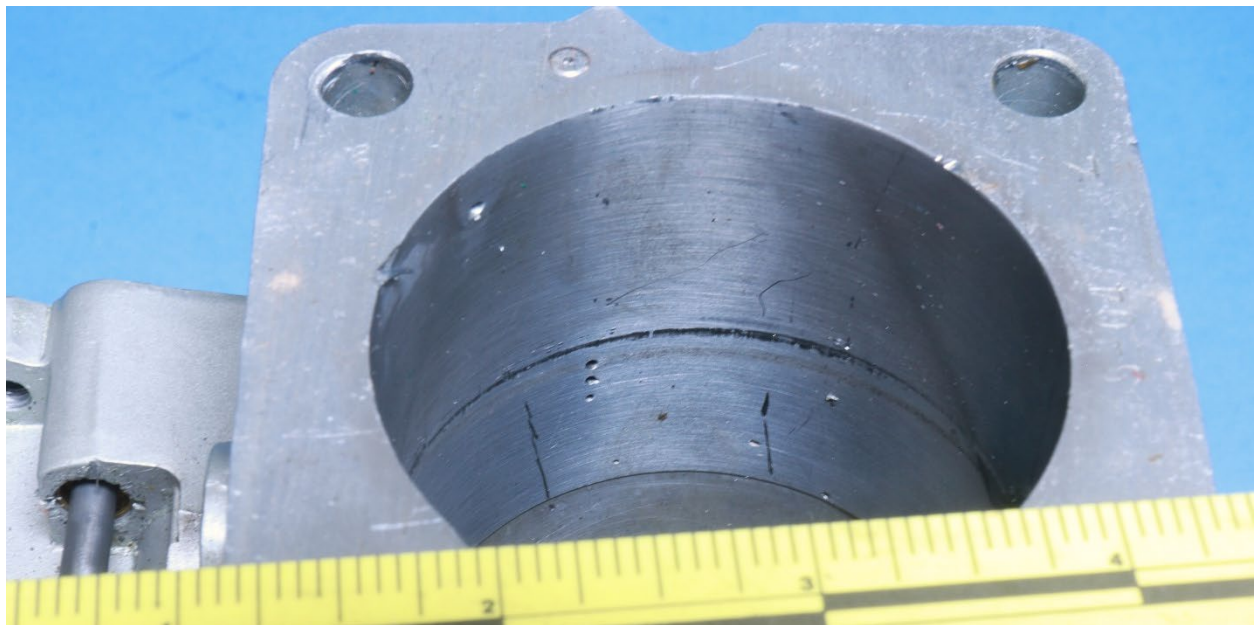
Figure 9. Angled view of the interior of the carburetor housing, after removal of the throttle arm assembly and plate, showing the circular witness mark in the bore from the plate edge.

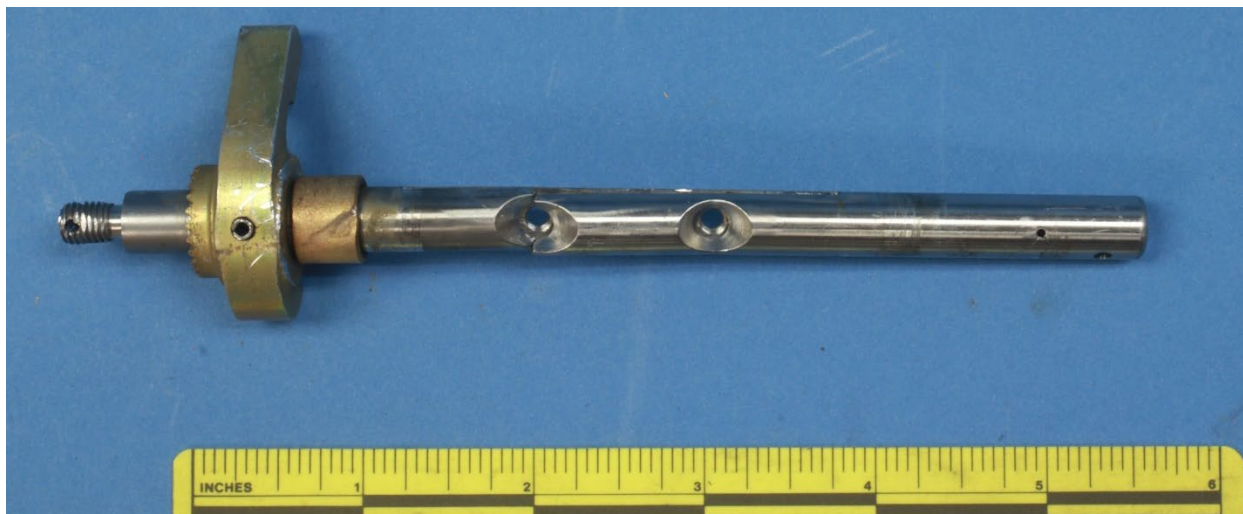
Figure 10. The throttle arm and stop assembly, after disassembly from the carburetor body assembly.

The arm assembly was removed from the carburetor, as is shown in Figure 10. Figure 11a shows the arm from the side, demonstrating the bending deformation of the shaft about the stop, pinned to the arm on the right in the figure. Figure 11b. shows the deformed arm from the opposite side, showing the outward bowing of the arm half that had fractured about the screw hole. The arm exhibited two fracture locations, which were oriented perpendicular to the arm longitudinal direction. Once the screw was removed, the fracture surfaces and near side of the arm on the near side of the slot shifted position, demonstrated in Figure 12.

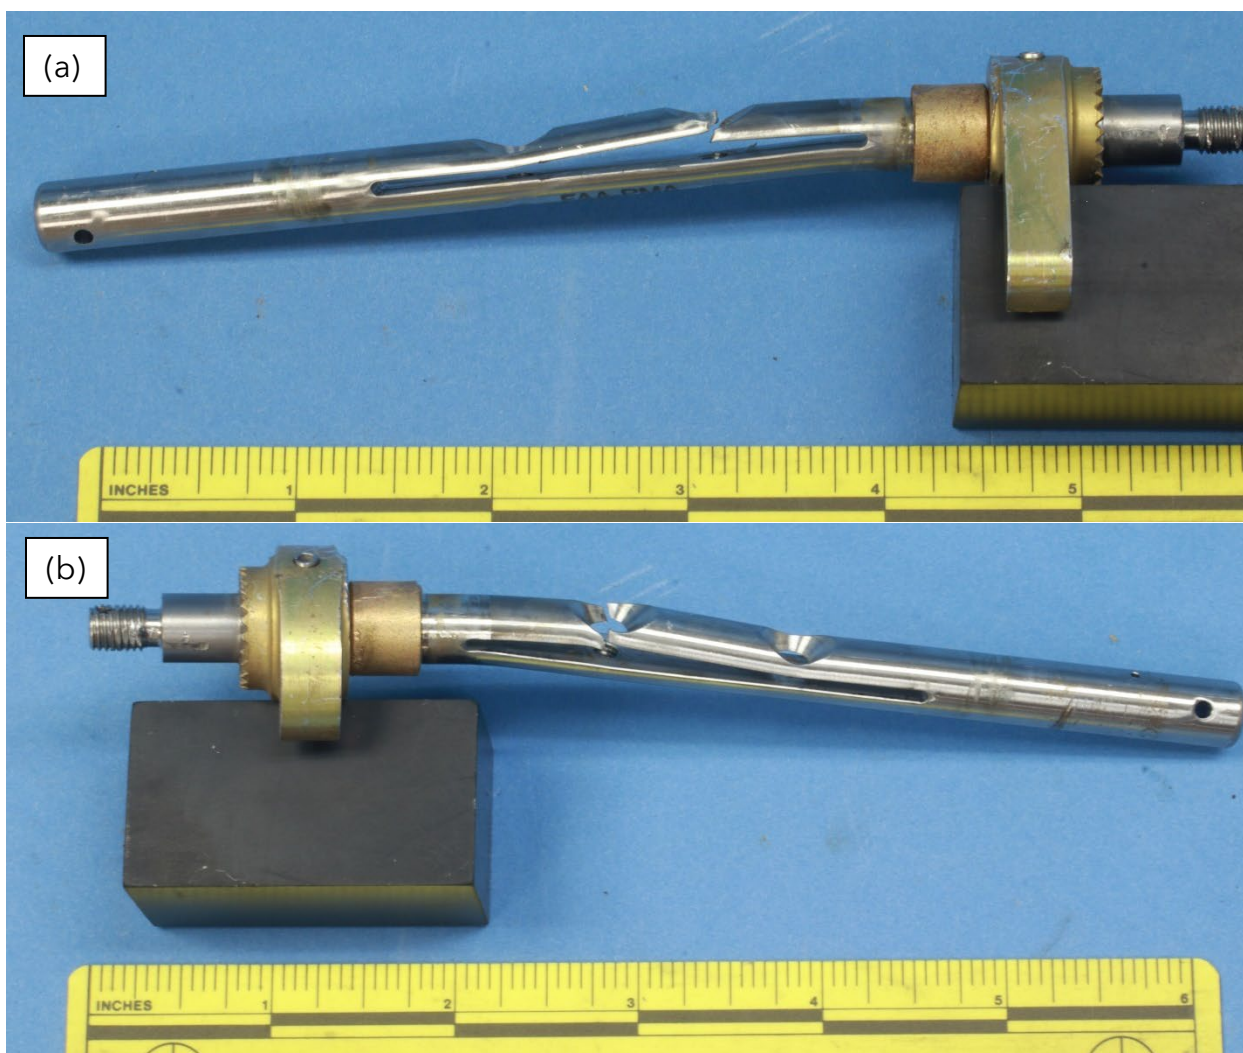
Figure 11. Side view of the fractured and deformed throttle arm and stop assembly.

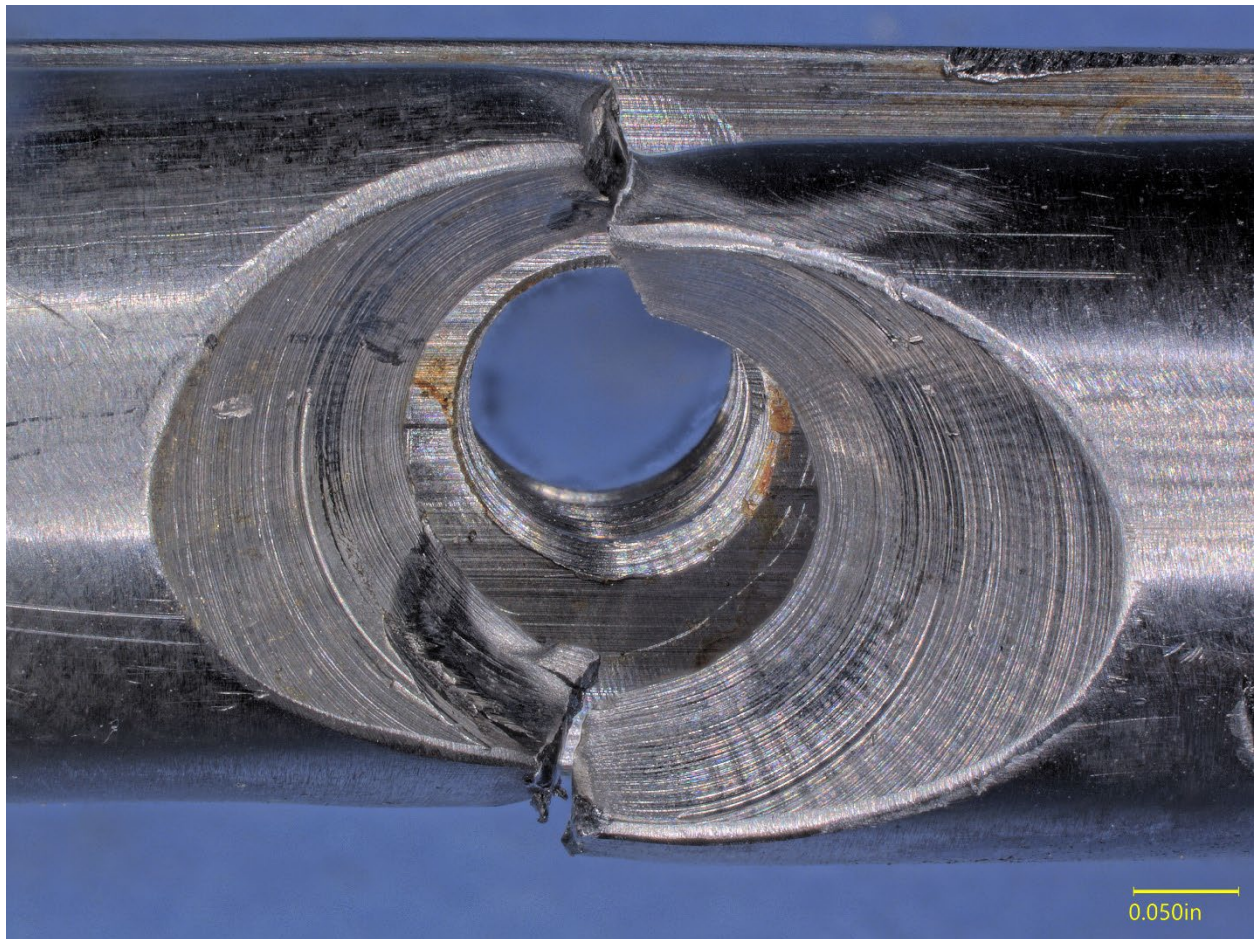
Figure 12. View of the fractured area of the throttle arm from Figure 11, after disassembly from the valve.

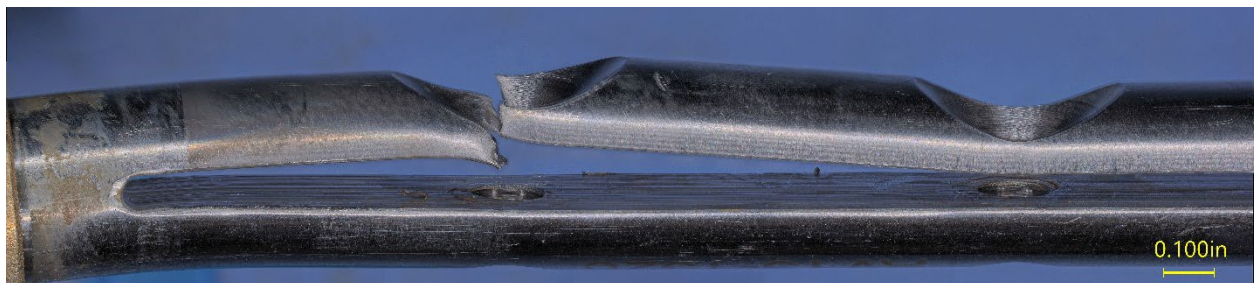
Figure 13 shows a closer view of the side of the throttle arm that had been attached to the valve by the two screws. Figure 14 shows opposite side views of the throttle arm fracture surfaces, after disassembly. The material near the fracture surfaces exhibited necking. The surfaces also exhibited upward or downward shearing deformation, antiparallel to each other, consistent with up and down shearing deformation, as oriented in the figures.

Figure 13. Side view of the throttle arm, showing the upward bending of part of the arm and shearing deformation and necking about the filaments around the screw hole.

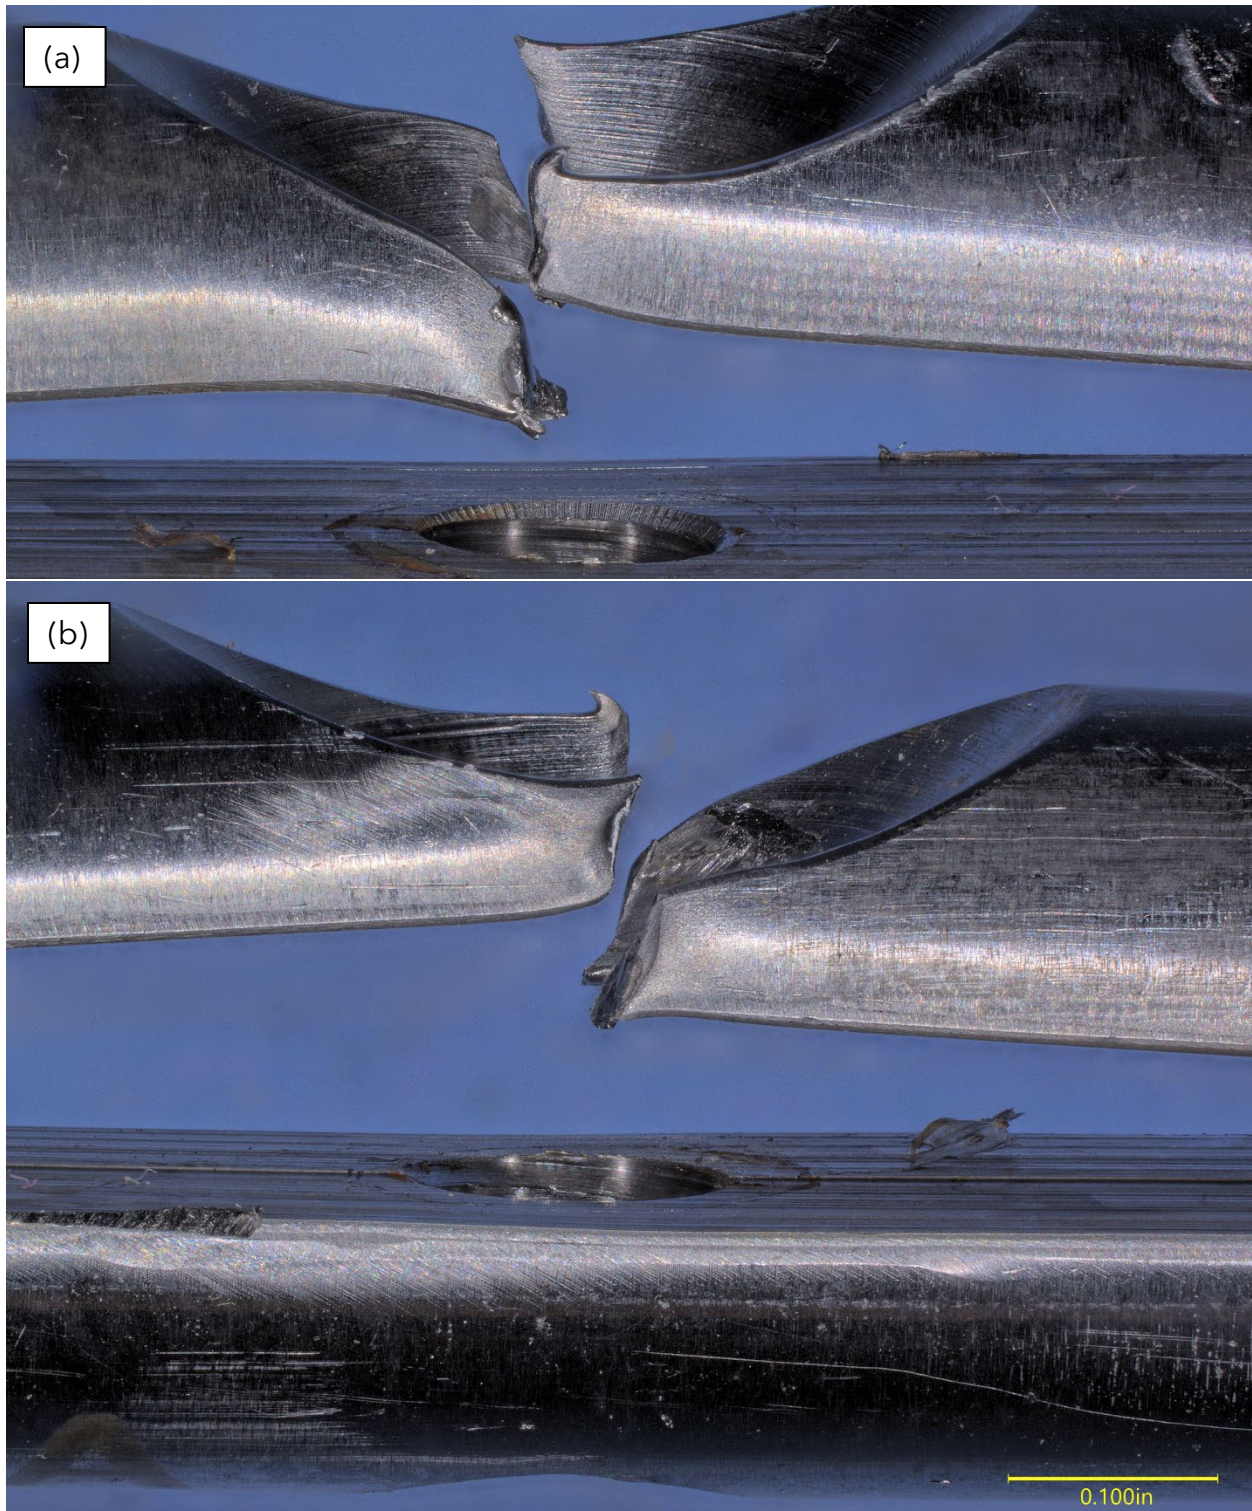
Figure 14. Side views of the fractured arm half, viewed from opposite sides.

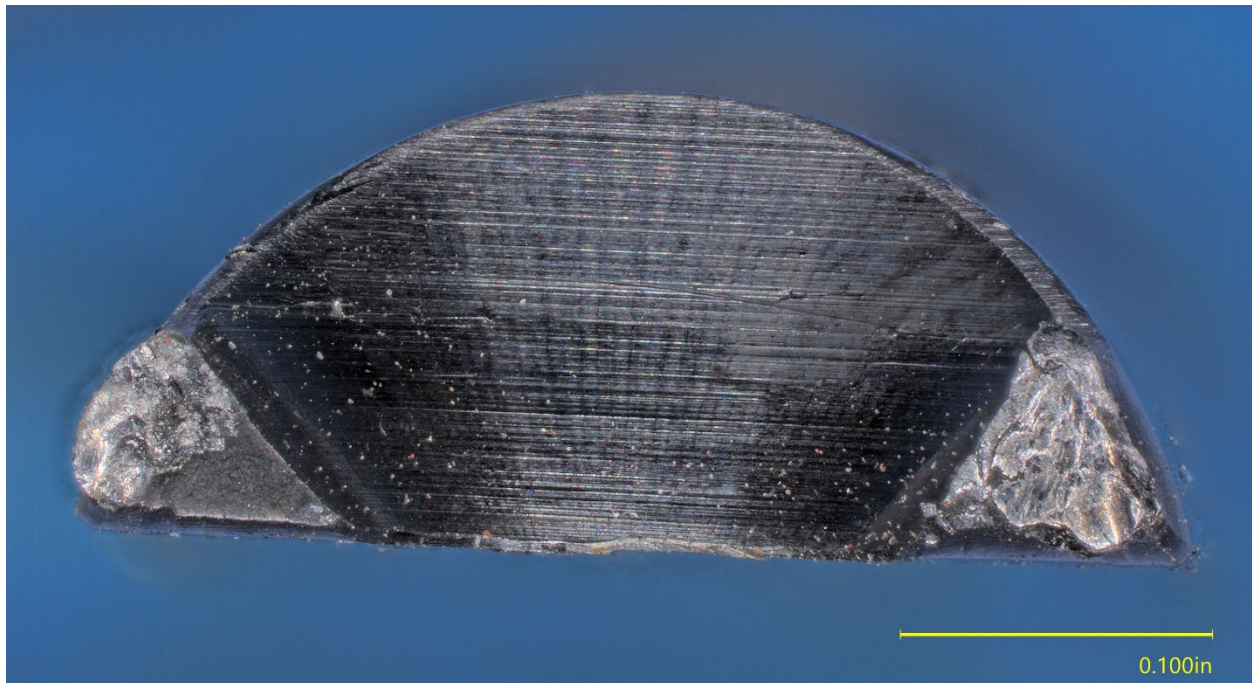
The intact half of the arm on the far side of the slot was sectioned to allow examination of the fracture surfaces. One of the mating sides is shown in Figure 15. Much of the fracture surfaces exhibited flat, reflective regions, consistent with smearing from post-fracture damage. These smeared regions were mirrored on the mating sides, indicating contact and rubbing of these surfaces after fracture.

Figure 15. Direct view of two of the fractured filaments of the upper throttle arm.

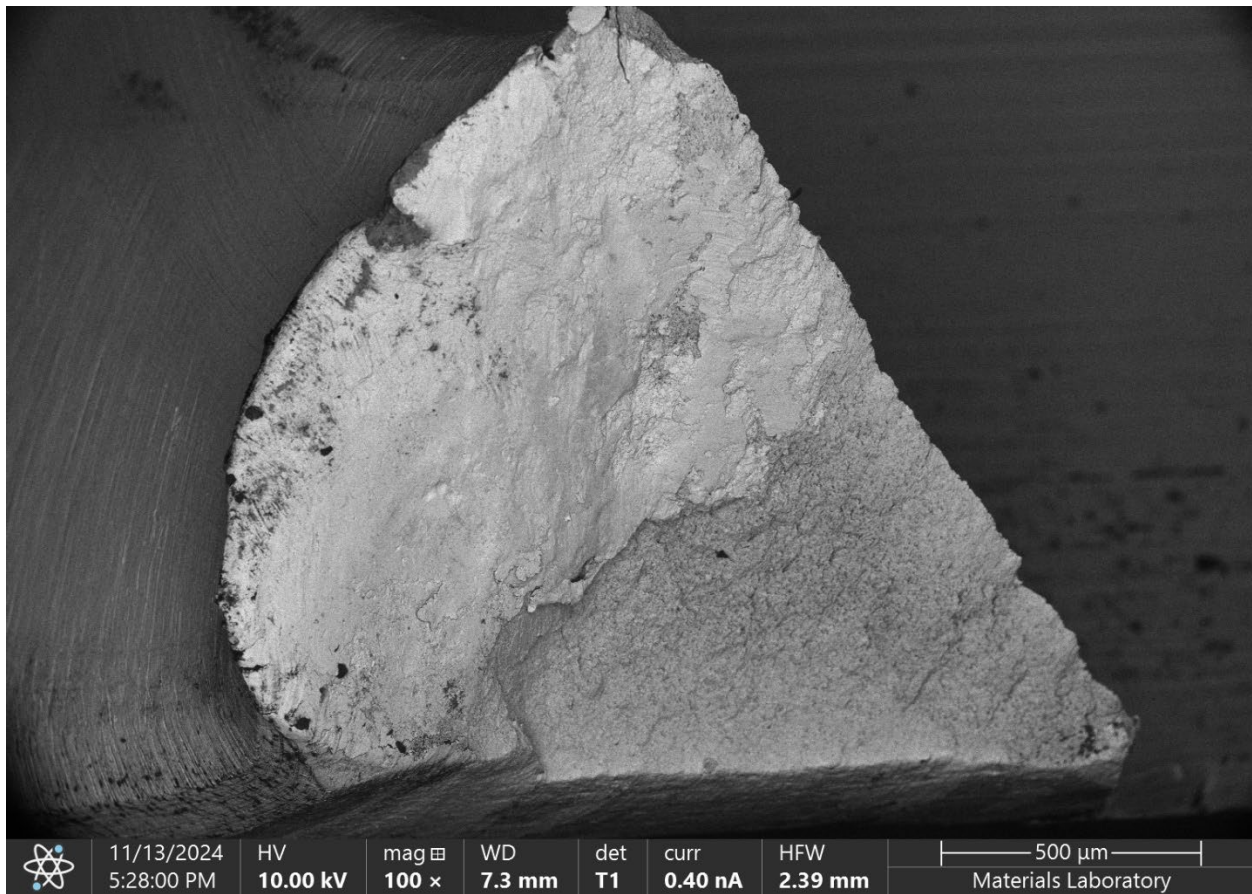
The areas that were undamaged were examined using a field emission scanning electron microscope (SEM). Figure 16 shows one of the fracture sides. The undamaged area exhibited dimpled rupture, as typified in Figure 17. These features were consistent with overstress fracture of the arm about the screw hole, in tensile, bending, and shearing directions.

Figure 16. Backscattered electron (BE) micrograph of the left filament surface in Figure 15.

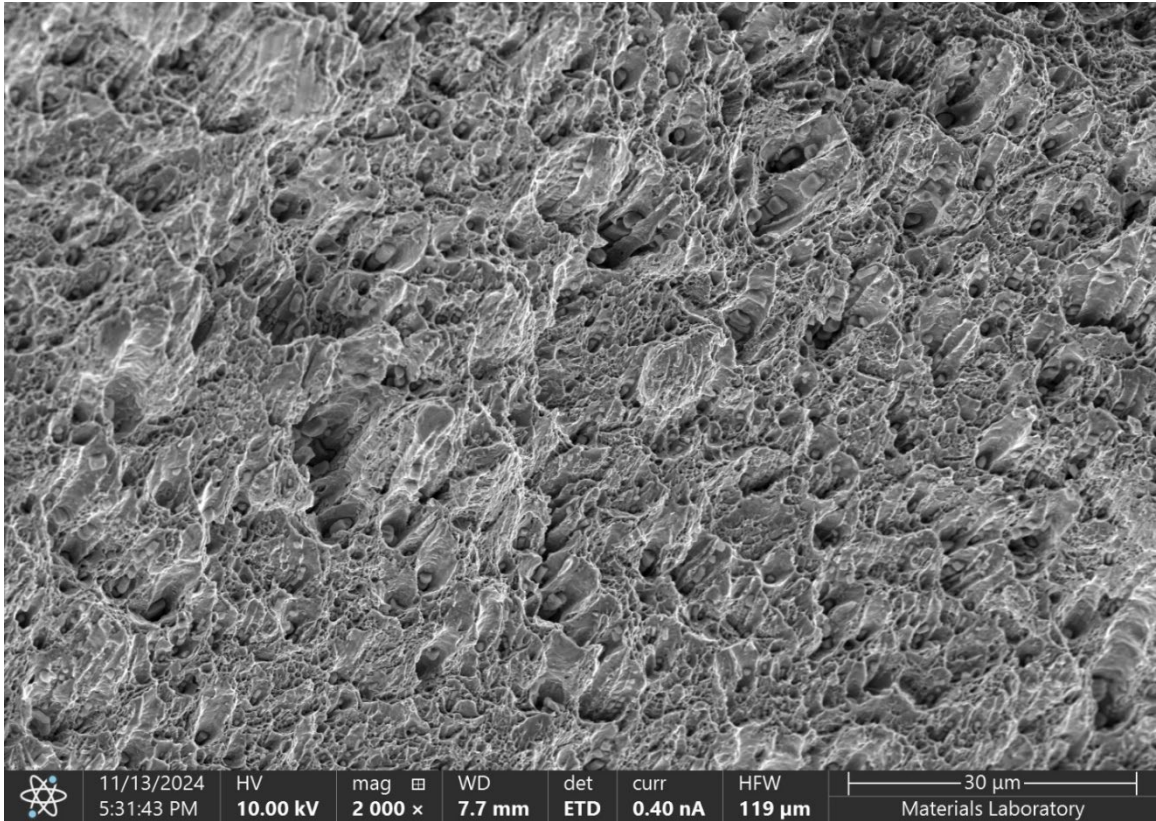
Figure 17. Secondary electron (SE) micrograph of dimpled rupture on the fracture surface in Figure 16.

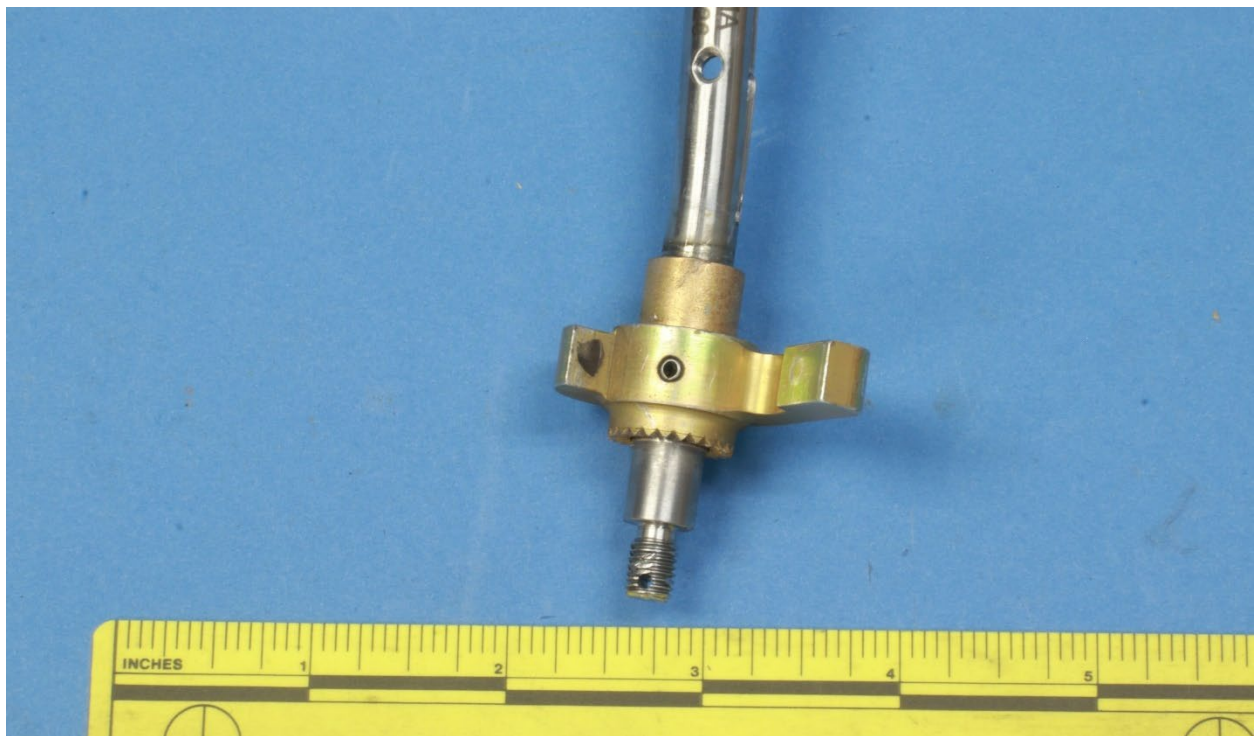
Figure 18. The end of the throttle shaft with the stop end.

Figure 18 and Figure 19 highlight the throttle arm stop, with a sawtooth-shaped face that mates with the throttle lever. When still assembled, the deformation in the throttle arm manifest as rightward-facing bending of the stop, consistent with a missing portion of the cylindrical housing boss (Figure 19). The throttle lever was still attached by way of bolt and nut, secured with a cotter pin. The interlocking teeth between the mating faces of the arm stop and the throttle lever were not settled, and they exhibited play and separate rotational movement intermittently when the lever was actuated. Figure 20 shows a closer view of the interlocking teeth while still assembled. In this position, the lever could move about the stop. The lever teeth, on the right side in Figure 20, exhibited rounding relative to the more pronounced points of the stop. Figure 21 shows the condition of the teeth when the lever is rotated to seat the teeth together.

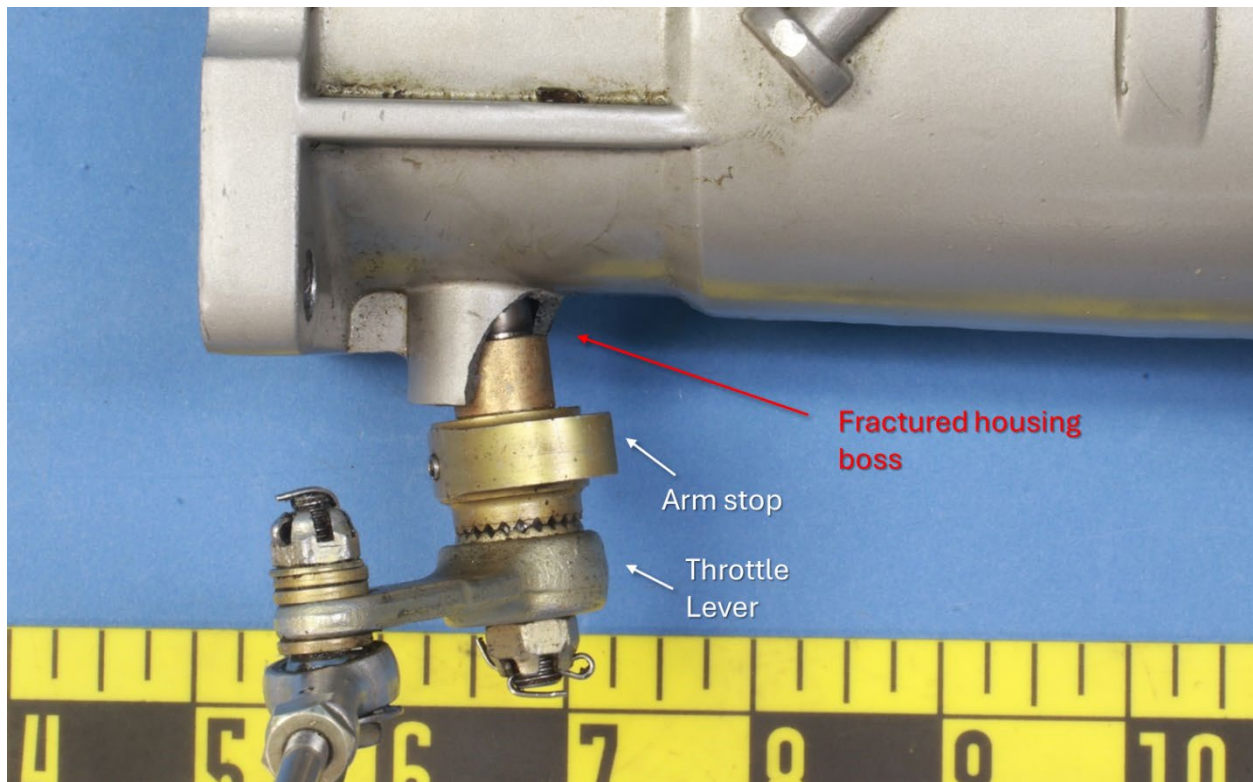
Figure 19. The joint of the throttle arm stop and lever arm, showing rightward deformation and the boss housing fracture.

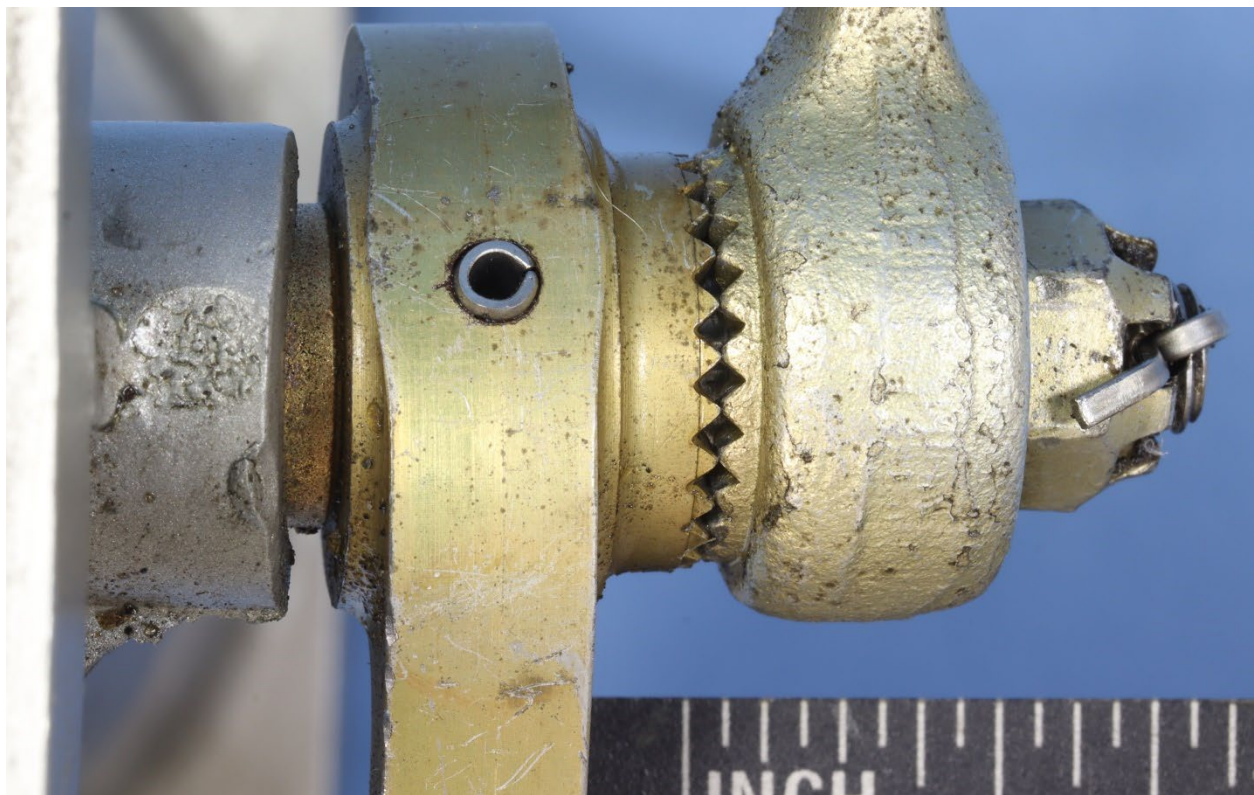
Figure 20. View of the engagement teeth between the throttle lever (right) and stop (left).
