# National Transportation Safety Board

ERA24FA157

## **MATERIALS LABORATORY**

Factual Report 24-084

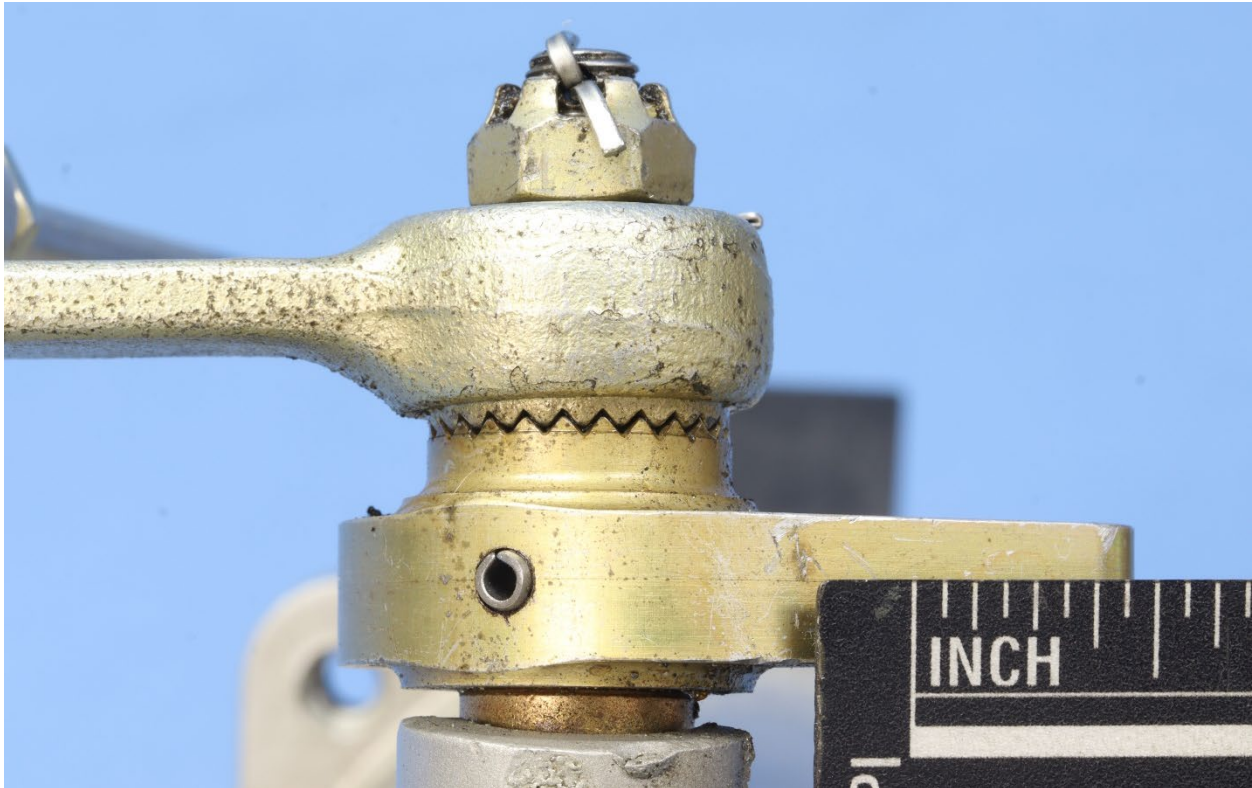
Figure 18 and Figure 19 highlight the throttle arm stop, with a sawtooth-shaped face that mates with the throttle lever. When still assembled, the deformation in the throttle arm manifest as rightward-facing bending of the stop, consistent with a missing portion of the cylindrical housing boss (Figure 19). The throttle lever was still attached by way of bolt and nut, secured with a cotter pin. The interlocking teeth between the mating faces of the arm stop and the throttle lever were not settled, and they exhibited play and separate rotational movement intermittently when the lever was actuated. Figure 20 shows a closer view of the interlocking teeth while still assembled. In this position, the lever could move about the stop. The lever teeth, on the right side in Figure 20, exhibited rounding relative to the more pronounced points of the stop. Figure 21 shows the condition of the teeth when the lever is rotated to seat the teeth together.

Figure 21. Side view of the stop and lever teeth after rotation to full engagement.

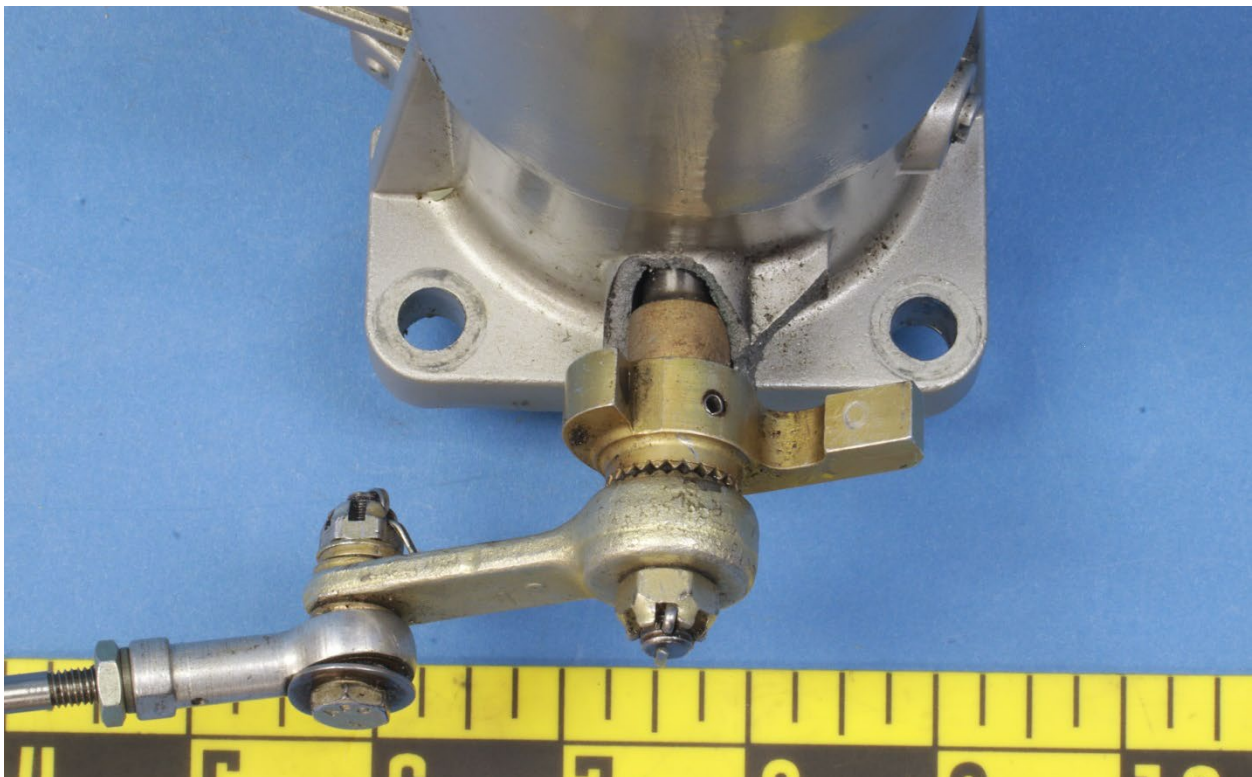
Figure 22 shows a 90° view of the fractured housing and deformed throttle arm assembly. The slanted orientation of the fractured housing was consistent with outward deformation of the boss during fracture. This direction faces the reader in Figure 22, but was in the same direction as the outward bending of the throttle arm assembly and stop shown from the side in Figure 19.

Figure 22. Angled view of the throttle arm stop and lever, as received, showing the upward bend and housing fracture.

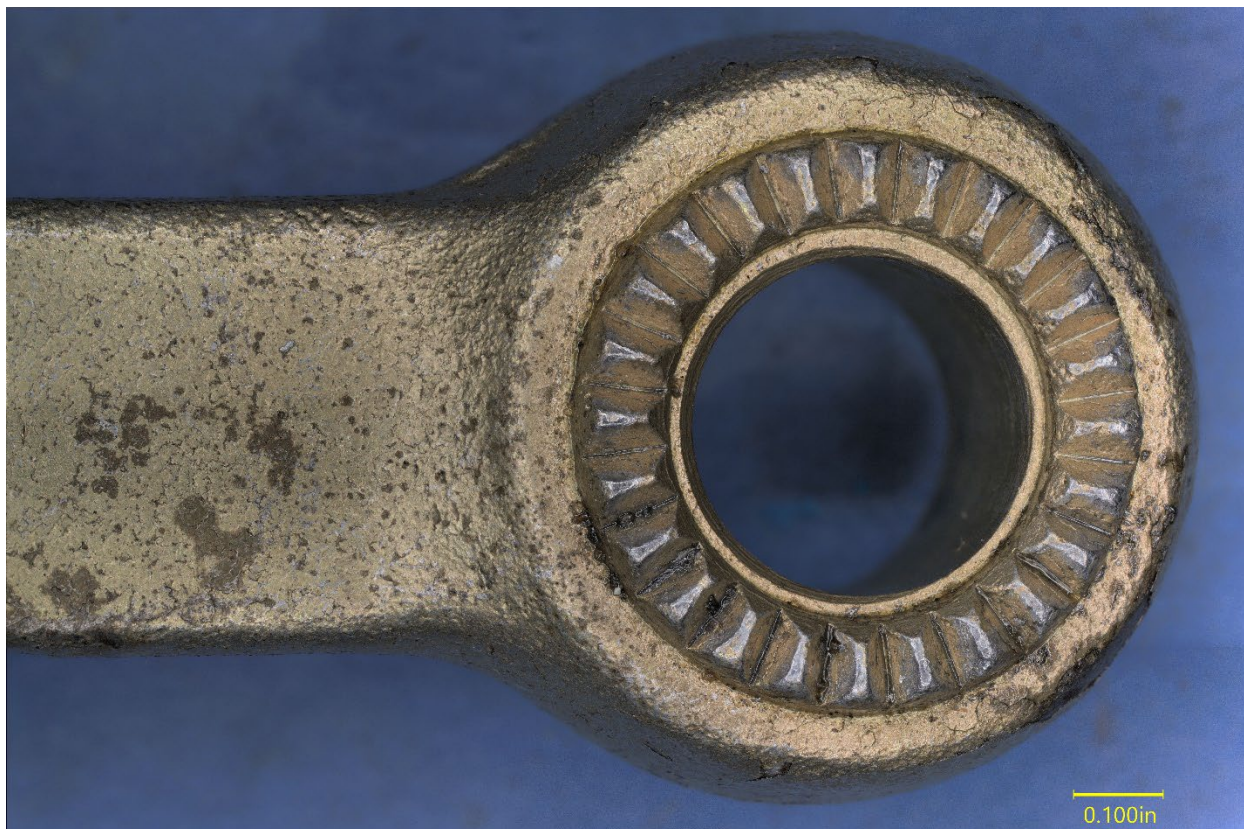
Figure 23 shows the face of the throttle lever, with the teeth that had engaged the throttle arm stop teeth facing the reader. The crests of the teeth exhibited a silver-metallic color, in contrast with the golden color of the surface coating. The sides of the lever, shown from opposite 180° locations in Figure 24, demonstrate the rounding of the teeth along the crests.

Figure 23. View of the teeth on the throttle lever, after disassembly and cleaning.

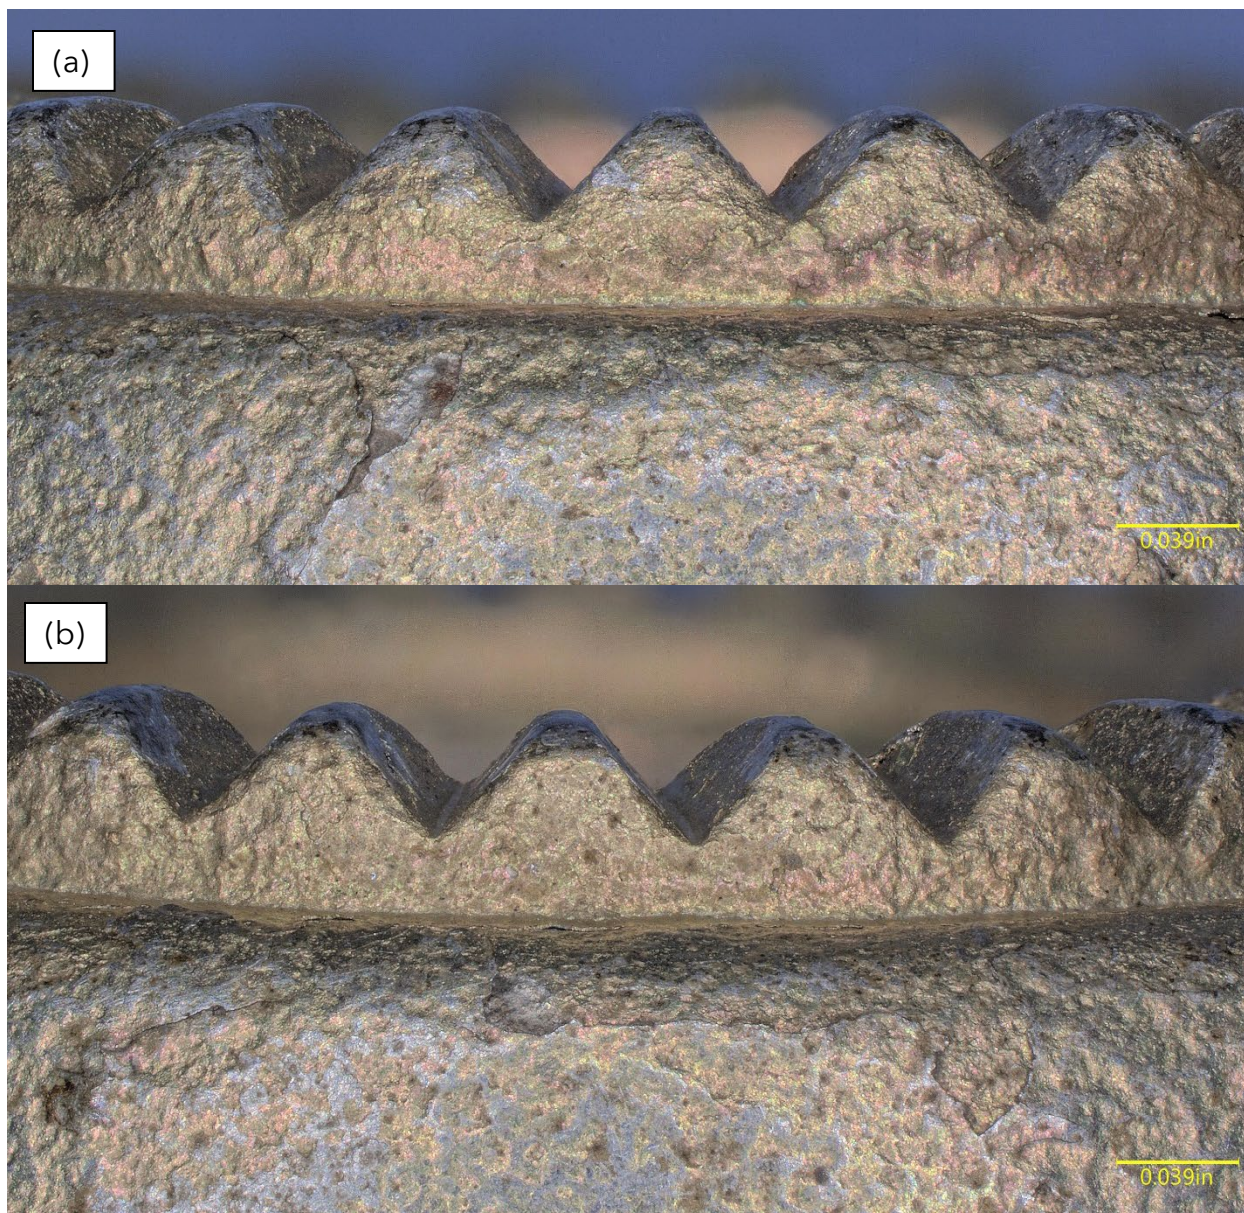
Digital calipers were used to measure several dimensions of the throttle lever. The inner diameter (hole) of the lever arm measured 0.374 inches, whereas the outer diameter measured 0.860 inches. The height of the teeth was also measured, and the height of the crests (from the back face) measured between 0.4585 and 0.4640 inches. This was a difference of 0.0055 inches, or 0.14 mm.

Figure 24. Side views of the throttle lever teeth from (a) the top of Figure 24 and (b) the bottom, showing rounding on the crests.

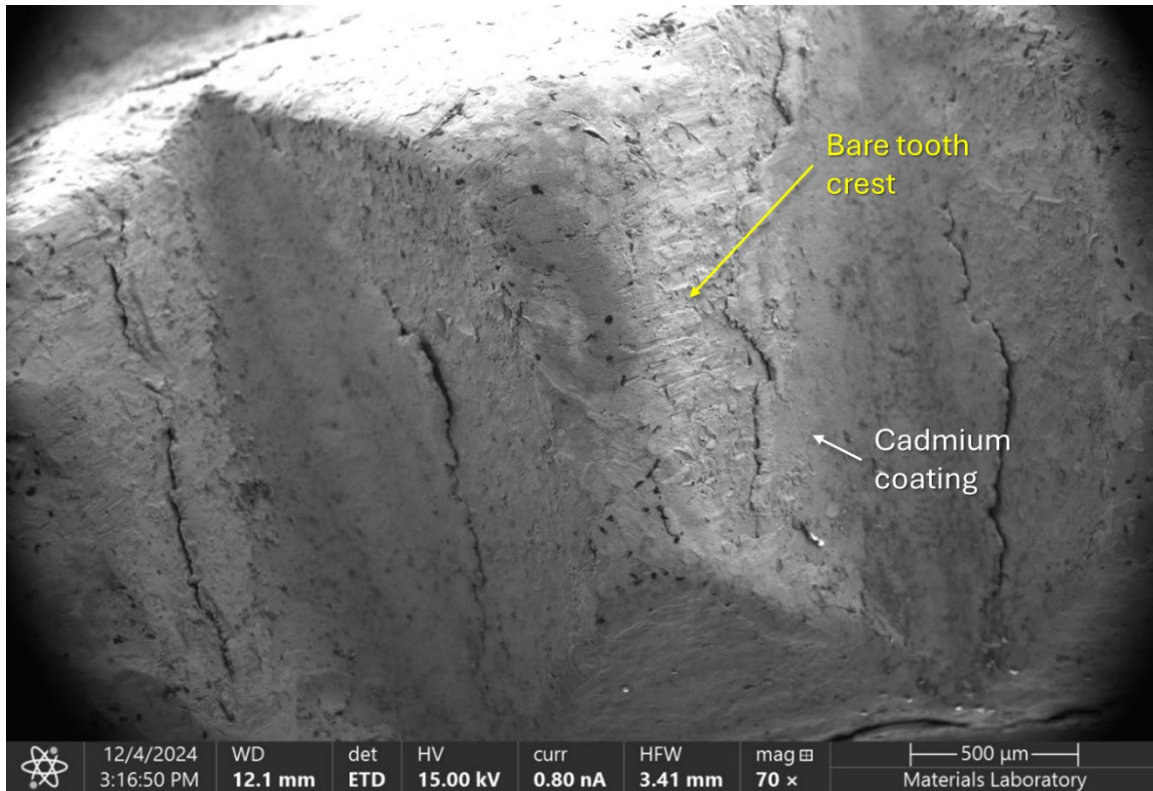
Examination of the lever using a SEM revealed a loss of the outer coating in many areas of the crests. Energy dispersive spectroscopy (EDS) found the lever material to be consistent with alloy steel, and the coating to be consistent with cadmium. As shown in Figure 25 and Figure 26, the teeth exhibited circumferentially-oriented wear scars and gouges. The backscattered image demonstrated both removal of the outer coating material, as well as deposition of non-metallic material into the lever arm teeth (shown by the darker spots in Figure 26).

Figure 25. SE micrograph of a worn lever tooth crest, showing spalling of the Cd coating.

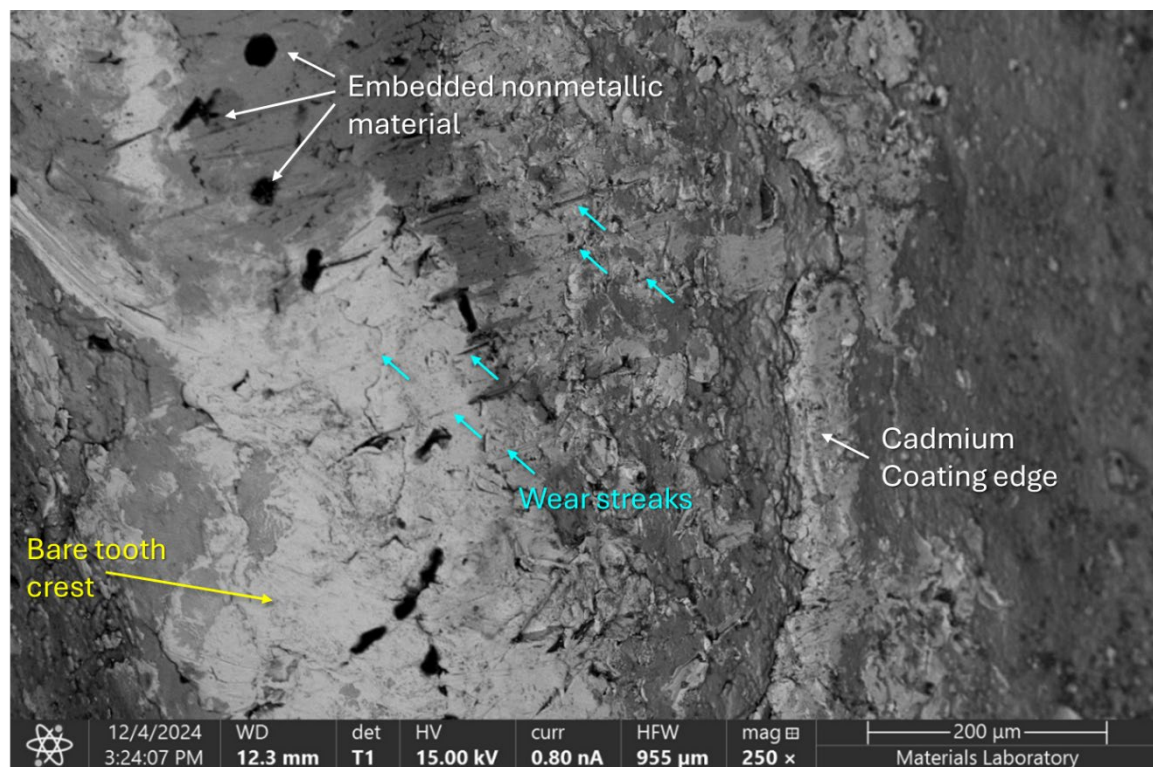
Figure 26. BE micrograph of the side of the tooth crest in Figure 26, showing missing surface coating and wear scars and localized deformation.

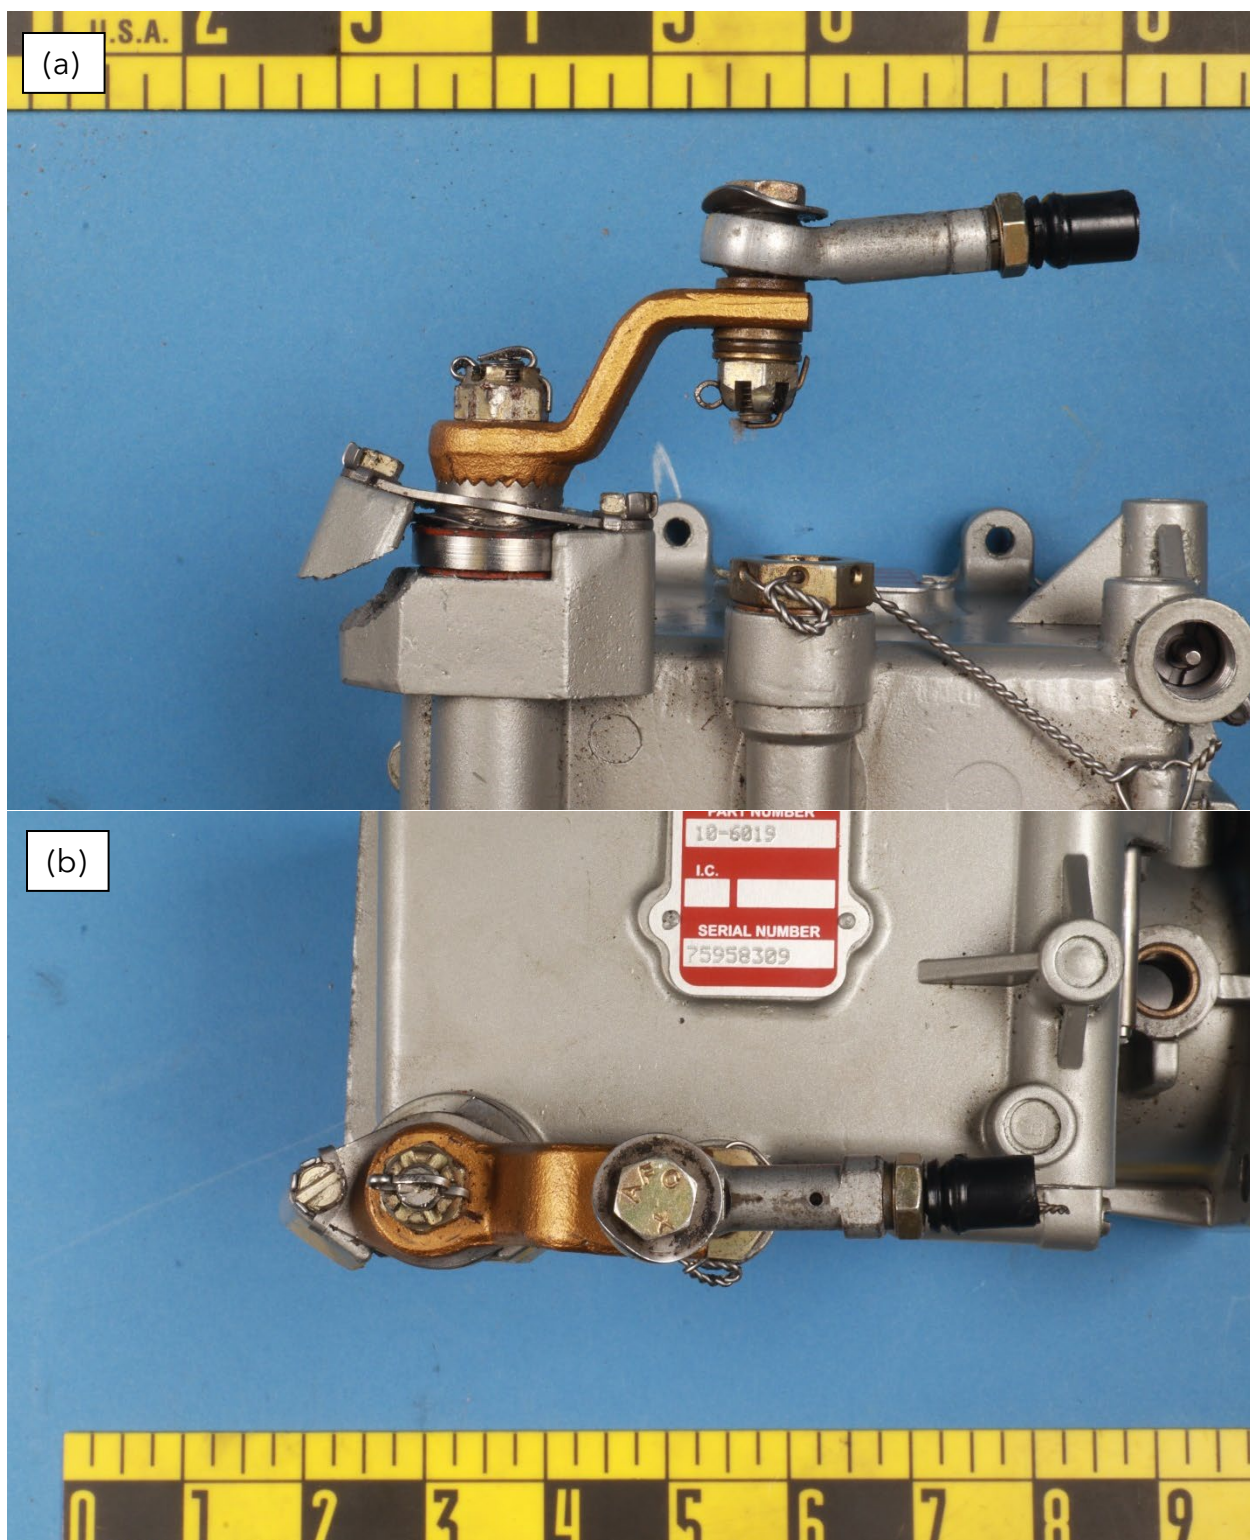
The last area of damage on the carburetor is shown in Figure 27. This shows the fuel cut off valve lever assembly, along with the surrounding subcomponents, which were still attached. The area of the housing near this lever had fractured, exhibited a slanted orientation with fracture surfaces that had features consistent with overstress. The rod joined to the opposite end of the lever had been deformed in an upward bending, as shown in Figure 27a.

Figure 27. Views from (a) the side and (b) the top of the fuel cut off valve lever assembly, showing fracture of the housing where the retainer is affixed via a screw.
