# National Transportation Safety Board

ERA24FA160

## **MATERIALS LABORATORY**

Factual Report 24-026

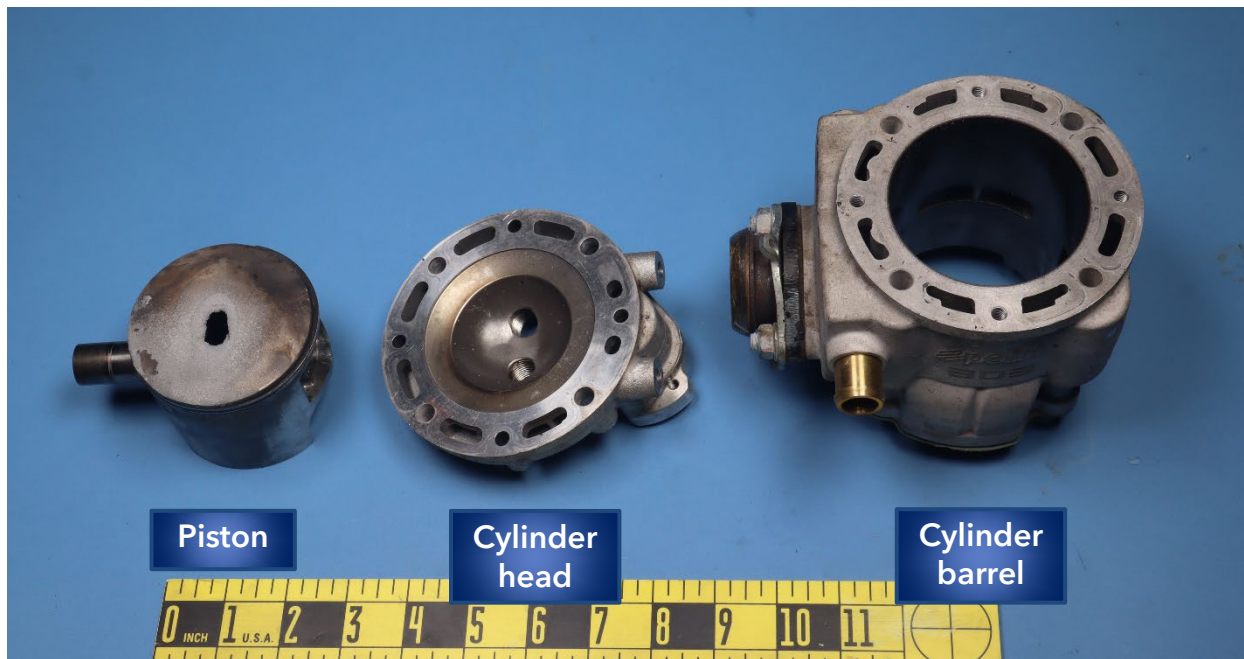
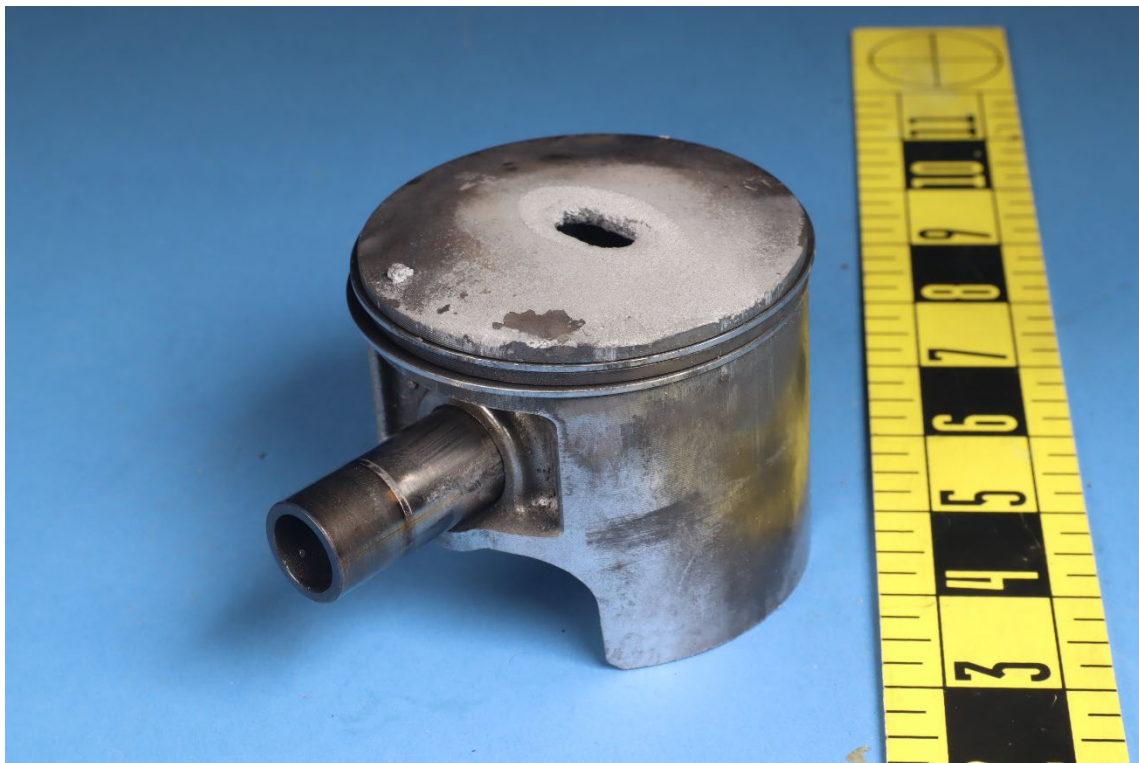
An overall view of the submitted components is shown in figure 1. The piston had a hole in the middle of the crown as shown, and the surrounding areas had light gray deposits covering portions of the crown surface. The remaining area of the piston crown and interior surfaces of the cylinder head appeared to be free of heavy combustion deposits. Machining marks and partial vibro-peen markings were visible on the piston crown.

The piston crown had features consistent with pre-ignition damage. As noted in the references listed in the footnote below, pre-ignition occurs when an ignition source such as an overheated spark plug tip, glowing hot carbon or lead deposits in the combustion chamber, or a burned exhaust valve prematurely ignites the fuel/air mixture in the cylinder during the combustion cycle. Additional possible causes for pre-ignition include use of unsuitable fuel with an octane rating that is too low or that has been contaminated with diesel, excessive leaning that results in higher combustion temperatures, or inadequate ventilation or general overheating of the engine.<sup>1</sup>

**Figure 1.** Overall view of the submitted components as received (upper image) and a closer view of the piston assembly showing a hole in the middle of the crown (lower image).
