# National Transportation Safety Board

ERA24FA160

## WRECKAGE EXAMINATION

Location: Mulberry, Florida  
Date: April 2, 2024  
Time: 1038 EDT  
1438 UTC  
Motorglider: N622PC; Aeromarine Merlin Lite

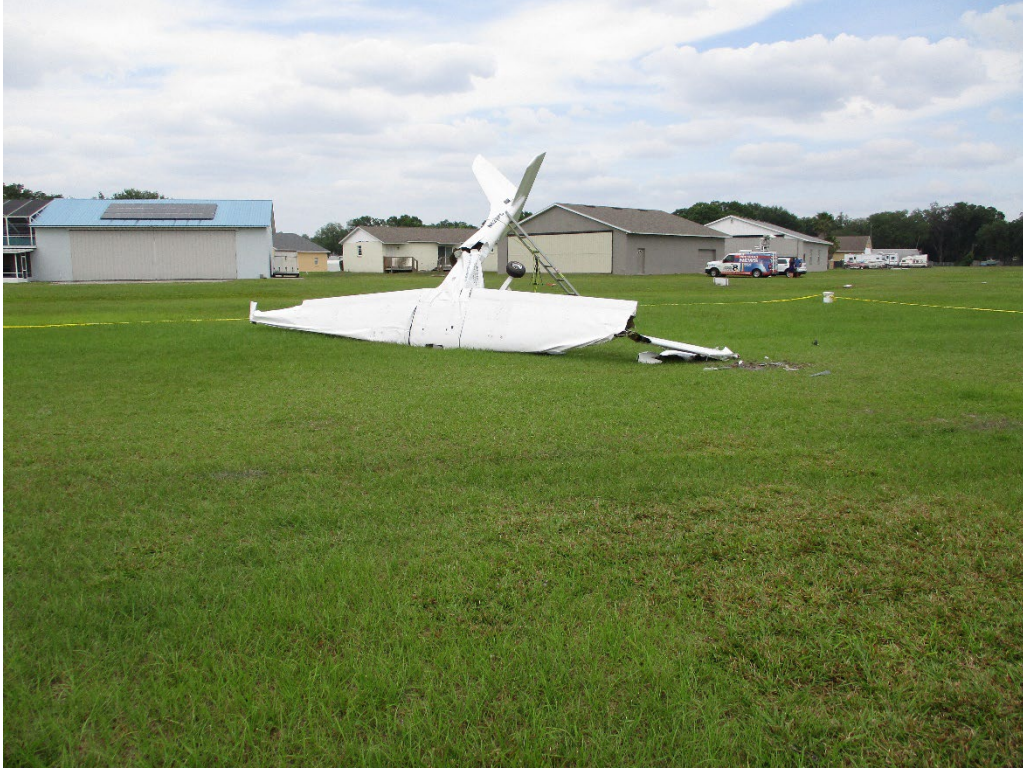
The motorglider came to rest on runway 14/32 at South Lakeland Airport (X49), Lakeland, FL about 1500 ft from the threshold of runway 14.

**Photo 3: View of the motorglider at the accident site. (FAA Photo)**

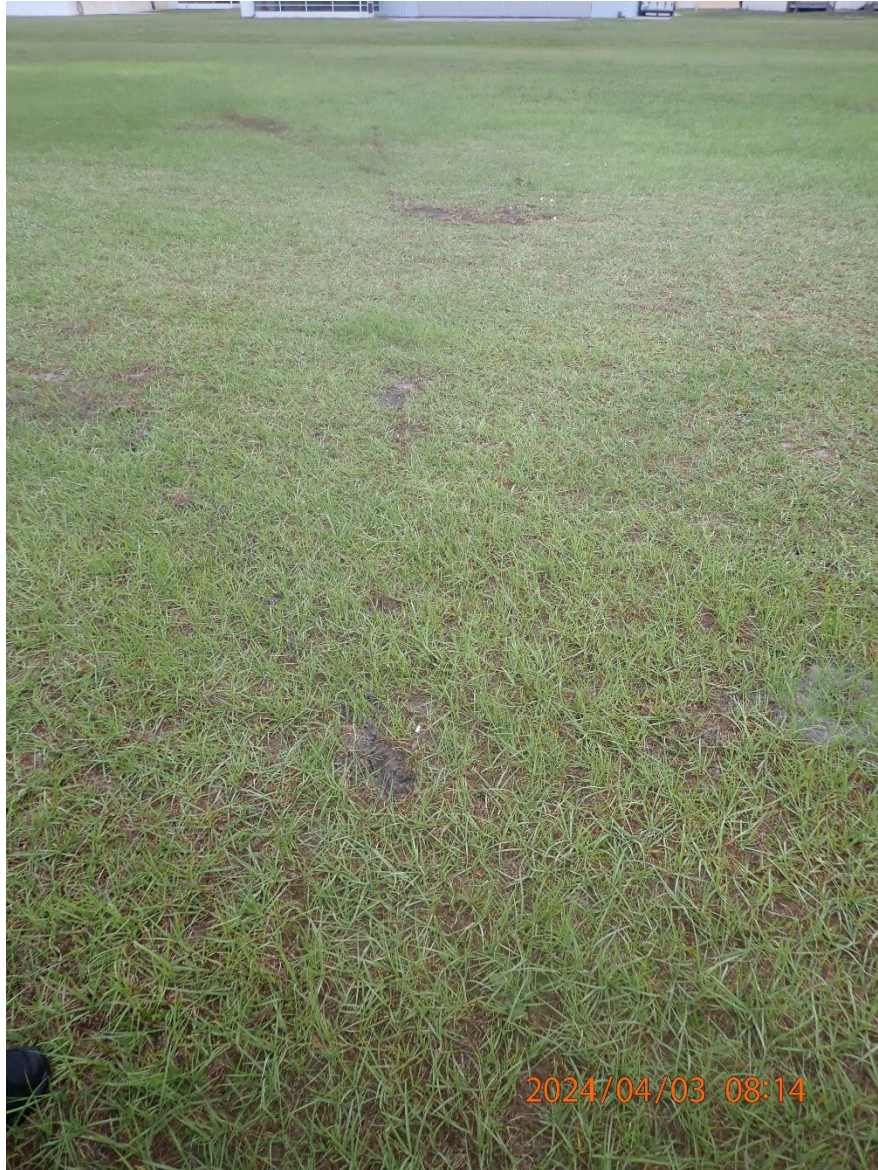
**Photo 4: View of ground impact scars.**

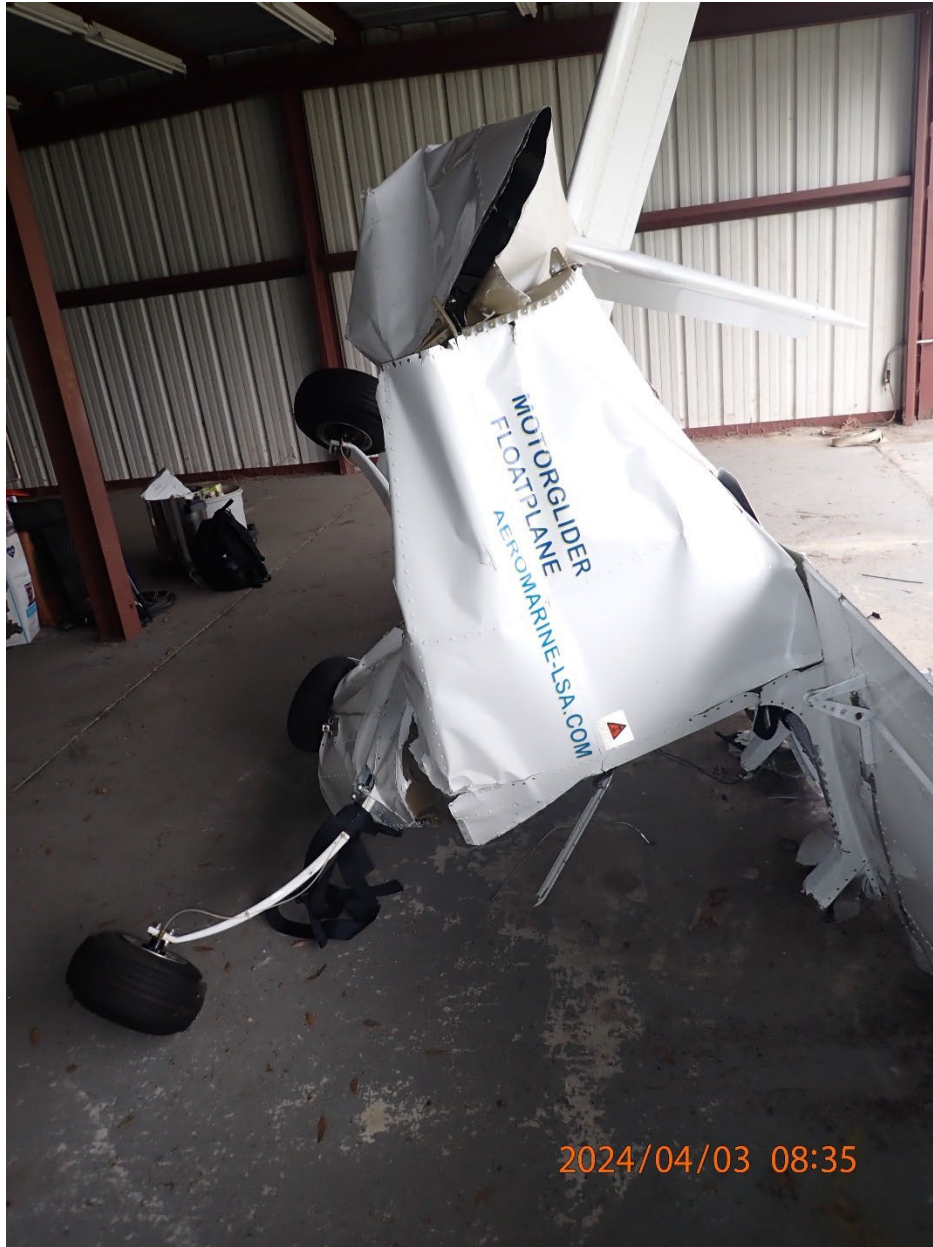
The fuselage had sustained substantial damage and displayed crushing and buckling in multiple locations.

**Photo 5: View of damage to the fuselage.**

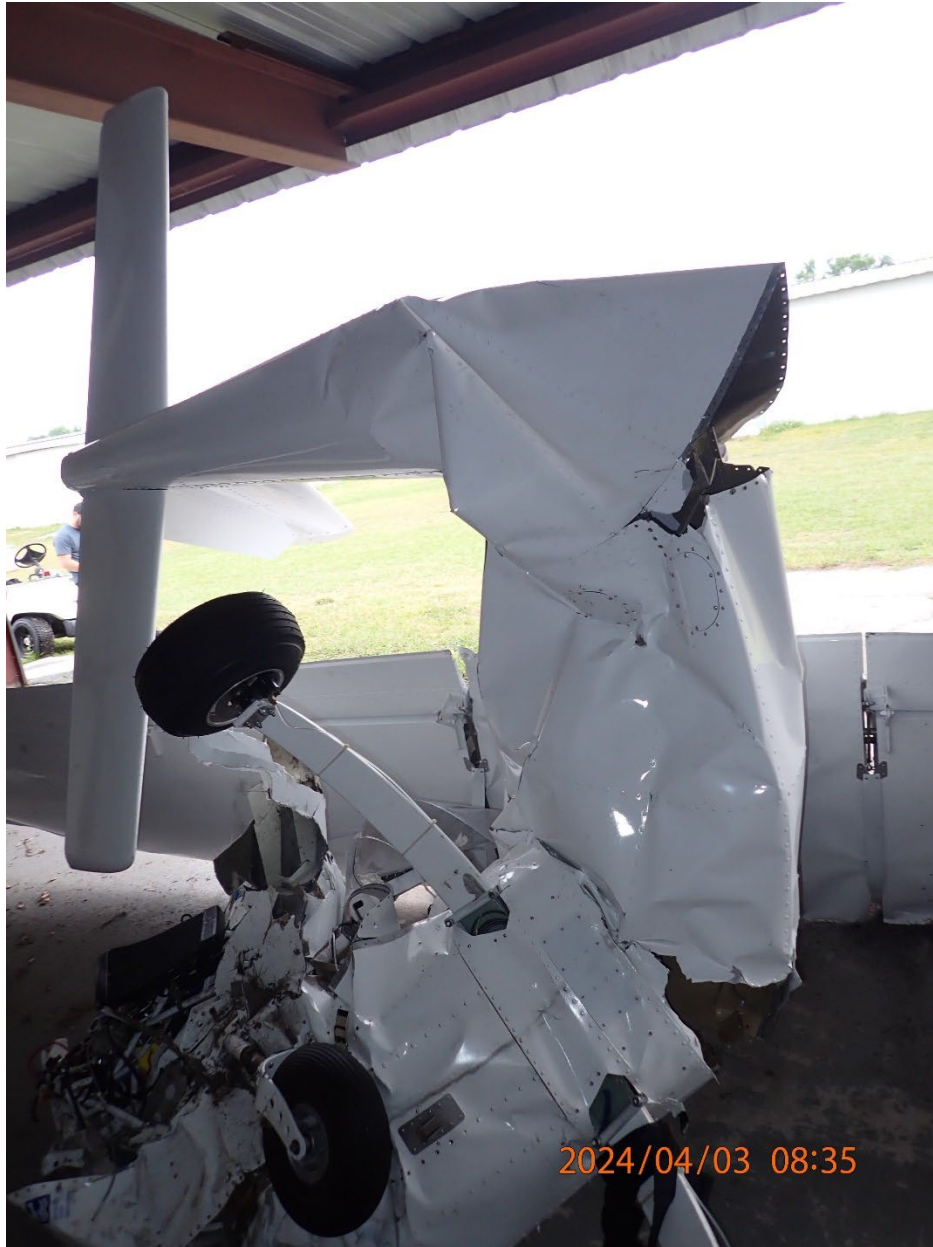
The empennage was partially separated and remained attached to the fuselage by the rudder and elevator control cables and rods and the bottom skin. The vertical stabilizer and rudder remained attached at all attachment points and were undamaged. Control continuity was confirmed from the rudder to the flight controls in the cockpit through a fractured rod end consistent with overload. The horizontal stabilizer and elevator remained attached at all attachment points and were

**Photo 6: View of damage to the bottom of the empennage and fuselage.**

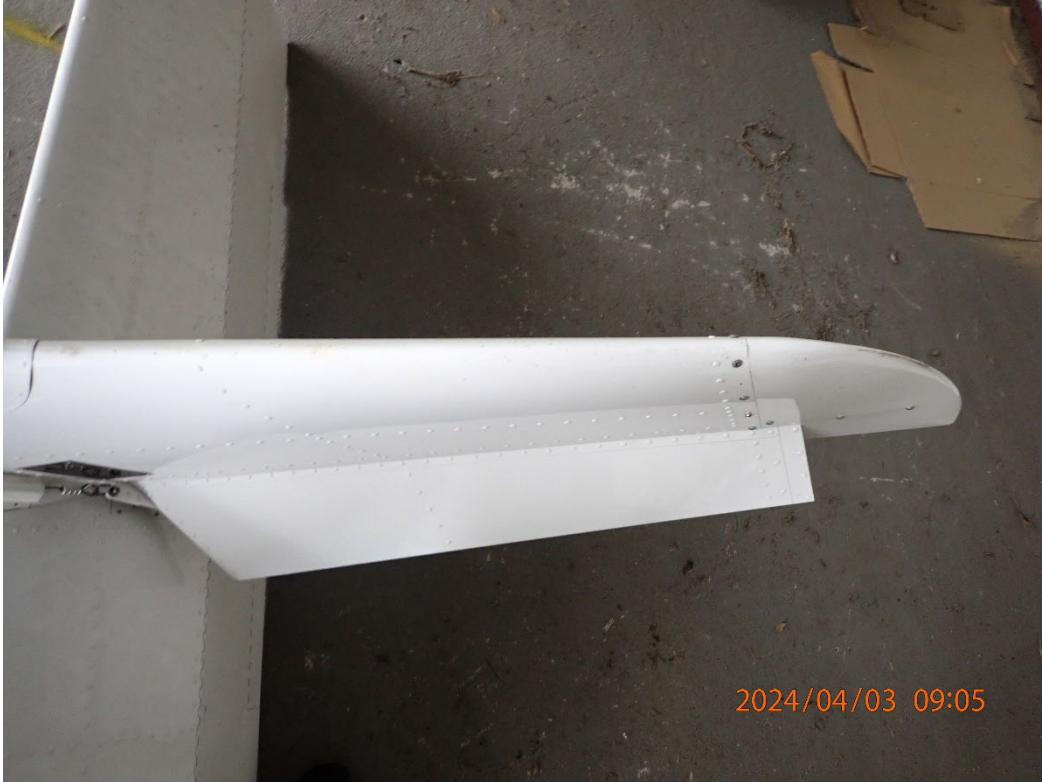
**Photo 7: View of the vertical stabilizer and rudder.**

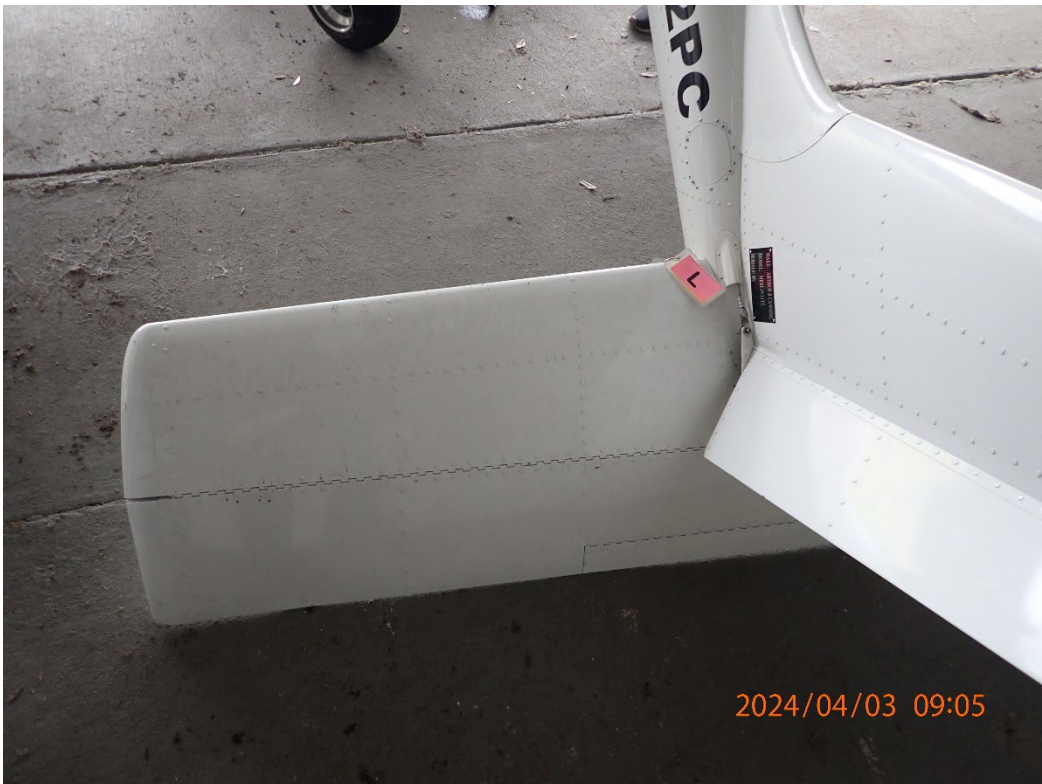
**Photo 8: View of the left horizontal stabilizer and elevator.**

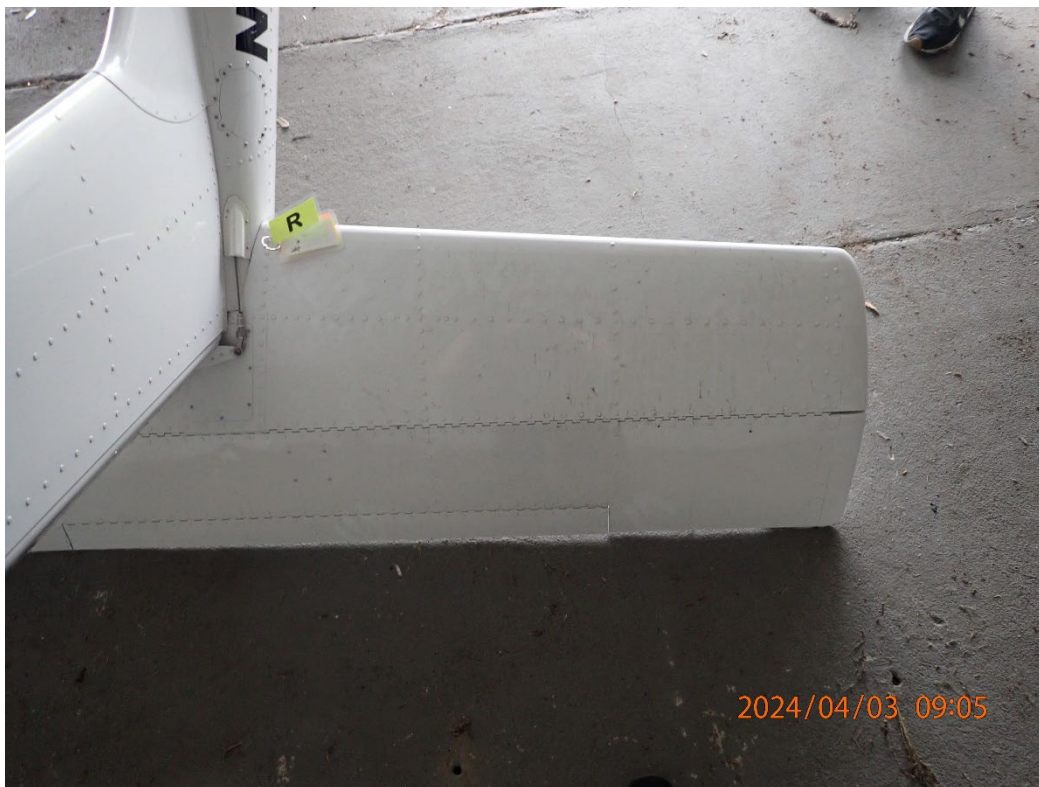
**Photo 9: View of the right horizontal stabilizer and elevator.**

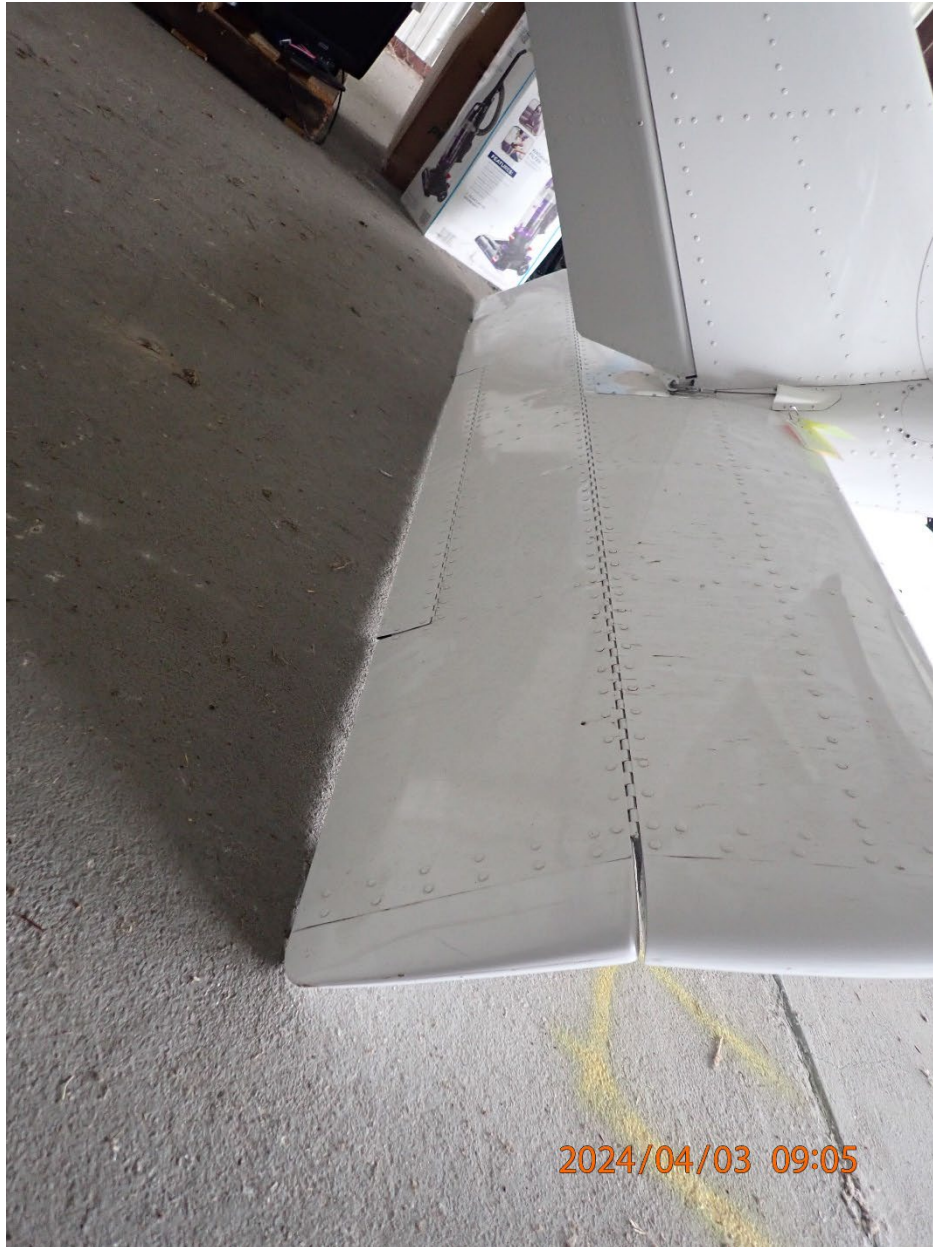
undamaged. Control continuity was confirmed from the elevator to the flight controls in the cockpit. The electric trim was visually in a neutral position and remained attached to the elevator at all attachment points.

**Photo 10: View of the elevator trim tab.**

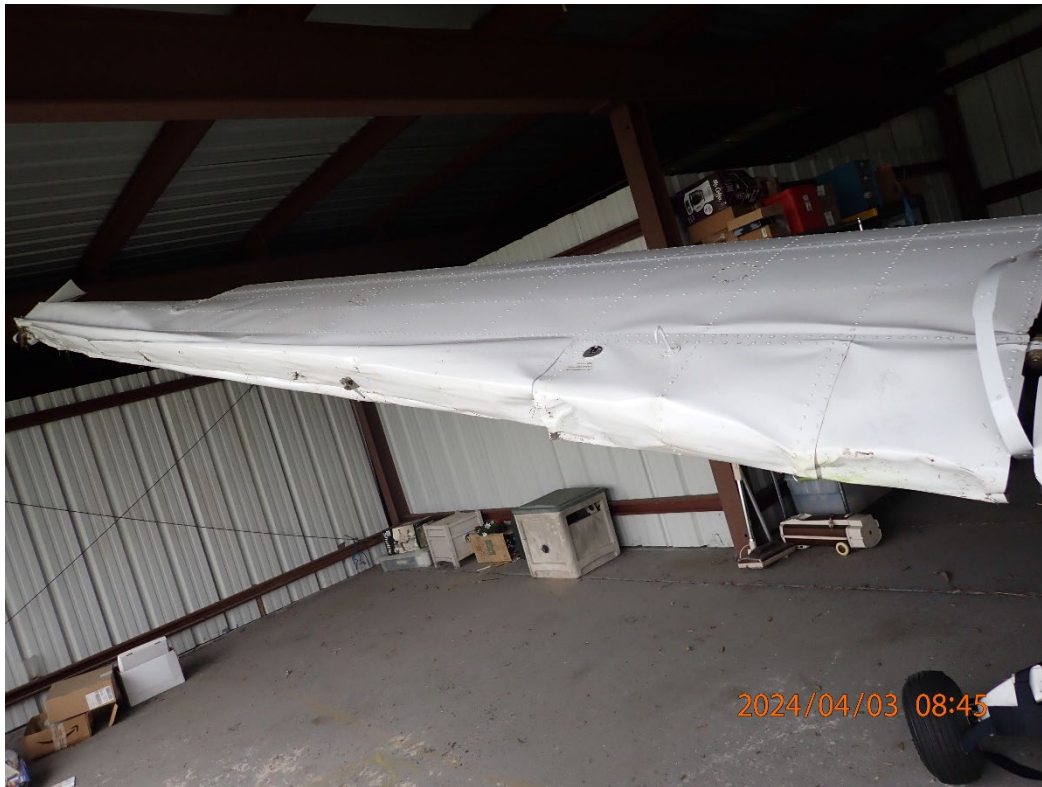
The right wing remained attached to the fuselage at all attachment points. The leading edge was impact crushed aft along the full length. The right aileron remained attached to the wing at all attachment points and exhibited impact damage. Continuity was confirmed from the right aileron flight control surface to the controls in the cockpit. The right flap was in the up position and remained attached to the wing.

**Photo 11: View of damage to the right wing.**

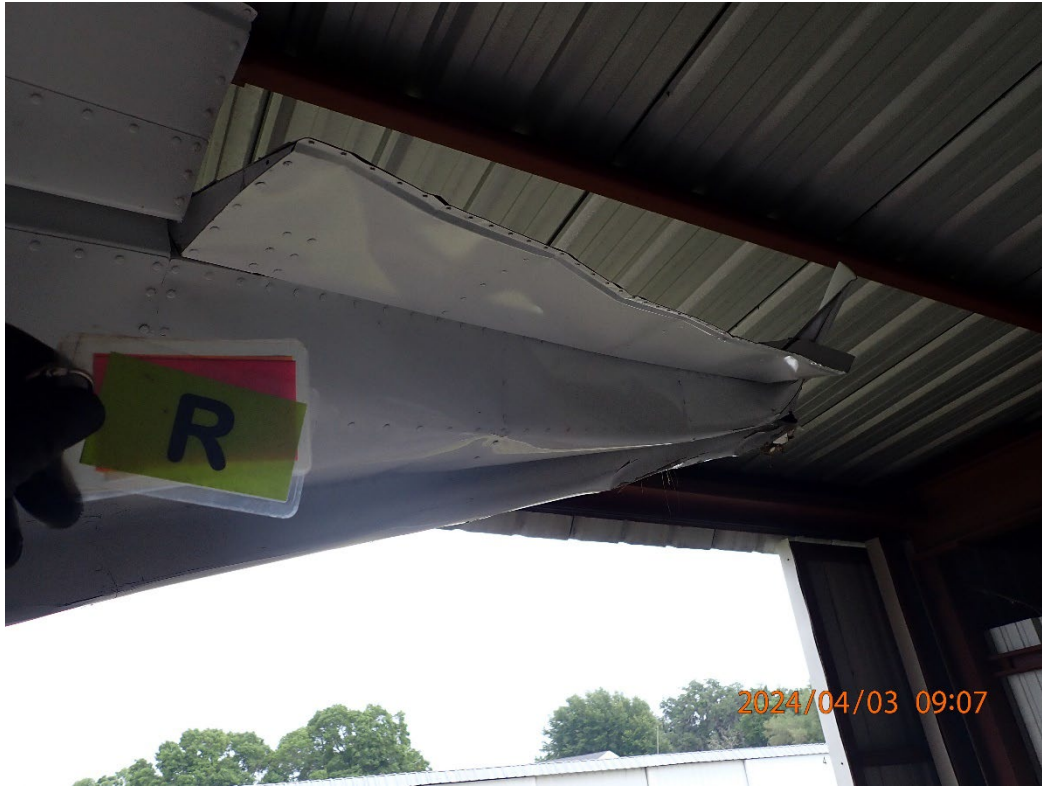
**Photo 12: View of damage to the right aileron.**

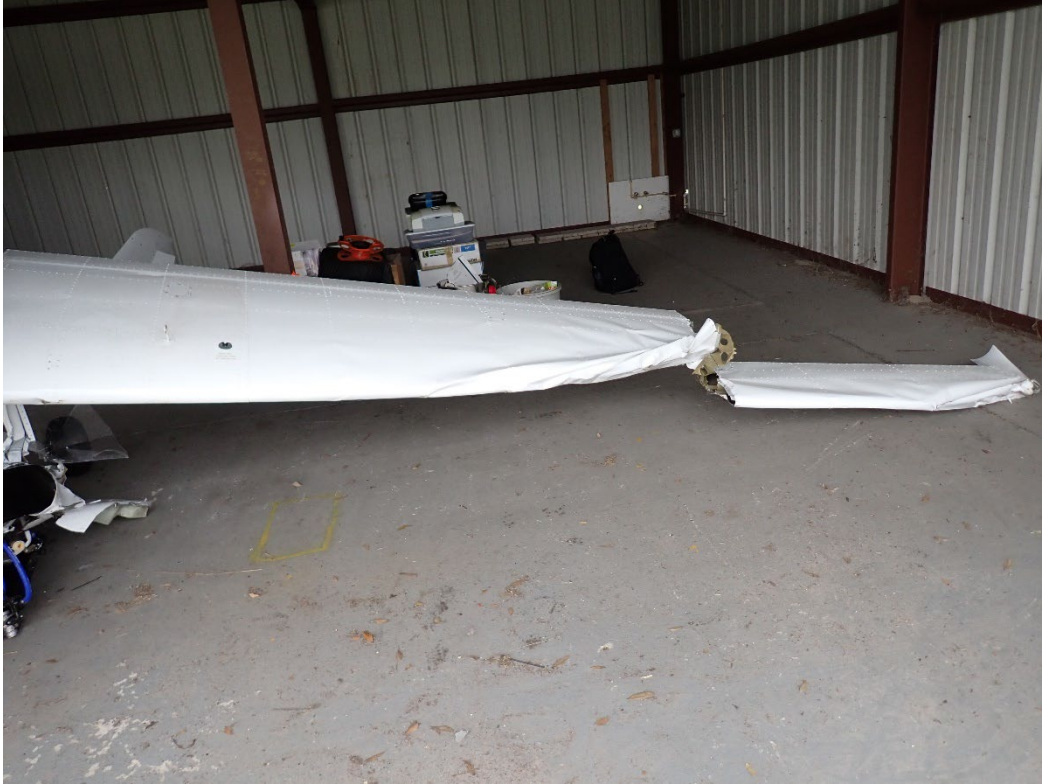
The left wing remained attached to the fuselage at all attachment points. The left wing was impact fractured outboard of the flap and remained attached through the left aileron control rod. The outboard two thirds of the left wing leading edge exhibited impact crushing aft. The left aileron remained attached at all attachment points and the inboard trailing edge corner exhibited impact damage. Continuity was confirmed from the left aileron flight control surface to the flight controls in the cockpit. The left flap was in the up position and remained attached at all attachment points. Continuity was confirmed from the left flap flight control surface to the flight control in the cockpit.

**Photo 13: View of damage to the left wing.**

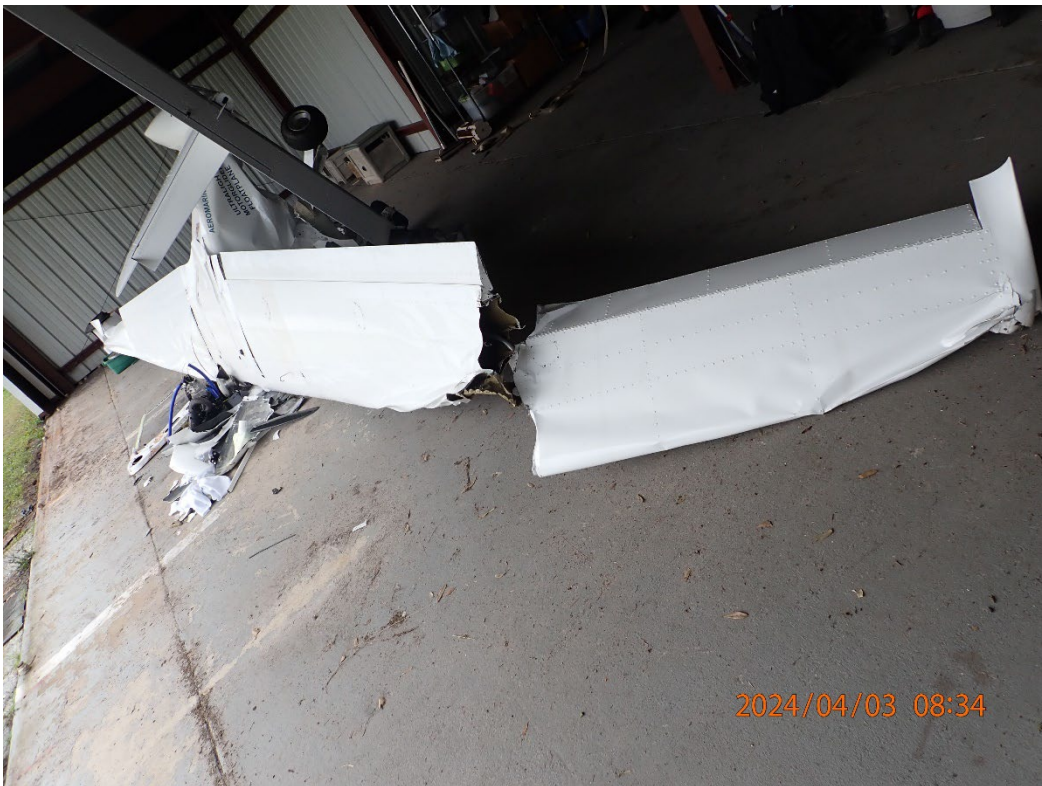
**Photo 14: View of damage to the outboard left wing.**

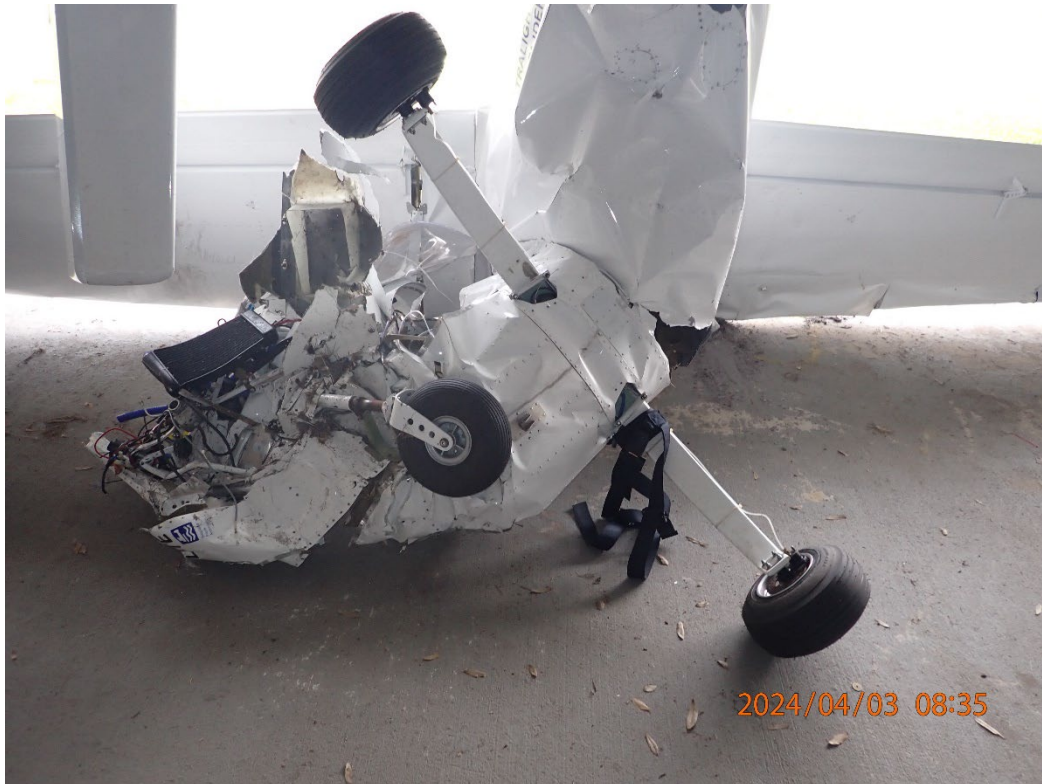
The nose landing gear remained attached to the forward fuselage and was impact crushed up and aft. The main landing gear remained attached to the fuselage and were undamaged.

**Photo 15: View of the landing gear.**

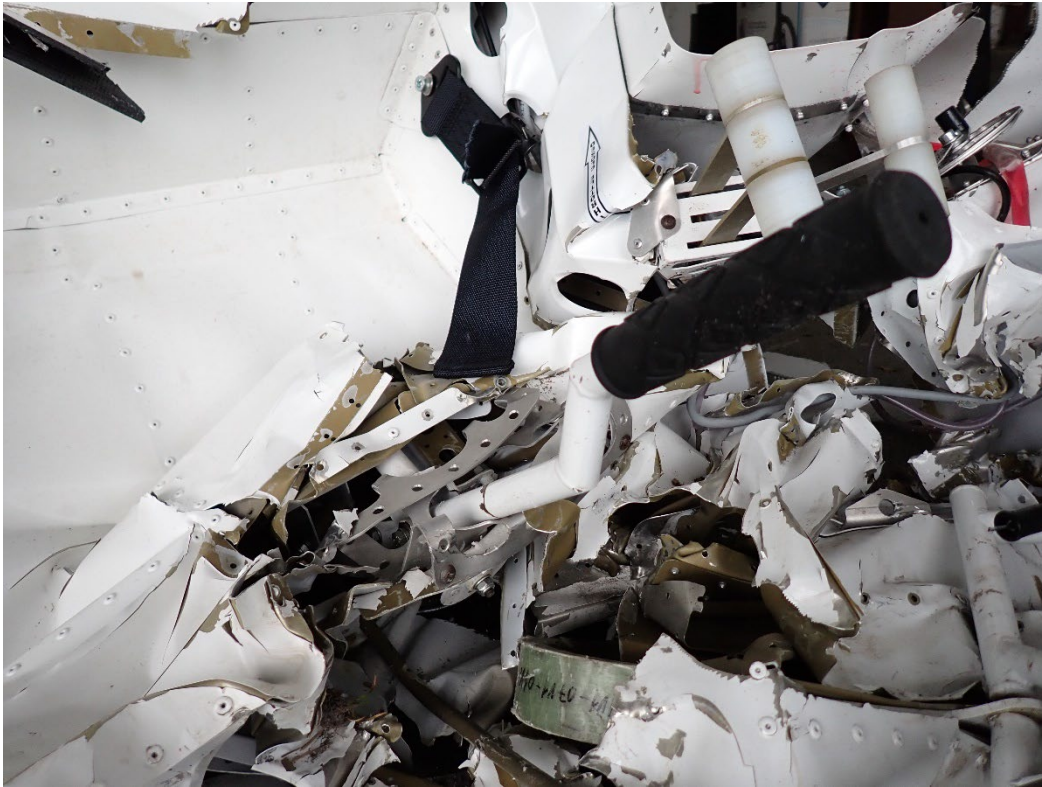
The cockpit sustained a significant amount of impact damage and was crushed aft. The iPad normally mounted by hook-and-loop fasteners to the center of the instrument panel was impact separated and destroyed. The IFD-NET electronic flight instrument system remained installed in the instrument panel. The instrument was removed to see if a memory card was installed, a memory card was not installed. The left fuel gauge was impact separated from the instrument panel, and indicated 0, no slap mark from the indication needle was observed. The avionics switch was in the on position. The right fuel on/off lever was in the on position, the left fuel on/off lever was halfway between on and off and was bent from impact. The master switch was in the on position. The throttle was fully aft near the idle position and operated

**Photo 16: View of damage to the cockpit area.**

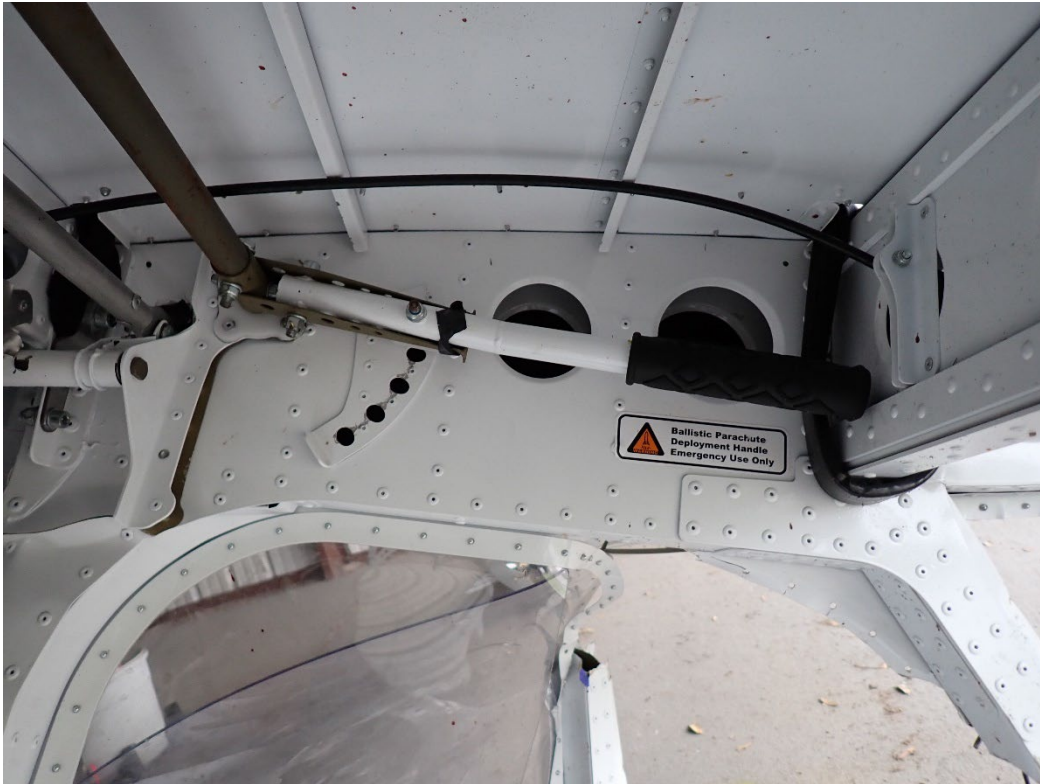
normally. The flight control stick and rudder pedals exhibited impact damage. The flap handle was found stowed in the up position.

**Photo 17: View of the flap handle as found.**

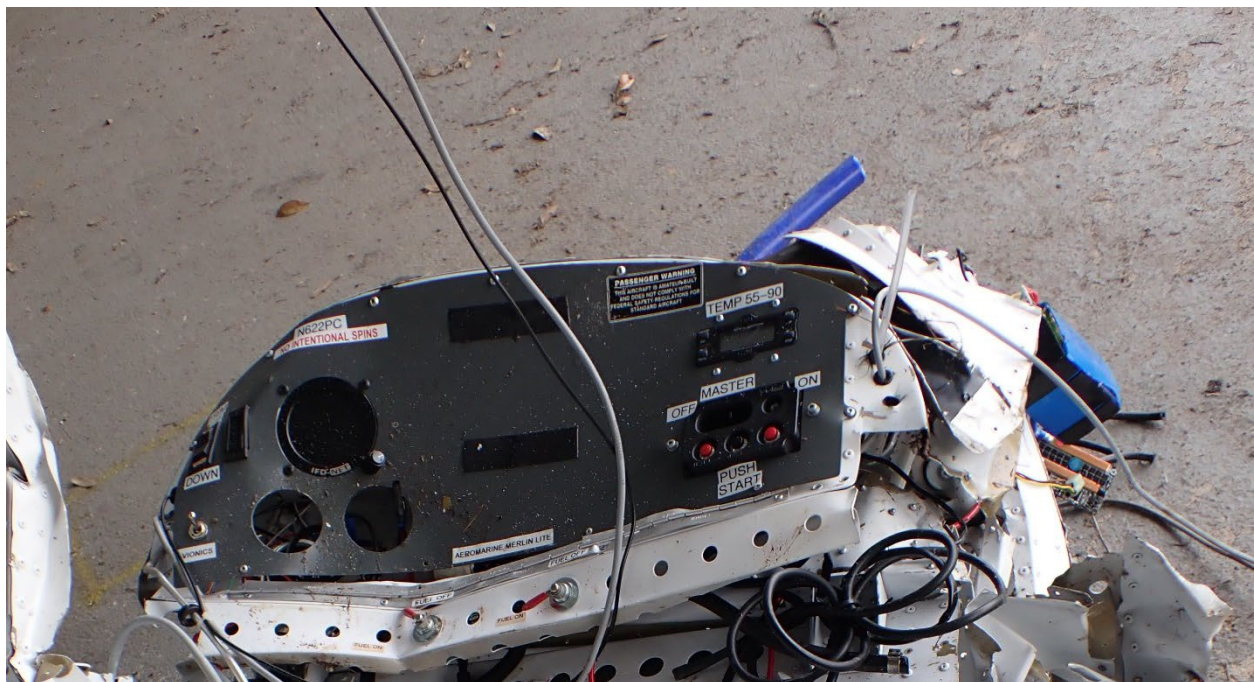
**Photo 18: View of the instrument panel.**

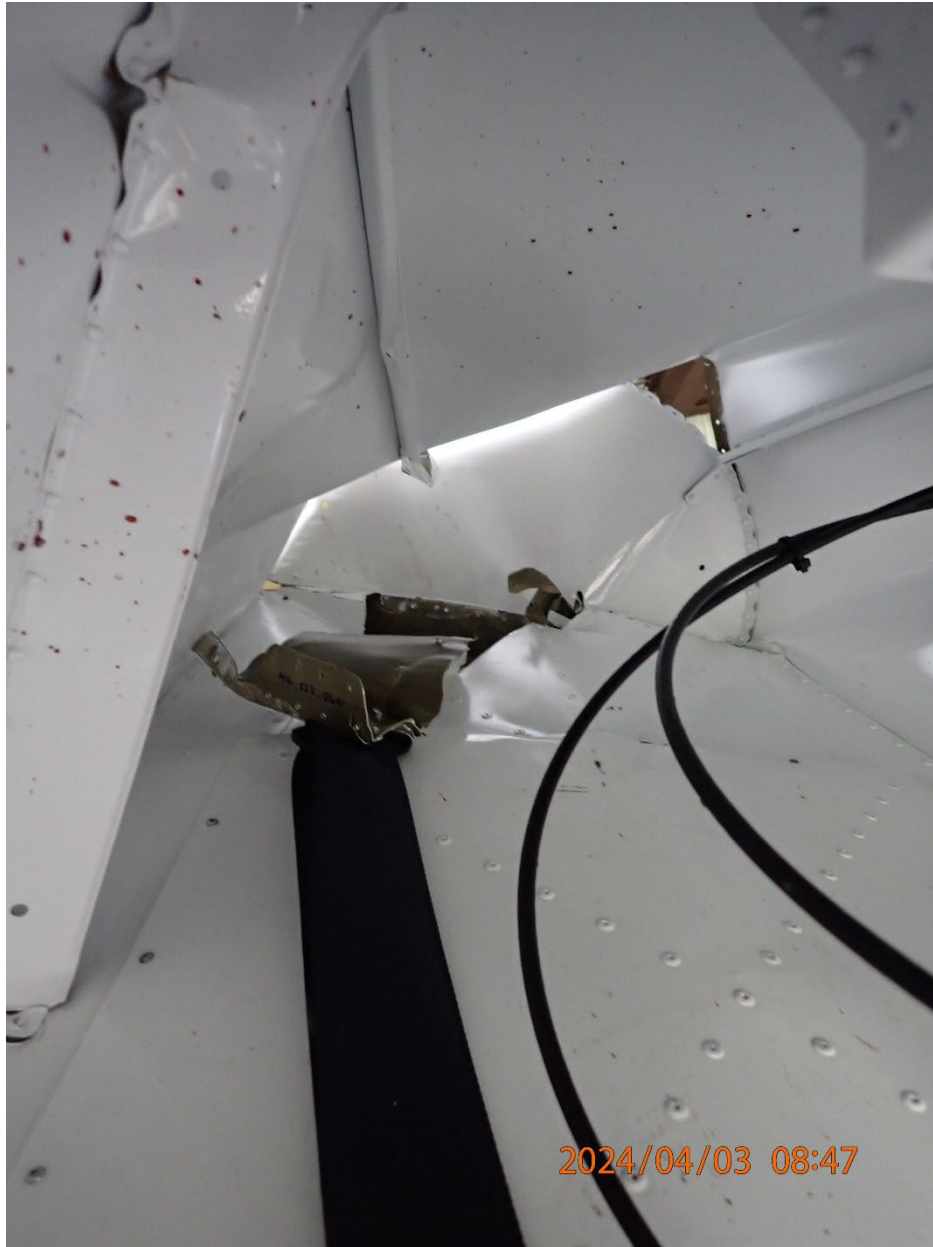
The motorglider was equipped with a 4-point harness. Both lap belt attachments remained attached to the fuselage. The shoulder harness attachment point was partially torn from the airframe attachment point. The seatbelts had been cut by first responders to facilitate recovery of the pilot. The seat belt buckle remained buckled and operated normally. The pilot was wearing a helicopter type helmet.

**Photo 19: View of the shoulder harness attachment point pulled from the airframe.**

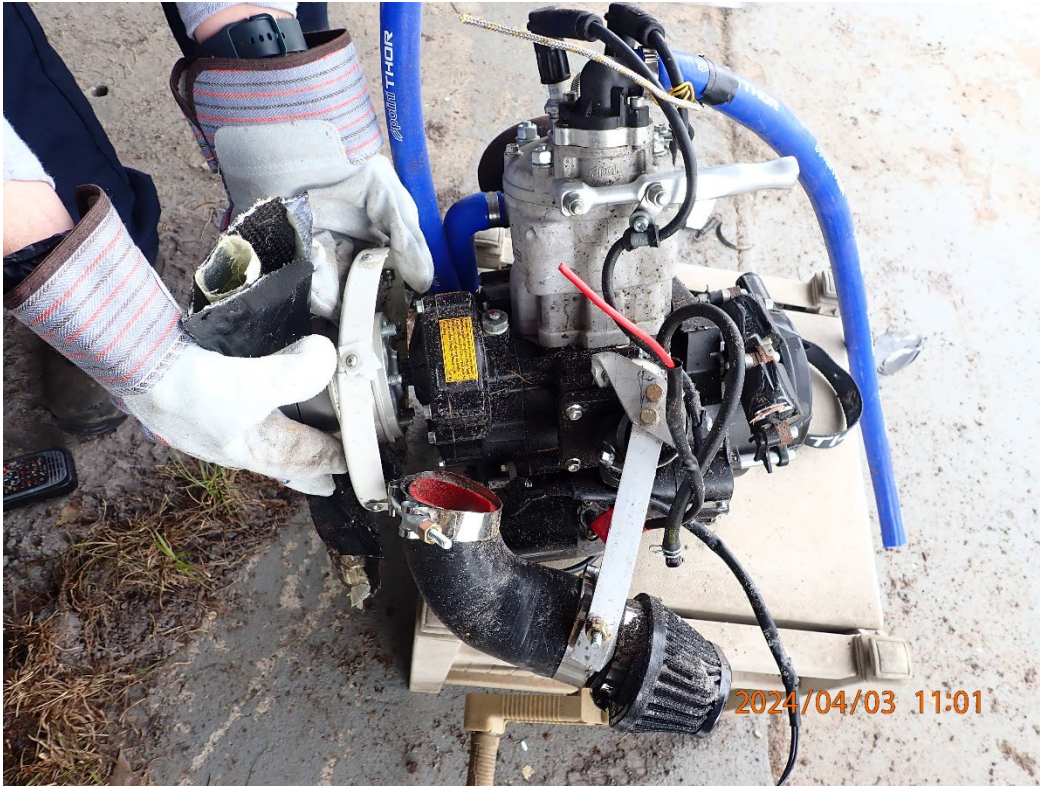
The single cylinder, 2-stroke reciprocating engine had broken free from the airframe and displayed impact damage signatures. The propeller flange was impact separated from the propeller drive shaft. The cylinder head and cylinder sleeve were removed from the engine. There was a quarter sized hole in the middle of the piston and the piston material around the hole had been eroded. The cylinder sleeve displayed minor scoring of the cylinder walls and the cylinder head was undamaged. The intake and exhaust ports of the cylinder were unobstructed and displayed normal operating signatures. It was noted that one of the cylinder studs displayed deposits and corrosion consistent with an exhaust leak around the cylinder. The piston was removed from the connecting rod; the connecting rod and the piston pin bearing displayed normal operating and lubrication signatures. The crankcase displayed impact damage signatures and a portion of the forward crankcase was cracked and pushed aft. The crankshaft was rotated by hand and could rotate freely for about 330° of movement. The crankshaft was incapable of rotation when the connecting rod was near bottom dead center, which was consistent with the impact damage observed to the crankcase.

**Photo 20: Overview of the impact separated engine.**

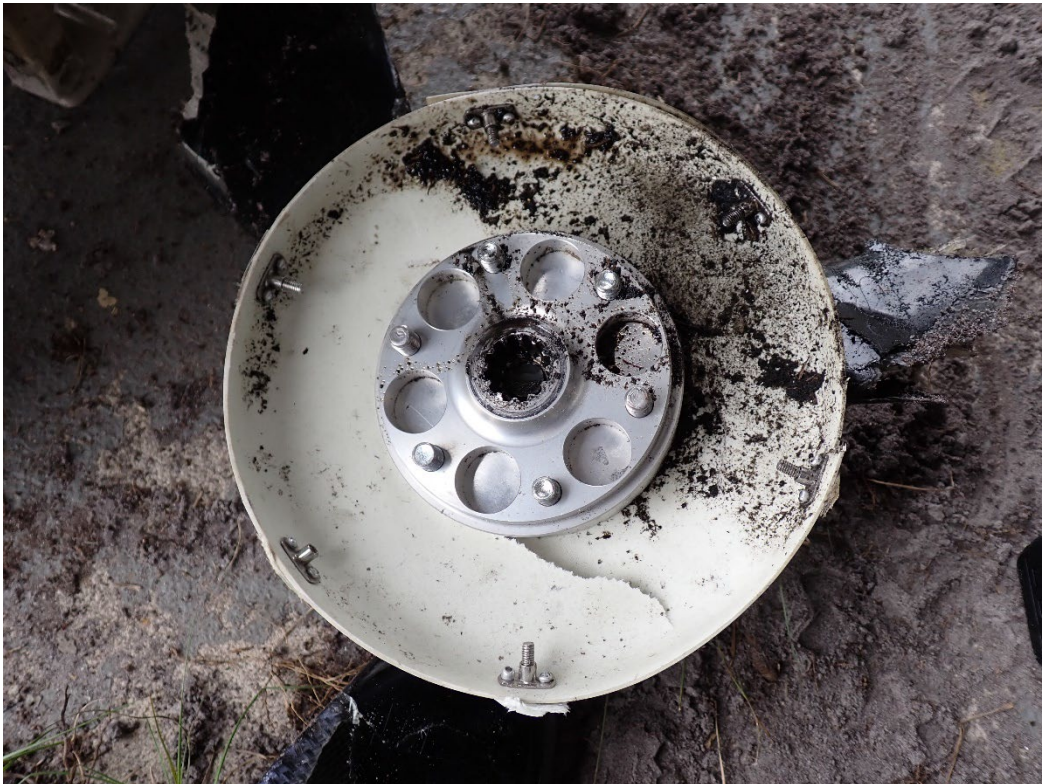
**Photo 21: View of the impact separated propeller flange.**

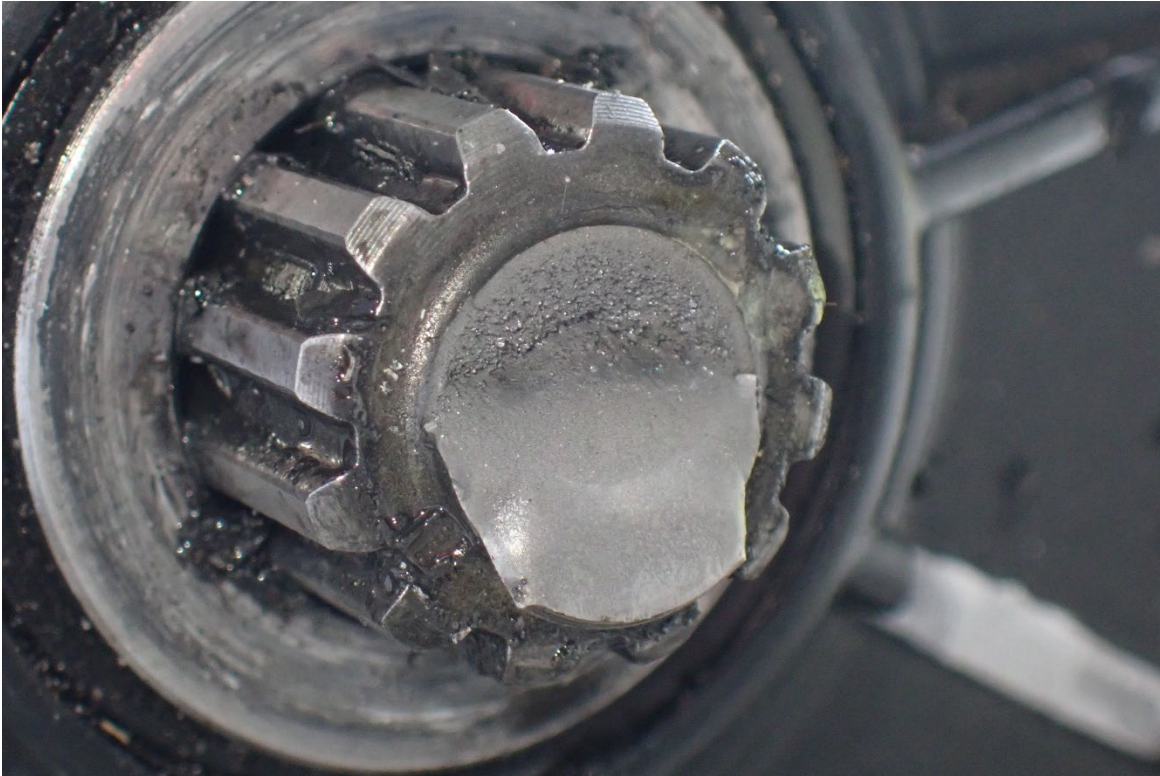
**Photo 22: View of the overload fractured propeller driveshaft.**

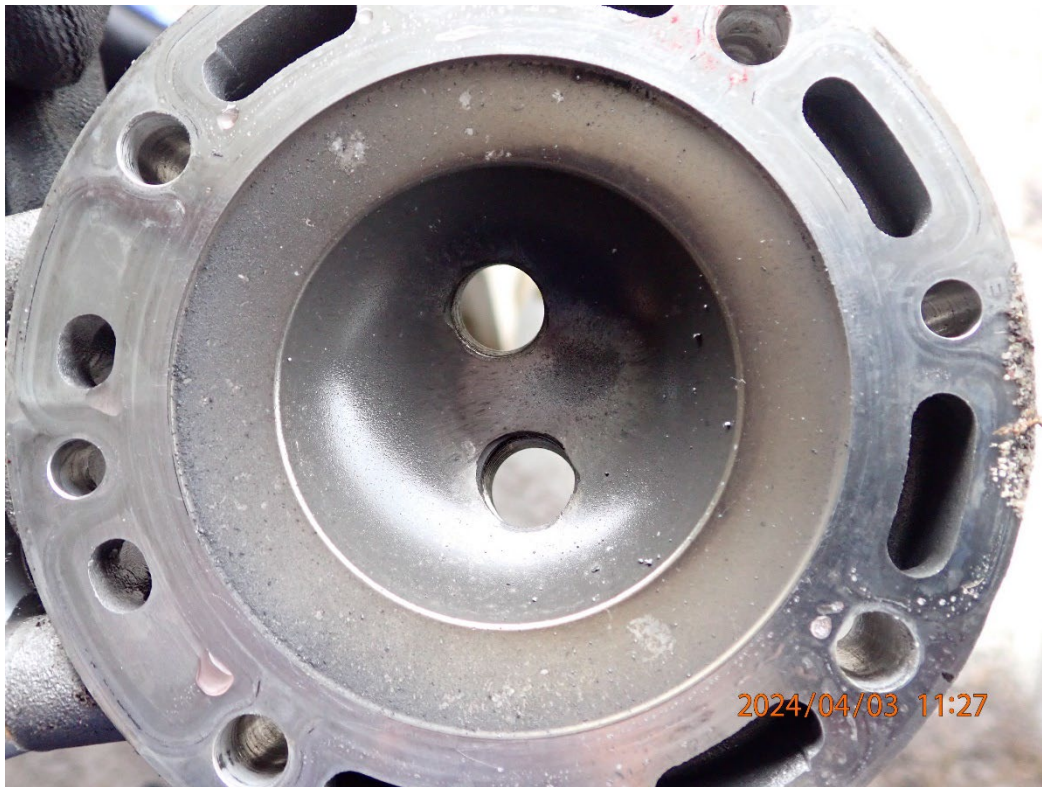
**Photo 23: View of the cylinder head.**
