# National Transportation Safety Board

ERA24FA160

## WRECKAGE EXAMINATION

Location: Mulberry, Florida  
Date: April 2, 2024  
Time: 1038 EDT  
1438 UTC  
Motorglider: N622PC; Aeromarine Merlin Lite

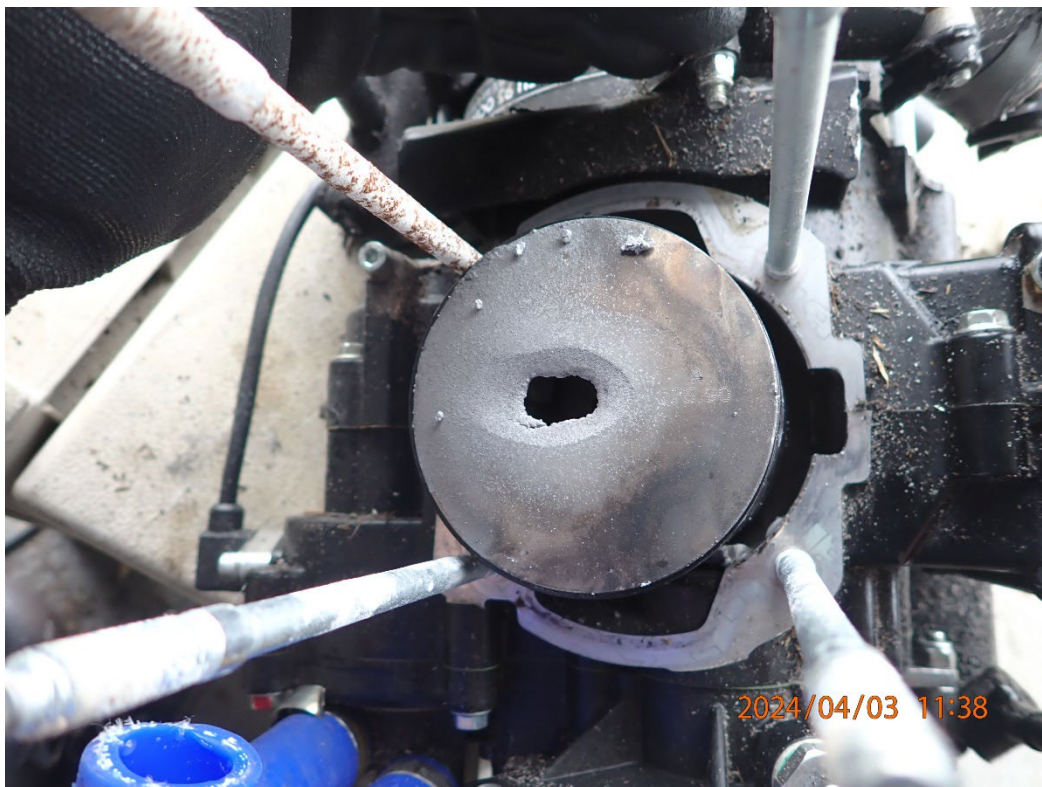
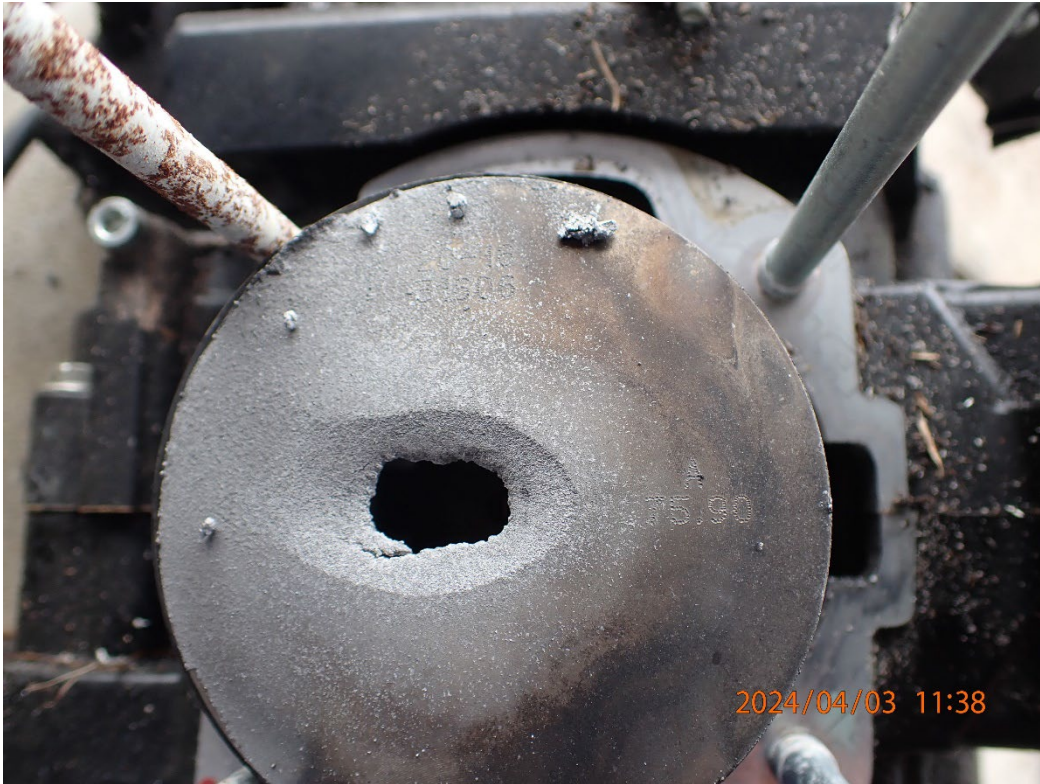
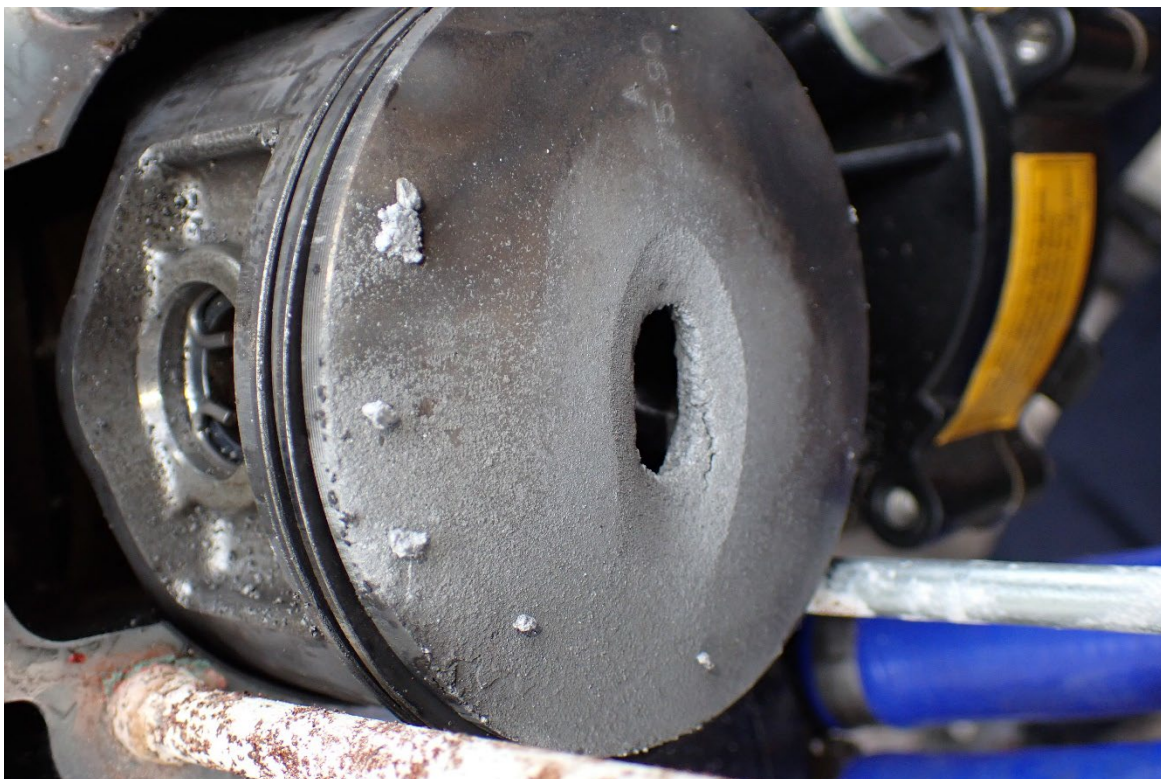
The single cylinder, 2-stroke reciprocating engine had broken free from the airframe and displayed impact damage signatures. The propeller flange was impact separated from the propeller drive shaft. The cylinder head and cylinder sleeve were removed from the engine. There was a quarter sized hole in the middle of the piston and the piston material around the hole had been eroded. The cylinder sleeve displayed minor scoring of the cylinder walls and the cylinder head was undamaged. The intake and exhaust ports of the cylinder were unobstructed and displayed normal operating signatures. It was noted that one of the cylinder studs displayed deposits and corrosion consistent with an exhaust leak around the cylinder. The piston was removed from the connecting rod; the connecting rod and the piston pin bearing displayed normal operating and lubrication signatures. The crankcase displayed impact damage signatures and a portion of the forward crankcase was cracked and pushed aft. The crankshaft was rotated by hand and could rotate freely for about 330° of movement. The crankshaft was incapable of rotation when the connecting rod was near bottom dead center, which was consistent with the impact damage observed to the crankcase.

**Photo 24: View of the piston head.**

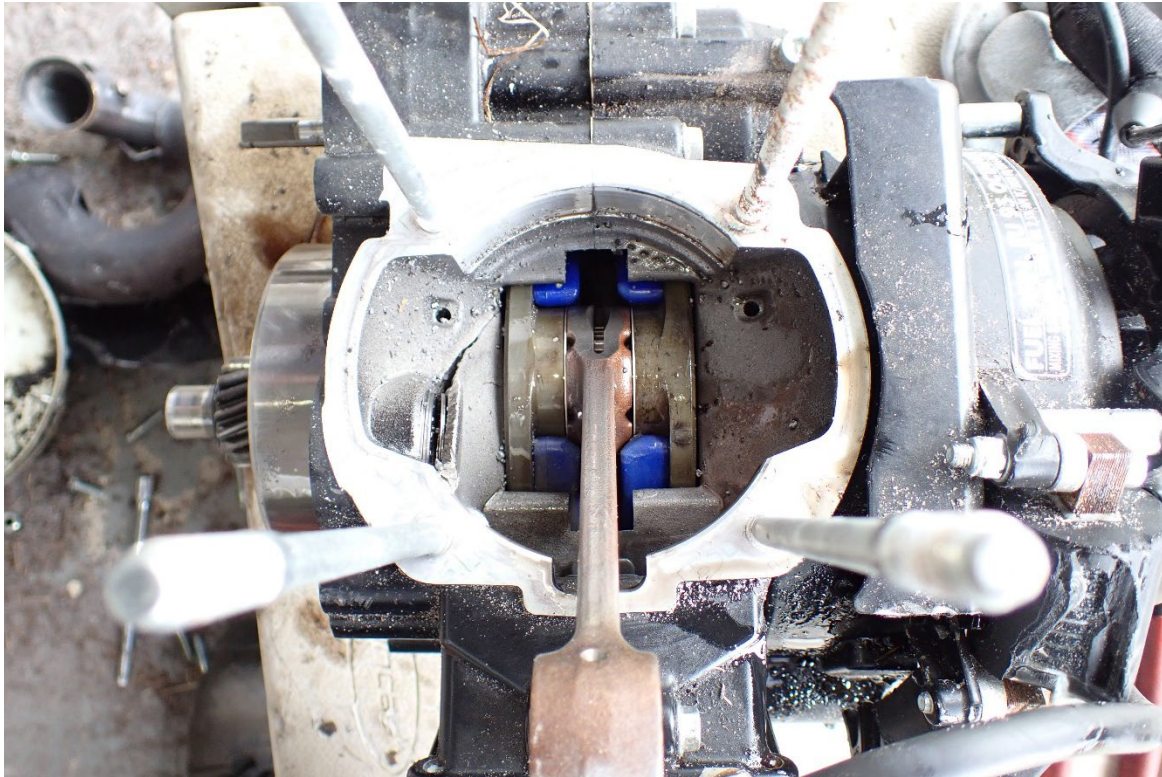
**Photo 27: View of the piston rod, crankshaft, and fractured crankcase.**

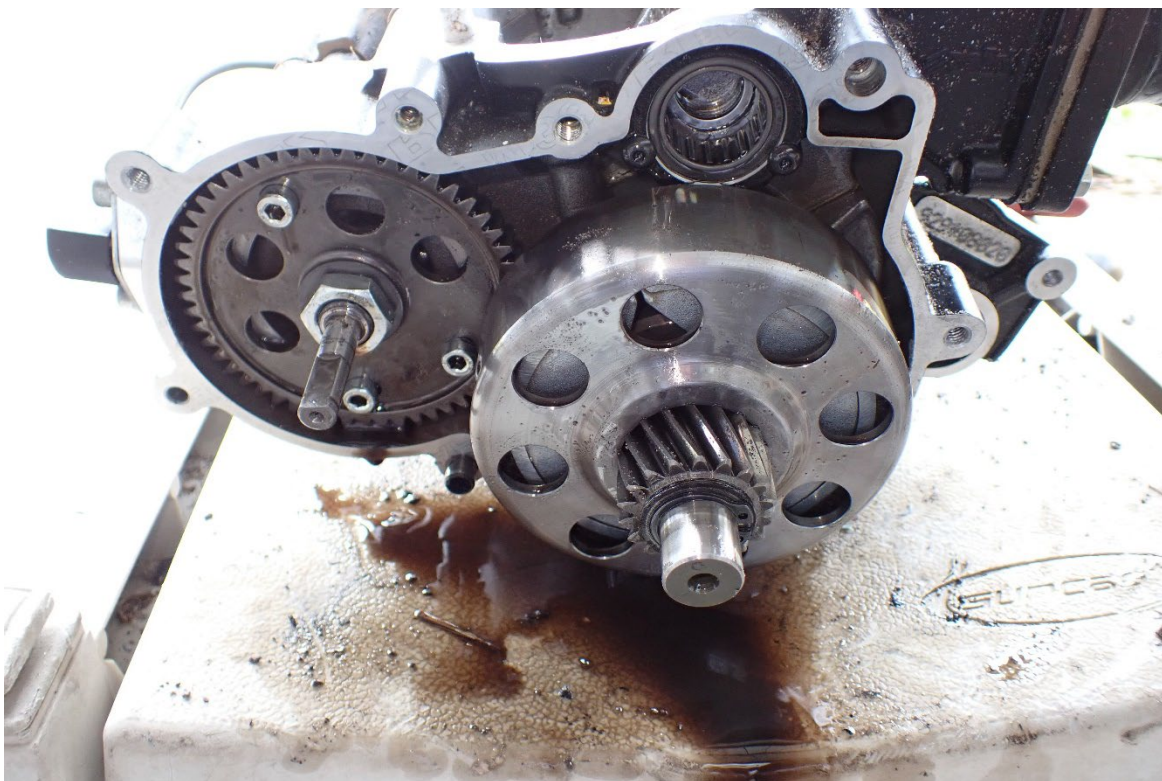
The propeller reduction gearbox was removed and disassembled. The internal components displayed normal operating and lubrication signatures. The coolant pump was disassembled and visually inspected. The coolant pump gears remained intact and fluid that was consistent with engine coolant was found inside the coolant pump housing.

**Photo 28: View of the propeller reduction gear.**

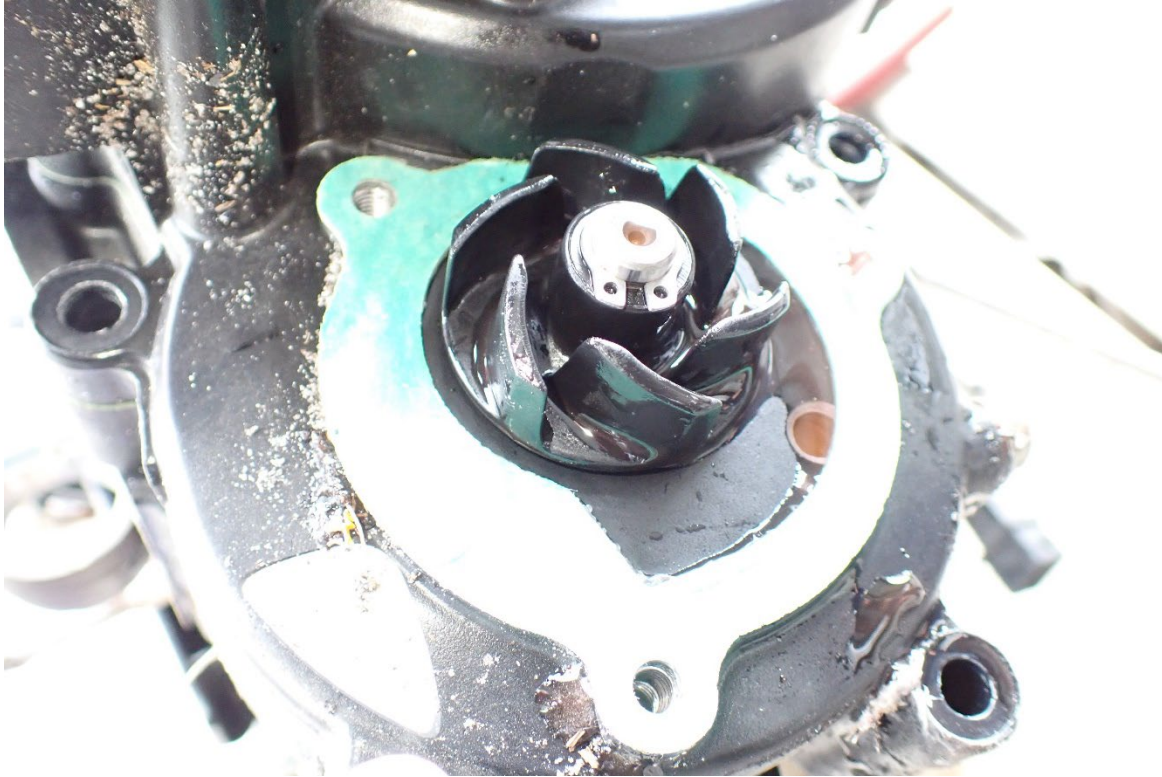
**Photo 29: View of the disassembled coolant pump.**

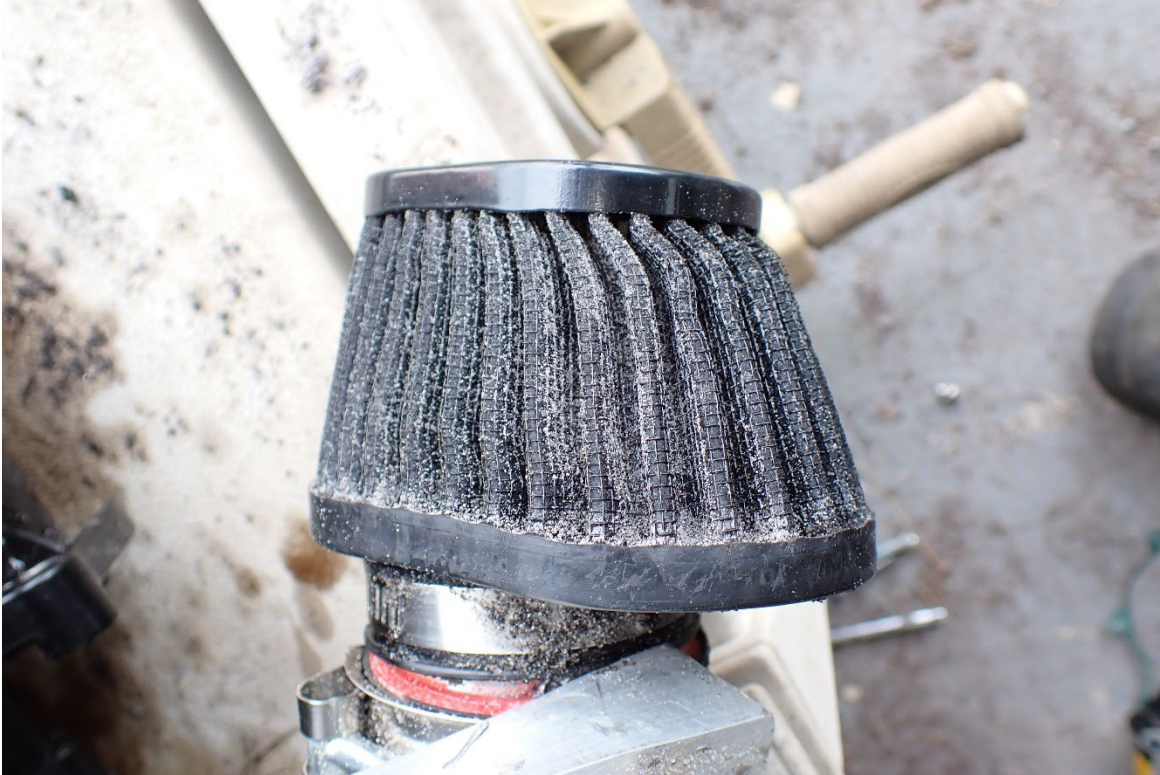
The air intake and exhaust were impact separated from the engine and exhibited impact crushing.

**Photo 30: View of air intake filter.**

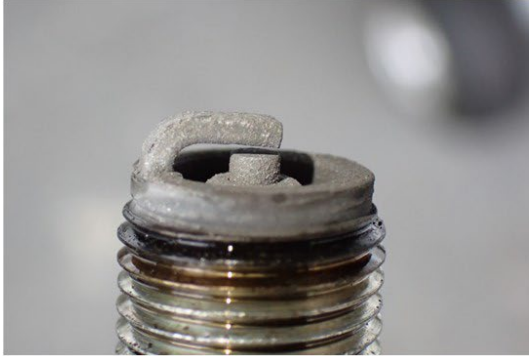
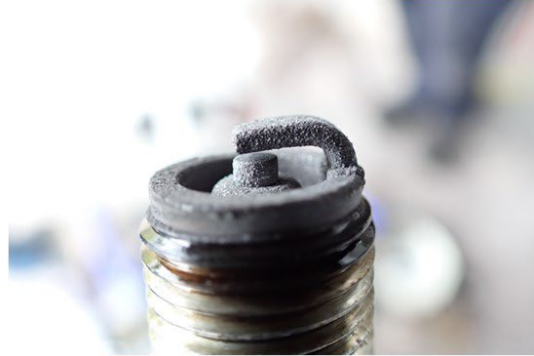
**Photo 31: View of the electrodes of both spark plugs.**

Both spark plugs remained secured to the cylinder and the ignition leads remained attached to both spark plugs; however, the ignition leads were impact separated from their respective coils. The spark plugs were arbitrarily labeled A and B for identification purposes. Both spark plugs displayed normal wear signatures and had material that was adhered to the spark plug electrodes that was consistent with eroded piston material. The engine was equipped with a dual ignition system controlled by two separate capacitor discharge ignition (CDI) systems. Neither CDI could be tested at the time of the examination.

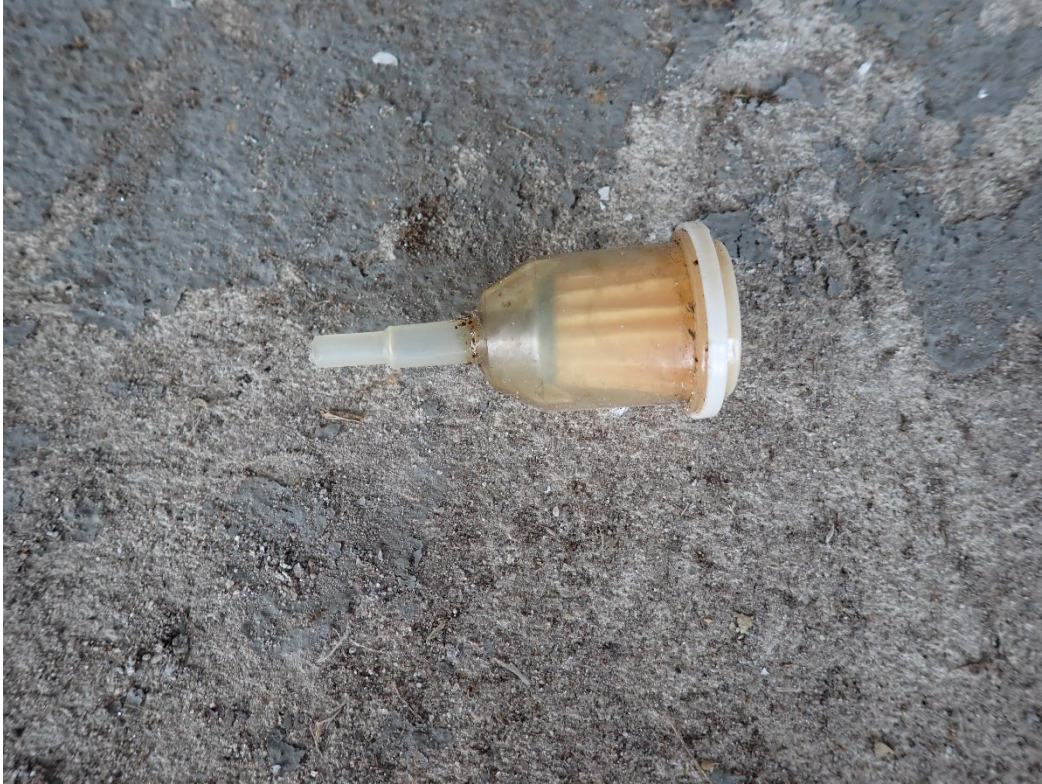
The inline fuel filter was removed and examined, and no debris was found in the filter pleats. The engine driven vacuum fuel pump was removed and disassembled. Both rubber diaphragms were undamaged and pliable with no debris noted. The carburetor was separated from the engine which was consistent with the observed impact damage. The cockpit throttle control was actuated, and the carburetor throttle valve was noted to operate normally. The carburetor was disassembled, and the internal components were visually inspected. All of the components displayed normal operating signatures and there were no obstructions noted in the carburetor tubes and jets.

**Photo 32: View of the inline fuel filter.**

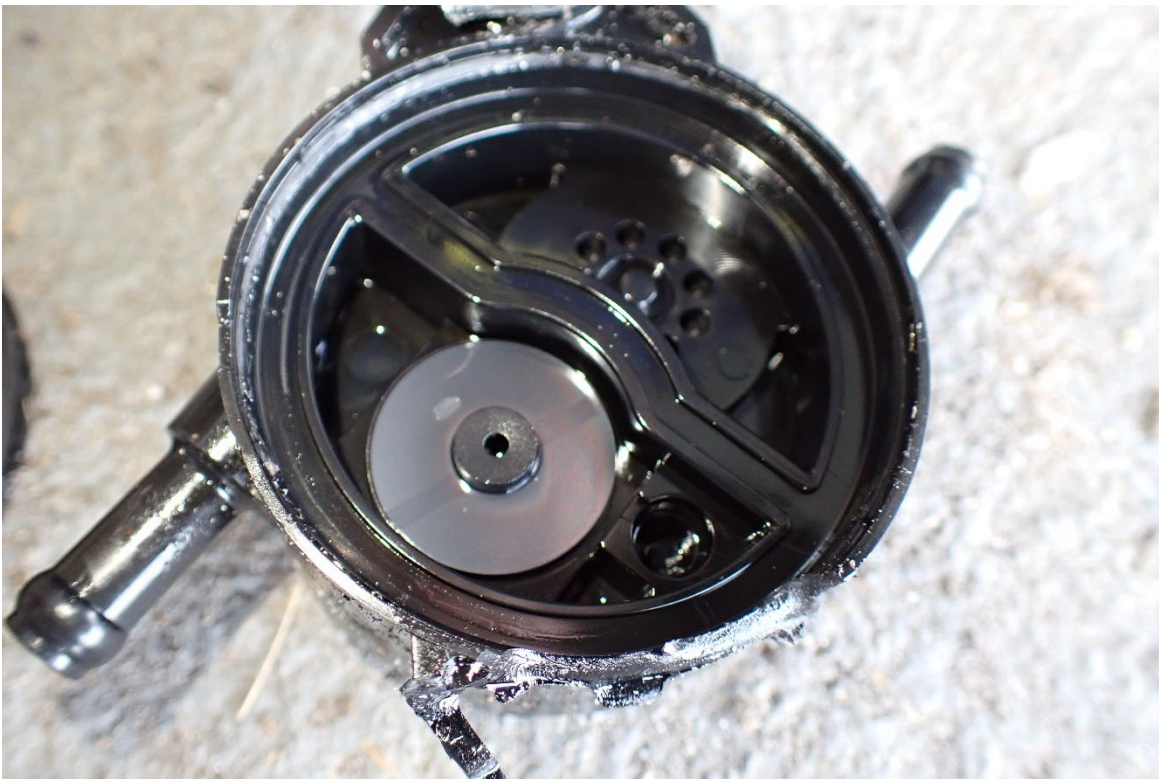
**Photo 33: View of the disassembled fuel pump.**

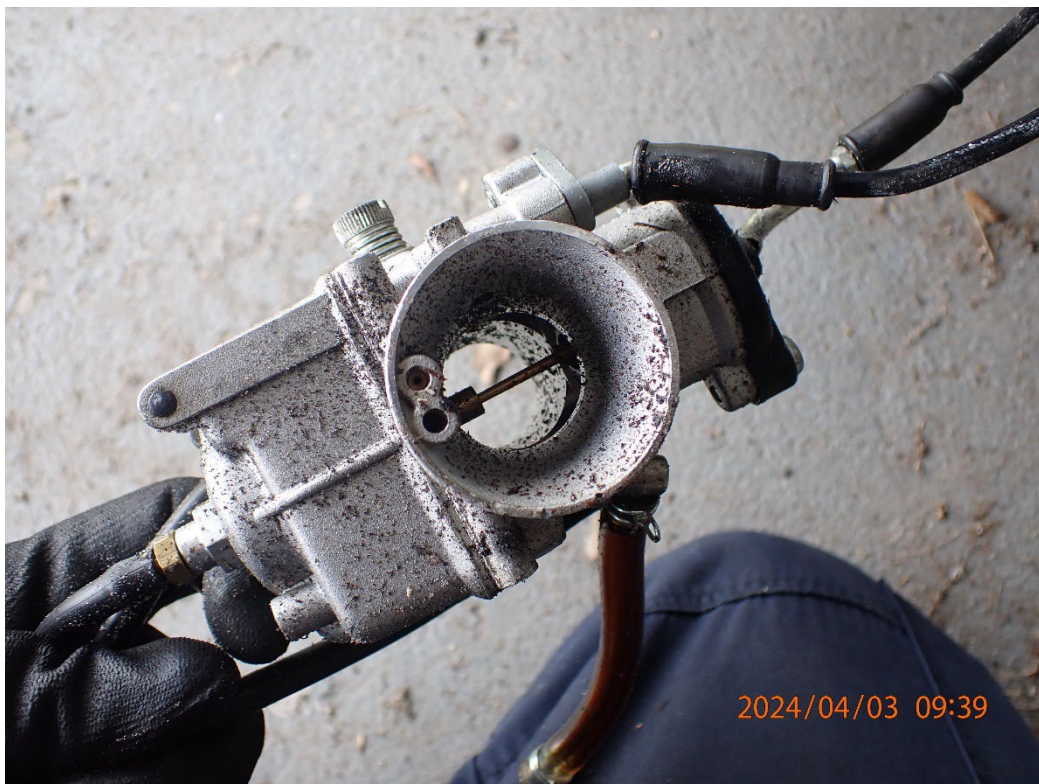
**Photo 34: View of the carburetor as found.**

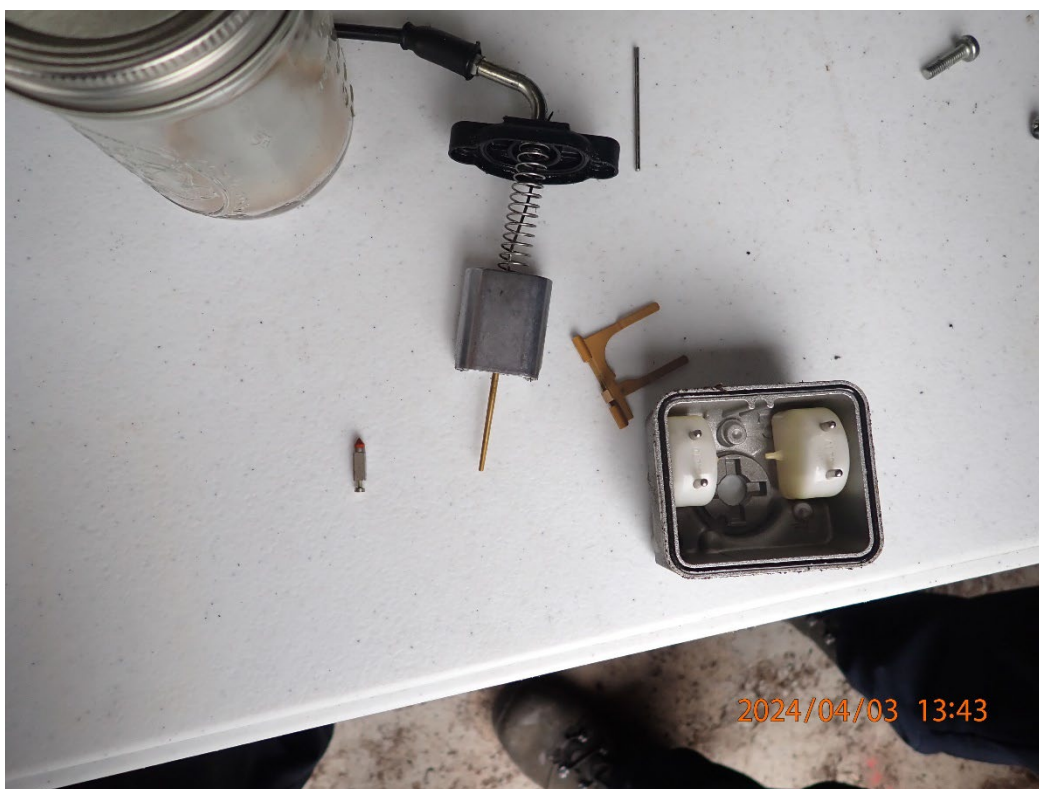
**Photo 35: View of the disassembled carburetor pieces.**

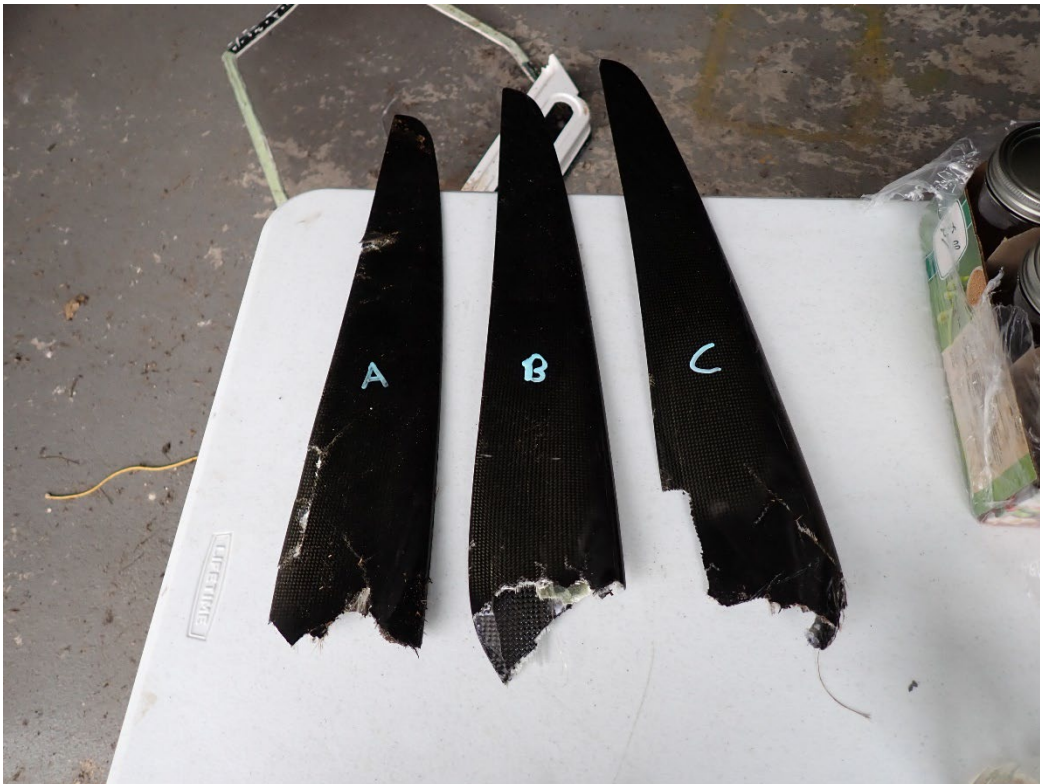
The three blade, fixed pitch propeller remained attached to the propeller flange; however, the propeller flange was fracture separated from the propeller drive shaft. All three of the propeller blades were separated from the propeller hub and were arbitrarily labeled A, B, and C for identification. There was no significant chordwise scratching or leading edge gouging noted in the propeller blades.

**Photo 36: View of the 3 impact separated propeller blades.**
