# National Transportation Safety Board

ERA24FA176

## **FLIGHT PATH DATA STUDY**

Location: Knoxville, Tennessee  
Date: April 12, 2024  
Time: 16:33 eastern daylight time (EDT)  
Airplane: Piper PA-32R-301, N9236J

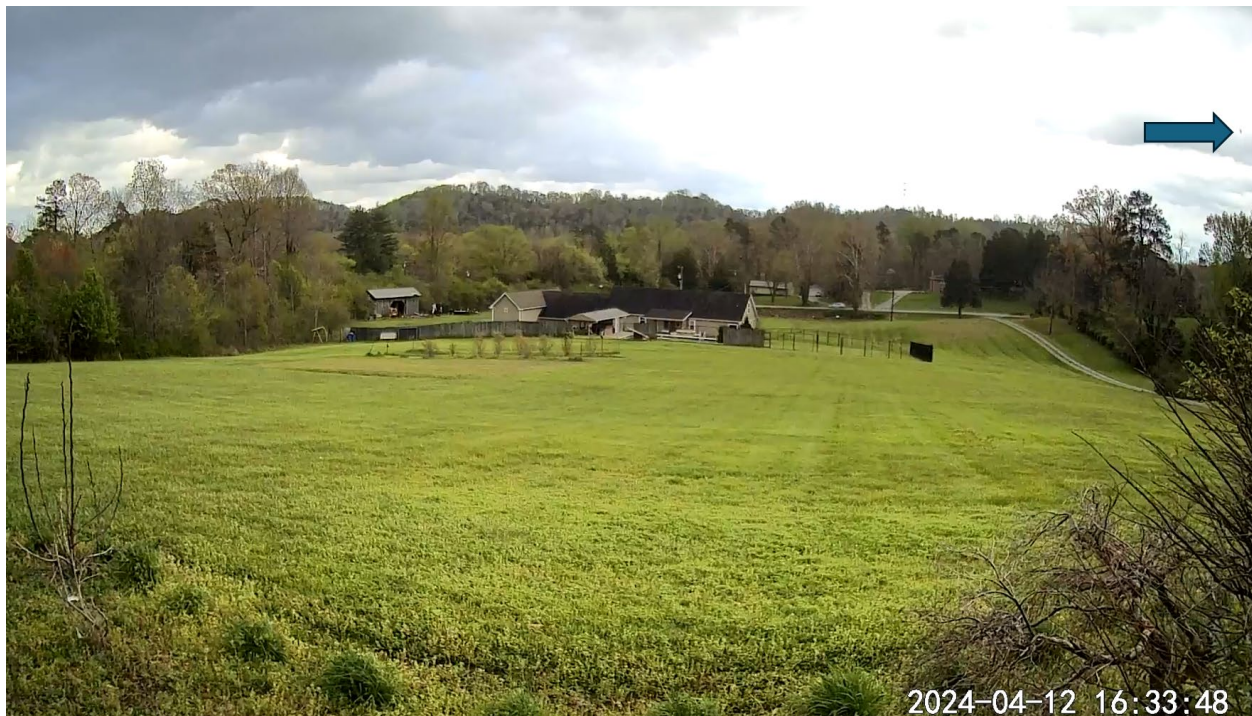
Airport-recorded weather reported few clouds at 5,500 ft above ground level (AGL) and a broken ceiling at 25,000 ft. Visibility was 9 statute miles. The definition of "few clouds" is clouds covering 1/8<sup>th</sup> to 1/4<sup>th</sup> of the sky<sup>1</sup>. However, security video of the accident showed the airplane, whose maximum altitude was below 9,000 ft mean sea level (MSL), descending out of more significant cloud cover (Figure 2).

**Figure 2.** Security video showing airplane descending from clouds (blue arrow pointing to airplane which is a small black speck).

Returning to Figure 2, elevations in the area were between 800 and 1,000 ft MSL and the weather summary recorded the cloud ceiling to be about 5,500 ft AGL. The security video likely captured the airplane at the end of the recorded flight data or just after. Therefore, the airplane was likely in the clouds during the left roll upset and subsequent right spiral descent.

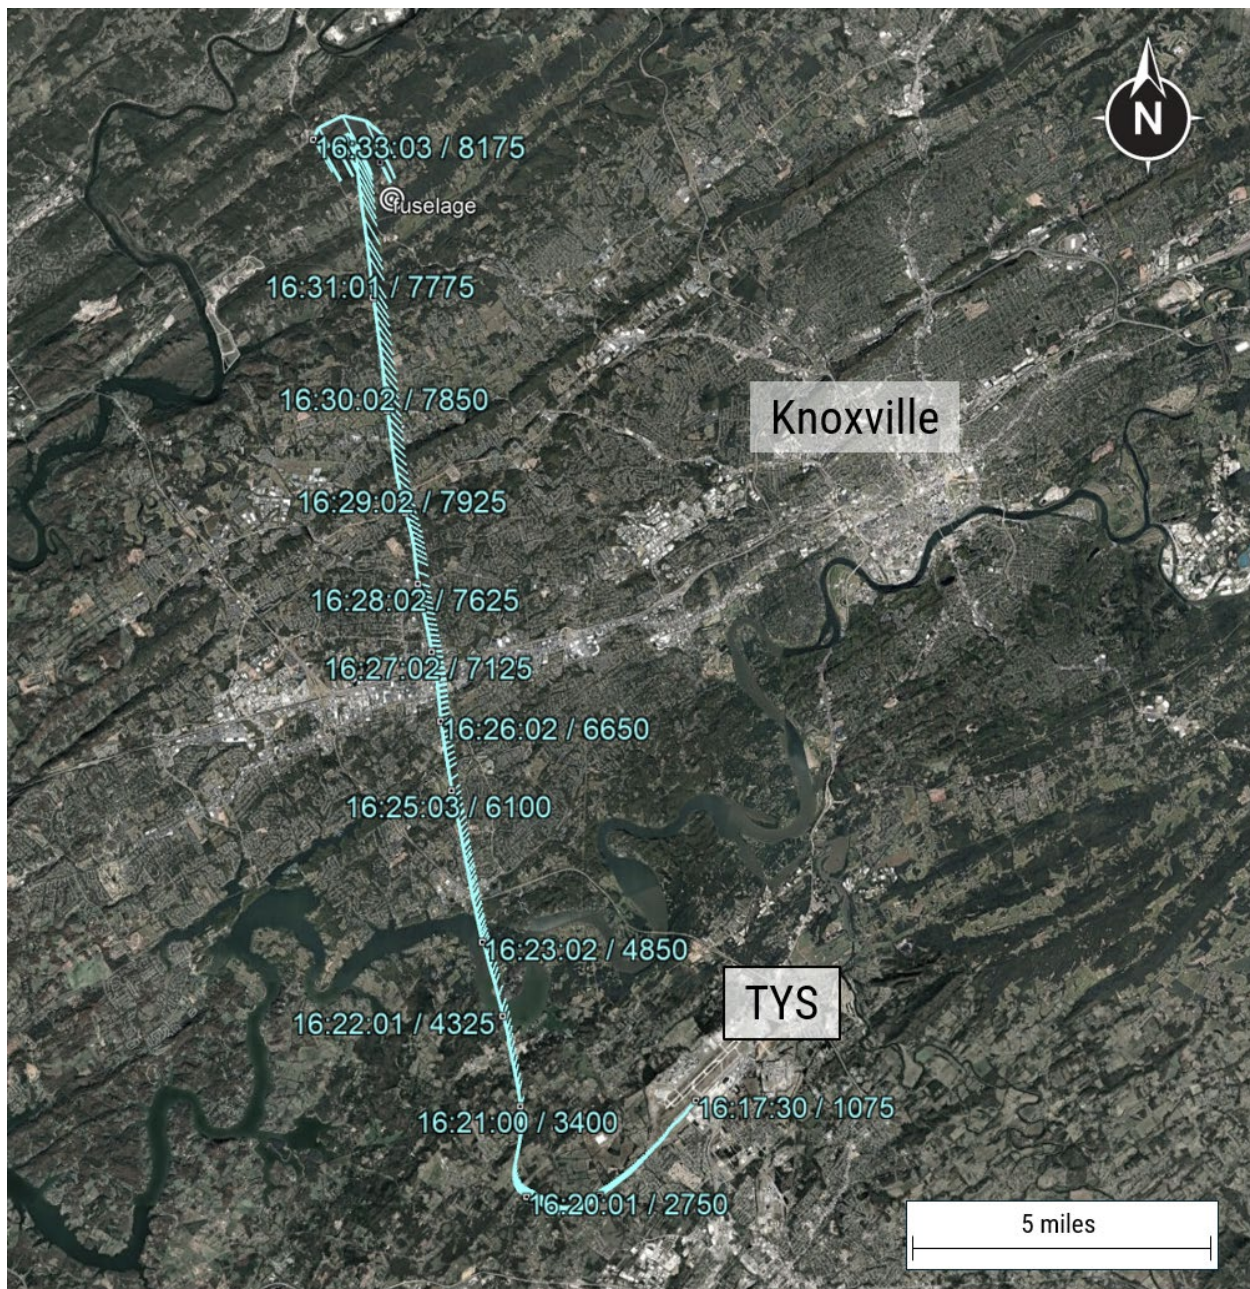
The airplane took off from runway 23L at TYS at 16:17:30 (Figure 3). Shortly after takeoff it turned right onto a northerly heading by 16:21 while climbing. Calibrated airspeed during the climb varied between 85 and 105 kts (Figure 4). About 16:28:30, the airplane stopped climbing and leveled out near 8,000 ft MSL and airspeed increased to over 110 kts.

**Figure 3.** Airplane flight path with selected times and altitudes shown.

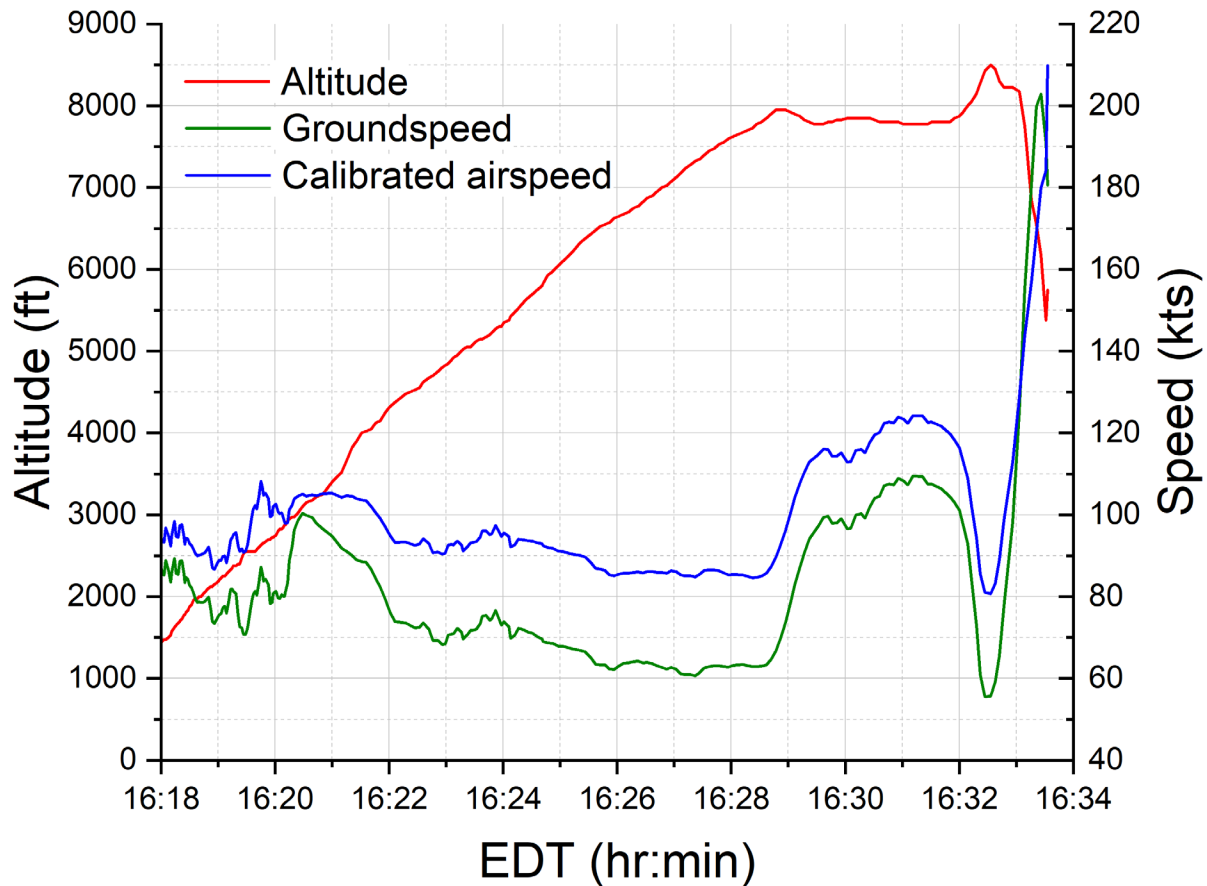
**Figure 4.** Airplane recorded altitude and calculated groundspeed and calibrated airspeed.

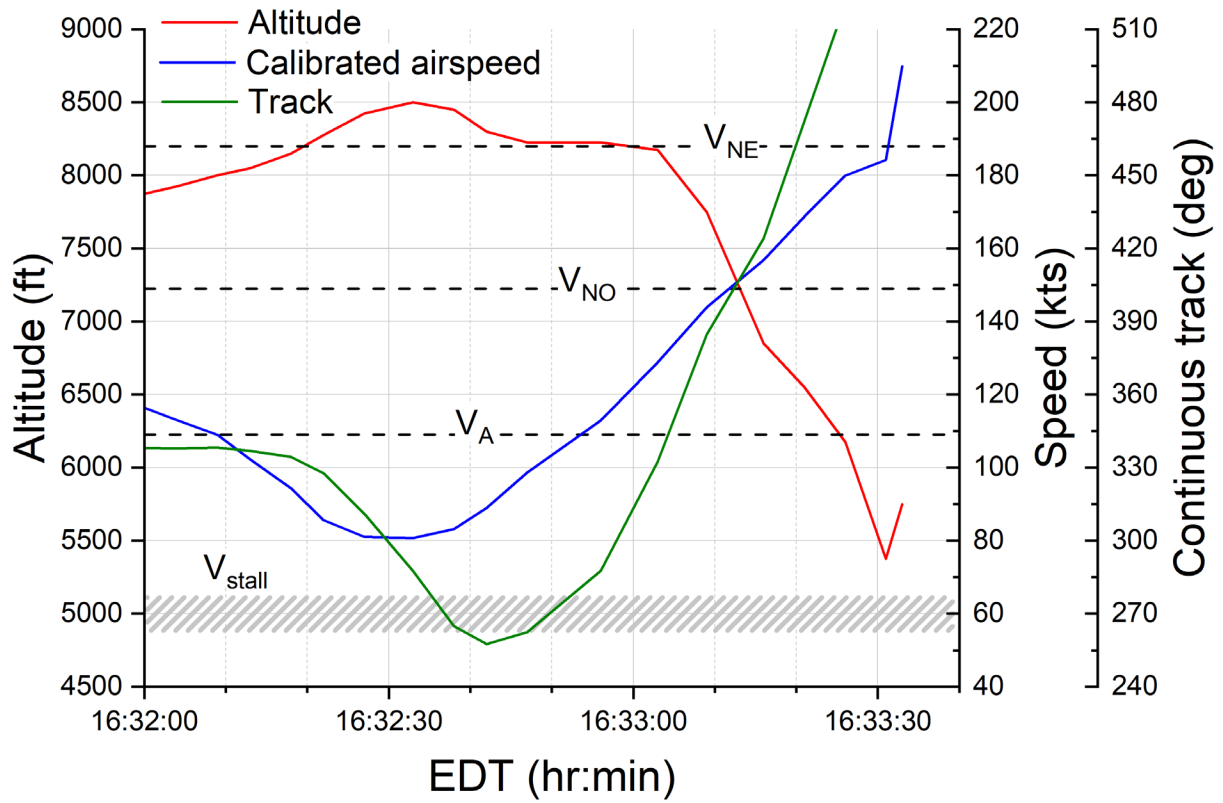
The airplane resumed climbing at about 16:32 and it rapidly lost airspeed, dropping from over 120 kts to 80 kts in 43 seconds. At 16:32:33, the airplane reached a maximum altitude of 8,500 ft, coinciding with its lowest speed of 80 kts. The airplane then rolled left and turned more than 90° in 11 seconds while descending at an initial rate of 1,300 ft/min.

**Figure 5.** Recorded altitude with calculated calibrated airspeed and flight path track.

The sudden roll off and descent while at a minimum airspeed was consistent with aerodynamic stall. However, the stall speeds listed in the Pilot's Operating Handbook [2] show a highest wings-level stall speed as 65 kts for power off, no flaps, heavy. The lowest calculated airspeed using winds aloft was about 80 kts, or 15 kts higher than the highest stall speed.

Ice accumulation on the wings could result in stall at an airspeed 15 kts higher than expected. The meteorological factual report showed that moderate icing was predicted in the area [1]. Moderate ice is defined as an ice accretion rate of ¼ inch in 5 - 15 minutes. The pilot had contacted air traffic control (ATC) and stated that the

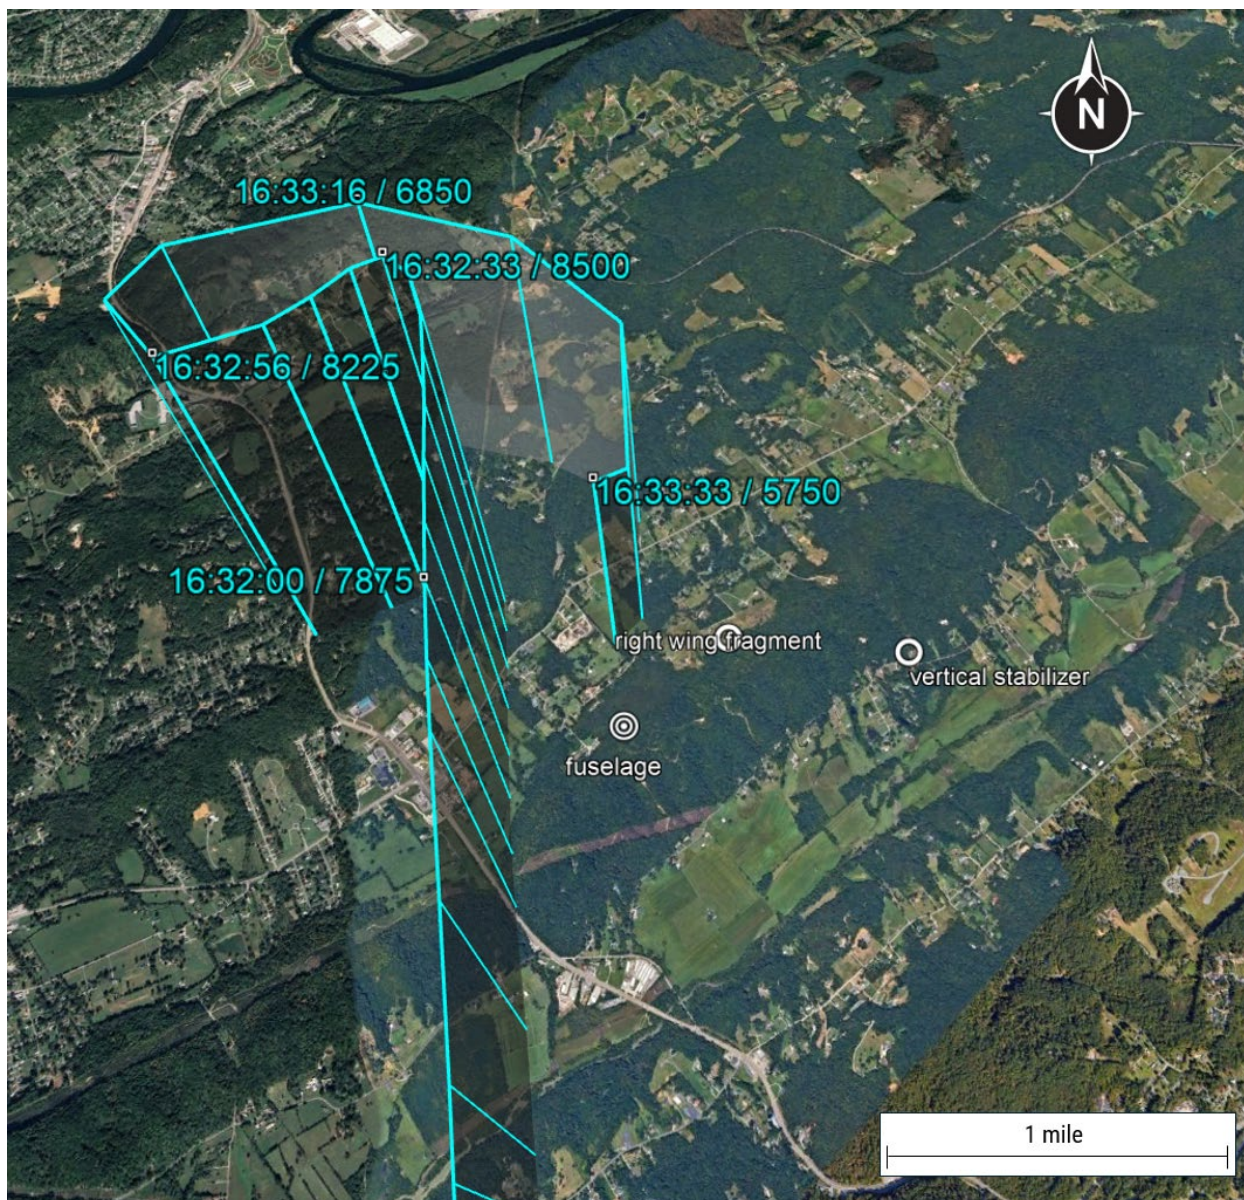
**Figure 6.** End of flight with selected times and altitudes annotated. Also shows is the final position of the fuselage and some other wreckage.

By 16:32:42, the airplane arrested its left turn and by 16:32:47 it leveled out briefly at 8,200 ft. However, airspeed continued to increase through the maneuvering speed,  $V_A^2$ , as the airplane began a right turn. After 16:33:03, the airplane began rapidly descending at a rate exceeding first 2,000 ft/min then 6,000 ft/min. The airplane exceeded  $V_{NO}^3$  by 16:33:16 and the never exceed speed,  $V_{NE}^4$ , by the end of the recorded flight. Exceeding these speeds while in a turn would put the airplane at risk of structural failure, consistent with the in-flight breakup and debris field.
