# National Transportation Safety Board

ERA24FA176

## **WRECKAGE EXAMINATION**

**Aircraft:** Piper PA-32R-301

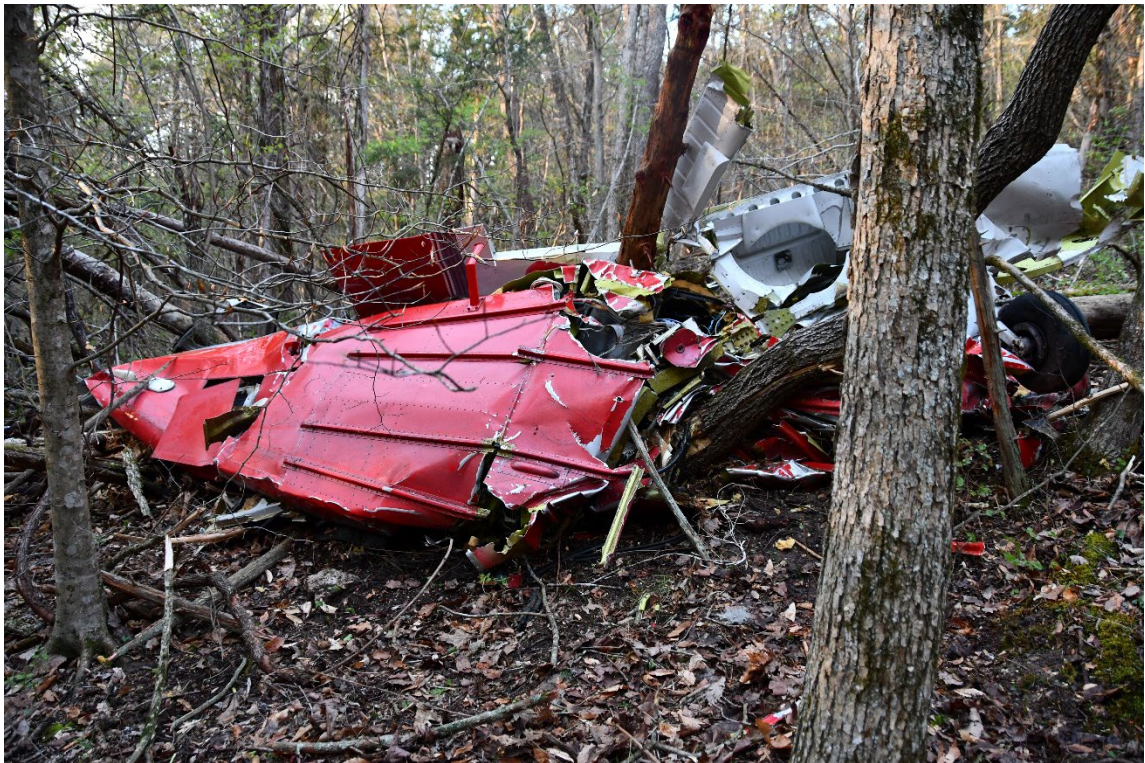
Figure 1 - Main Wreckage Site

The wreckage was located in a wooded area near a residential neighborhood. The main wreckage, consisting primarily of the fuselage, was found in a nose-down attitude on a wooded hillside. The debris field extended over a distance of several thousand feet and was oriented along the final flight path. Multiple aircraft components, including portions of the empennage and wings, were located at varying distances from the main wreckage. The distribution of debris, including major structural components separated from the fuselage, was consistent with an in-flight breakup.
