ERA24FA176

## INVESTIGATION PHOTOGRAPHS

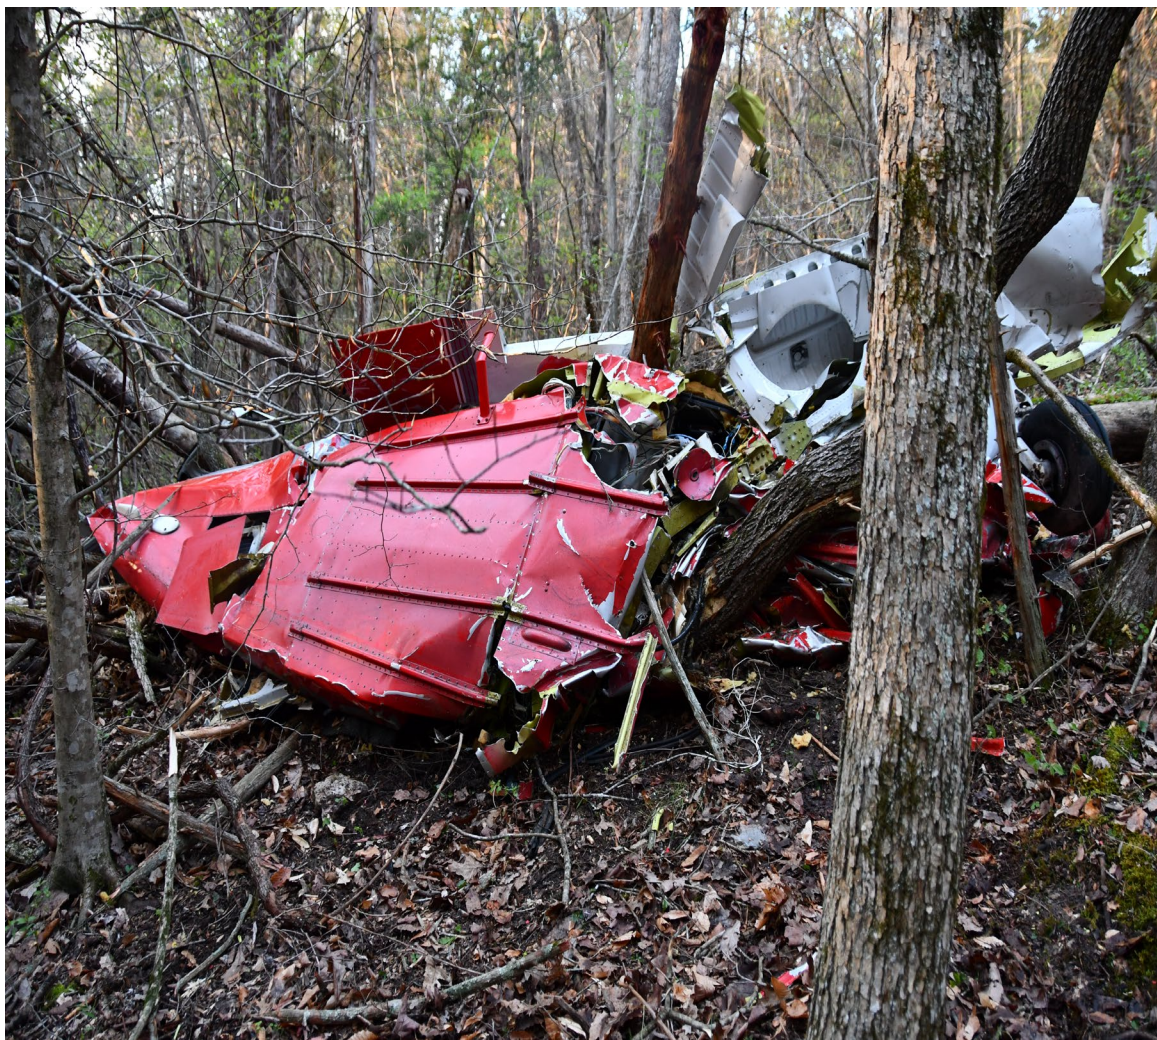
**Photograph 1 - View of main wreckage**

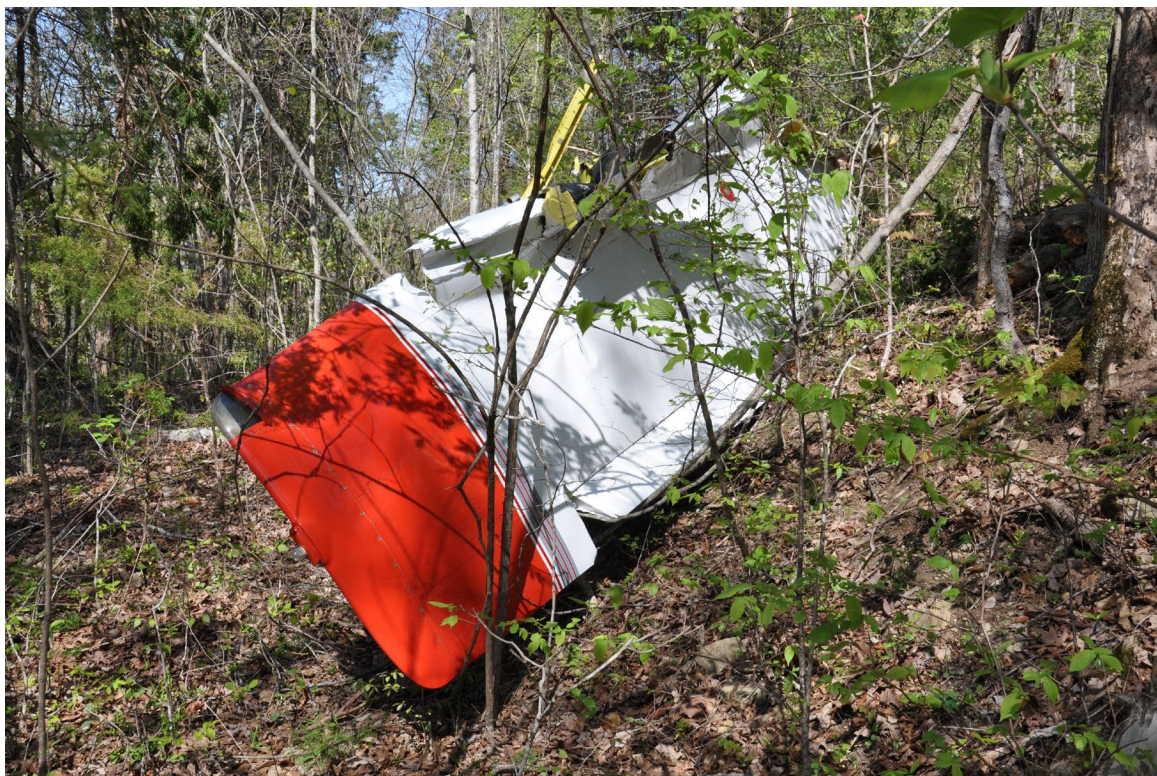
**Photograph 2 - View left wing**

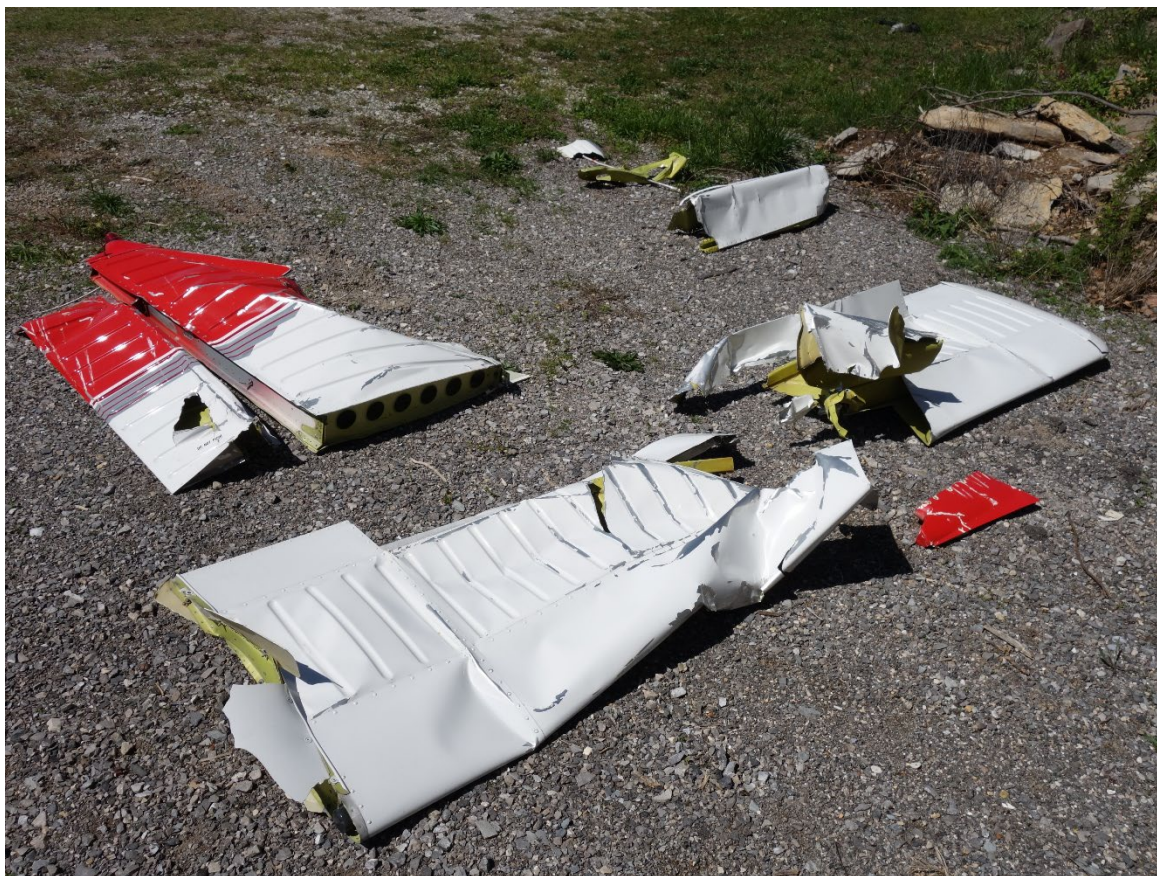
**Photograph 3 - View of vertical stabilizer, rudder and horizontal stabilizer.**

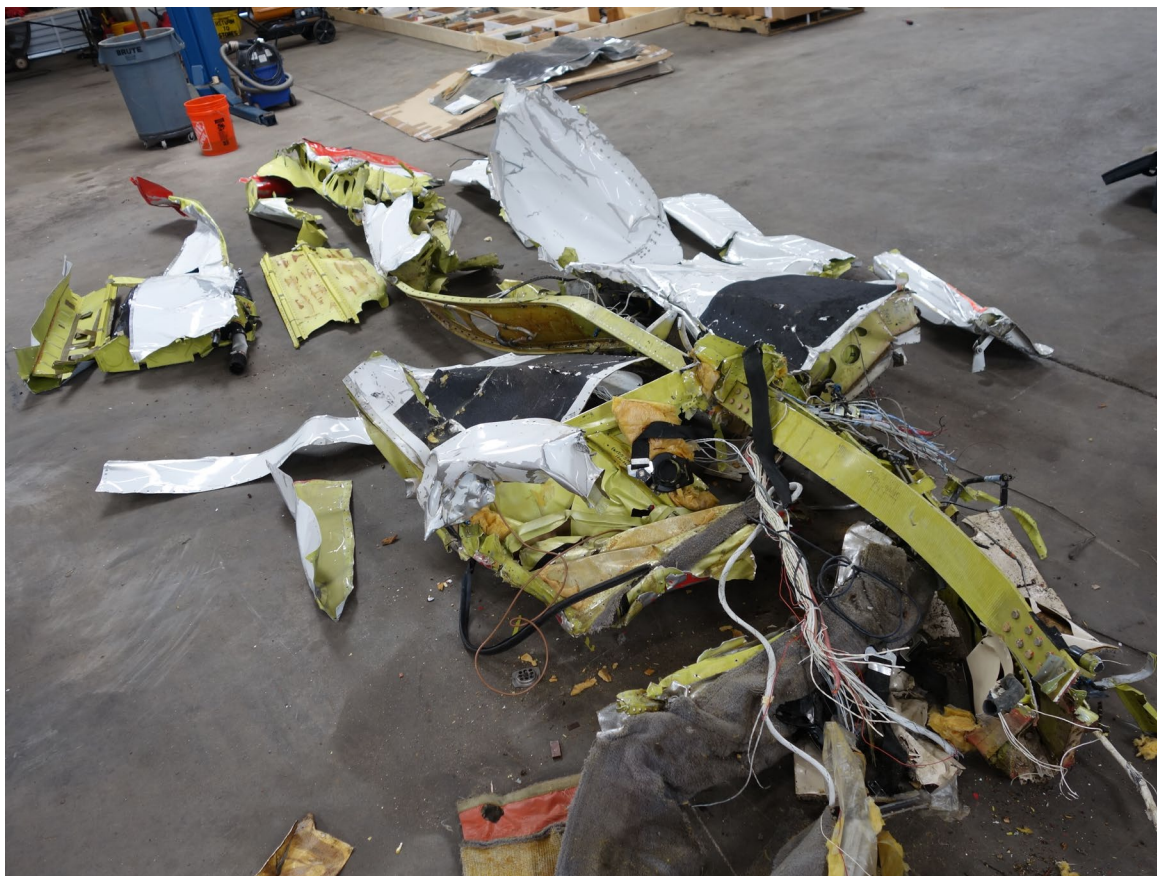
**Photograph 4 - View of right-wing post examination**

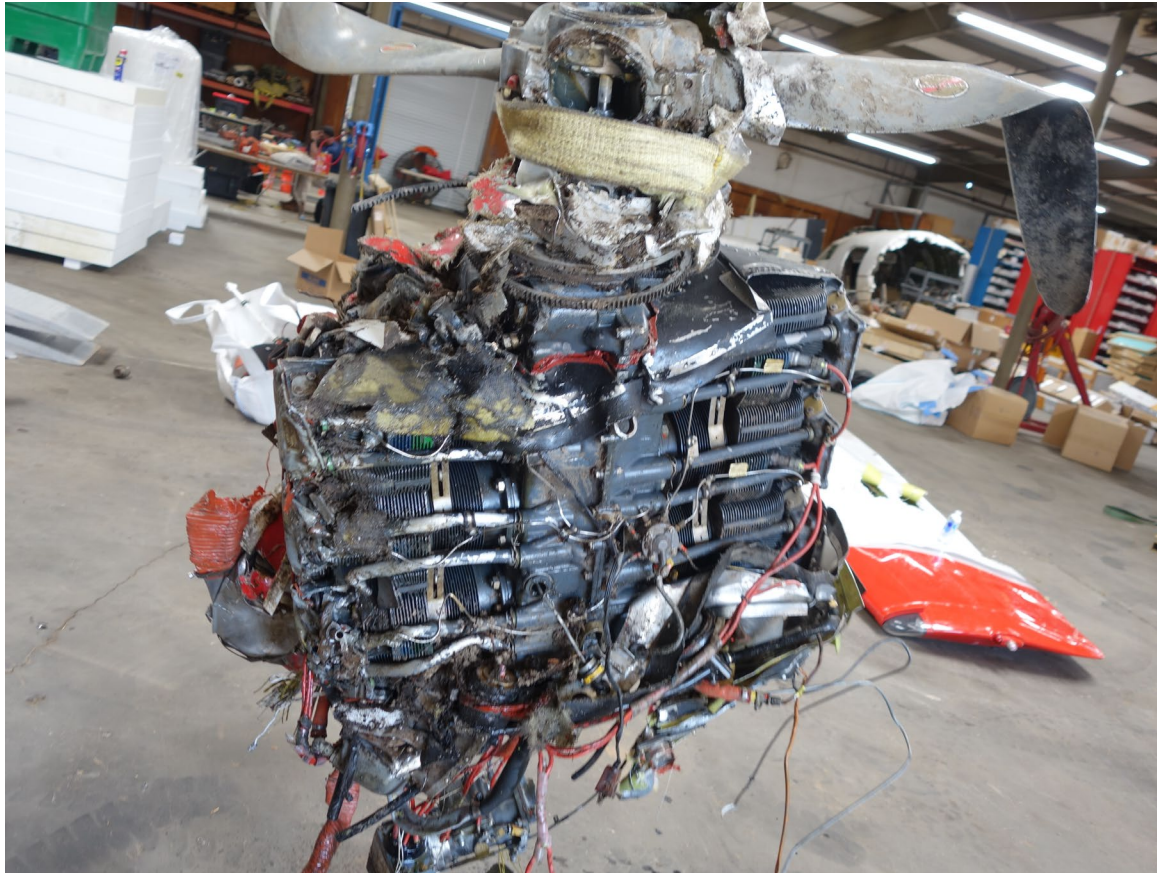
**Photograph 5 - View of engine post-accident.**
