# National Transportation Safety Board

ERA24FA206

## **WRECKAGE EXAMINATION**

Location: Augusta, Georgia  
Date: May 2, 2024  
Time: 0713 EDT  
1113 UTC  
Airplane: N629BE; Raytheon Aircraft Company A36

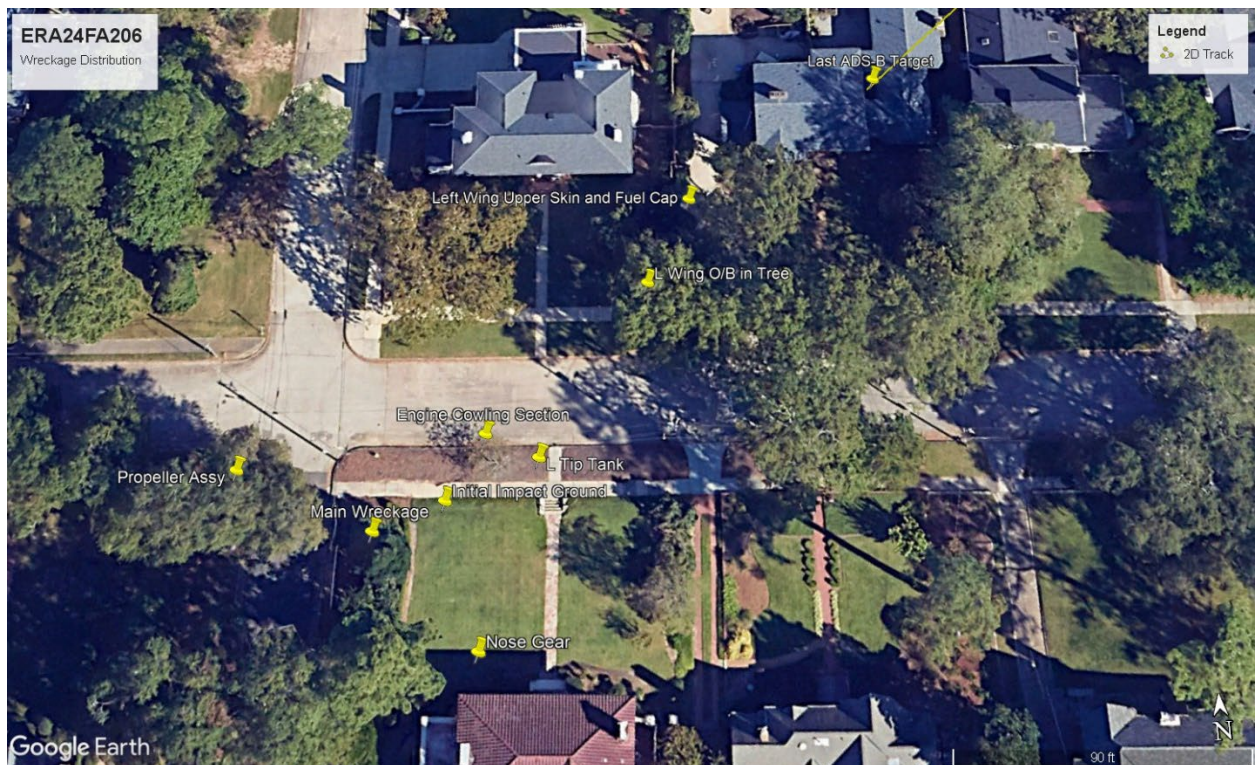
Figure 1 - Wreckage Diagram

The airplane initially collided with the top of a large oak tree, severing the outboard half of the left wing. The outboard wing section remained lodged in the tree, about 60 ft above the ground. The airplane continued and impacted the front yard of a residence, coming to rest upright at coordinates 33.47759, -82.03308 (Figure 1).

The magnetic heading from the initial tree strike to the main wreckage was 240°, and the fuselage was found oriented on a heading of 265°. The entire wreckage path was about 150 ft long and about 55 ft wide. The descent angle from the initial tree strike to the first point of ground impact was about 31°.
