# National Transportation Safety Board

ERA24FA209

## **STRUCTURES**

Group Chair's Factual Report

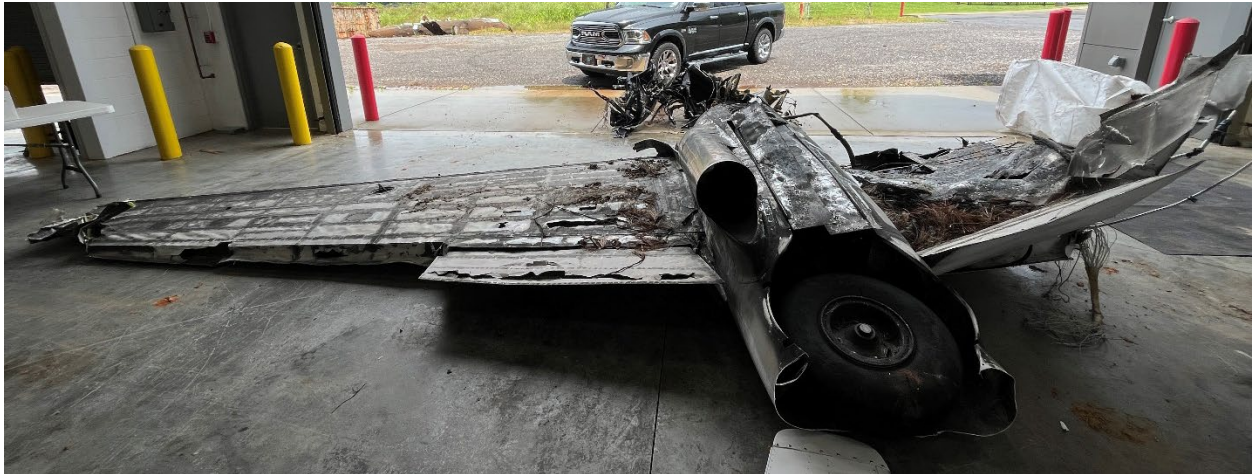
The entire lower skin showed evidence of heat damage with areas of skin penetration (Figure 3). The lower surface inboard of the engine was burnt through the skin into the frame structure which was burnt and melted. The areas of the upper

skin that were observed exhibited minor heat damage to the paint. The right wing structure was deformed in a downward direction between the fracture at the root and the nacelle. The fractured surfaces were visually inspected, and they had a dull, grainy appearance consistent with overstress fractures.

**Figure 3.** Right Wing Damage (aft looking forward at lower surface) (NTSB photo)

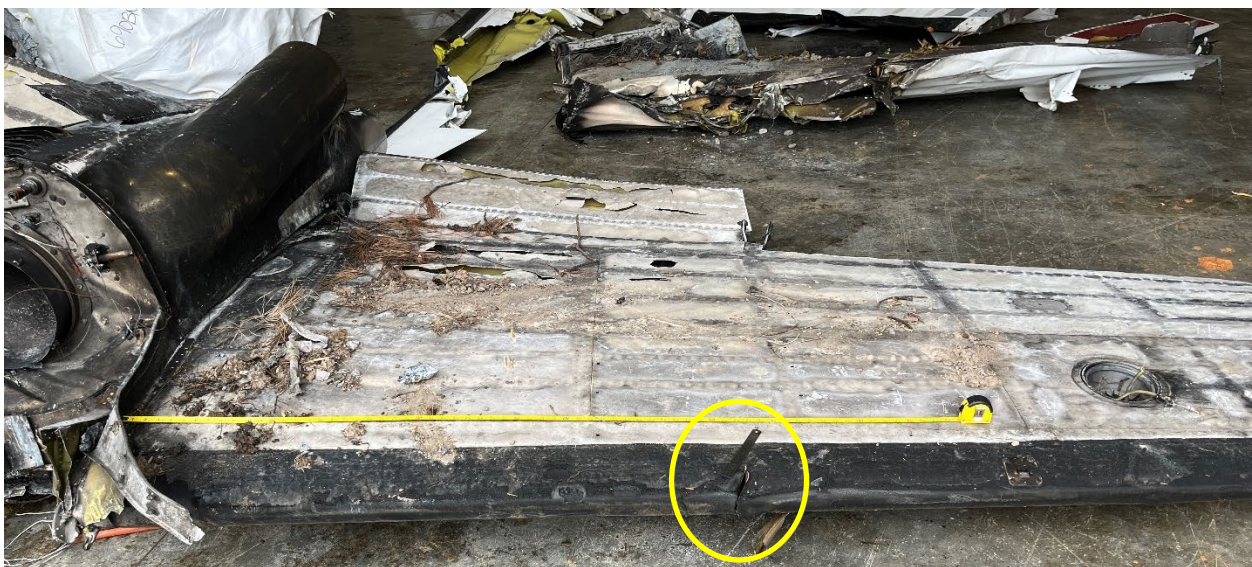
The leading edge of the right wing had a cut approximately 50 inches from the outboard edge of the nacelle (Figure 4). The cut was through the leading edge and extended approximately 2 inches aft on the lower skin and 4 inches aft on the upper skin. The leading edge skin was deformed upward on the upper and lower surfaces.

**Figure 4.** Right Wing Damage (forward looking aft) (NTSB Photo)

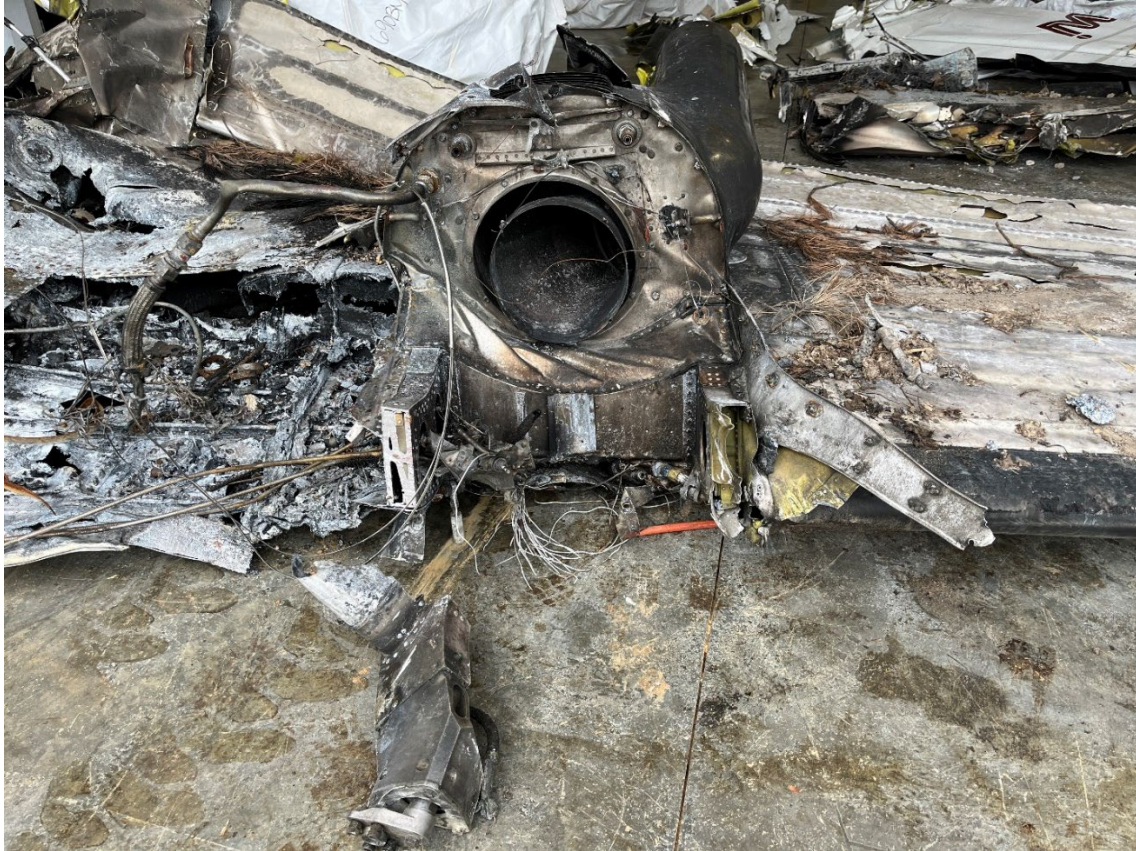
The inboard mount block remained attached to the wing and did not show signs of deformation (this section was cut during recovery operations). The outboard mount fractured and deformed in the outboard direction (Figure 5).

**Figure 5.** Right Engine Mounts (NTSB Photo)

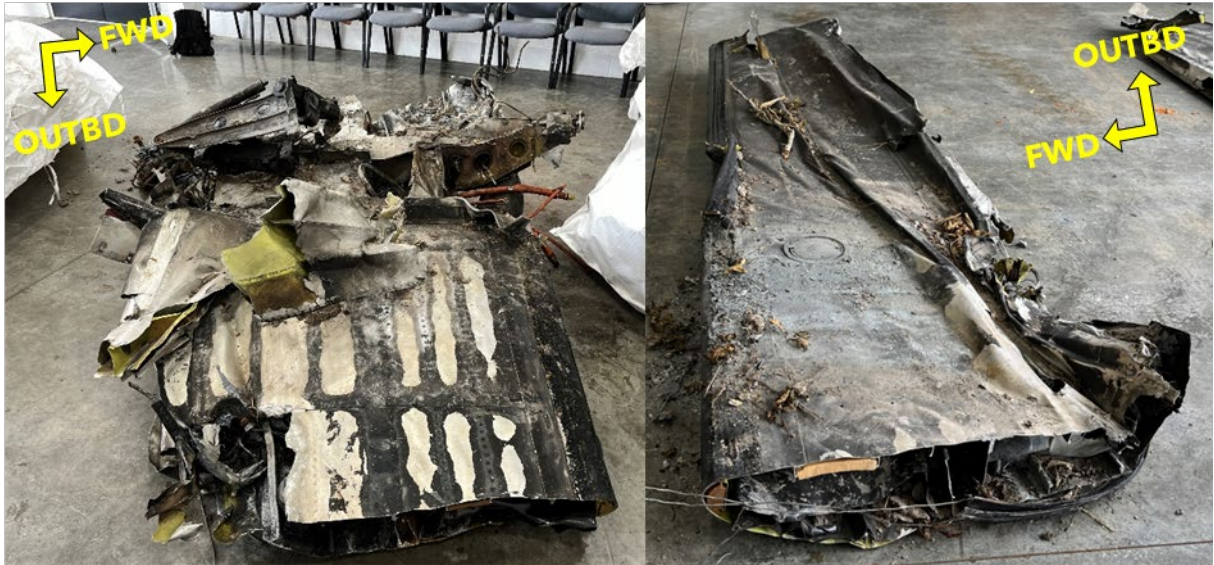
The entire lower skin showed evidence of heat damage with areas of skin penetration (Figure 6). The lower surface of the left wing inboard of the engine was burnt though and the frame structure melted. The areas of the upper skin that could be observed exhibited minor heat damage to the paint. The left wing had a deformation in the downward direction near the wing root.

**Figure 6.** Left Wing Damage (lower surface) inboard (left) outboard (right) (NTSB Photo)

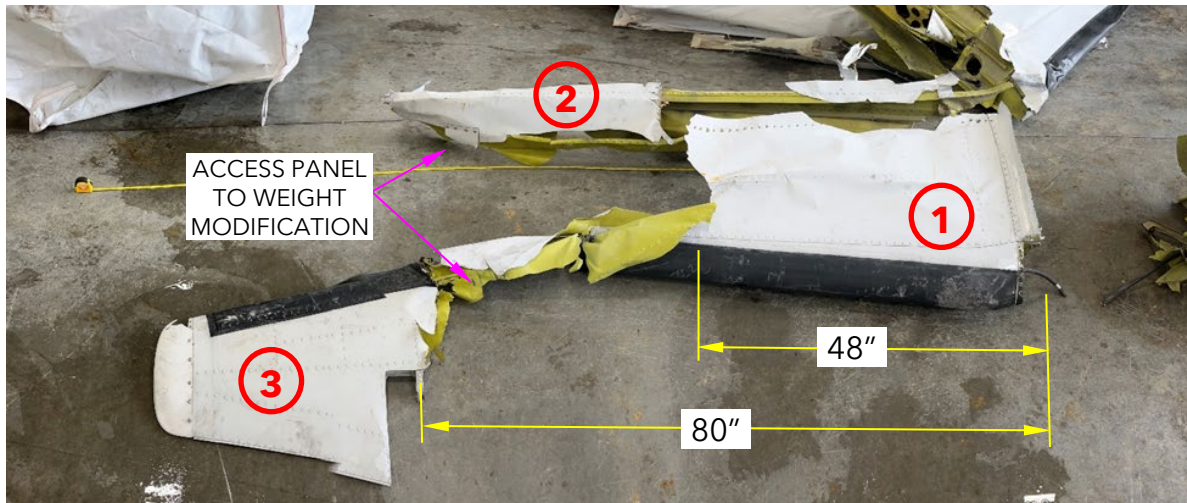
The right horizontal stabilizer separated from the airplane and was recovered in the debris field in three major pieces with no heat or fire damage (Figure 7). The right elevator was not recovered. The first piece consisted of the right horizontal stabilizer forward spar, leading edge, the center spar, and most of the upper and lower skins from the root to about 80 inches outboard. The forward spar was completely fractured about 80 inches outboard of the root. The forward spar was partially fractured about 48 inches outboard of the root and the forward spar, leading edge and portions of the upper and lower skins were twisted about 180° leading edge down between 48 and 80 inches outboard of the root. There was an aluminum access door on the upper skin, approximately 43 inches from the wingtip (between stations 70 and 78). There were weights attached to the forward spar at this location. The second piece consisted of the right horizontal stabilizer aft spar, portions of the center spar, and the upper and lower skins from about 5 inches inboard of the root to about 80 inches outboard of the root. The third piece consisted of the outboard end of the right horizontal stabilizer that spanned from about 80 inches outboard of the root to the tip. The third piece was mostly intact with little damage. The fractured surfaces were visually inspected, and they had a dull, grainy appearance consistent with overstress fractures.

**Figure 7.** Right Stabilizer (NTSB Photo)

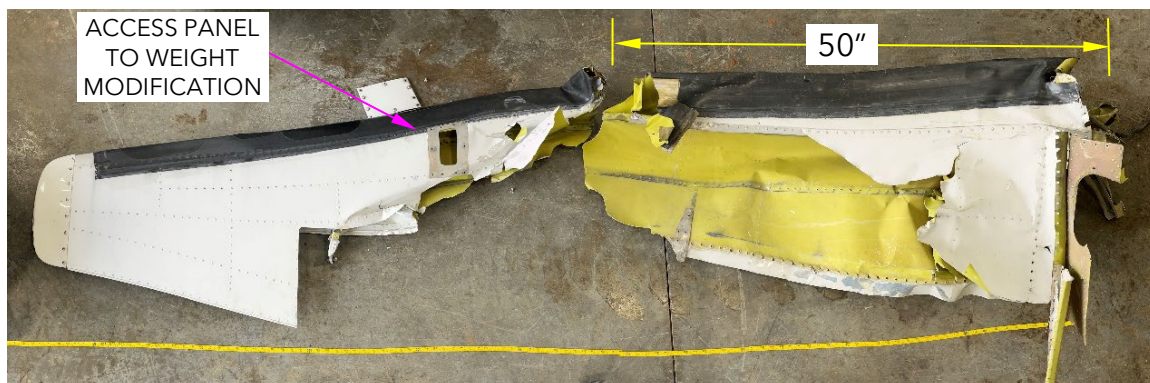
The left horizontal stabilizer separated from the airplane in two major pieces with no heat or fire damage (Figure 8). The elevator and most of the aft and center spars separated from the rest of the stabilizer and were not recovered. The first piece comprised the left horizontal stabilizer forward spar, leading edge and most of the upper and lower skins from the root to about 50 inches outboard. The forward spar was fractured approximately 50 inches from the root. The second piece comprised the outboard section of the left stabilizer from about 50 inches outboard of the root to the tip with little damage to the outboard end. The aft spar was fractured approximately 45 inches from the tip and the center spar was fractured approximately 39 inches from the tip. The forward spar and leading edge were deformed at the fracture location consistent with the elevator tip moving upwards and slightly leading edge up (Figure 9). There was an aluminum access door on the upper skin, approximately 43 inches from the wingtip, between stations 70 and 78. There were weights attached to the forward spar at this location. The fractured surfaces were visually inspected, and they had a dull, grainy appearance consistent with overstress fractures.

**Figure 8.** Left Stabilizer (NTSB Photo)

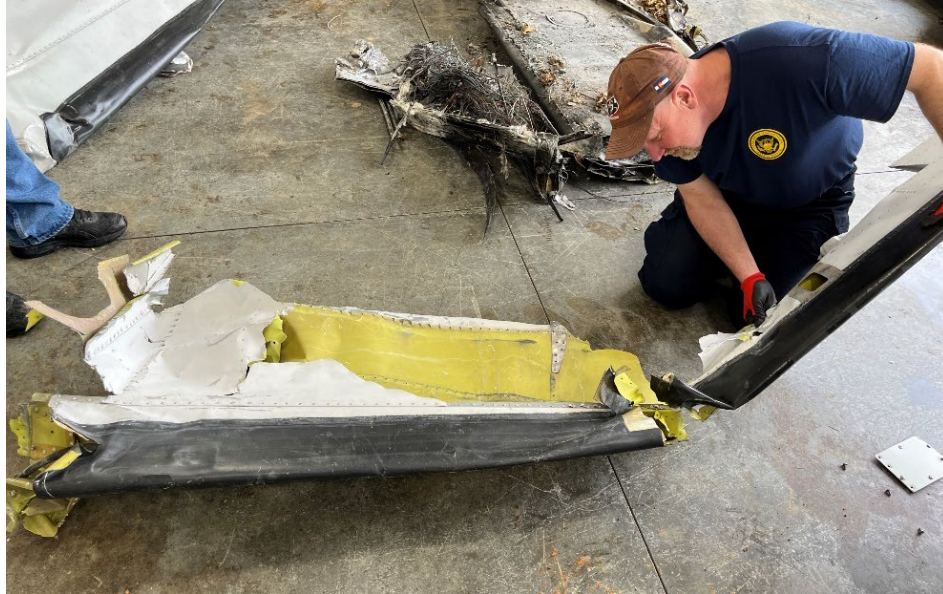
**Figure 9.** Left Stabilizer Deformation (NTSB Photo)

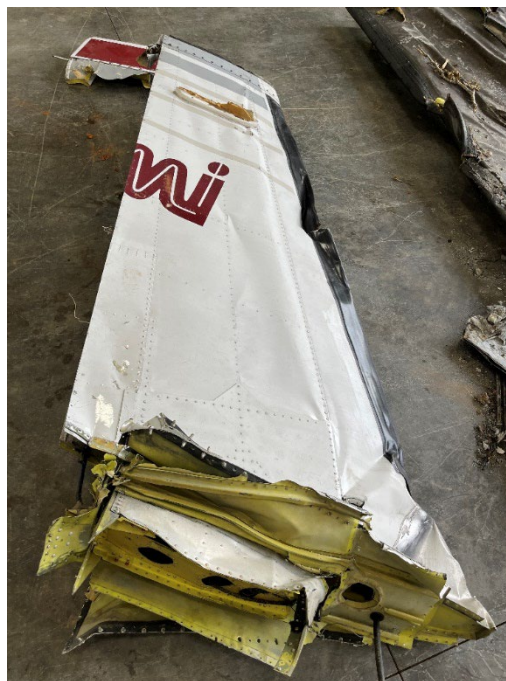
The vertical stabilizer separated from the airplane with no heat or fire damage (Figure 10). The rudder and rudder tip cap with counterweight separated from the rest of the stabilizer. The rudder was not recovered. The vertical stabilizer was deformed to the right relative to the fuselage mount structure attached at the base (Figure 11). The fractured surfaces were visually inspected, and they had a dull, grainy appearance consistent with overstress fractures.

**Figure 10.** Vertical Stabilizer (NTSB Photo)

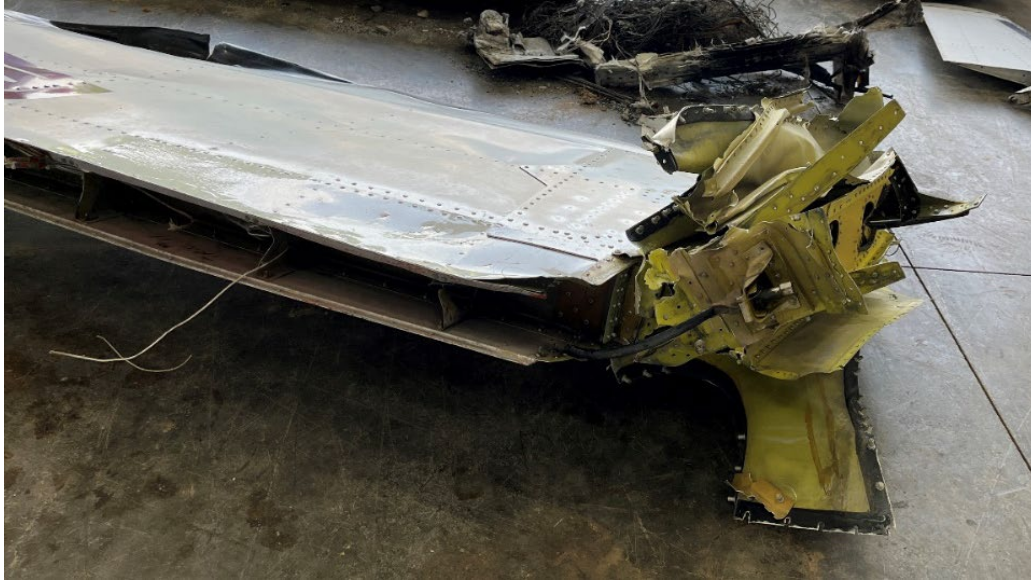
**Figure 11.** Vertical Stabilizer Deformation (NTSB Photo)
