# National Transportation Safety Board

ERA24FA217

## **AUTOMATIC DEPENDENT SURVEILLANCE- BROADCAST (ADS-B) STUDY**

Aircraft Performance Study

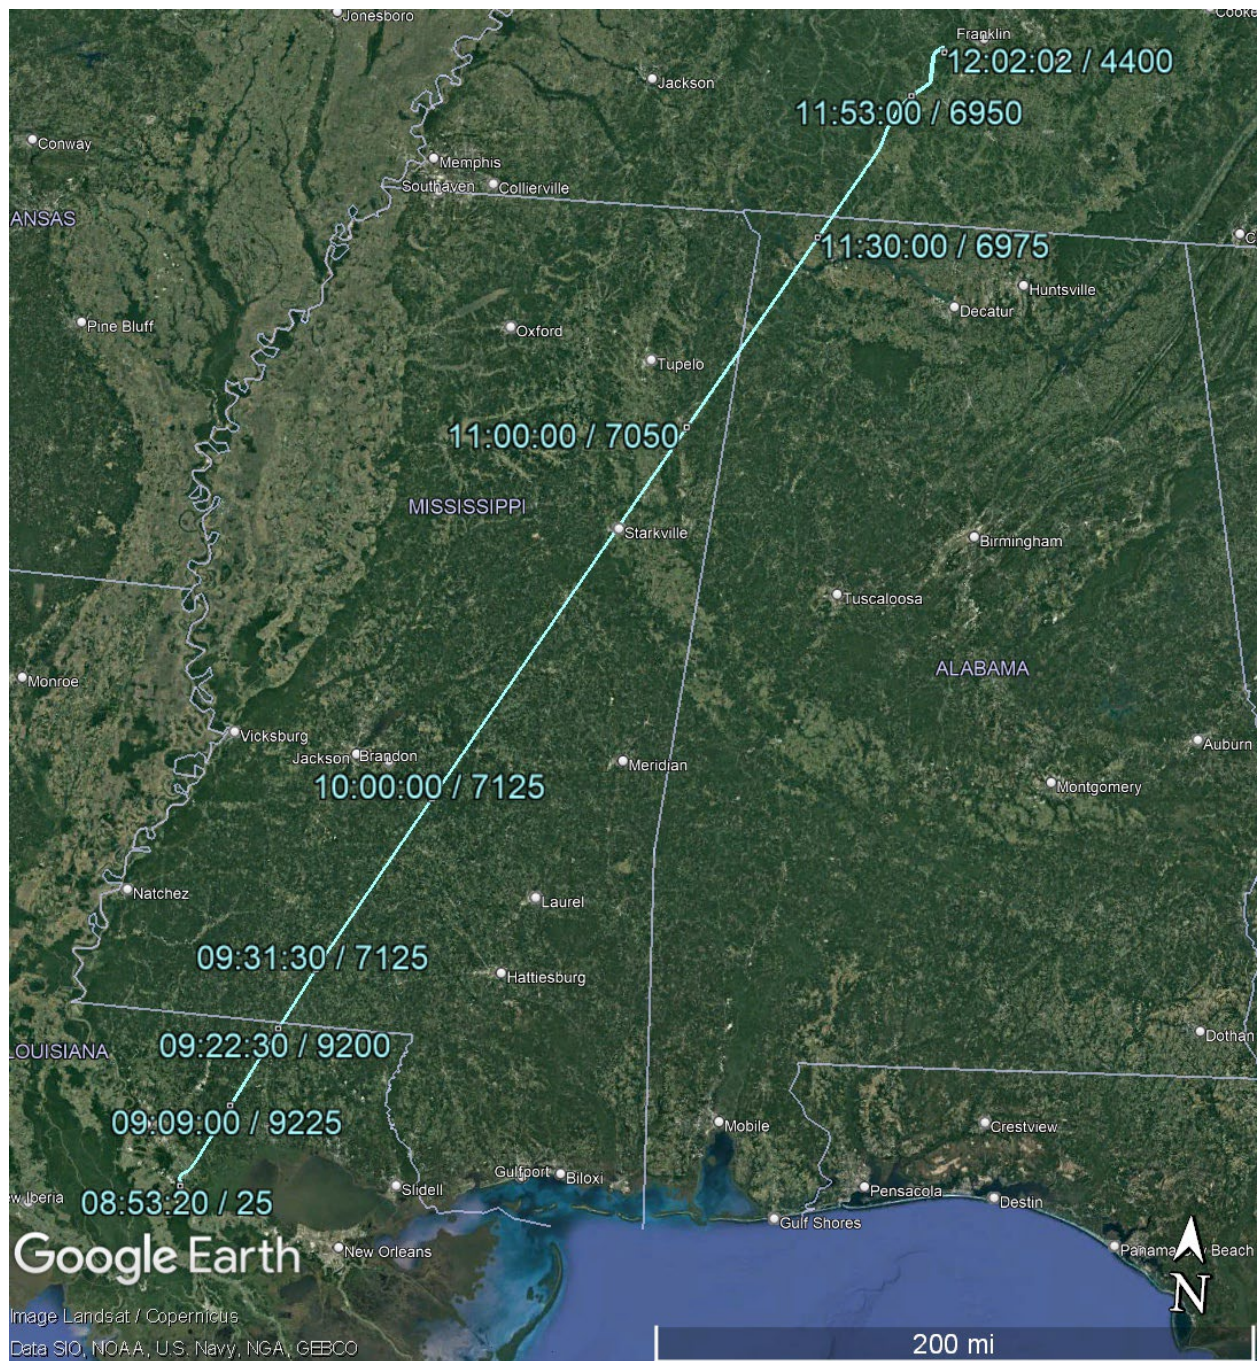
The airplane departed Louisiana Regional Airport (REG), in Gonzales, Louisiana on an instrument flight rules (IFR) flight plan about 08:50 and was enroute to Bowman Field Airport (LOU), Louisville, Kentucky. The airplane initially climbed to 9,200 ft before descending to 7,000 ft msl. It maintained 7,000 ft and a north-easterly track of 30° from 9:30 until 11:42 while maintaining a groundspeed between 125 and 135 kts. This track was aligned with the navigation aid EWO (referred to by ATC as Echo-Whiskey-Oscar) which was 37 miles south of LOU.

**Figure 2.** ADS-B flight path with selected times and altitudes notated.

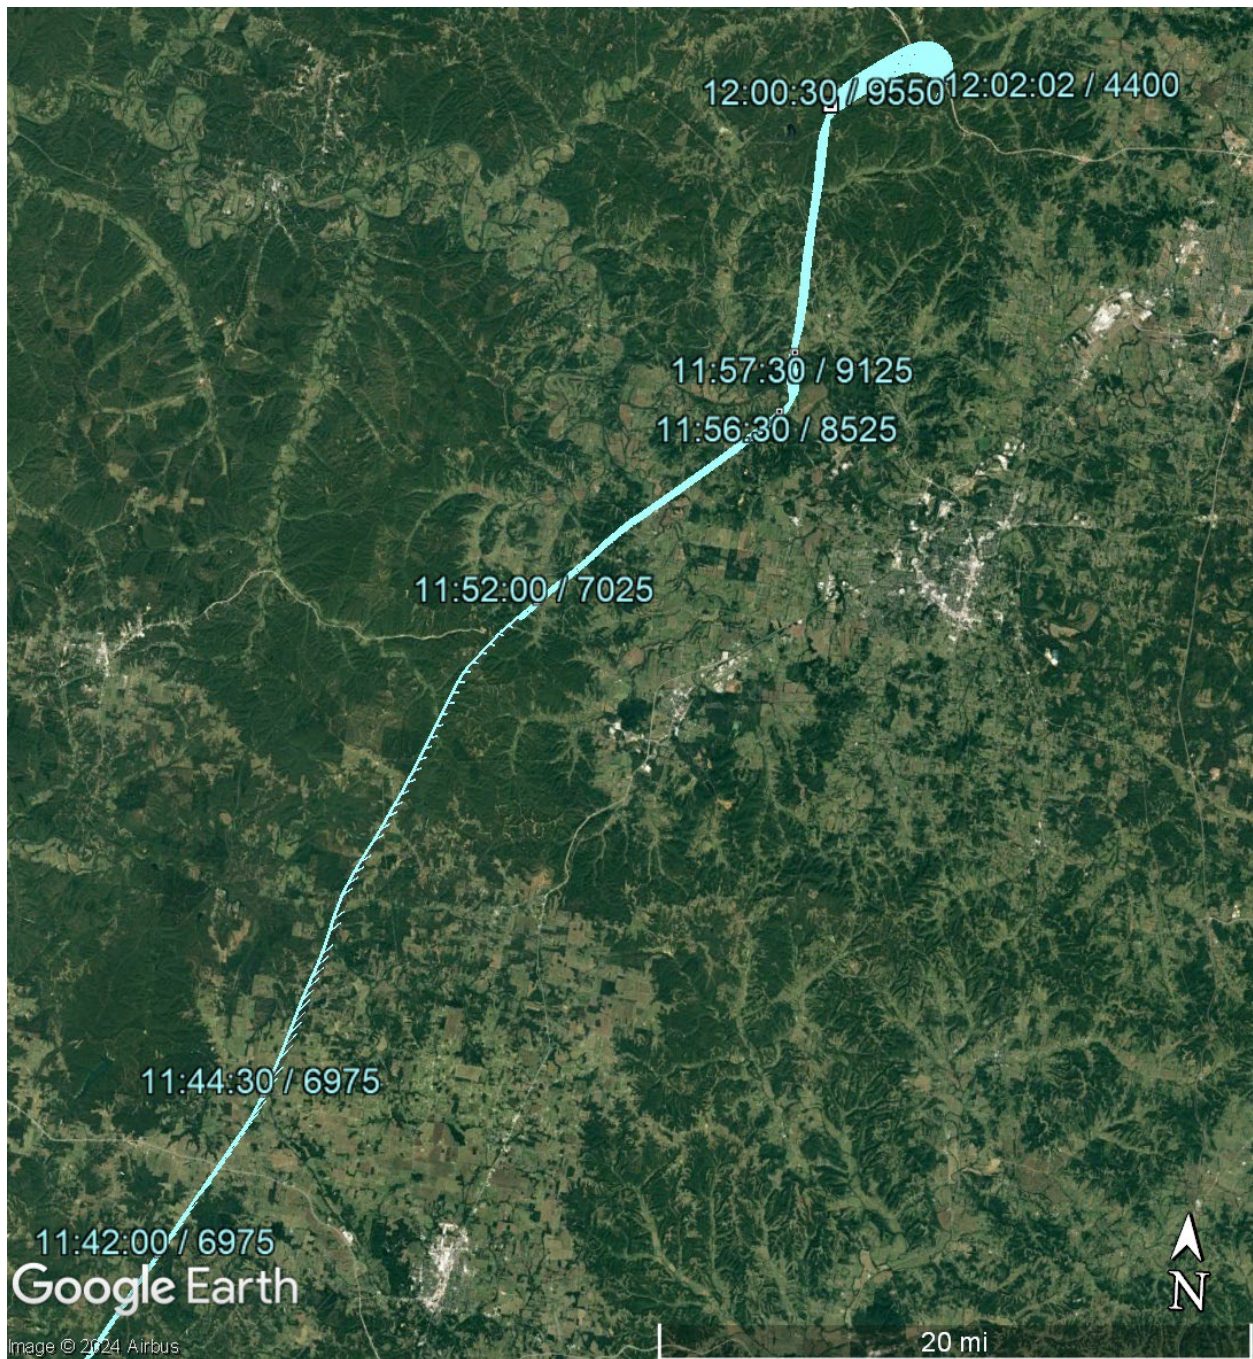
About 11:42, the pilot requested a short deviation from heading and was issued 20° left or right. The airplane began a series of slight turns onto tracks between 13° and 50° (Figure 4). Nine minutes later, at 11:52, the pilot requested a higher altitude of 9,000 ft. The airplane began to climb (Figure 5) and slowed to a calibrated airspeed under 100 kts.

**Figure 4.** ADS-B flight path with selected times and altitudes notated.

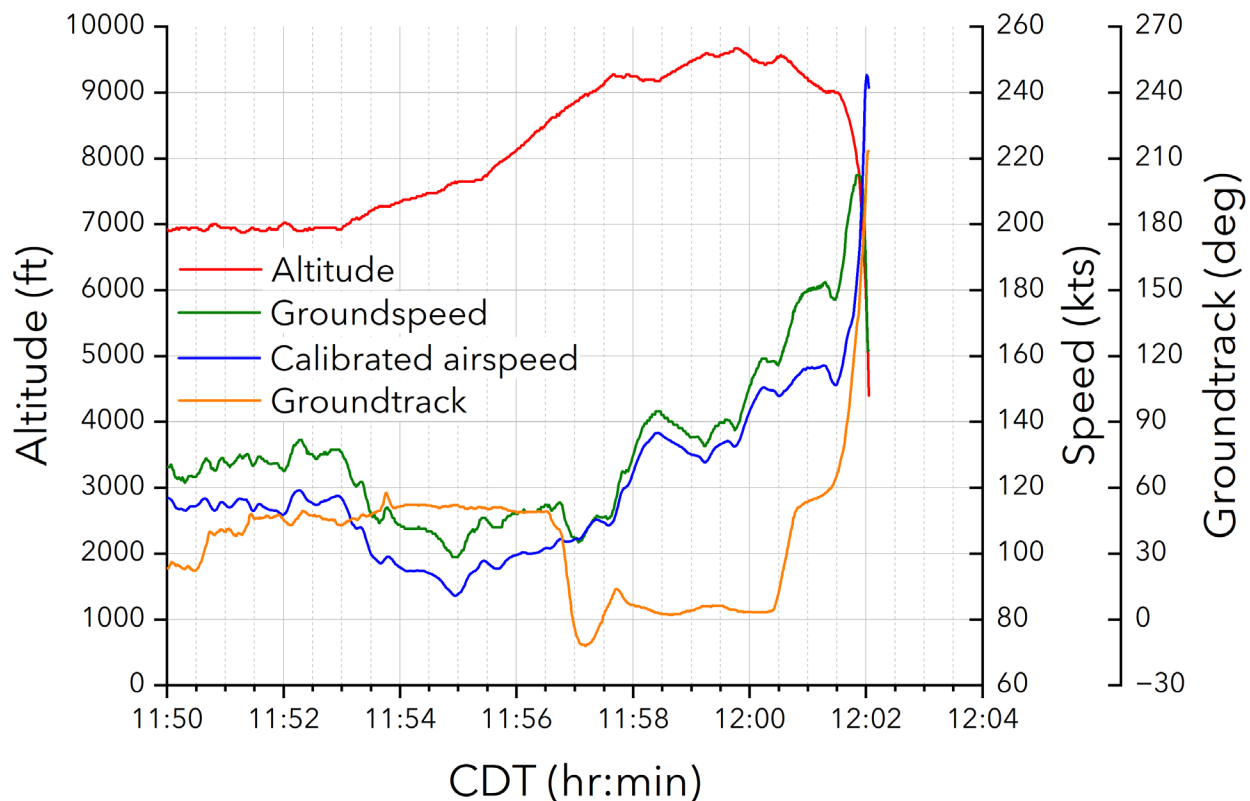
**Figure 5.** Altitude, groundspeed, calibrated airspeed, and groundtrack for the end of flight.

After 11:58, the airplane's speed increased from 110 kts to 160 kts calibrated airspeed. The airplane's maneuvering speed,  $V_A$ , is 132 kts of calibrated airspeed and its never exceed speed,  $V_{NE}$ , is 195 kts [2]. The airplane was near or above its maneuvering speed for the winds aloft provided for the area for the remainder of the

flight and accelerating. During this time the airplane was between 9,000 and 9,700 ft. While above 9,000 ft, ATC issued three corrections to the airplane to maintain 9,000 ft at 11:59:08, 11:59:54, and 12:00:39. After the first two corrections, the airplane briefly descended before climbing again. However, with the third correction the airplane descended to 9,000 ft which it held from 12:01:18 to 12:01:30.

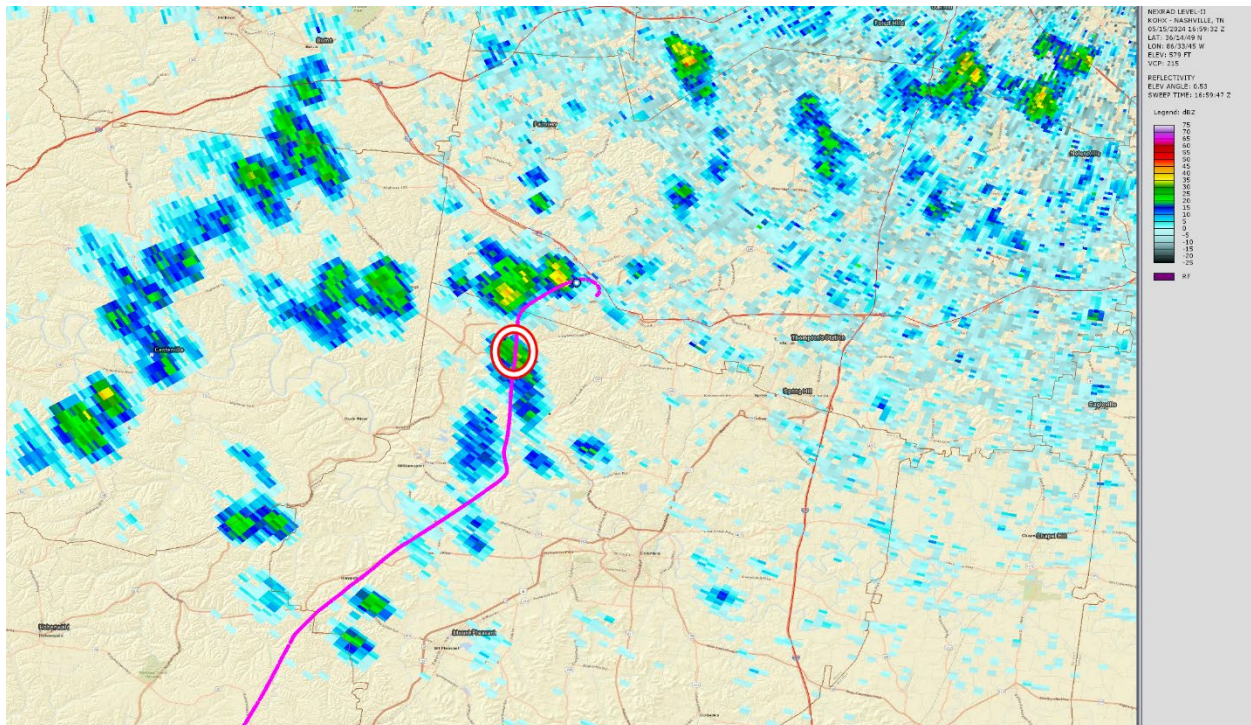
Figure 6 shows weather reflectivity imagery from the weather surveillance radar in Nashville, Tennessee, about 30 miles north each of the airplane at 11:59. This imagery is discussed in detail in the Weather Factual Report, but the images show light to heavy rain showers and storms moving through the area.

**Figure 6.** Weather radar at 11:59 CDT. The red circle indicates the airplane's position on the flight path (magenta) at the noted time. Blue, green, and yellow imagery show rain showers or atmospheric instability of increasing intensity.

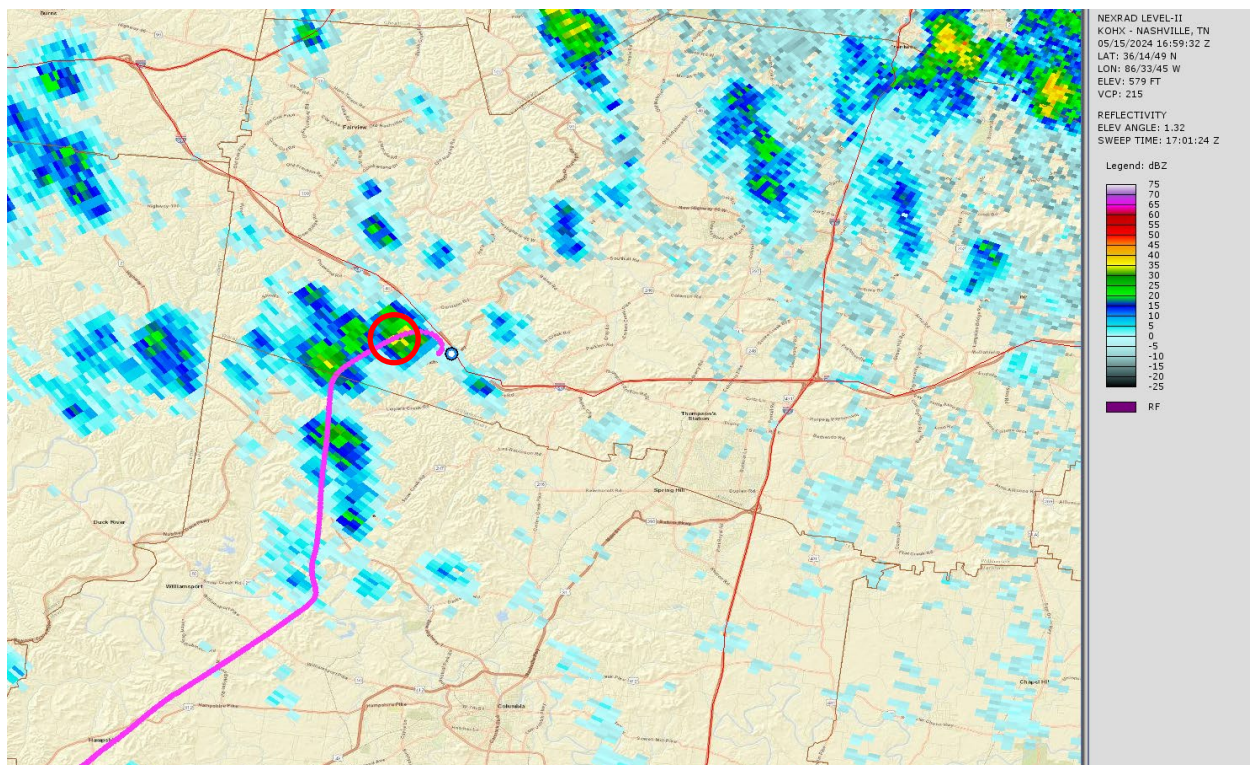
Just after 12:00, the airplane began a right turn onto a track of 45° without informing ATC. Figure 7 shows weather conditions at 12:01. The airplane's position was overlaid with a higher intensity area of atmospheric instability.

**Figure 7.** Weather radar at 12:01 CDT. The red circle indicates the airplane's position on the flight path (magenta) at the noted time. Blue, green, and yellow imagery show rain showers or atmospheric instability of increasing intensity.

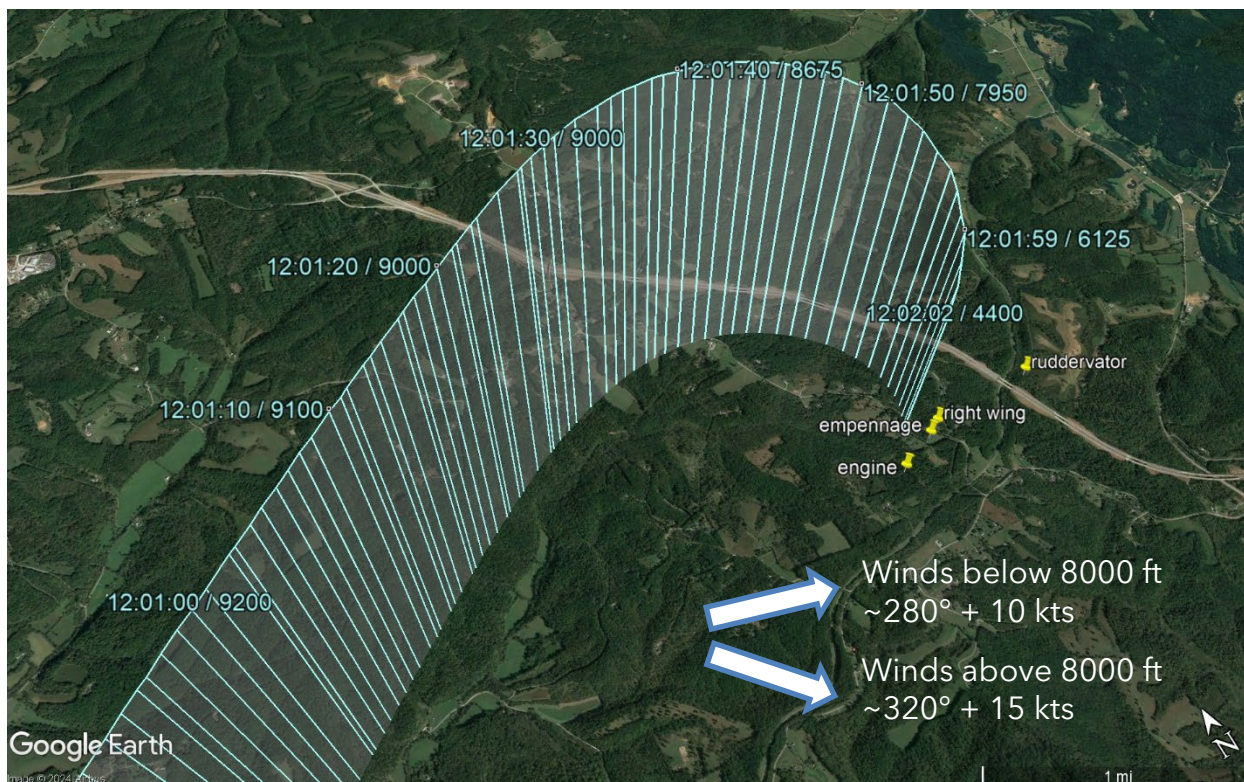
Figure 8 and Figure 9 show the end of ADS-B recorded flight. At 12:01:30, while at a groundspeed of 180 kts (calibrated airspeed 152 kts), the airplane's right turn tightened, and it began to descend. Initially, the rate of descent did not exceed 3,000 ft/min as the airplane's groundspeed increased to over 200 kts. The calibrated airspeed shown in this figure used winds aloft data for the area, but while in the weather cell, the airplane's airspeed cannot be accurately determined because the localized wind conditions are unknown. Just after 12:01:45, when the groundspeed was more than 210 kts, the descent rate rapidly increased.

The dispersal of wreckage indicated that the airplane broke up in flight. Winds were consistent with the breakup occurring after 12:01:40 with lighter pieces of debris being carried along the wind path and heavier pieces continuing along the flight path.

**Figure 8.** End of ADS-B flight path with selected times and altitudes notated. Also included is the location of some wreckage pieces and wind direction.

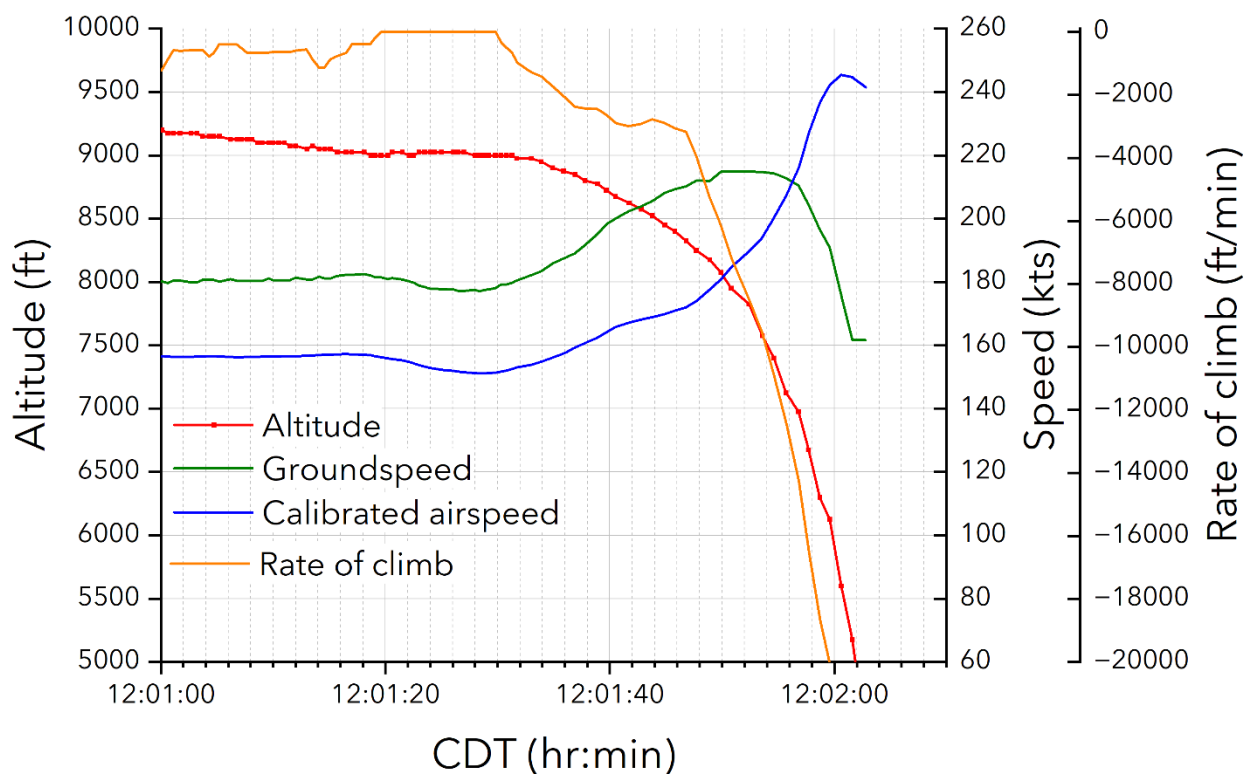
**Figure 9.** End of flight altitude, groundspeed, calibrated airspeed, and rate of climb.

The airplane's acceleration during the final minutes of flight put it above its maneuvering speed. Additionally, the airplane was in weather that could produce updrafts in addition to light to heavy rain. If significant control inputs were made while the above  $V_A$ , it could have caused a structural or control surface failure that initiated a loss of control that led to the inflight breakup. Localized winds may have also been such that the airplane was closer to  $V_{NE}$  at the time of breakup than could be determined with the data available.
