# National Transportation Safety Board

ERA24FA217

## EXAMINATION

Location: Franklin, TN  
Date: May 15, 24  
Time: 1201 Local 1701 Z  
Airplane: N47WT, Beechcraft V35, SN: D-3217

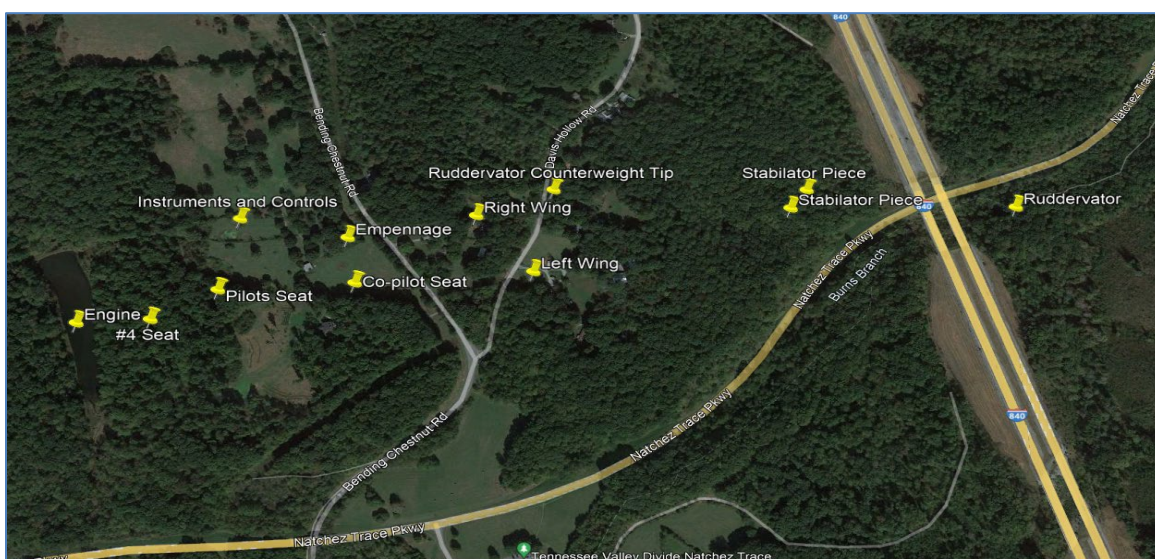
Figure 1 Incomplete map of wreckage path and location of wreckage.

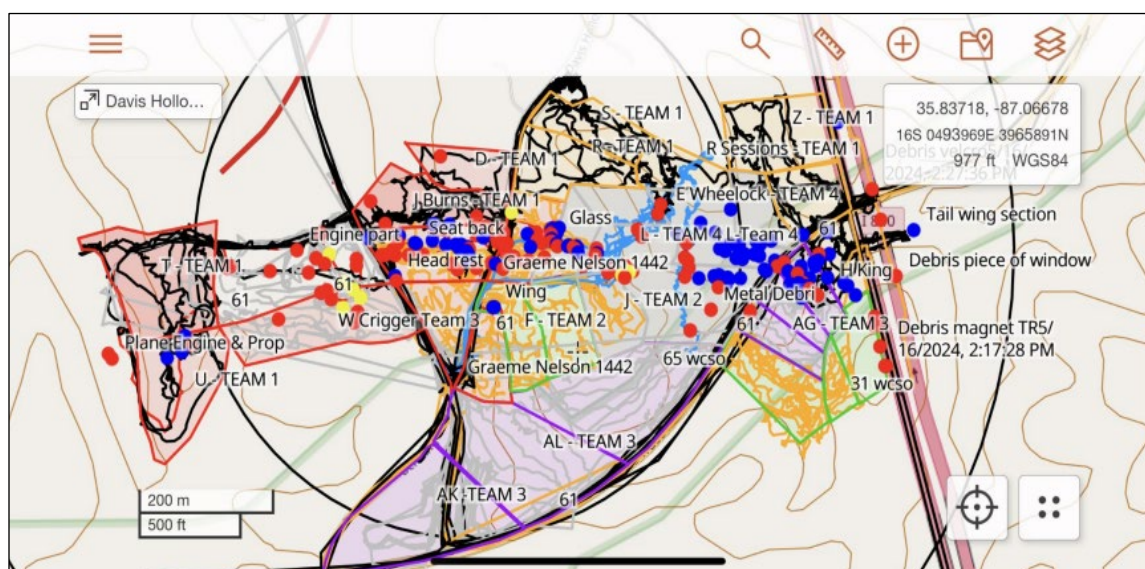
Figure 2 Local authorities search grid and wreckage locations.

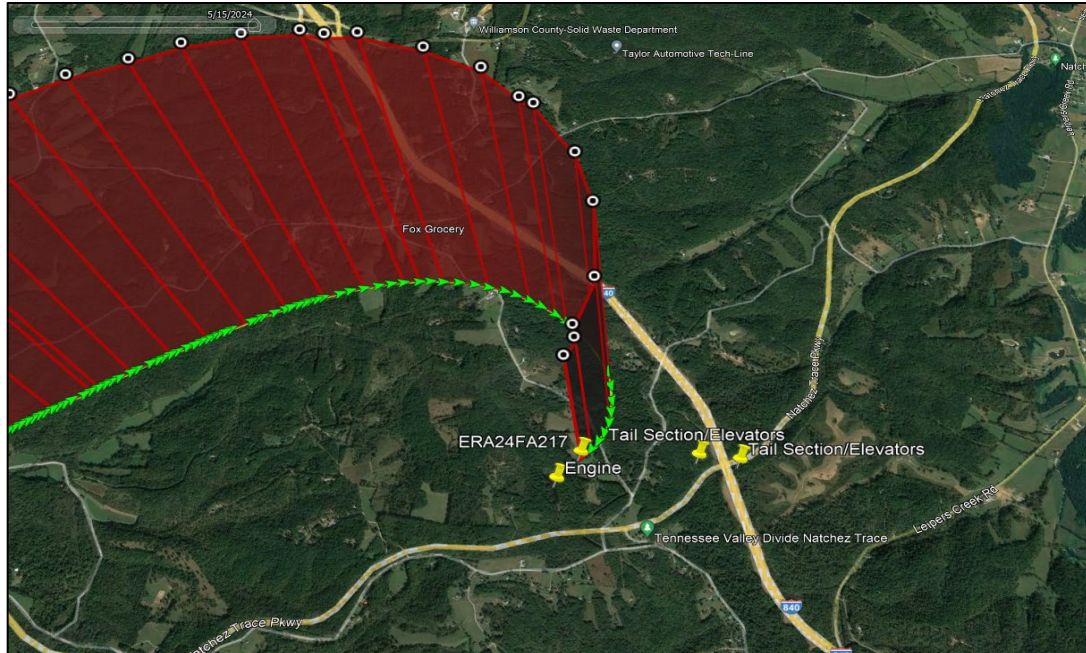
While transitioning the area enroute to LOU from REG, while at 9,500 ft msl, the airplane descended, and a tight right turn developed as it passed through 7,500 ft mean sea level. During the descent, the airspeed and rate of decent rapidly increased before the target/radar contact was lost. The pilot was communicating with ATC at the time.

Figure 3 Preliminary ATC/ADS-B data indicating final moments of flight near wreckage site.

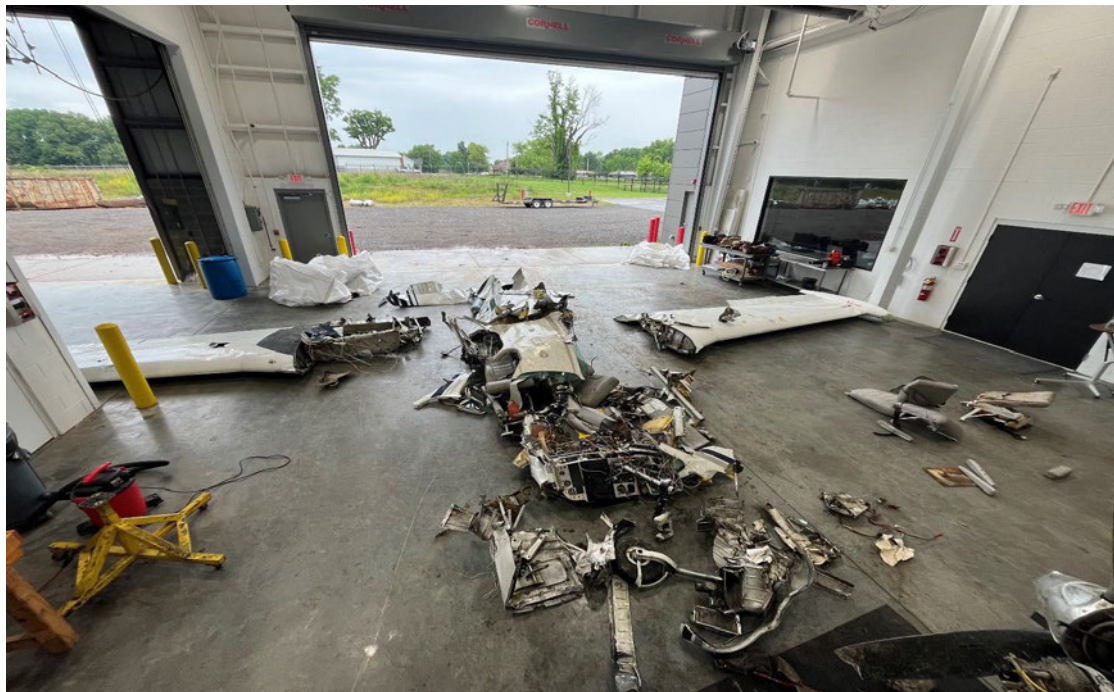
Figure 4 Partial wreckage reconstruction/layout on hanger floor.

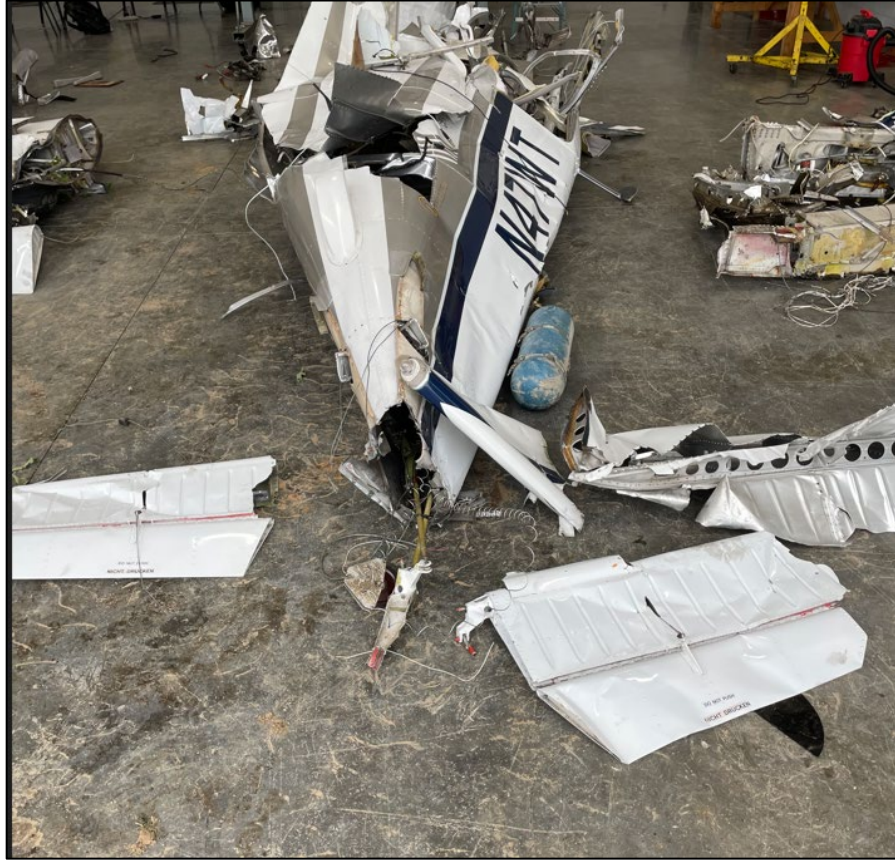
The right stabilizer was separated and had more than half of the right ruddervator attached. The ruddervator trailing edge was separated and the skins were splayed open. The remaining portion of right ruddervator was recovered separately. Only a portion of the left inboard ruddervator was recovered from the left side of the empennage. The deformation of the stabilizer spars on both sides indicate failure in an aft and leading edge down direction.

The downward failure of the stabilizers and downward failure of the wings, combined with the location of the wreckage locations are indicative of a tail first breakup, and all indications point to overload. The airplane was equipped with stabilizer cuffs and updated control rods were installed so any flutter would likely occur well above V<sub>ne</sub>. There were no signs of flutter on the tail.

*Figure 5 Empennage showing stab/ruddervators.*

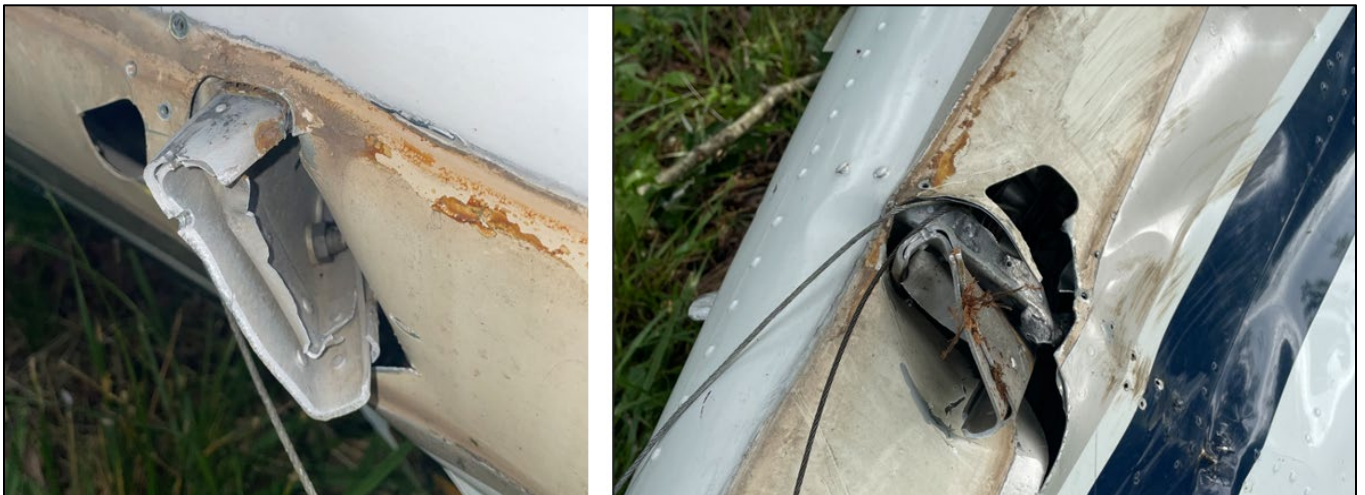
There were no indications of preexisting damage (corrosion, cracks) observed on the fracture surfaces. Photographs sent to the Materials lab for examination of the fracture surfaces for confirmation. They concurred that there were no indications of preexisting damage. The stabilator spars had symmetrical deformation where the spars were bent aft and twisted leading edge down before fracture, and the fracture surfaces had slant angles consistent with ductile overstress fracture.

*Figure 6 Closeup of stabilizer damage at the fuselage.*

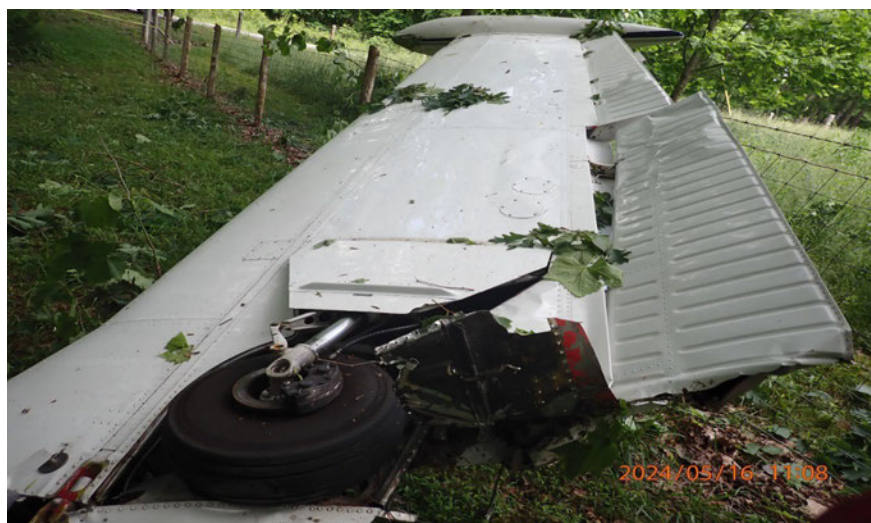
Both wings separated from the fuselage in flight and were found at separate locations within the debris path. The left wing separated in flight at the root and was found on the easterly side of the debris field against a fence. The wing was moved on-scene and aviation fuel began to spill from the main fuel tank outlet. The gas cap was removed, and the o-ring was unremarkable. The left wing tip tank was intact and unbreeched with no fuel remaining. The top, forward, wing mounting bolt. Photographs of wing damage signatures and their overall condition were sent to the materials lab for examination. The left wing main spar had a separation at the upper attachment bolt and a bending overstress fracture at the lower attachment fitting, consistent with a downward overload following failure of the stabilizers.

*Figure 7 Left wing as observed on site.*

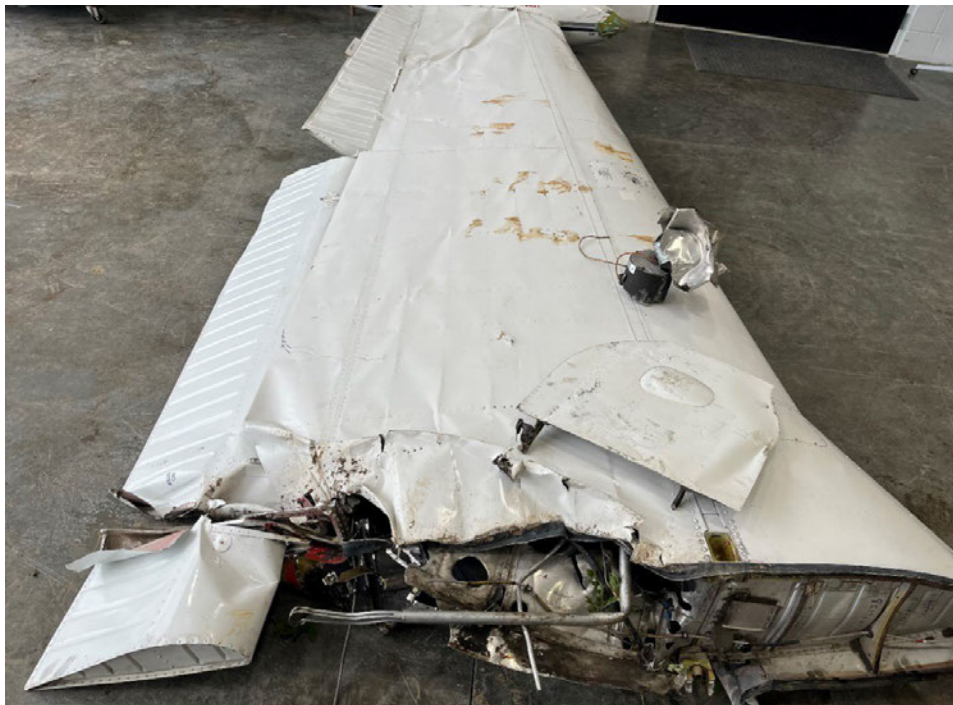
*Figure 8 Left wing top view at examination facility.*

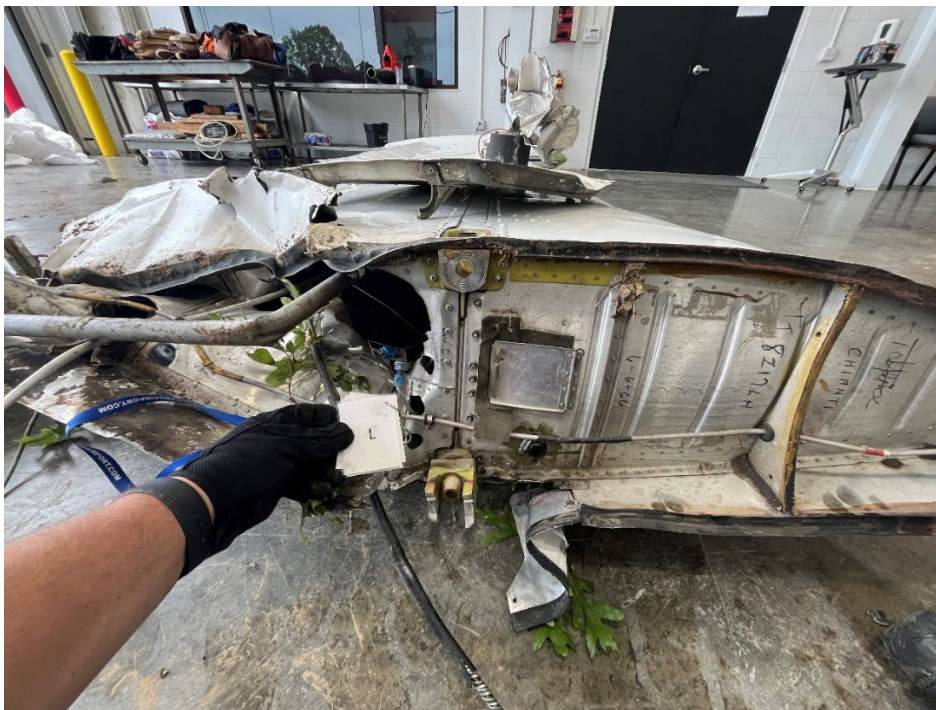
The lower wing mounting bolt pulled through the wing spar attach fitting. The aft two mounting bolts pulled through both wing spar attach fittings. The left wing forward spar separated at the wing attach point and the rear spar separated a couple of feet outboard of the attach point. The left forward upper bathtub fittings were intact with no obvious damage to the hole bores indicating a tension failure of the upper forward bolt. The forward lower bolt and wing bathtub fitting remained intact and installed with a fractured portion of the center section fitting retained. The forward lower center section bathtub fitting fractured in bending overload and the damage to the adjacent structure indicates downward bending. The left wing rear spar attach bolts remained intact. The lack of deformation on the rear spar upper cap at the fracture location and the buckling deformation on the rear spar lower cap indicate failure in a downward direction.

*Figure 9 Left Wing Spar Shear Points*

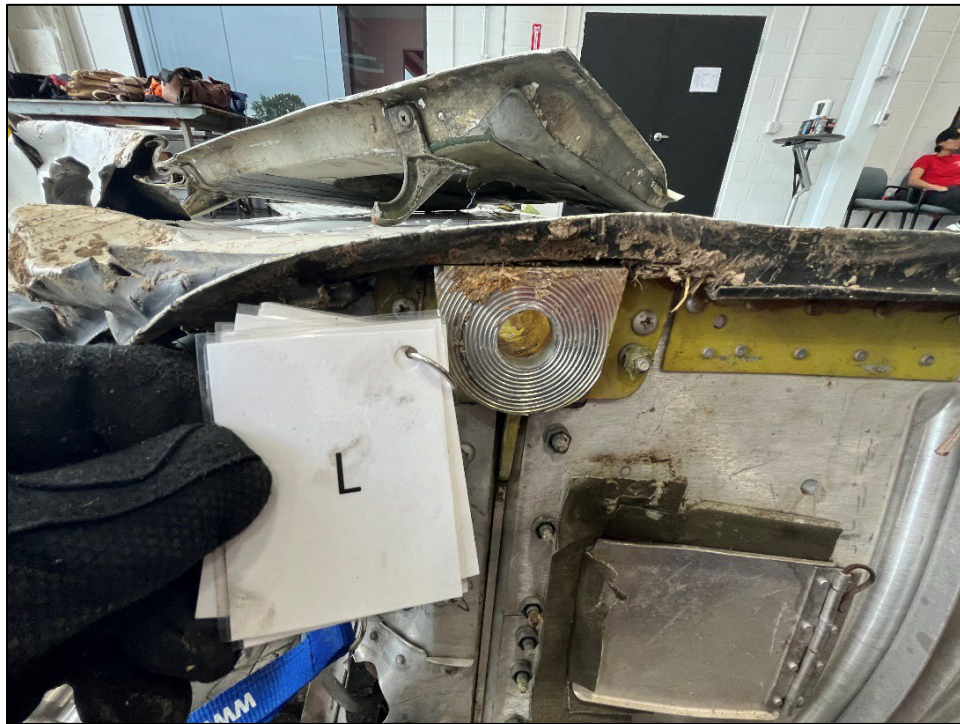
Figure 10 Left wing forward Upper Mounting Hole

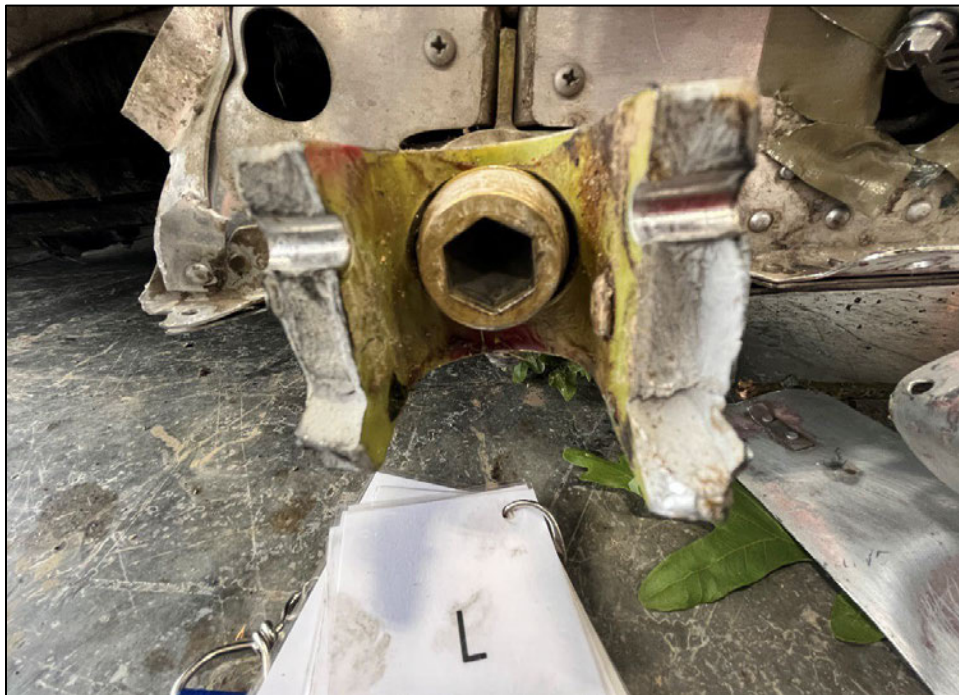
Figure 11 Left wing lower aft Spar attach Point.

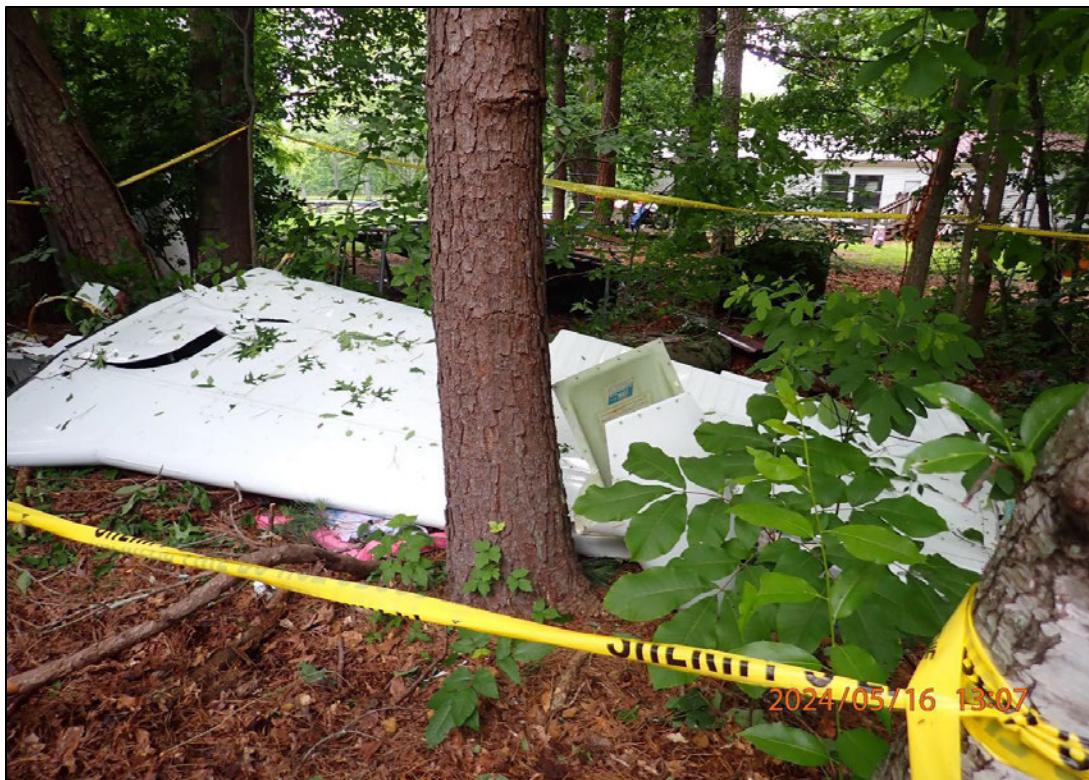
The right wing separated in flight from the fuselage. The aft spar carry through was not attached to either wing and was recovered separately. The right wing was found wedged between trees approximately in the middle of the debris field. The emergency gear handle remained attached. The fuel cap was removed, and the o- ring was unremarkable. The right-wing tip tank had separated from the wing and destroyed. The right wing forward spar attach point was intact and remained connected to the center section that was separated from the fuselage. The right wing rear spar was separated at the attach point. The rear center section was separated from the fuselage. The right rear upper attach bolt was intact and retained in the intact center section bathtub fitting and fractured right rear upper fitting. The right rear upper wing fitting was fractured and pulled from the right wing structure. The right rear lower attach bolt was intact and retained in the right rear lower wing fitting. There were no photos of the right rear lower center section fitting.

*Figure 12 Right wing as discovered on the accident site.*

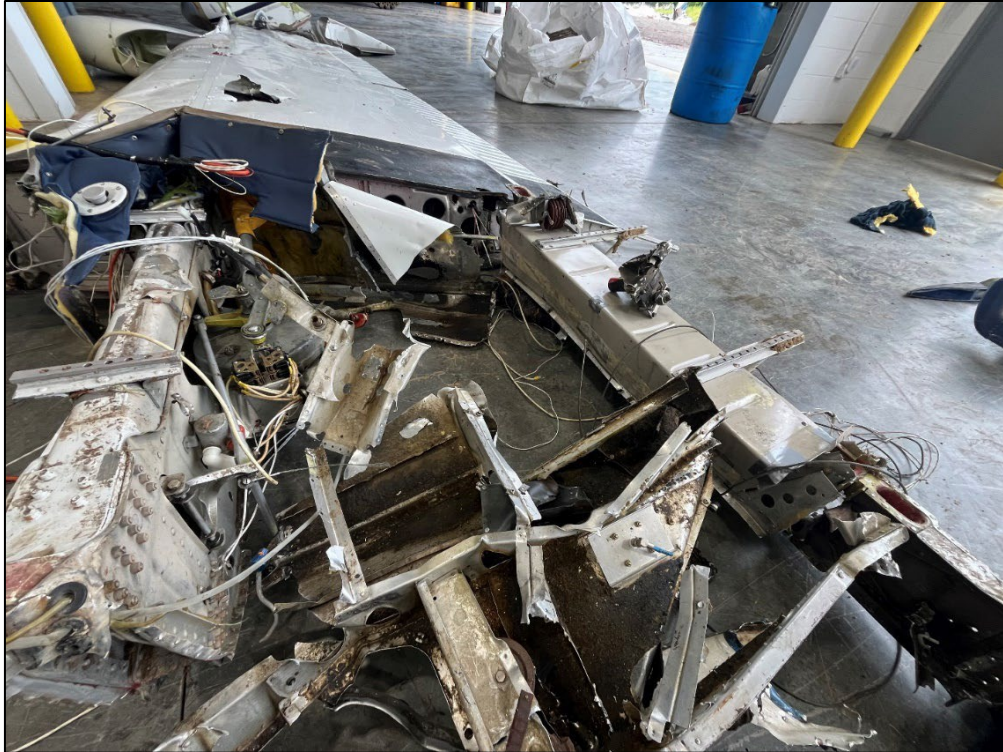
*Figure 13 Right wing spar and aft spar structure at examination site.*

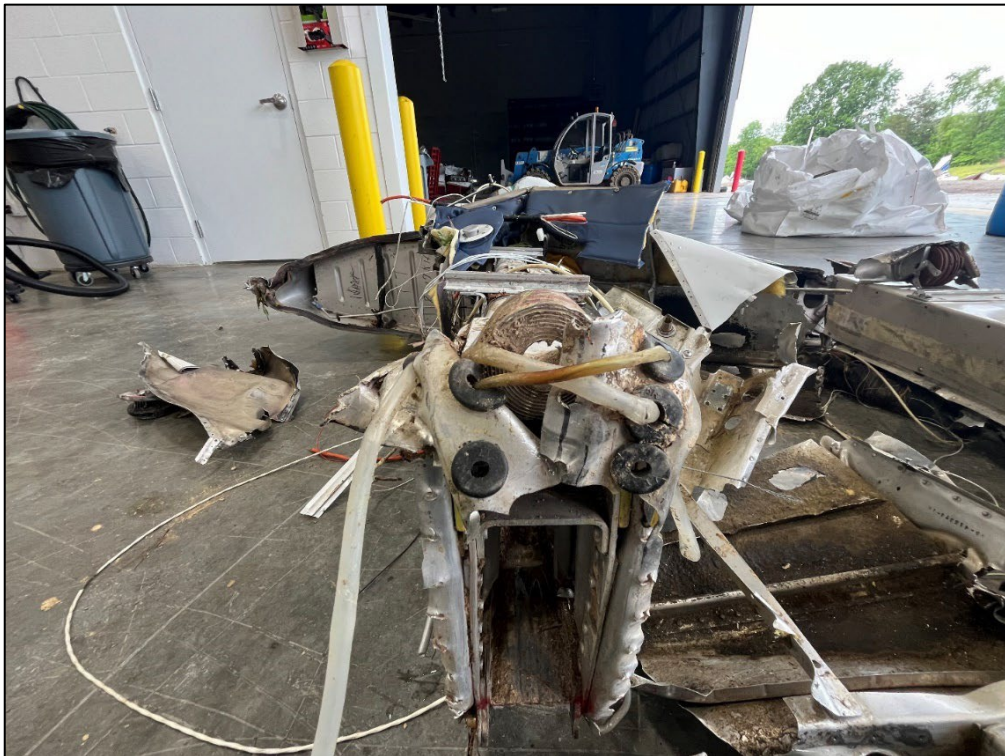
*Figure 14 Right wing forward spar fracture surface.*

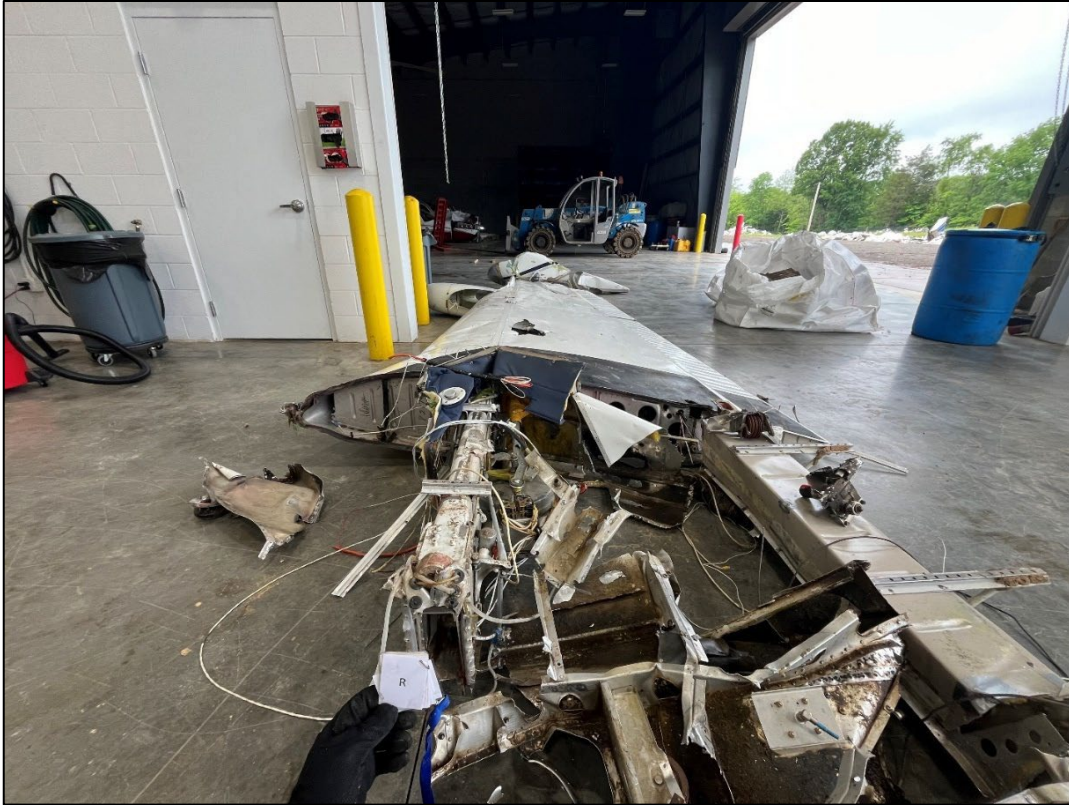
*Figure 16 Right wing overview.*

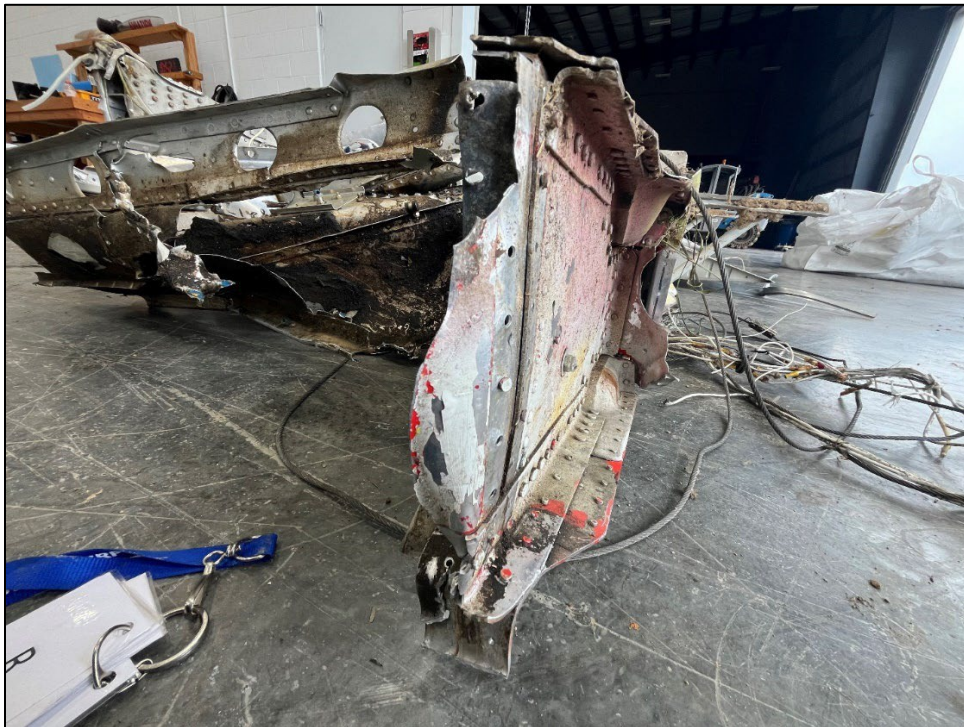
*Figure 15 Right wing aft spar fracture surface.*

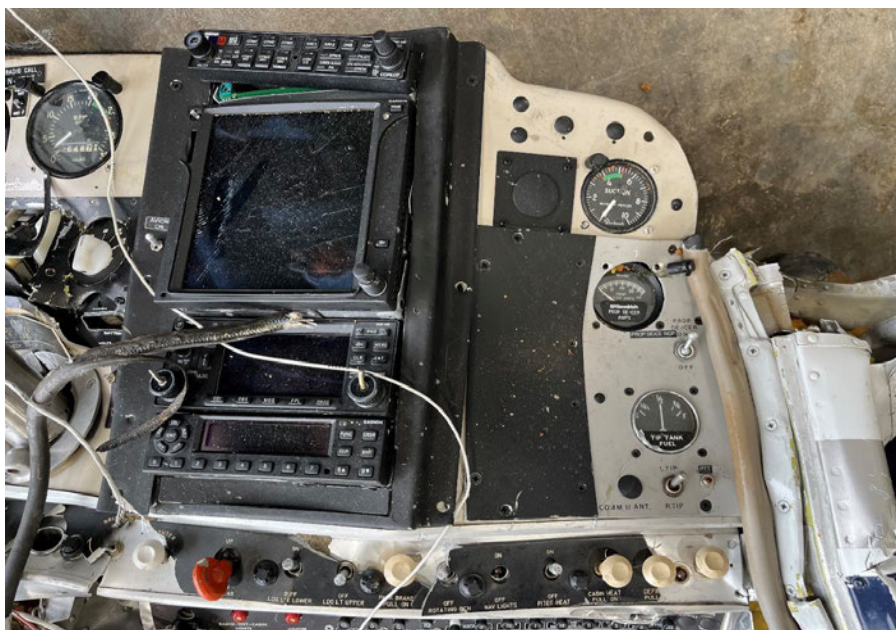
*Figure 17 Co-Pilot's Side Navigation and Communication Panels.*

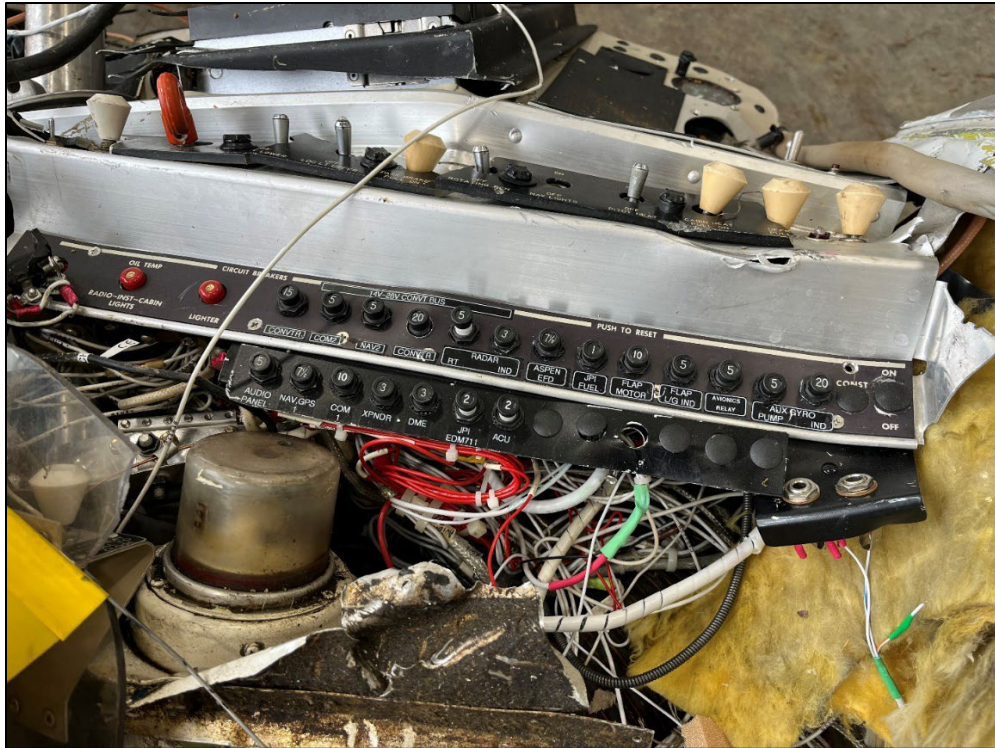
As found, the throttle, mixture, and propeller control levers were full forward. The boost pump was in the "off" position. The flap motor, RADAR RT, RADAR IND, JPI EMD711, and ACU circuit breakers were in the tripped positions. The landing gear lever was down. The JPI fuel flow indicator was damaged behind the panel from impact forces. Engine RPM gauge reading is 0. The tach hours meter reading was 2648.7. The altimeter reading is 4100 feet. The VOR OBS reads 080. The propeller de-ice switch was "on." The de-ice amps reading is 0. Suction is 0. The transponder and GNS400 were undamaged. Oxygen supply pressure reads 0.

Figure 18 Circuit breakers.

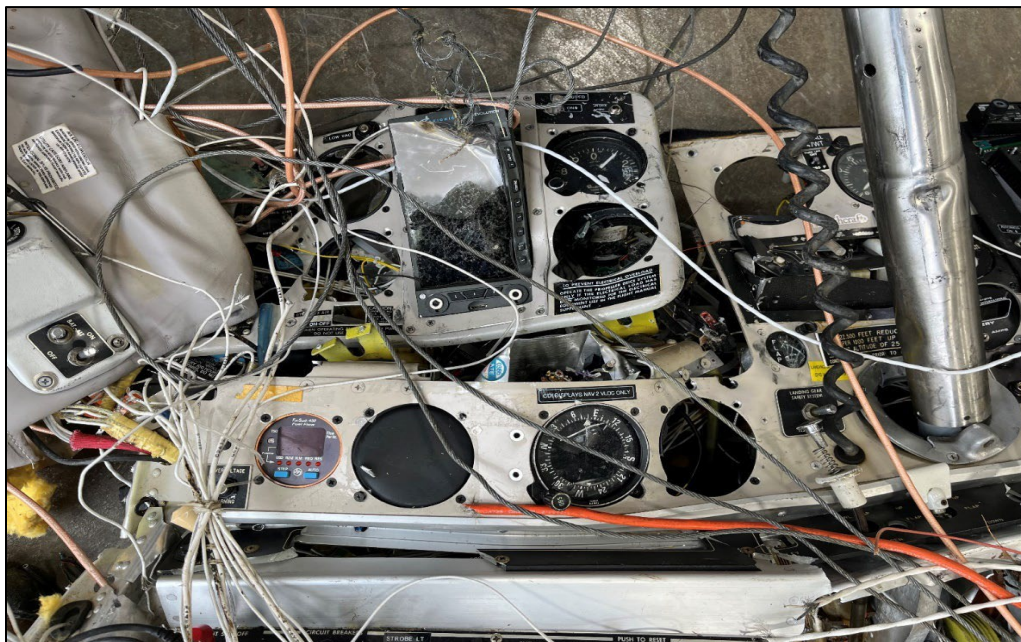
Figure 19 Instrument panel gauges and instruments.

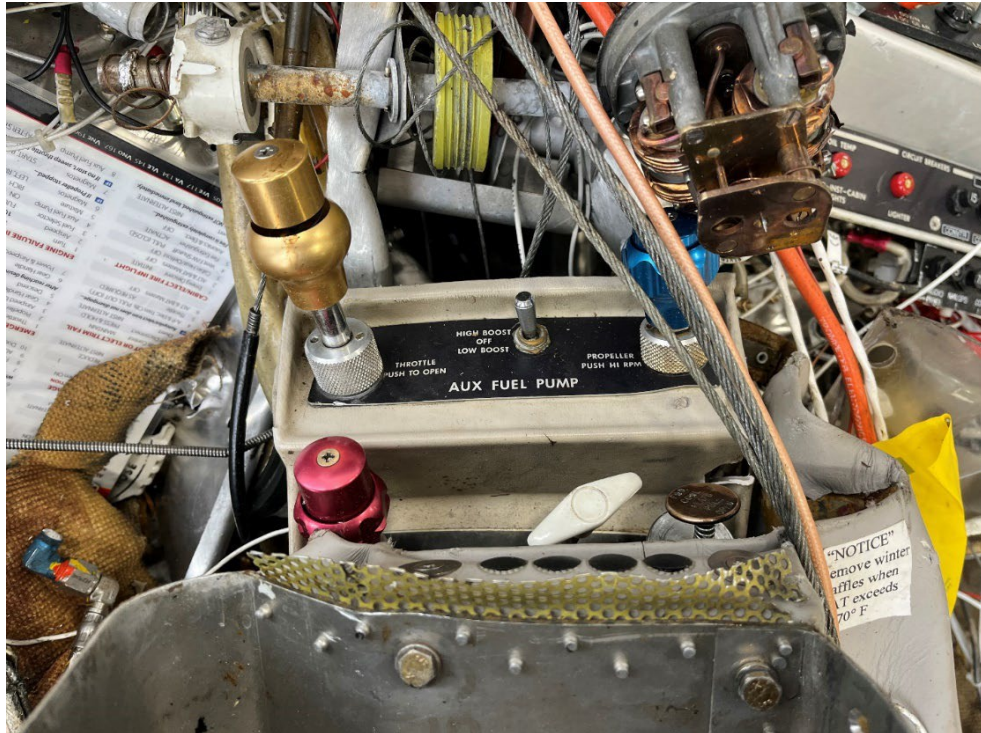
Figure 20 Engine and fuel controls.

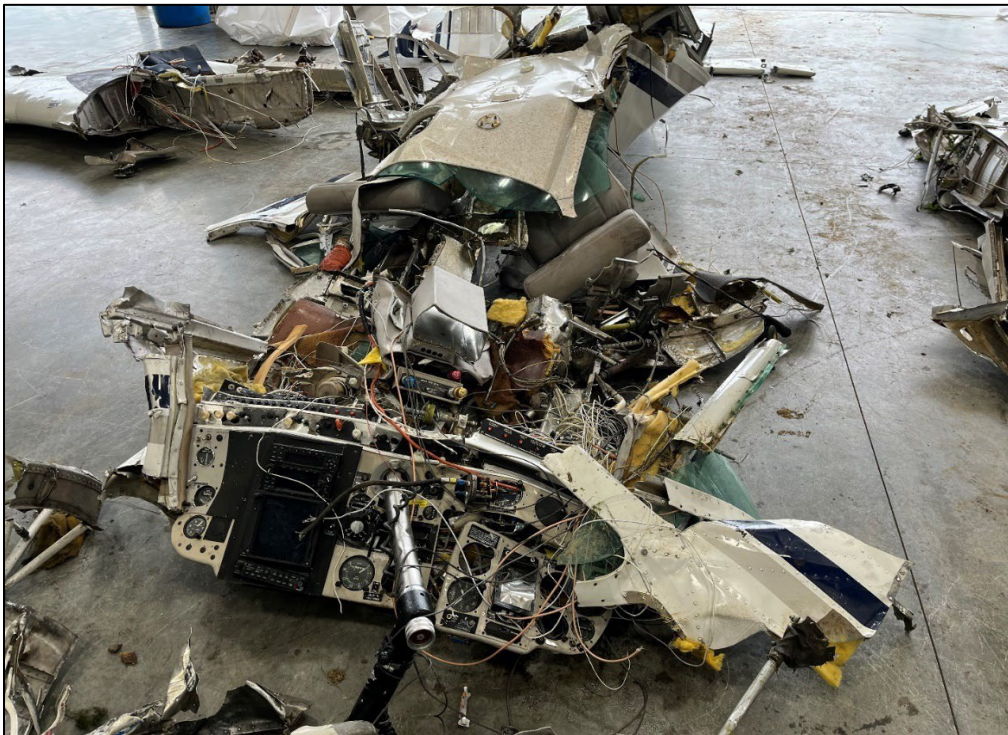
The instrument panel had an Aspen EFD-1000 installed on the pilot side and a Garmin 750 and 430 installed in the center rack. The aircraft had a Century III autopilot system. Many of the switches did not click through their detents when operated and moved freely. A switch marked "L Tip" and "R Tip" was in the "L Tip" position. A switch marked "Ldg Gear Safety" was in the "On" position. Data cards from the Garmin 750 and Aspen EFD-1000 were located and sent to the lab for analysis.

Figure 21 Cockpit and instrument panel during hanger floor layout.

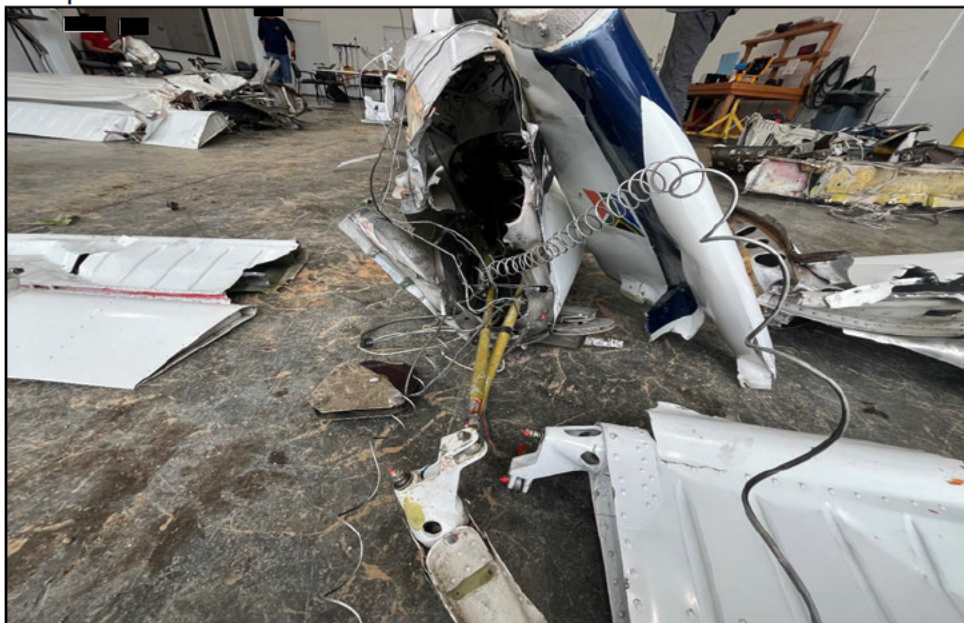
All cable separations showed signs of a "broomstraw" appearance which is indicative of tensile overload failures. The rudder cables were continuous from the cockpit to the rudder mixers but separated from the forward bellcranks. Control cable continuity could not be accurately established for any of the other systems due to cable separations and impact damage however, during examination and layout on the hanger floor, cables were traced partially to their respective locations throughout the fuselage and controls. There is a singular elevator trim actuator, a measurement was taken but the cables leading to the actuator appeared to have pulled when the aircraft separated. Three autopilot servos were recovered, none of the servo cable loops were continuous.

*Figure 22 Empennage Control Cables Displaying Overload Damage.*

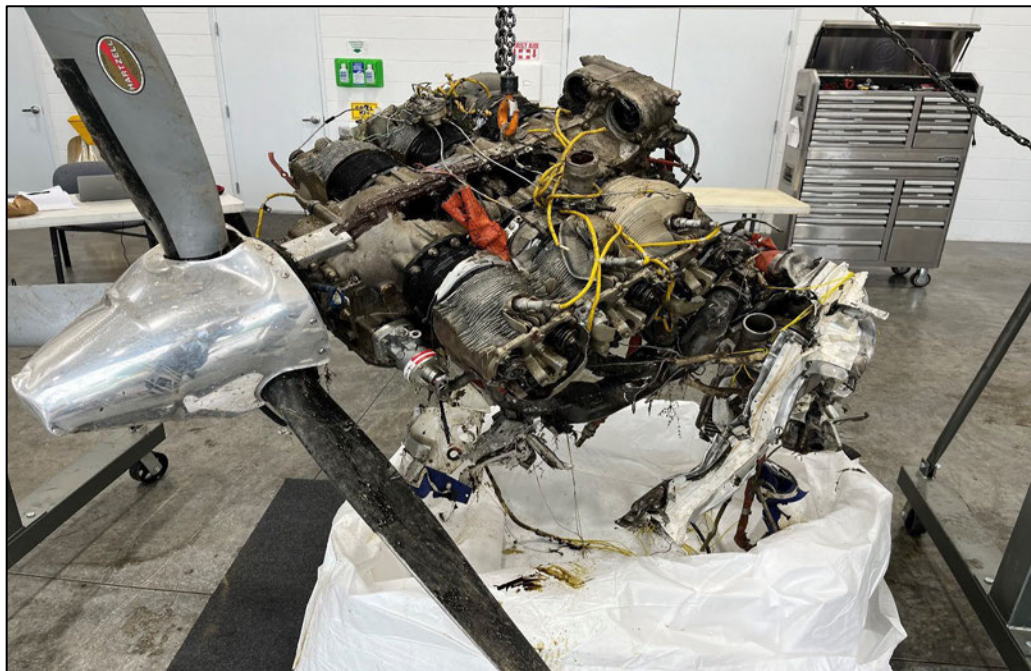
The engine came to rest in a small lake at the westerly end of the 3,800 ft debris field. The engine was submerged in murky fresh water prior to recovery. The top and left-hand side of the engine was heavily impact damaged; it impacted the pond and was submerged in 8 ft of water. All cylinders have extreme cylinder fin damage, the left-hand crankcase half was broken open measuring 12" long by 3.5" wide. Through this hole, crankshaft continuity could be confirmed. The alternator, starter and both magnetos were separated by impact damage and were not recovered. A portion of the ignition wire harness was still connected to engine, and some related spark plugs.

- Cylinder Nos. 2, 4, 5, and 6 rocker covers were not recovered.
- Cylinder Nos 1, 3, 5, had impact damage to their respective spark plugs, making them unable to be removed.
- Cylinder Nos 2, 4, 6, were successfully borescoped and they showed normal wear and operation. Cylinder Nos 1, 3, 5, were completely blocked with mud and silt.

*Figure 23 Engine Overview*
