ERA24FA217

## INVESTIGATION PHOTOGRAPHS

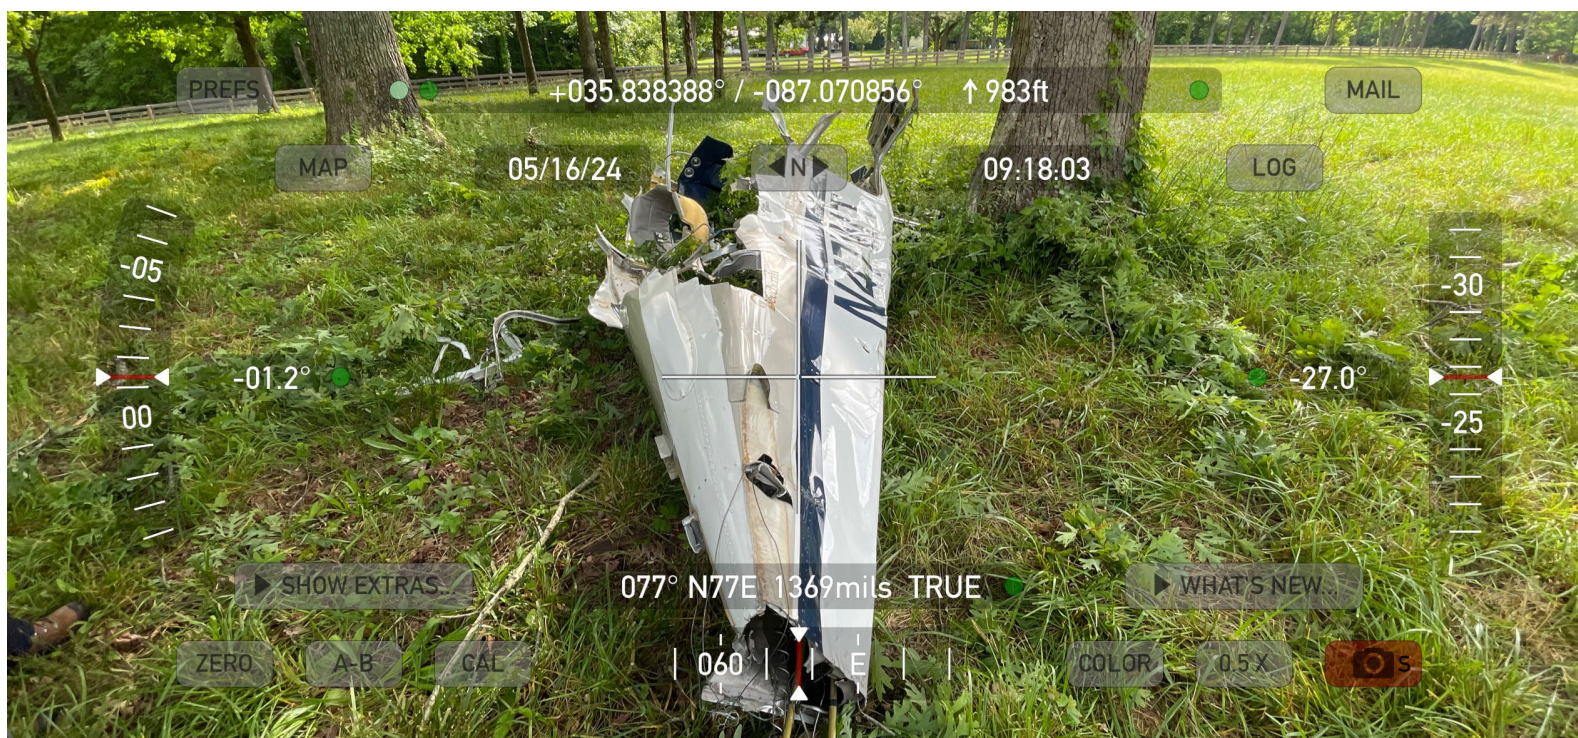
**Photograph 1 - View of cabin/fuselage showing latitude and longitude, elevation, and magnetic heading. (NTSB)**

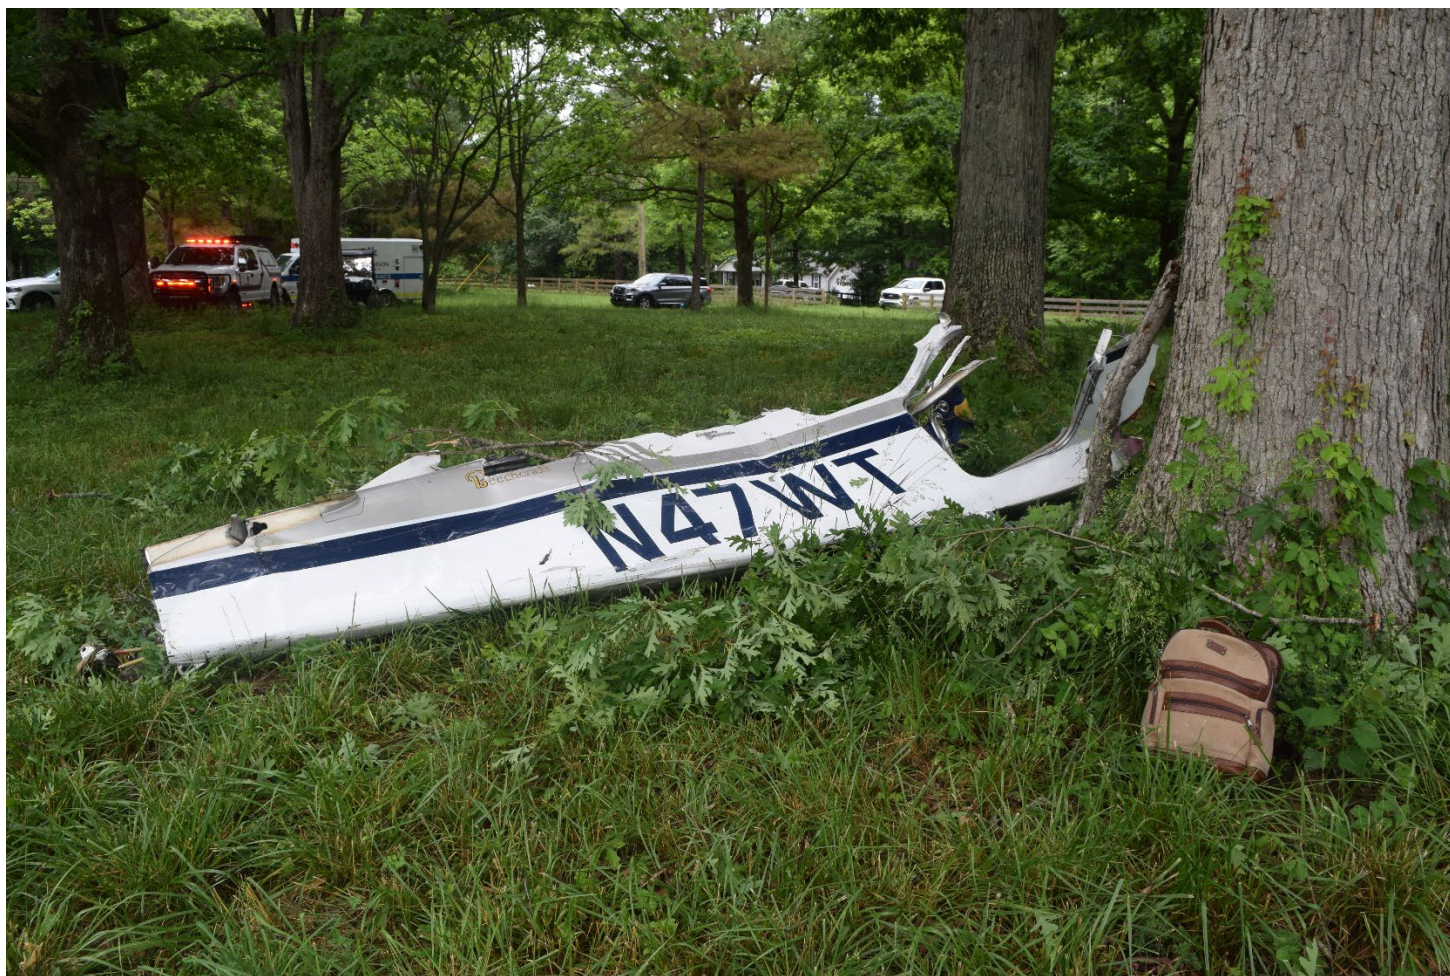
**Photograph 2 - View of partial cabin/fuselage against tree. (NTSB)**

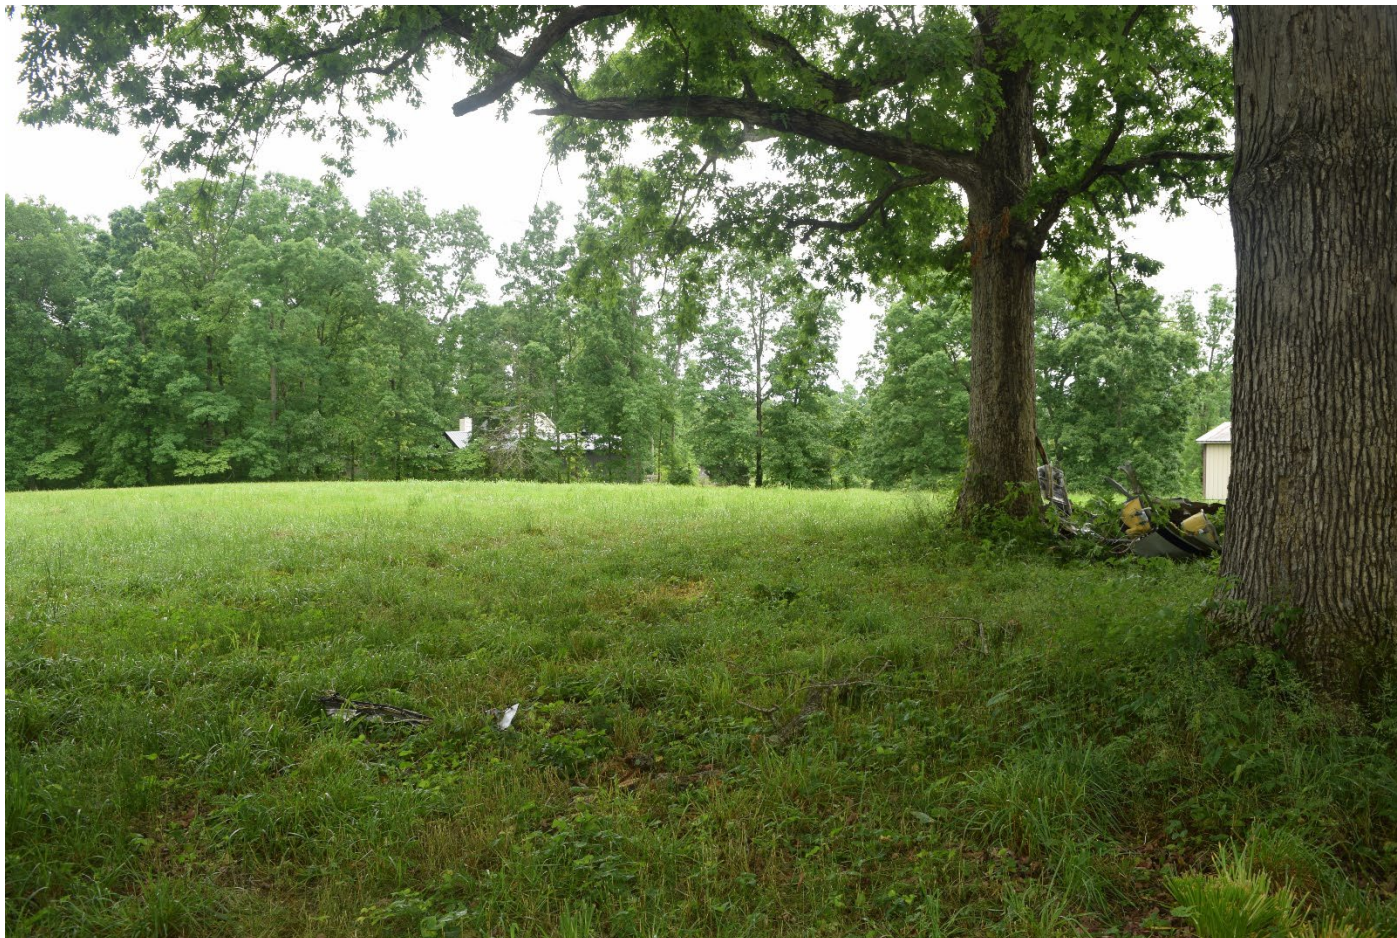
**Photograph 3 - View of field and wreckage. (NTSB)**

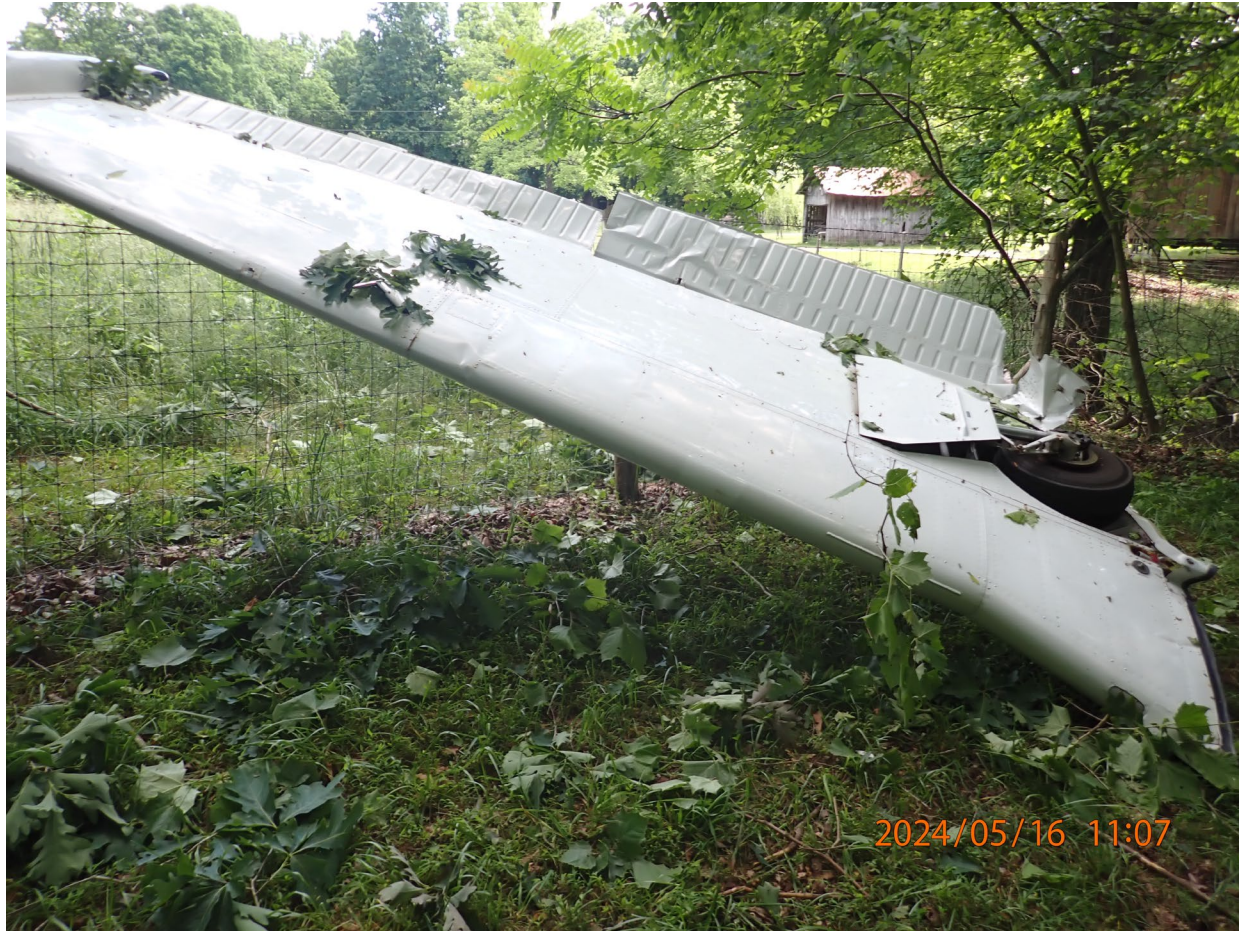
**Photograph 4 - View of separated left wing resting against fence. (NTSB)**

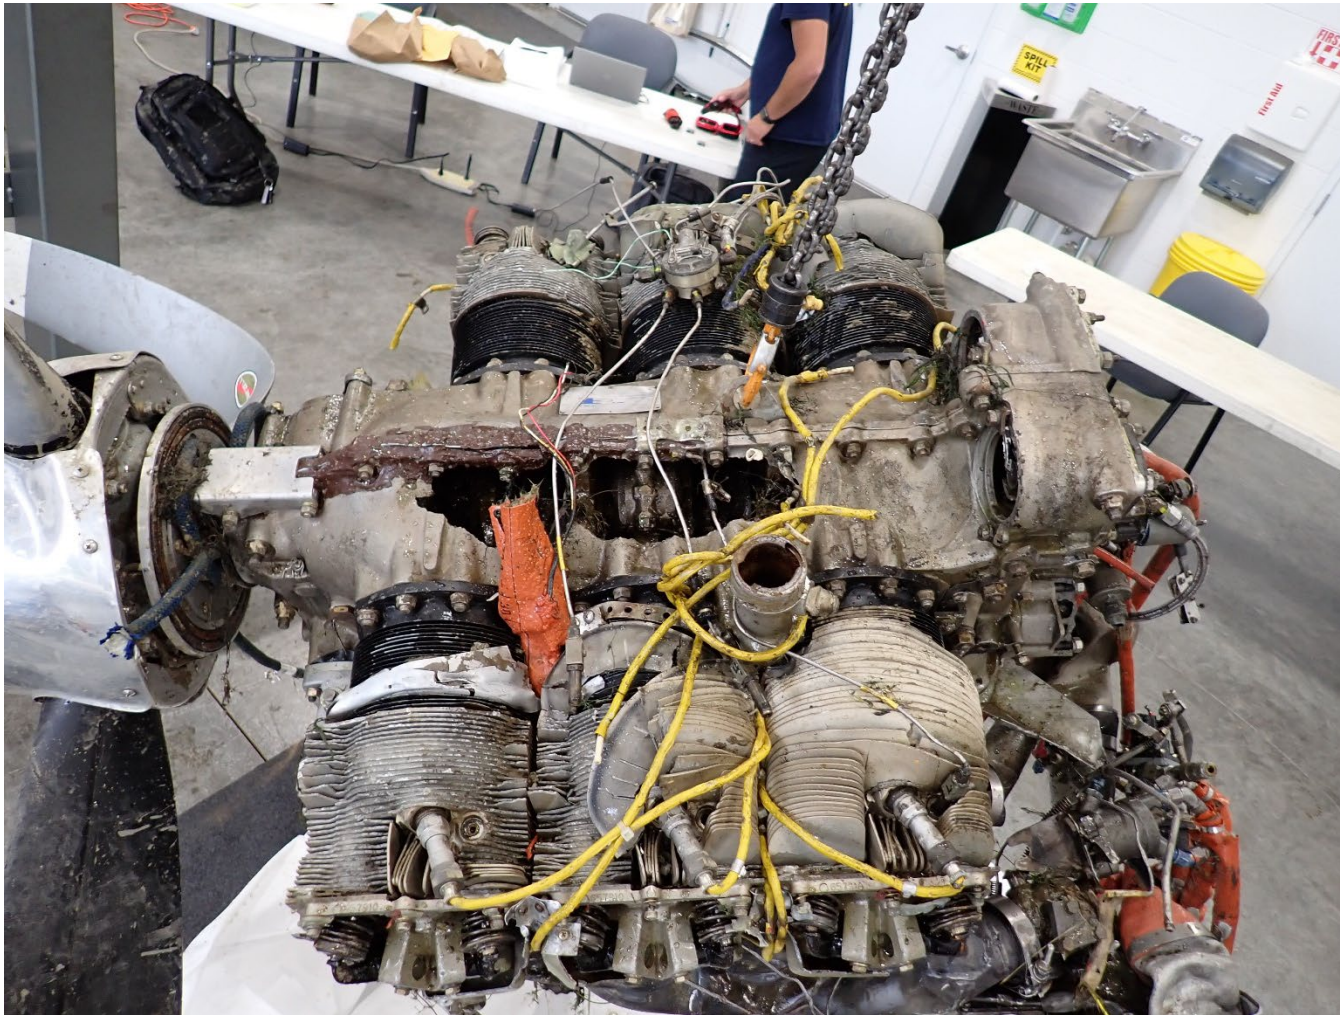
**Photograph 5 - View of engine after recovery. (NTSB)**

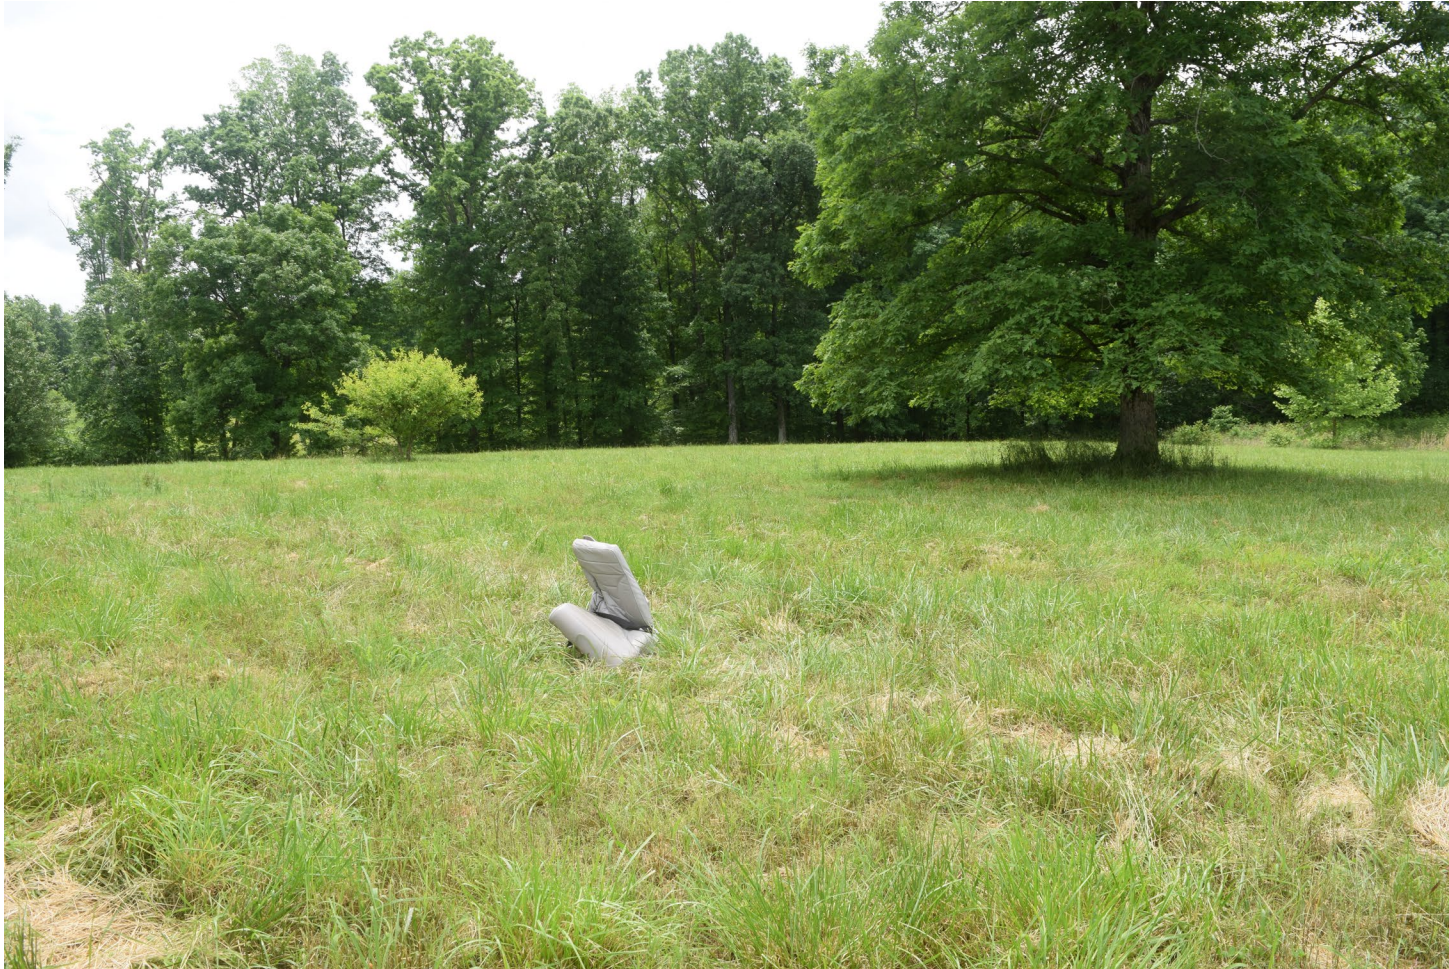
**Photograph 6 - View of aft passenger seat in field. (NTSB)**

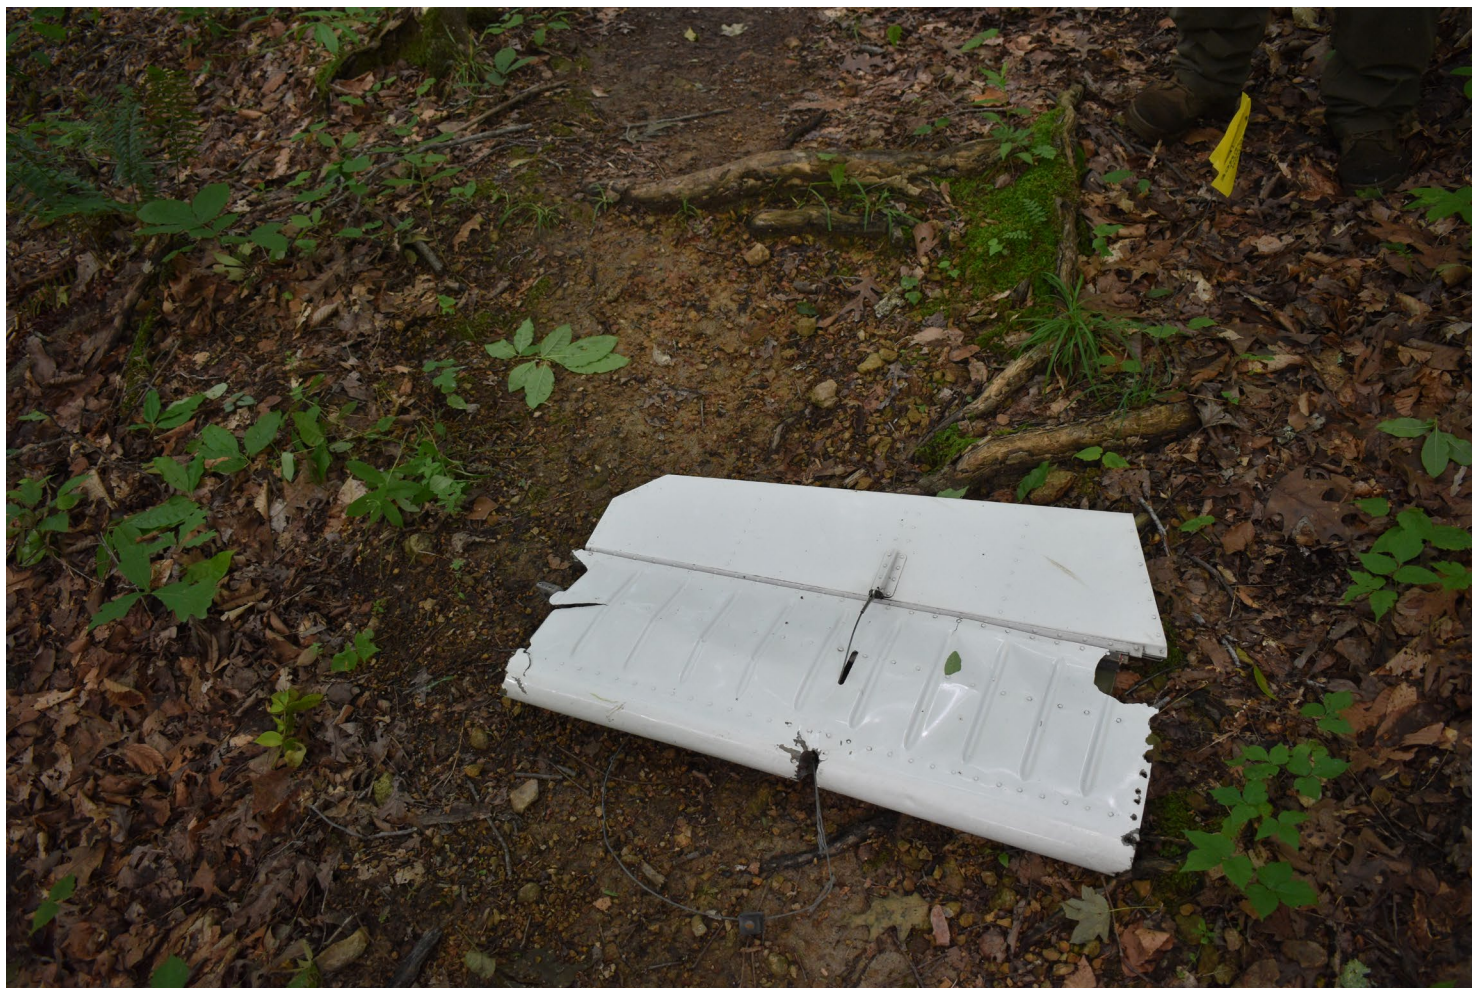
**Photograph 7 - Elevator-rudder (ruddervator) located at beginning of wreckage path. (NTSB)**

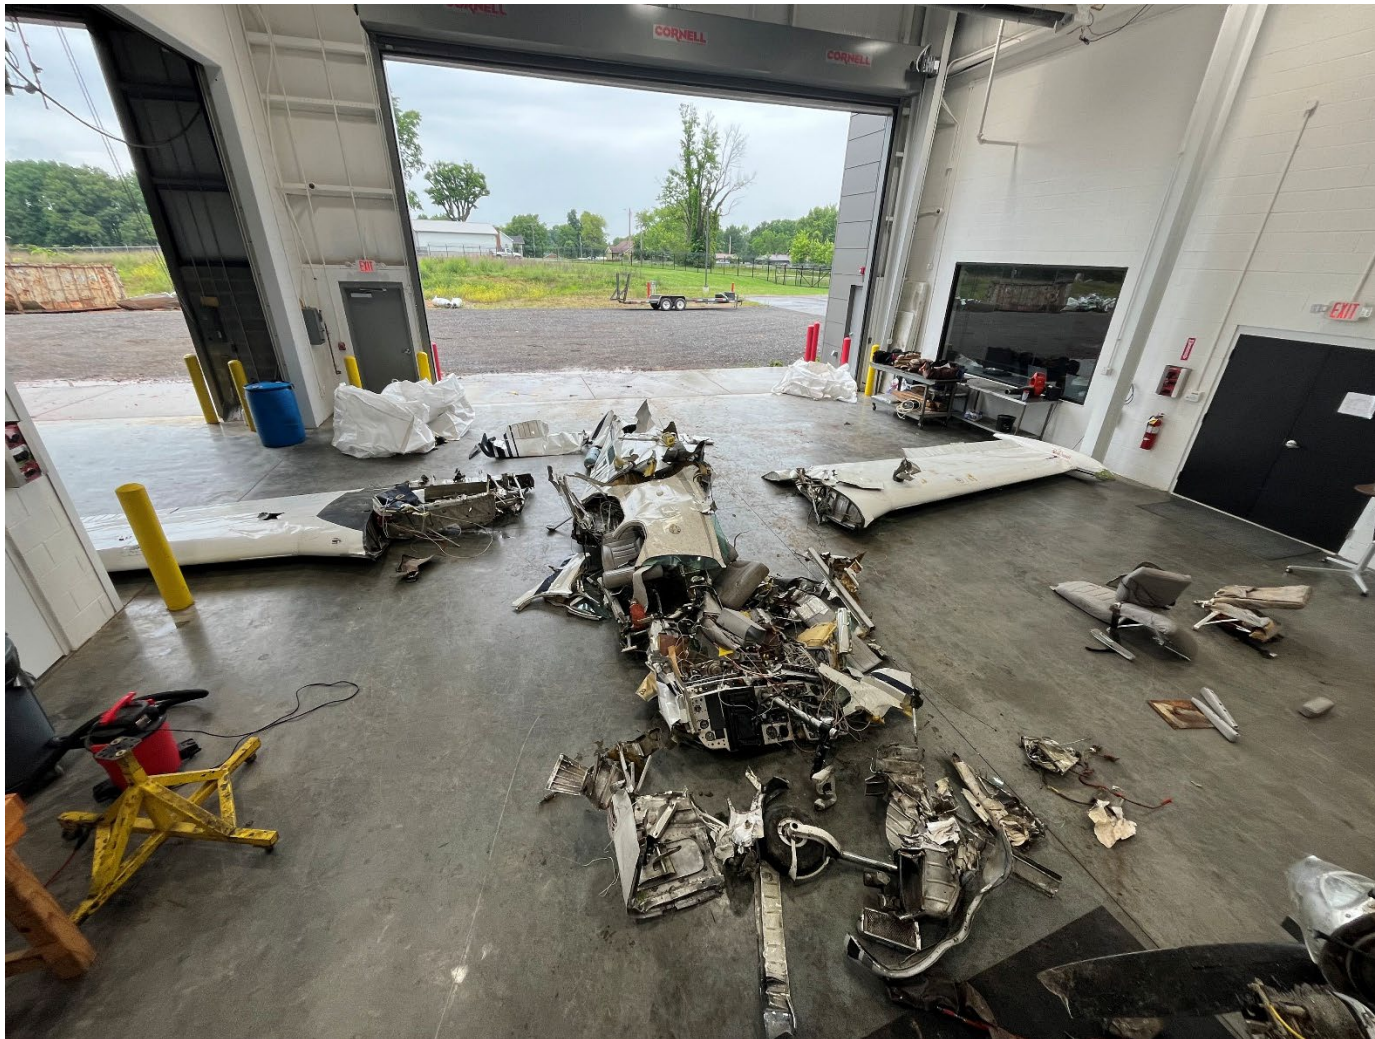
**Photograph 8 - Recovered wreckage layout on hangar floor. (NTSB)**

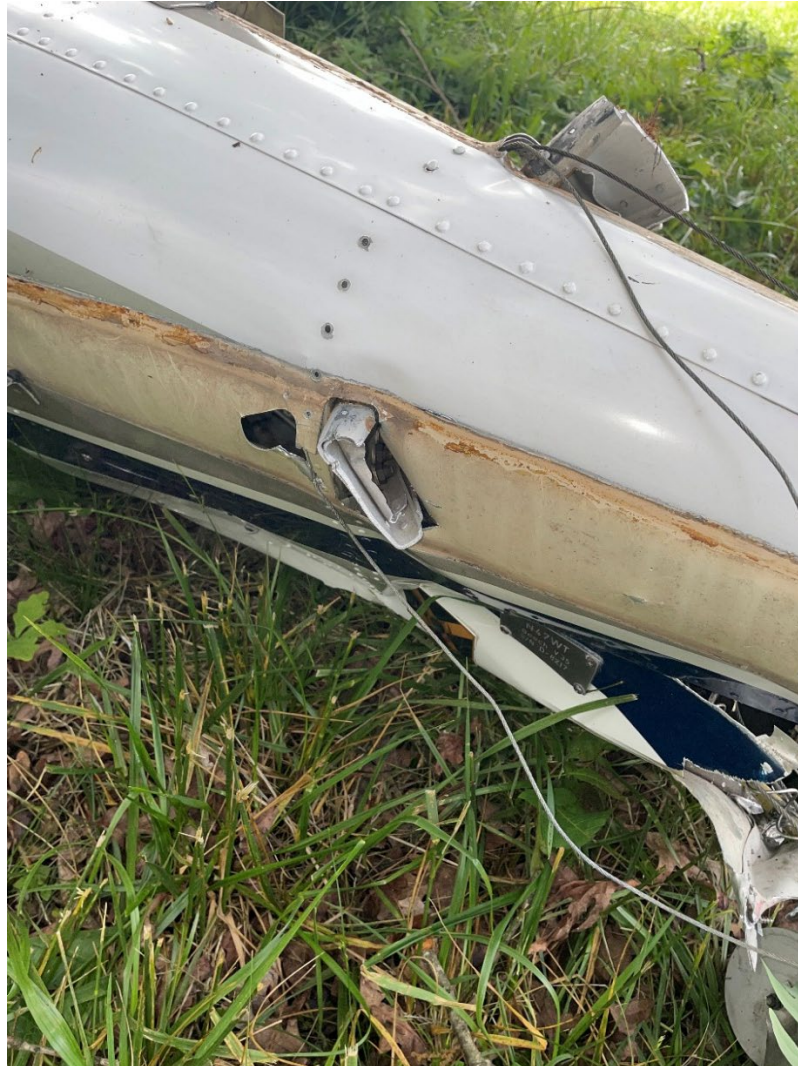
**Photograph 9 - View of stabilator spar showing preimpact deformation damage. (NTSB)**

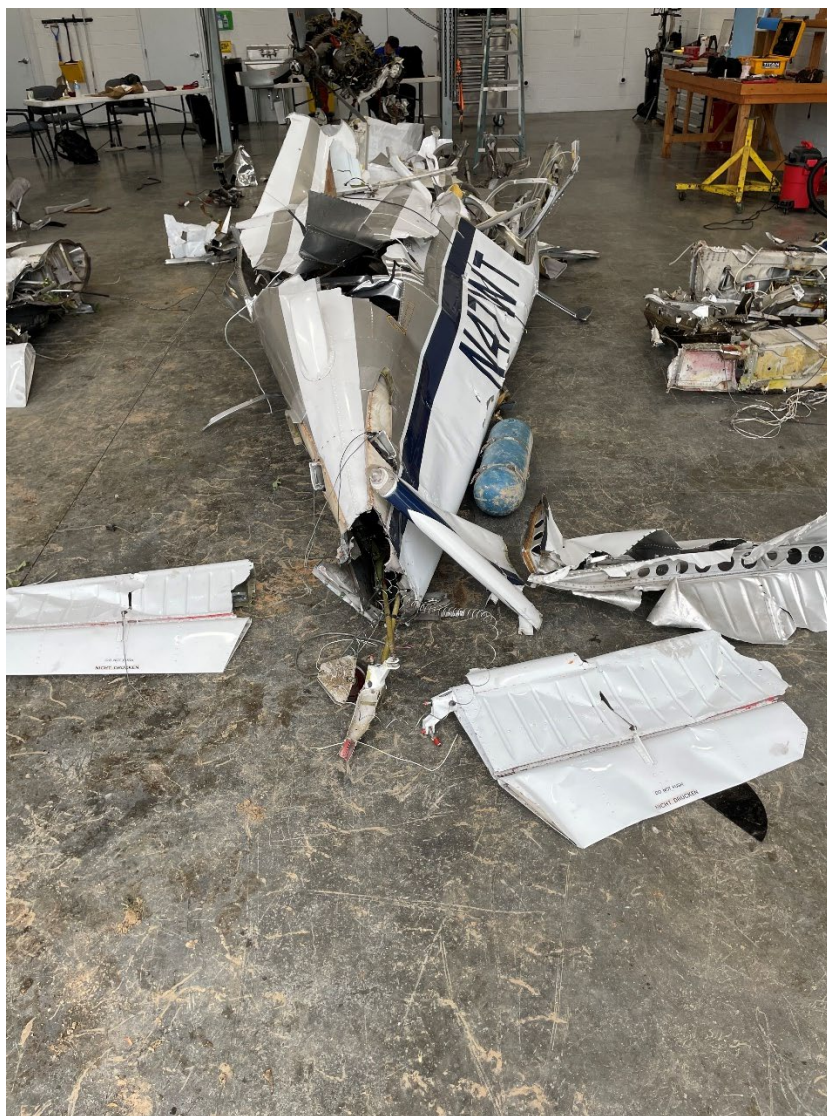
**Photograph 10 - View of wreckage looking from tail forward. (NTSB)**

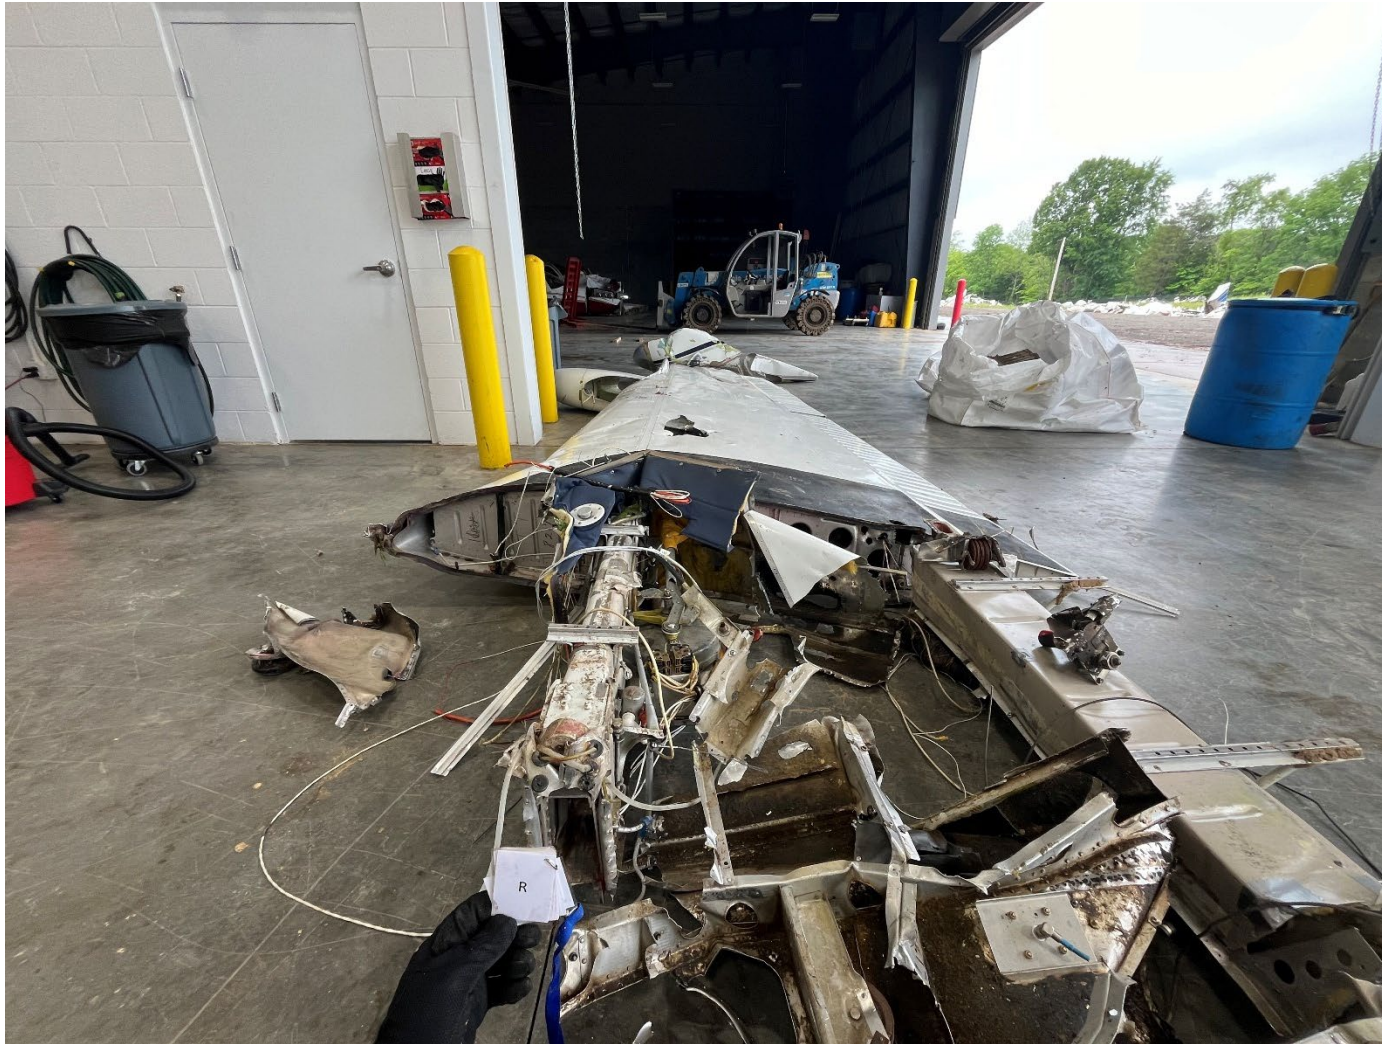
**Photograph 11 - View of right wing and spar looking outboard. (NTSB)**
