## Carburetor Icing Probability Graph – ERA24FA261

Airplane: Piper PA-28-140

Accident Date: 06/14/2024

Accident Location: Siler City, NC

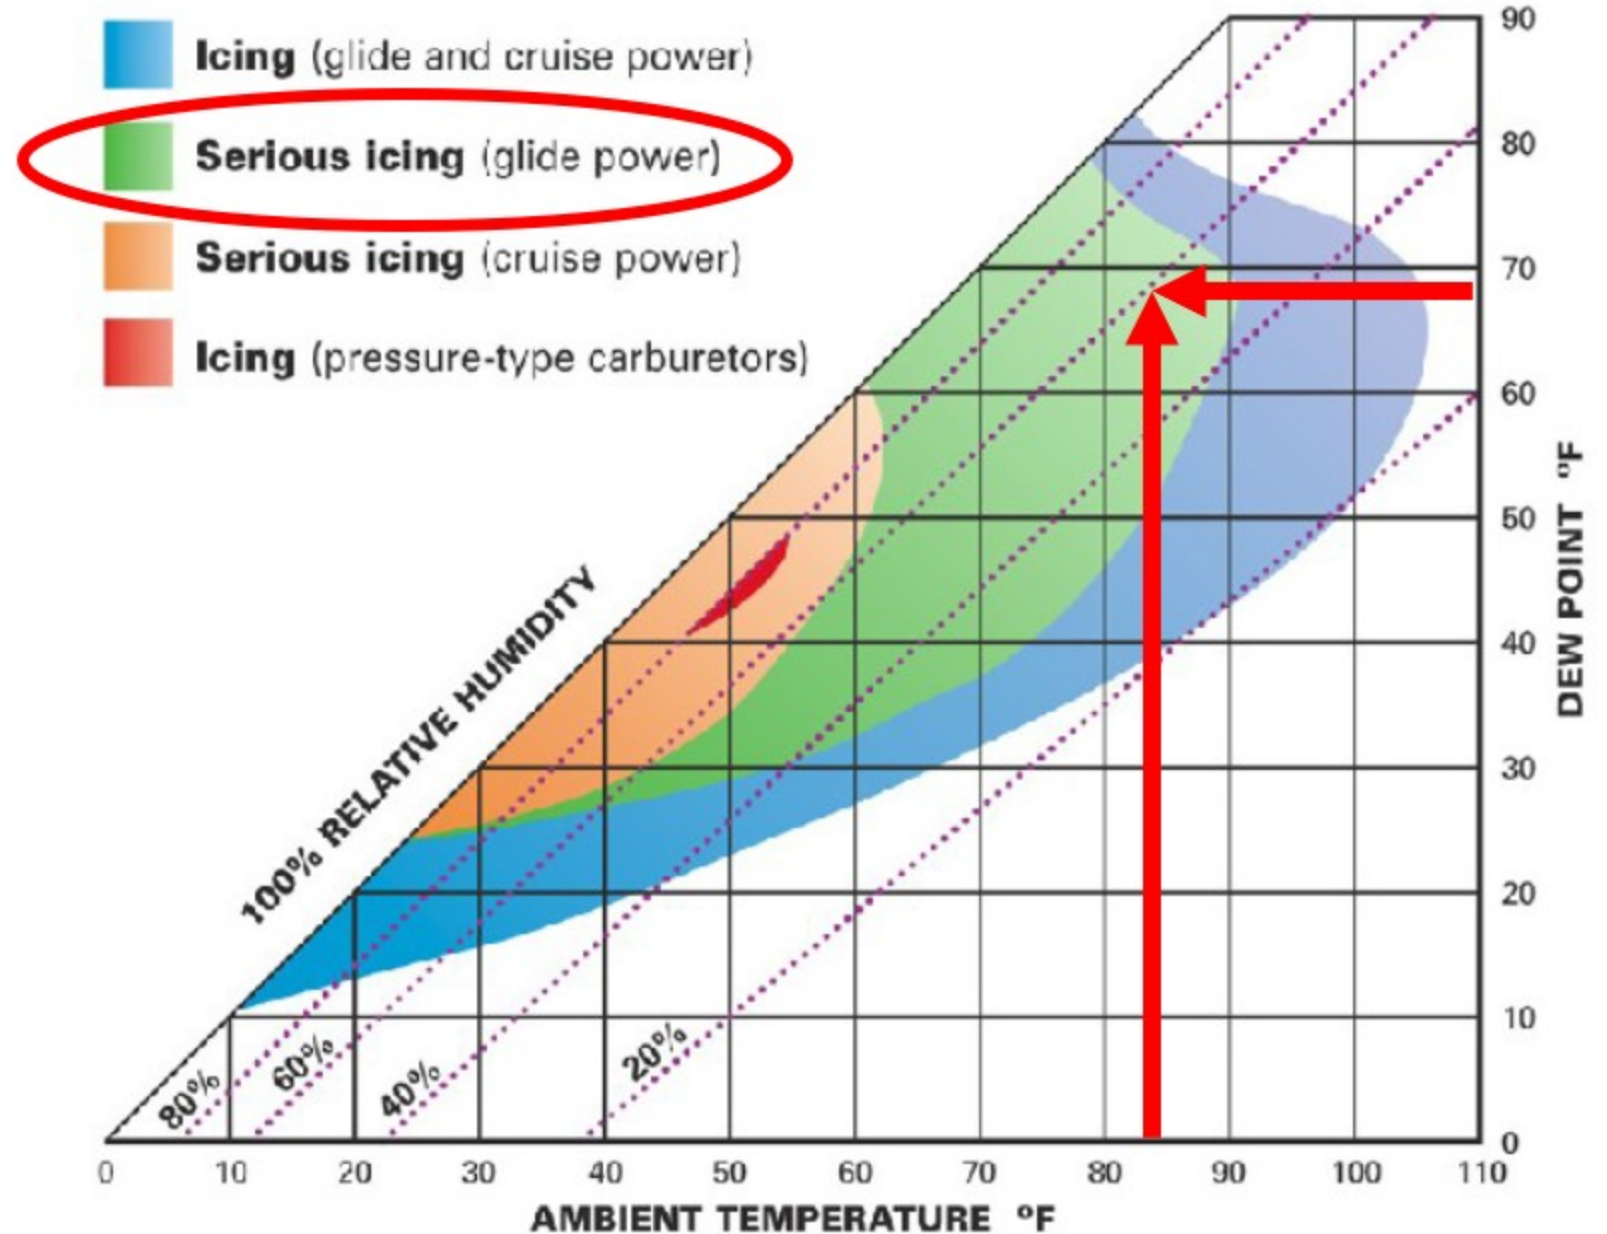
Weather: KSCR 141645Z AUTO 00000KT 10SM CLR  
29/20 A2996 RMK AO2 T02870196

Temperature, 29° C = 84.2° F

Dew Point, 20° C = 68° F
