# National Transportation Safety Board

ERA24FA261

## EXAMINATION SUMMARY

Location: Siler City, North Carolina  
Date: June 14, 2024  
Time: 1248 EDT  
1648 UTC  
Airplane: Piper PA-28-140, N515DH, SN: 28-25331

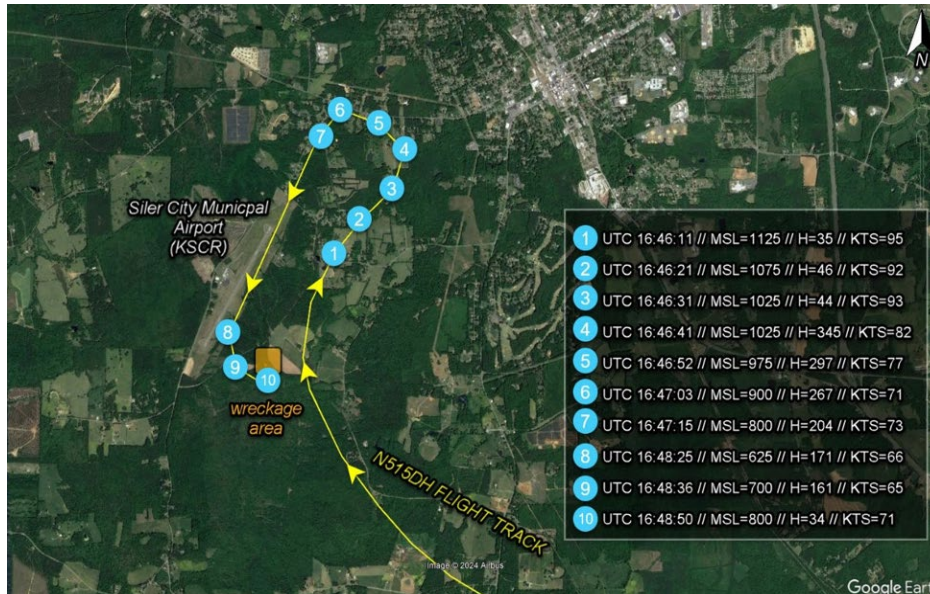
ADS-B track data from the FAA depicted the accident airplane's traffic pattern entry, and its flight on the downwind leg about 1,100 ft mean sea level (msl) around

90 knots (kts) groundspeed. The airplane turned and slowed on the left base leg to the low 80-kt range, and then entered the final approach leg, slowing into the low 70-kt range before the ADS-B track data was lost.

About 1 minute later, the track data resumed in the vicinity of the runway's departure end at 625 ft msl and 66 kts ground speed. Over the next 25 seconds, a 90° left turn was depicted. The final two targets displayed 700 ft and 65 knots, and 800 ft and 71 knots; respectively, before track data ended.

FAA ADS-B Flight Track Data. Times are reported as coordinated universal time (UTC) (NTSB).

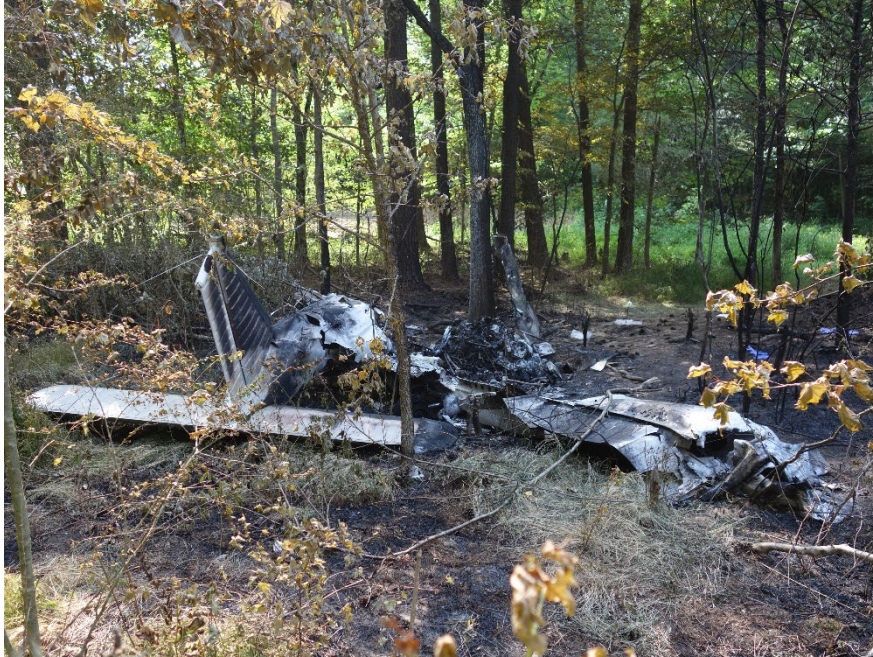
The accident site was located in wooded terrain about 2,260 ft southeast of the departure end of runway 22 of SCR. Examination of the wreckage revealed that the airplane came to rest in its initial impact crater at 562 ft elevation, oriented 330° magnetic, and was mostly consumed by a postcrash fire that extended to the empennage. The leading edges of both wings displayed uniform crushing across their entire spans. The engine was exposed, and the propeller, while buried, remained attached. The engine accessories were destroyed by fire.

Photograph of accident site and main wreckage. (Courtesy of Piper)

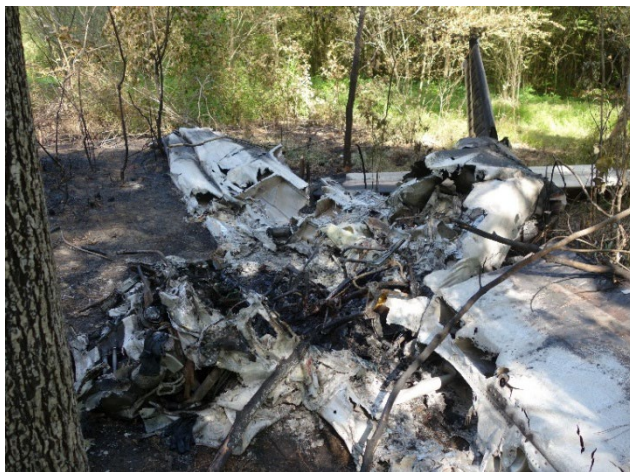
The fuselage was mostly destroyed by the postaccident fire. The cabin door remained attached to the fuselage and was mostly destroyed. The instrument panel and engine controls were destroyed. The recording tachometer was thermally damaged with its indicator static about 2,300 RPM. The flap lever exhibited impact and thermal damage. Flap control continuity was established from the lever to the flap torque tube. Impact and thermal damages precluded verification of flap position; however, the flaps were observed in the retracted position. Flight control continuity was established from the cockpit to each control surface.

Photograph of fuselage. (Courtesy of Piper)

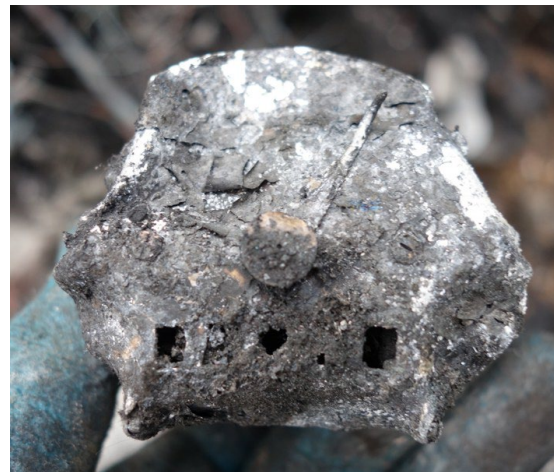
Photograph of tachometer. (Courtesy of Piper)

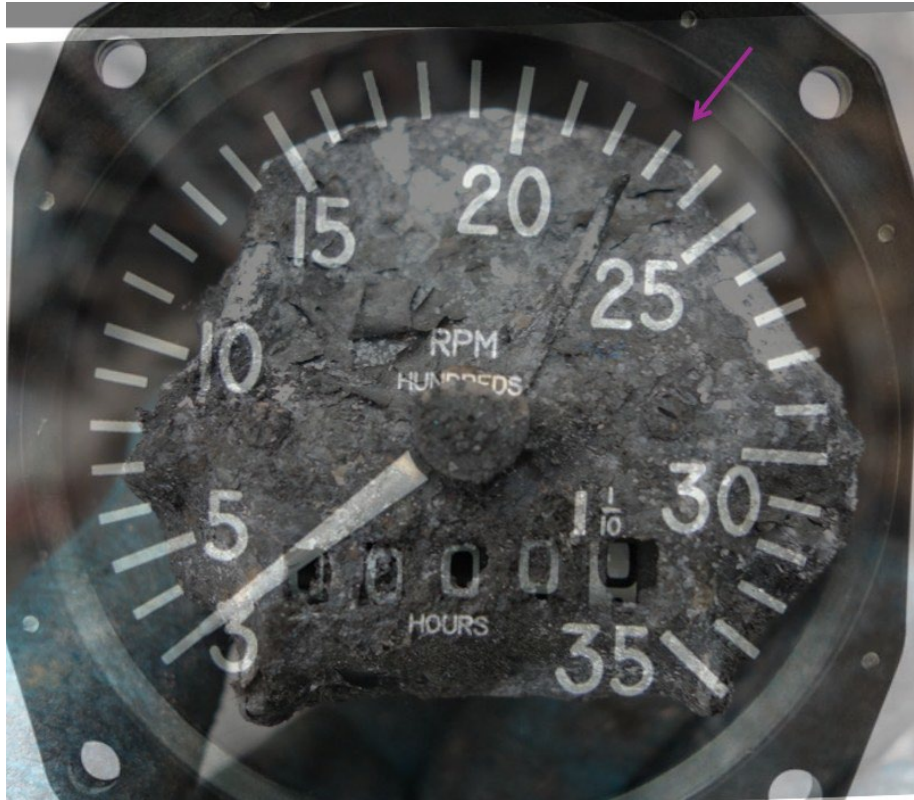
Annotated Piper photograph of the recording tachometer with transparent overlaid photograph of similar make/model tachometer. (NTSB)

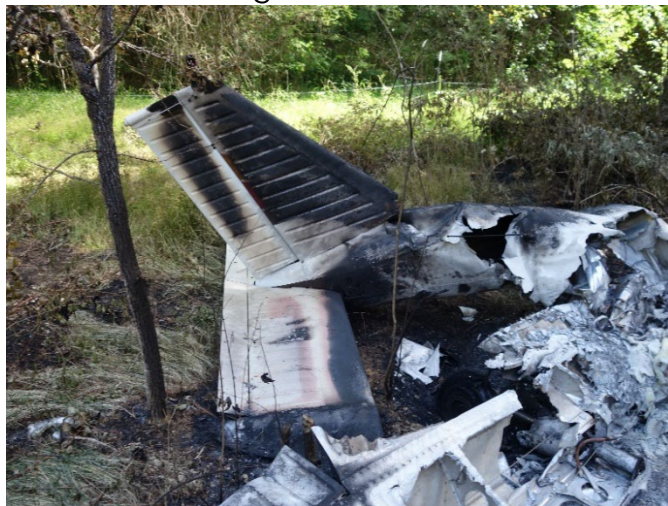
The vertical stabilizer and rudder remained attached to their mounts and exhibited thermal discoloration to their right sides. The stabilator assembly remained attached to its mounts with thermal damage and discoloration noted to its right side. The top of the stabilator trim barrel exposed about 5 threads of the jackscrew which corresponded to a neutral trim setting.

Photograph of empennage. (Courtesy of Piper)

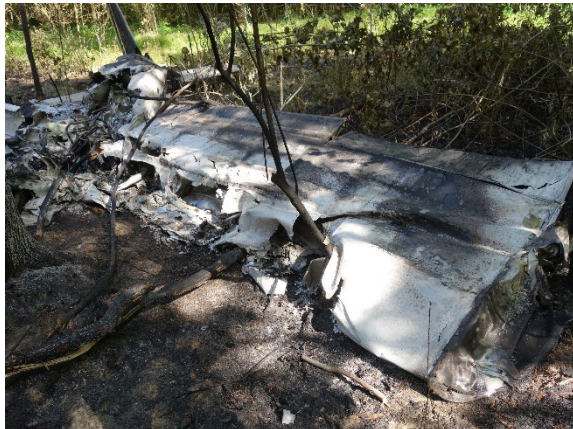
The left and right wings were partially separated from the fuselage and exhibited thermal and impact damage. The flaps and ailerons remained attached to the wings. The lift detector was thermally separated from the left wing.

Photograph of left wing. (Courtesy of Piper)

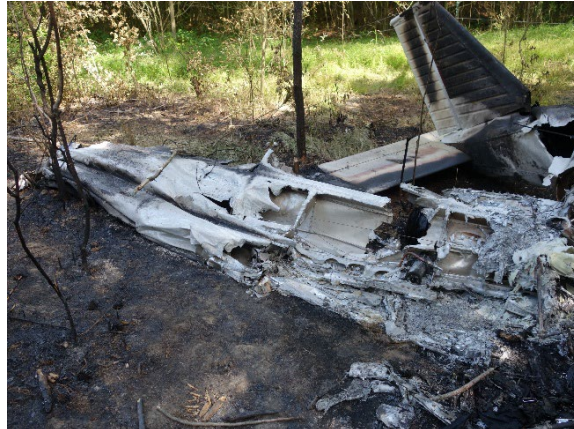
Photograph of right wing. (Courtesy of Piper)

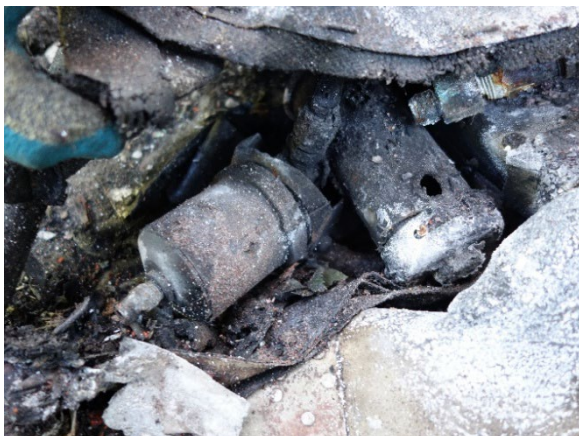
The left- and right-wing fuel caps remained attached to their receptacles and the fuel tanks were destroyed from impact and thermal damage. The fuel primer plunger was stowed and locked. The fuel strainer bowl was covered in soot, and the surrounding structure was impact damaged. No liquid was observed in the strainer bowl, and the fuel strainer screen was free of blockage. The electric fuel pump was thermally damaged and could not be tested. The fuel selector handle was consumed by fire. The fuel selector valve was impact and thermally damaged, which allowed the valve shaft to rotate freely in the valve housing. The fuel selector valve and handle positions at the time of impact could not be determined.

Photograph of gascolator and electric fuel pump. (Courtesy of Piper)

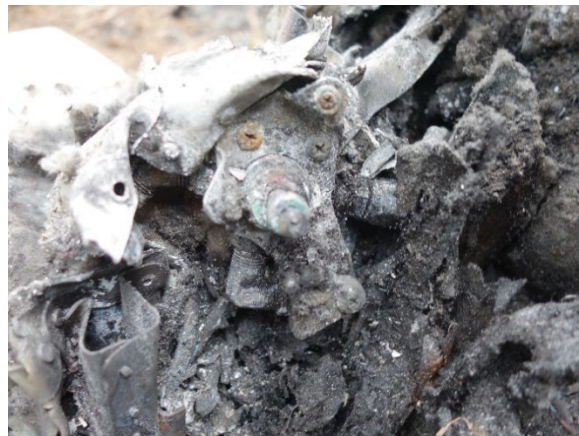
Photograph of fuel selector valve. (Courtesy of Piper)

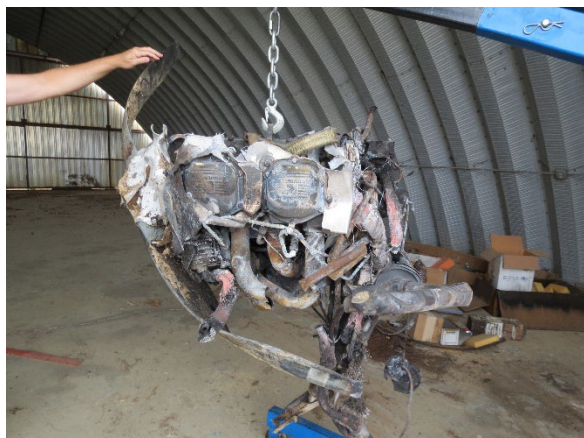
Examination of the engine revealed that the rear-mounted accessories were destroyed by fire. The carburetor was thermally damaged and partially separated from the engine, and its fuel inlet screen was clear of debris, and its internals were thermally damaged. The throttle and mixture control cables remained attached to the carburetor. The induction alternate air box was crushed, and its position was unknown due to thermal and impact damage. The engine driven fuel pump and both magnetos were mostly destroyed by fire. The spark plug electrodes were gray in coloration and normal wear when compared to the Champion Check-A-Plug card. The starter and alternator were impact damaged and partially separated from the engine. The intake tubes, exhaust tubes, and the exhaust muffler were partially crushed. The crankshaft flange was bent, and the starter ring gear support was fragmented.

The engine was suspended from a lift and partially disassembled to facilitate examination. The exhaust tubes were cut and the muffler removed. The propeller and starter ring gear support were removed, and the bent portion of the crankshaft flange cut away to allow the crankshaft to be rotated through 360°. The engine crankshaft was rotated using a tool inserted in the engine accessory case vacuum pump drive pad. Continuity of the crankshaft to the rear gears and to the valve train components was confirmed. Compression and suction were attained from all 4 cylinders. The interiors of the cylinders were observed with a lighted borescope and no anomalies were noted. Oil was observed in the sump, and the oil pump suction screen was clear of debris. Thermal damage was noted to the oil filter media.

Photograph of engine. (Courtesy of Lycoming)

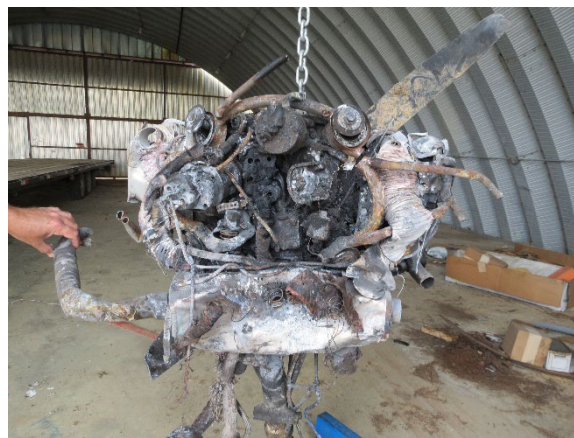
Photograph of engine accessory section. (Courtesy of Lycoming)

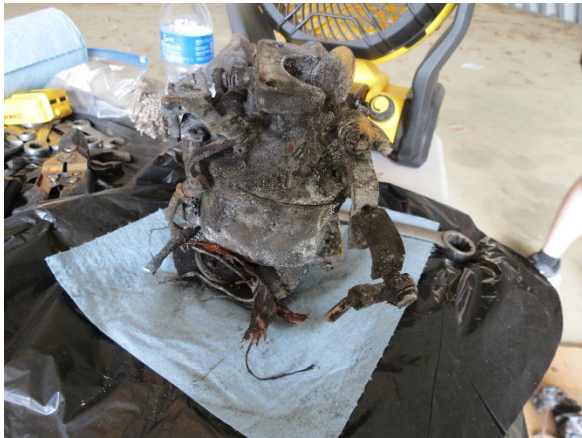
Photograph of carburetor.  
(Courtesy of Lycoming)

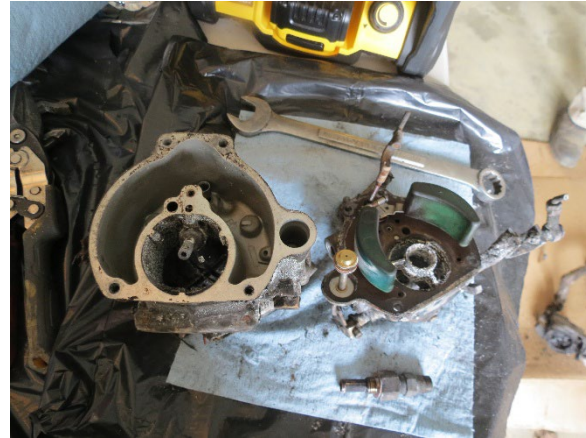
Photograph of carburetor float and inlet screen.  
(Courtesy of Lycoming)

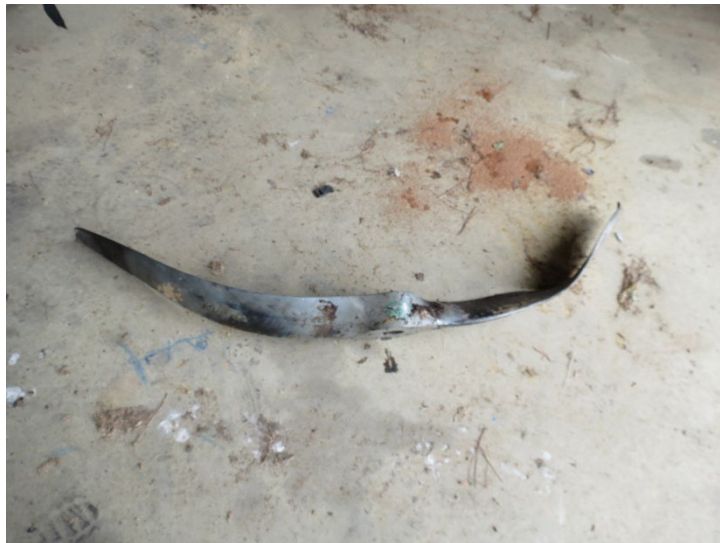
The Sensenich aluminum two-bladed propeller was attached to the engine crankshaft flange. The propeller spinner was impact crushed. One propeller blade was deformed aft about 45° about mid-span and exhibited longitudinal twisting toward the blade face. The other blade was deformed aft about 30° with longitudinal twisting toward the blade face. Chord-wise abrasions were noted to both blades.

Photograph of propeller. (Courtesy of Lycoming)

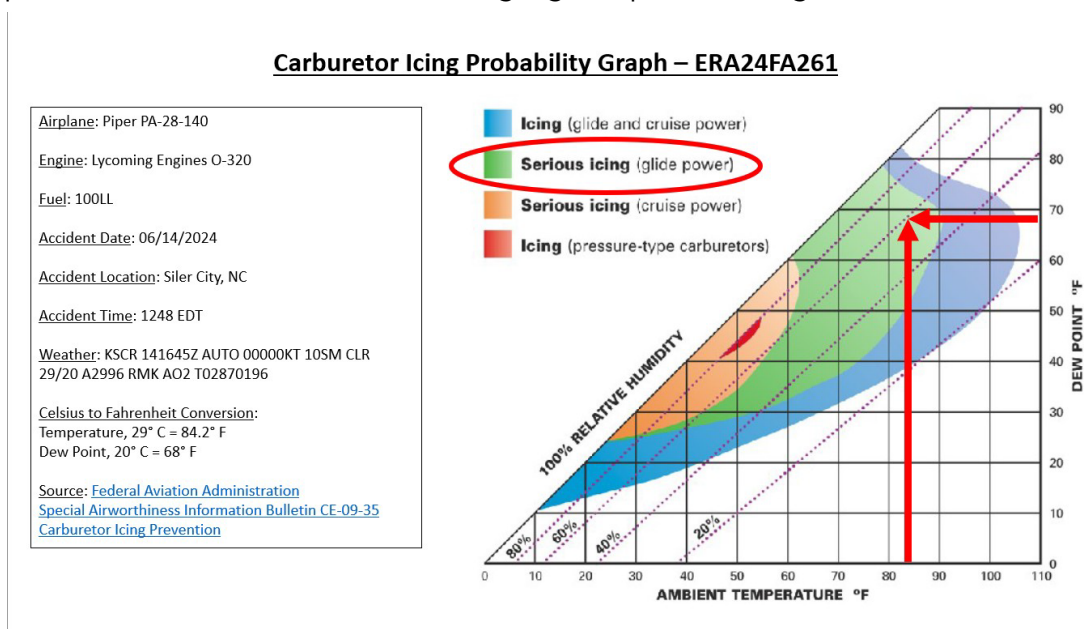
The recorded temperature and dew point near the accident site was about 84.2 and 68 degrees, respectively. On a carburetor icing probability chart, those temperatures were in the "serious icing - glide power" range.

FAA Carburetor icing probability graph. (NTSB)
