ERA24FA266

## INVESTIGATION PHOTOGRAPHS

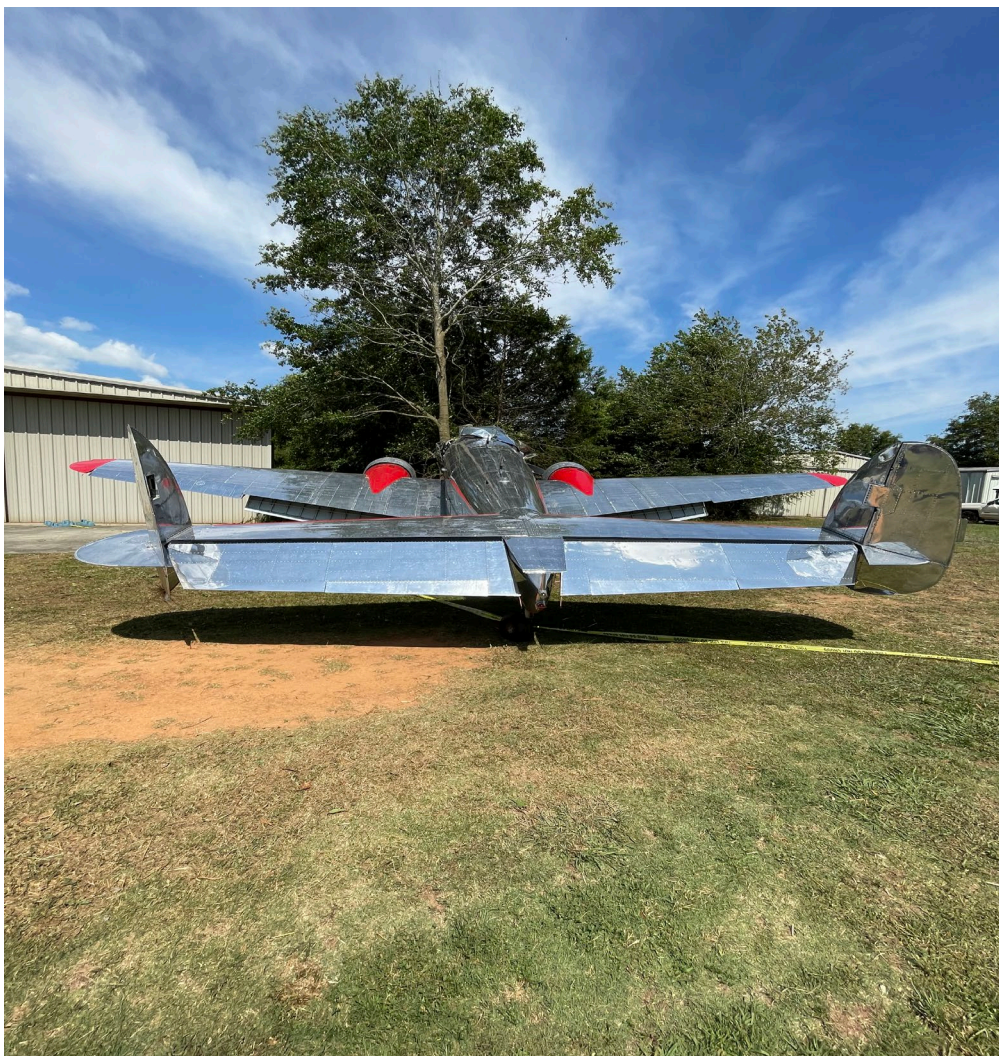
**Photograph 1 - Aft view of airplane.**

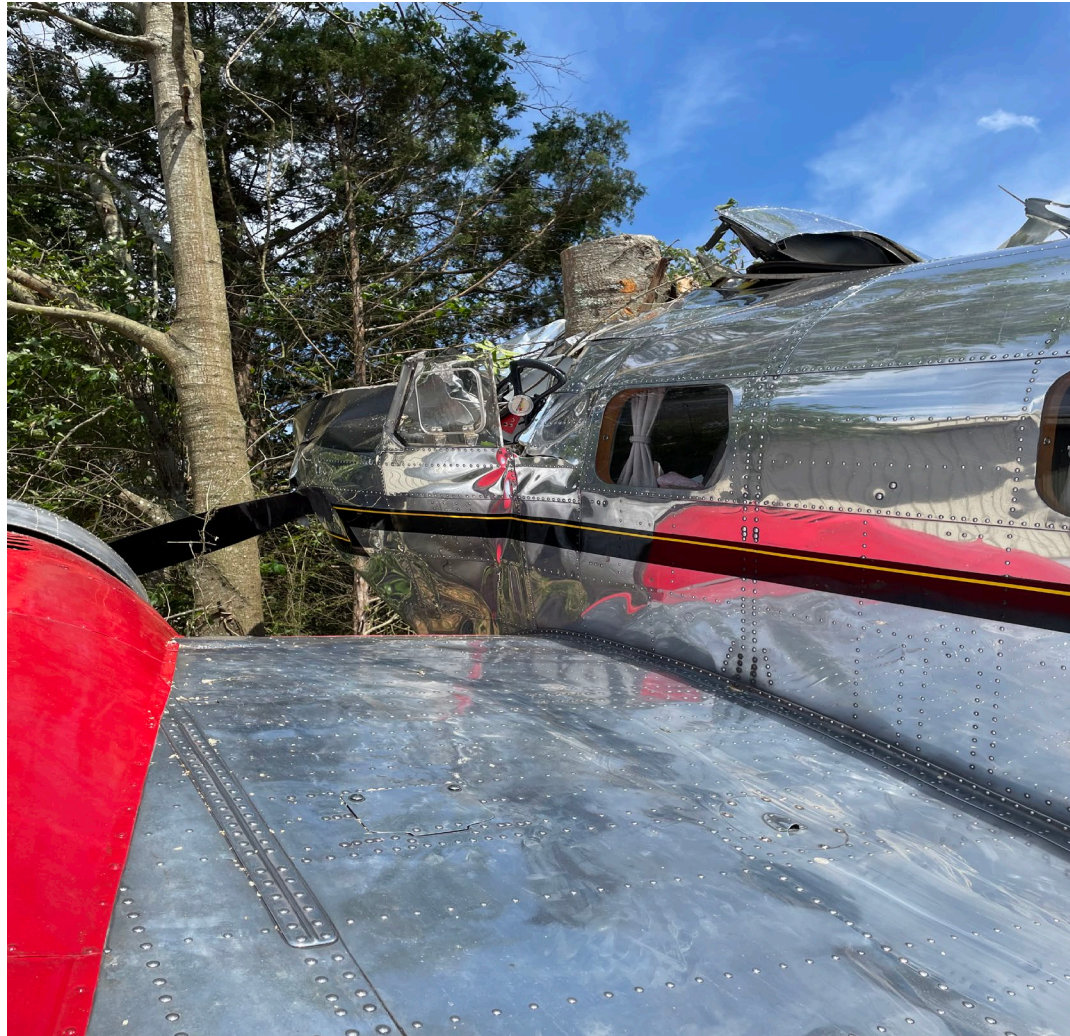
**Photograph 2 - Left side view of airplane.**

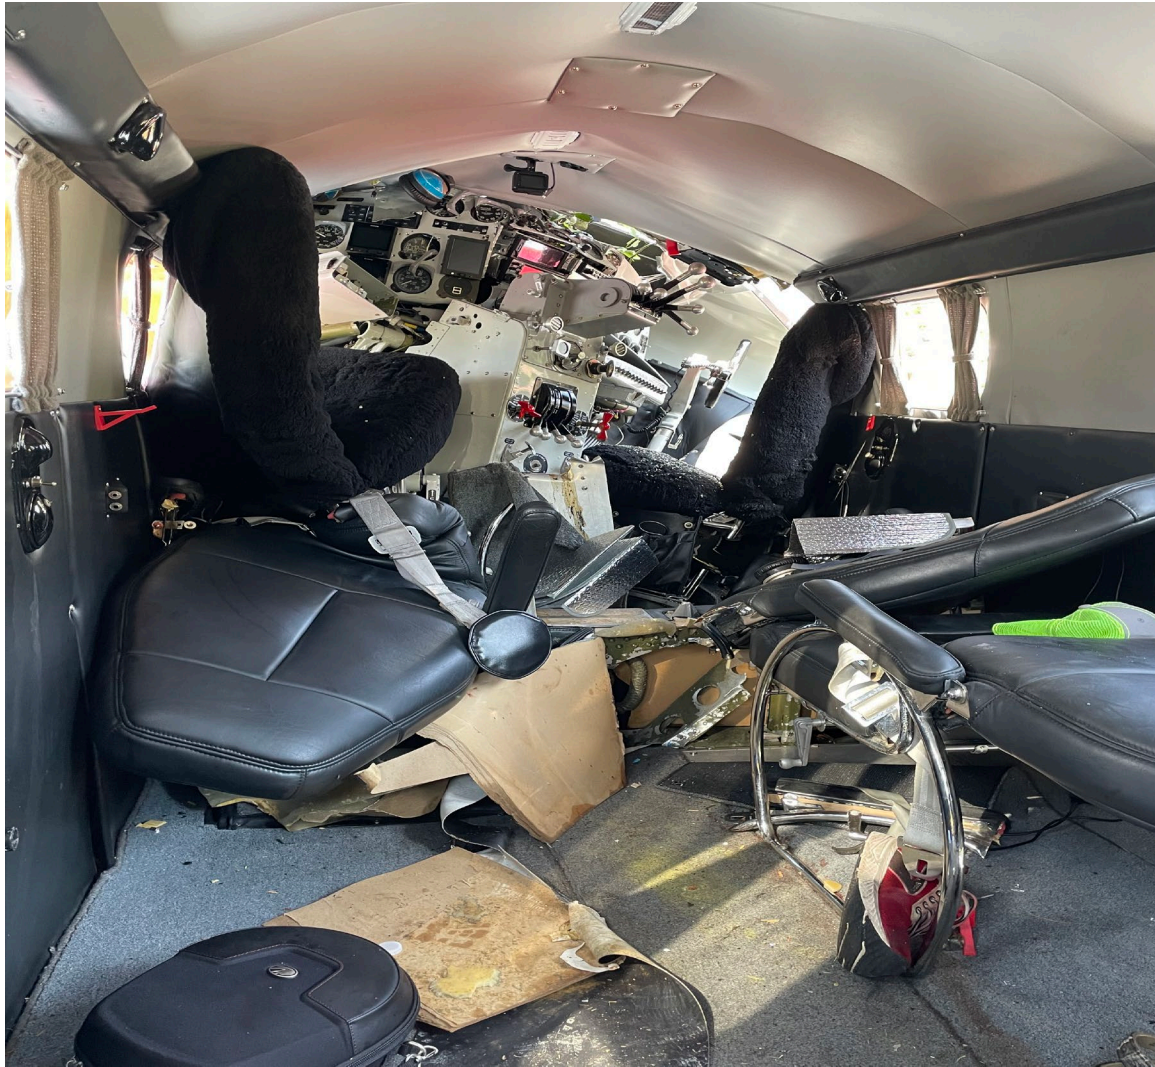
**Photograph 3 - View of inside cockpit.**

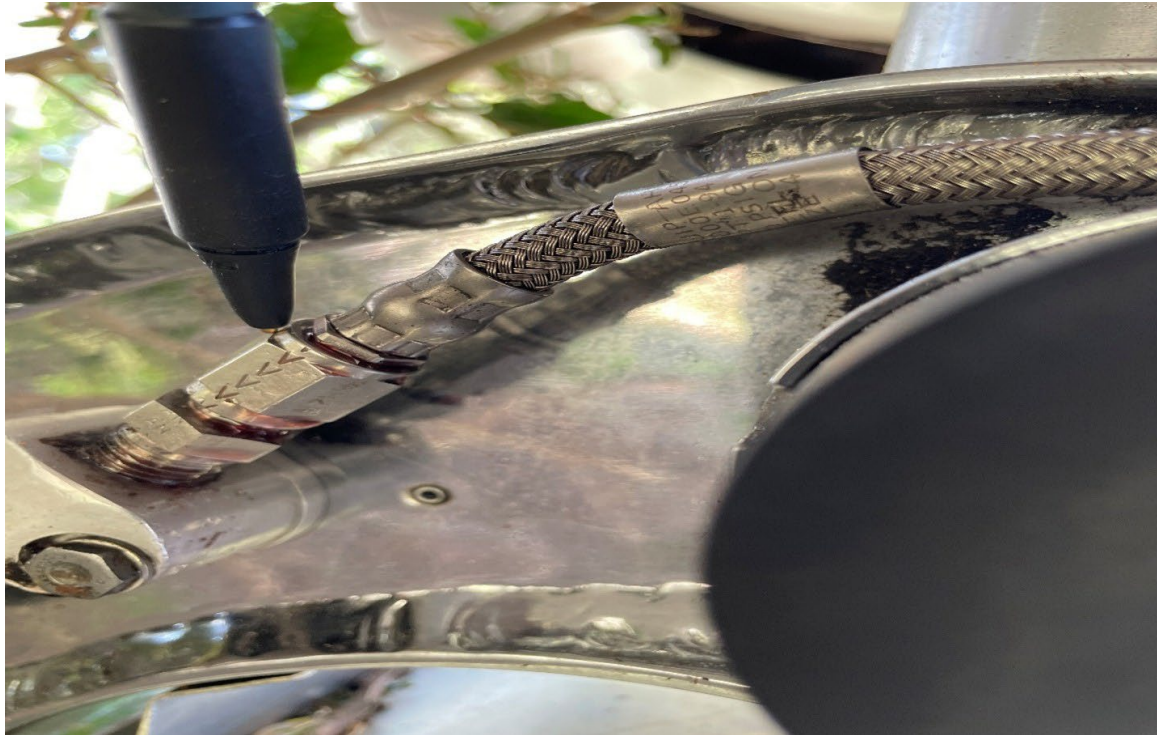
**Photograph 4 - Close up view of loose B-Nut fitting hydraulic fluid leakage.**

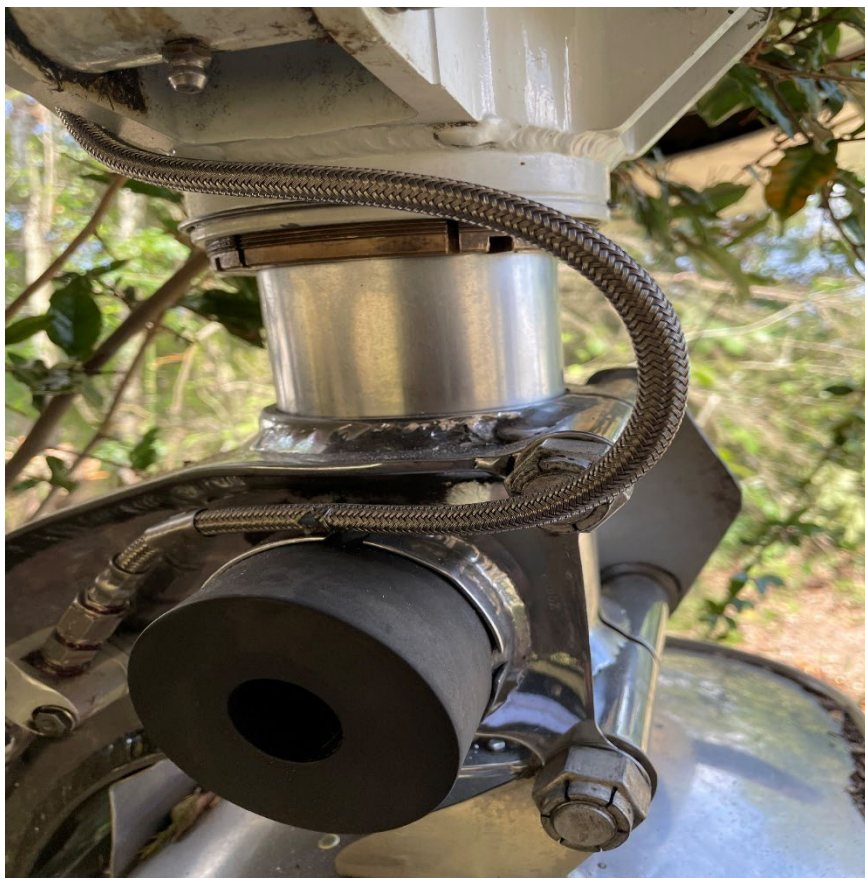
**Photograph 5 -View of landing gear strut and brake line.**

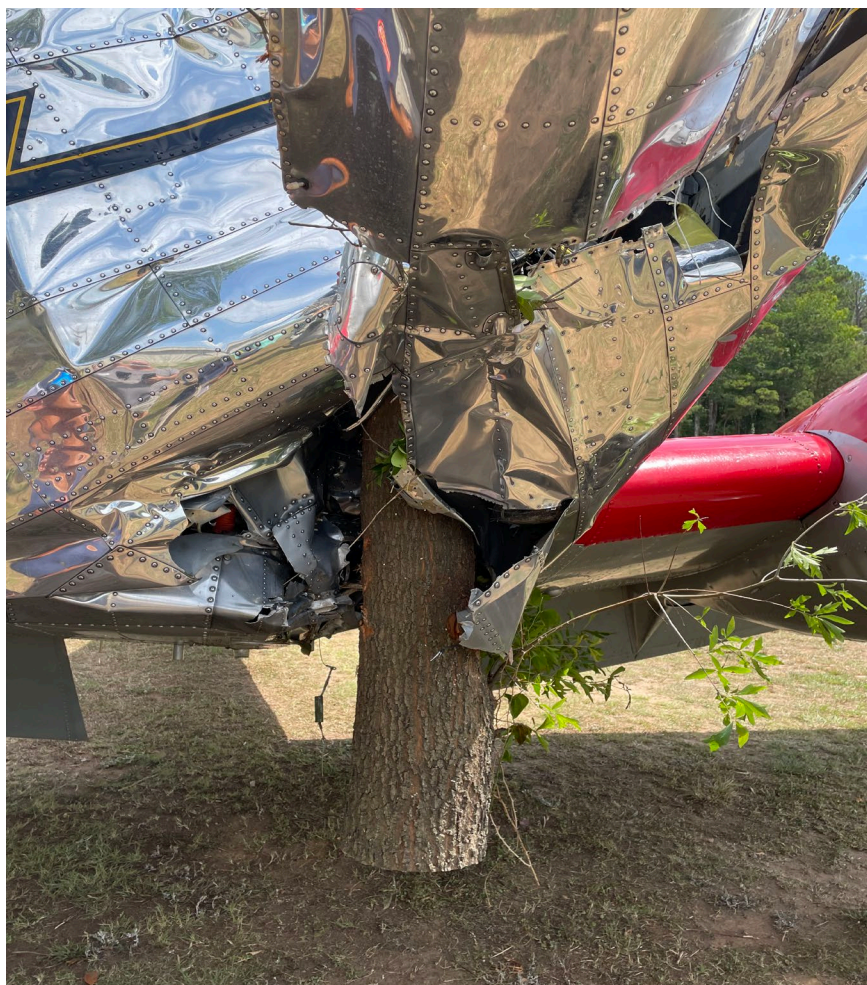
**Photograph 6 - View of damaged underside of airplane.**
