# National Transportation Safety Board

ERA24FA266

## WRECKAGE EXAMINATION

Aircraft: Lockheed 12A

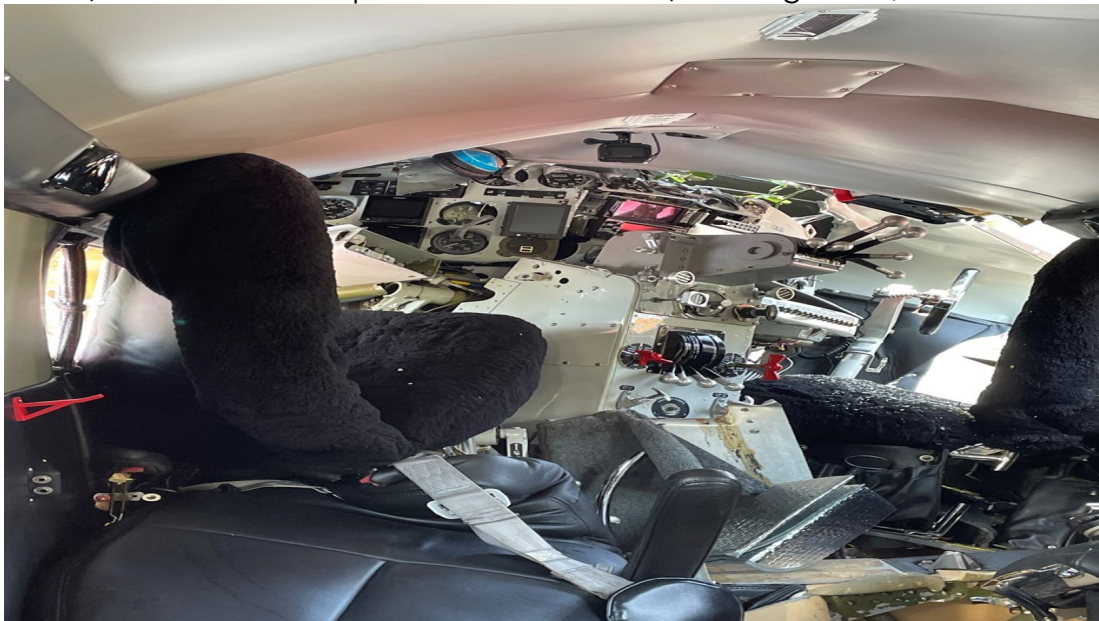
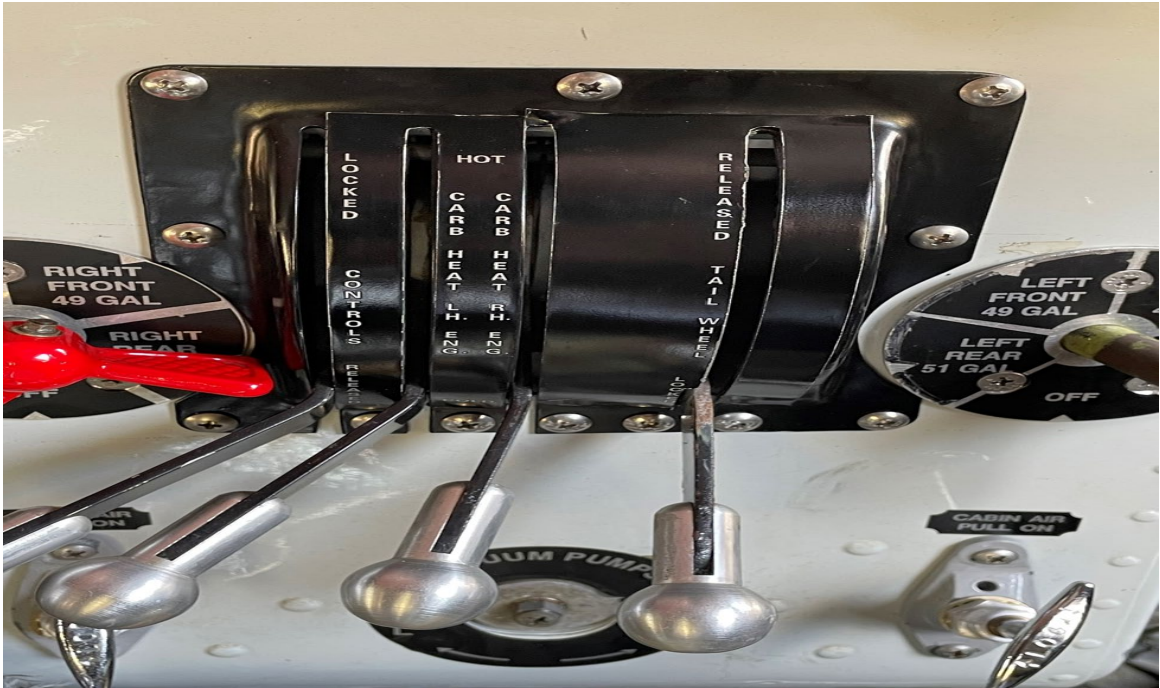
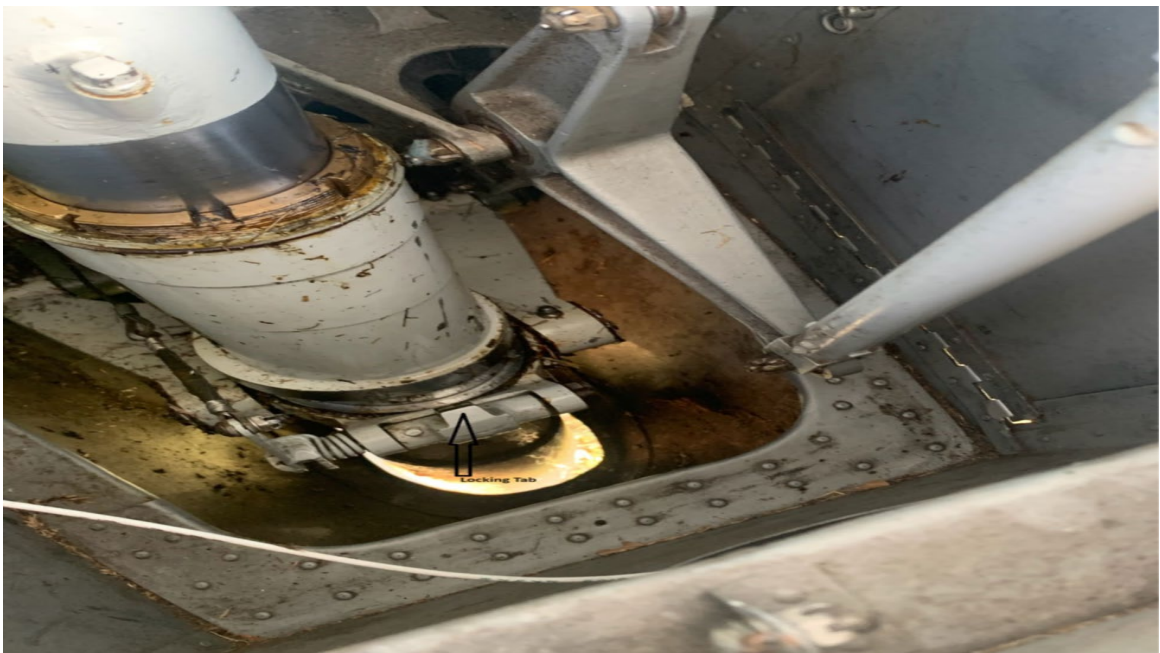
rest about 1,682 ft down runway 36 and approximately 50 ft off the side of the runway. The airplane's cockpit was crushed aft towards the cabin section. A tree trunk, about two ft in circumference, was observed within the cockpit. The instrument panel was buckled around the tree trunk within the cockpit. The pilot's, co-pilot's, and passenger seats were crushed up and back towards the cabin.

All flight control surfaces remained intact, and flight control continuity was observed to the cockpit. The flaps were found in the extended position. Upon examination of the cockpit, it was noted that the engine throttle controls were in the closed position. The left and right propellers were set to 'high pitch/decrease rpm.' Additionally, the left and right mixture controls were in the lean position.

Examination of the left fuel tank selector revealed it was in the "OFF" position. The fuel tank selector on the right side was protruding from the panel, rendering its position unreliable.

The carburetor heat controls were observed in the cold position. The control lock was released, and the tailwheel control lever was locked; however, despite being in the locked position, the locking tab mechanism on the tail wheel assembly was found to be unlocked.

(Note: the control panel was crushed aft). See Figures 1, 2 and 3.

**Figure 1.** Cockpit

**Figure 3.** Picture taken by FAA inspector during onsite examination.

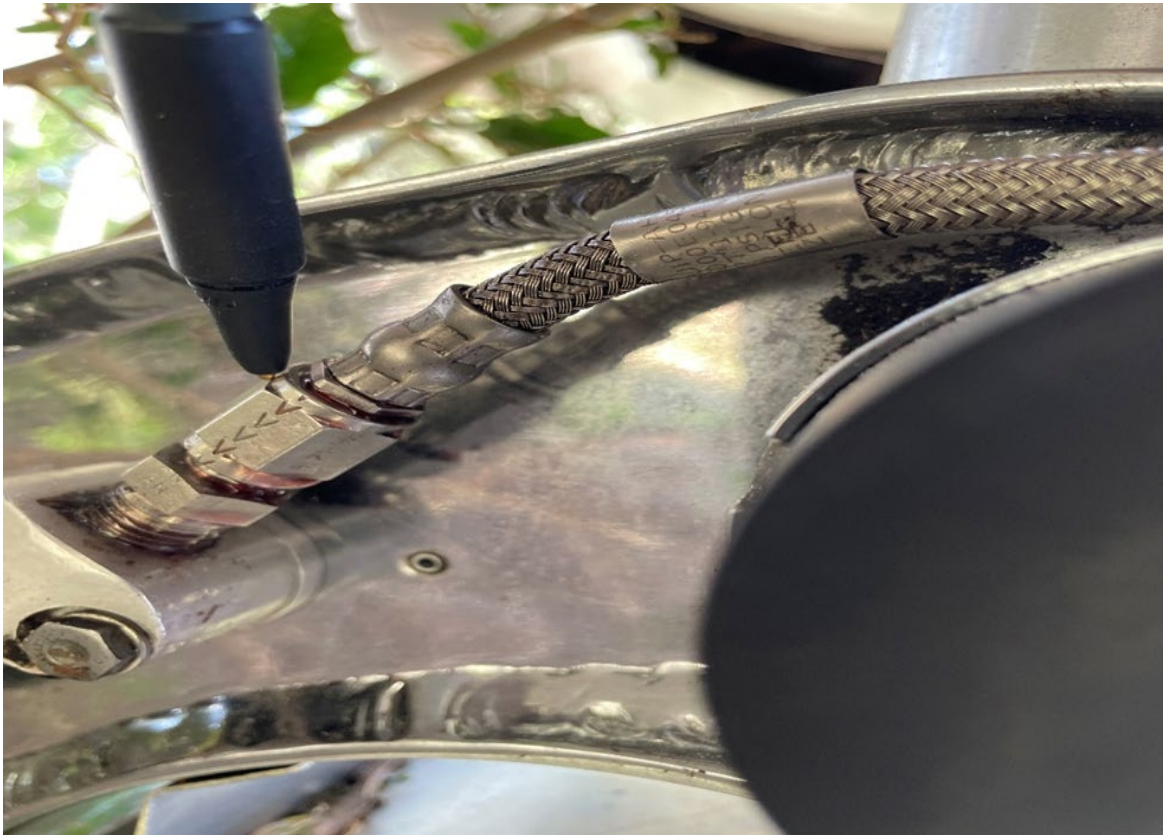
Examination of the main landing gear braking system revealed that the B-nut fitting on the right-side main landing gear was finger-tight, with hydraulic fluid observed leaking around it.

**Figure 4.** Hydraulic fluid was observed “leaking” around the right-side B-Nut fitting.

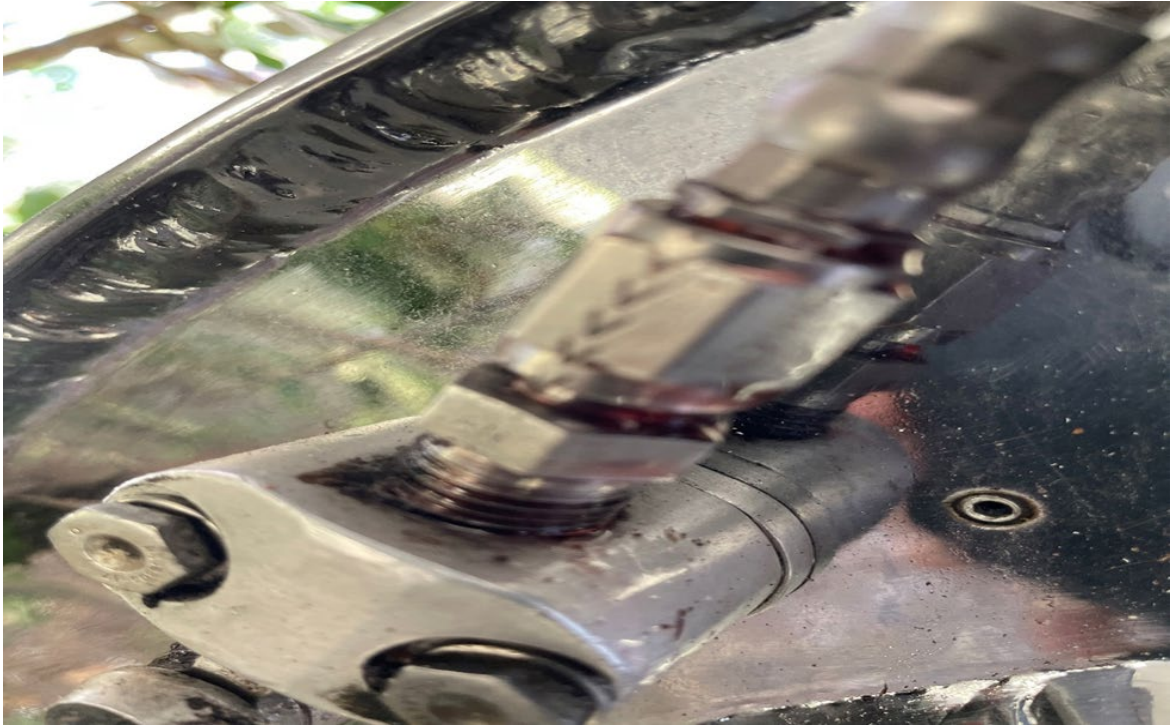
**Figure 5.** Right-side loose B-Nut fitting & hydraulic fluid leakage.

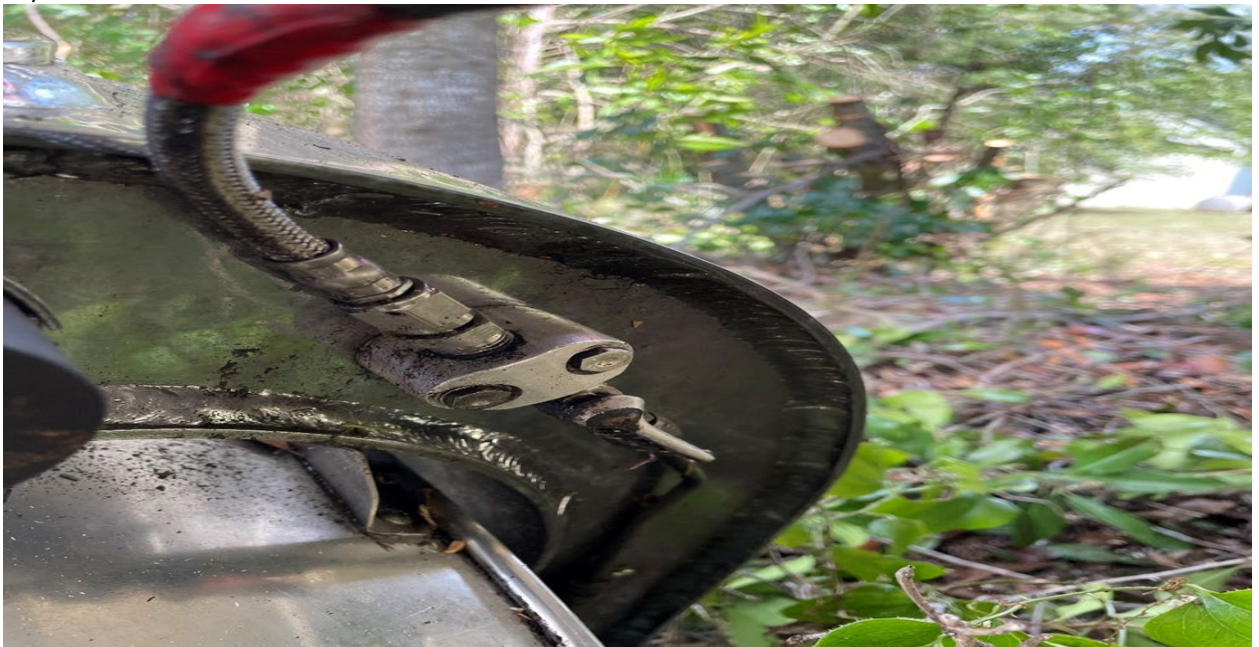
Examination of the left main landing gear reveal that the "B-Nut" fitting was tight and could not be moved by hand. Fluid was not observed leaking from the "B-Nut", but hydraulic residue was observed around the fitting. (See Figure 6.)

**Figure 6.** Hydraulic fluid residue
