# National Transportation Safety Board

ERA24FA283

## WRECKAGE EXAMINATION

Location: Trout Creek, NY  
Date: June 30, 2024  
Time: 1355 EDT  
1755 UTC  
Airplane: N85PG; PA-46-310P

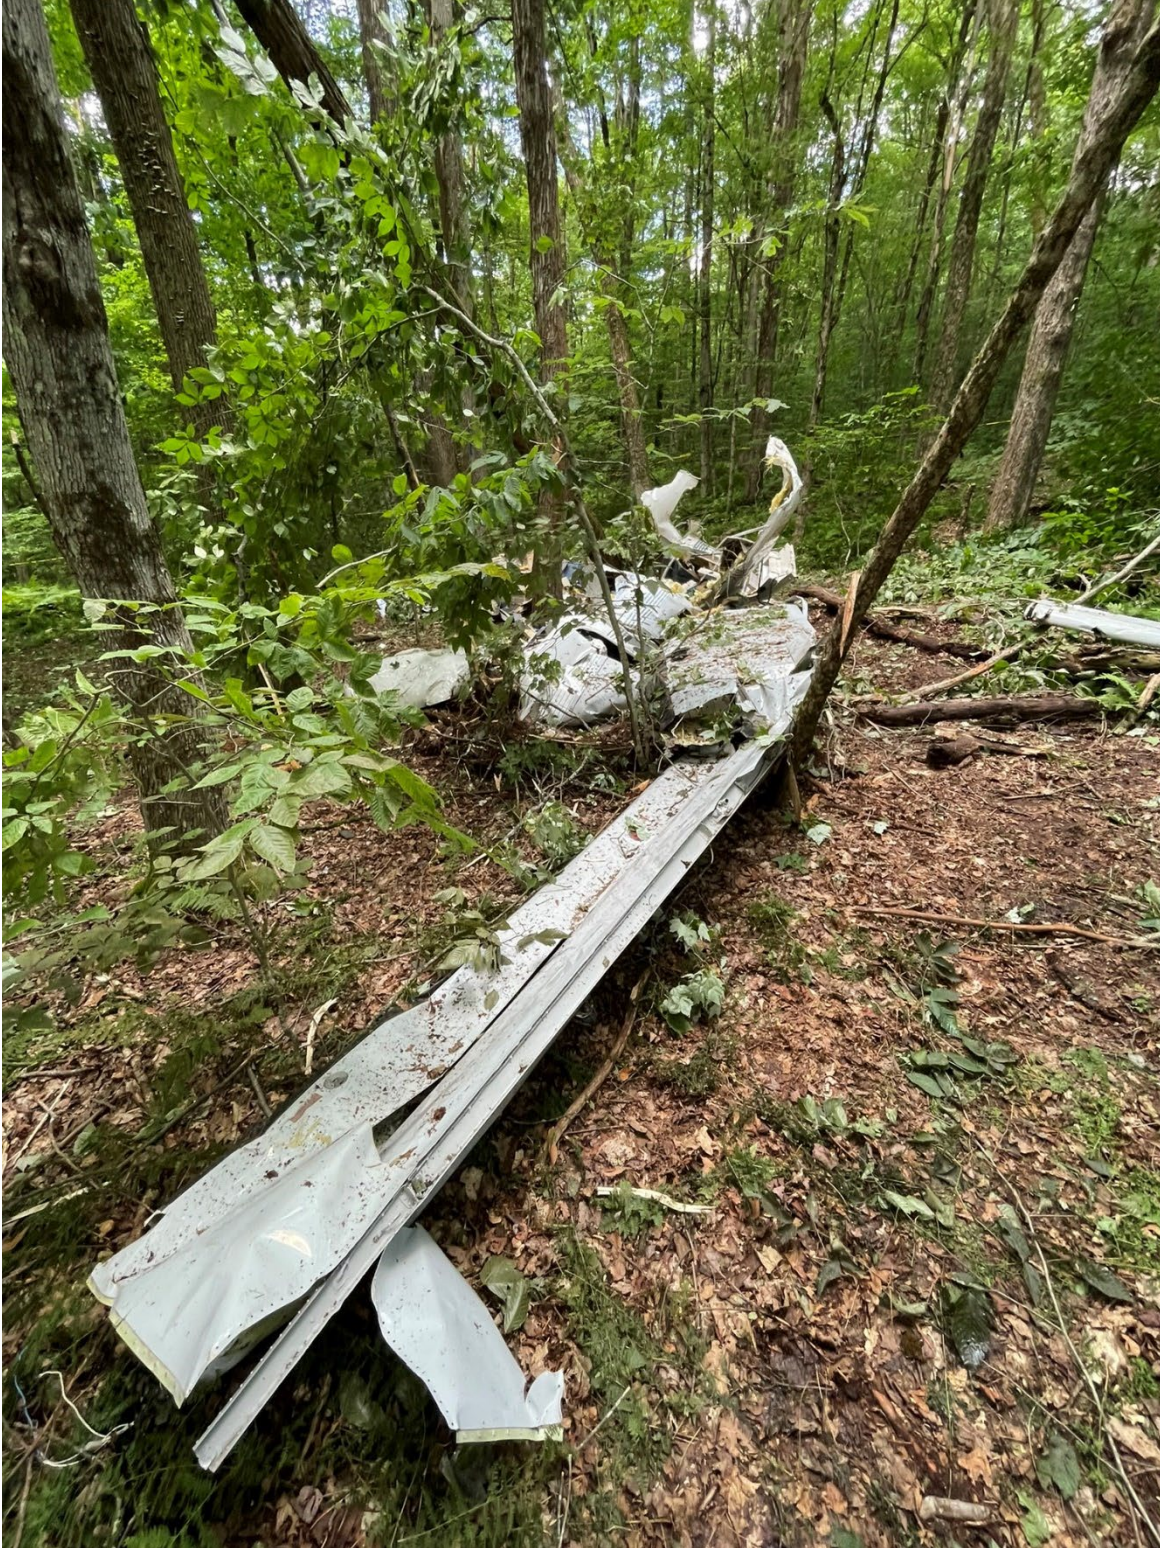
Observed on-scene, the fuselage was laying on its right side and partially buried in the ground at the base of several large trees. The cabin top had been cut and portions removed by first responders. The upper half of the cabin door and the emergency exit door were located adjacent to the fuselage along with some of the cabin seats/cushions, and a number of interior trim panels. Portions of the flight control cables were visible through fractures in the lower fuselage skin, however the continuity from the wing spar to the cockpit controls could not be confirmed due to the extensive crushing of the fuselage. First responders reportedly removed 75 lbs of baggage from the aft baggage area in the cabin. Two backpacks, one rollaboard luggage, a large bag of toiletries, and several souvenir baseball bats were also retrieved from the forward baggage compartment.

**Photo 2: View of the main wreckage site.**

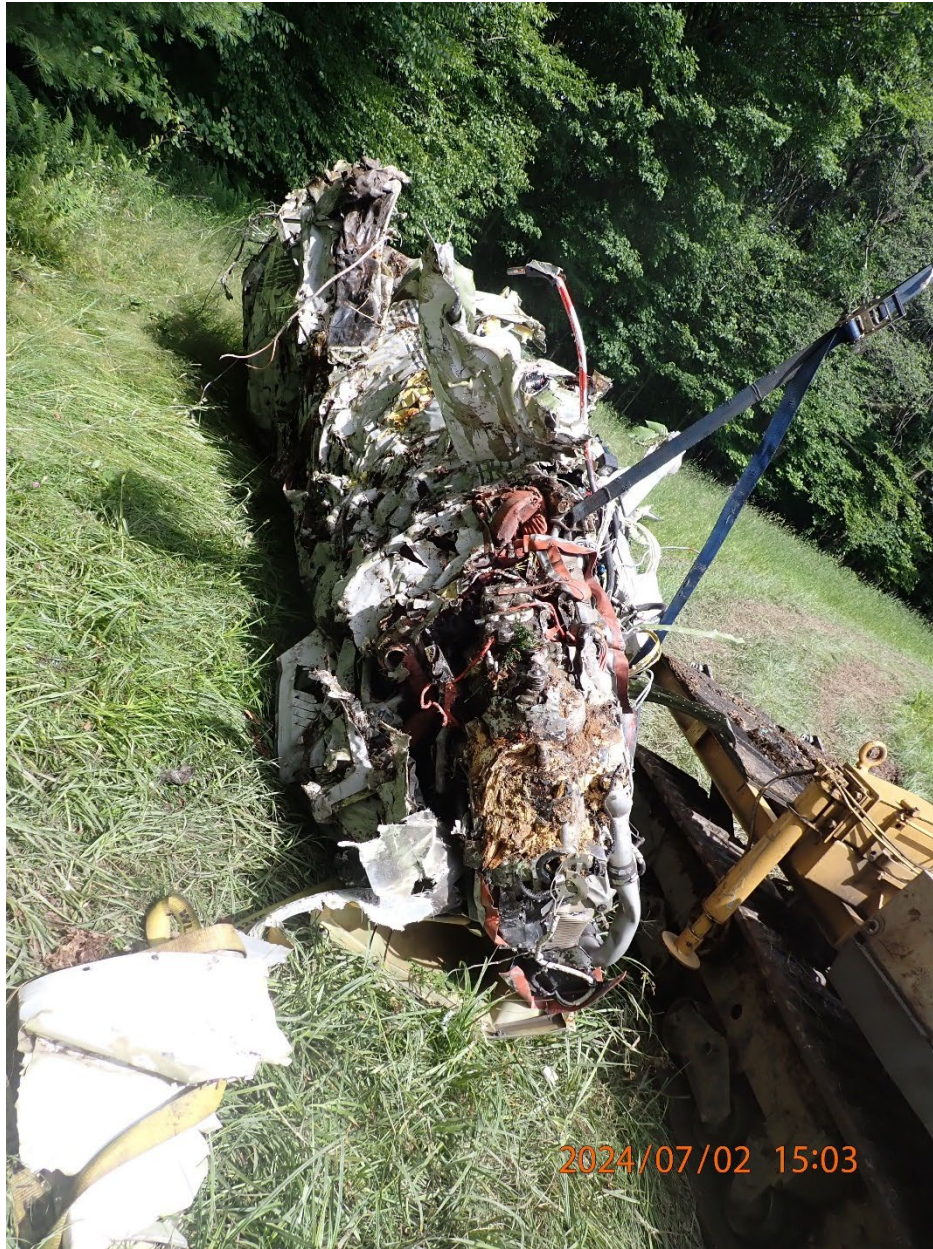
**Photo 3: View of the right side and bottom of the fuselage after being recovered from the main wreckage site.**

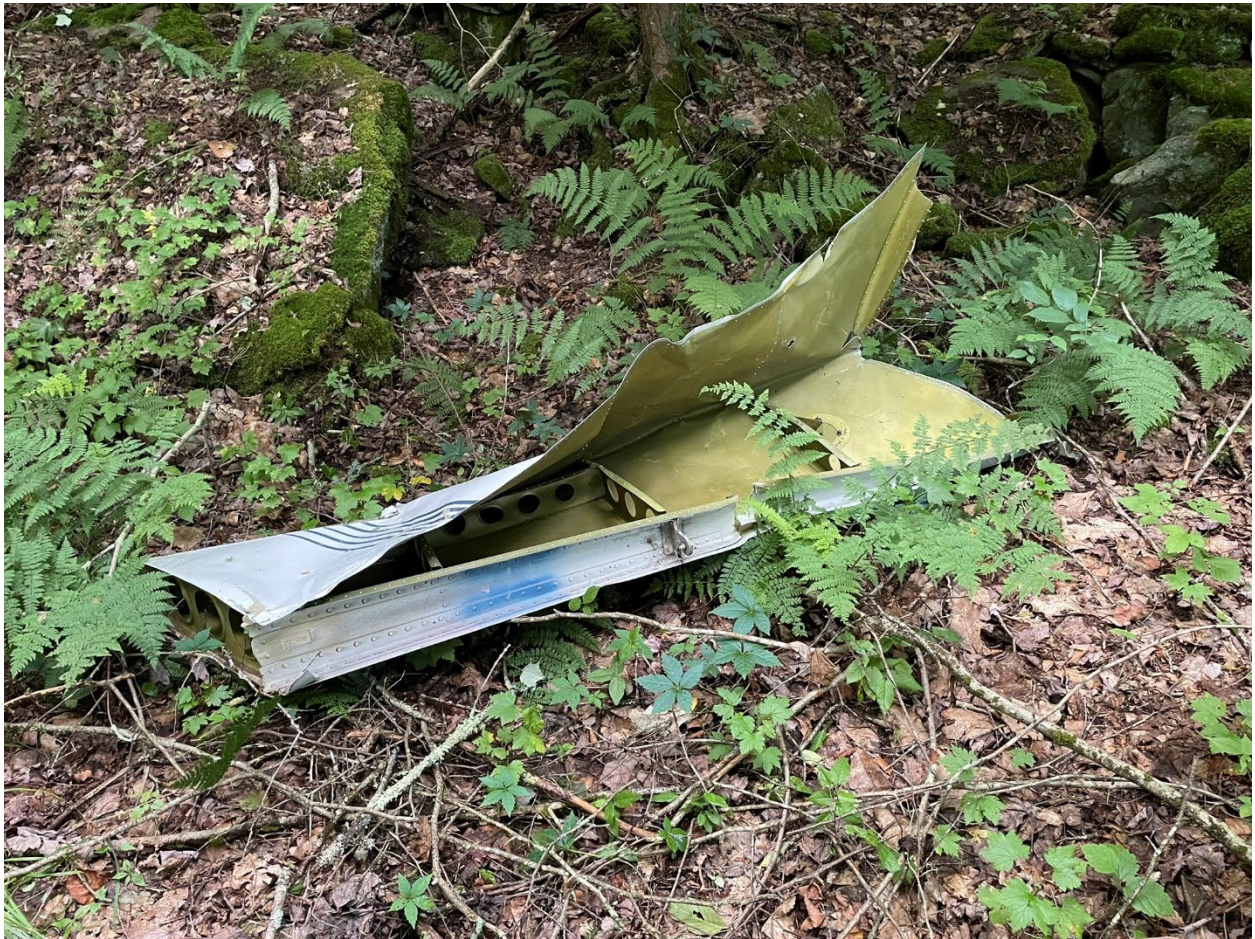
The vertical stabilizer was separated from the tailcone and located in the debris field about 5,800 ft from the fuselage. The skin on the left side of the vertical was separated from the aft spar except for a small section near the lower end. The left side of the vertical stabilizer also exhibited some black scuff marks about mid span. The rudder was separated from its hinges and not immediately located. It was located

**Photo 4: View of the vertical stabilizer as found.**

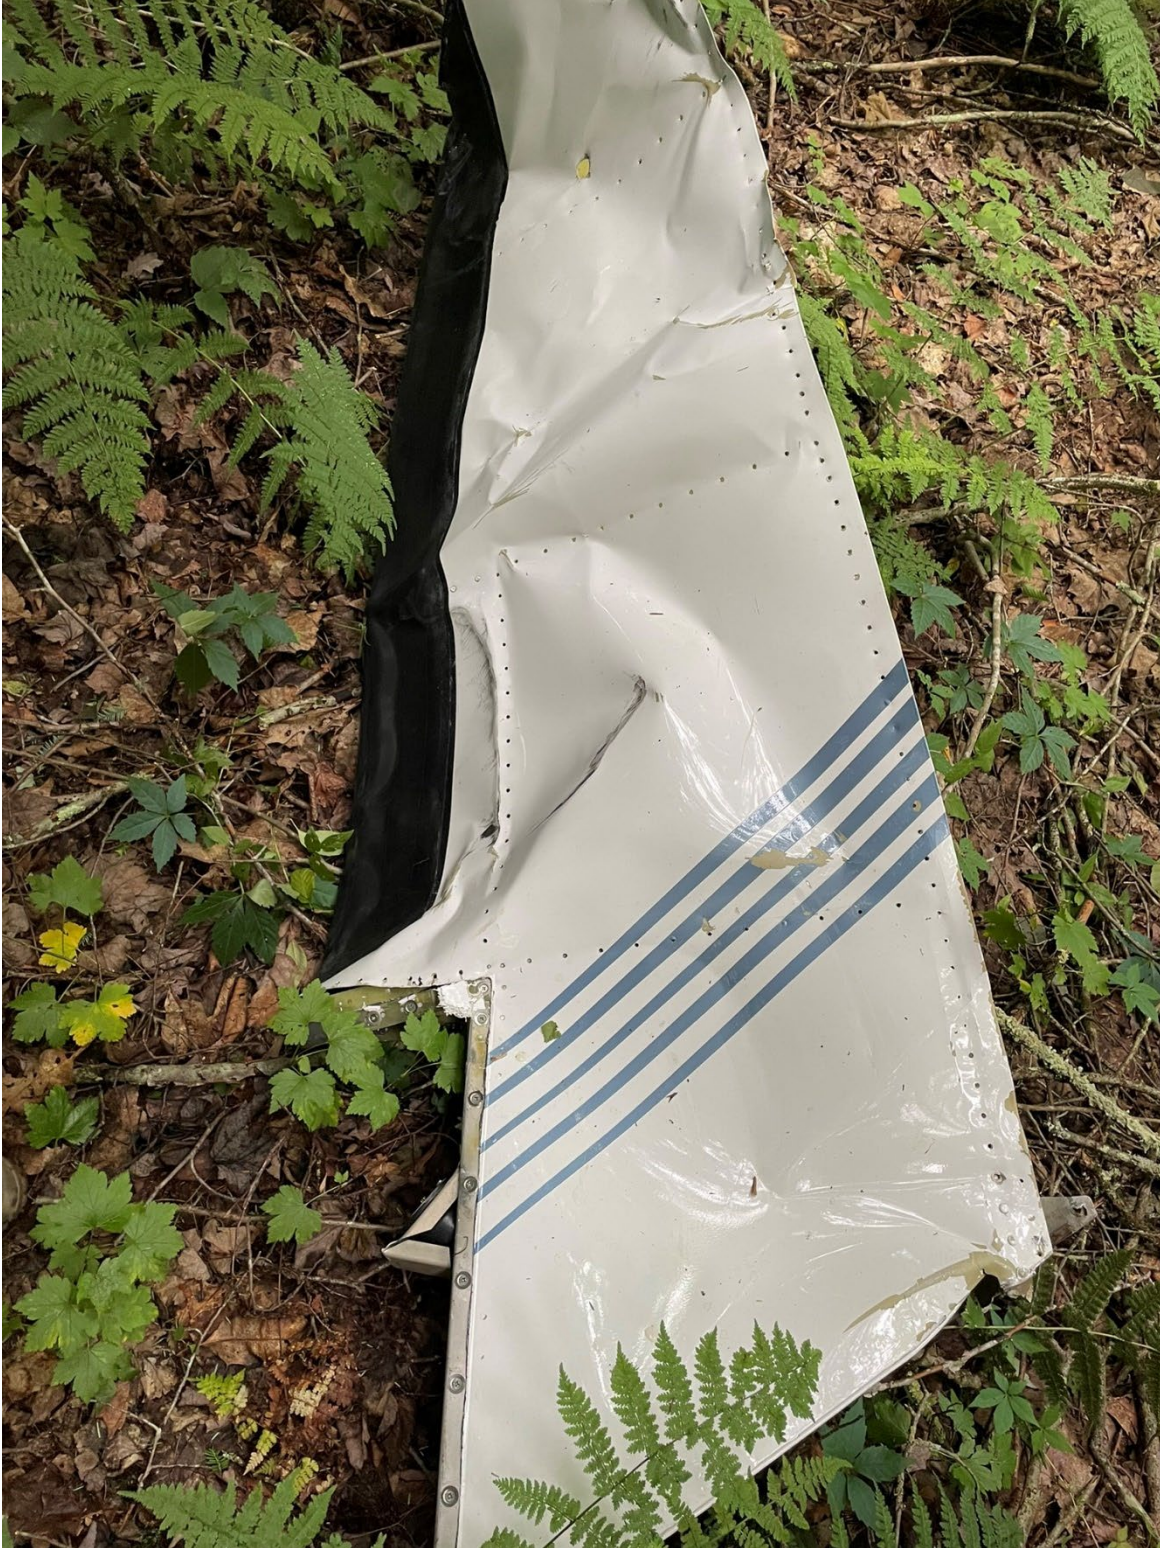
**Photo 5: View of the left side of the vertical stabilizer.**

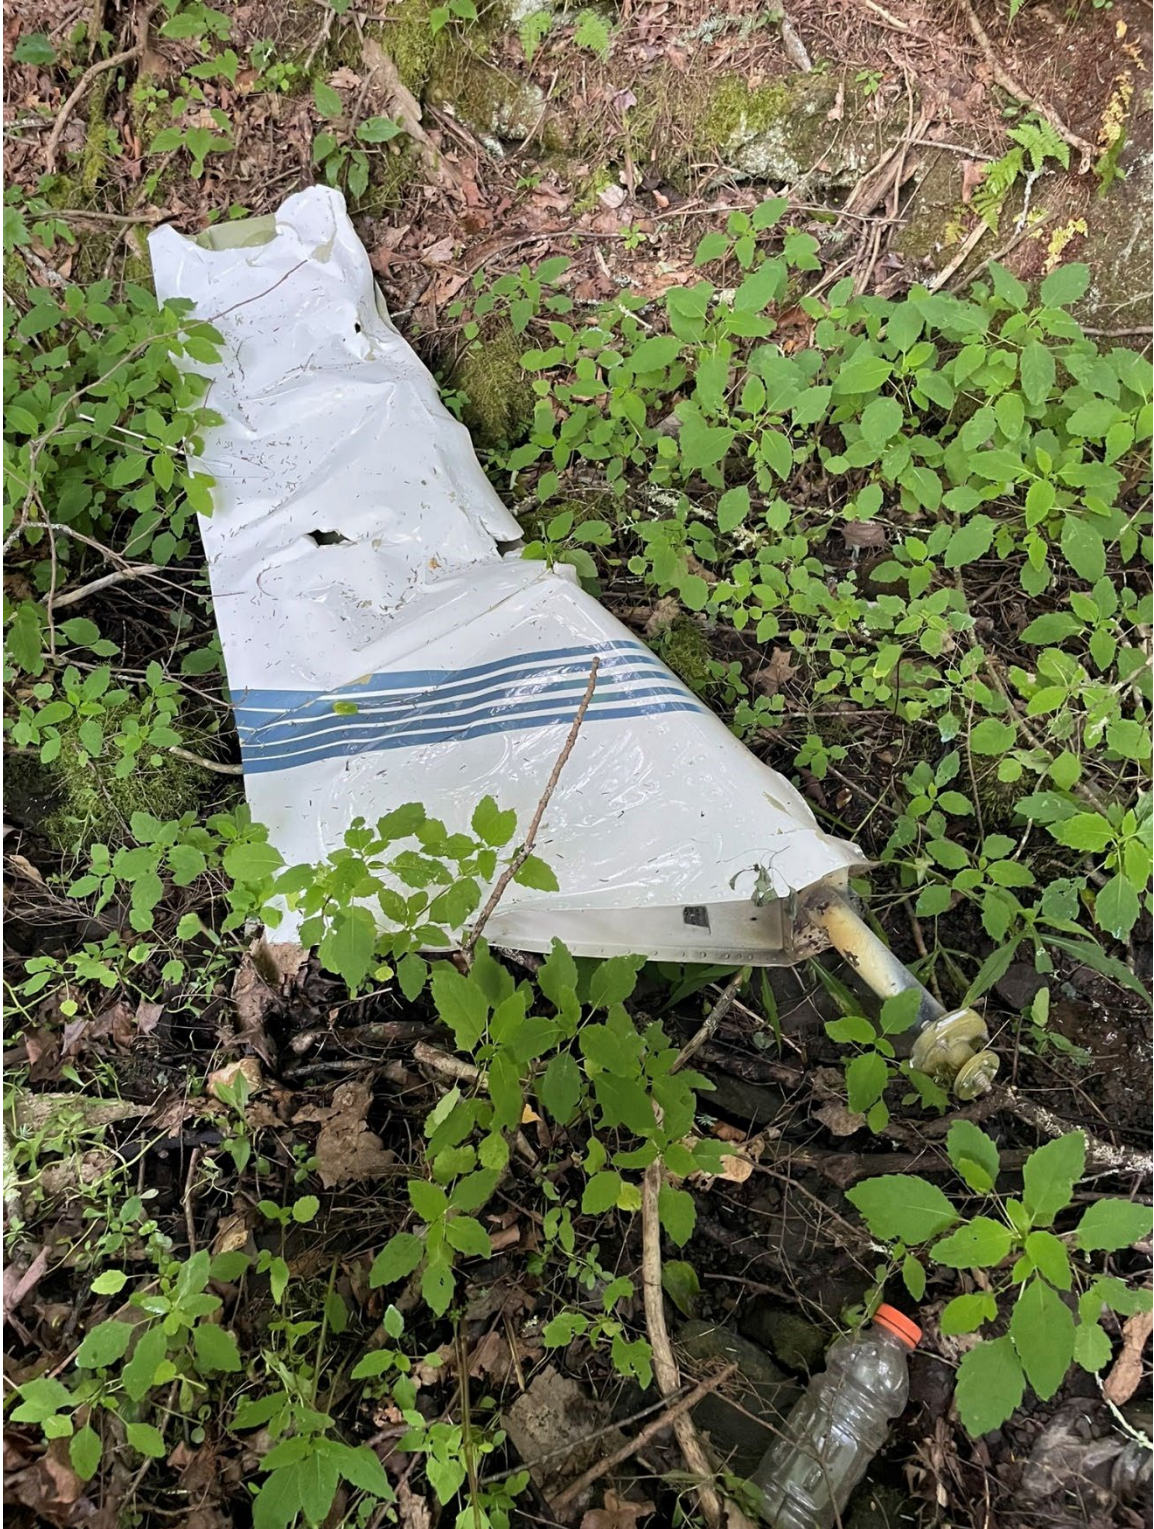
shortly after the investigative team had departed the scene about 5,920 ft from the fuselage.

**Photo 6: View of the rudder found after the investigative team departed. (Photo courtesy of Trout Creek Fire Department)**

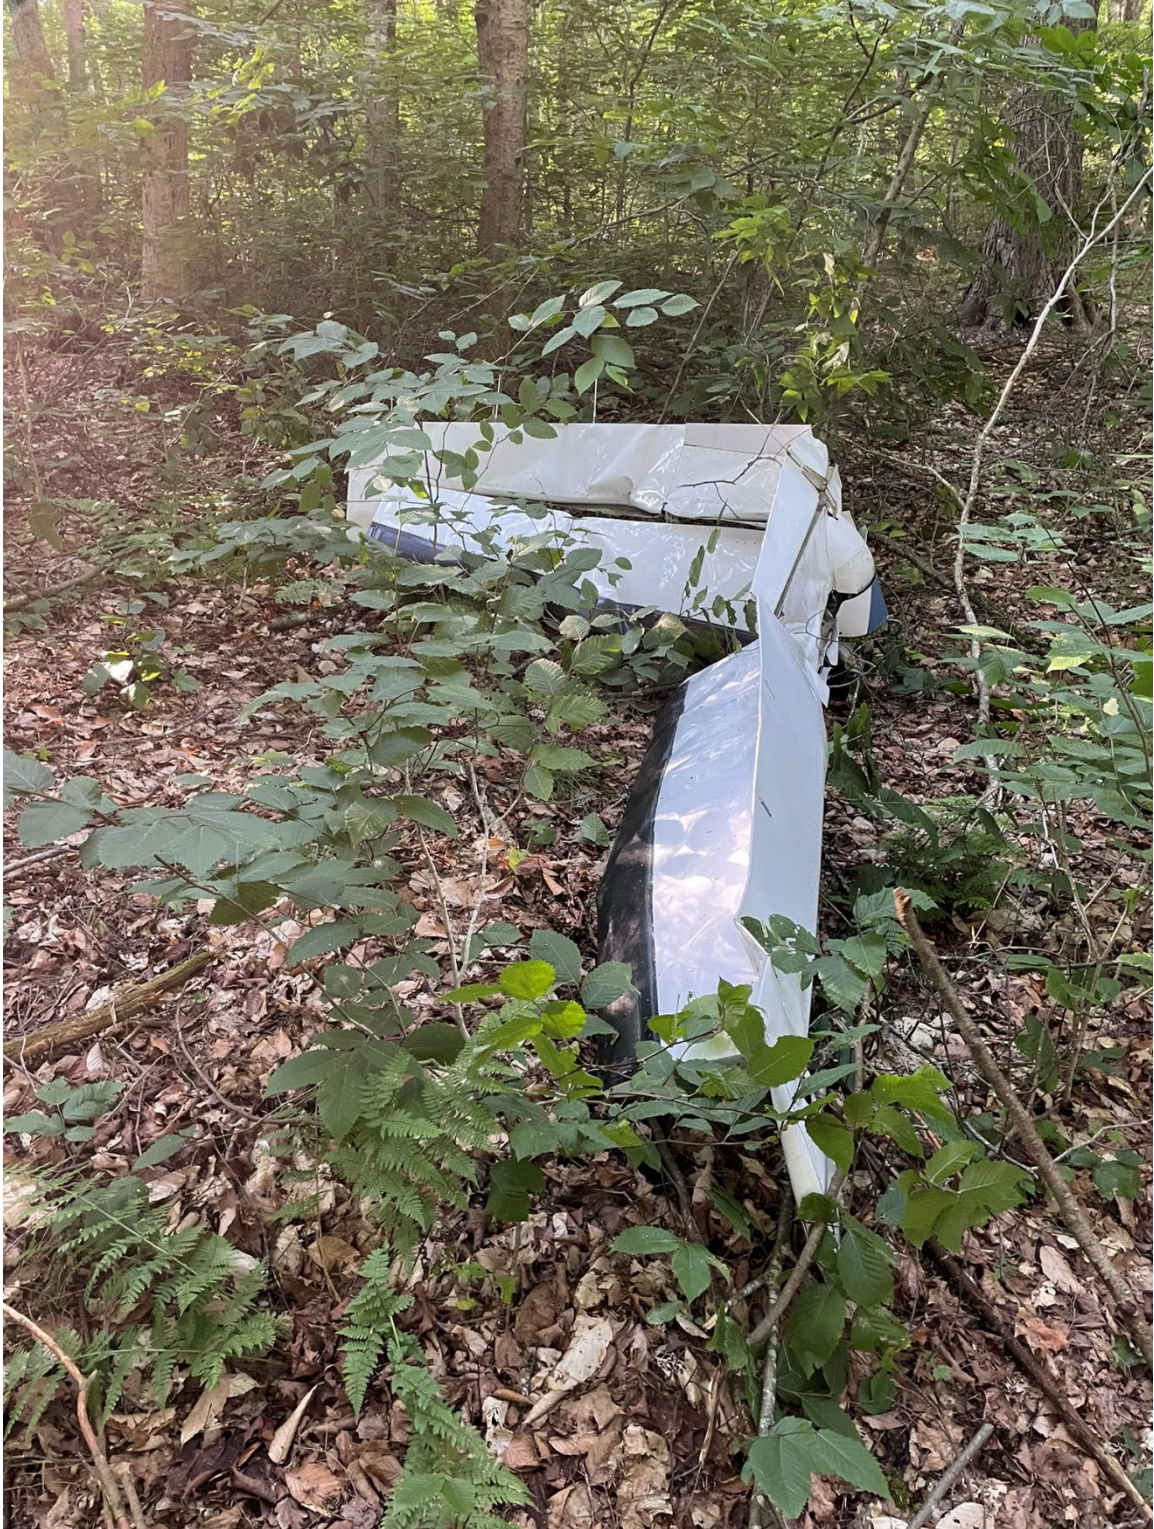
The horizontal stabilizer remained attached to the aft tailcone bulkhead and the bulkhead was separated from the tailcone. The elevator remained attached to the horizontal stabilizer and the elevator trim tab remained attached to the elevator. The right side of the horizontal stabilizer, elevator, and trim tab were fractured and torn about 18"-24" outboard from the aircraft centerline with the outboard portion bent upwards approximately 90°. The horizontal stabilizer, elevator, and trim tab were located in the debris field about 4,500 ft from the fuselage.

**Photo 7: View of the horizontal stabilizer, elevator, and elevator trim tab as found.**

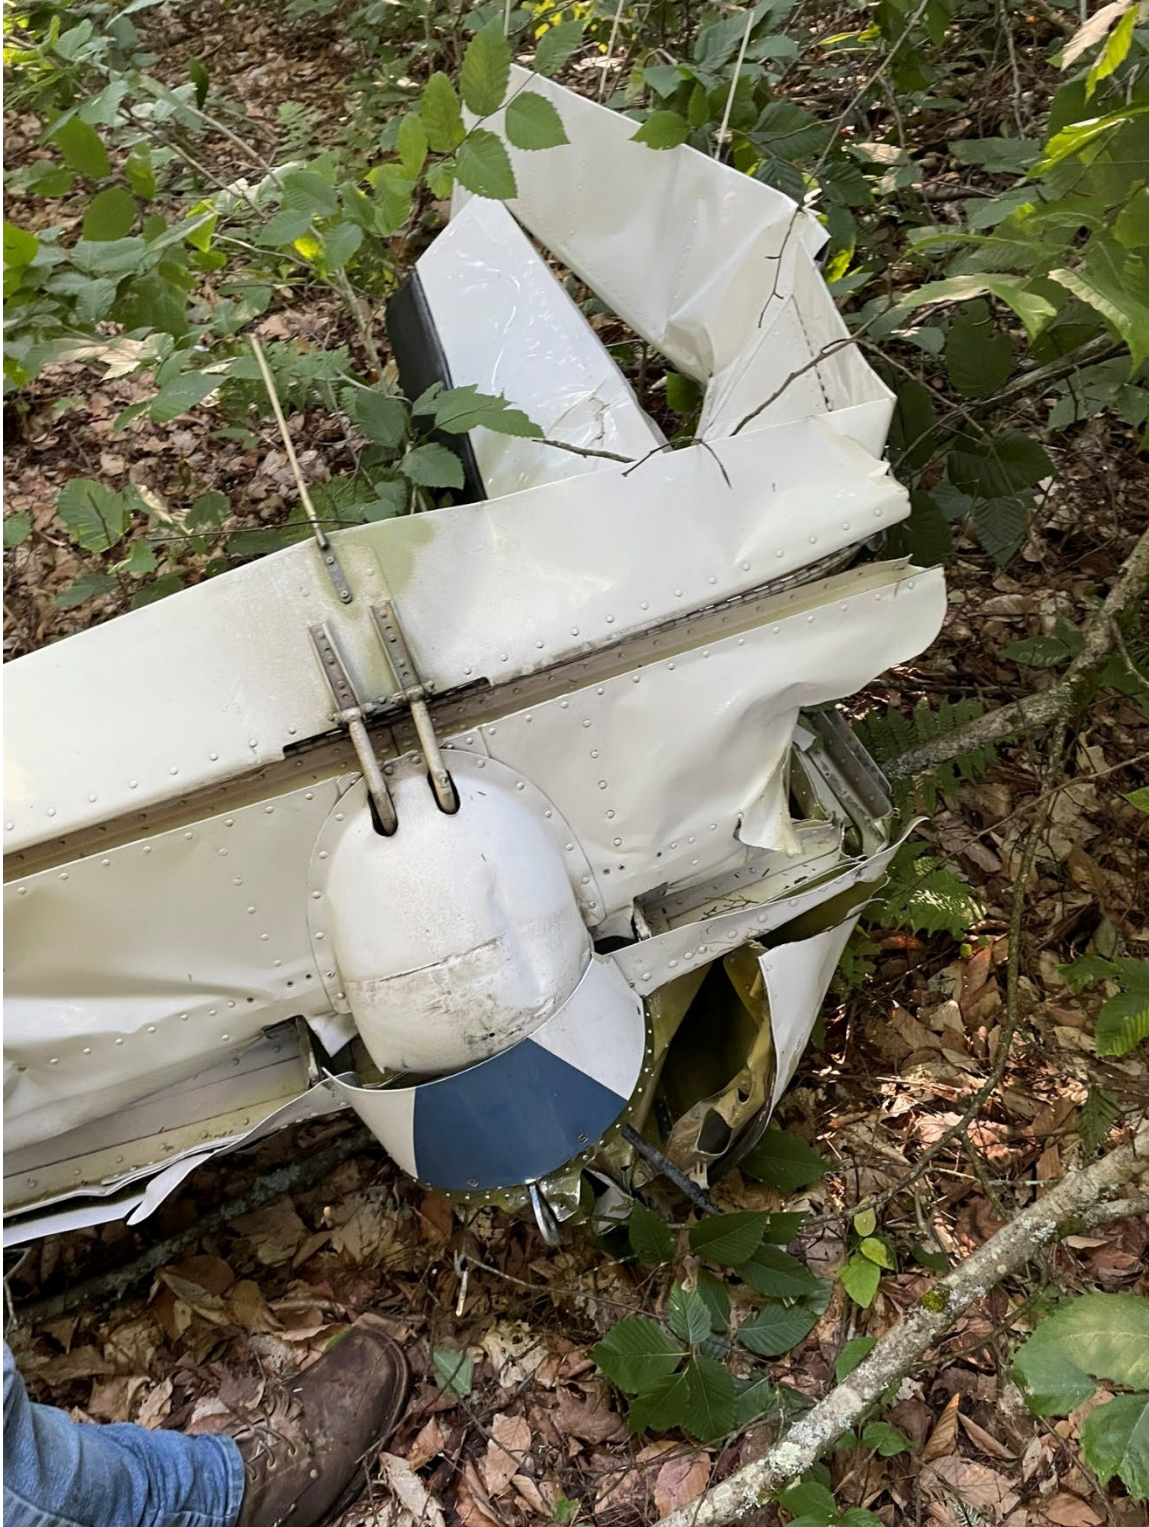
**Photo 8: View of the bottom of the horizontal stabilizer, elevator, and elevator trim tab.**

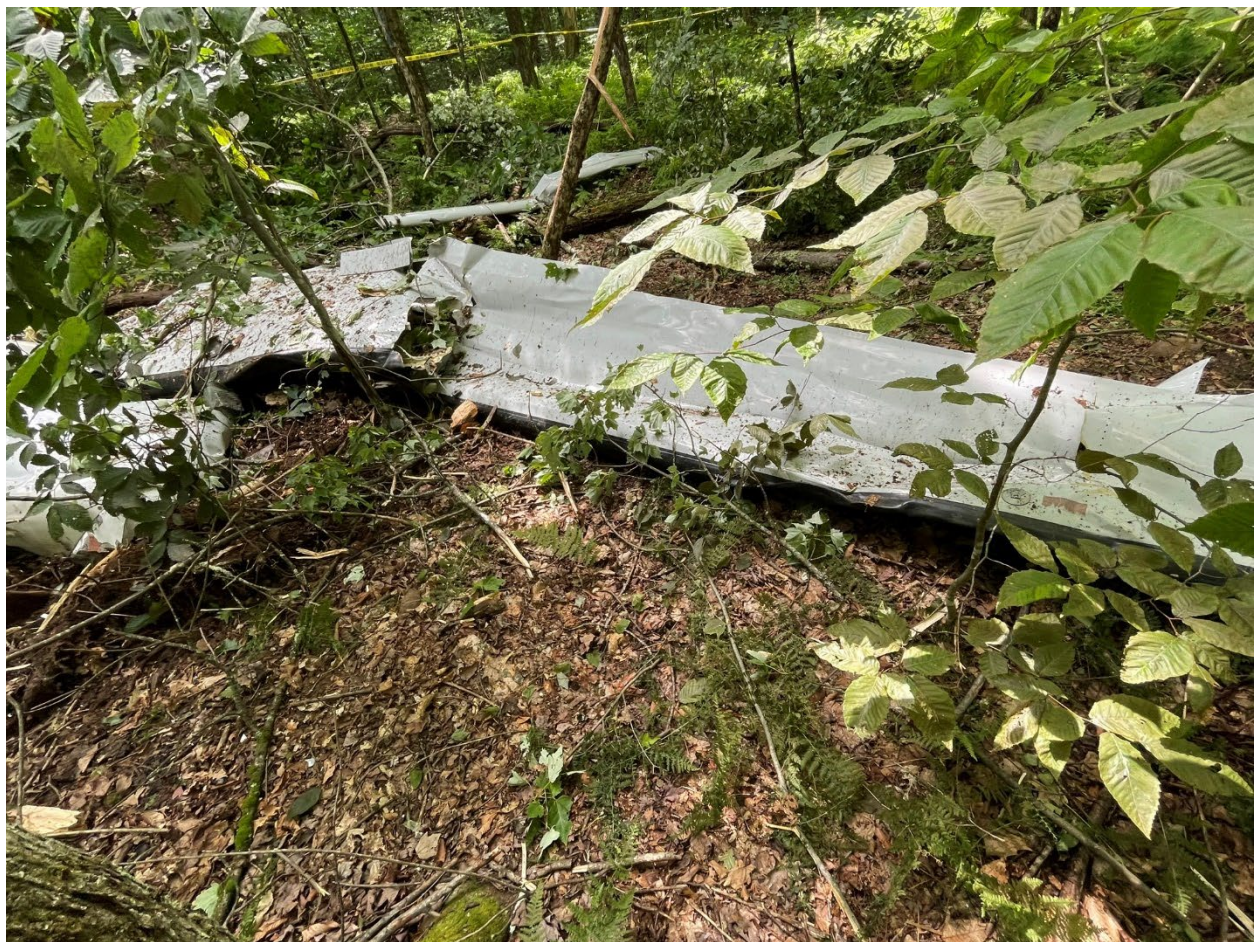
The left wing remained partially attached to the fuselage by the forward wing attach fitting. The main spar and aft wing attach fitting were fractured and impact separated. The aileron and flap were separated from the wing and located in the debris field adjacent to the left wing and fuselage. The aileron drive cable was separated from the sector and remained continuous to the center section of the fuselage. The balance cable remained attached to the sector and was separated at the side of the fuselage. The balance cable separation exhibited a "broomstrawed" appearance consistent with failure under overload. The pitot mast and lift detector both appeared intact in their respective mounts.

**Photo 9: View of the left wing with the left flap in the background.**

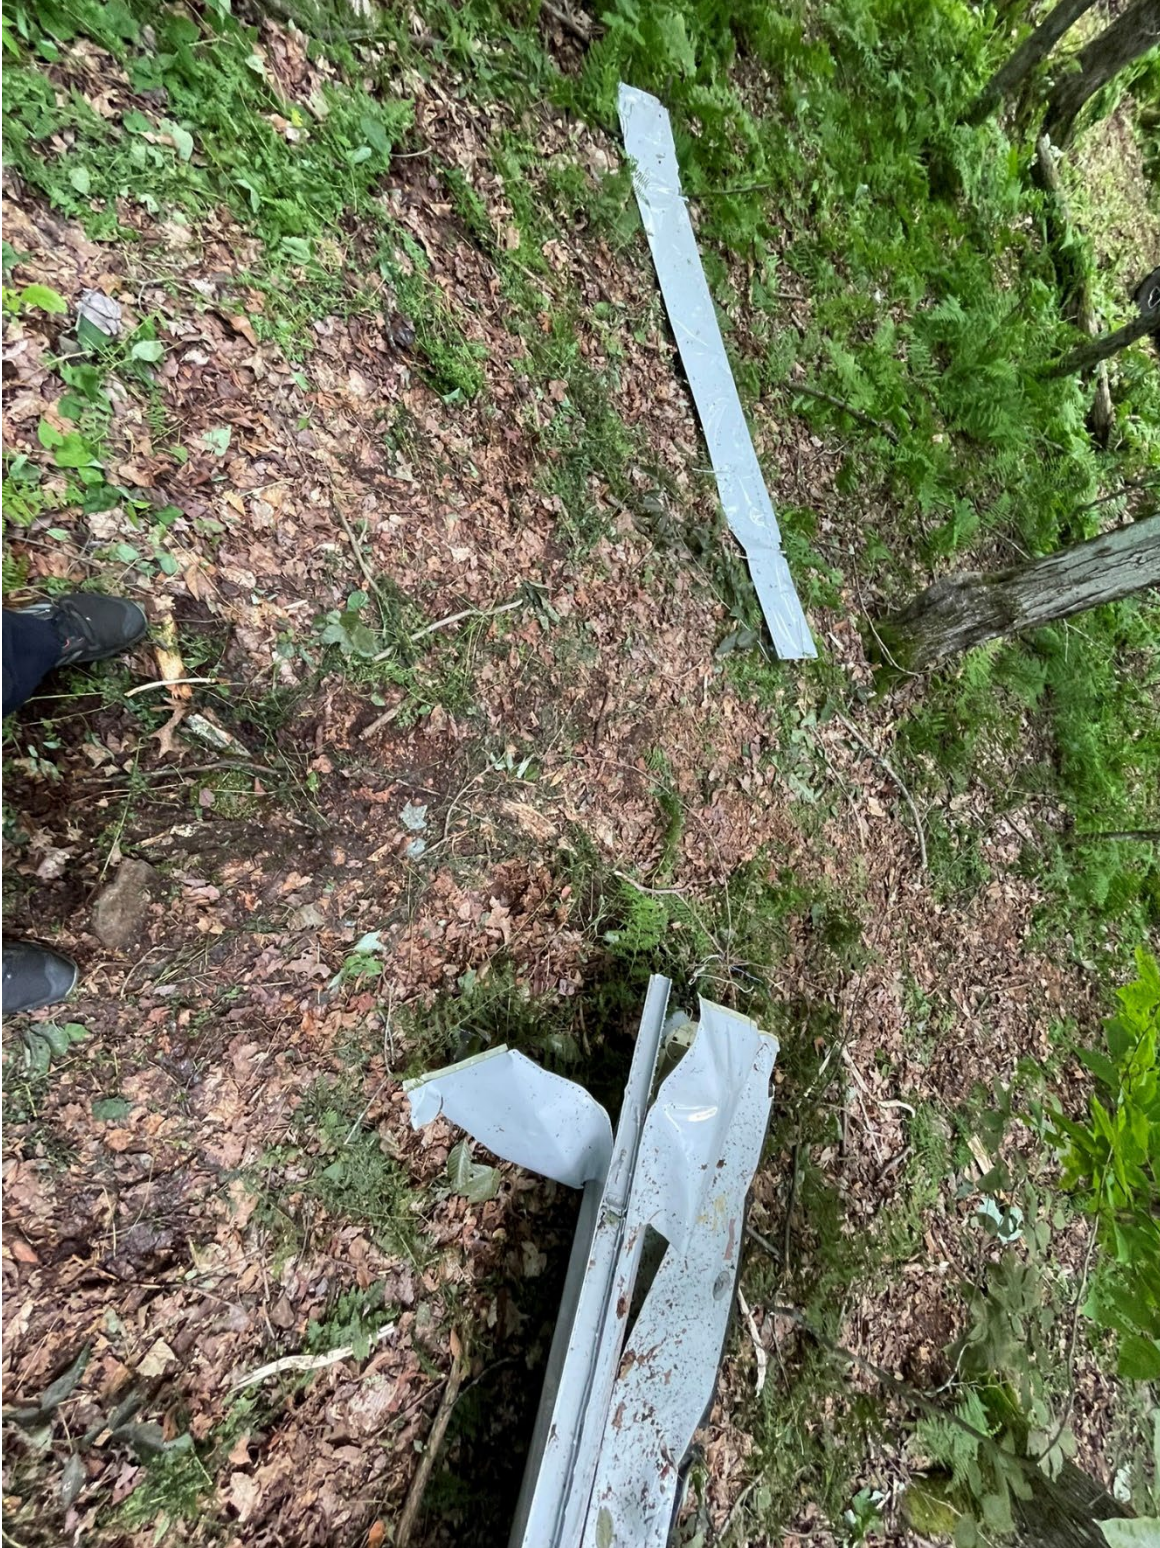
**Photo 10: View of the left wing tip and left aileron.**

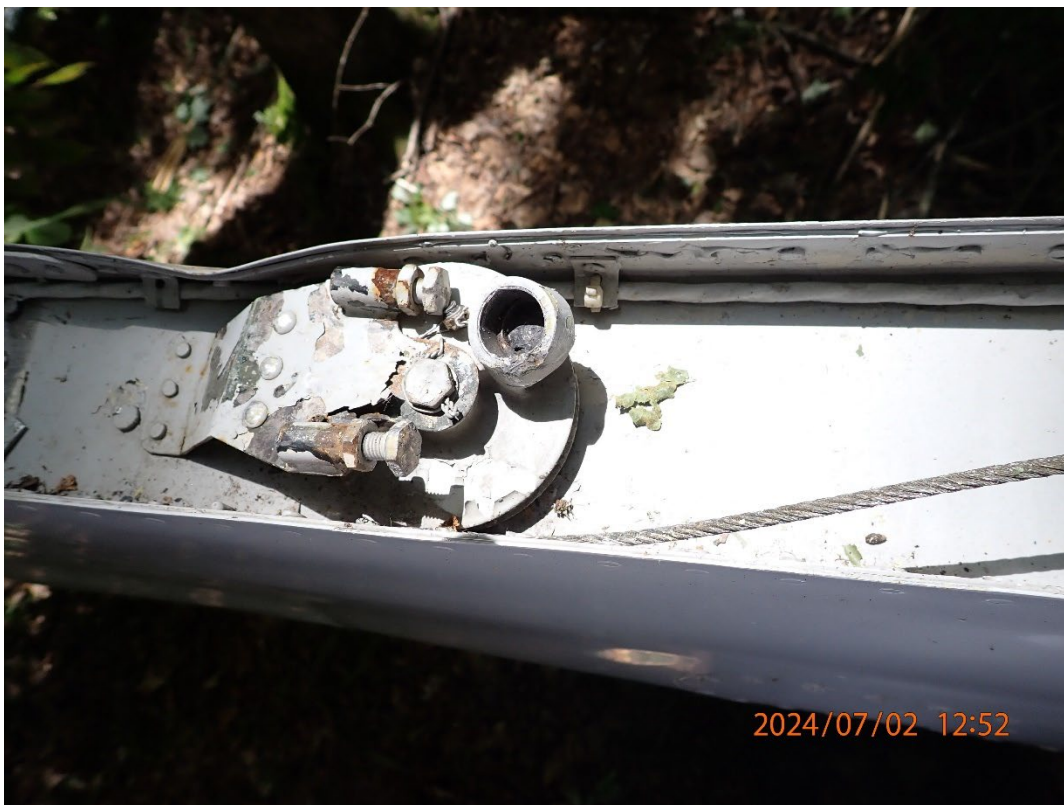
**Photo 11: Left aileron sector with balance cable attached.**

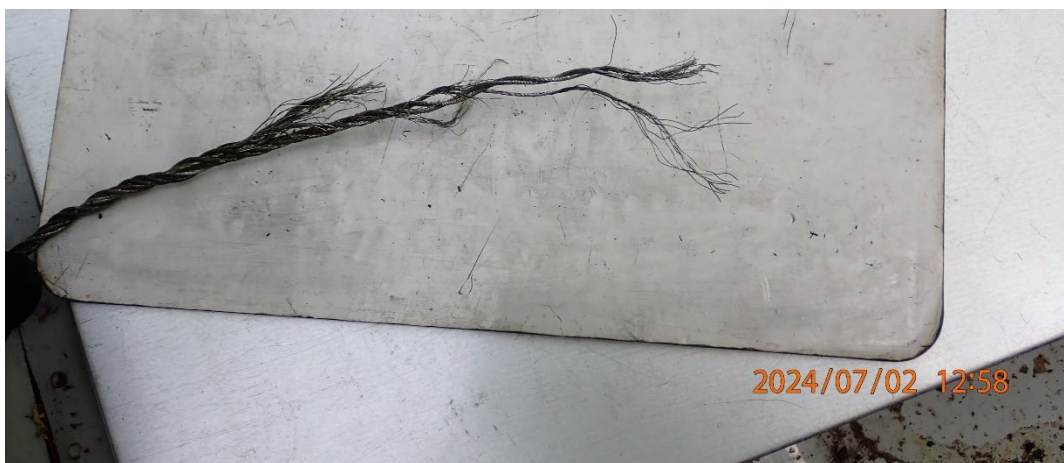
**Photo 12: Broomstraw of the left aileron balance cable.**

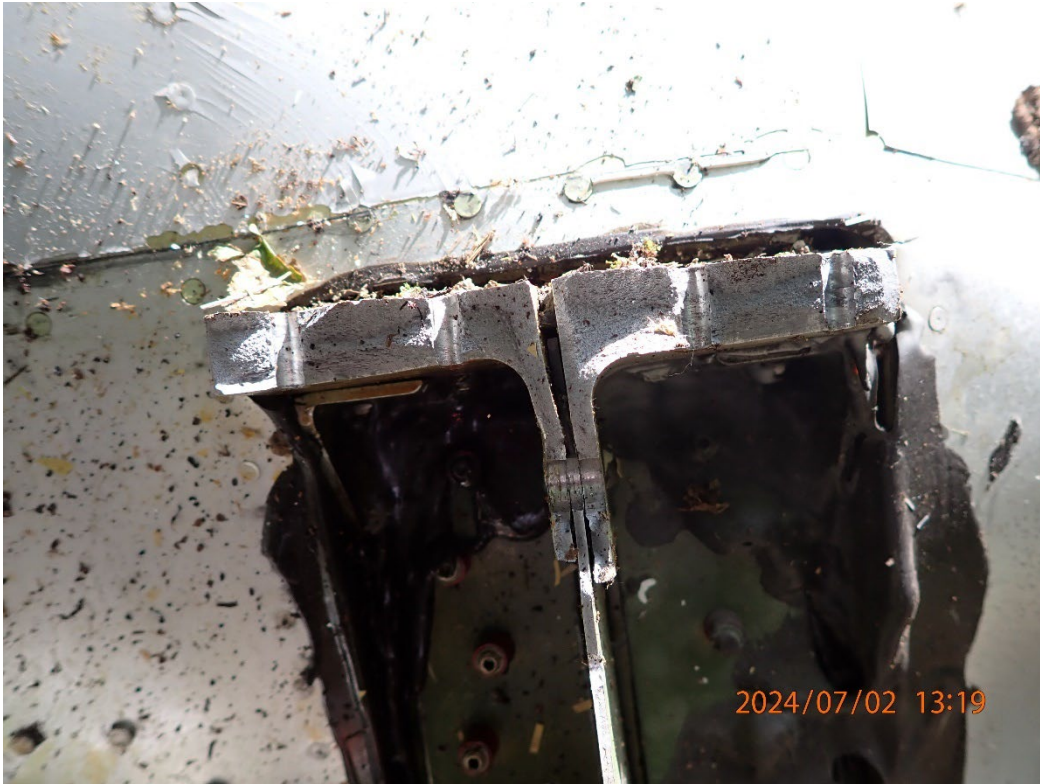
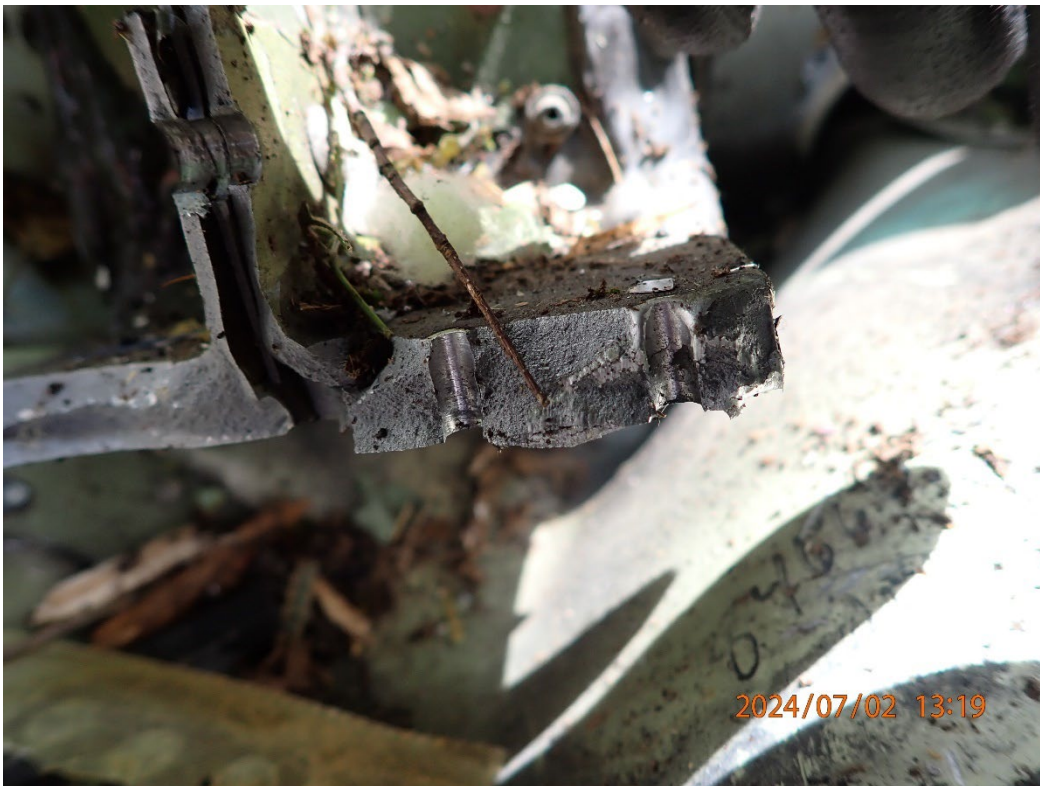
**Photo 13: View of the left main wing spar.**

**Photo 14: View of the left main wing spar.**

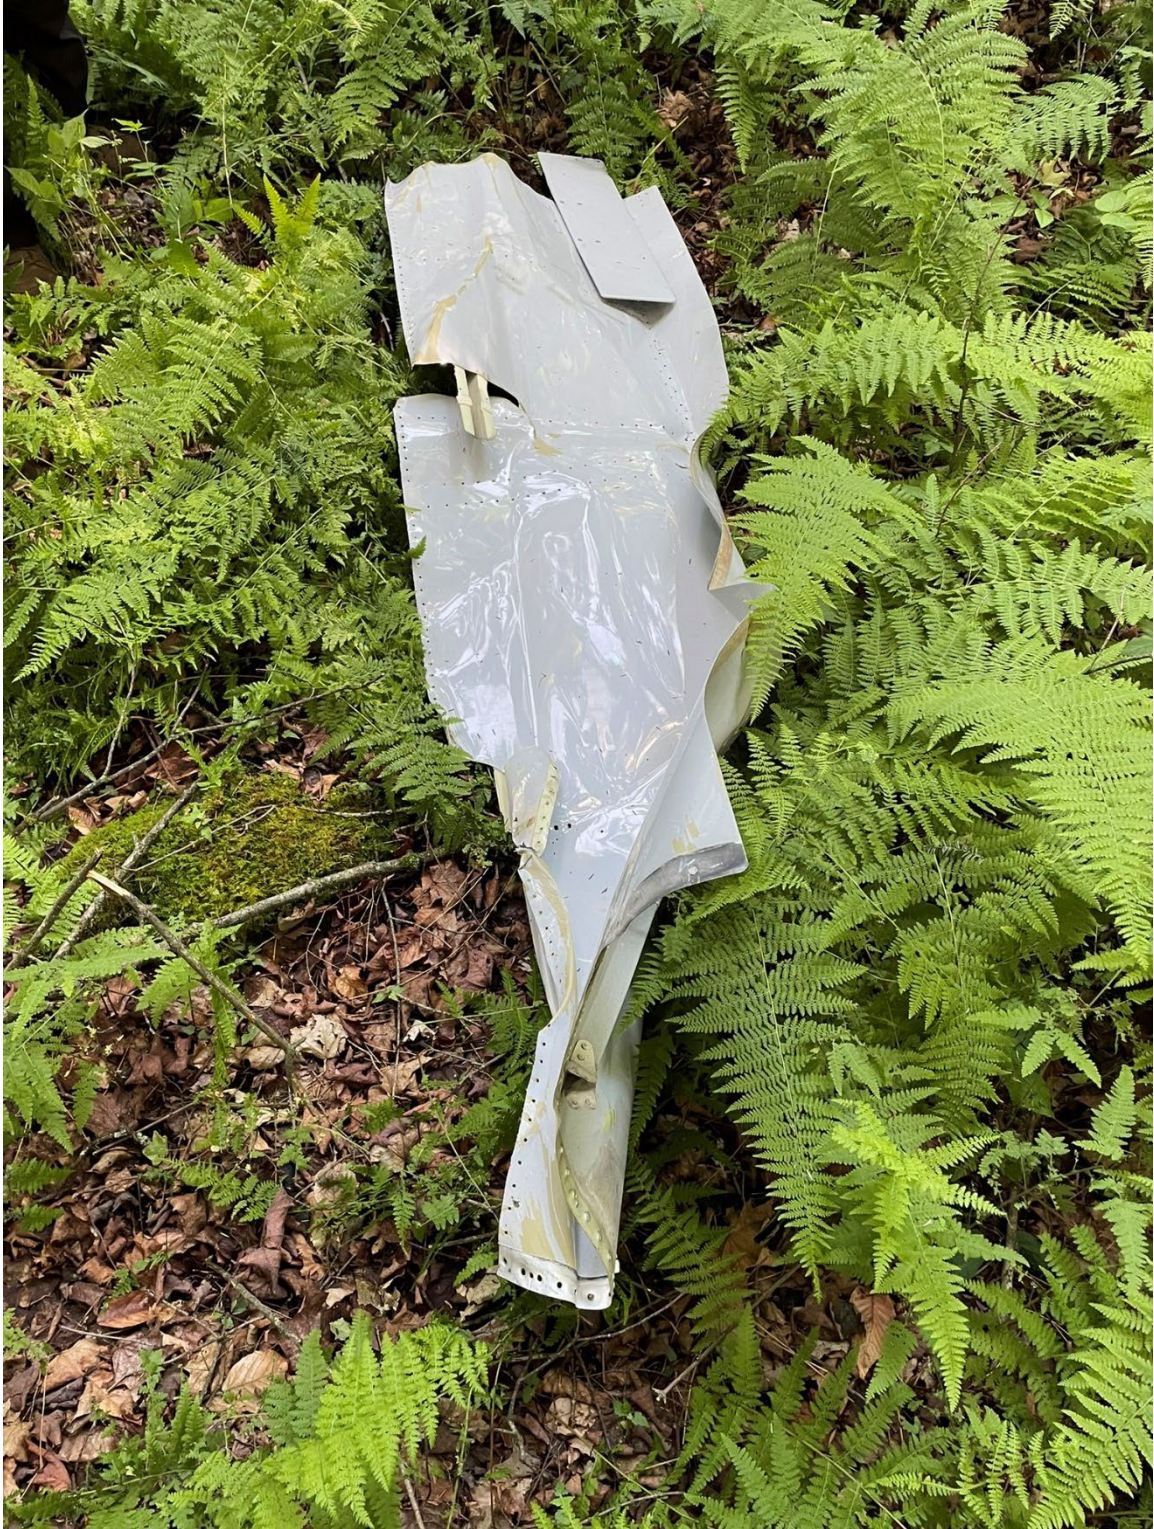
The right wing, outboard of the landing gear, was separated chordwise and located in the debris field about 3,600' from the fuselage. The aileron and flap were also separated from the wing and located in the debris field about 4,500' and 5,700' from the fuselage respectively. The aileron drive cable remained attached to the sector and was continuous to the wing root where it was separated. The separation exhibited a "broomstrawed" appearance consistent with failure under overload. The right side of the balance cable was separated from the sector and continuous from the left side of the fuselage to the swaged ball on the sector end of the cable.

**Photo 15: View of right wing skin and right speed brake found in the debris field.**

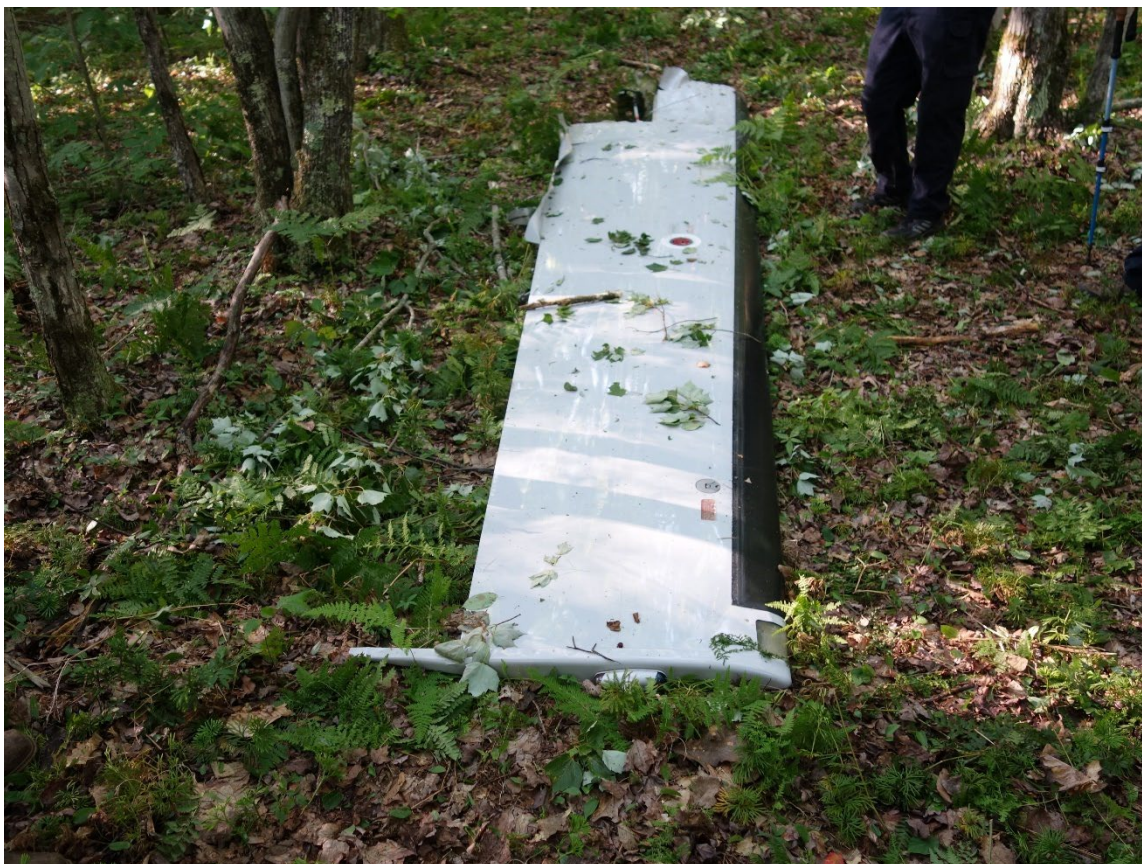
**Photo 16: View of the right wing as found. (Photo Courtesy of Piper)**

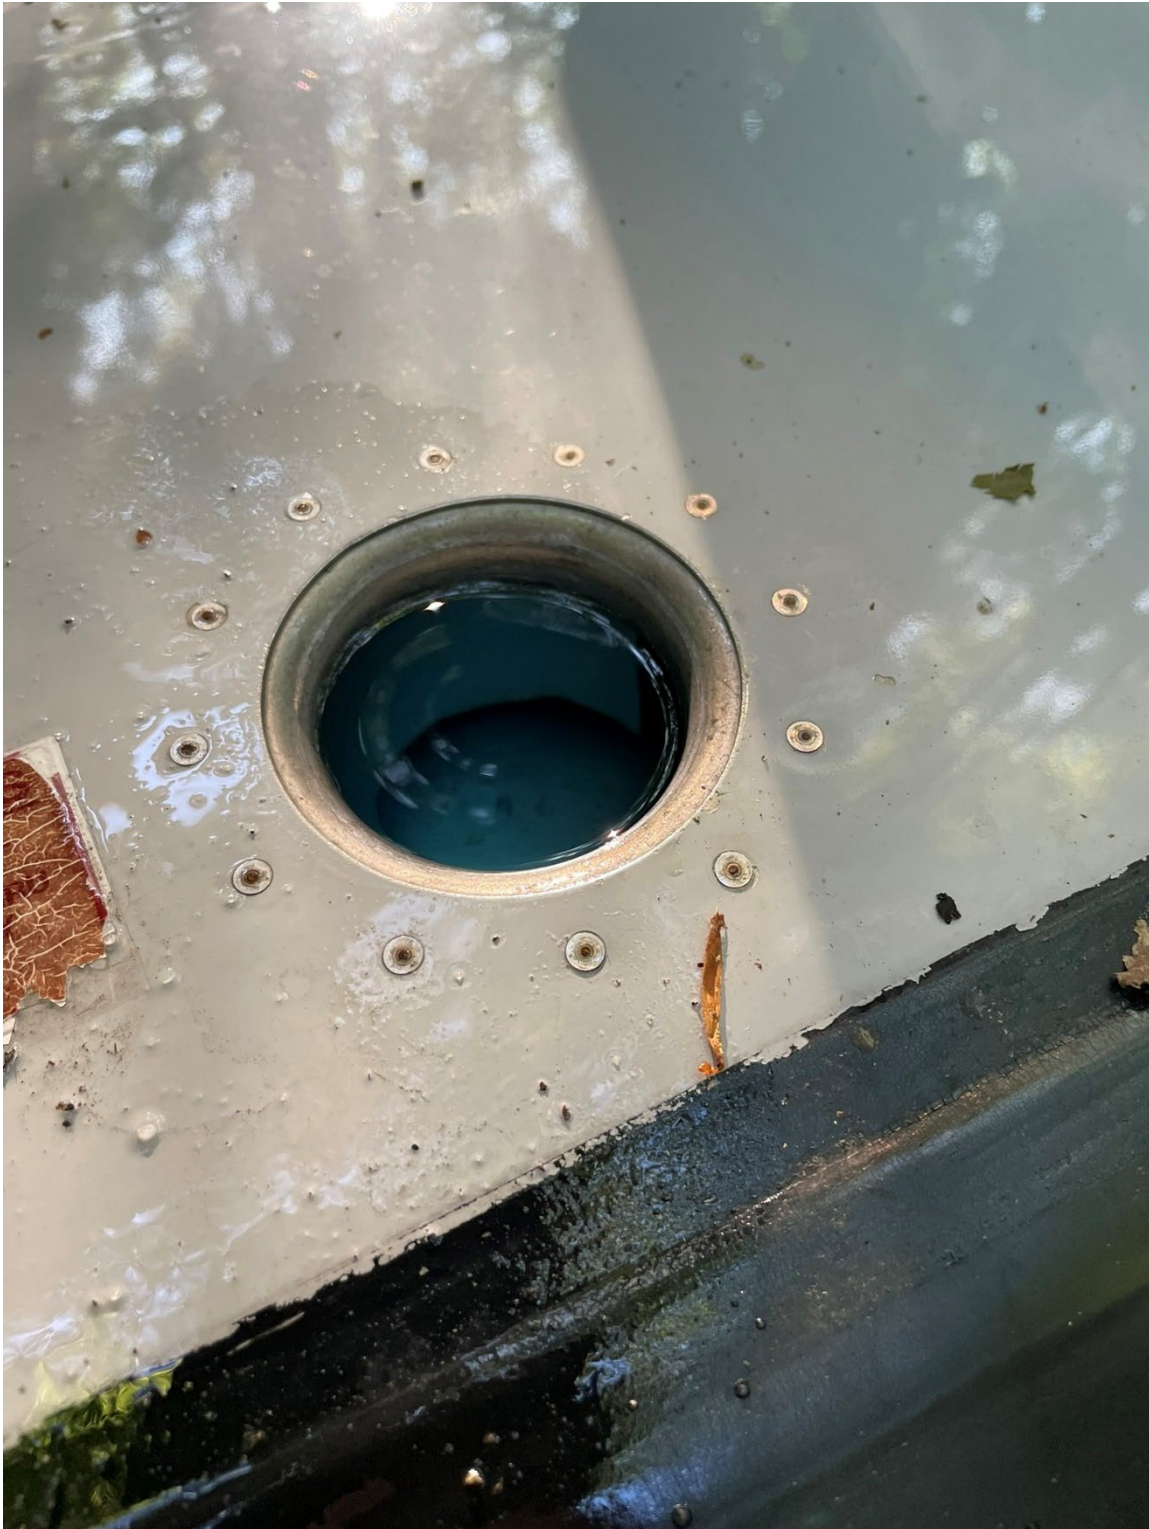
**Photo 17: View of fuel remaining in the right wing.**
