# National Transportation Safety Board

ERA24FA283

## WRECKAGE EXAMINATION

Location: Trout Creek, NY  
Date: June 30, 2024  
Time: 1355 EDT  
1755 UTC  
Airplane: N85PG; PA-46-310P

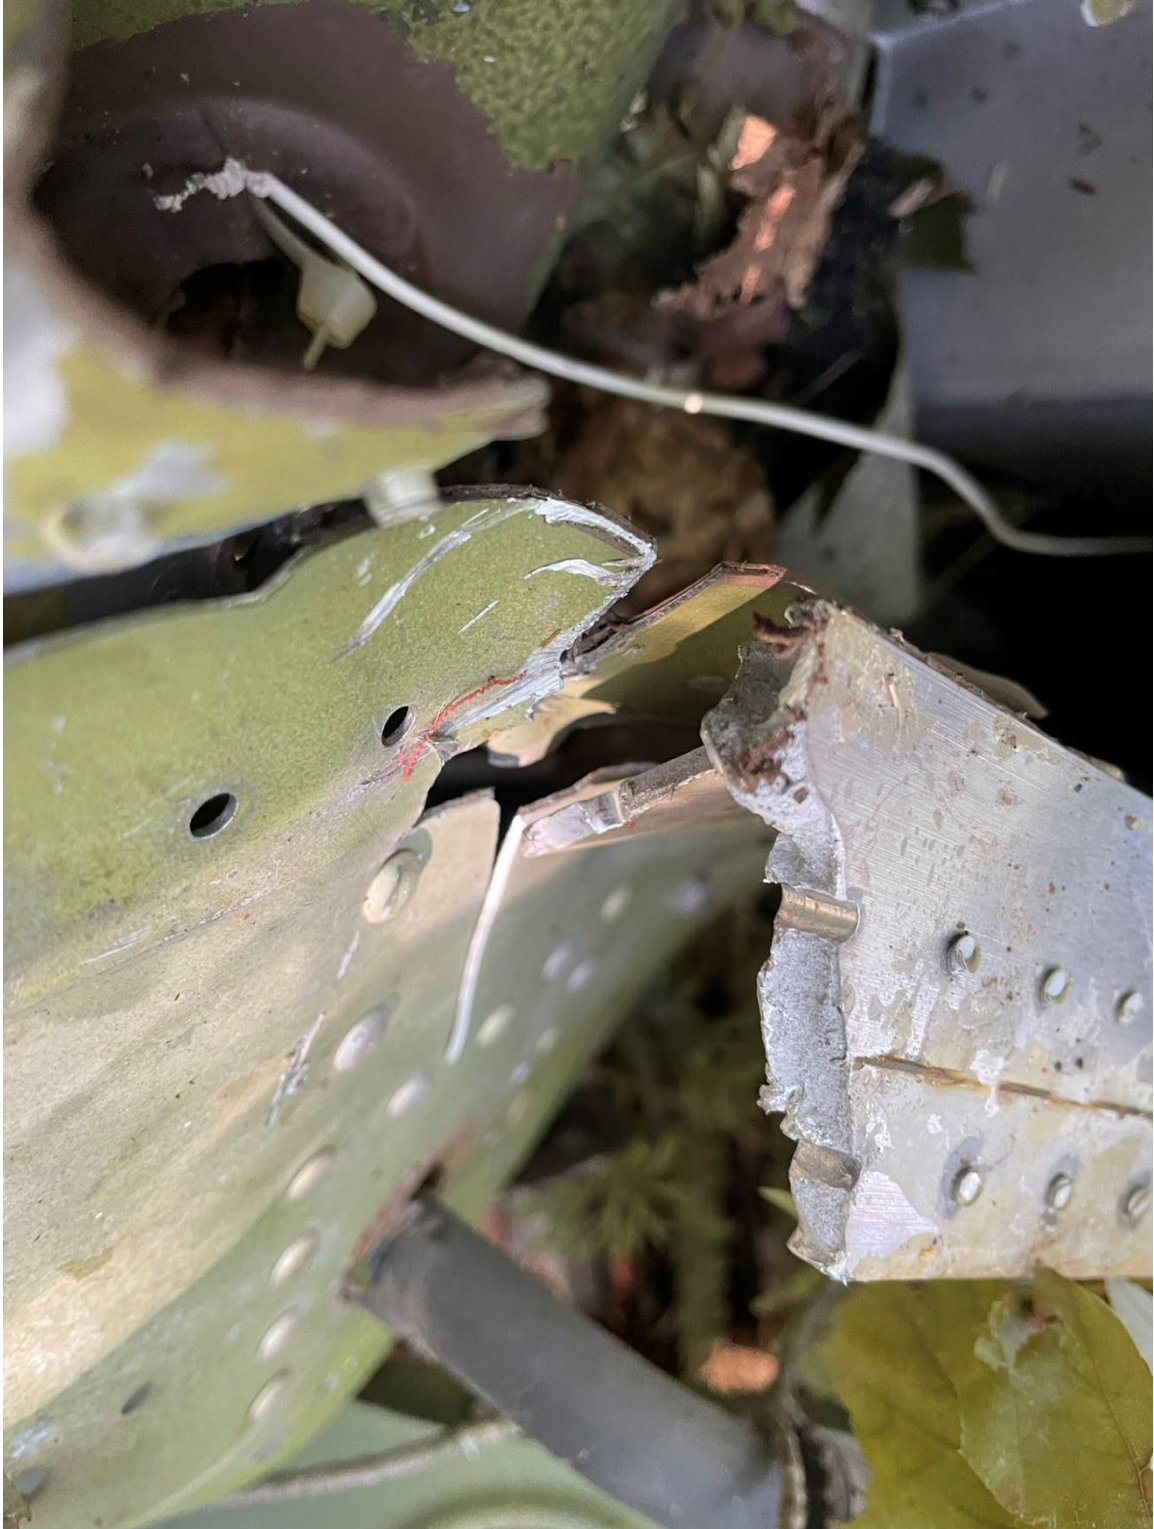
**Photo 18: View of the right wing spar.**

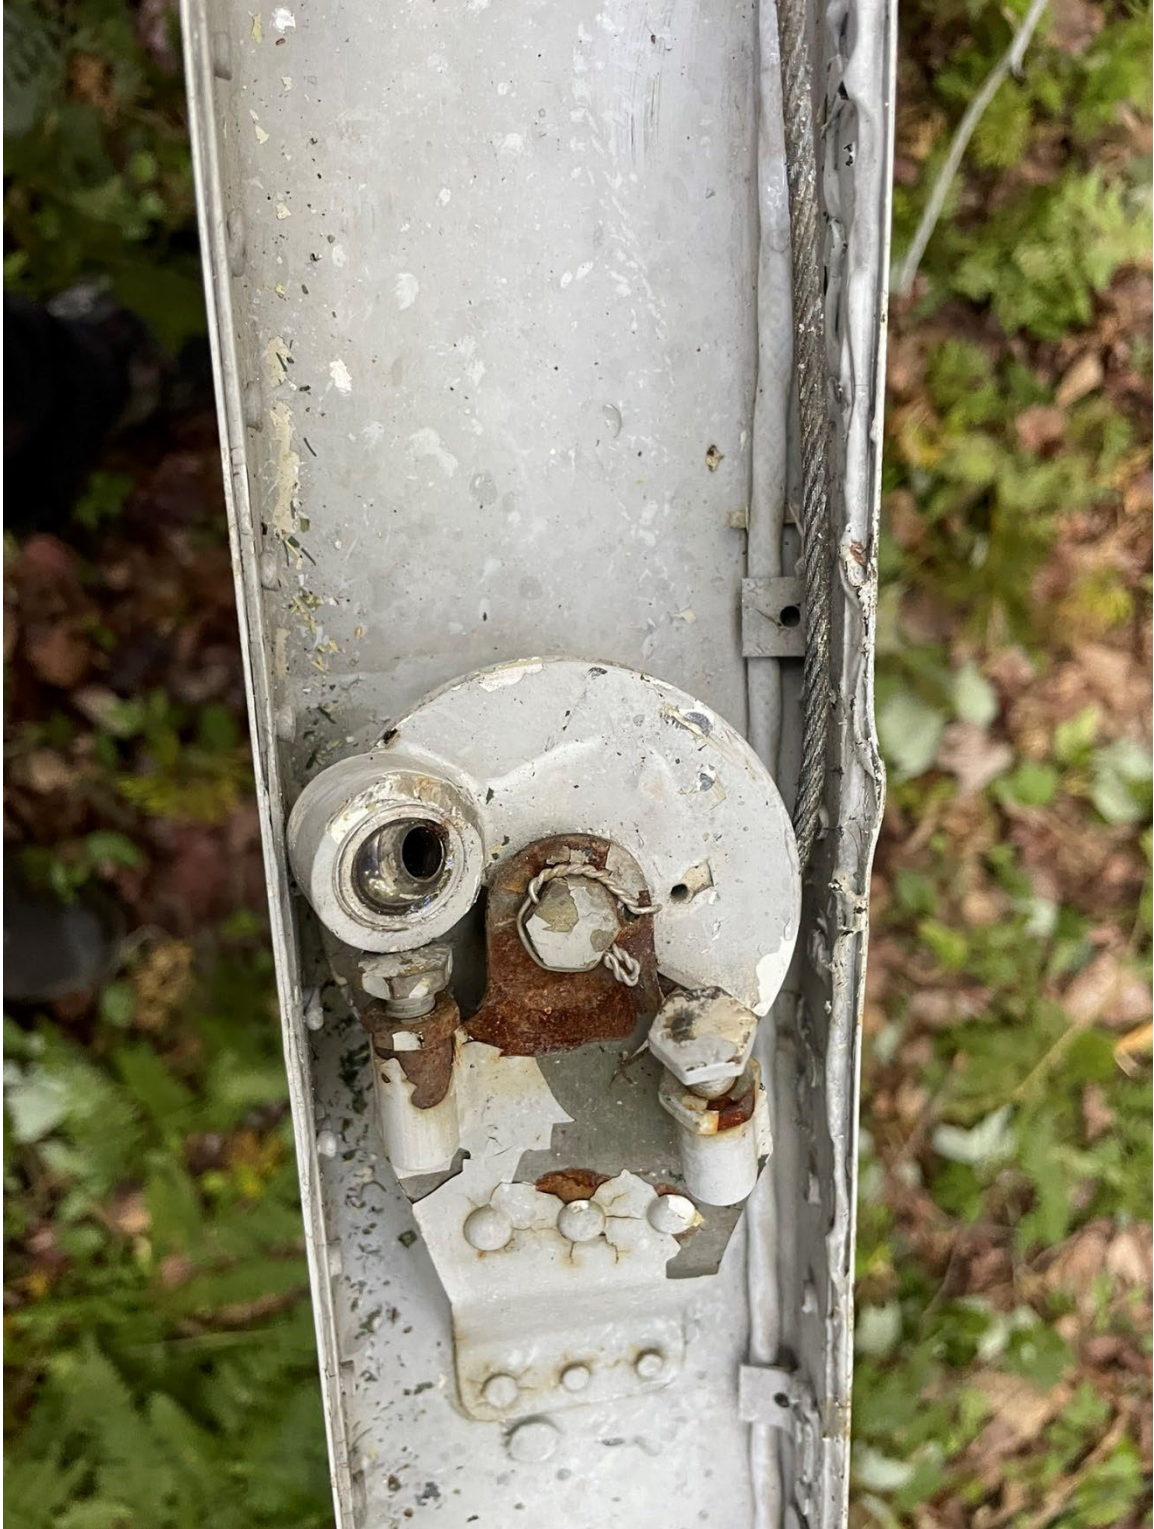
**Photo 19: View of right wing sector with right aileron drive cable attached.**

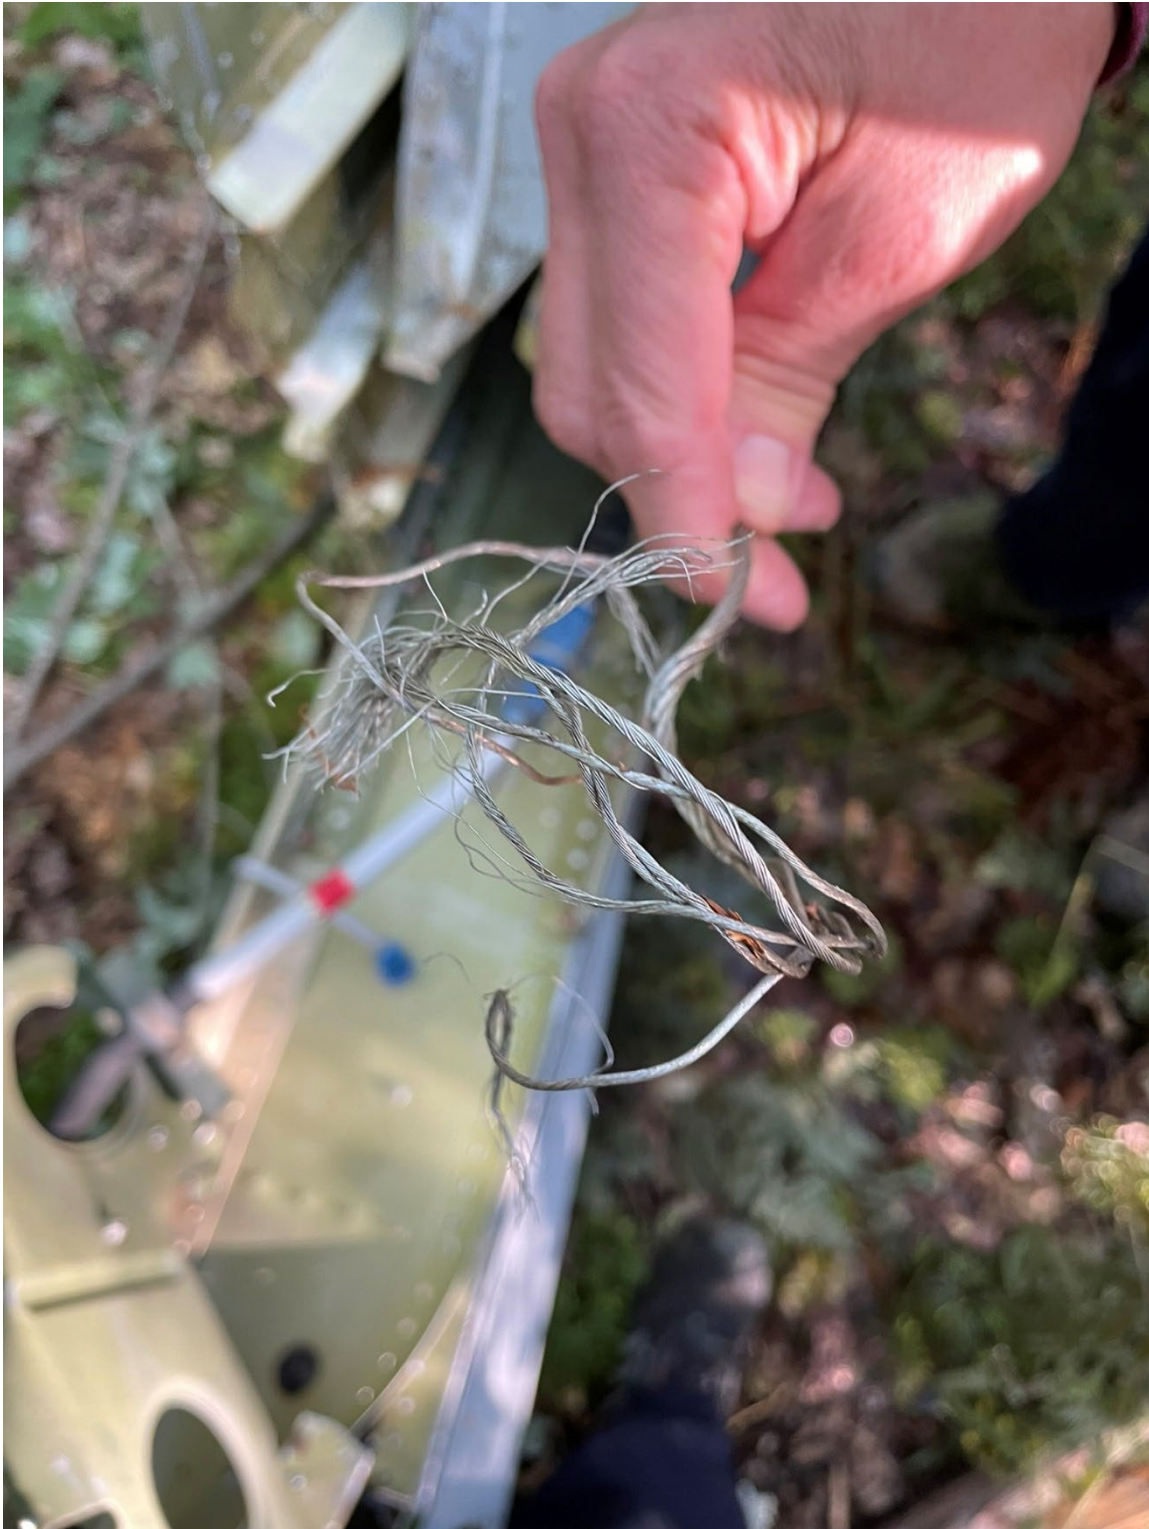
**Photo 20: Broomstick of the right aileron drive cable.**

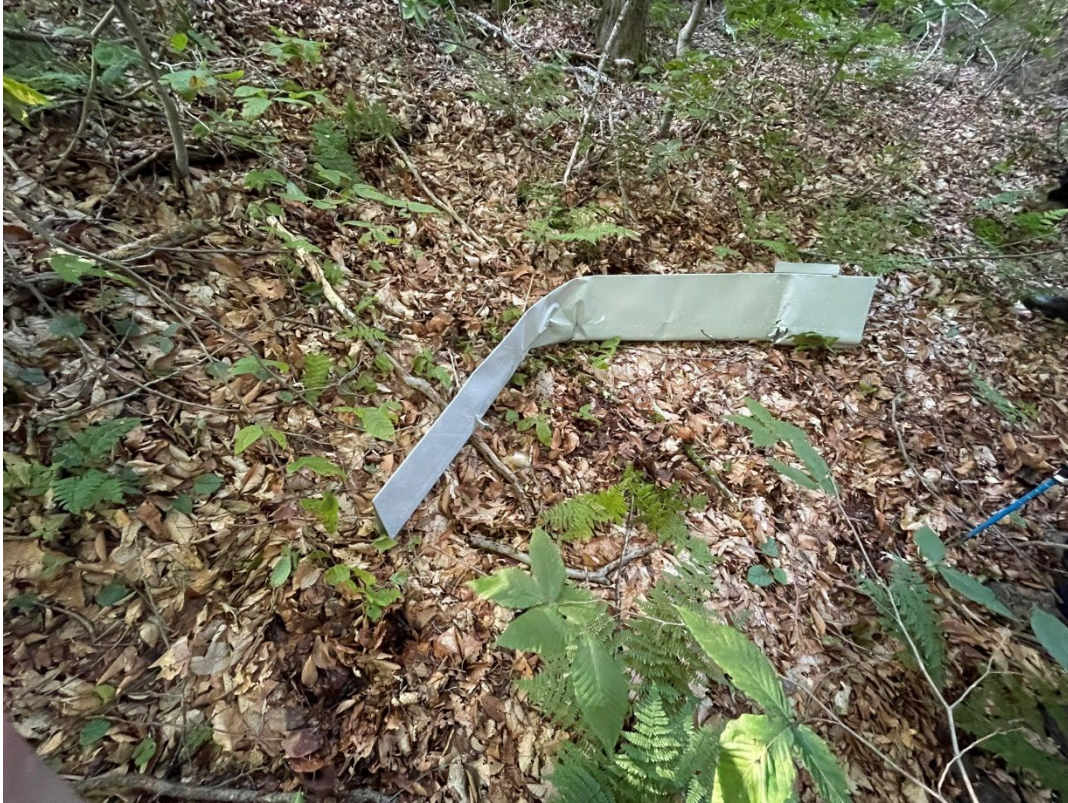
**Photo 21: View of the right aileron as found.**

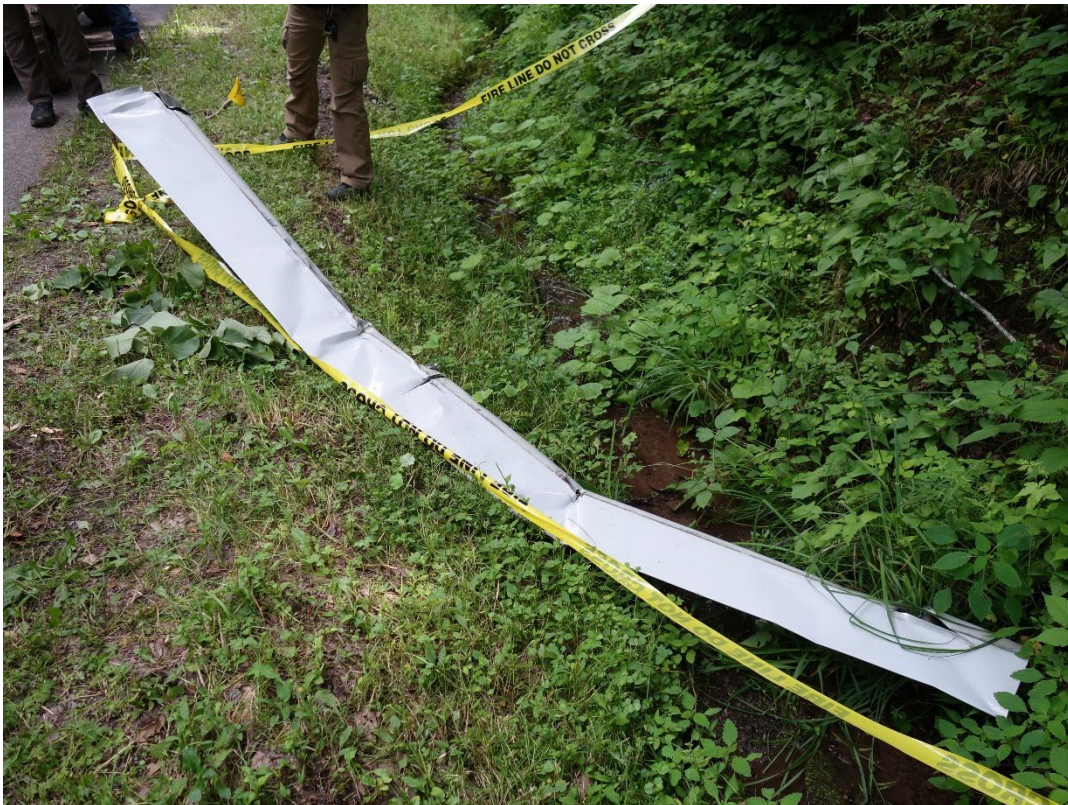
**Photo 22: View of the right flap as found.**

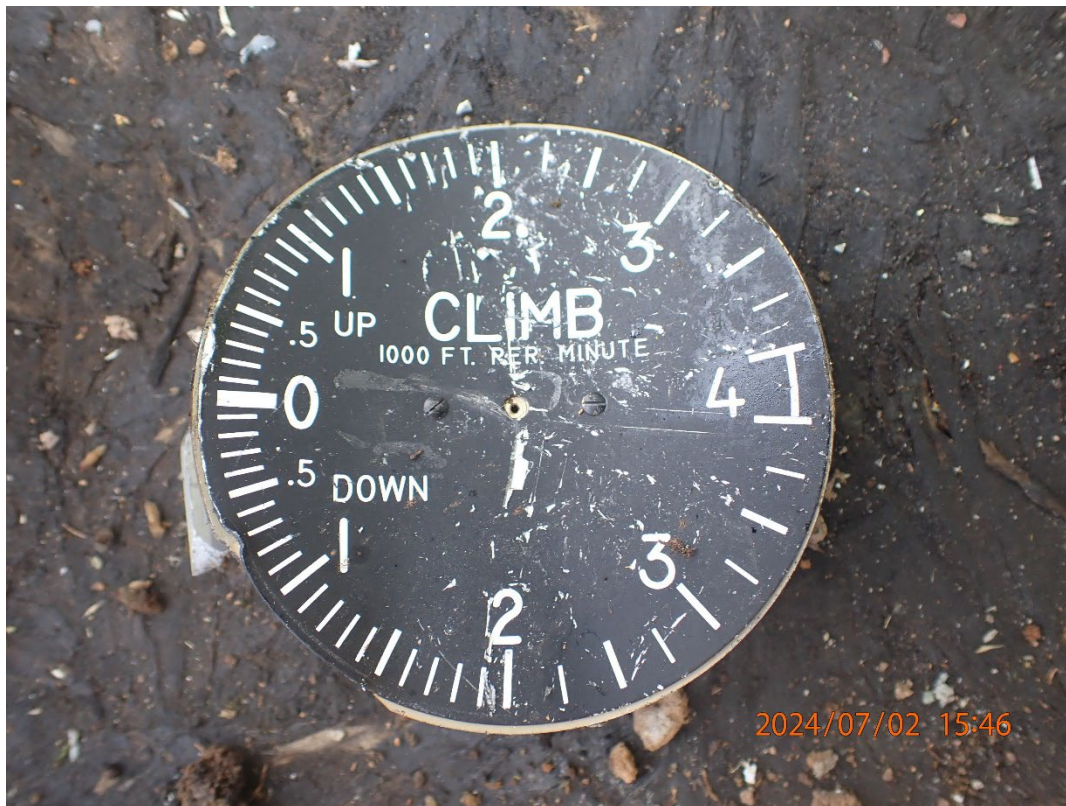
A majority of the cockpit was unrecognizable due to impact damage eliminating the possibility of determining the pre-impact position of any controls or switches in the cockpit. The pilot's side attitude indicator, airspeed indicator, altimeter, and turn coordinator were removed. The face of the vertical speed indicator was located, and a slap mark was observed indicating a 4000 ft/min rate of descent. The gyros from the attitude indicator and electric turn coordinator were removed and examined. The electric gyro exhibited rotational scoring on both the gyro and the housing. The vacuum gyro in the attitude indicator exhibited rotational scoring on both the gyro and the housing.

**Photo 23: View of the vertical speed indicator with slap mark.**

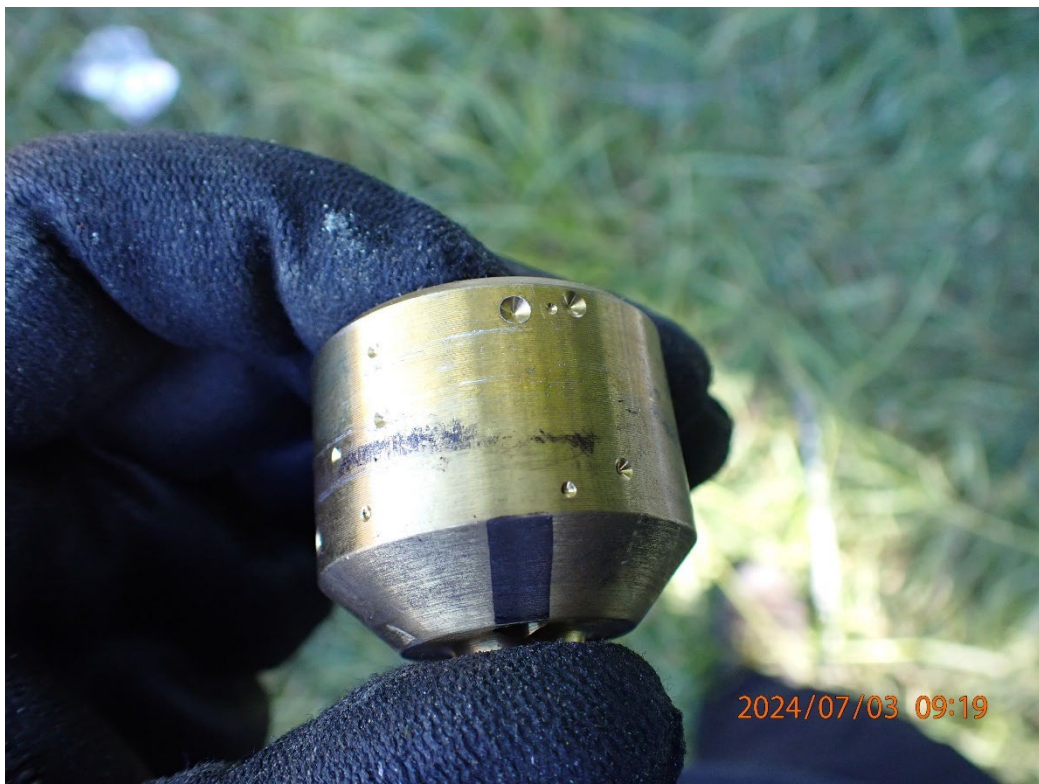
**Photo 24: View of rotational scoring on the electric gyro.**

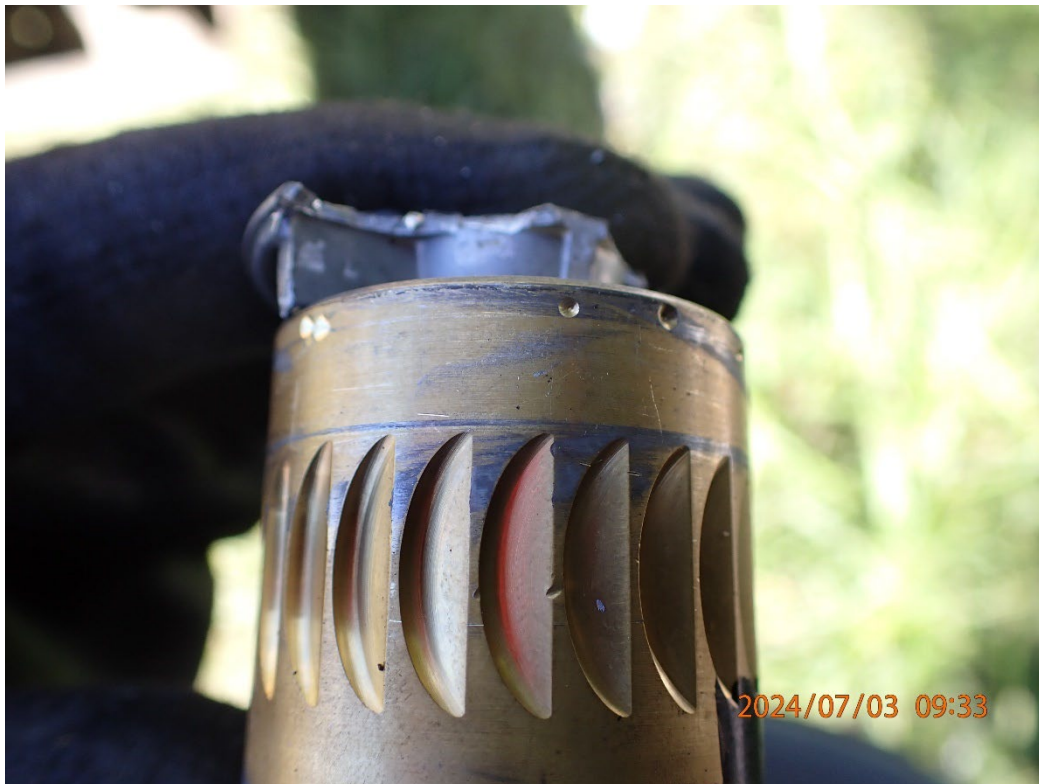
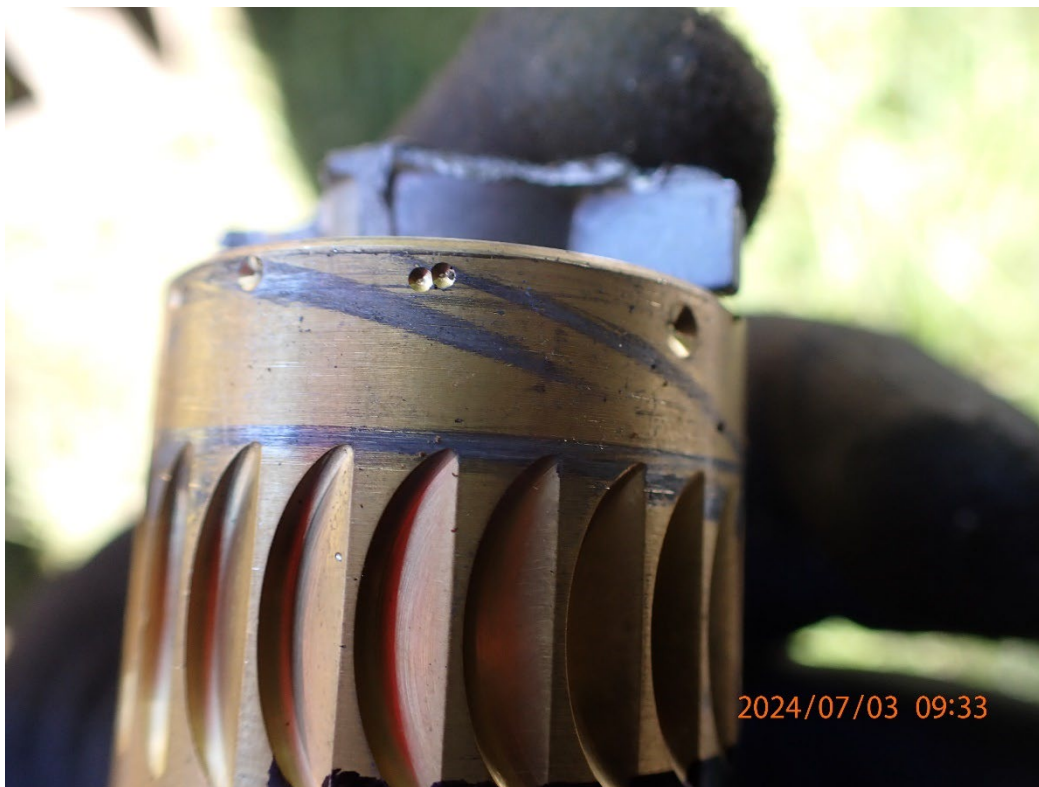
**Photo 25: View of rotational scoring on the vacuum driven gyro.**

**Photo 26: View of rotational scoring on the vacuum driven gyro.**

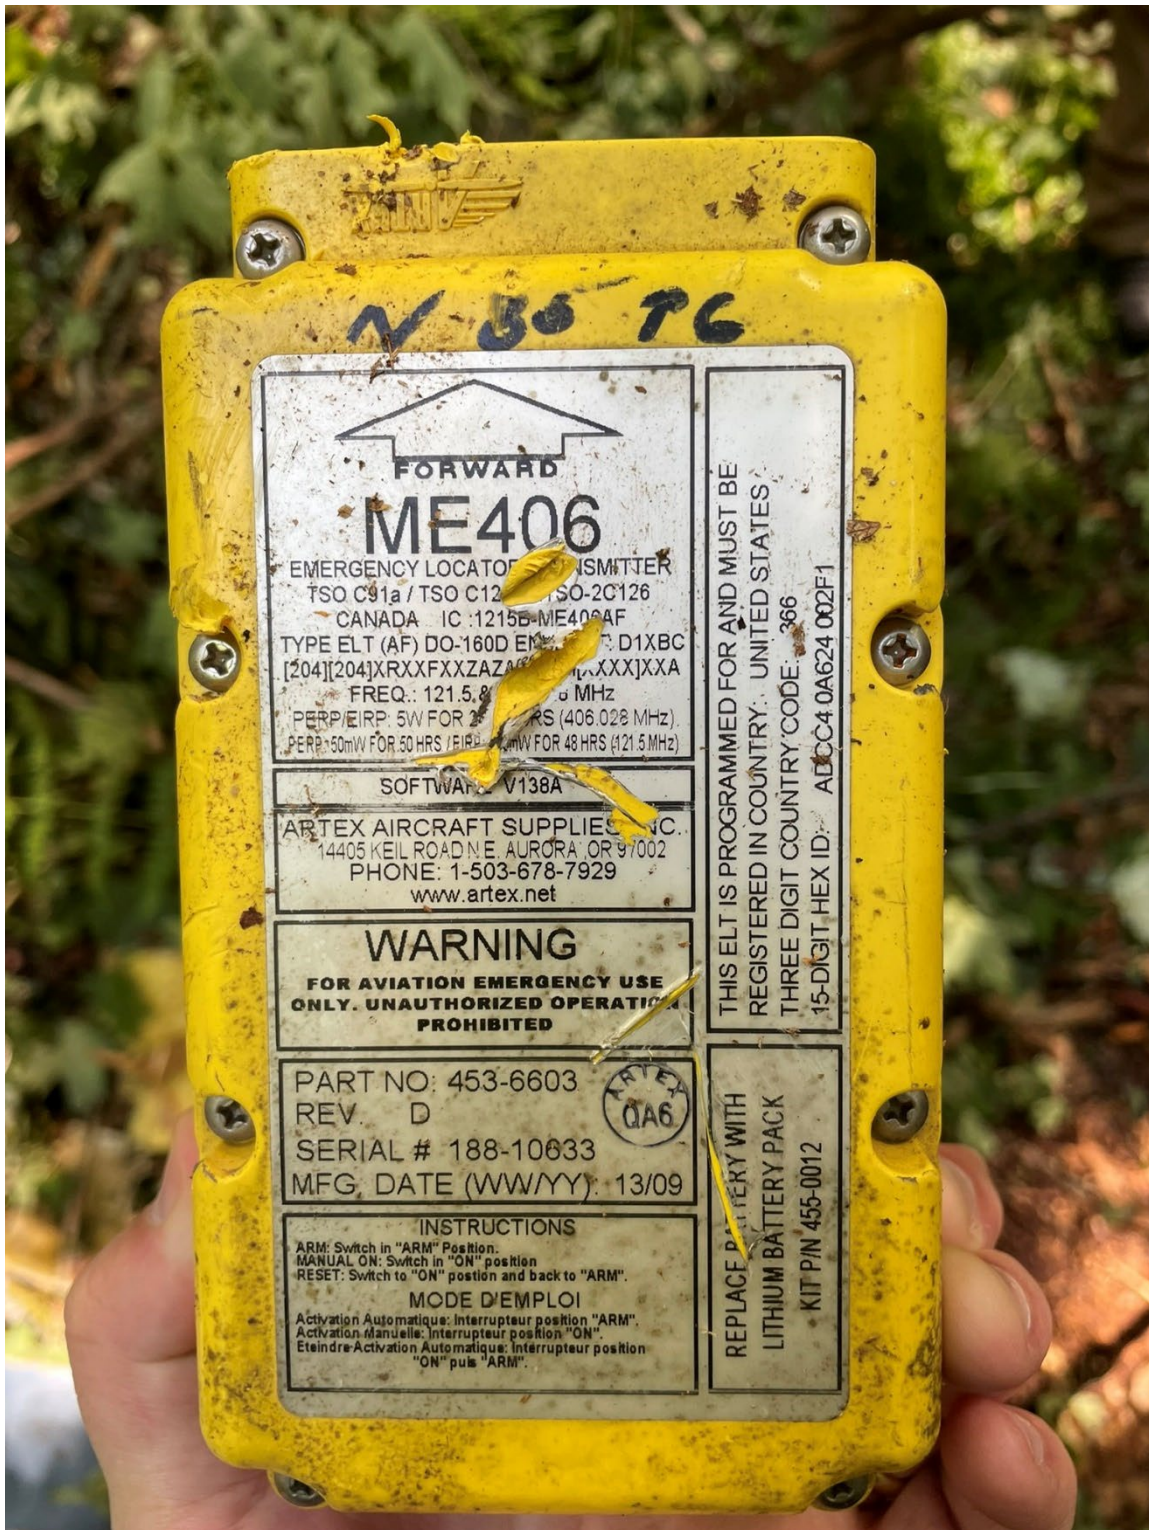
The ELT was located in the aft portion of the fuselage and had been separated from the mount and antenna. It was removed and was observed to be in the ON position.

Photo 27: View of the ELT.

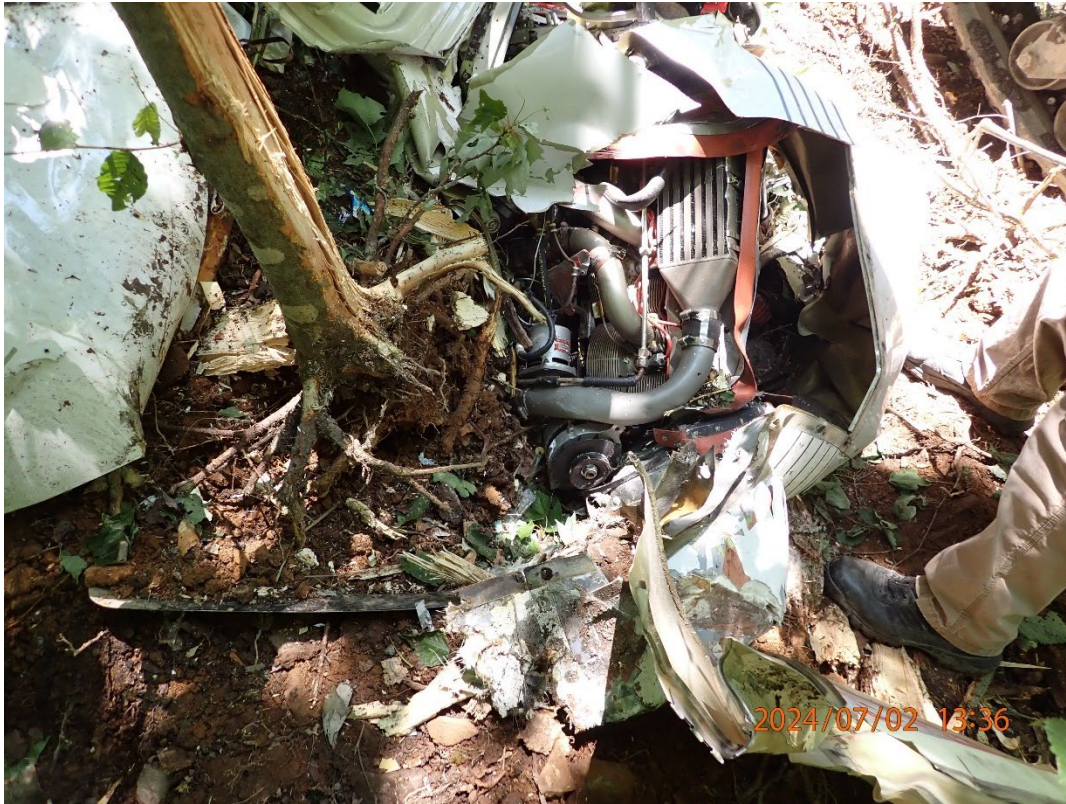
The engine upon first view was on the right side buried about 3 ft in the ground attached to the fuselage. The Nos. 1, 3, and 5 cylinder heads, and a majority of components on the right side of the engine exhibited severe impact damage. The engine crankshaft was not able to be rotated.

**Photo 28: View of the engine at the main wreckage site.**

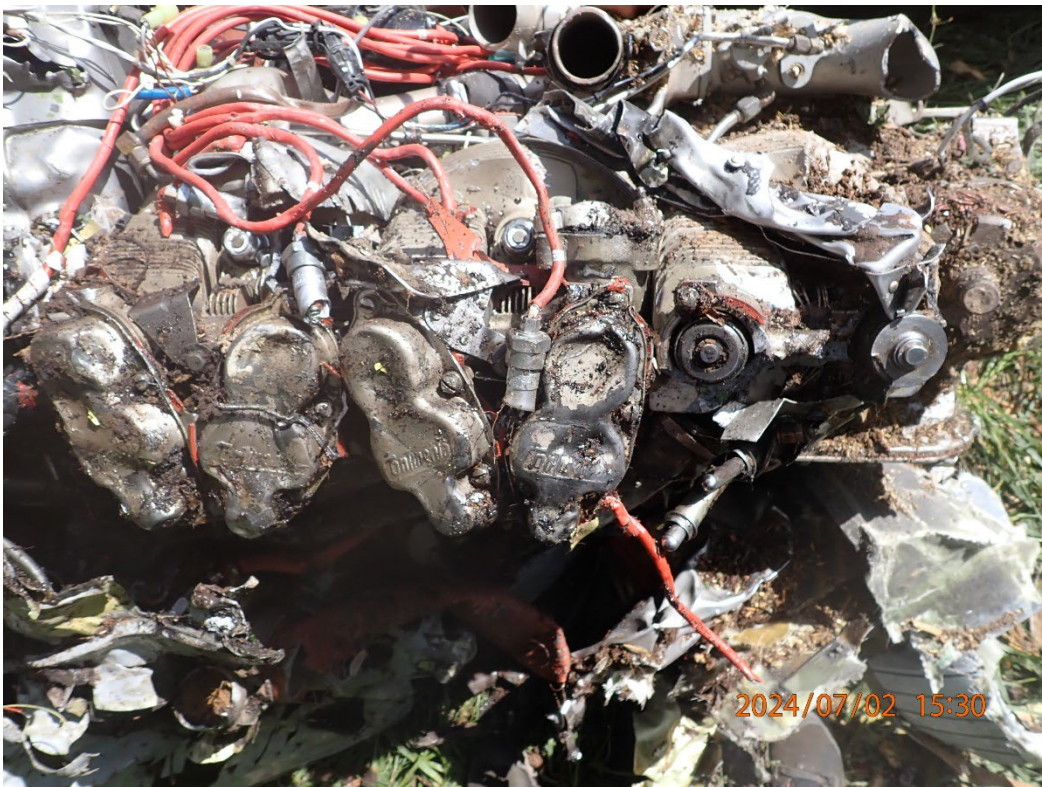
**Photo 30: View of the right side of the engine.**

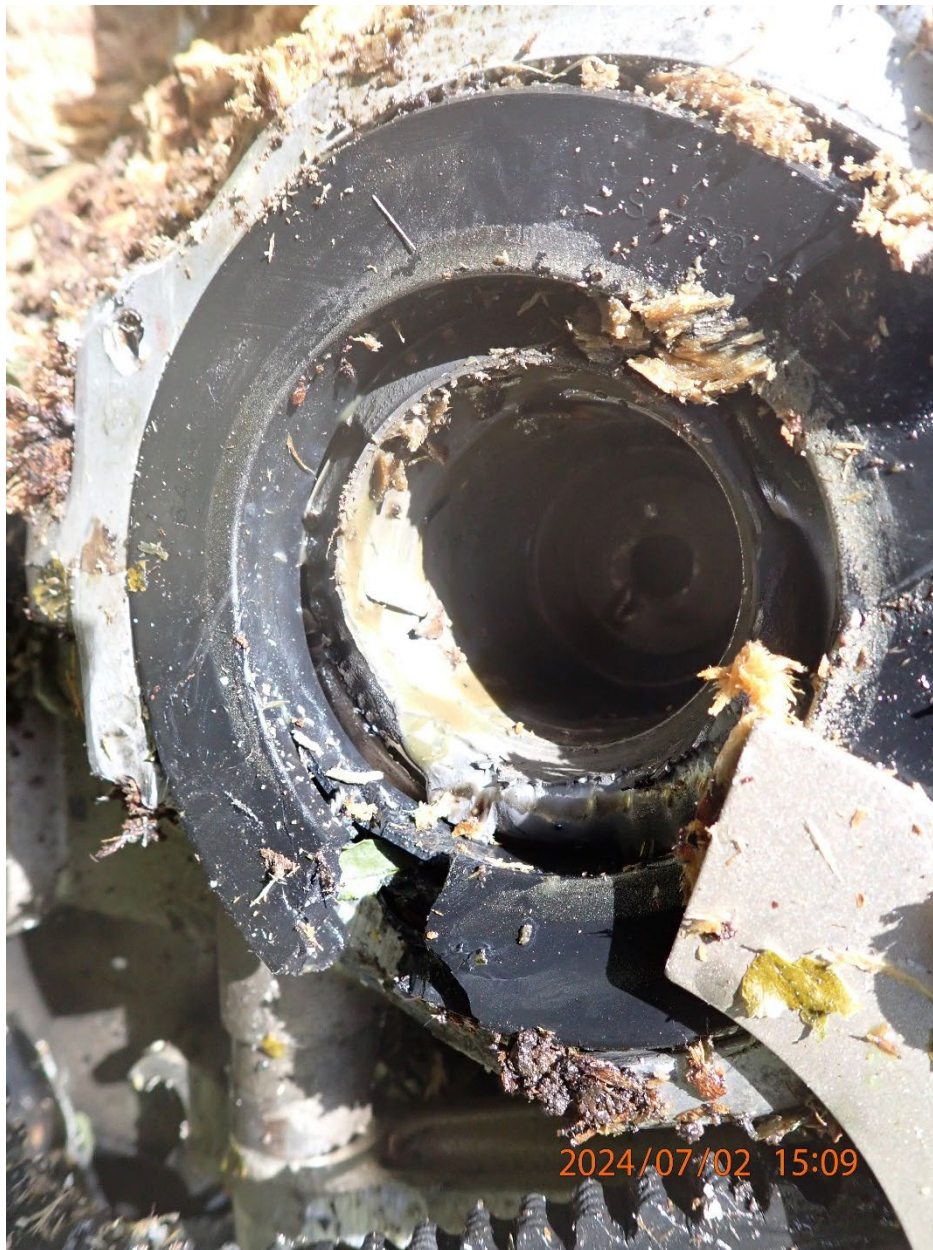
**Photo 31: View of the impact fractured engine crankshaft.**

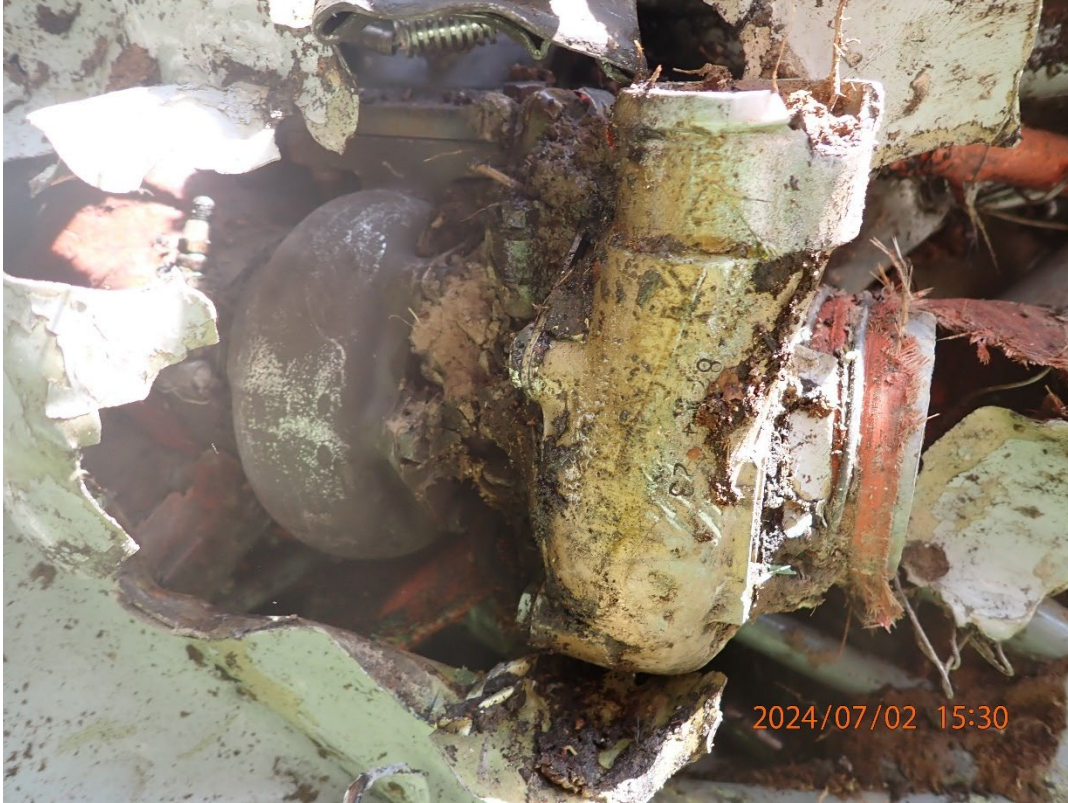
The right side induction and exhaust system were impact crushed. The left side intercooler remained attached at all attachment points and was unremarkable. The right turbo remained attached to the engine at all attachment points and exhibited impact damage. The left turbo remained attached to the engine at all attachment points and was unremarkable.

**Photo 32: View of the right turbo.**

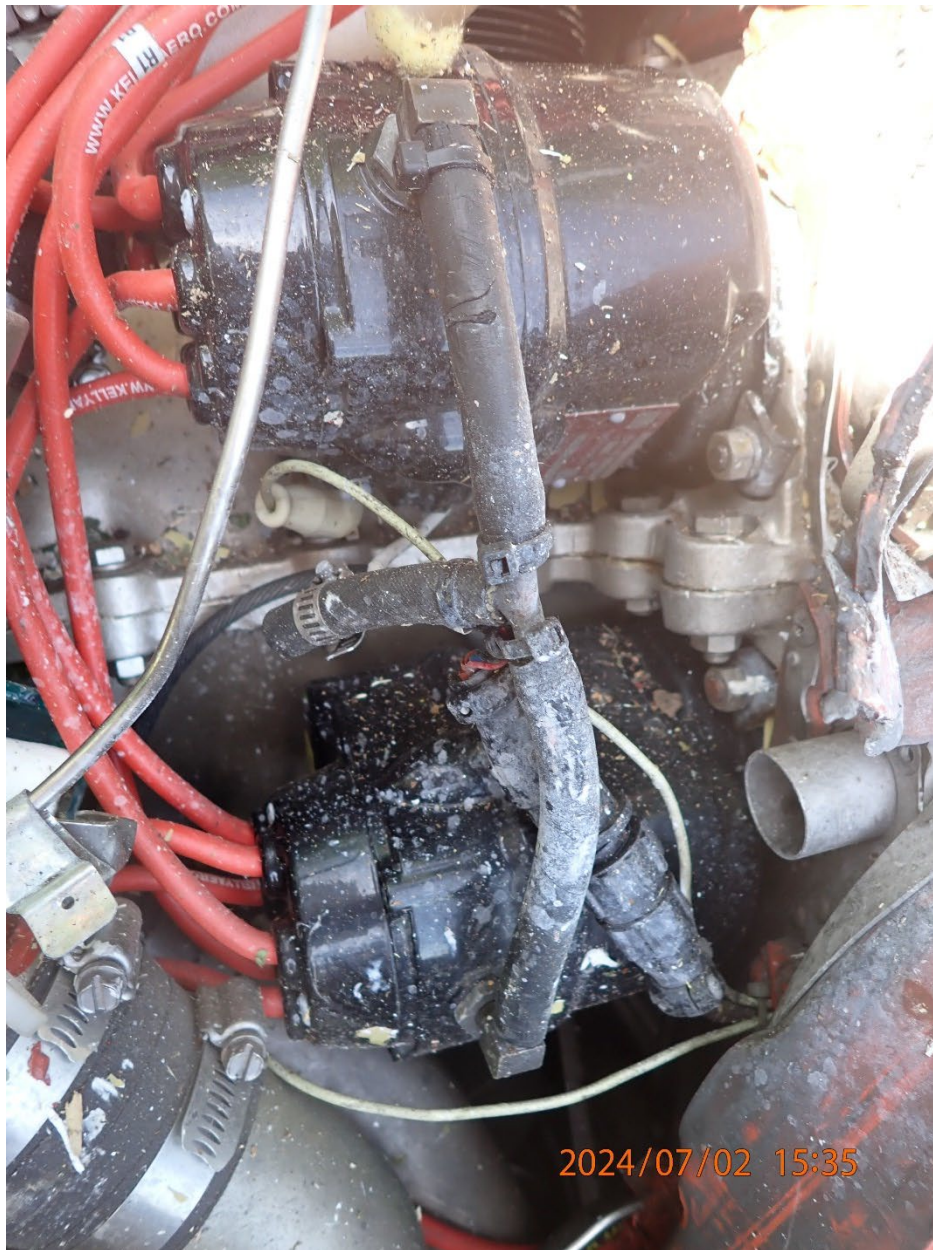
Both magnetos remained attached to the engine at all attachment points and were removed for examination. Both magnetos sparked on all towers when rotated by hand and with an electric drill.

**Photo 35: View of the magnetos installed on the engine.**

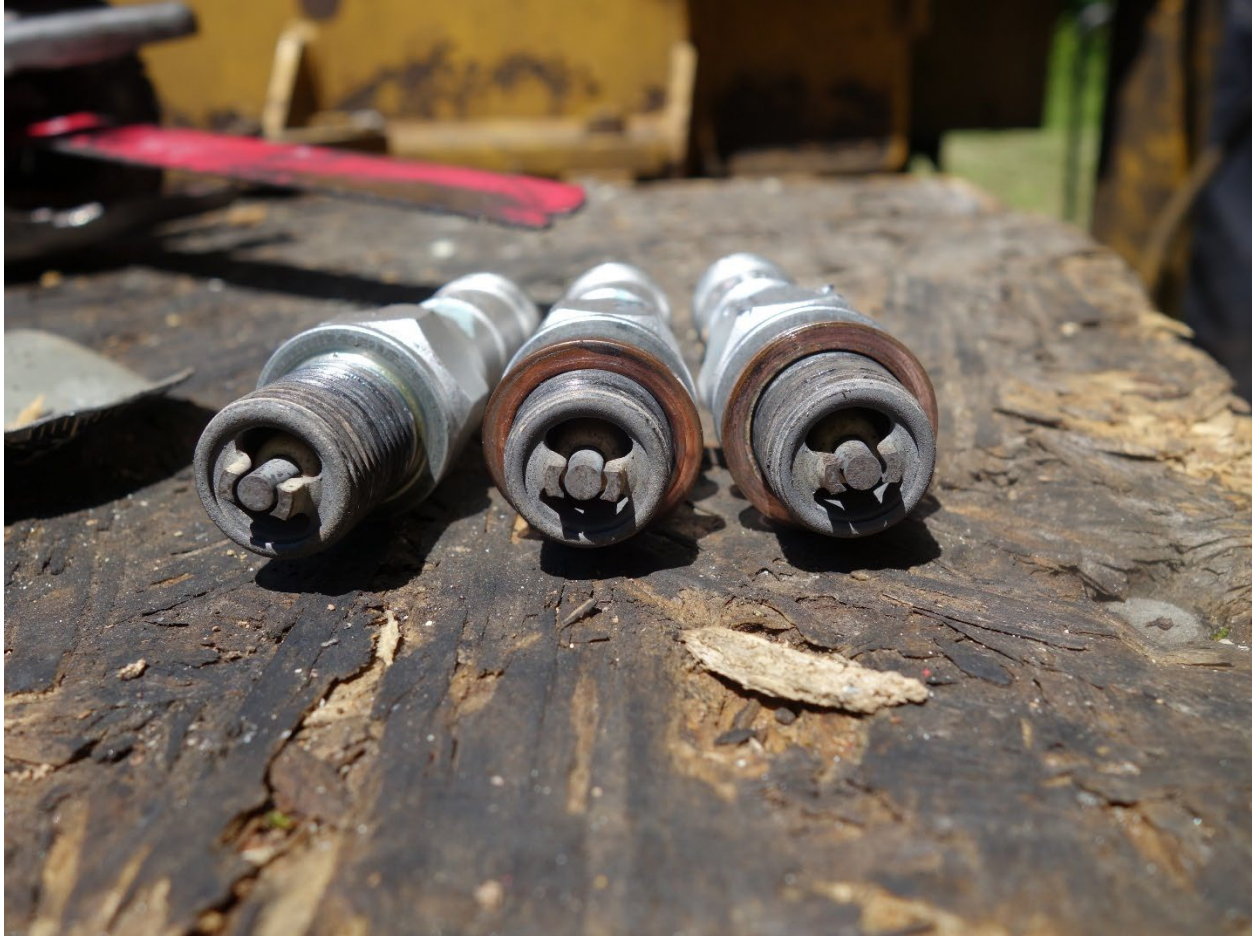
The right side sparkplugs exhibited impact damage and all of the wires of the ignition harness to the right side of the engine were severed. The left Nos. 2, 4, and 6 bottom sparkplugs were removed and exhibited normal wear when compared to the Champion Aerospace Aviation Check-A-Plug chart. The ignition harness on the left side of the engine remained intact and all leads remained attached to their respective spark plugs.

**Photo 36: View of the Nos. 2, 4, and 6 bottom spark plugs.**

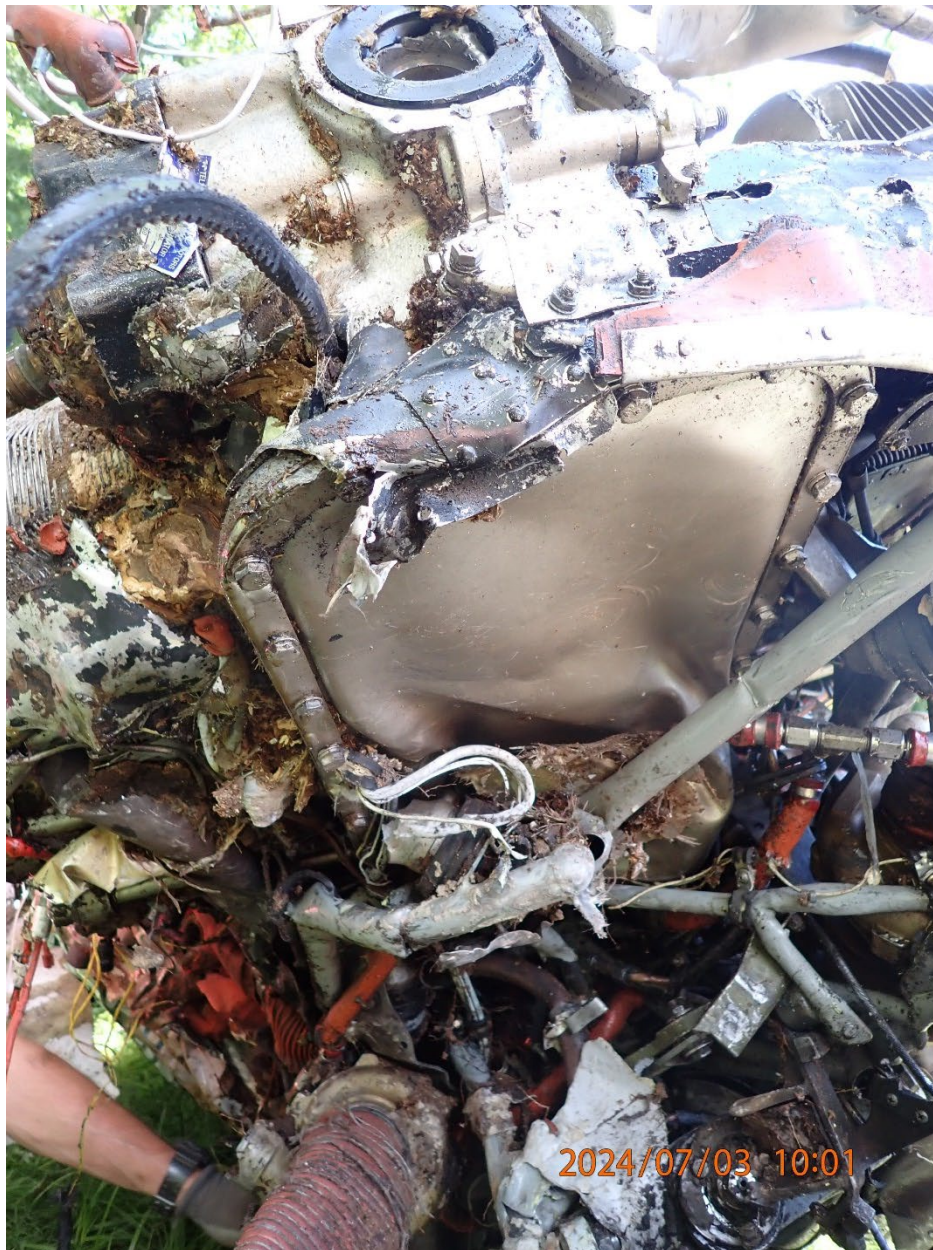
The oil pan was impact crushed upwards into the crankcase. The drain plug remained safety wired and screwed in place. The dip stick was able to be removed and was bent and deformed. The oil filter neck was impact fractured and the oil filter was impact separated from the engine.

**Photo 37: View of the impact crushed oil pan.**

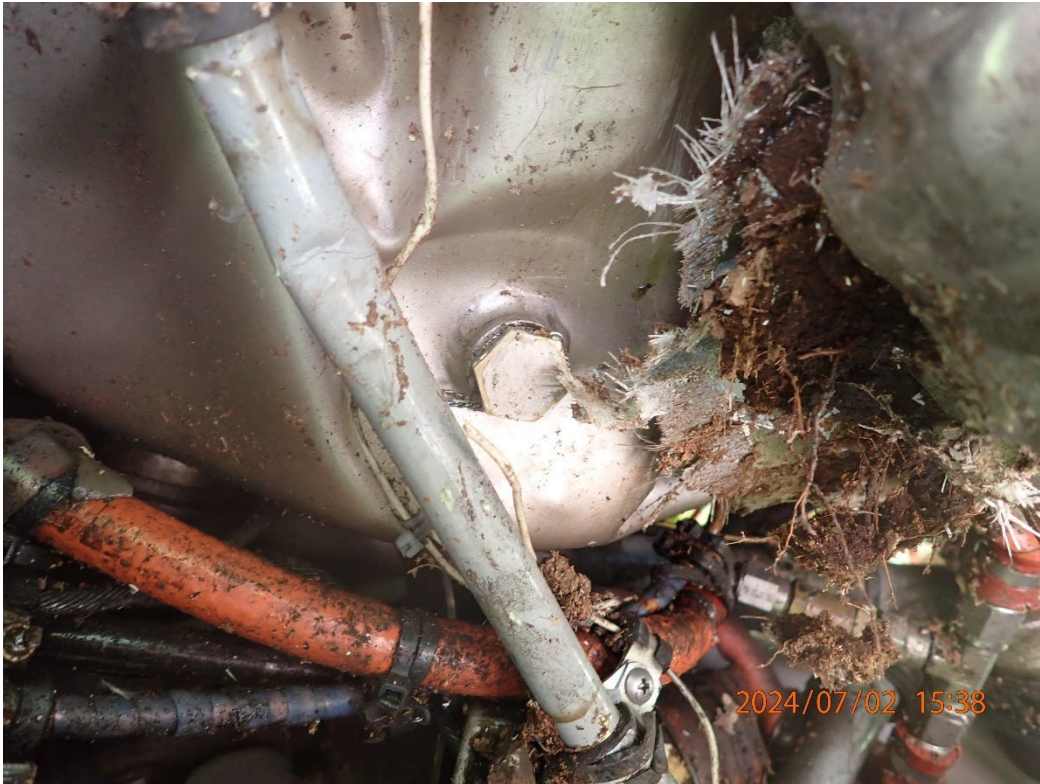
**Photo 38: View of the oil drain plug seated in place.**

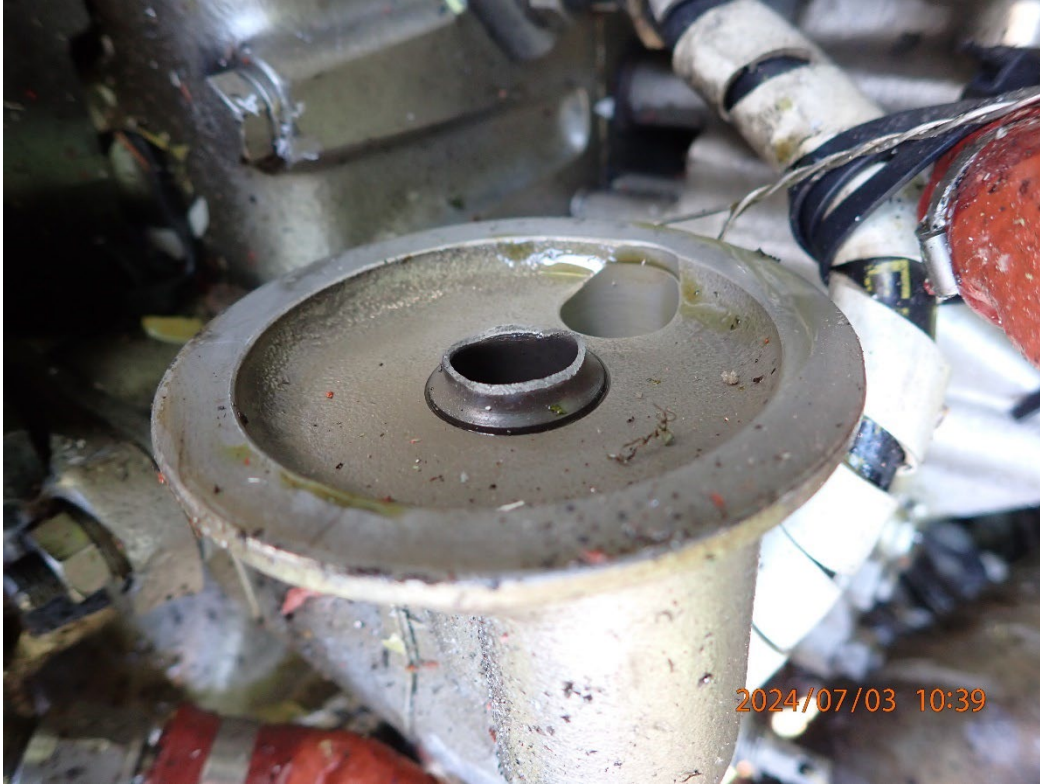
**Photo 40: View of the impact fractured oil filter neck.**

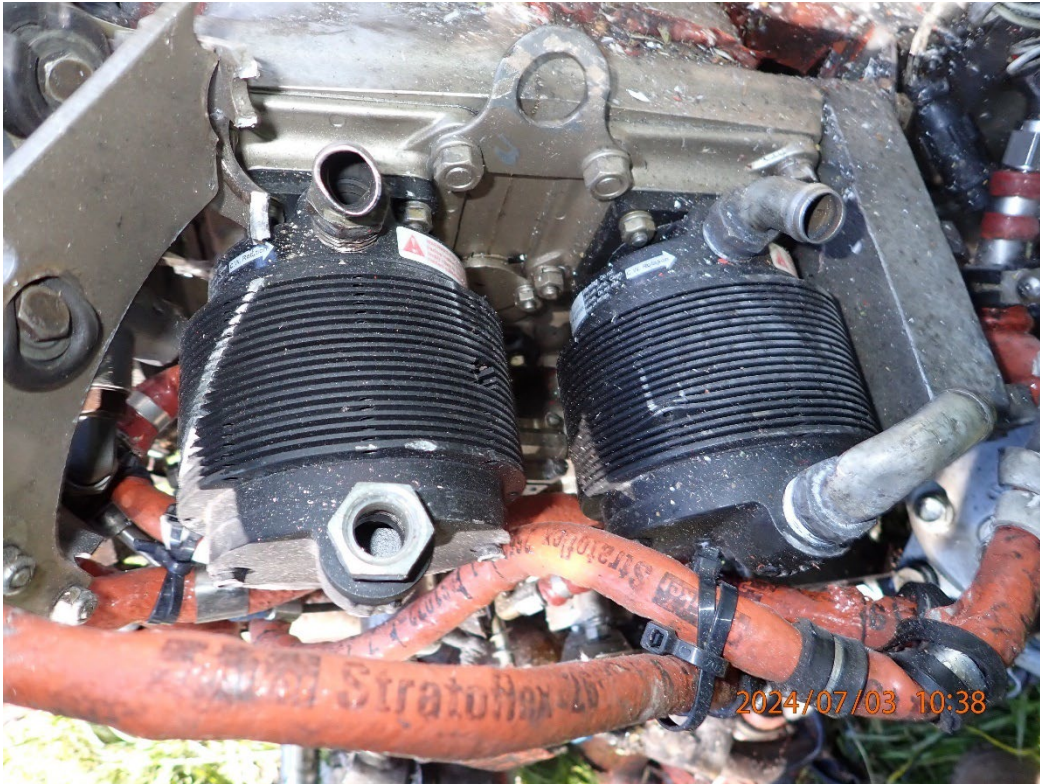
Both vacuum pumps on the engine exhibited some impact marks on their cases. The drive couplings for both vacuum pumps were intact. The vacuum pumps were disassembled for examination and the rotors and vanes were intact inside each of the vacuum pumps.

**Photo 41: View of the vacuum pumps installed on the engine.**
