# National Transportation Safety Board

ERA24FA283

## WRECKAGE EXAMINATION

Location: Trout Creek, NY  
Date: June 30, 2024  
Time: 1355 EDT  
1755 UTC  
Airplane: N85PG; PA-46-310P

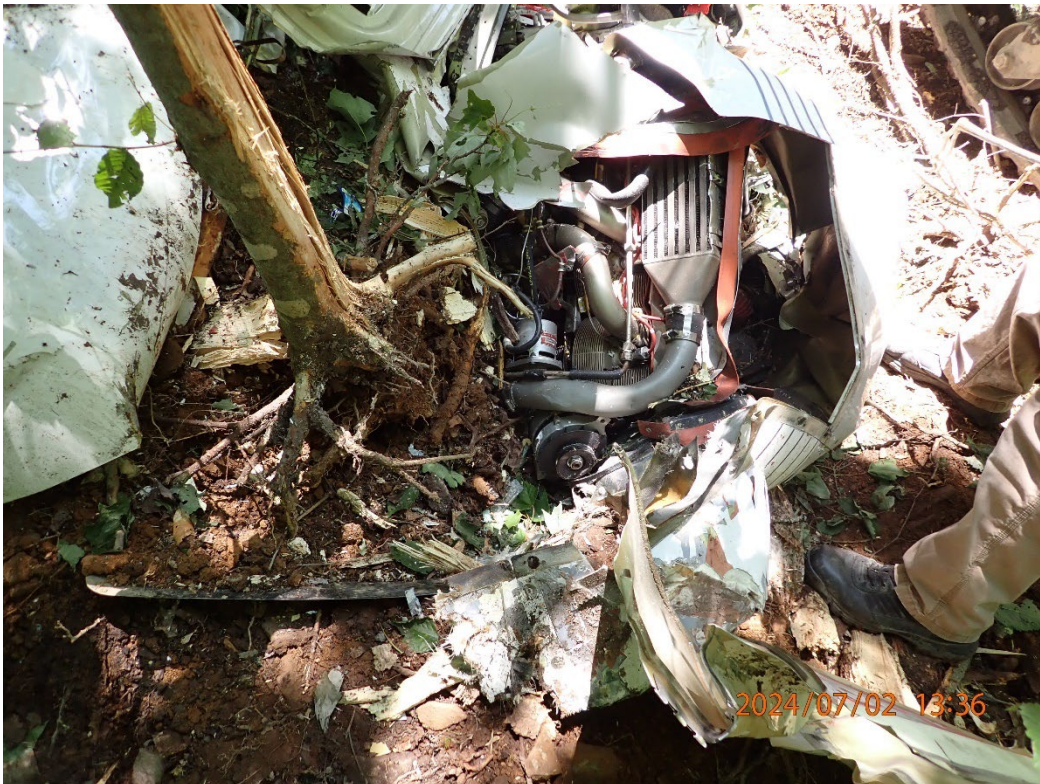
Observed on-scene, the two-blade constant speed propeller remained attached to the crankshaft propeller flange. The crankshaft was fractured and separated at the forward end of the crankcase. The propeller was partially buried in the terrain immediately in front of the engine. Both propeller blades were retained in the hub.

**Photo 45: View of the propeller buried at the accident site.**
