# National Transportation Safety Board

ERA24FA292

## **WRECKAGE EXAMINATION**

Location: Lock Haven, Pennsylvania  
Date: July 4, 2024  
Time: 1010 EDT  
1410 UTC  
Airplane: N739GV; Cessna 172N

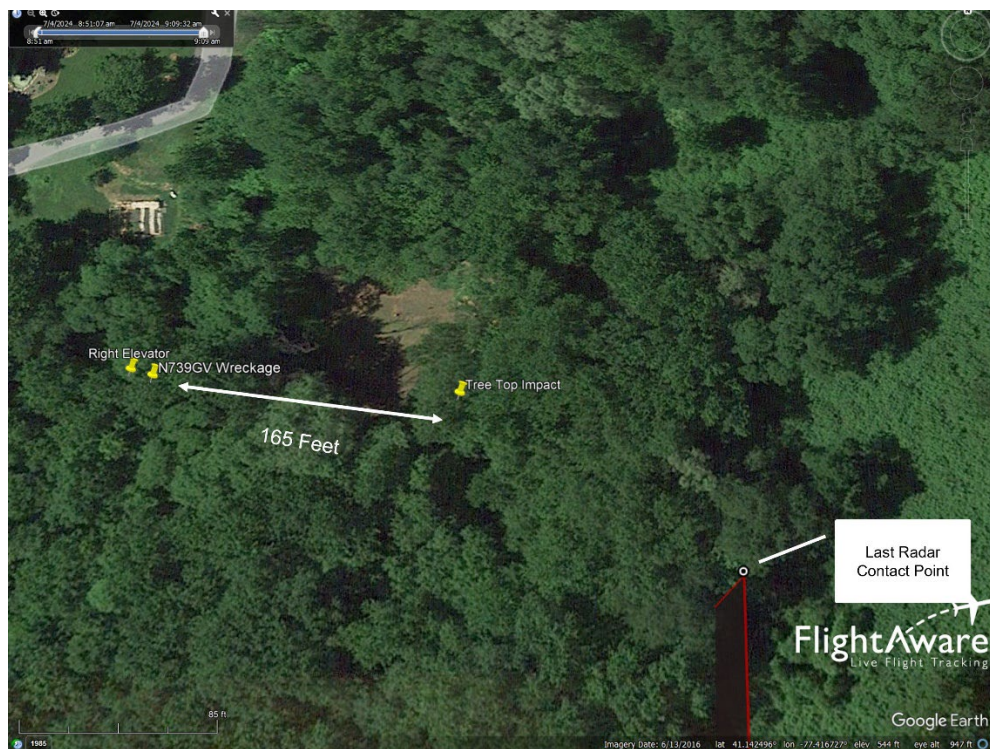
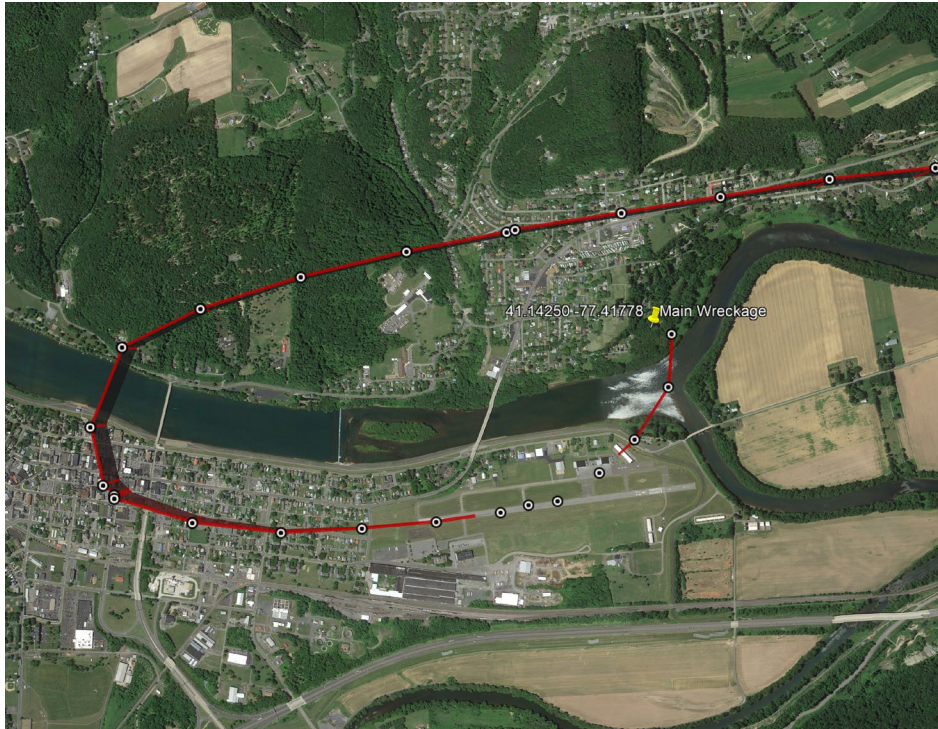
The airplane initially collided with the top of a large maple tree at coordinates 41.142579, -77.417208. The airplane continued for about 165 ft until it struck another tall tree, about 4 ft in diameter, and about 55 ft up the tree and the main wreckage came to rest, upright, at the base of the same tree on a westerly heading. A postaccident fire consumed a majority of the wreckage.

Several fragments of tree limbs with diameters up to about 6 inches were observed in the impact area with cuts at about 45 degrees consistent with propeller strikes. One of the cuts displayed dark colored paint transfer consistent with the paint from the propeller blades.
