# National Transportation Safety Board

ERA24FA294

## INVESTIGATION AND EXAM SUMMARY

Location: Rutherfordton, NC.  
Date: July 7, 2024  
Time: 2107 EDT  
0107 UTC  
Airplane: N2198G, Cessna 182A

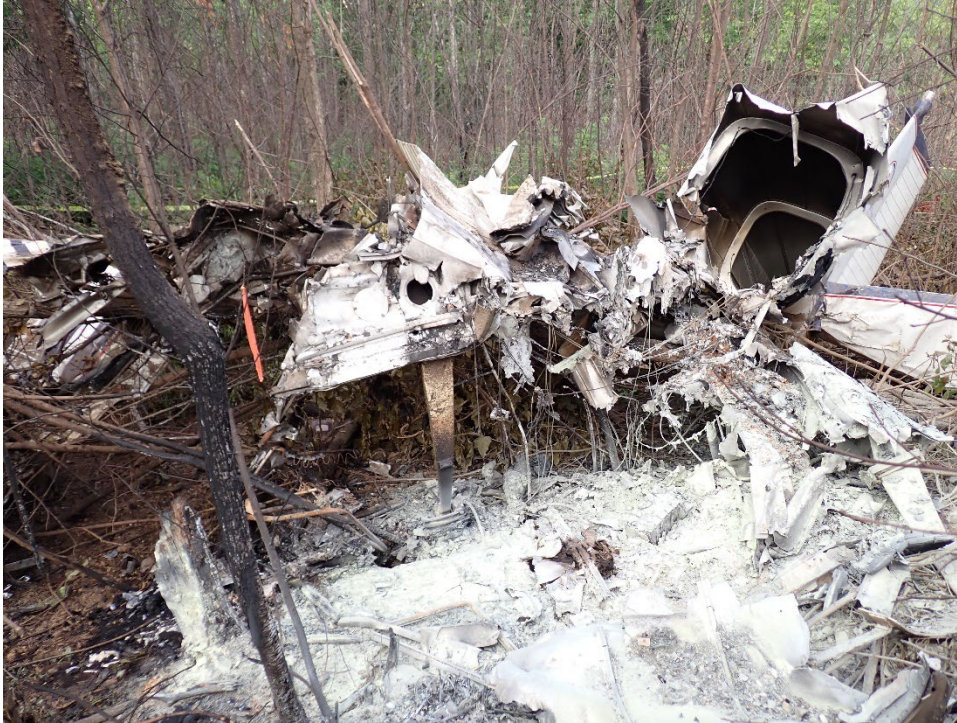
The majority of the fuselage and cockpit were thermally damaged.

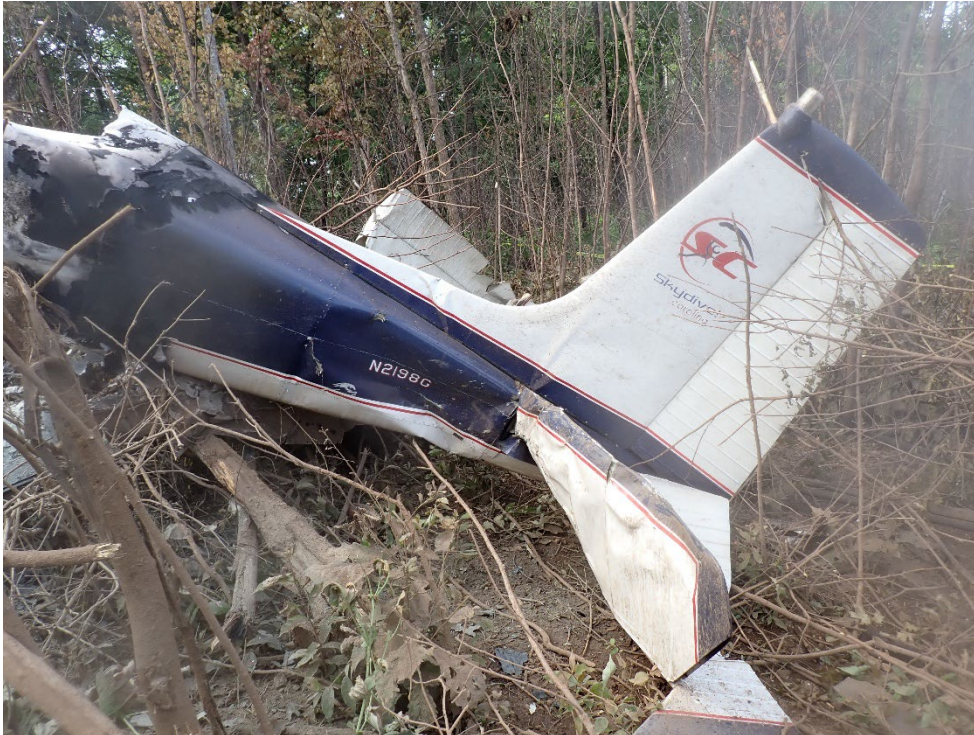
The empennage was impact and thermally separated near the baggage bulkhead. Both horizontal stabilizers were displaced upwards and had leading edge damage. The right elevator separated from its mounting location. The vertical stabilizer forward dorsal skin displayed wrinkling.

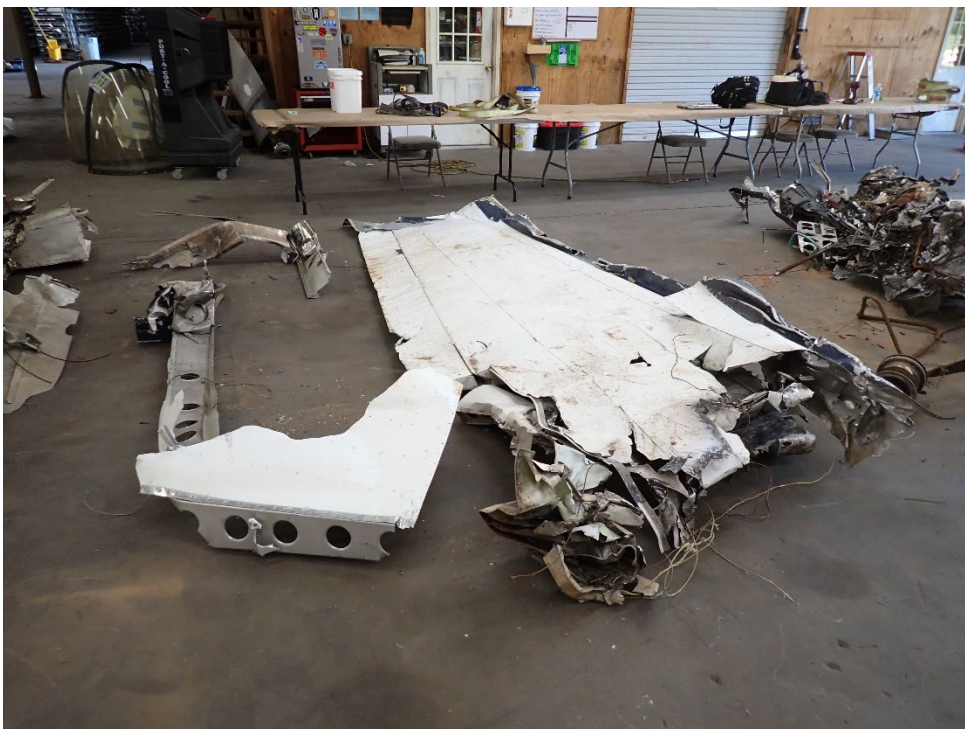
The left wing had impact damage at the tip, leading edge and through the root. The left flap was destroyed. The left aileron was still in tact and secured to the wing by its hinges. The trailing edge of the aileron was impact damaged.

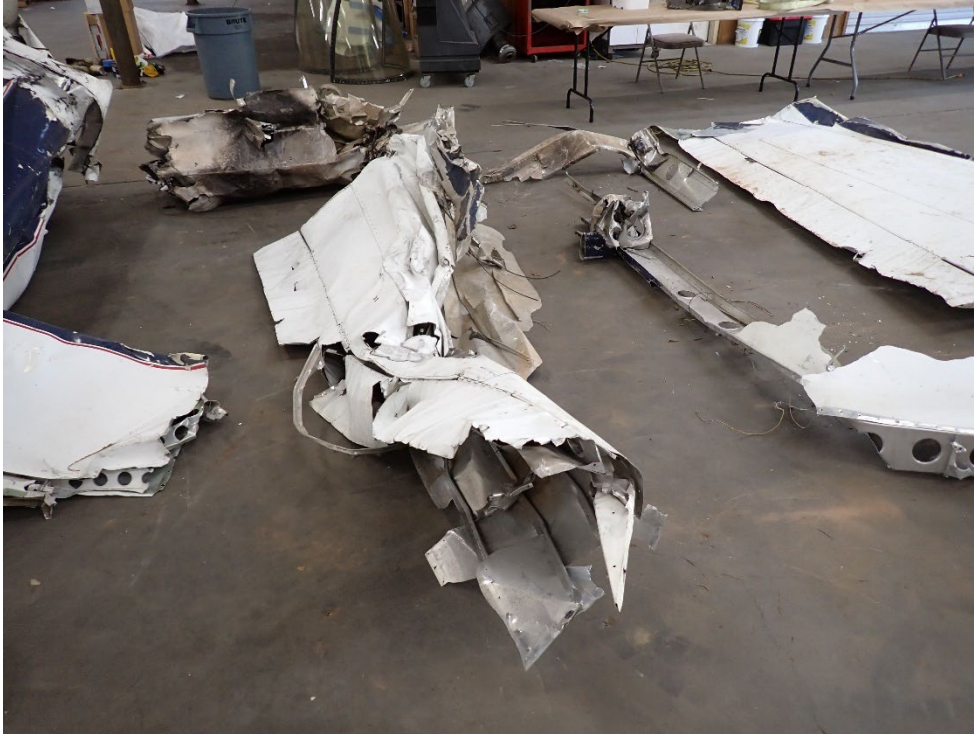
The right wing was fragmented from impact forces and the flight controls were fragmented and crushed. The majority of the right wing main spar was recovered with little to no other structure attached.

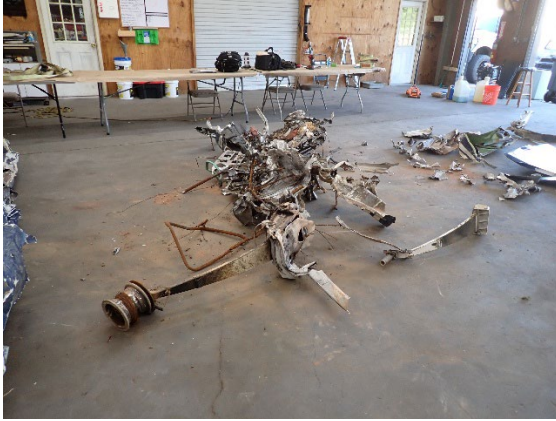
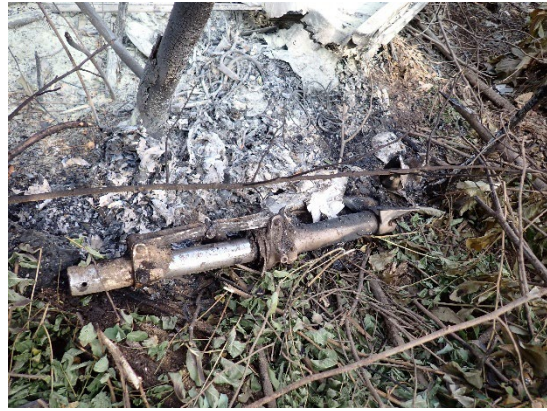
Both main landing gear legs were separated from the airplane with their mountings still attached. The left main landing gear wheel was still attached to the axle and gear leg but the tire and tube were thermally destroyed.

The right main landing gear was still attached to a section of the fuselage fitting. The wheel assembly was detached from the axle and the axle was still attached to the gear leg.

The Nose landing gear was separated from the firewall with its mounts still attached and the steering control arms broken free of their mountings. The nose wheel fork was separated from the lower oleo.

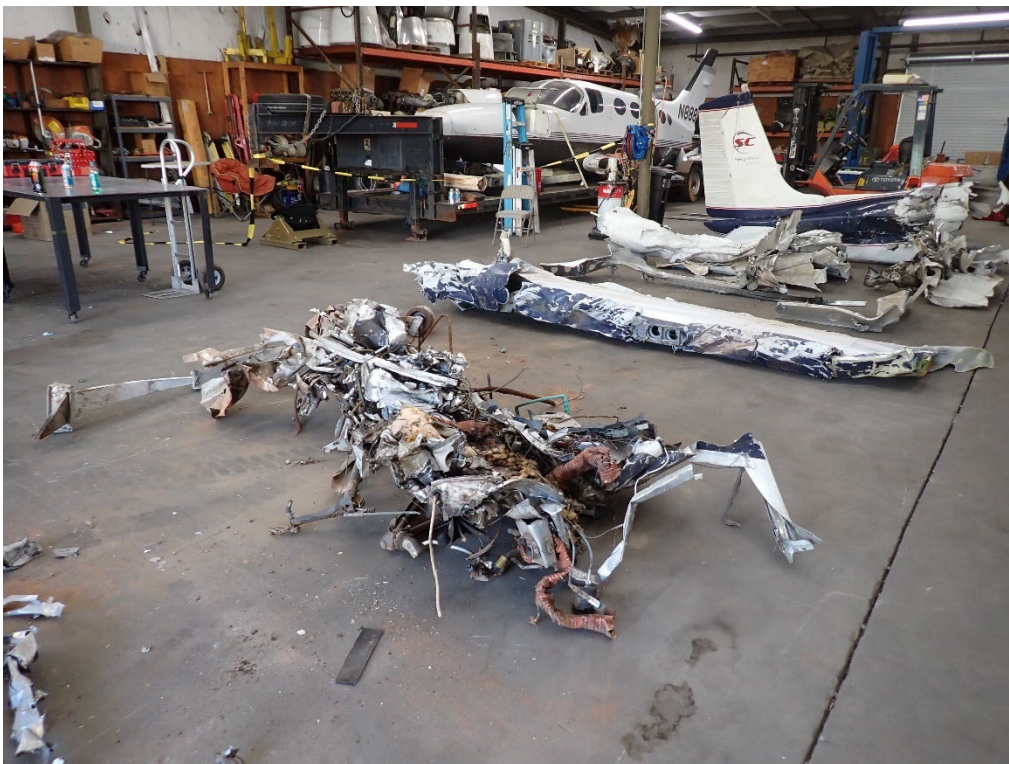
The cockpit was thermally damaged and crushed. Most environmental and icing control positions could not be determined. Only one seat was observed in the wreckage.

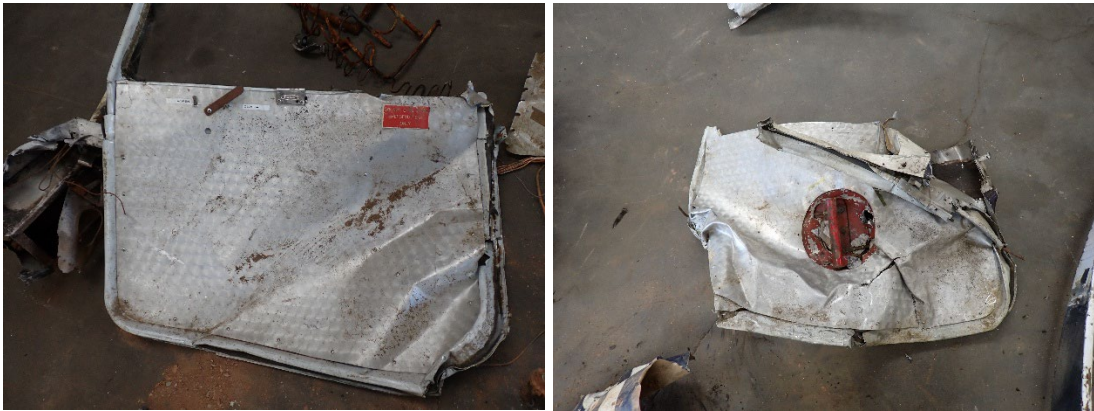
According to airworthiness records, the passenger seats were previously removed for sky diving operations. Multiple attach points were found with the restraint fabric most likely consumed by thermal damage. The instrument panel was heavily crush and thermally damaged. The left cabin door was mostly in tact with the door latch in the closed position and the latch pins

extended. The right cabin door was fragmented with the latch shown to be in the closed position with latch pins extended.

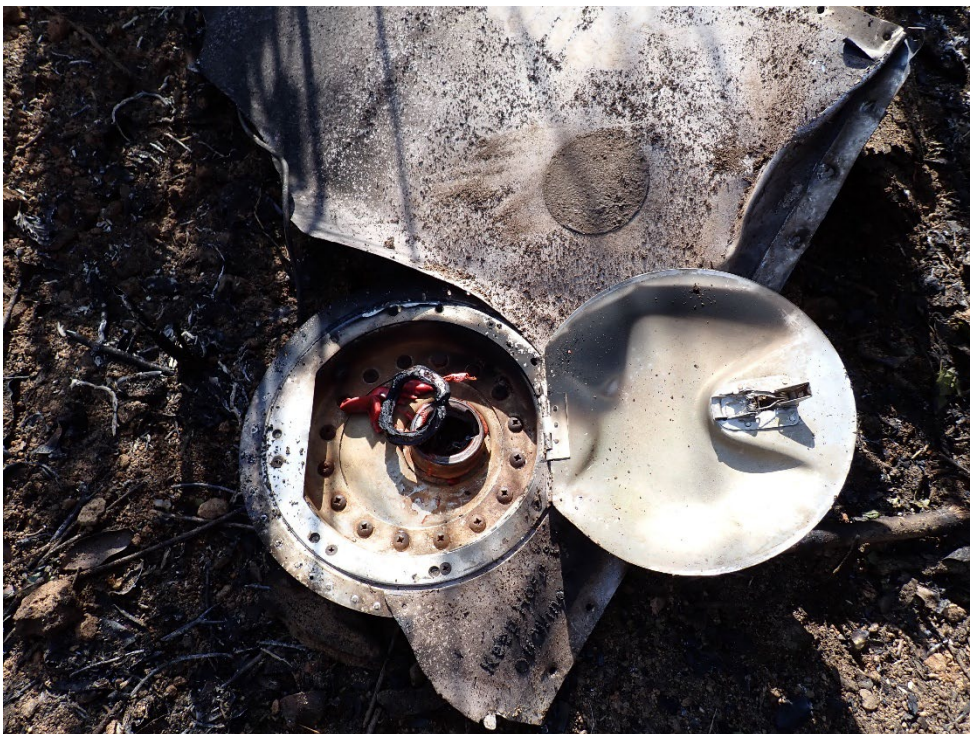
Both fuel tanks were thermally damaged, portions of the right fuel cap assembly was found in the wreckage.

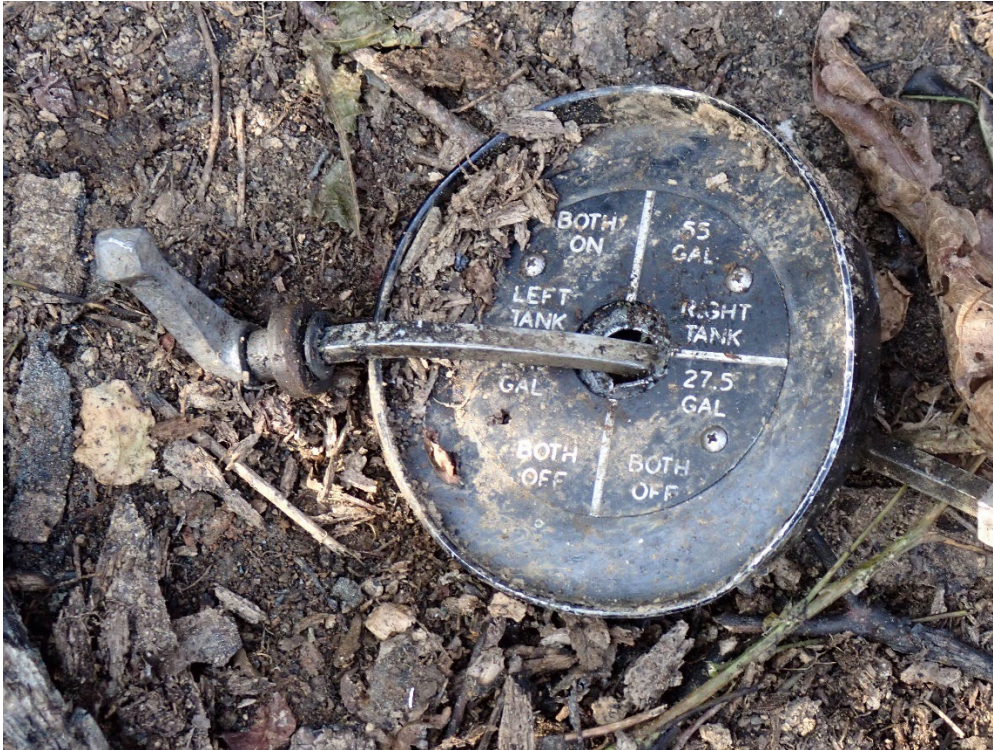
The fuel selector handle and face plate were found free in the wreckage with the connecting stem broken at the fuel selector valve. Air was blown through the selector valve and it was determined to be in the "Both" position. Fuel consistent in smell with 100LL was present in the lines of the selector.

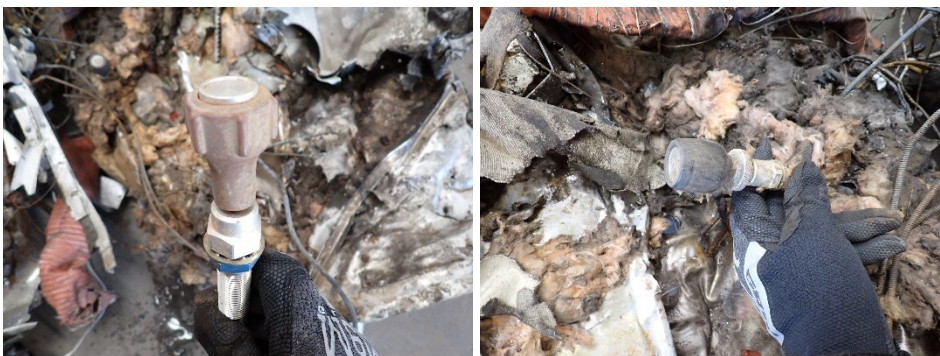
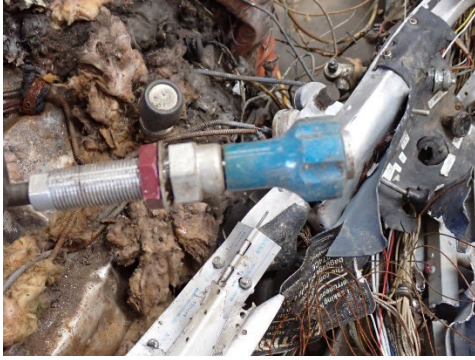
Flight control cable was not established due to the heavily damaged and contorted wreckage and the steep, hazardous terrain. The thermally damaged flap handle was found locked in the second notch indicating flaps were set to 10°. The mixture, propeller, and throttle controls were found in their full rich and full throttle (all the way in) positions.

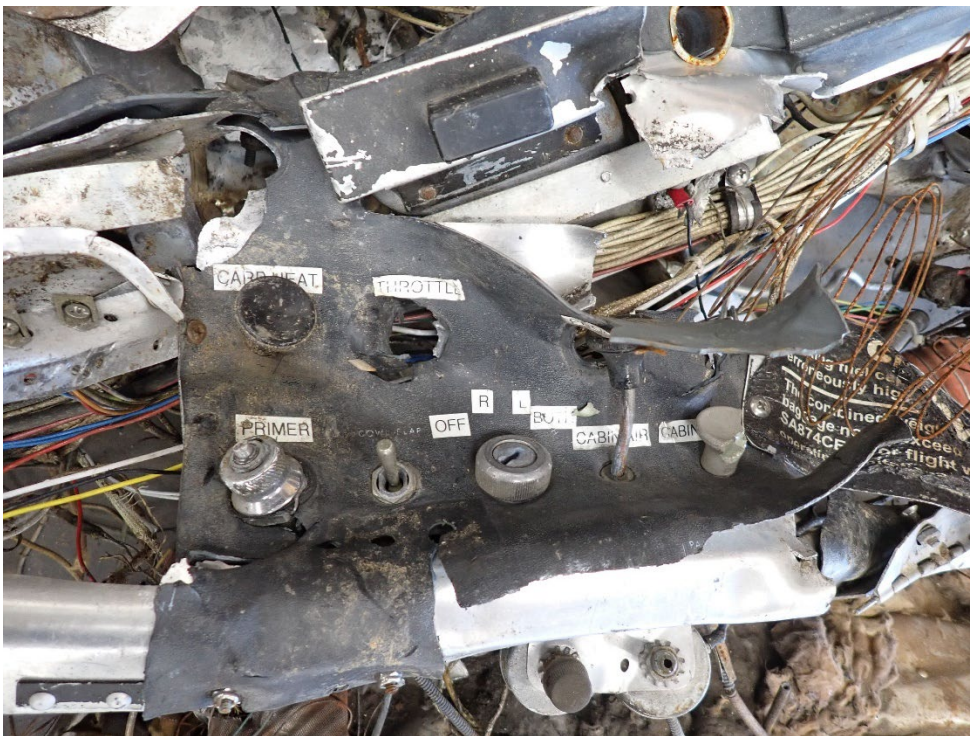
Carb heat was in the off position, the cowl flap switch was broken and position could not be determined, and the magneto switch was in the both position with the key removed. The cabin air control was pulled out and bent up and the cabin heat control was all the way in. The primer knob was broken off.

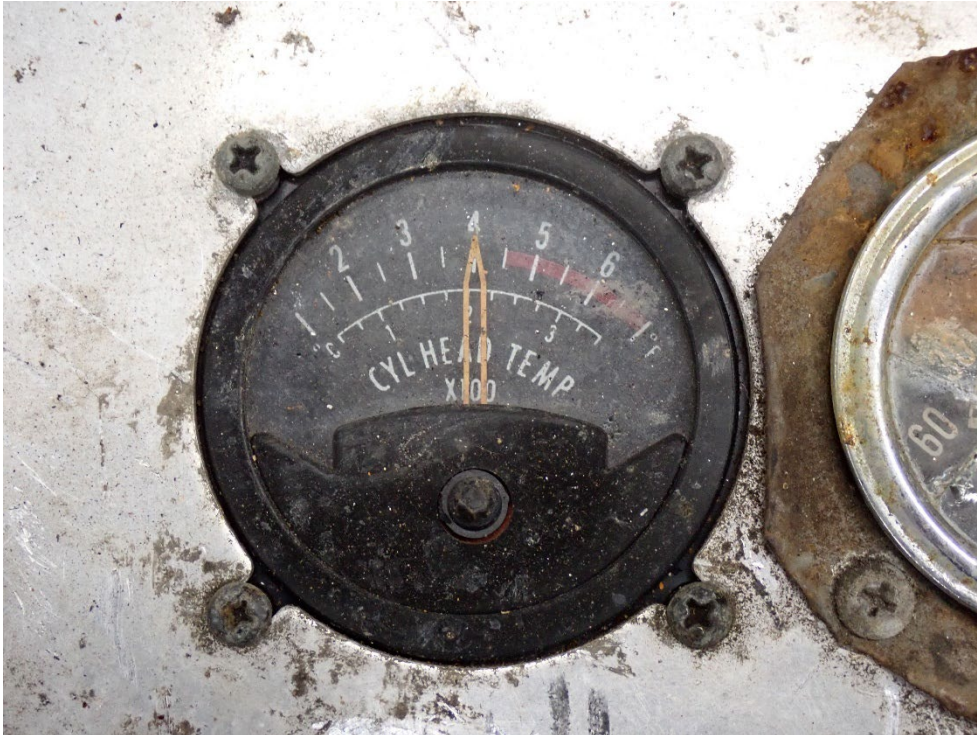
The Cylinder head temperature gauge was stuck at the 400°F mark.

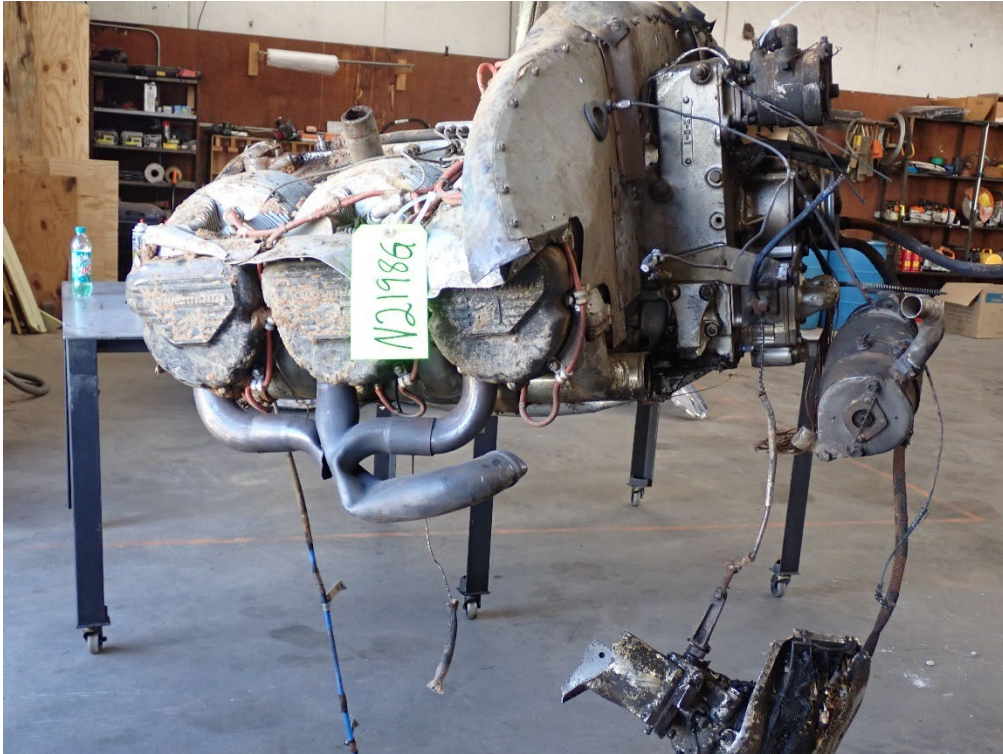
The engine was located forward of the burnt fuselage area free from it's mounts but partially attached to control cables and wires. The engine was impact separated from its mounted position and had dried mud coated on the exterior. The propeller hub assembly separated from the crankshaft forward of the nose seal. The carburetor was separated from the induction manifold and remained attached and hanging from the control cable. The throttle, propeller and mixture levers, as well as the carb heat control lever, were found in their full forward positions.

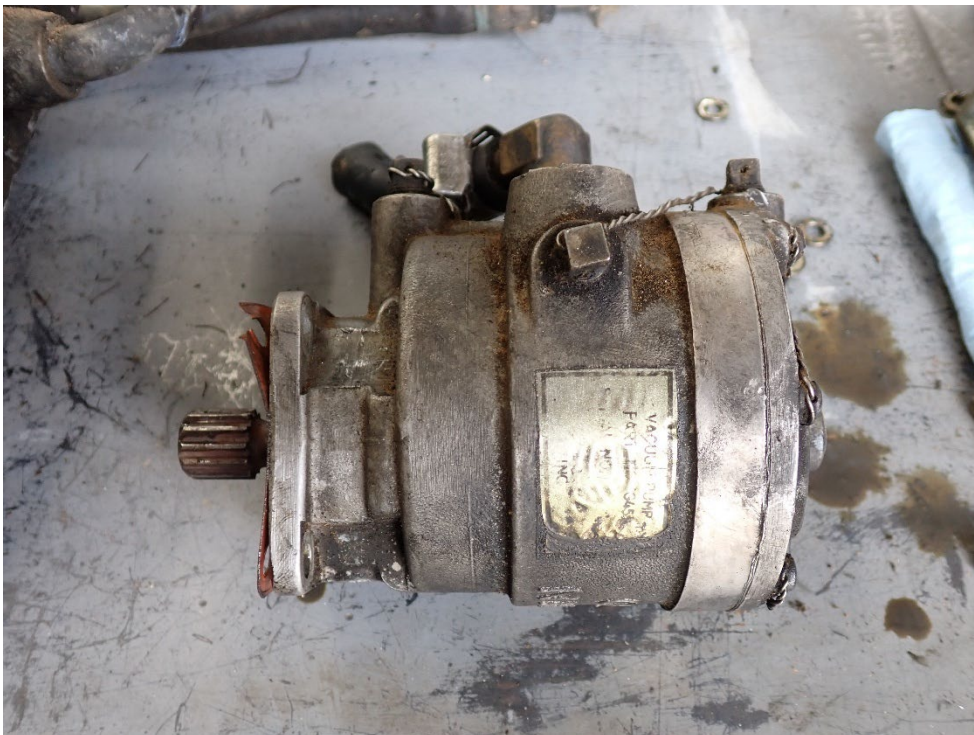
The vacuum pump was removed from the accessory case, the drive shaft remained intact, and no external anomalies were noted.

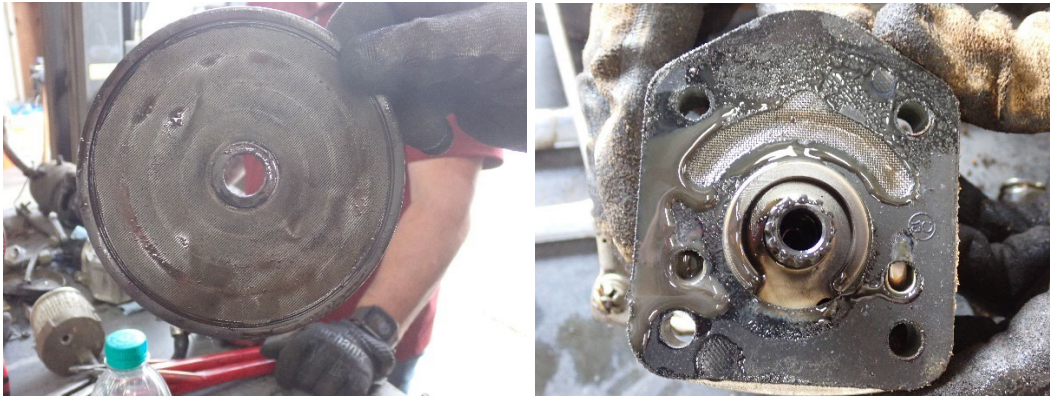
The crankshaft was rotated manually through the vacuum pump drive. Thumb compression and valve train continuity were established. The right magneto was impact separated from its mounting position. Both magnetos produced spark on all leads when rotated by hand. The STC oil filter, the oil sump screen, and the prop governor screen were all clean.

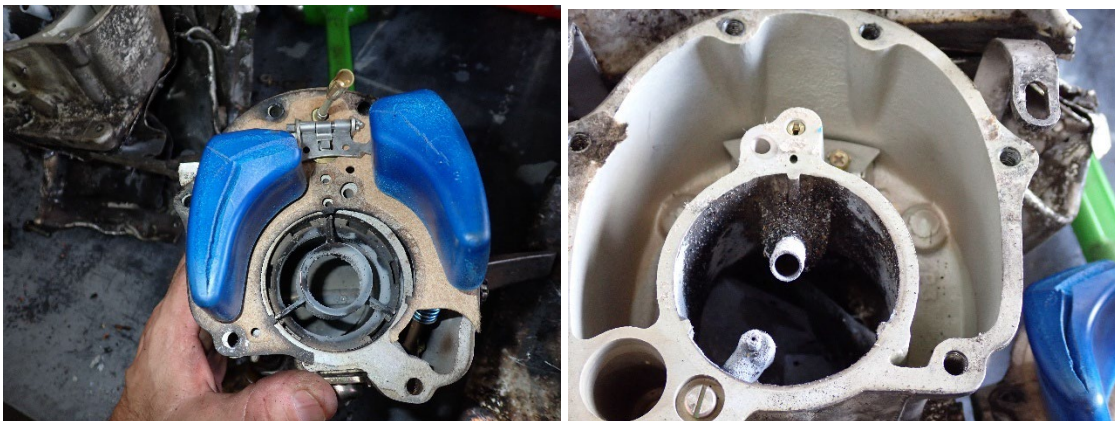
The carburetor was disassembled. The carburetor floats were the foam type and showed signatures consistent with thermal damage.

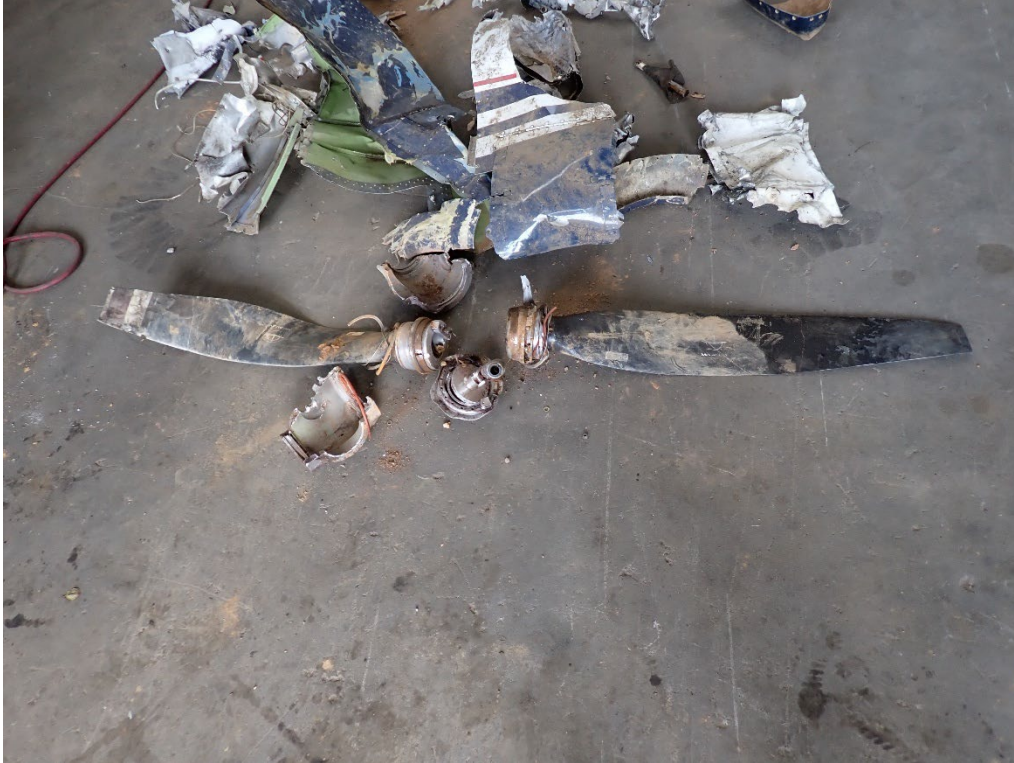
The STC installed, 2 bladed, variable pitch propeller assembly separated from the crankshaft. Both blades were lodged in the ground and when removed they were found free of the impact damaged propeller hub. The blades exhibited s-bending, leading edge damage, and some chordwise scratching.

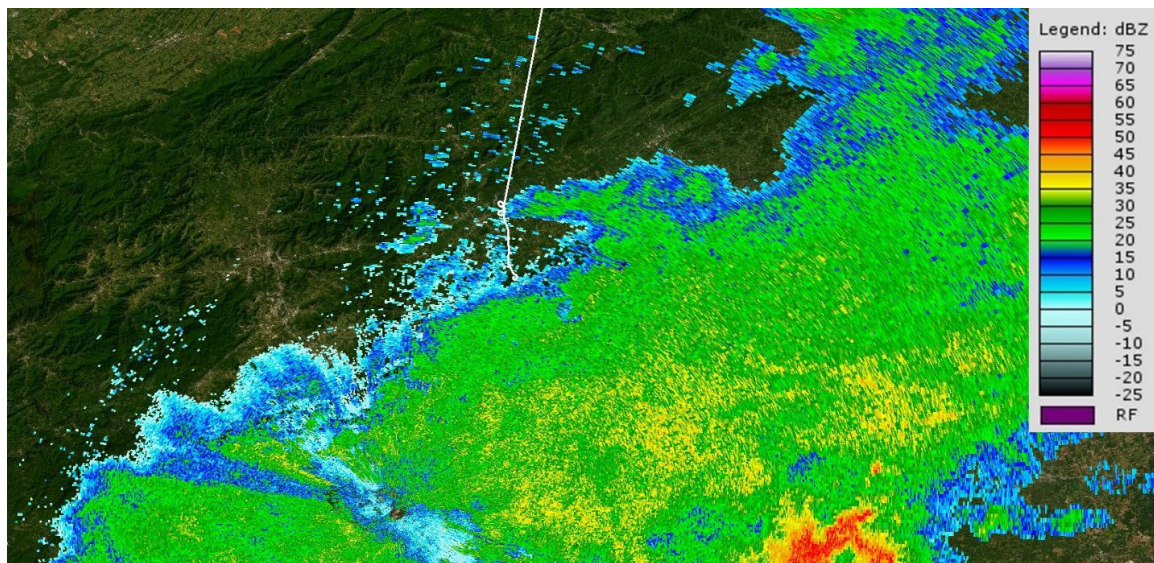
Weather radar data indicated that the accident aircraft's flight path terminated in an area of what was likely light rain. Precipitation can reduce visibility and lower ceilings. Weather model data identified an atmosphere that was conducive to clouds down to 1,800 feet amsl. At 2105, the FQD AWOS reported a calm wind, visibility of 7 statute miles, light rain, ceiling overcast at 700 feet above ground level (agl), temperature of 22°C and dew point temperature of 22°C, altimeter setting of 30.09 inches of mercury. The automated station with a precipitation discriminator detected lightning beyond 10 statute miles to the southeast, with a precipitation rate of 0.01 inches per hour. Meteorological data supported the presence of ceilings down to 1,800 feet, or possibly lower, in rain.
