ERA24FA294

## INVESTIGATION PHOTOGRAPHS

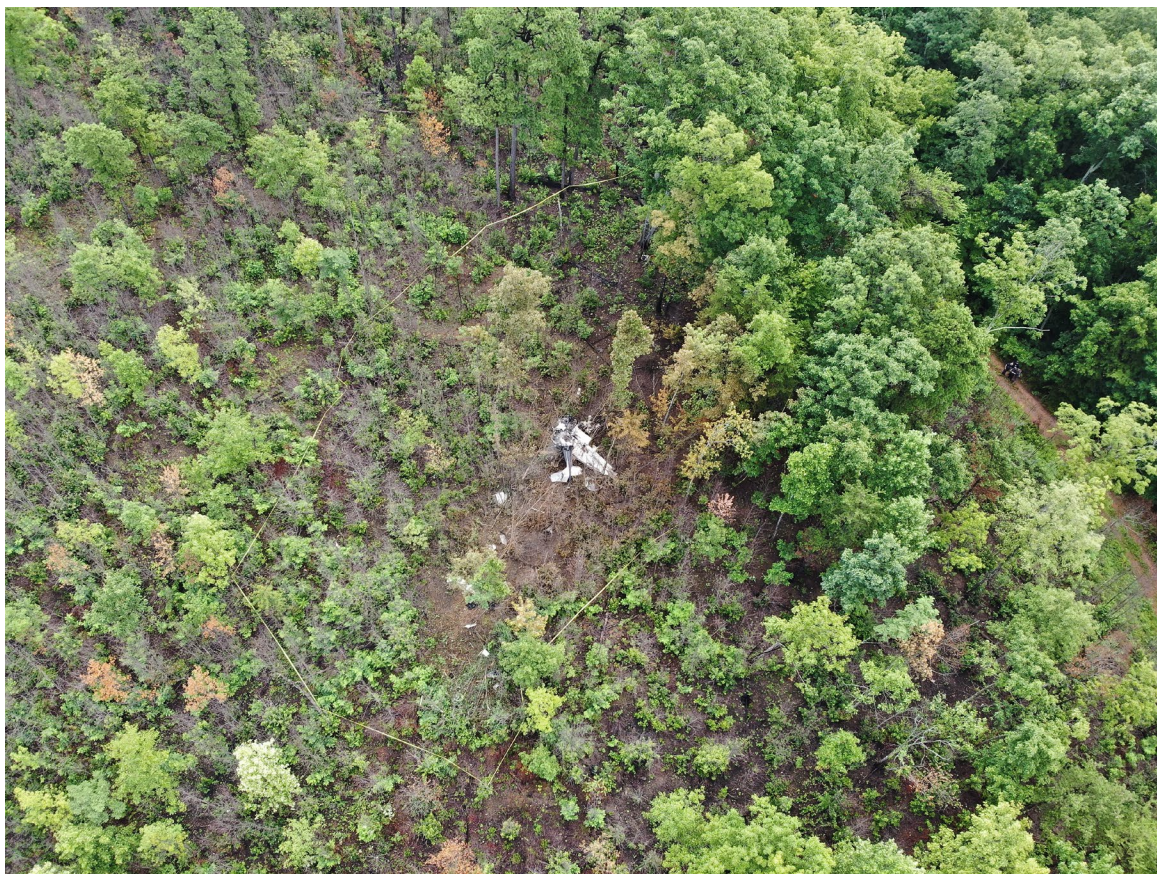
**Photograph 1 - Aerial view of accident site and wreckage (Courtesy of North Carolina State Police)**

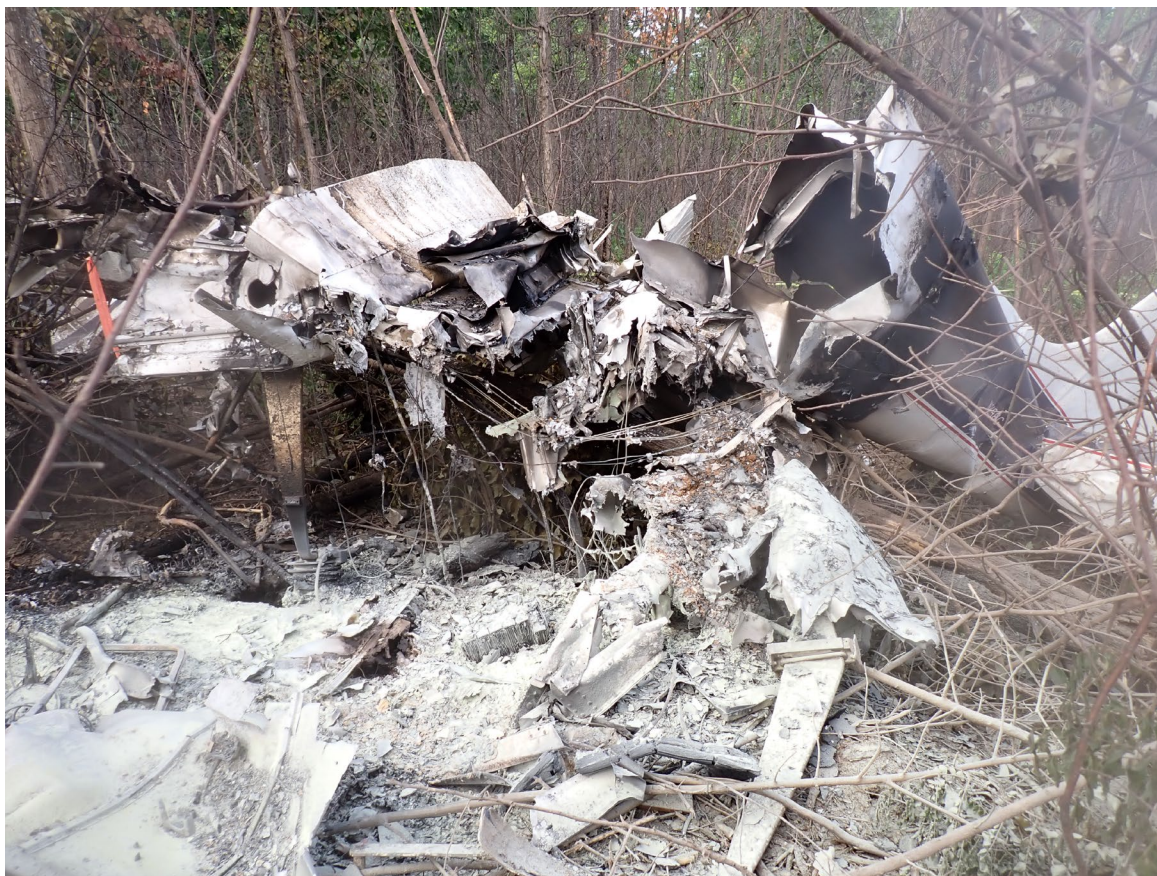
**Photograph 2 - Remains of the fuselage with tail and wing sections. (Courtesy of NTSB)**

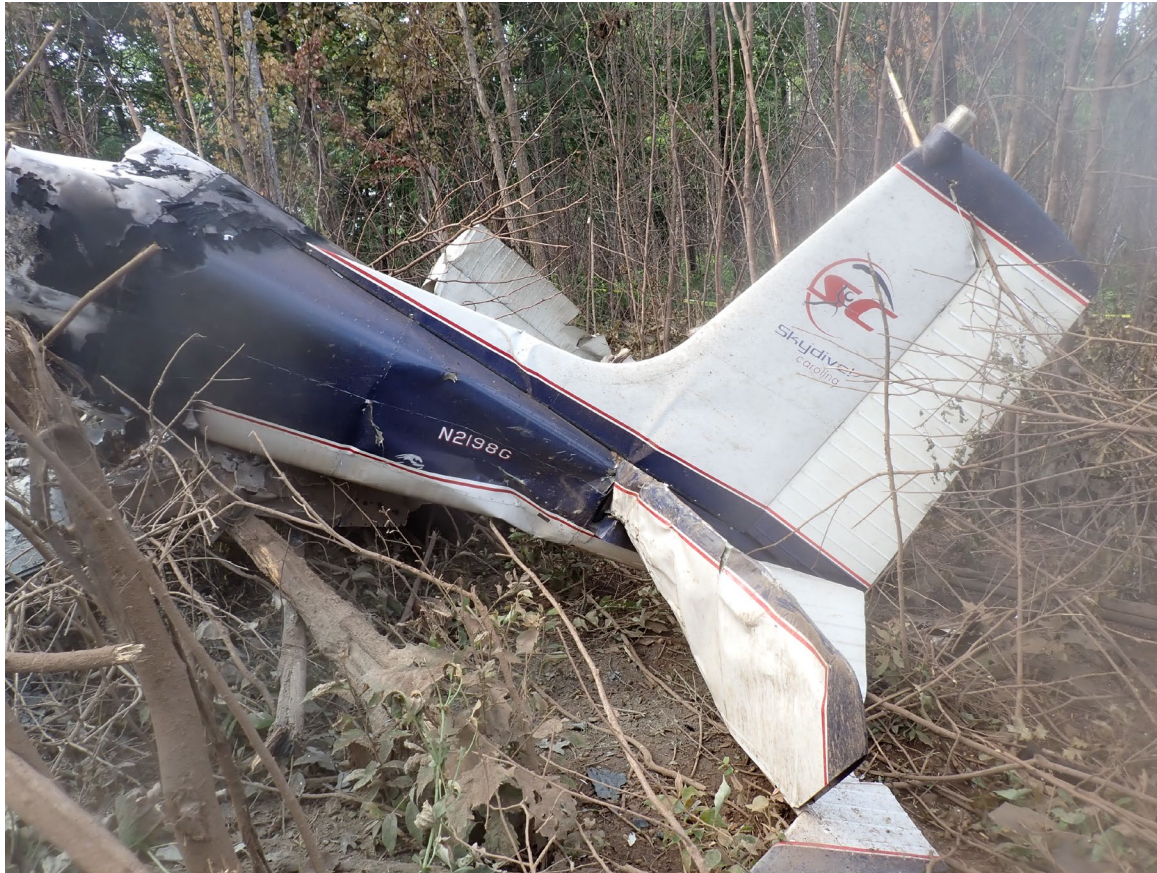
**Photograph 3 - Empennage with damaged structure, damaged left horizontal stabilizer and elevator and wrinkling of the vertical stabilizer. (Courtesy of NTSB)**

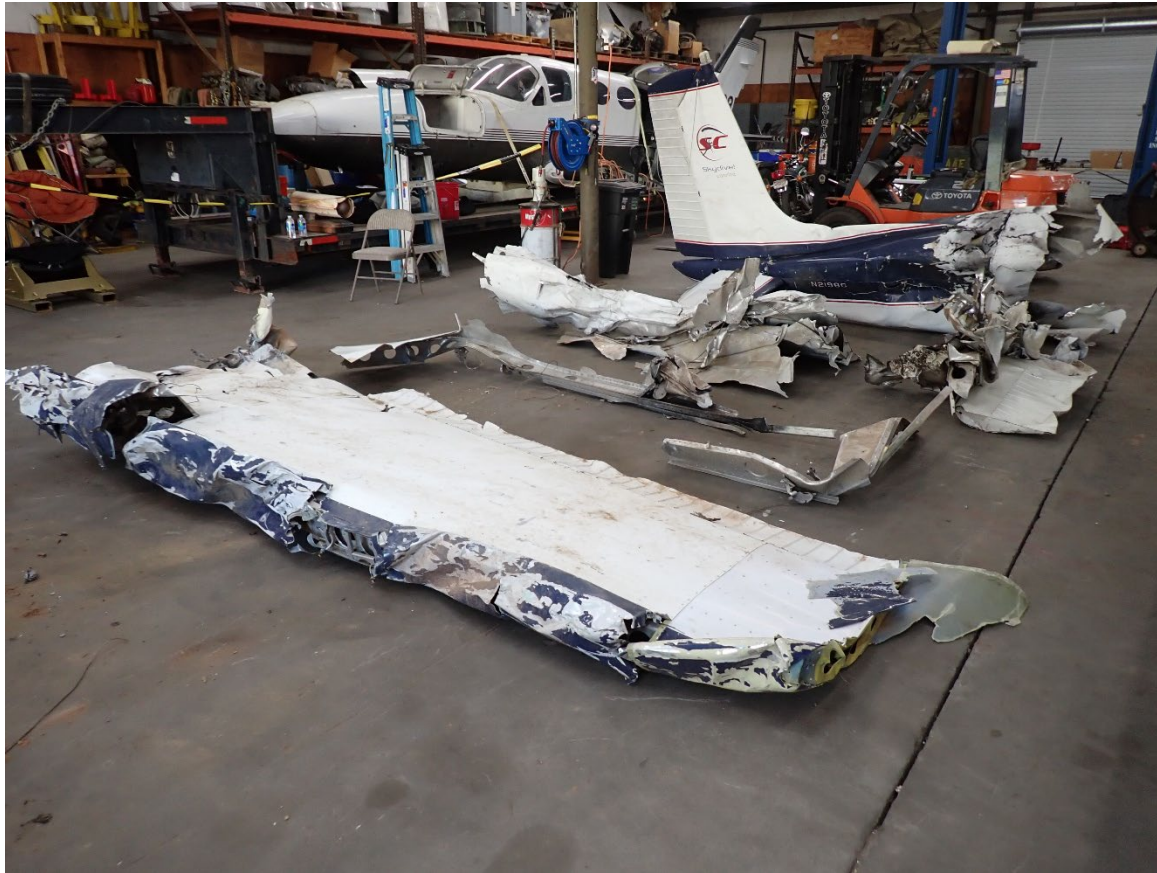
**Photograph 4 - Left wing with leading edge, tip and root damage, damaged aileron and crushed flap. (Courtesy of NTSB)**

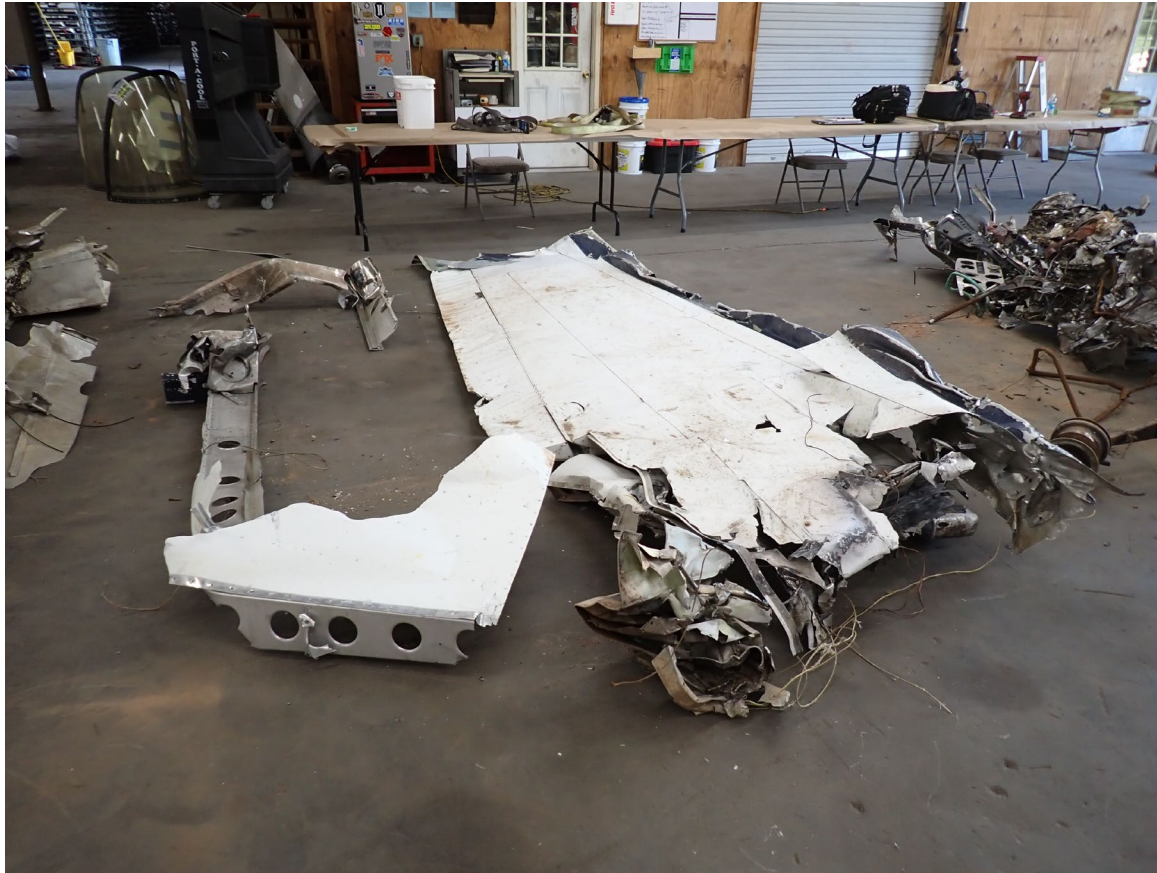
**Photograph 5 - Left wing with leading edge, tip and root damage, damaged aileron and crushed flap. (Courtesy of NTSB)**
