## **Examination Summary**

NTSB ACCIDENT NUMBER: ERA24FA301

ACCIDENT LOCATION: Aguadilla, Puerto Rico

AIRCRAFT MAKE: Cessna 402B

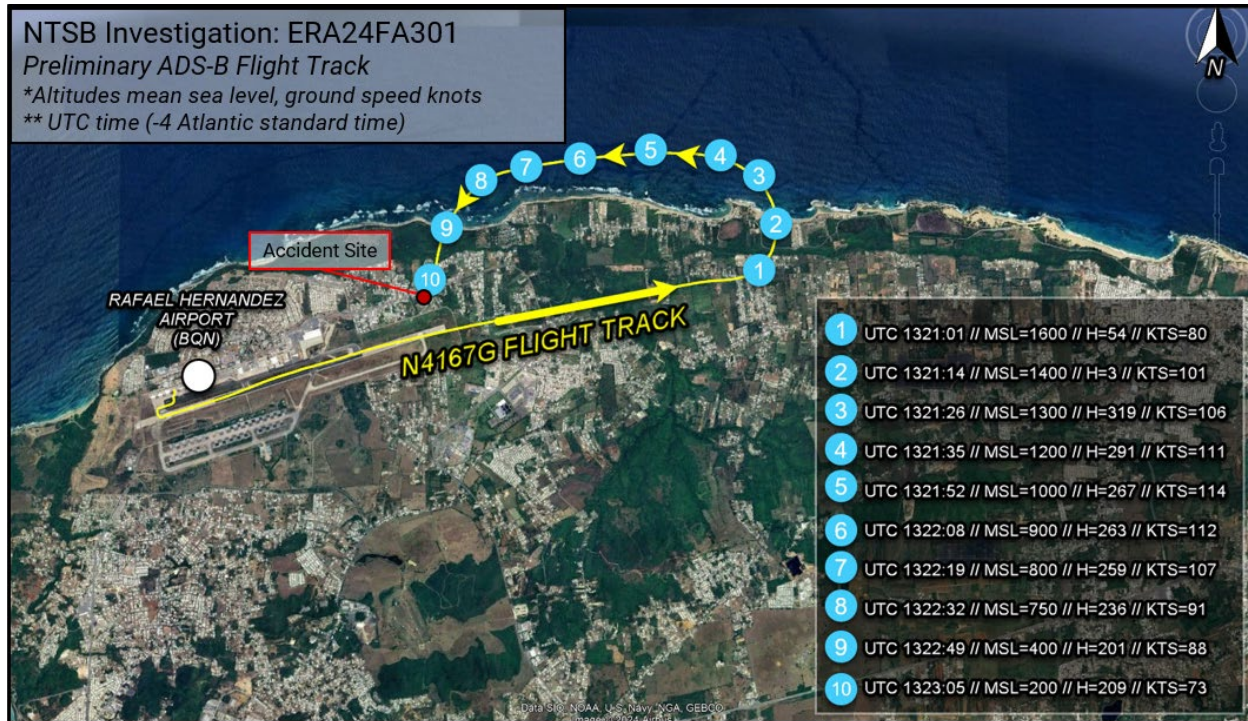
Figure 1: ADS-B Flight Track.

According to Federal Aviation Administration (FAA) ADS-B data, the airplane departed runway 8 and climbed to about 1,200 ft above ground level about 2 miles east of the end of runway 8. The airplane then circled to the left and began a descent in a left downwind. When the airplane reached about one mile northeast of the field, the track turned directly towards

the approach end of runway 26. In the final 30 seconds of data, the altitude and airspeed continued to decrease rapidly. The final recorded position showed the airplane about .30 miles northeast of the runway 26 threshold at 200 ft mean sea level, 73 knots ground speed. Figure 1 shows the ADS-B flight track, the airport environment, and the accident site.

According to FAA air traffic control audio, shortly after the pilot departed runway 8 on upwind he asked to return to the airport due to a rough running No. 2 engine. The pilot was cleared to enter the left downwind for runway 8. Subsequently, while in the downwind, the pilot declared Mayday and was cleared to land. There were no further communications from the pilot after the mayday call.

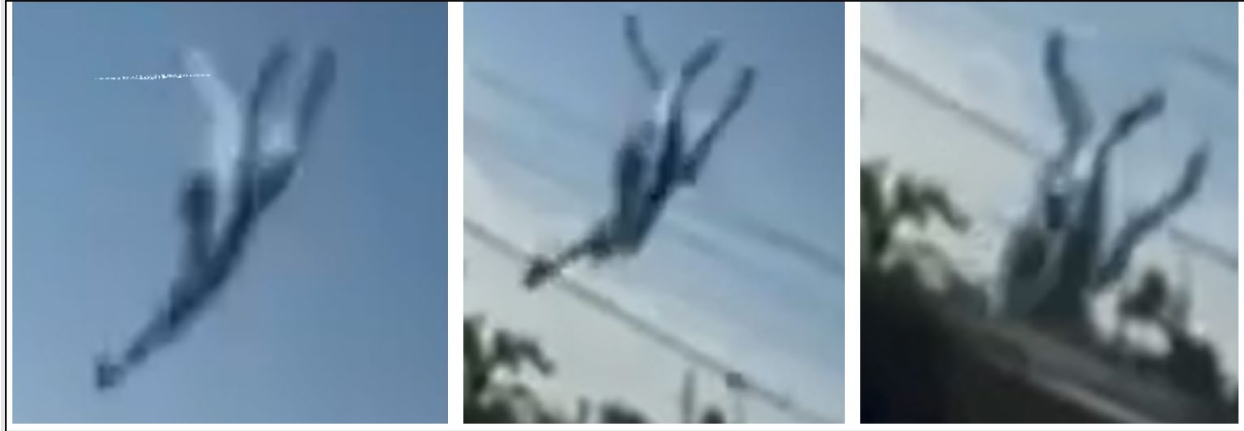
*Figure 2: Social media video showing the final seconds of flight.*

A video posted to social media shortly after the accident captured the final few seconds of flight. The video showed the airplane in a steep vertical descent and right roll. Upon impact an explosion and post-crash fire was observed. The landing gear appeared to be retracted.
