# National Transportation Safety Board

ERA24FA301

## **ENGINE EXAMINATION**

Location: Aguadilla, Puerto Rico  
Date: July 11, 2024  
Time: 0923 Atlantic standard time  
Airplane: N4167G, Cessna 402B

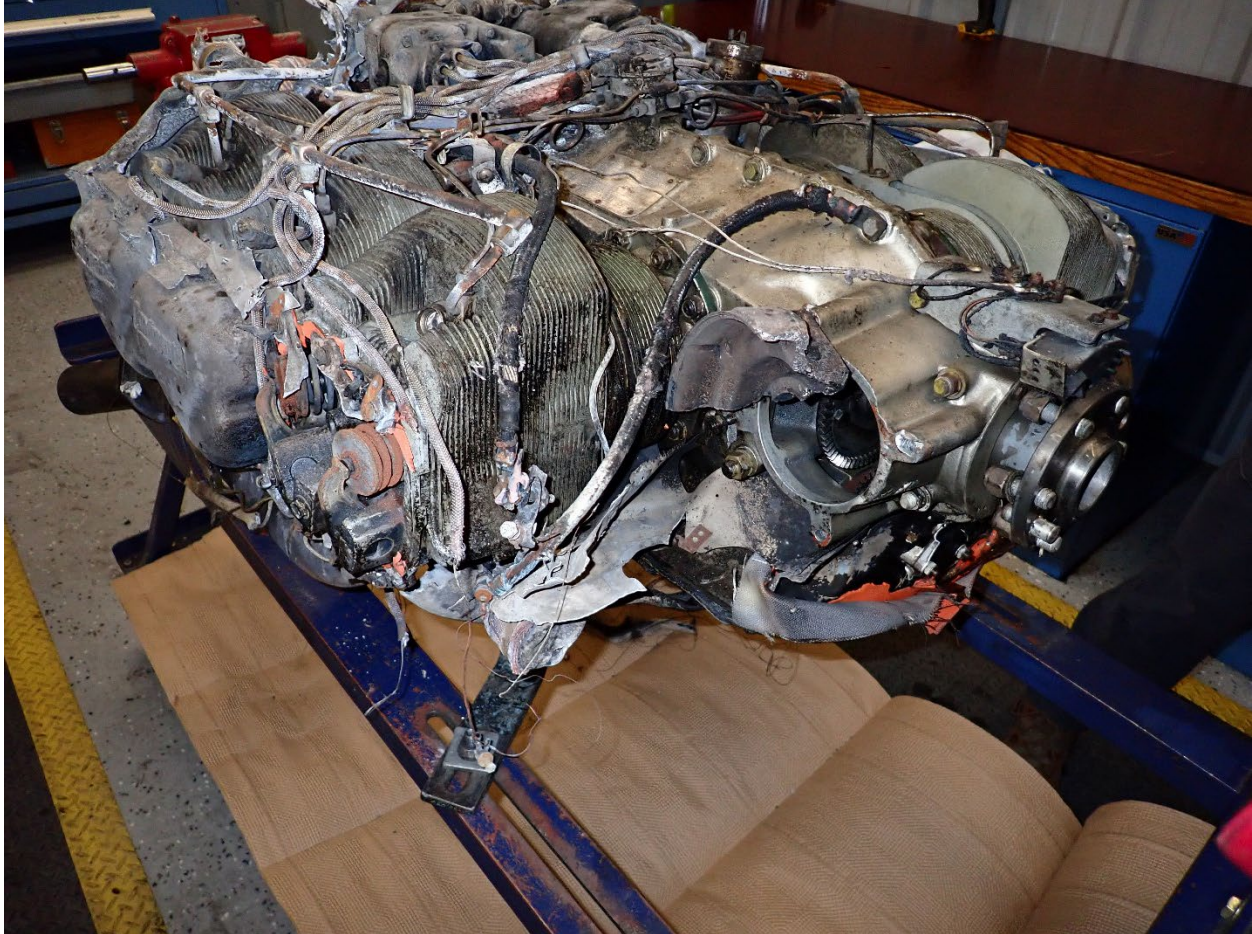
**Figure 1: Overview of the Right Engine**

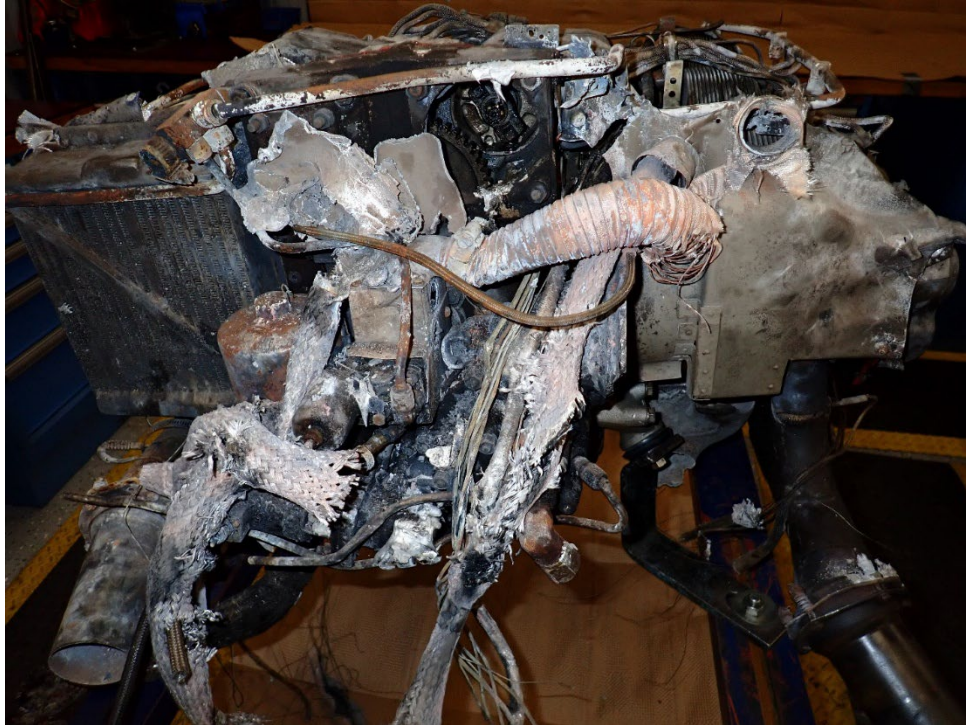
**Figure 2: Aft Section of the Right Engine**

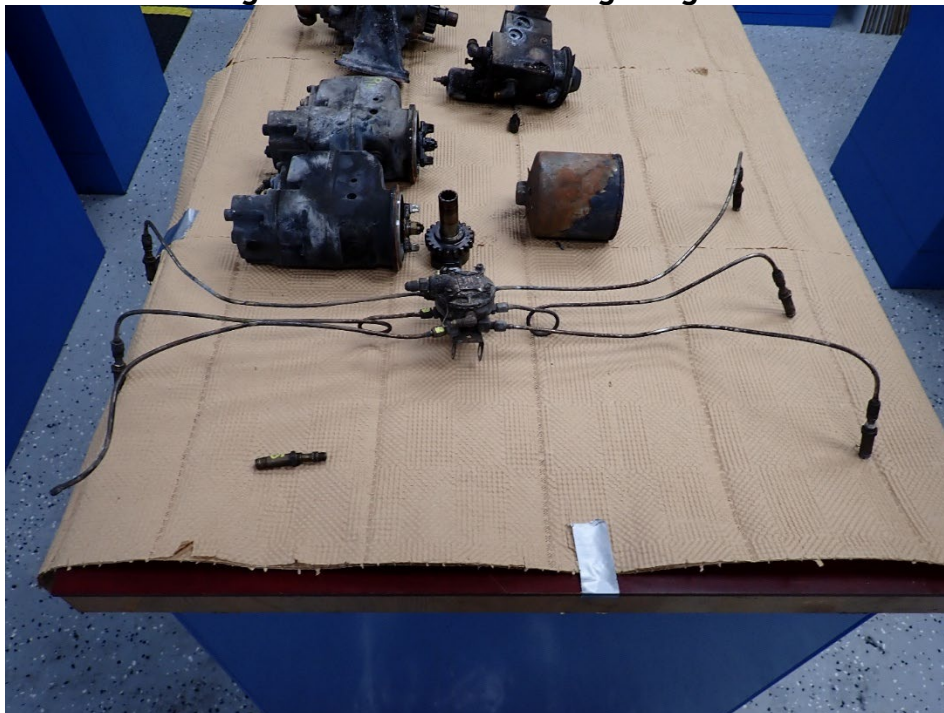
**Figure 3: Damage to the Accessories as Removed**

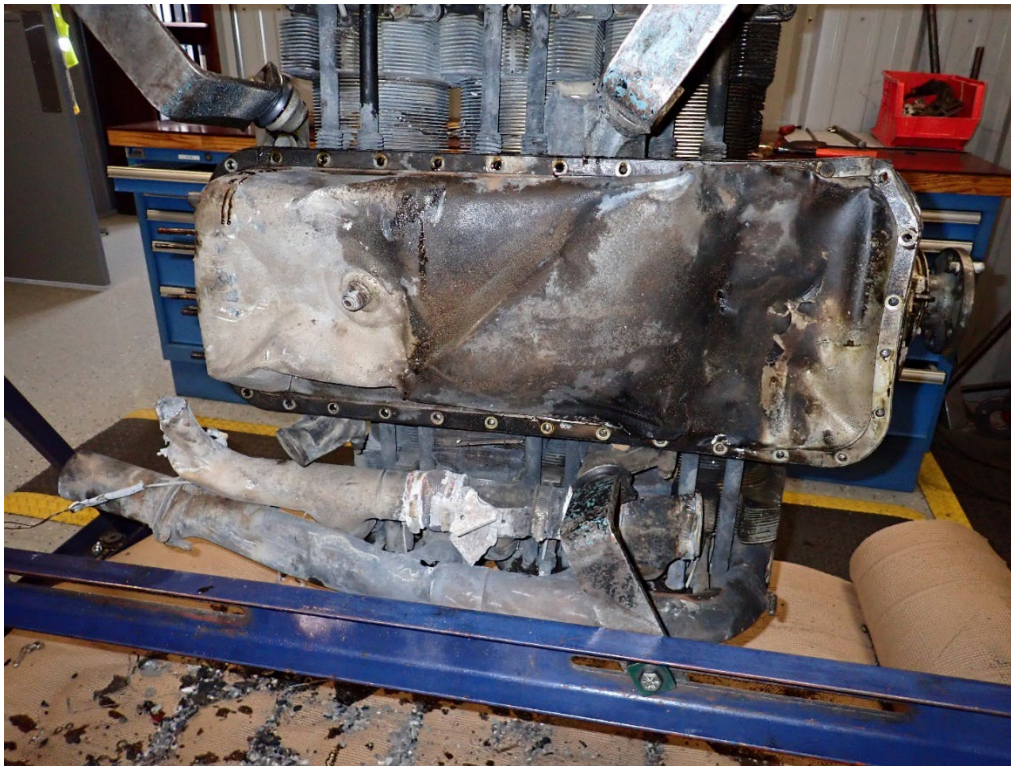
The engine oil filter element was destroyed. There was minor debris found within the oil sump and the oil sump had impact damage. The oil pump was undamaged and there were no scoring signatures. The oil cooler was impact damaged but there were no visible leaks.

**Figure 4: Damage to the Oil Sump Housing**

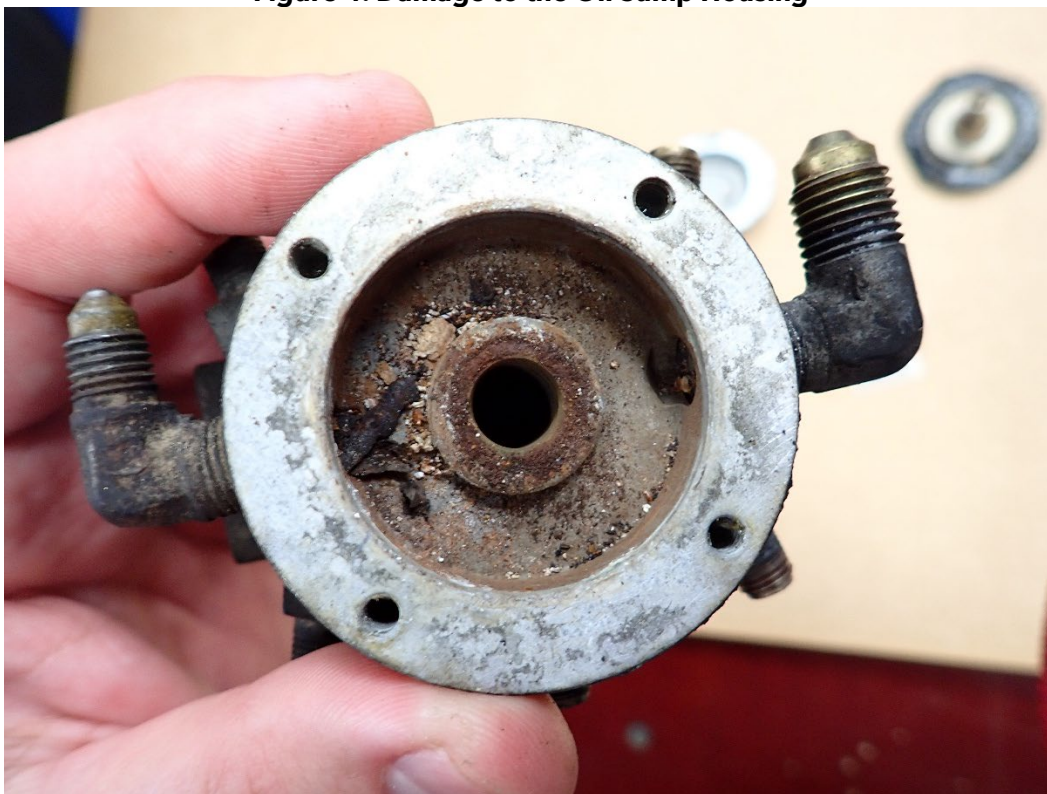
The right engine rotated 720° when force was applied to the crankshaft flange. Cylinder compression and valve action movement were observed on all cylinders. Both magneto condensers were damaged by thermal forces and the magneto's produced blue spark when a replacement condenser was added. The fuel manifold was damaged by thermal forces and was opened for further investigation. Visible corrosion and remains of diaphragm material were present. Below the screen at the fuel inlet within the manifold was a large quantity of debris and foreign material that was likely present prior to the accident.

The fuel servo was not shipped with the engine. The engine driven fuel pump remained attached to the accessory case but was damaged by thermal forces. The fuel pump coupling was intact, and the drive rotated freely. The fuel manifold was damaged by thermal forces and was opened for further investigation. Visible corrosion and remains of diaphragm material were present. Below the screen at the fuel inlet within the manifold was a large quantity of debris and foreign material that was likely present prior to the accident. The fuel lines from the fuel manifold to the fuel nozzles were secured. The fuel nozzles were unobstructed.

**Figure 5: Debris Found Within the Fuel Manifold**

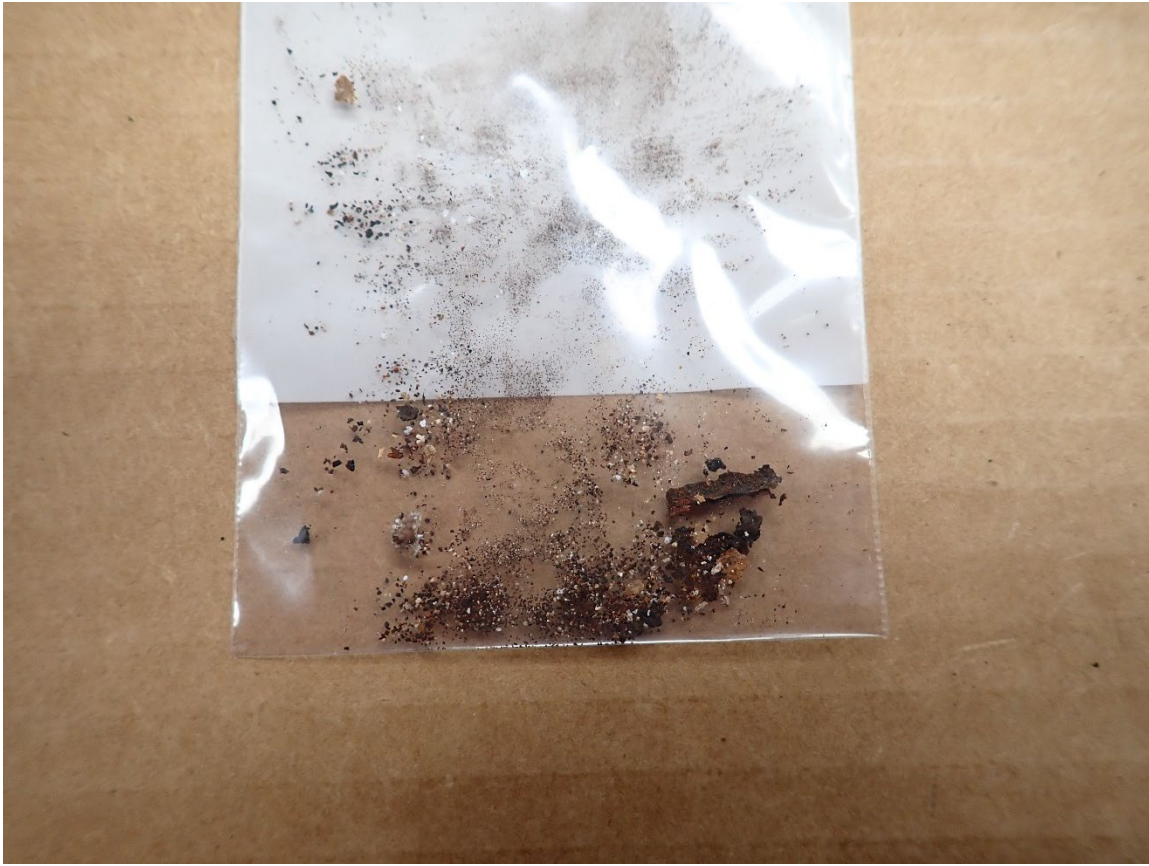
**Figure 6: Bagged Debris Removed from the Fuel Manifold**

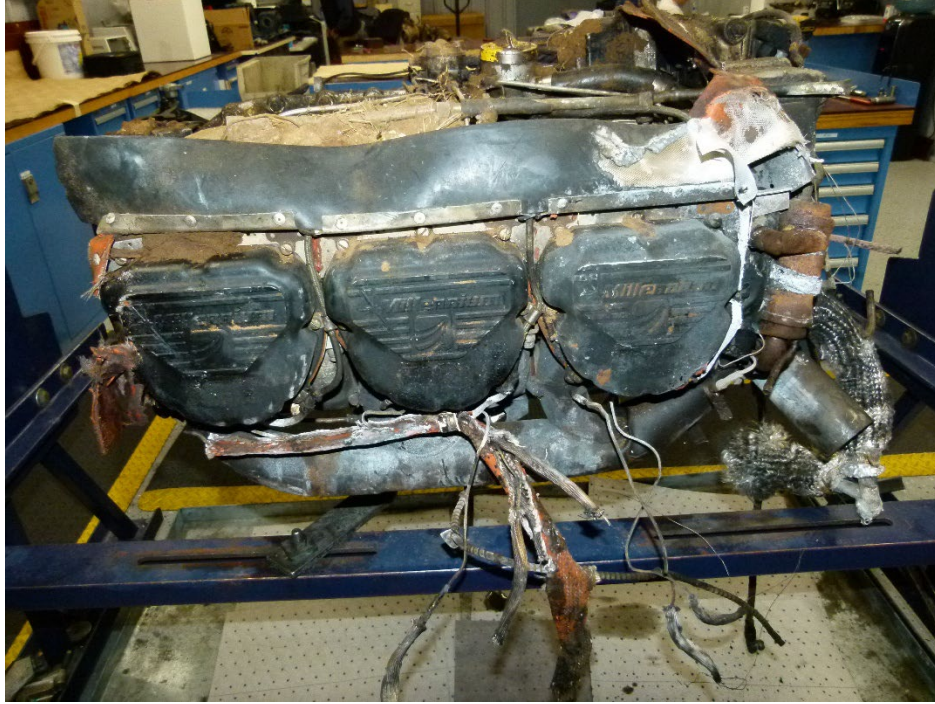
**Figure 7: Left Engine Overview**

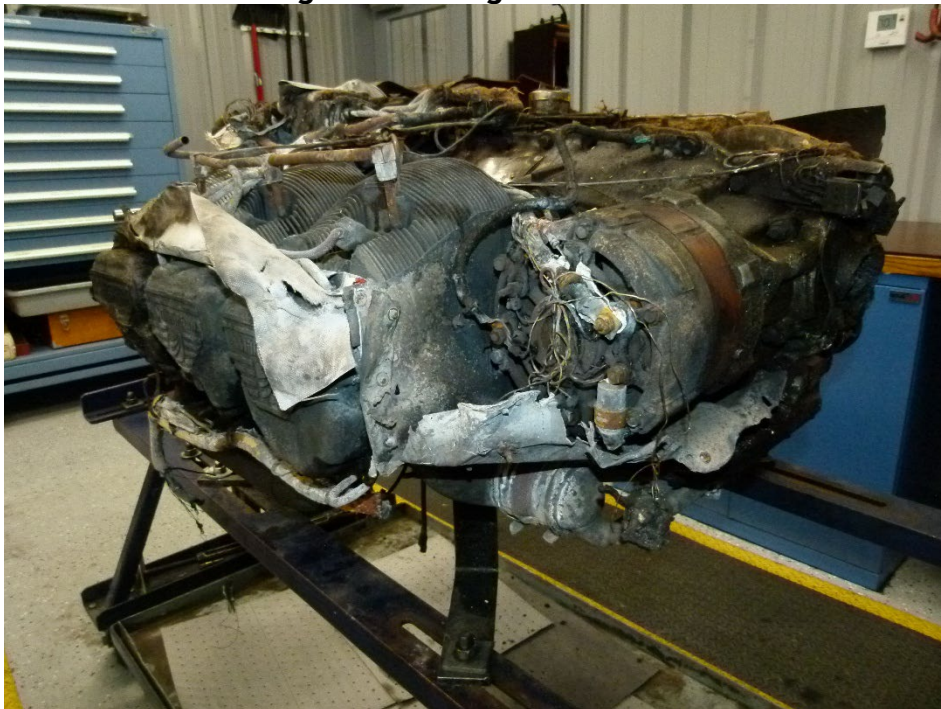
**Figure 8: Left Engine Overview**

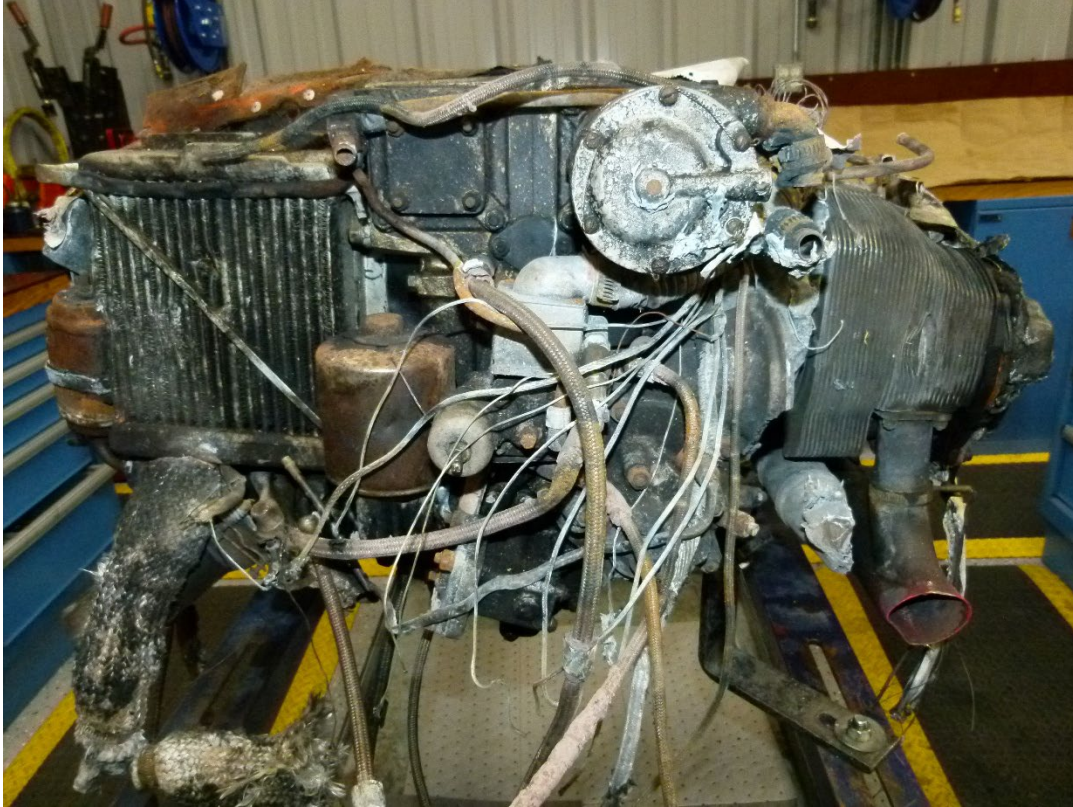
**Figure 9: Aft Section of the Left Engine**
