# National Transportation Safety Board

ERA24FA304

## EXAMINATION

Location: Cuba, Kentucky  
Date: July 13, 2024  
Time: 15:27 Local  
21:27 UTC  
Airplane: Air Tractor, AT-802A, N2003Y

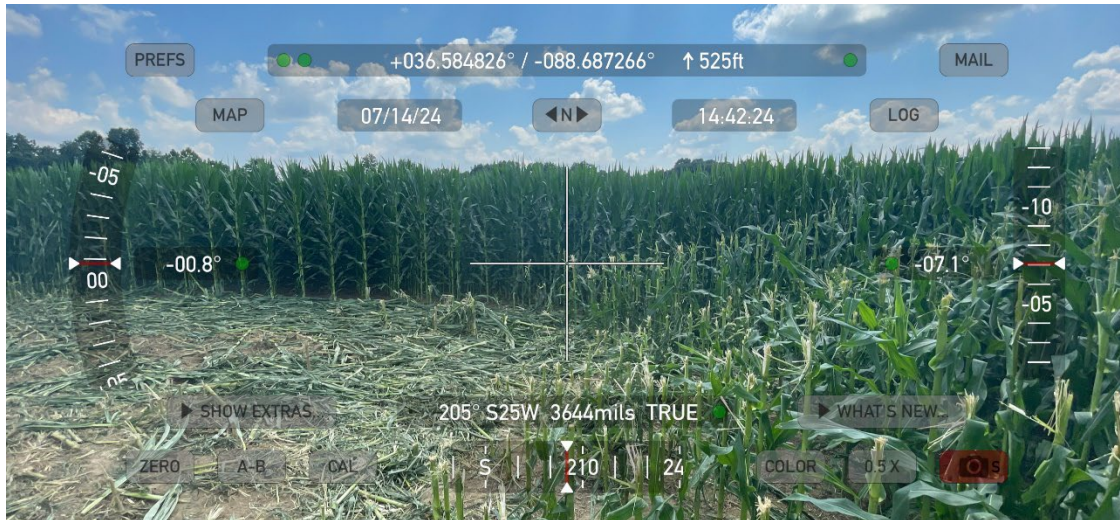
The airplane initially contacted a corn field on the west side of Grover Hall Road. The corn was neatly sliced in a progressively lower pattern in about a 20° angle and approximately 30 rows were displaced. Witness marks from the tail wheel and both main landing gear were observed. The airplane appears to have contacted in a wings level, pitch down attitude. The right wing was raised slightly based on slicing signatures of corn in the debris field. The aircraft then contacted a drainage ditch, slid across Grover Hall Road, and impacted a secondary embankment before coming to

rest in a bean field approximately 50 feet from the road. The wreckage path was approximately 100 feet long.

°**Figure 1 Accident site photo with lat/log, headings, and elevation.**

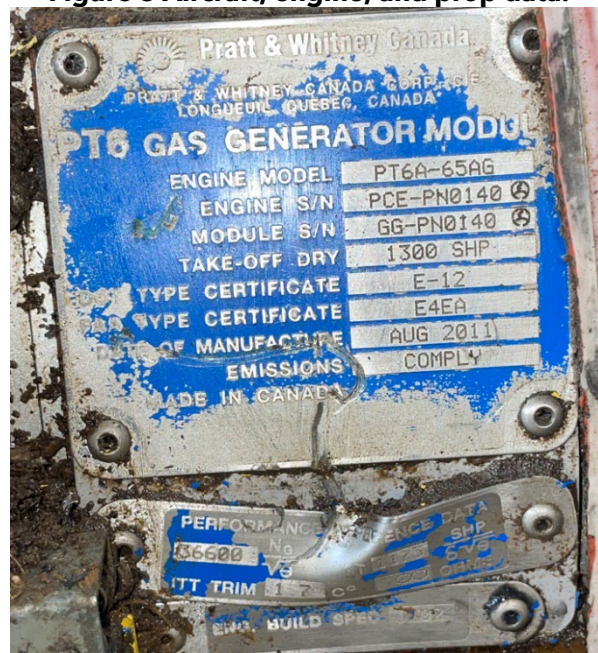
**Figure 3 Aircraft, engine, and prop data.**

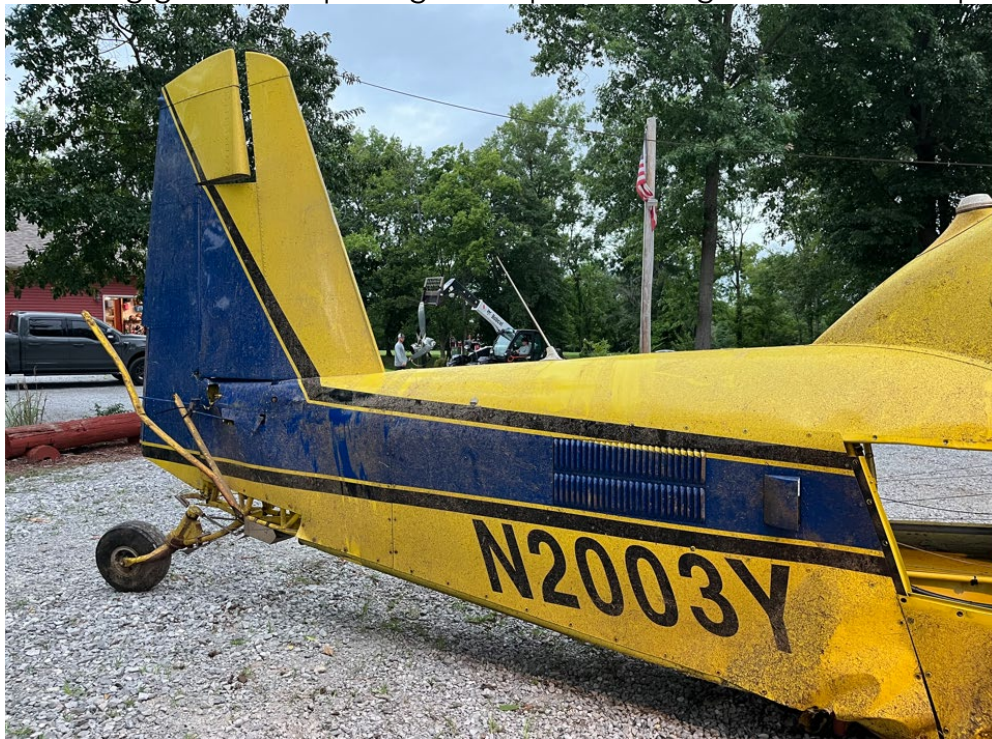
The empennage was mostly undamaged with the exception of the elevators. Bending of the tubular structure on the bottom of the airplane aft of the cockpit was present. Control cable continuity was established from the cockpit to the rudder. The left and right elevators were impact separated during the accident sequence. Control cable continuity was visually established from the cockpit to the elevator mounting points. The right elevator displayed significant leading-edge damage, likely from the right main landing gear tire departing the airplane during the accident sequence.

**Figure 5 Closeup of empennage.**

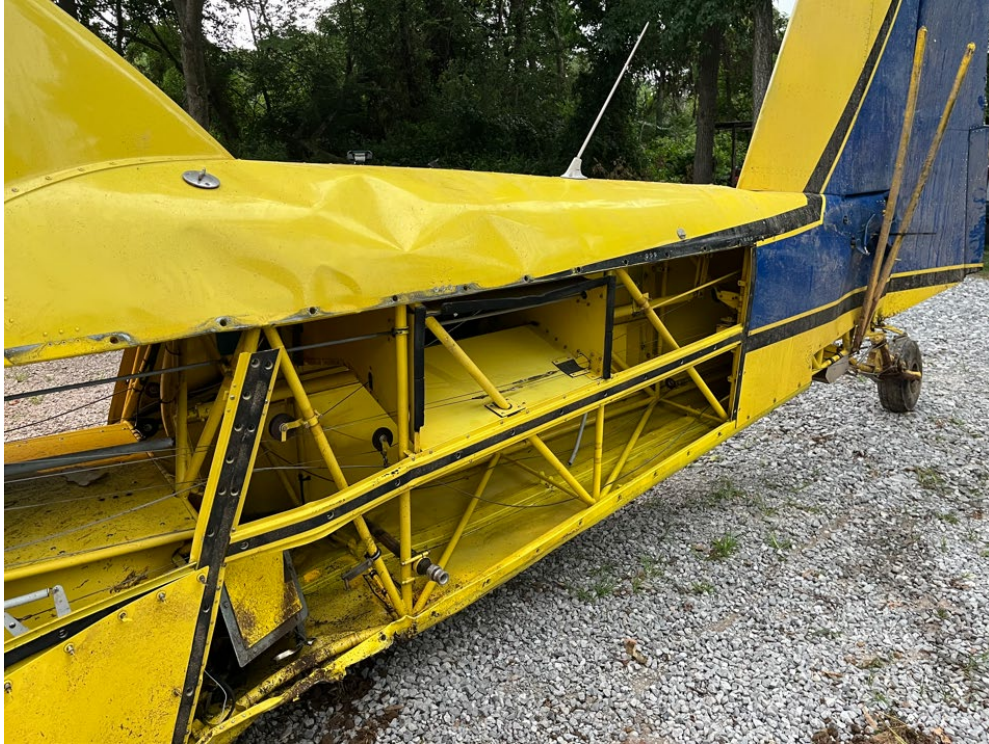
**Figure 6 Empennage with side panels removed.**

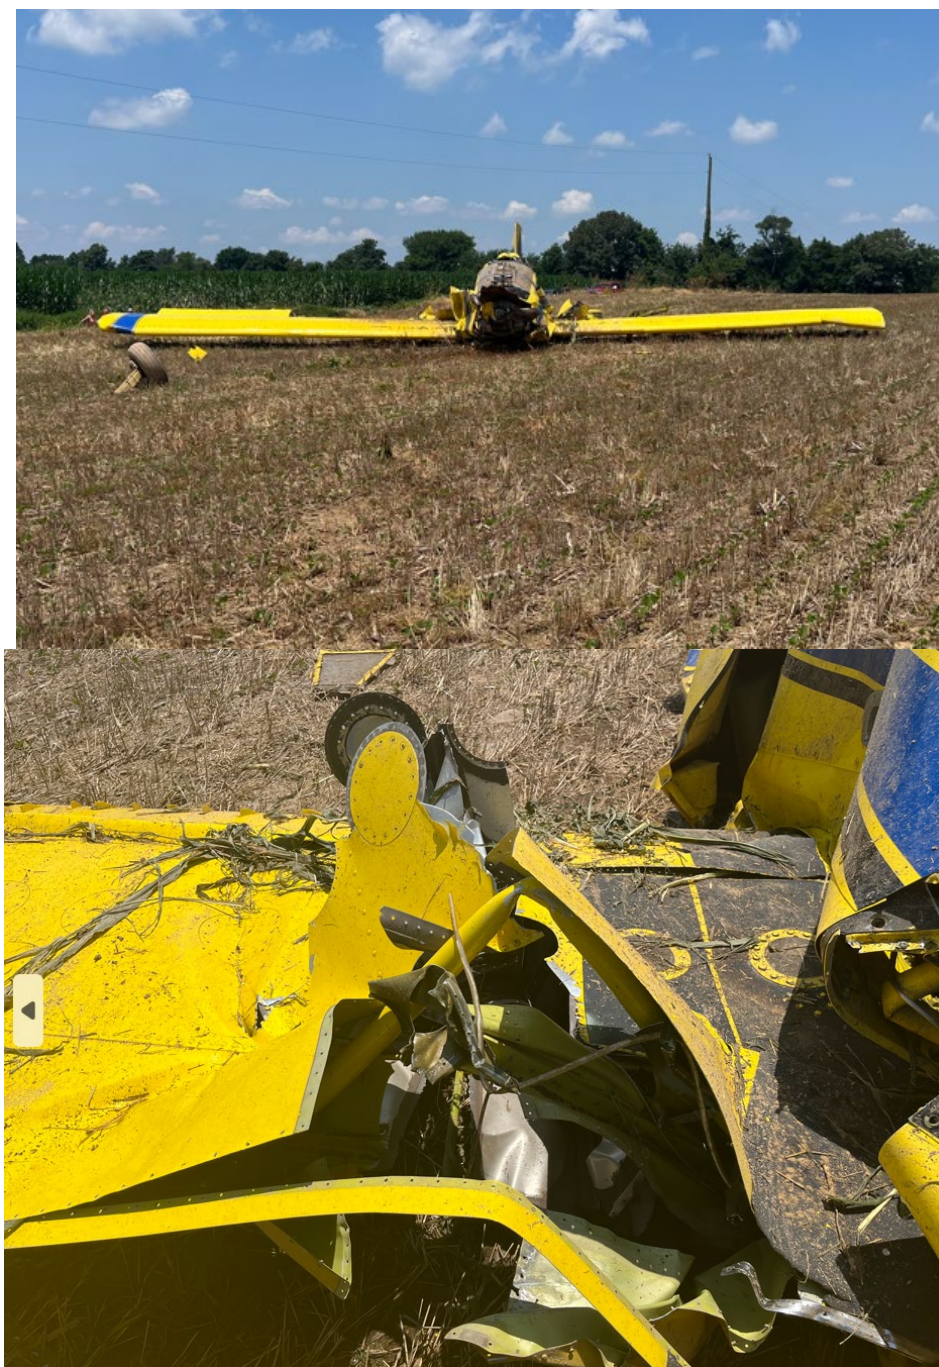
The left and right wings remained attached to the fuselage. Both wings were breached as a result of the impact forces and no fuel was found in either tank. The left-wing tip was separated from the wing. The left flap remained with the left wing but was partially separated. The left aileron was wrinkled. Significant damage was observed at the wing root. The right wing flap was separated from the wing. The right wing was significantly damaged at the wing root. Aileron control continuity was visually established. Fractures on both torque tubes below the cockpit were noted from impact damage.

**Figure 7 Front view of wreckage (above) and wing damage (lower)**

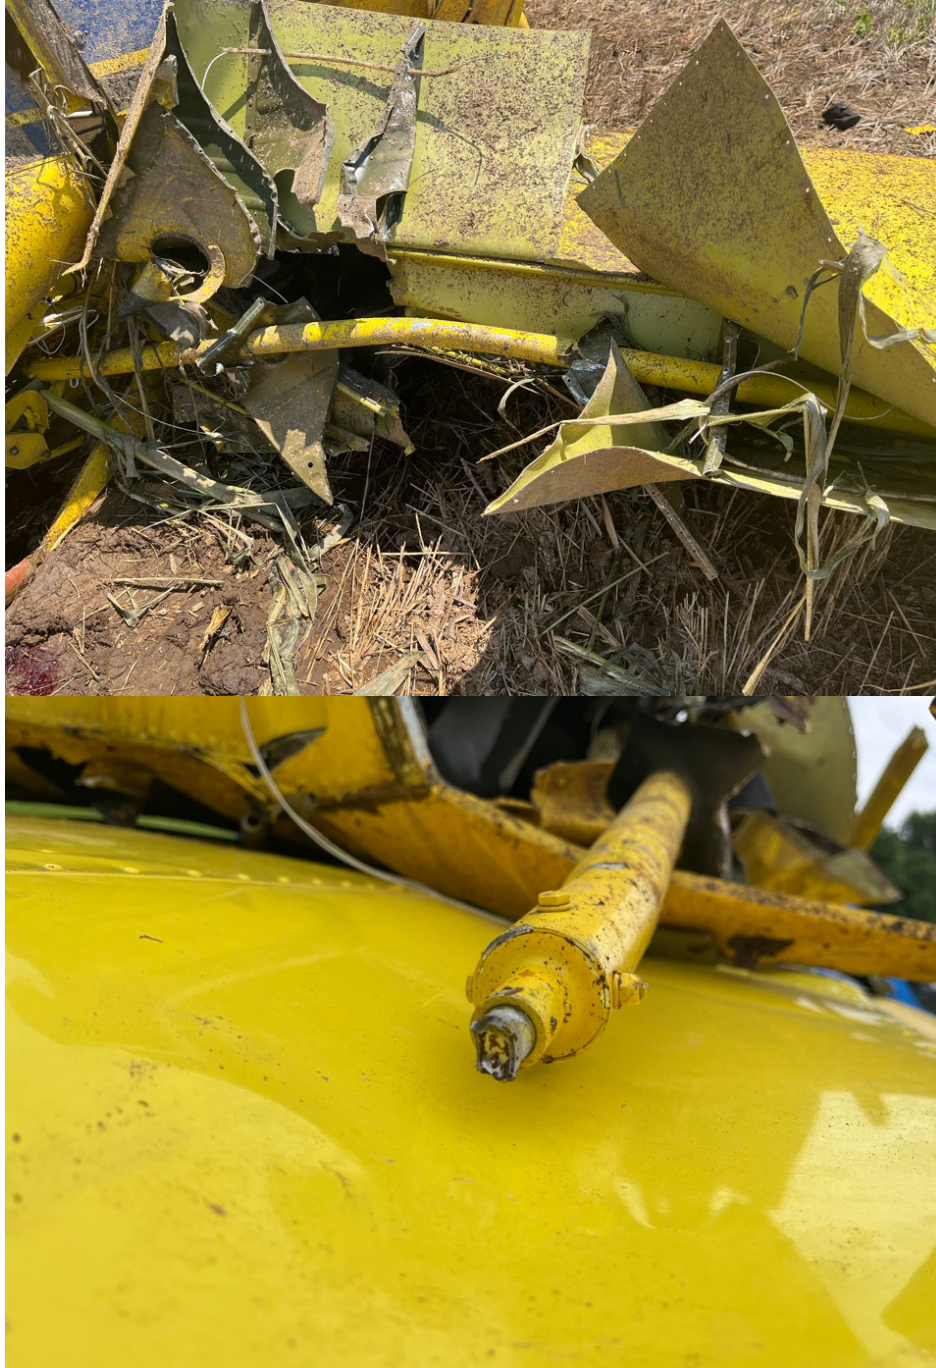
**Figure 8 Wing damage and control rod overload damage.**

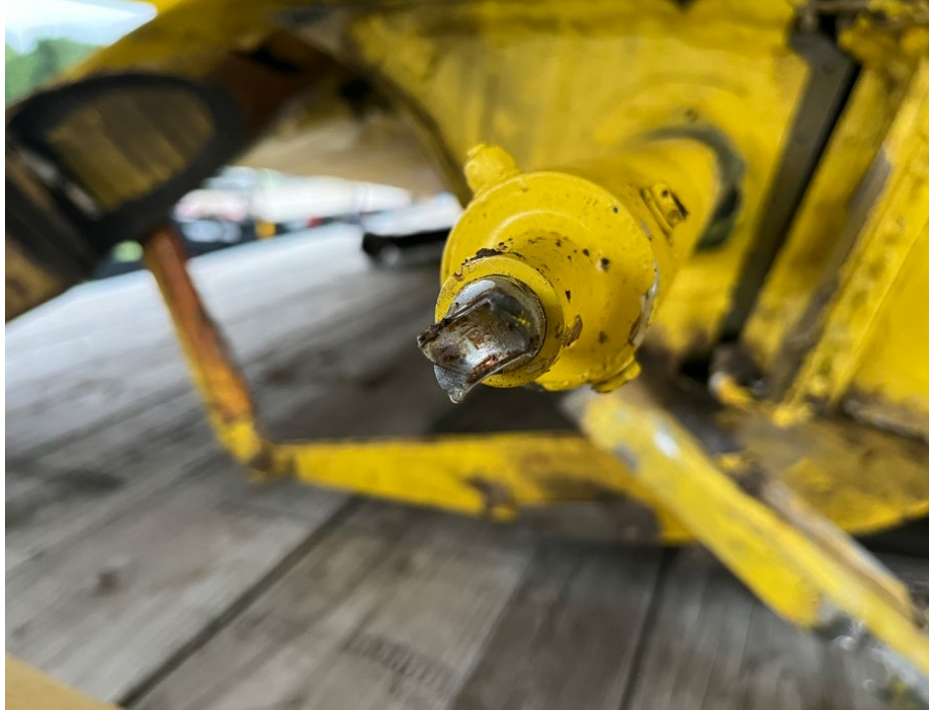
**Figure 9 Control rod overload damage.**

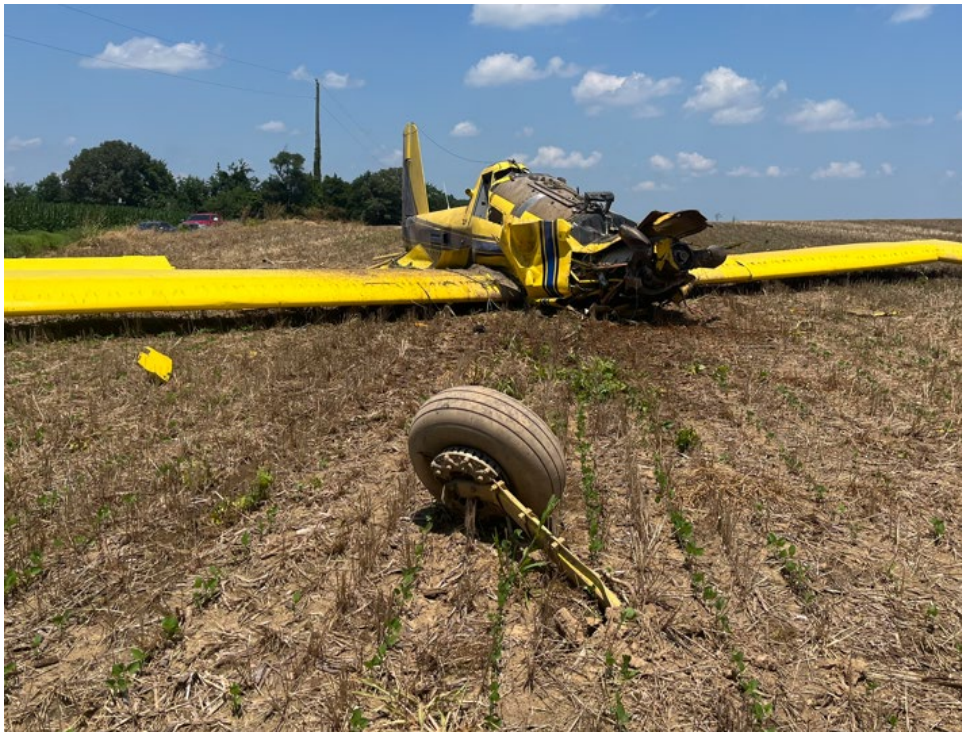
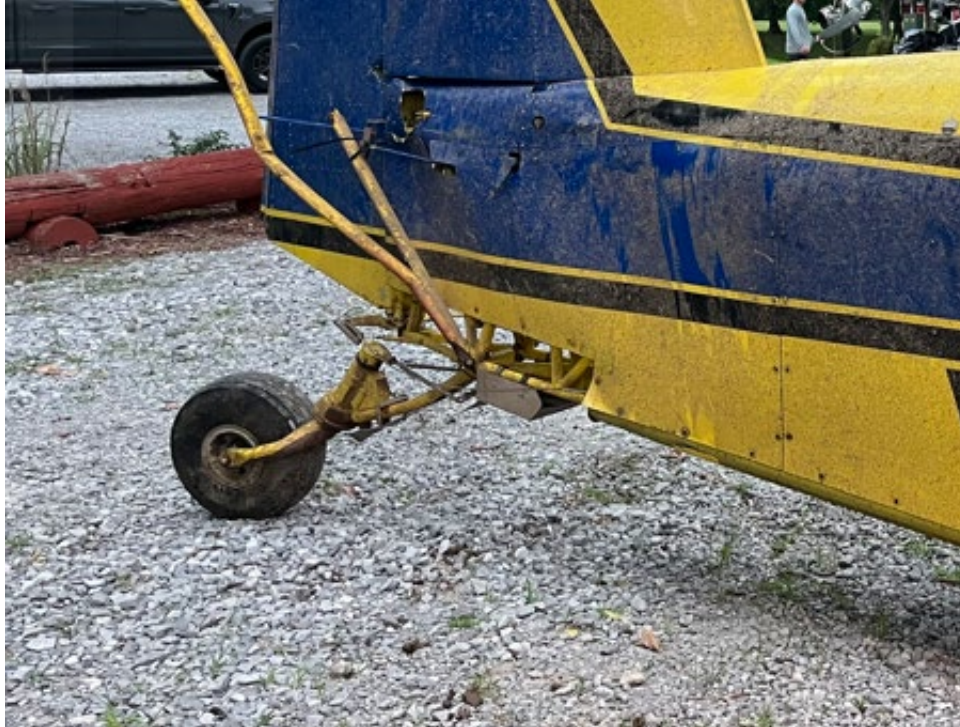
The fuselage was intact and sustained substantial damage to the frame structure in the area surrounding the hopper. The tubular steel structure was bent and fractured on both the left and right sides surrounding the hopper.

**Figure 10 Airframe damage pic (above) with tail wheel (lower)**

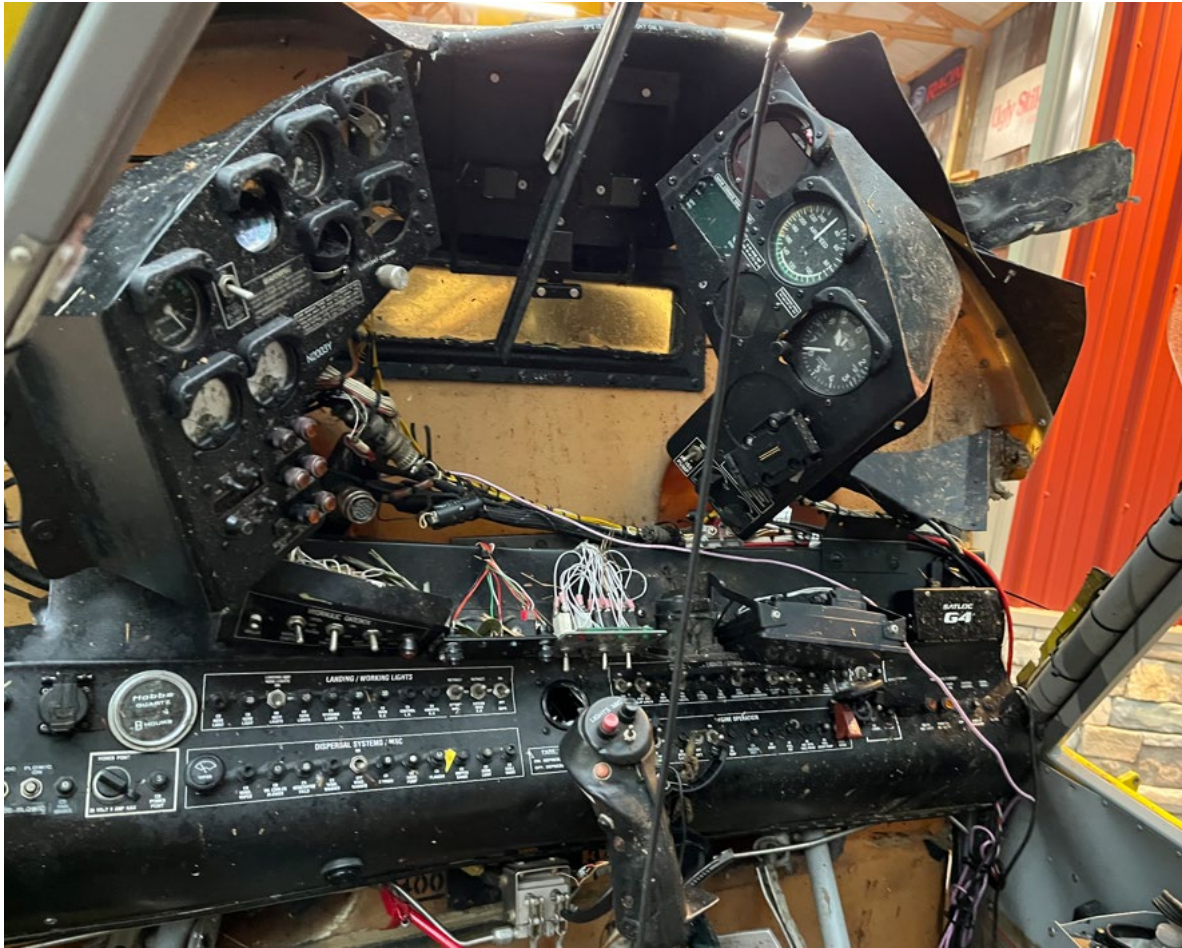
The airplane's Hobbs meter was damaged. The engine instrumentation was displayed to the left of the pilot and the navigation equipment was displaced to the right. The fuel pressure gauge was found off the scale right, the left and right fuel level gauges were off the scale left (0), the oil pressure and temperature gauge were illegible, the torque gauge was "0".

The attitude indicator was electronic. The airspeed indicator reading is "0". The altimeter read approximately 860 feet.

**Figure 11 Instrument panel.**

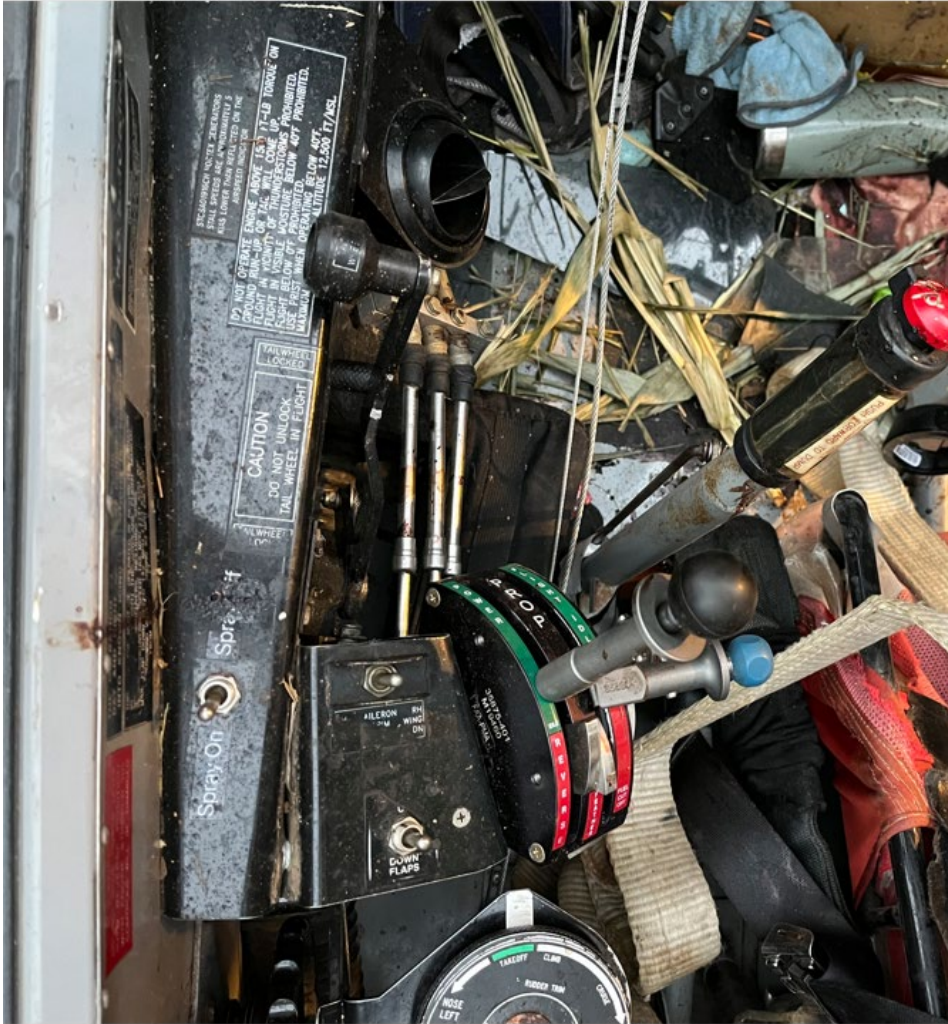
The flaps switch was in the up position. The power lever was approximately  $\frac{1}{2}$ " above "idle". The propeller lever was just above the feathering position. The fuel cutoff lever was at the bottom of the "flight idle" position but above the "fuel cut off" position. The tail wheel was in the "locked" position. The fuel shutoff lever was broken from impact forces. Note that emergency services personnel were in the cockpit post-accident conducting lifesaving and extraction efforts.

**Figure 12 Engine controls as found on site.**

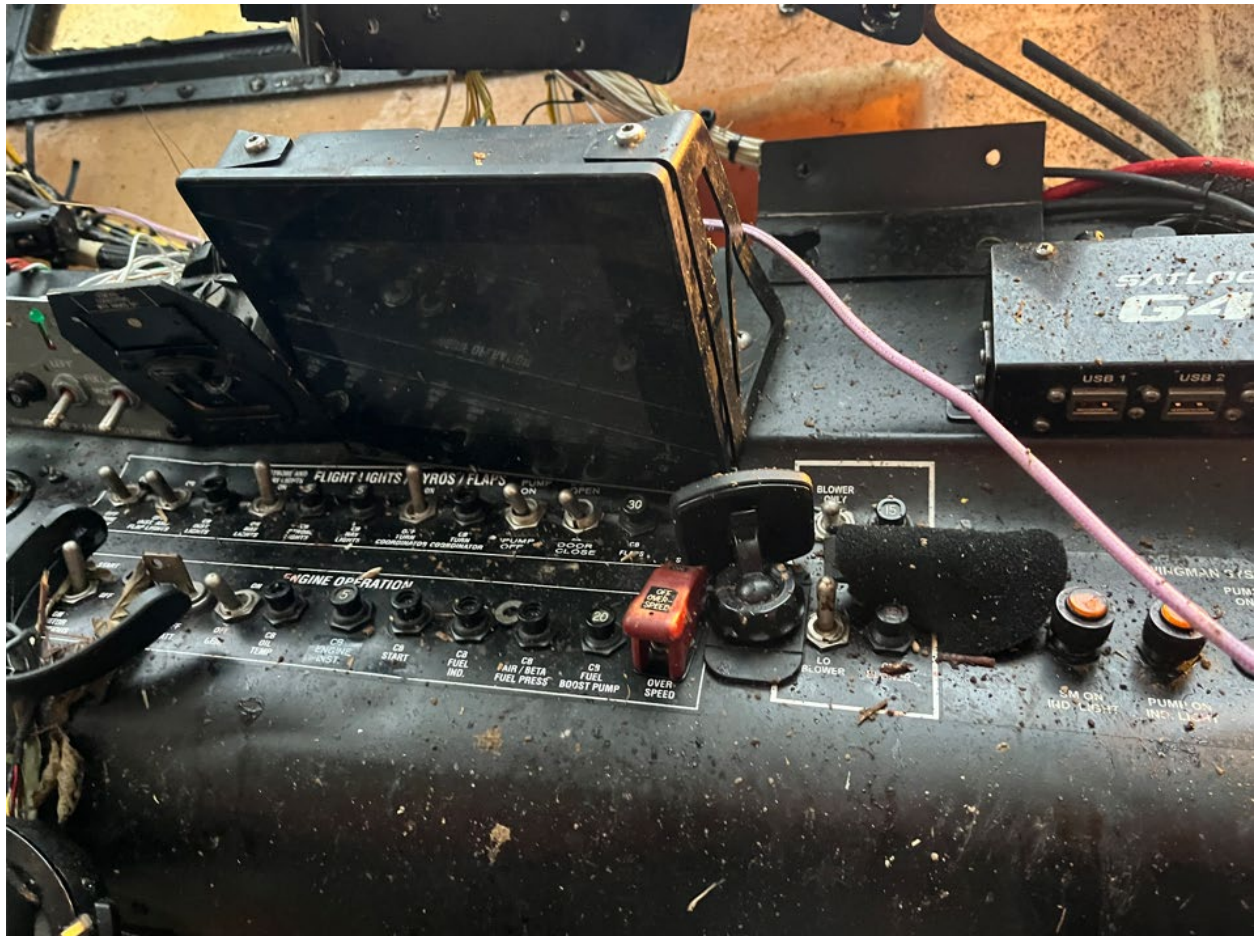
The engine start switch was in the "start" position. The generator switch was "off".

**Figure 13 Instrument panel with CB panel and Parker GPS display.**

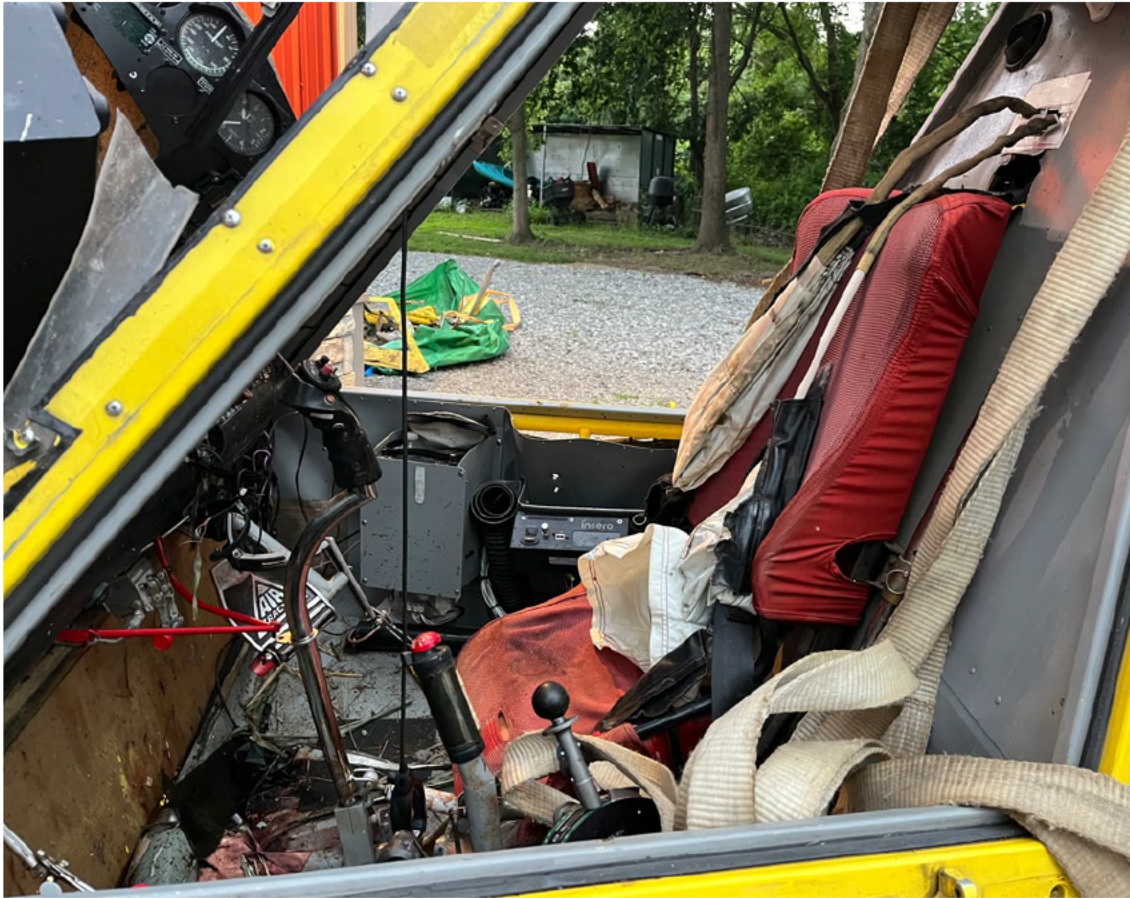
The airplane was equipped with a 5-point harness with airbags on the shoulder harness. The airbags deployed during the accident sequence. The pilot's seat was made of tubular steel. The seat structure bottom was folded down from the impact forces. The accident was not survivable.

**Figure 14 Cockpit and seat damage.**

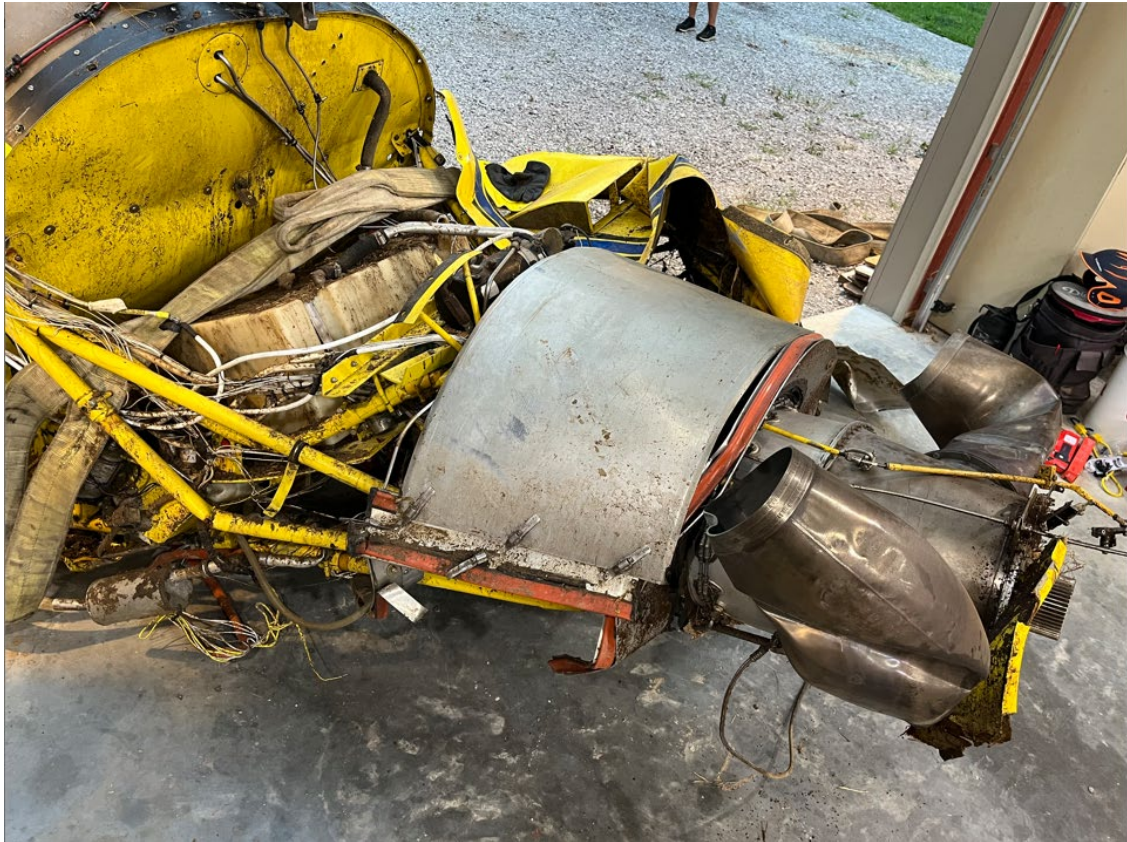
The compressor turbine disk was visually examined via borescope and no anomalies were observed. Typical operational wear was observed. The combustion chamber, large and small exit ducts were in good condition. The power turbine section was visually examined. The power turbine vanes and disc were undamaged and did not exhibit any rubbing on the blade tips or the shroud. Organic matter with a smell consistent of soil was found in the bottom of the shroud, indicative to ingestion during the accident sequence.

**Figure 16 Engine with cover removed.**

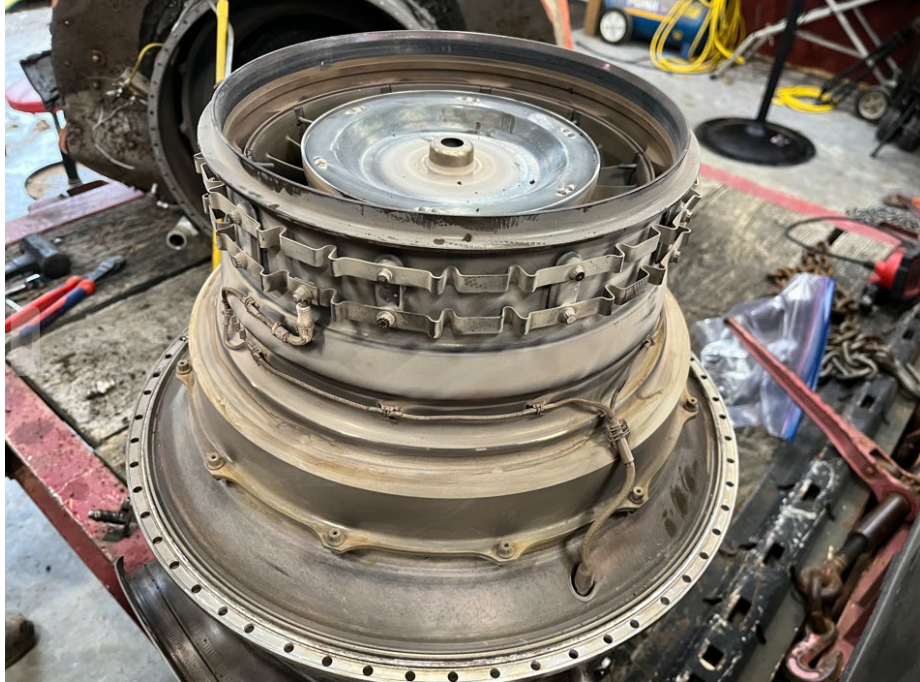
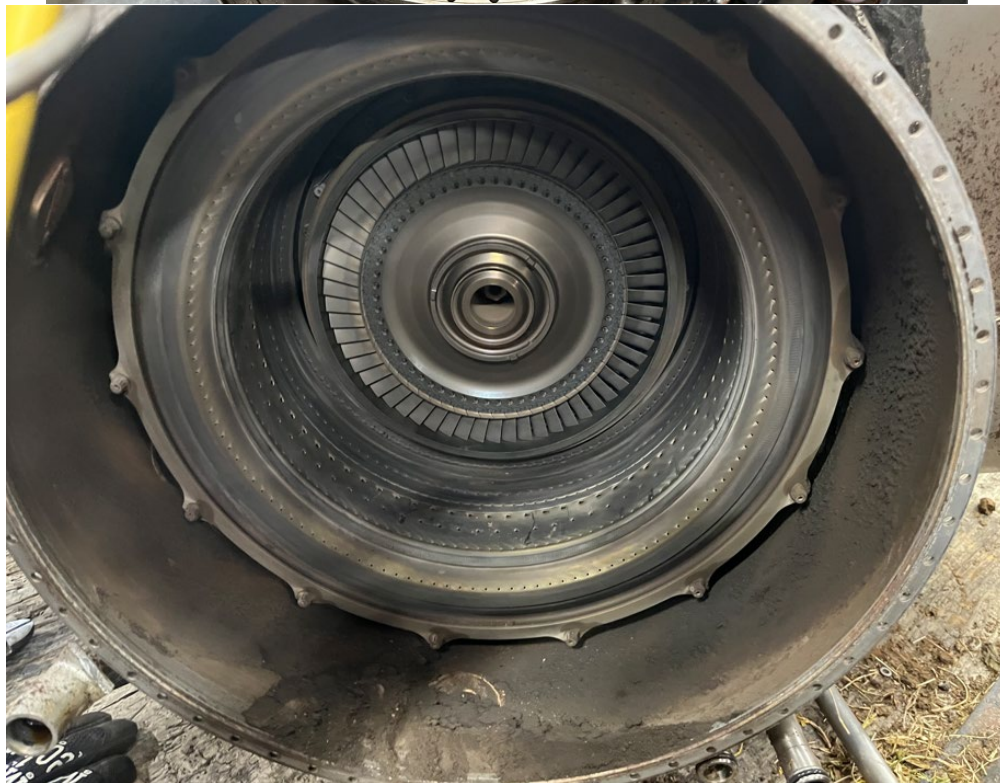
The engine would not rotate when force was applied to the front of the engine. The engine would partially rotate using the spline drive at the back of the engine. The engine was separated at the hot section for further examination. The engine would spin freely up to the combustion chamber, but the front of the engine would not spin after removal. The front of the engine was found to have deep impacted organic debris and pieces of fiberglass packed into the forward reduction gearbox teeth preventing rotation.

**Figure 19 Split open engine and turbines during exam.**

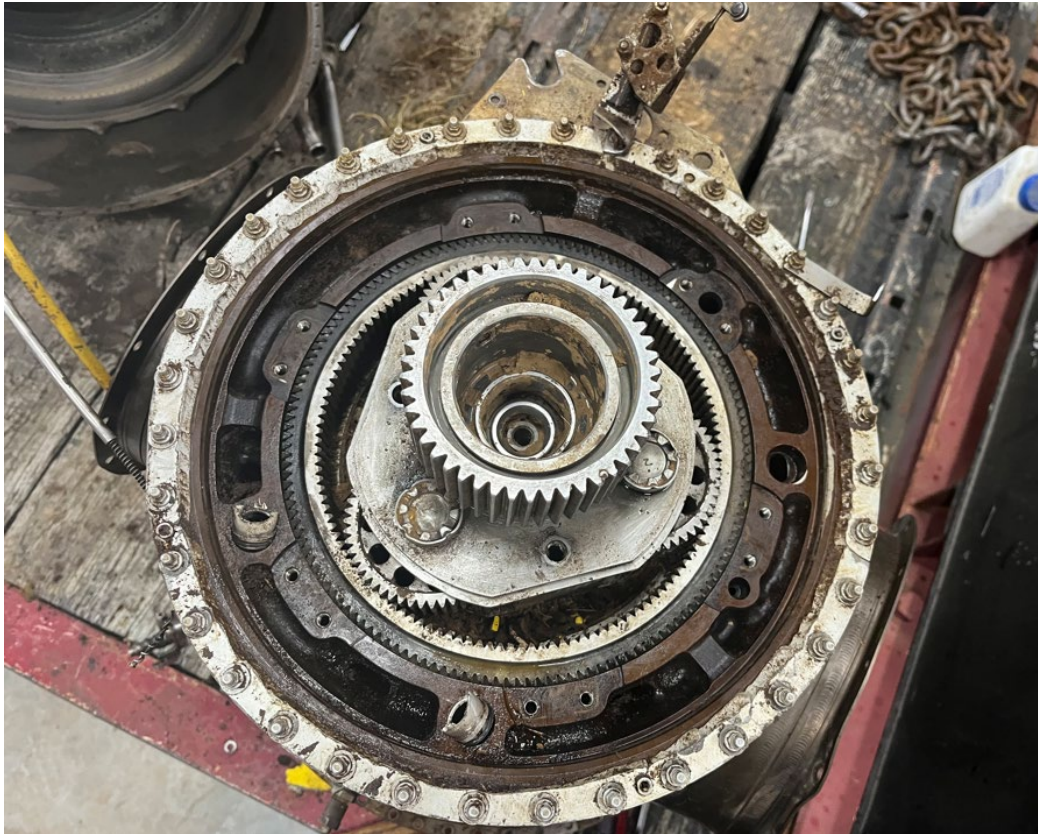
**Figure 20 Engine/Prop RGU**

Propeller HC-B5MP-3F, Serial Number EVA-3157, Blades # L16109, through L16113. The 5-blade metal Hartzell propellers, (designated A, B, C, D, E for identification) each blade exhibited features consistent with low or reduced power applied near the time of impact. The propeller assembly and reduction gearbox (RG) impact was separated at the engine shaft and was discovered on an embankment about 60 ft. from the main wreckage. When placed up on the RG, the propellers rotated about the axis smoothly through 720° with no limitations to movement or unusual noises. All gears were minimally damaged and showed no anomalous pre-impact damage at the RG assembly.

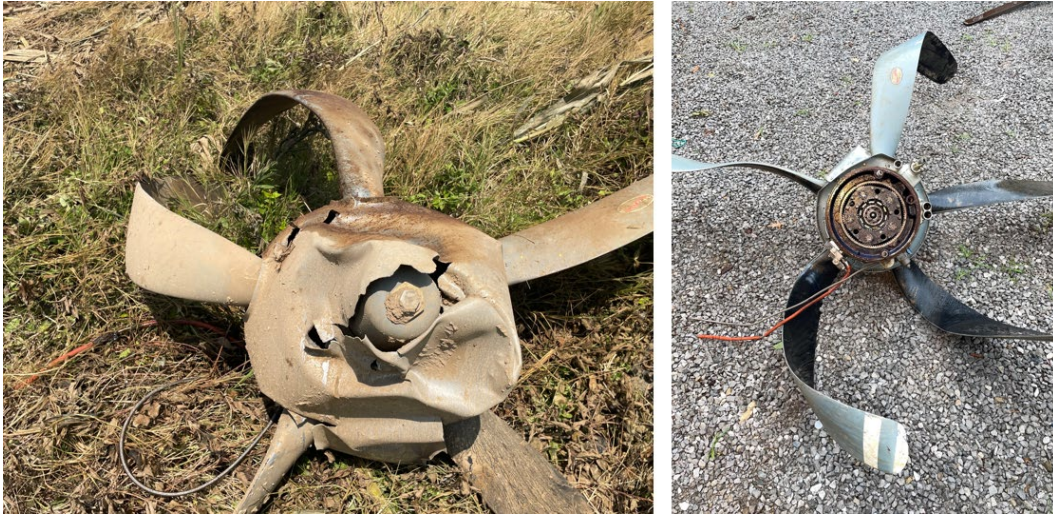
All 5 blades exhibited varying degrees of damage with the A and C blades exhibiting wave bending throughout the entire span. The B, D and E blades were bent uniformly aft mid span about 80° to 90° degrees. Four of the blades were at

their respective indicator (red line) pitch stops (13.9°) indicative they were at reduced or low power at the time of impact. The B blade was not on the pitch stop and rotated freely on its axis. Two of the blades contained a 3/4" deep gouge on the trailing edge of the blade about 15 inches from the tip and the additional blades contained dents and scrapes of lessor severity in about the same location indicative of impact damage being caused by wreckage and debris during the accident sequence. There was no damage indicative of a wire strike, and no wires were damaged on site or in the surrounding area. The blades exhibited chordwise/rotational abrasion. There was no damage to indicate the propellers were feathered or in a flight power setting prior to impact.

**Figure 22 Propeller assy. As found on site (L) and during examination. (R)**
