# National Transportation Safety Board

ERA24FA308

## **WRECKAGE EXAMINATION**

Location: Vienna Center, Ohio  
Date: July 19, 2024  
Time: 1904 EDT  
2304 UTC  
Airplane: N23553; Beech B-60

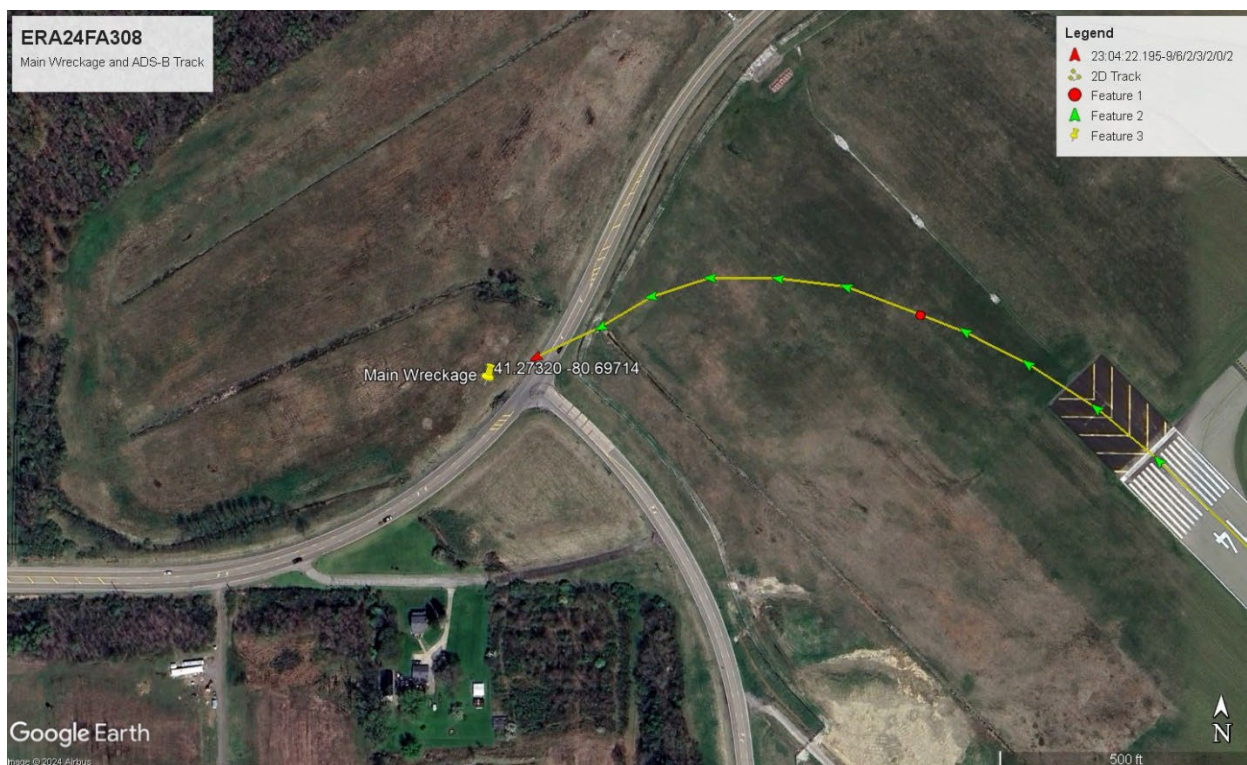
Figure 1 – Flight Path and Accident Site

The airplane crashed in a flat, grassy field, about ¼ nm west of the departure end of runway 32 at Youngstown/Warren Regional Airport (YNG). Accident site coordinates (GPS) were 41.2732, -80.69714.

The magnetic heading of the aircraft wreckage was 310°.

Ground imprints were consistent with the aircraft at an upright attitude and right wing low at impact.
