# National Transportation Safety Board

ERA24FA310

## **WRECKAGE EXAMINATION REPORT**

Location: Geneva, OH  
Date: 07/21/2024  
Time: 1754 EDT  
2154 UTC  
Airplane: Titan T-51 Mustang (N751TX)

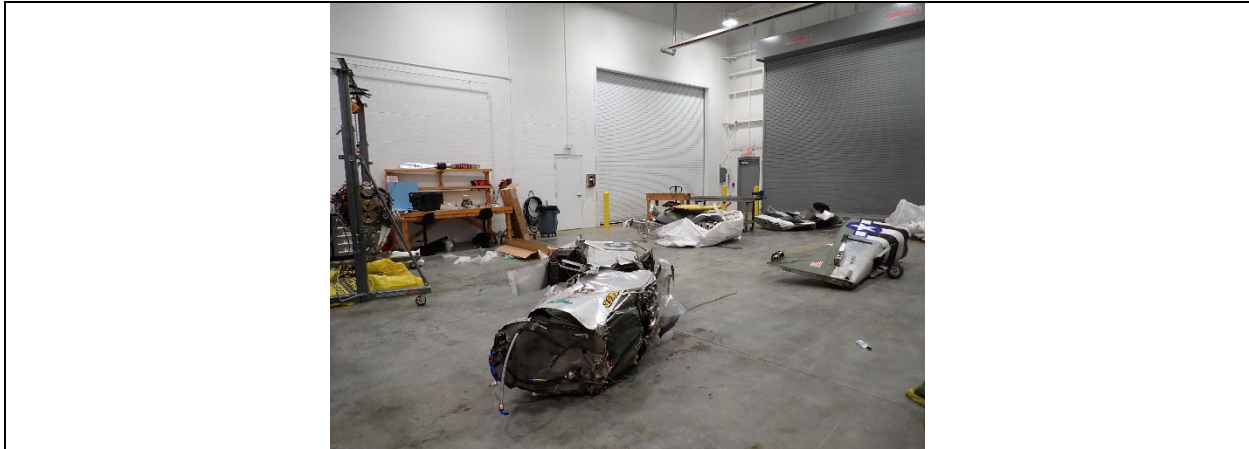
The airframe displayed significant impact damage to both wings, the fuselage, and the empennage. The airframe had also been cut into several sections by recovery personnel to facilitate transport to the salvage facility.

Flight control continuity was established for the elevator, rudder, and ailerons through breaks that were consistent with impact damage as well as recovery cuts. Continuity was established for the throttle and propeller controls through breaks that were consistent with impact damage.

The fuel tanks displayed impact damage and were devoid of fuel. The fuel caps remained secured to their respective fuel tanks. Fuel line continuity could not be established due to extensive fragmentation of the wreckage.

Figure 1: Airframe overview

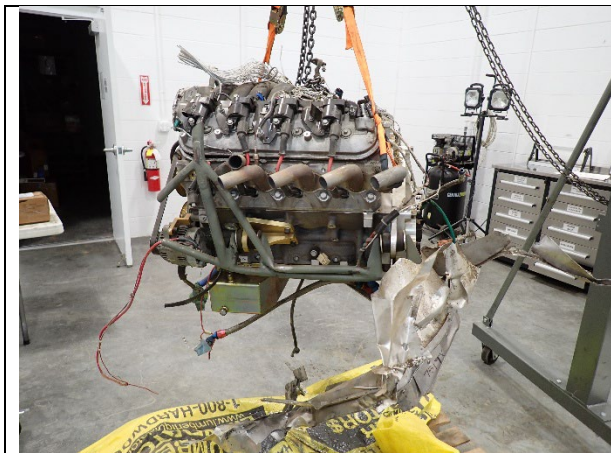
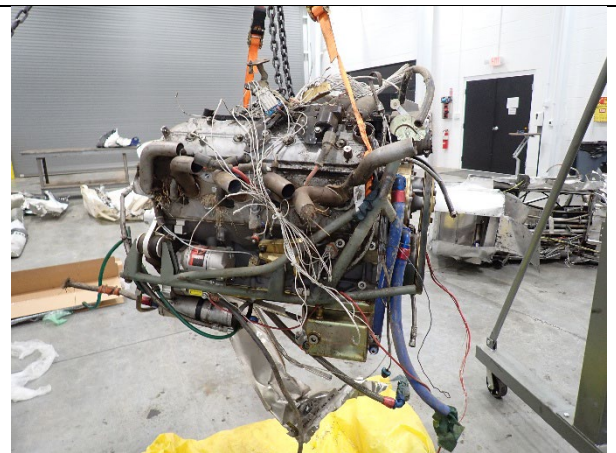
The engine had been removed from the airframe prior to the examination. The engine displayed impact damage signatures with most of the damage observed to the forward portion of the engine, intake manifold, and rocker arm covers. The propeller reduction gearbox had fracture separated from the engine and displayed impact damage signatures. A portion of the fractured propeller hub remained attached to the propeller drive shaft.

Figure 2: Engine overview

Figure 3: Engine overview

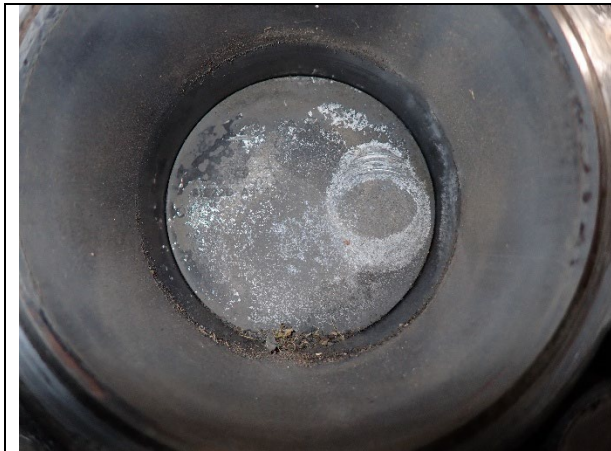
While attempting to rotate the crankshaft manually, it was found that the crankshaft would only rotate approximately 25° before binding and seizing. The engine was partially disassembled to facilitate examination. Both valve keepers for the No. 1 exhaust valve were found to have separated from the valve and spring

assembly, and one of the valve keepers for the No. 3 intake valve had also separated. The keepers were found in the rocker box assembly and appeared to be undamaged. The No. 1 exhaust valve was found to be seized in the valve guide. Upon further disassembly, the No. 1 exhaust valve was found to be bent and the No. 1 piston displayed semicircular impressions that were consistent with multiple valve strikes with the No. 1 exhaust valve. The damage observed to the valve and piston was consistent with a floating valve, which can occur during an engine overspeed. The rest of the rocker arms, valves, and valve springs displayed normal operating and lubrication signatures. The pistons and cylinders displayed varying amounts of corrosion and contamination from water intake. The contamination was consistent with impact/post-impact intake.

Figure 4: No. 1 piston with valve strike impressions

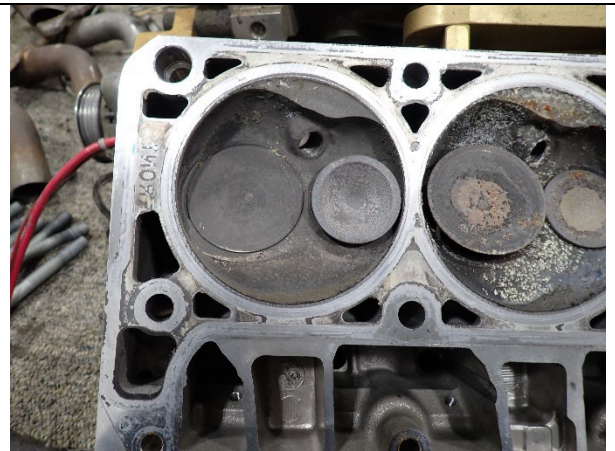
Figure 5: No. 1 cylinder head with valves

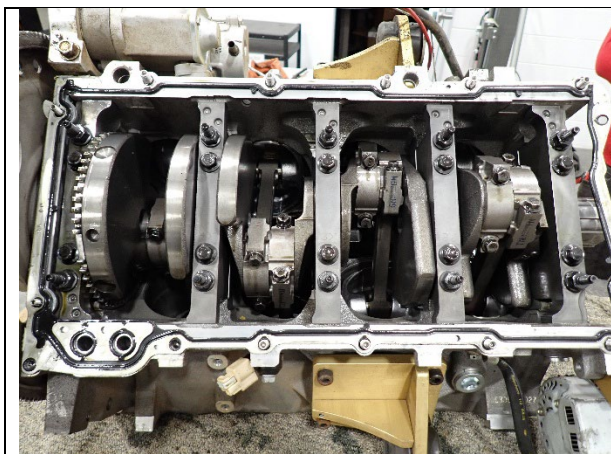
The crankshaft remained intact and after removing the cylinder heads, was capable of rotating 720 degrees without any signs of binding. The connecting rods remained attached to their journals and displayed normal operating and lubrication signatures. The camshaft and lifters were removed and the components displayed normal operating and lubrication signatures.

Figure 6: Crankshaft assembly

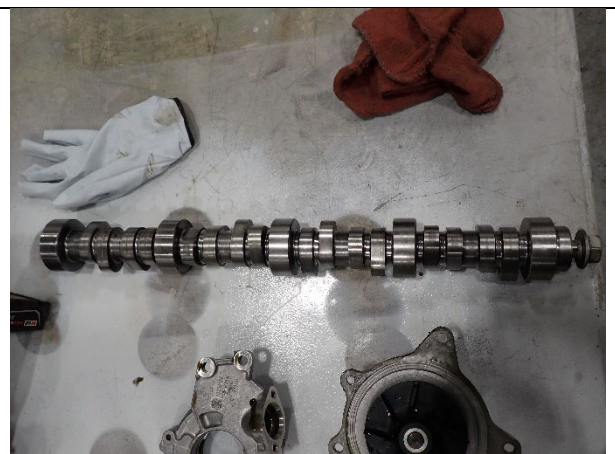
Figure 7: Camshaft

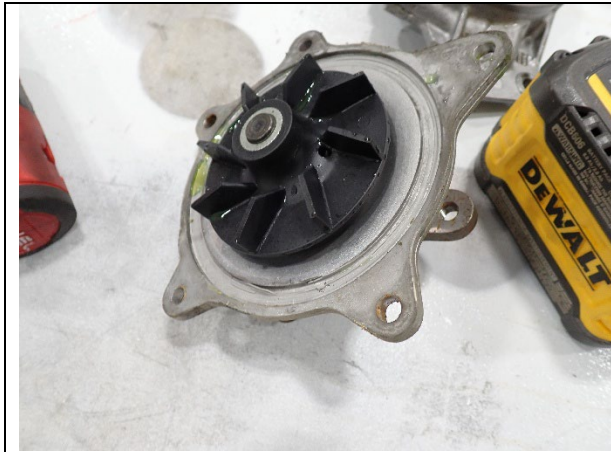
The coolant pump was removed and partially disassembled. The coolant pump vanes were intact, and the drive was capable of rotation. The engine radiator remained attached to the airframe and appeared to be undamaged. The coolant hoses going to the radiator remained secured to the radiator and there were no signs of a coolant leak.

Figure 8: Coolant pump

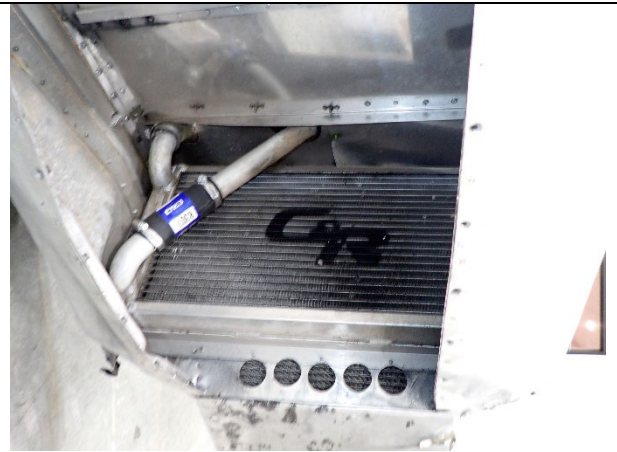
Figure 9: Radiator

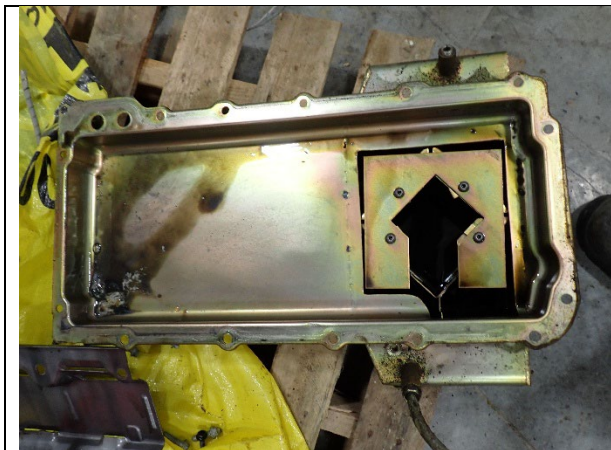
The oil sump remained intact and appeared to be undamaged. The sump was removed, and the oil sump contained an unquantified amount of fluid that was consistent with engine oil. The oil pickup tube remained attached to the oil pump and there were no obstructions observed. The oil pump was removed, and the pump drive gear was observed to be able to rotate without any binding and the pump could be heard pumping residual oil.

Figure 10: Oil sump

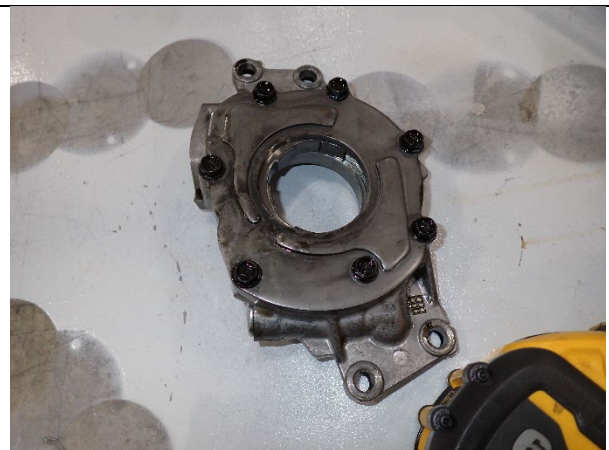
Figure 11: Oil pump

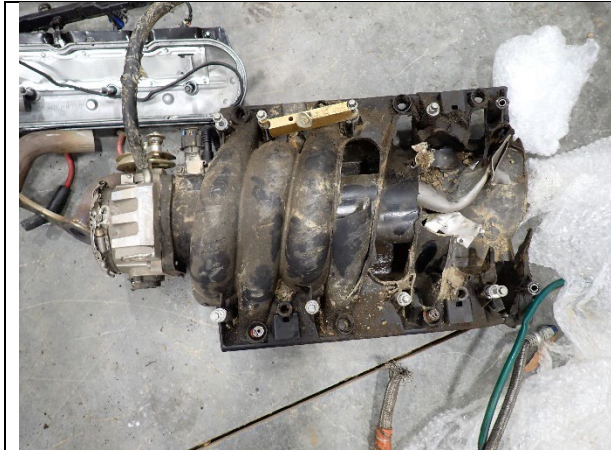
The throttle body remained attached to the induction manifold and displayed minor impact damage signatures. The throttle control arm was capable of normal movement and the throttle valve actuated normally. The fuel injectors displayed varying amounts of impact damage and most of the injector wiring was severed. The fuel pump was impact damaged and was unable to be functionally tested.

Figure 12: Intake manifold

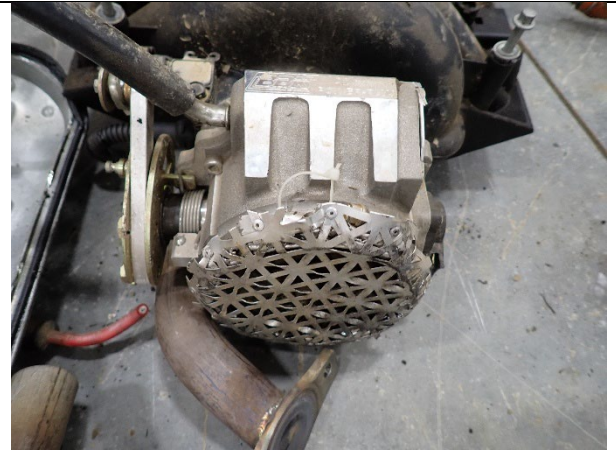
Figure 13: Throttle body

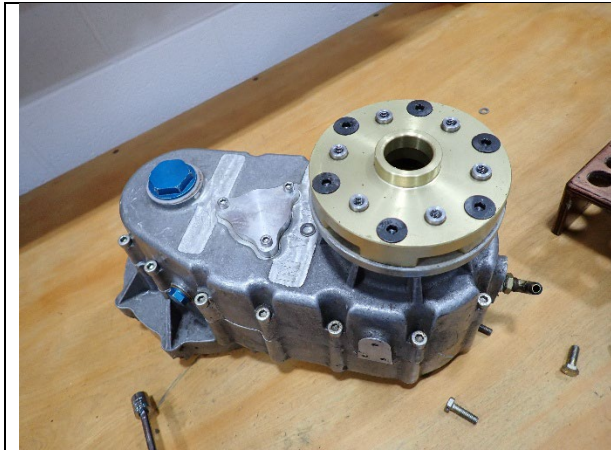
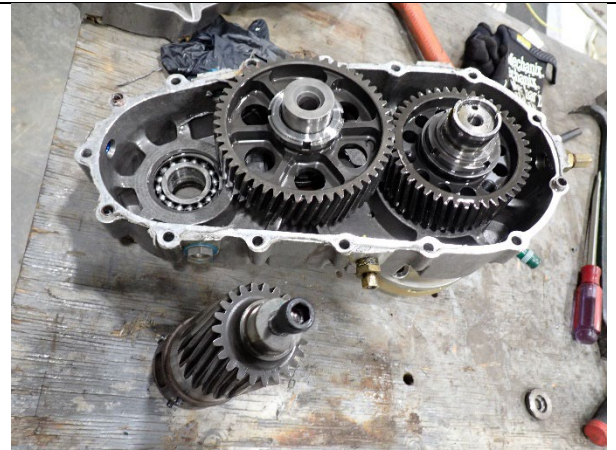
The propeller gearbox had impact separated from the rest of the engine and displayed impact damage signatures. A small amount of residual gearbox oil was within the gearbox housing. Continuity was established within the gearbox by rotating the drive shaft and observing propeller shaft movement. The reduction gearbox was disassembled and the internal components displayed normal operating and lubrication signatures.

Figure 14: Gearbox assembly

Figure 15: Gearbox assembly (partially disassembled)

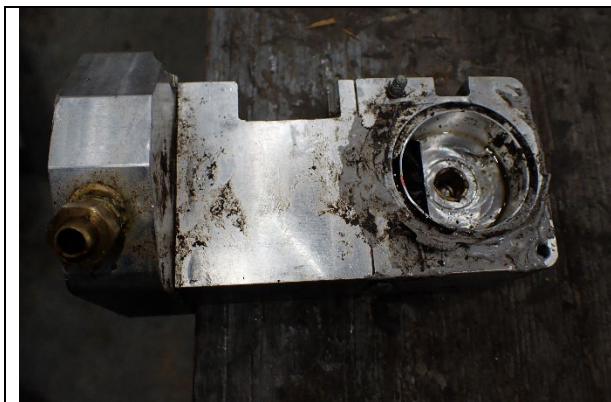
The propeller governor drive adapter had separated from the reduction gearbox and had impact damage signatures. The adapter drive gear to governor drive gear continuity was established by rotating the adapter drive gear. The propeller governor adapter oil galley was clear of obstructions. The propeller governor had minor impact damage. The propeller governor drive was rotated manually, and there were no signs of binding during rotation, and the pump could be heard pumping residual oil. The propeller control arm remained intact and operated normally during manual operation.

Figure 16: Propeller governor drive adapter

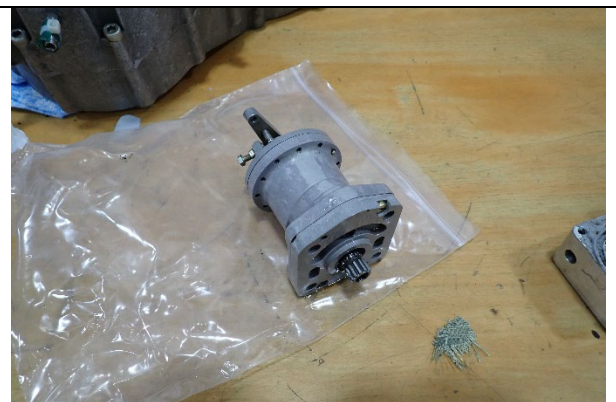
Figure 17: Propeller governor

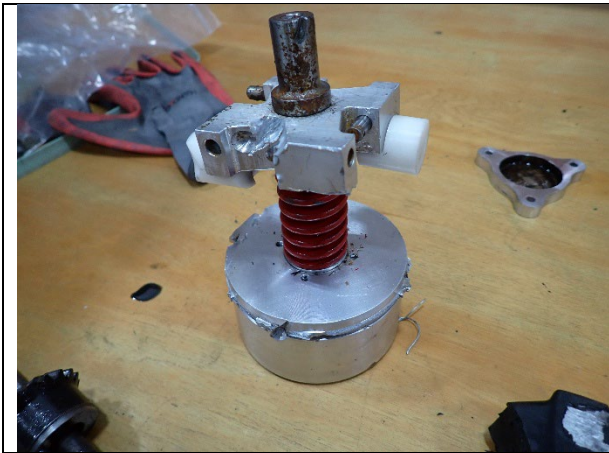
The propeller hub was fractured into multiple pieces; a portion of the hub remained attached to the reduction gearbox. The other portions of the hub were located on the ground around the airplane's flight path. The propeller blades were marked with "A", "B", "C", and "D" to identify each propeller. The propeller blade marked "A" remained intact and had separated from the propeller hub. There was a portion of impact damage about  $\frac{3}{4}$  of the propeller's length. The propeller blade marked "B" remained attached to a portion of the separated propeller hub and had impact damage to various portions of the propeller. Both propeller blades marked

Figure 18: Propeller piston

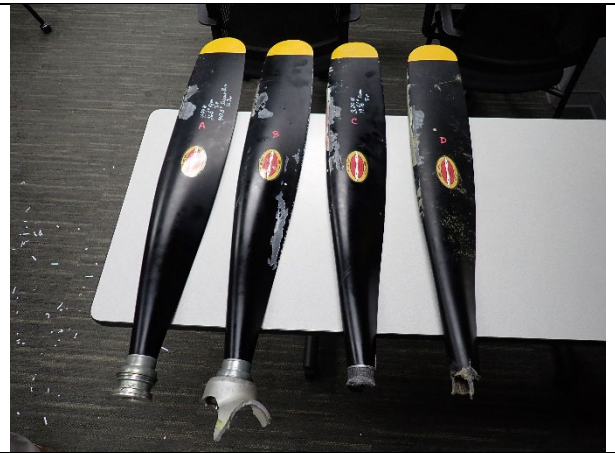
"C" and "D" had separated at the propeller shank and displayed impact damage at the leading edge of the propeller blades.

Figure 19: Propeller blades (Source: Hartzell)
