ERA24FA310

## INVESTIGATION PHOTOGRAPHS

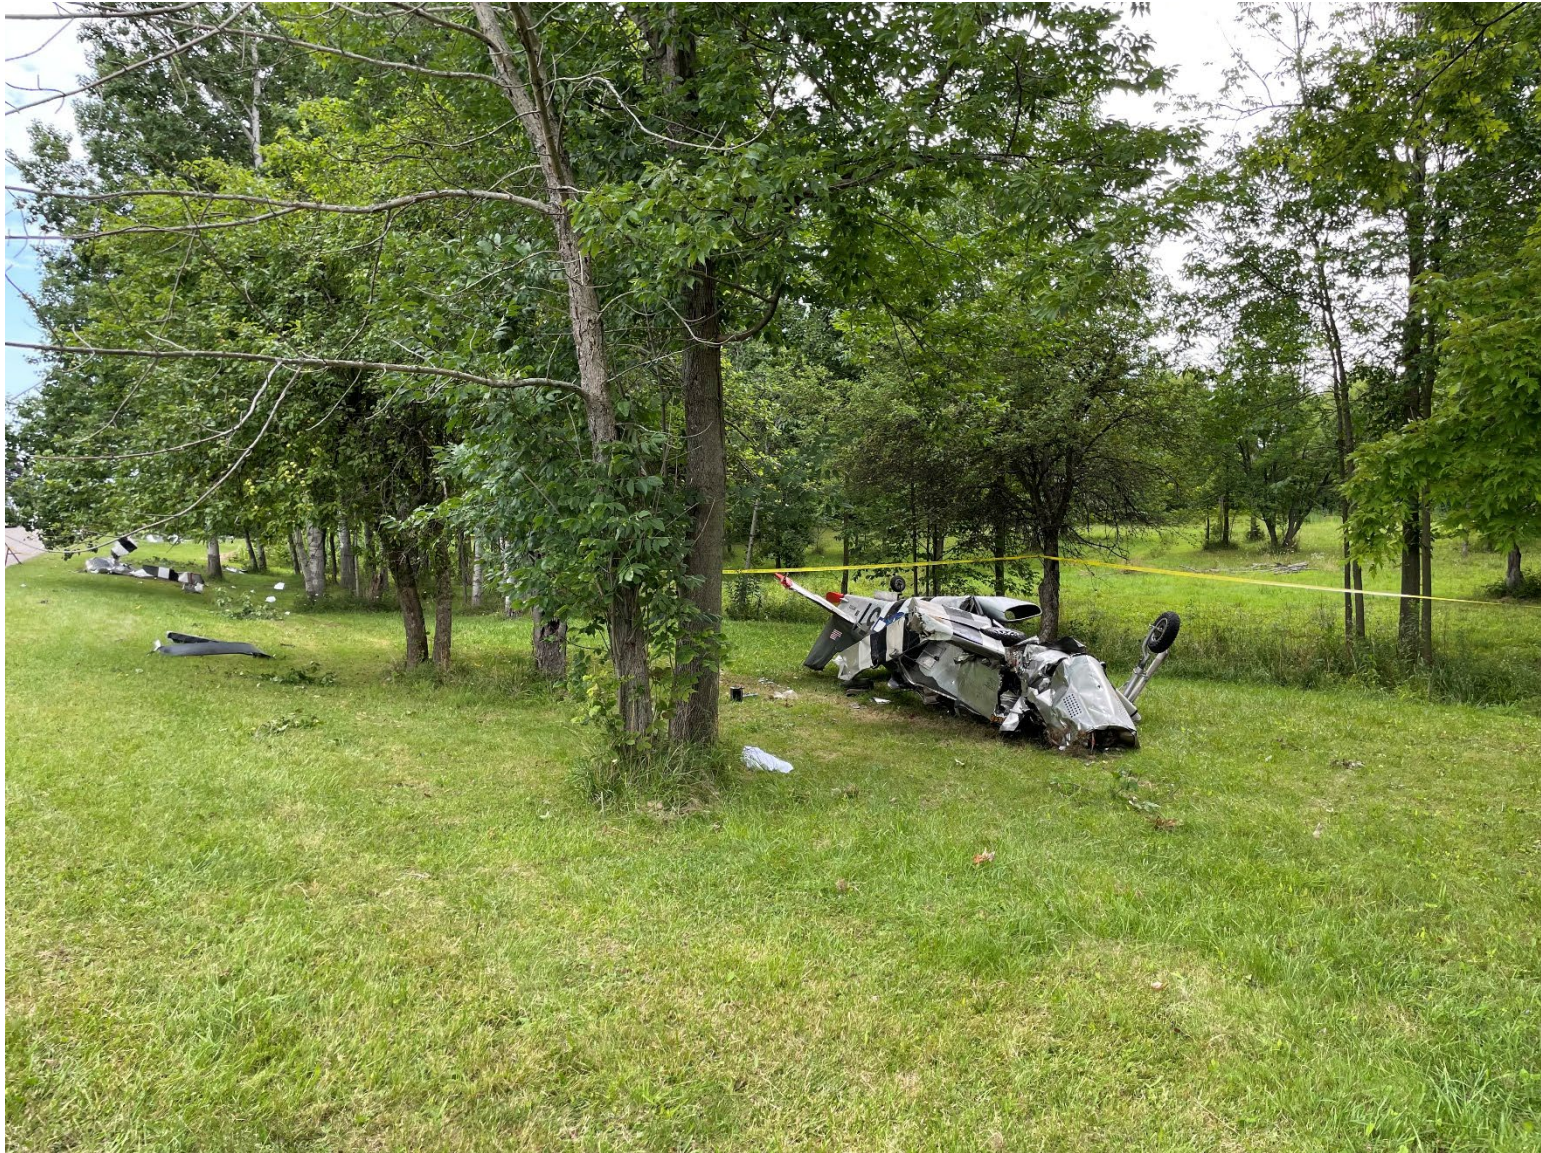
**Photograph 1 - Airplane at accident site**

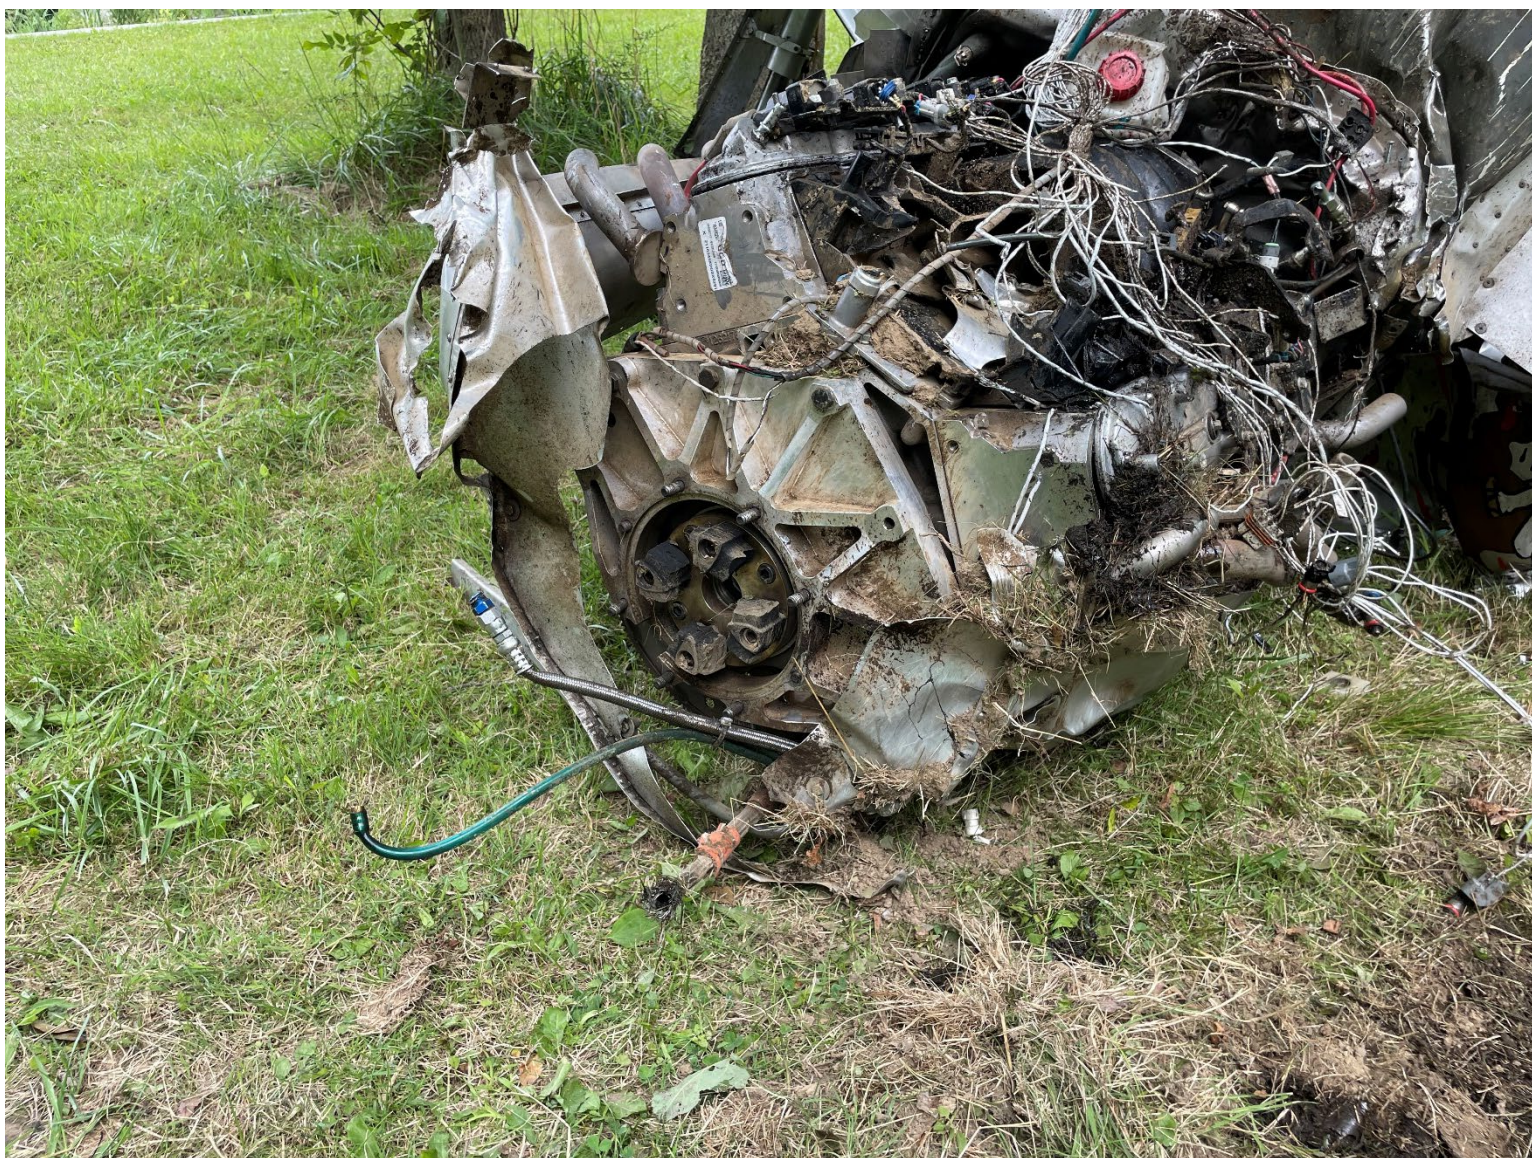
**Photograph 2 - Engine at accident site**

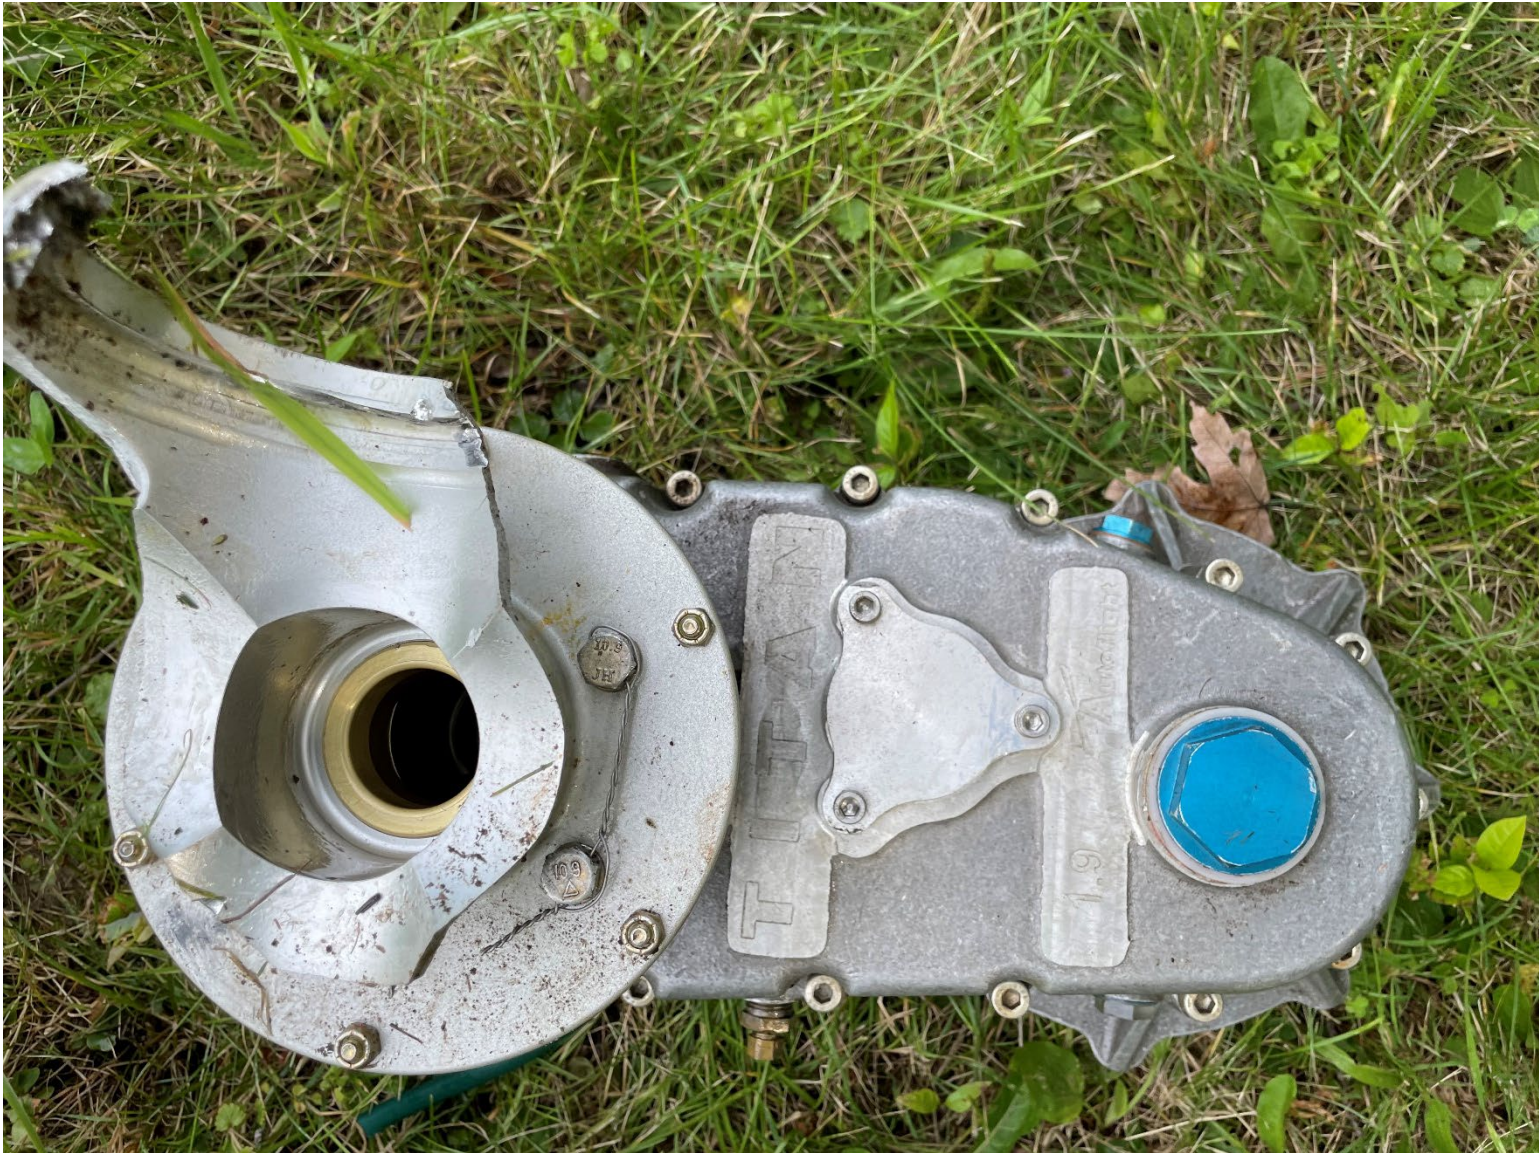
**Photograph 3 - Propeller gearbox at accident site**

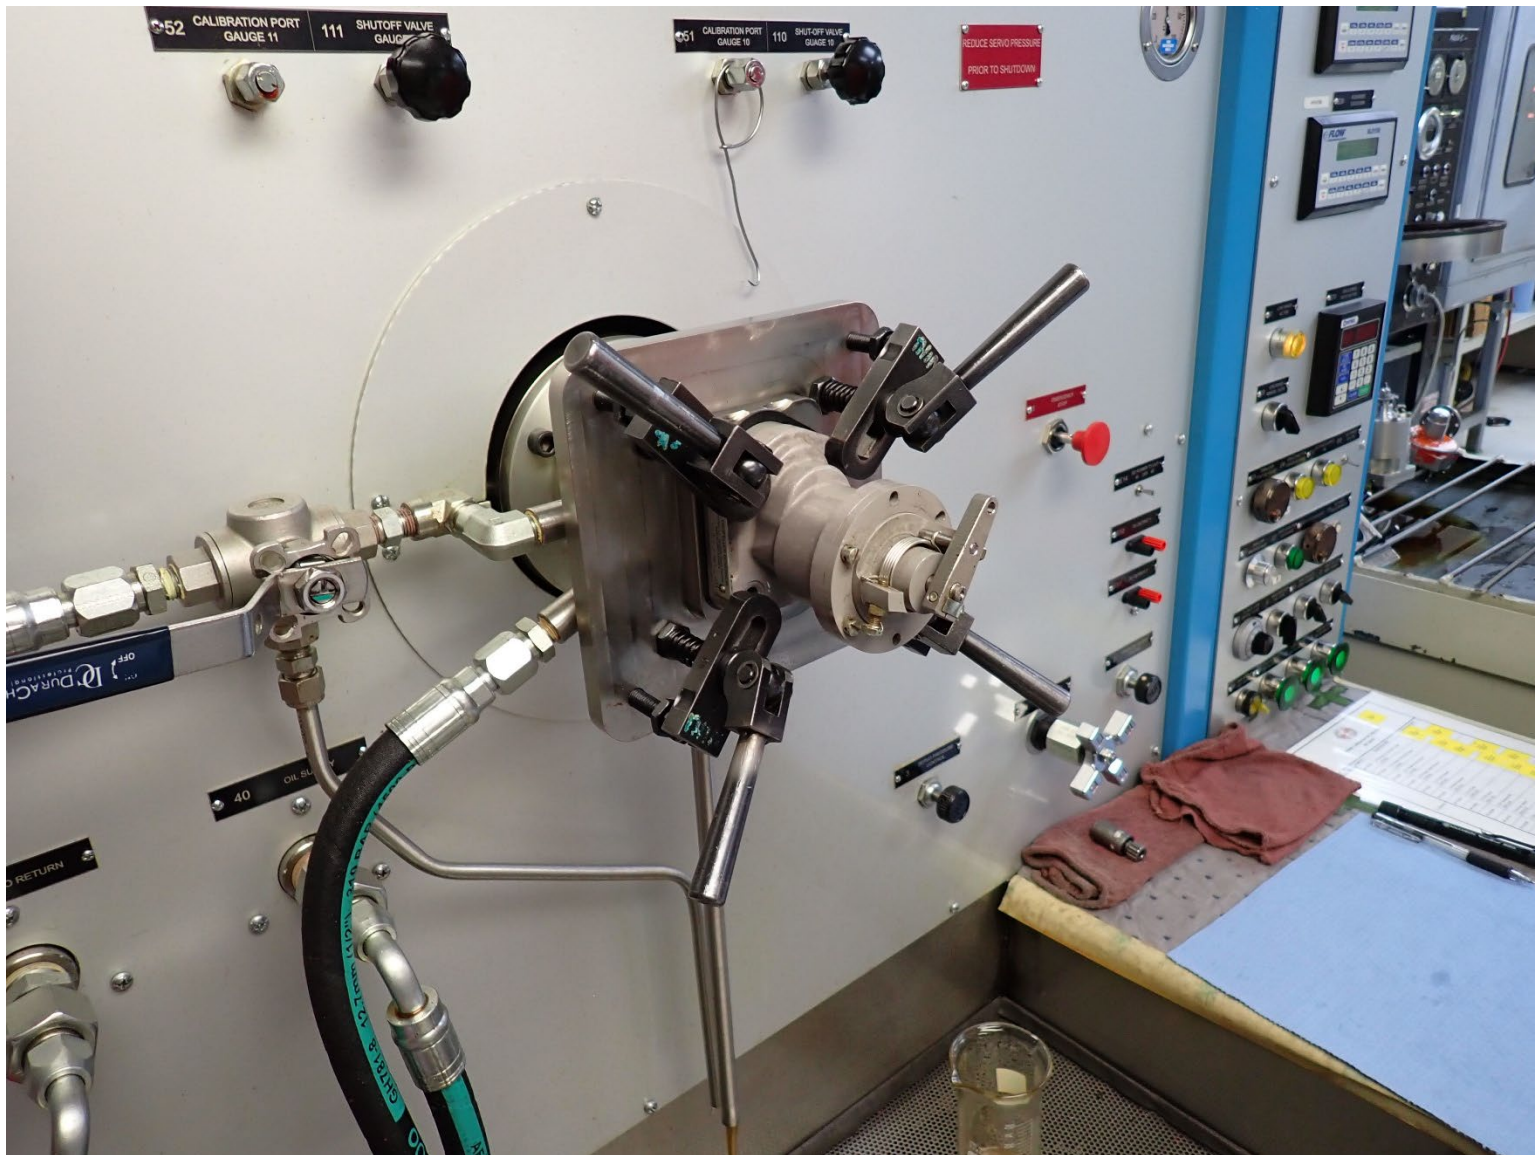
**Photograph 4 - Propeller governor on test bench (Courtesy of Hartzell)**

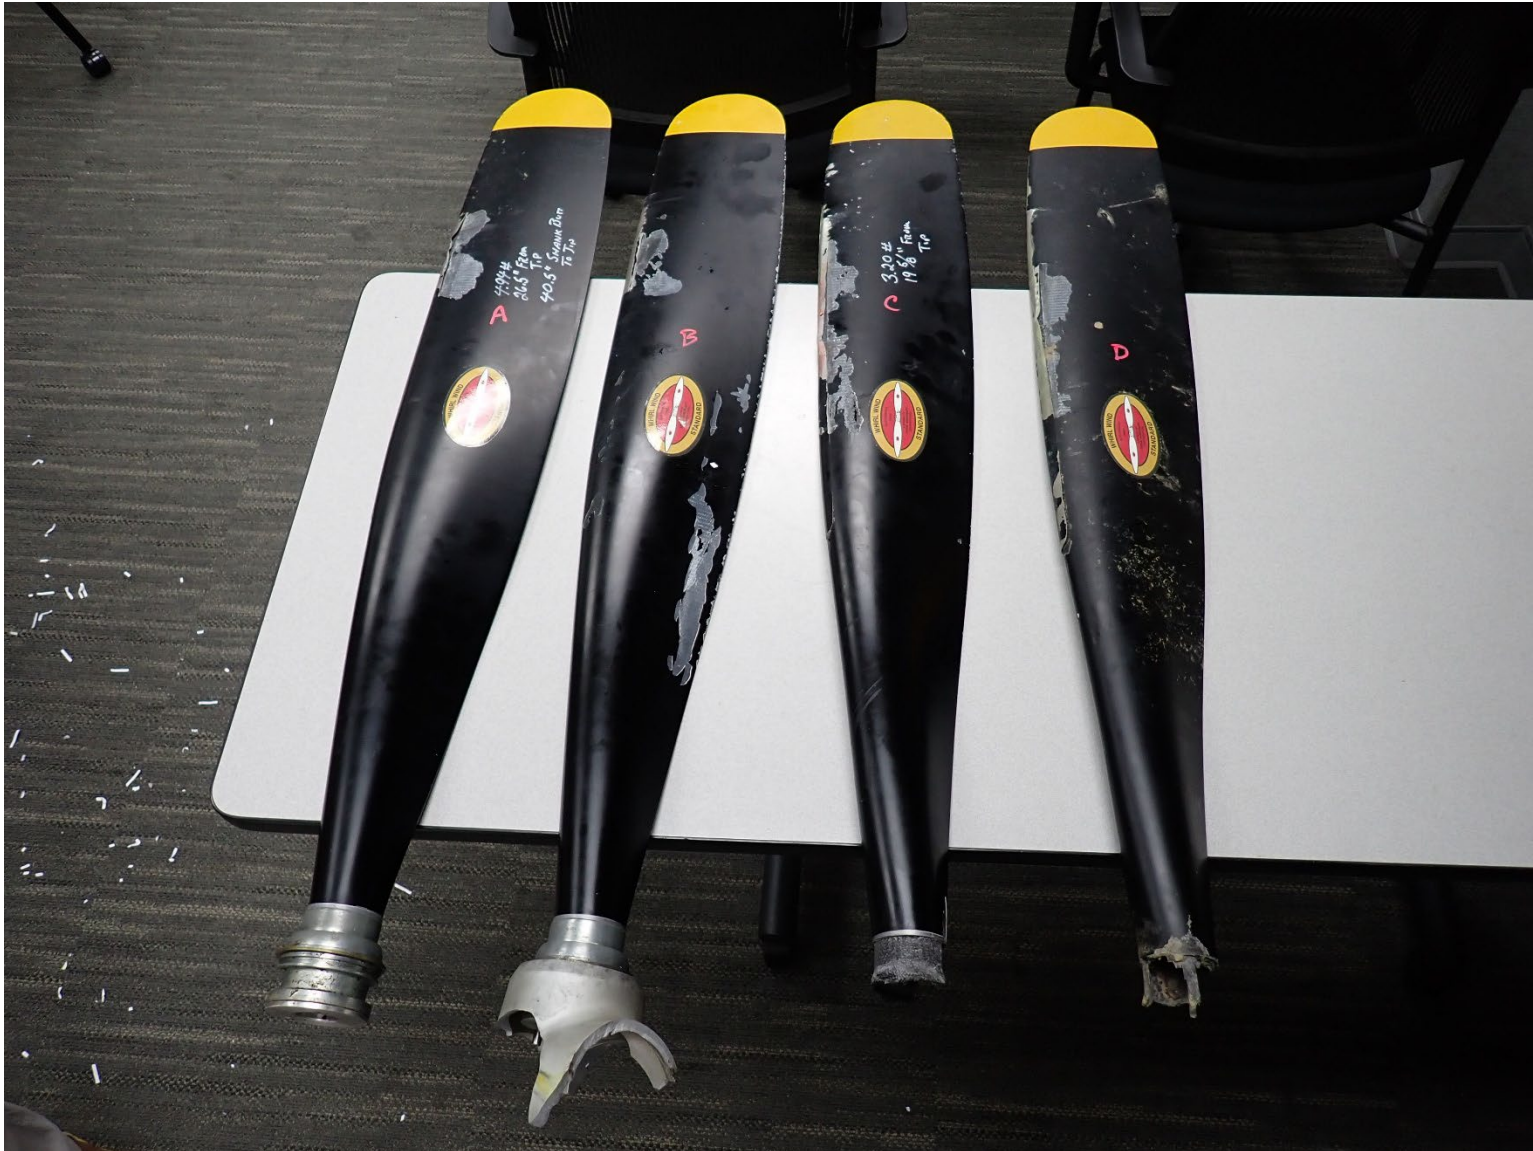
**Photograph 5 - Propeller blades (Courtesy of Hartzell)**

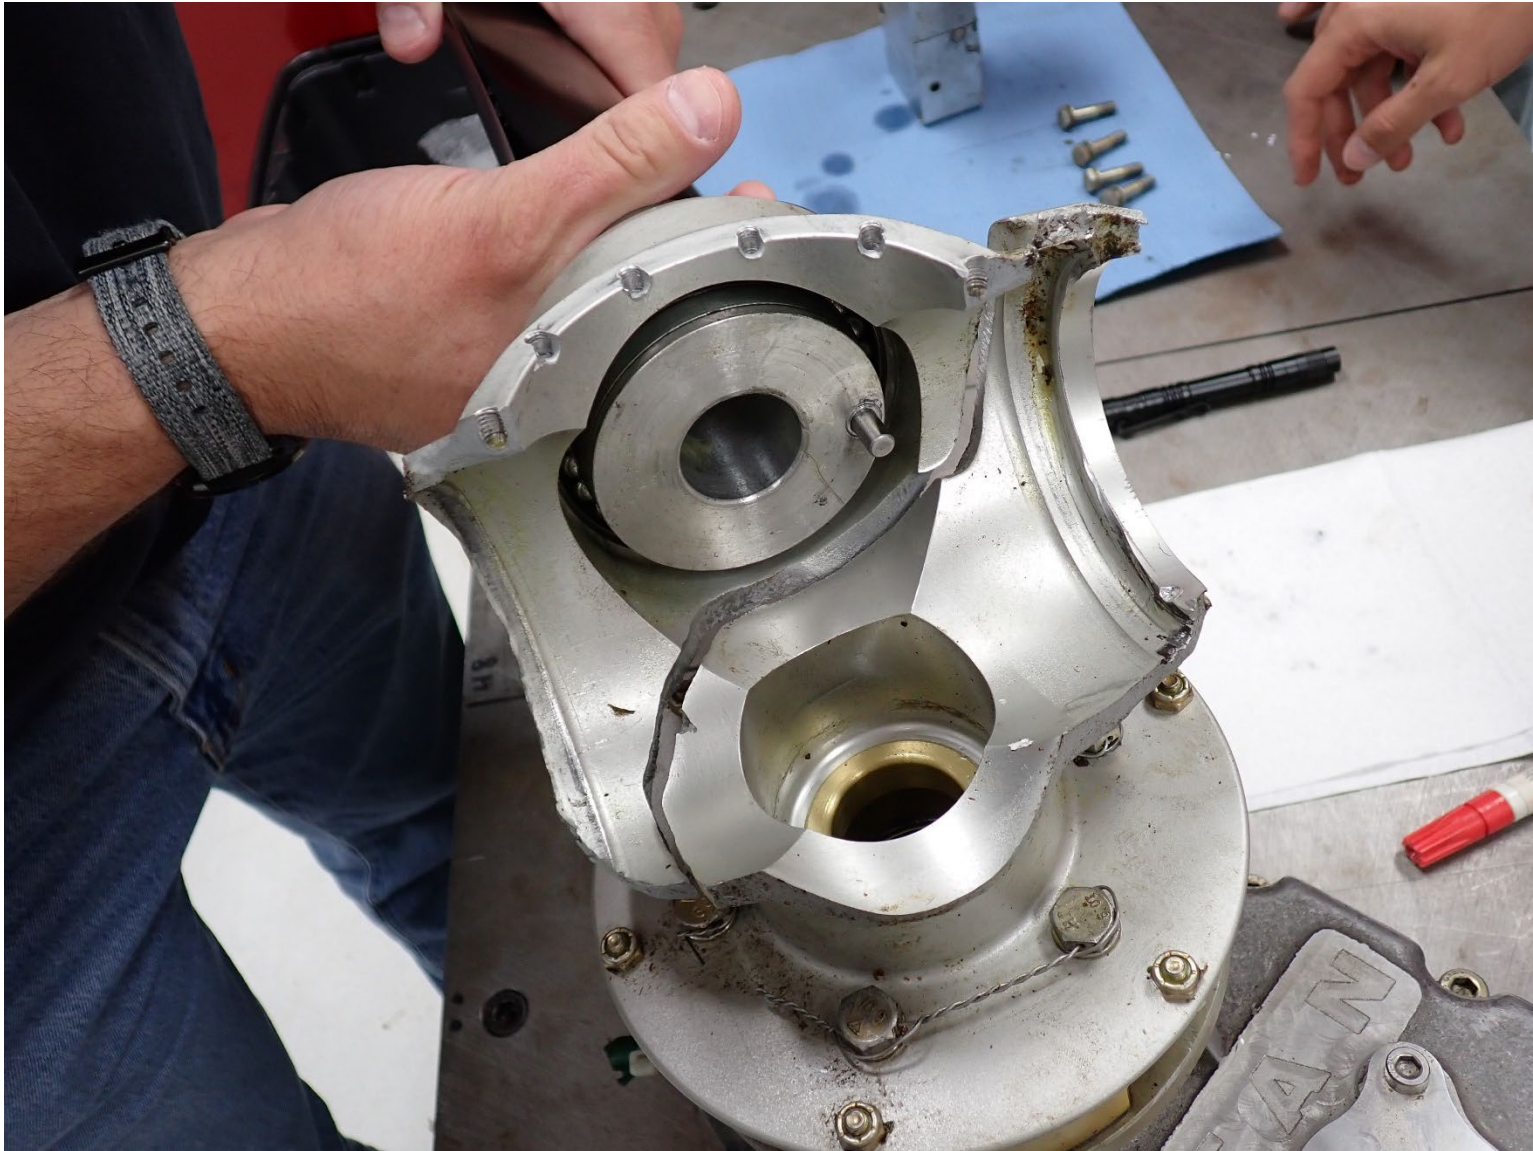
**Photograph 6 - Propeller hub (Courtesy of Hartzell)**

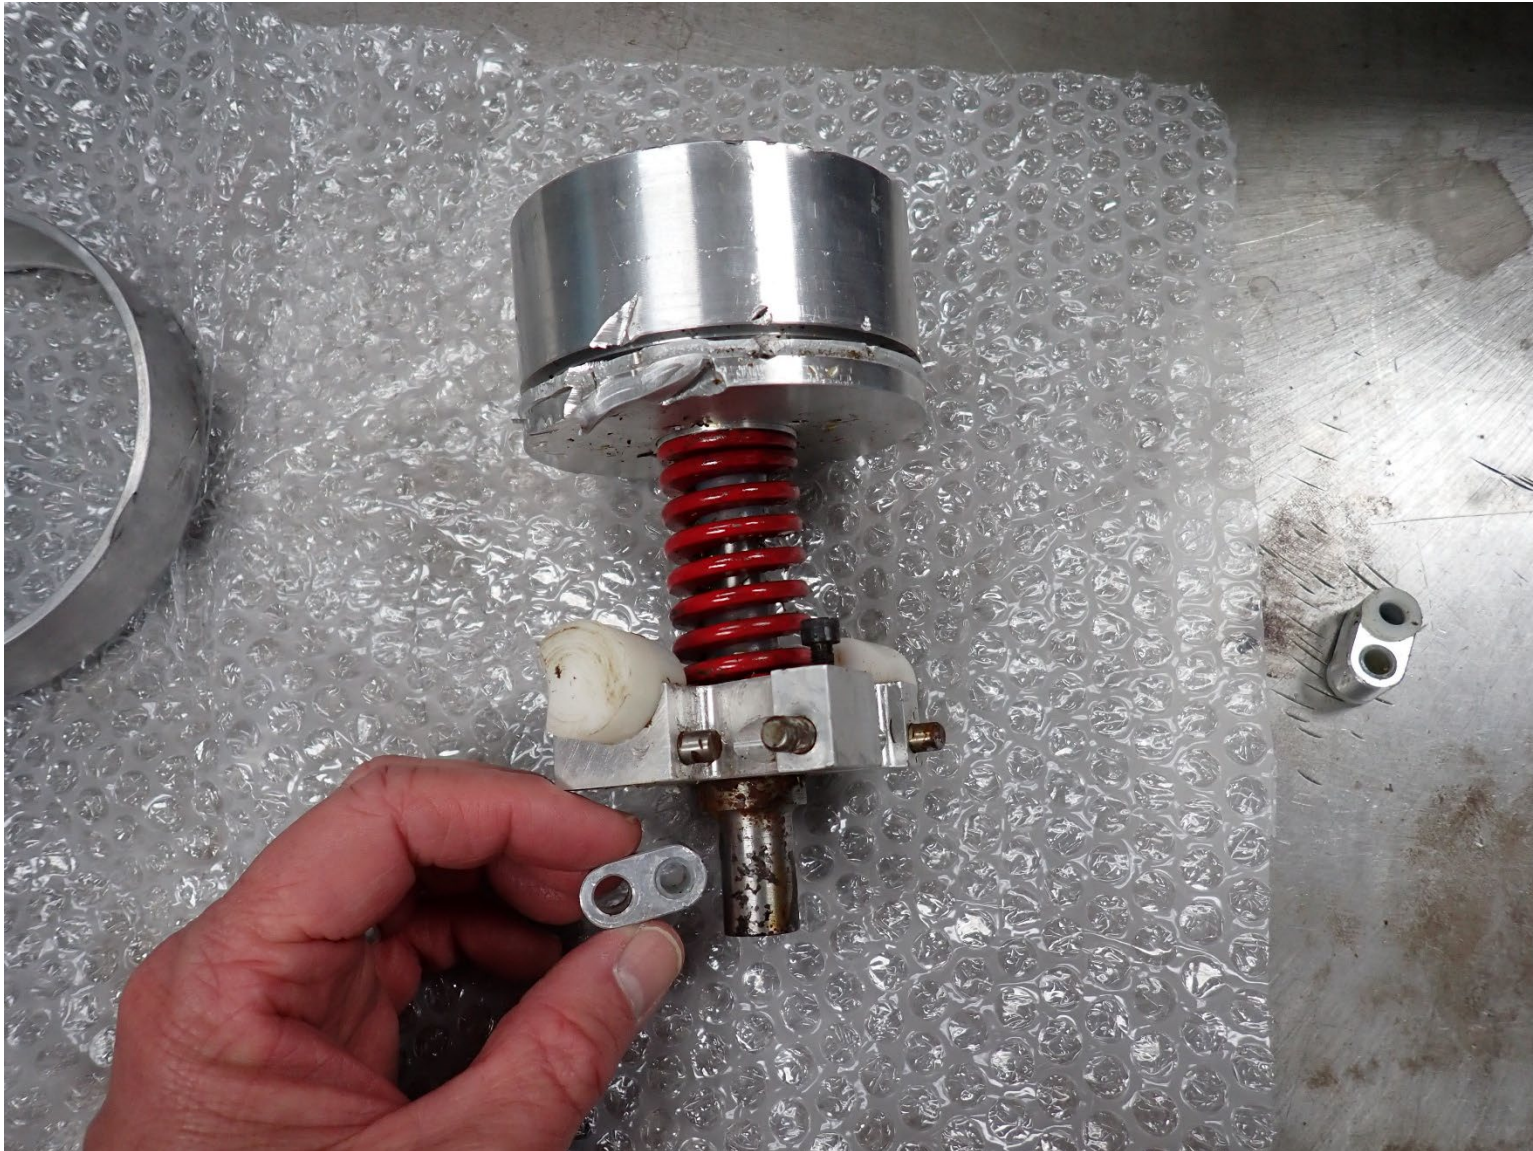
**Photograph 7 - Propeller piston (Courtesy of Hartzell)**

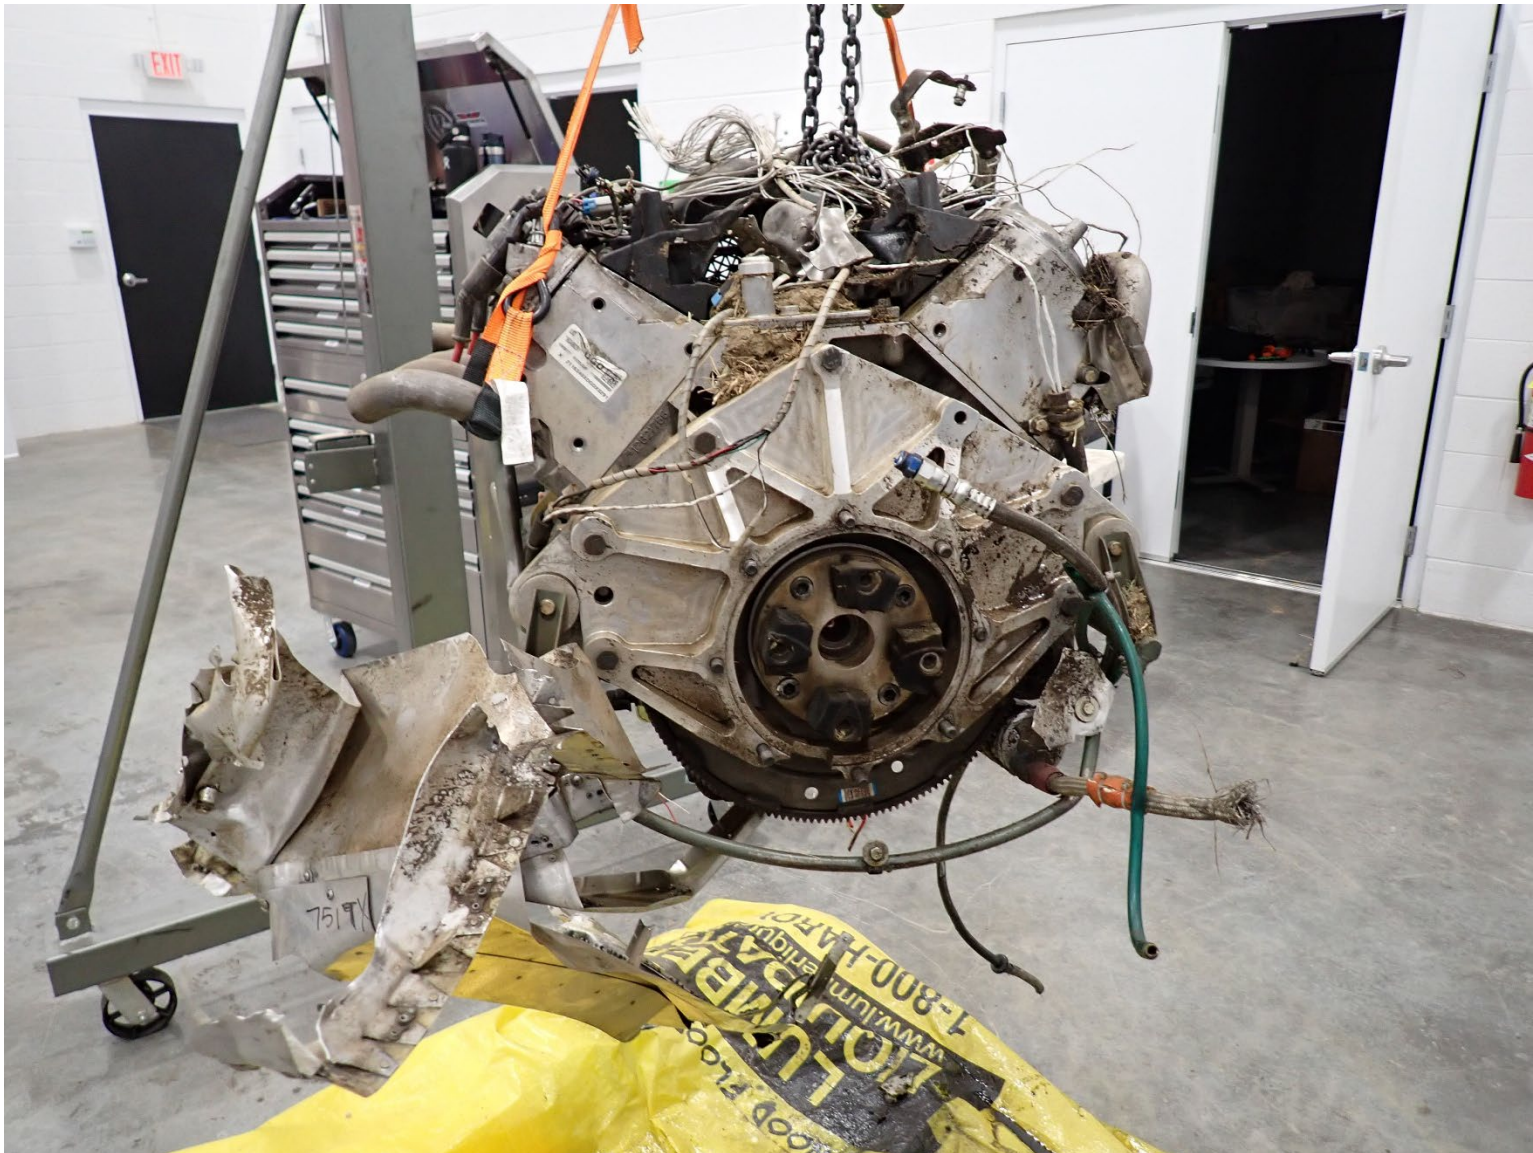
**Photograph 8 - Engine after recovery**

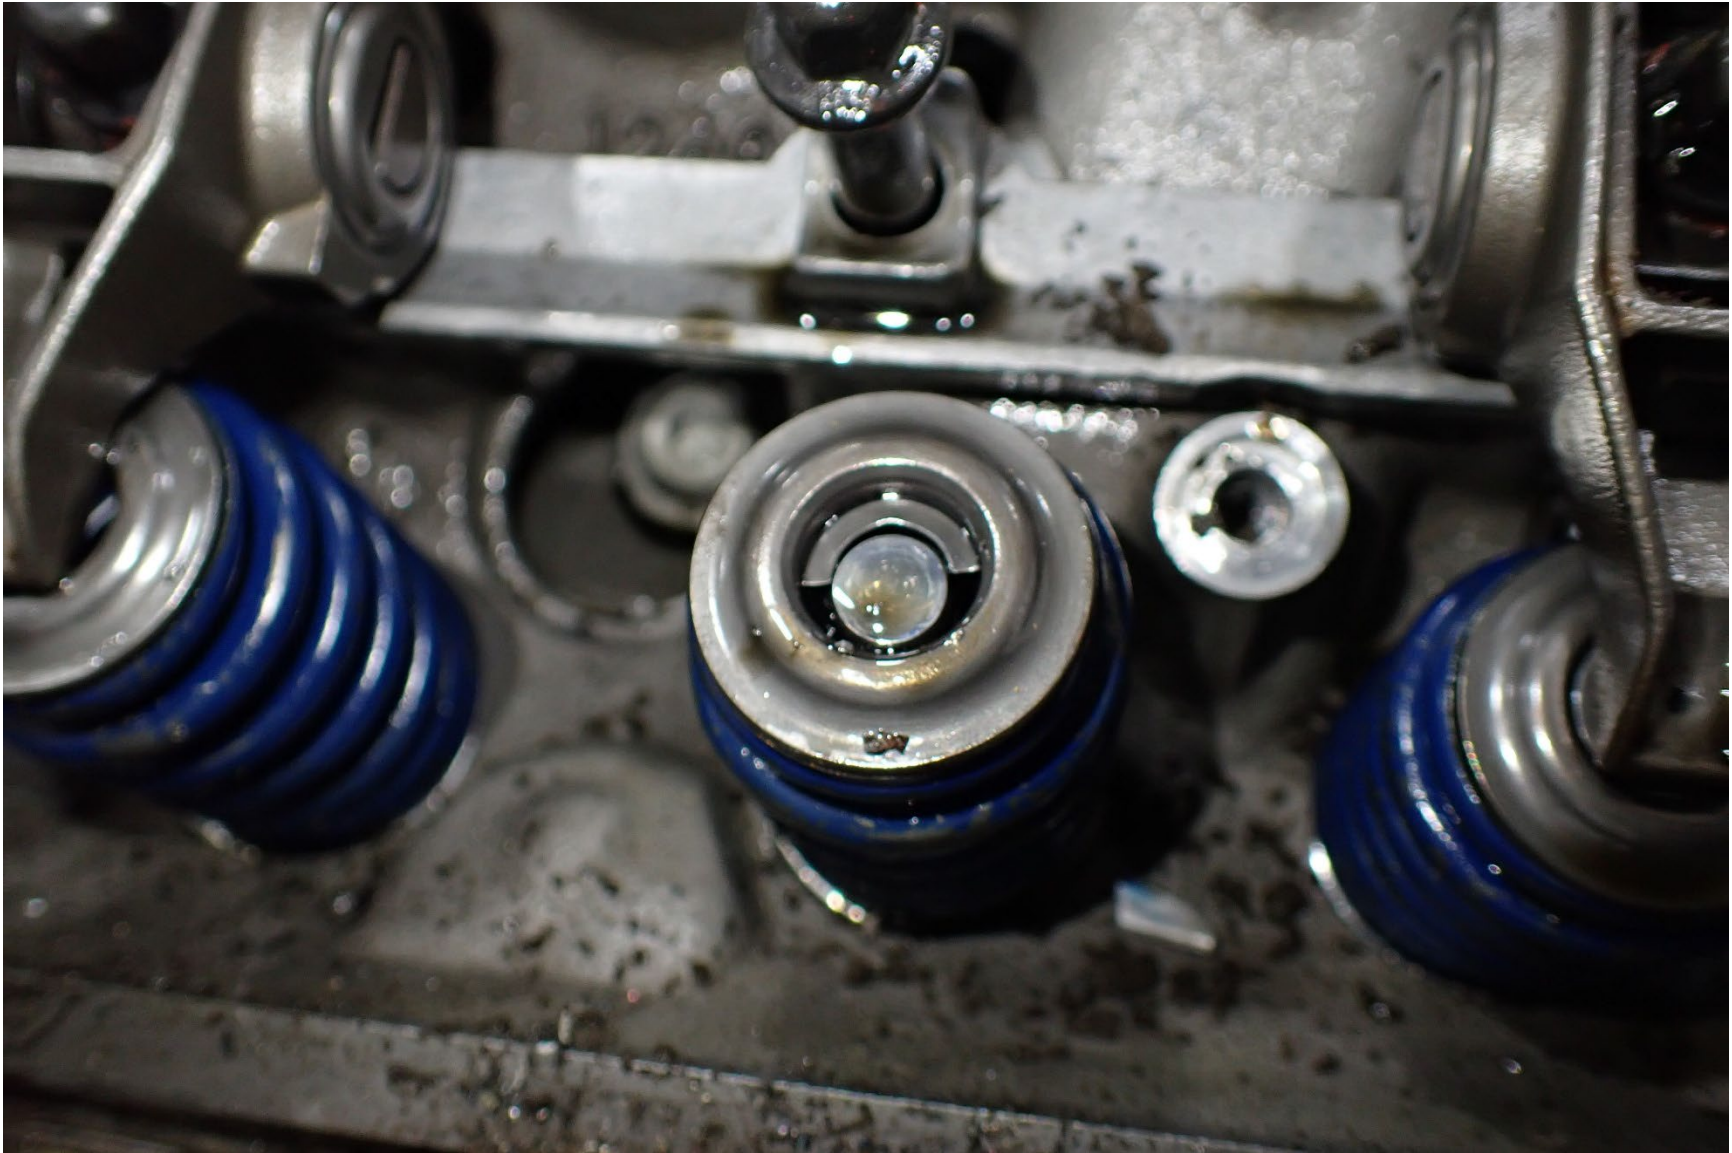
**Photograph 9 - No. 3 intake valve missing one valve key**

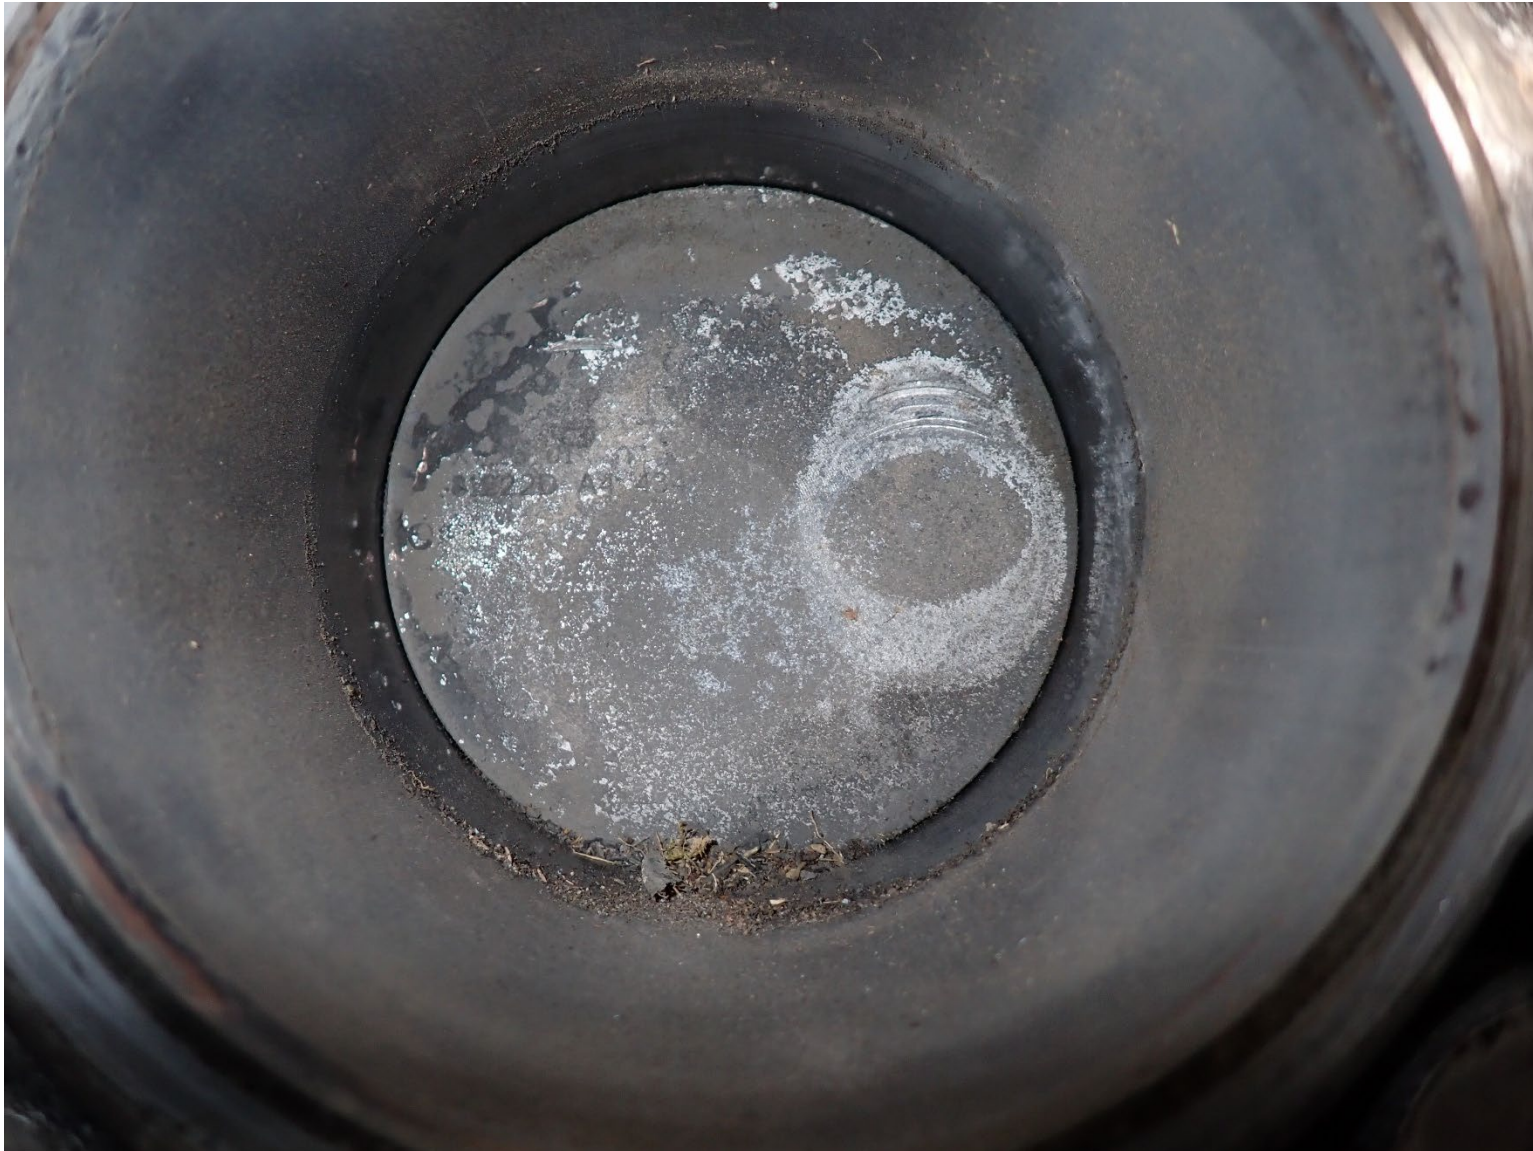
**Photograph 10 - No. 1 piston with valve strike impressions**

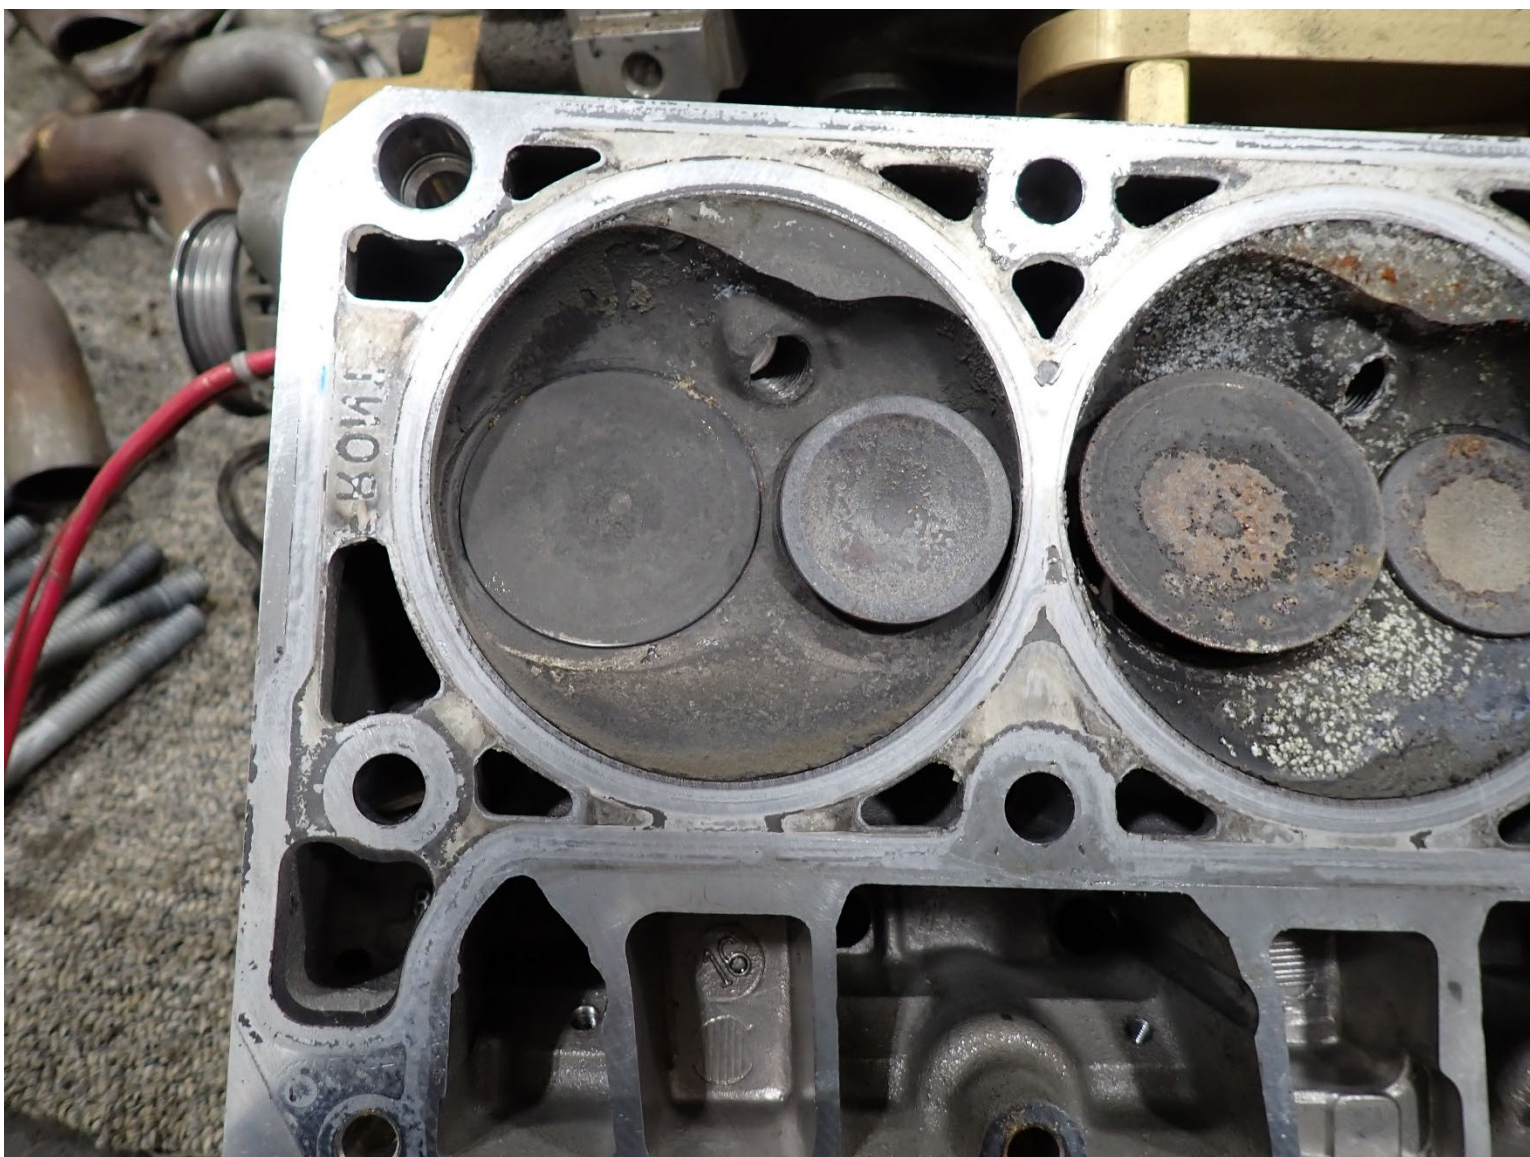
**Photograph 11 - No. 1 cylinder head with valves**

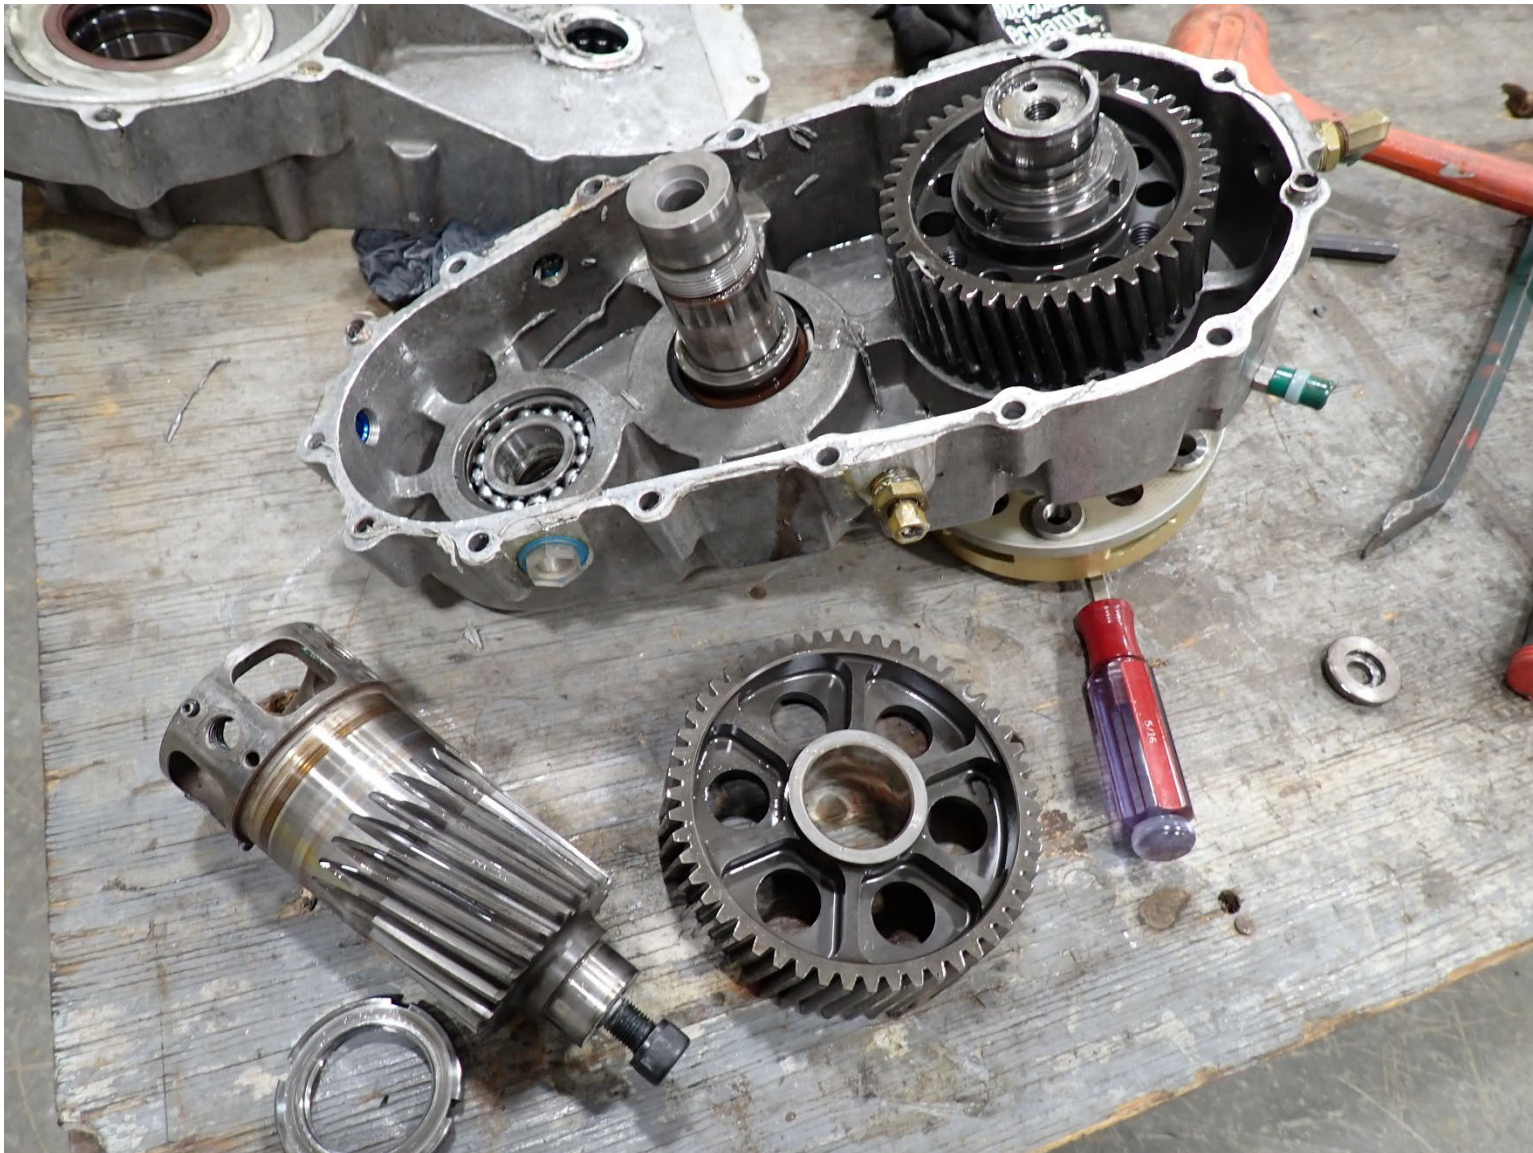
**Photograph 12 - Propeller gearbox after disassembly**
