ERA24FA318

## INVESTIGATION PHOTOGRAPHS

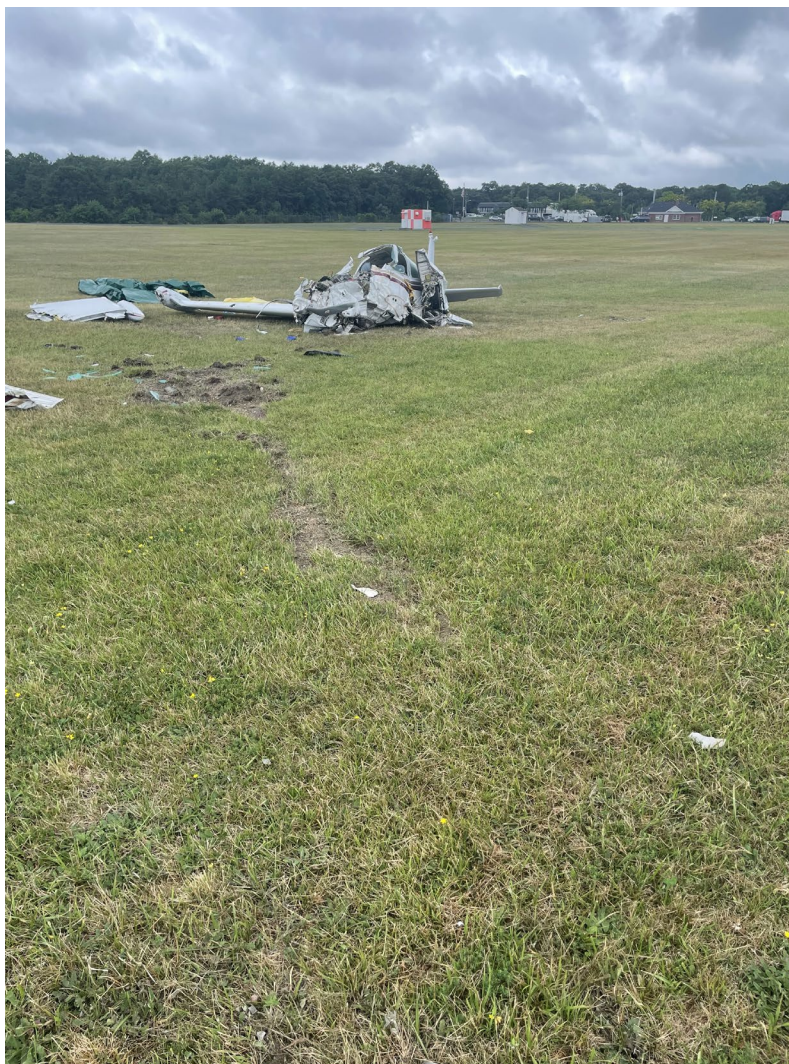
**Photograph 1 - Wide view of accident site. (NTSB)**

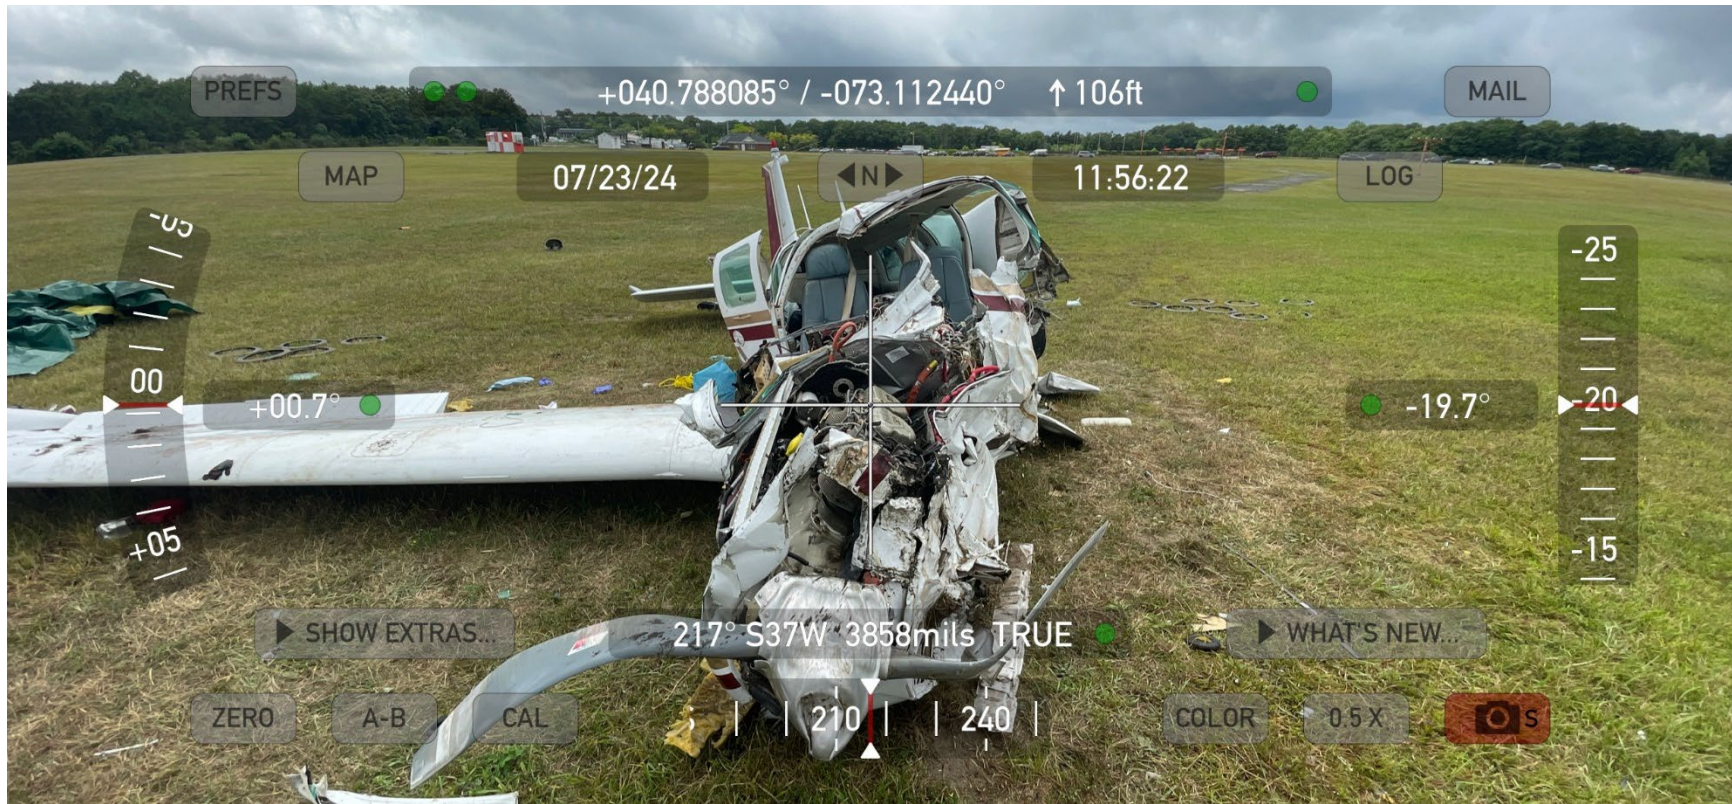
**Photograph 2 - Theodolite view of wreckage showing lat/long, elevation and magnetic heading. (NTSB)**

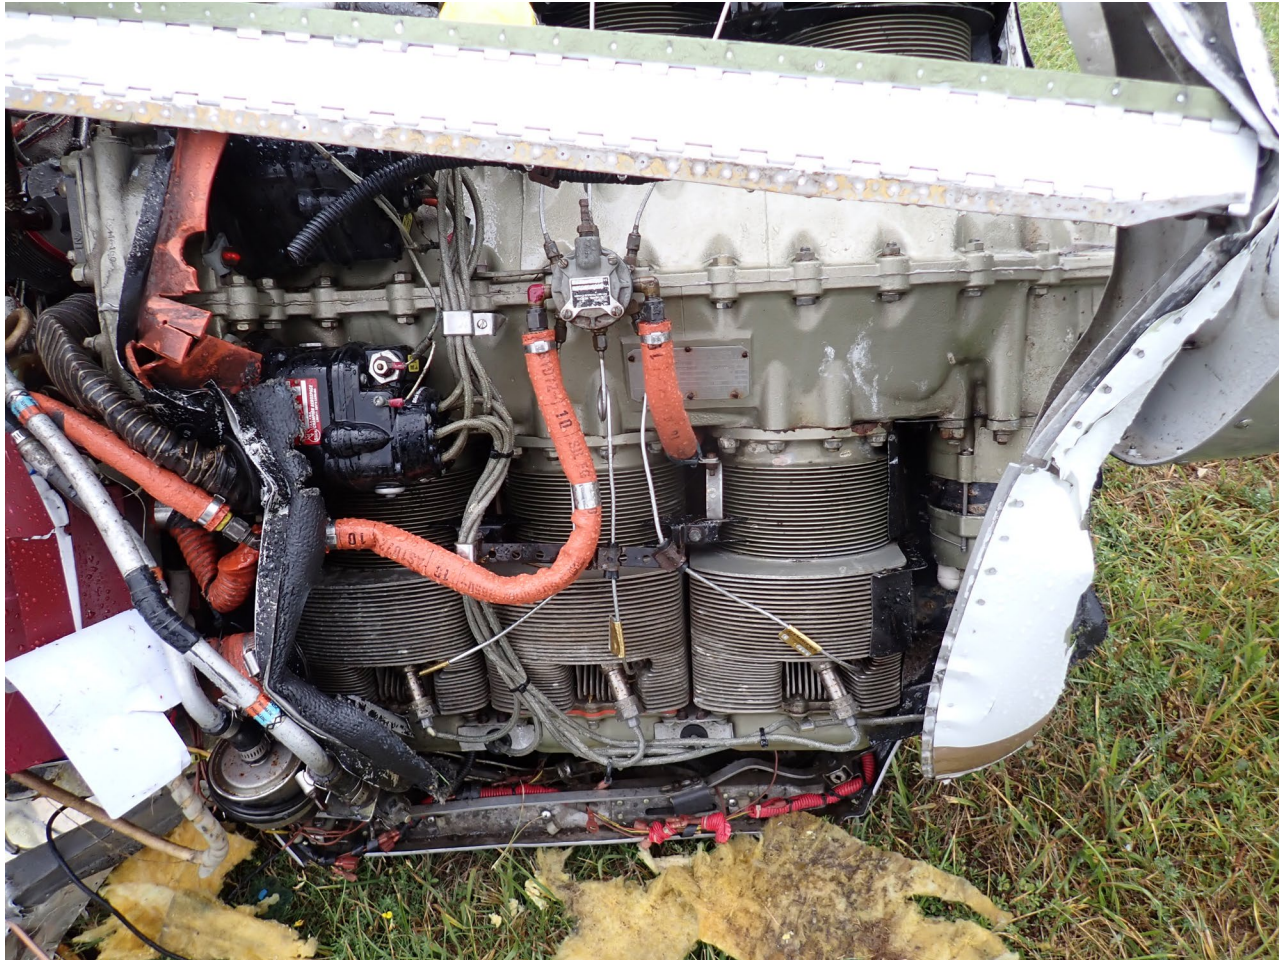
**Photograph 3 - View of the 1,3,5 side of the engine on site. (NTSB)**

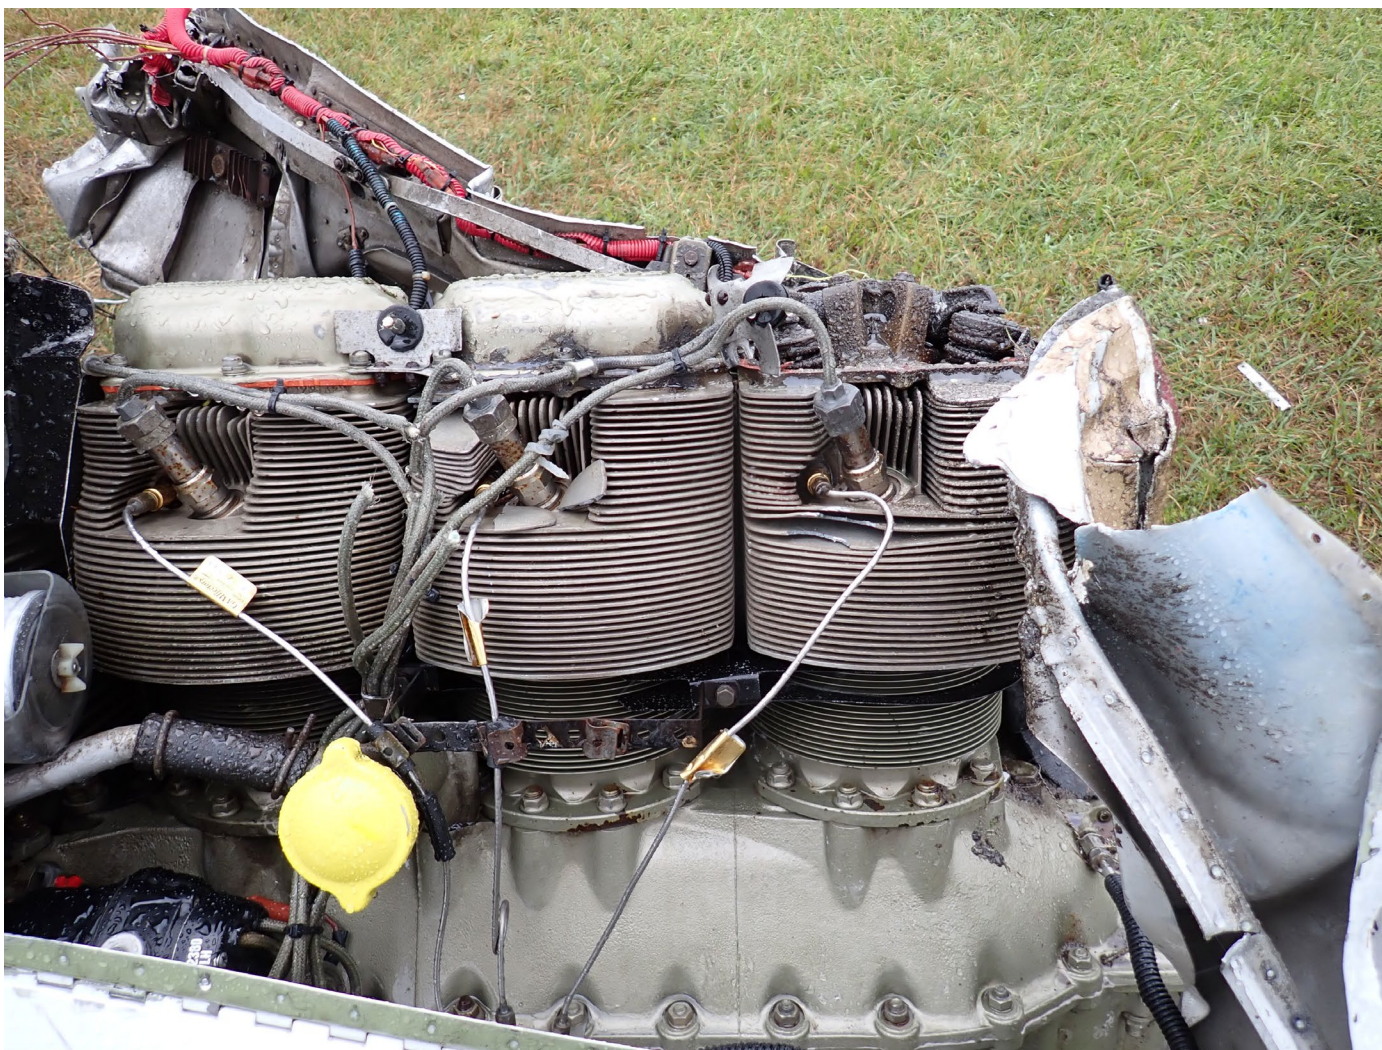
**Photograph 4 - View of the 2,4,6 side of the engine on site. (NTSB)**

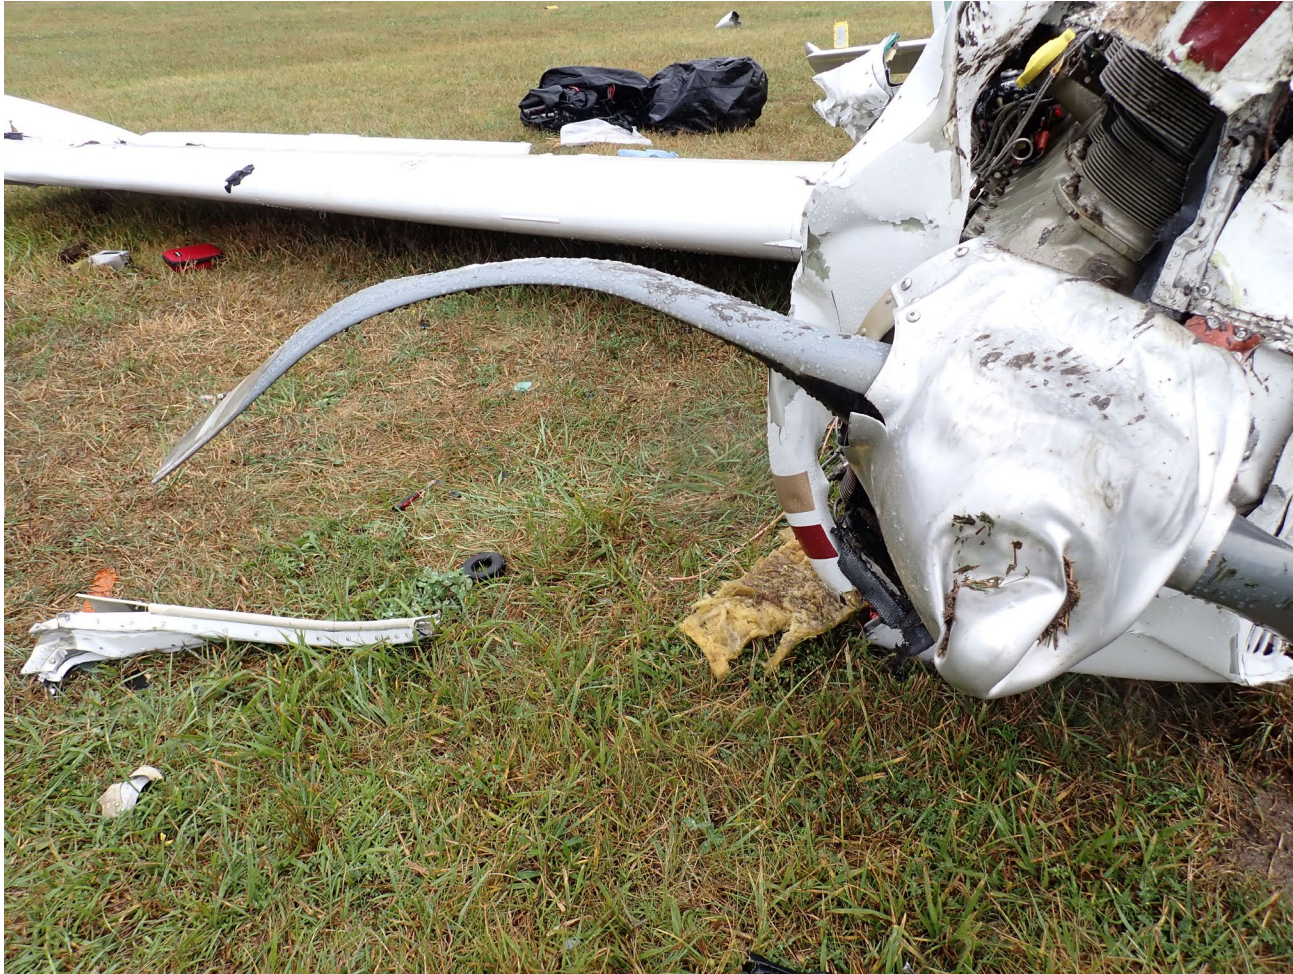
**Photograph 6 - View of propeller blade damage. (NTSB)**

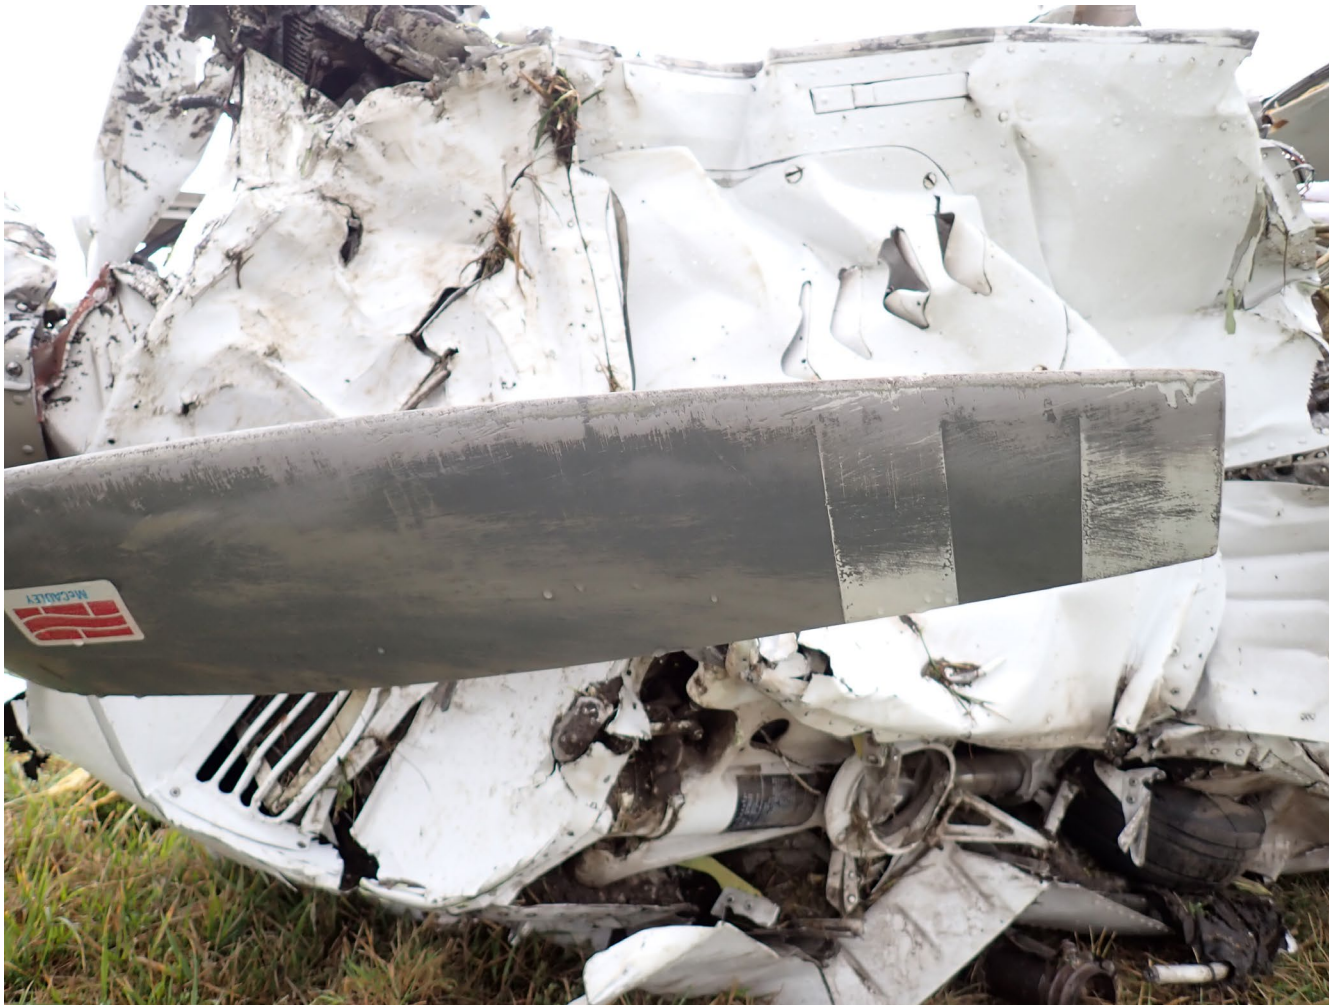
**Photograph 7 - View of propeller blade damage. (NTSB)**

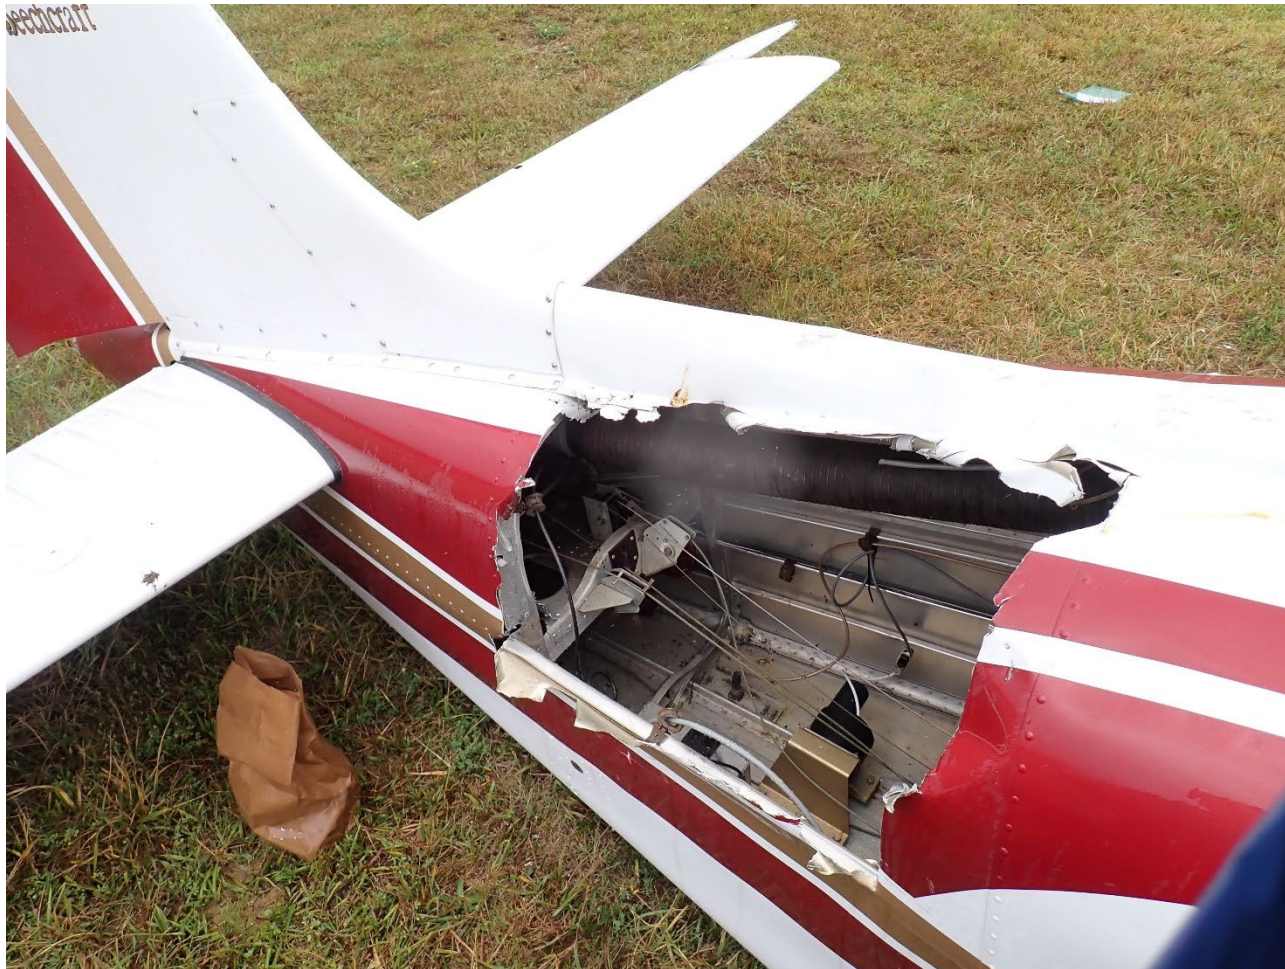
**Photograph 8 - View of empennage with hole cut into fuselage for examination of flight control cables. (NTSB)**

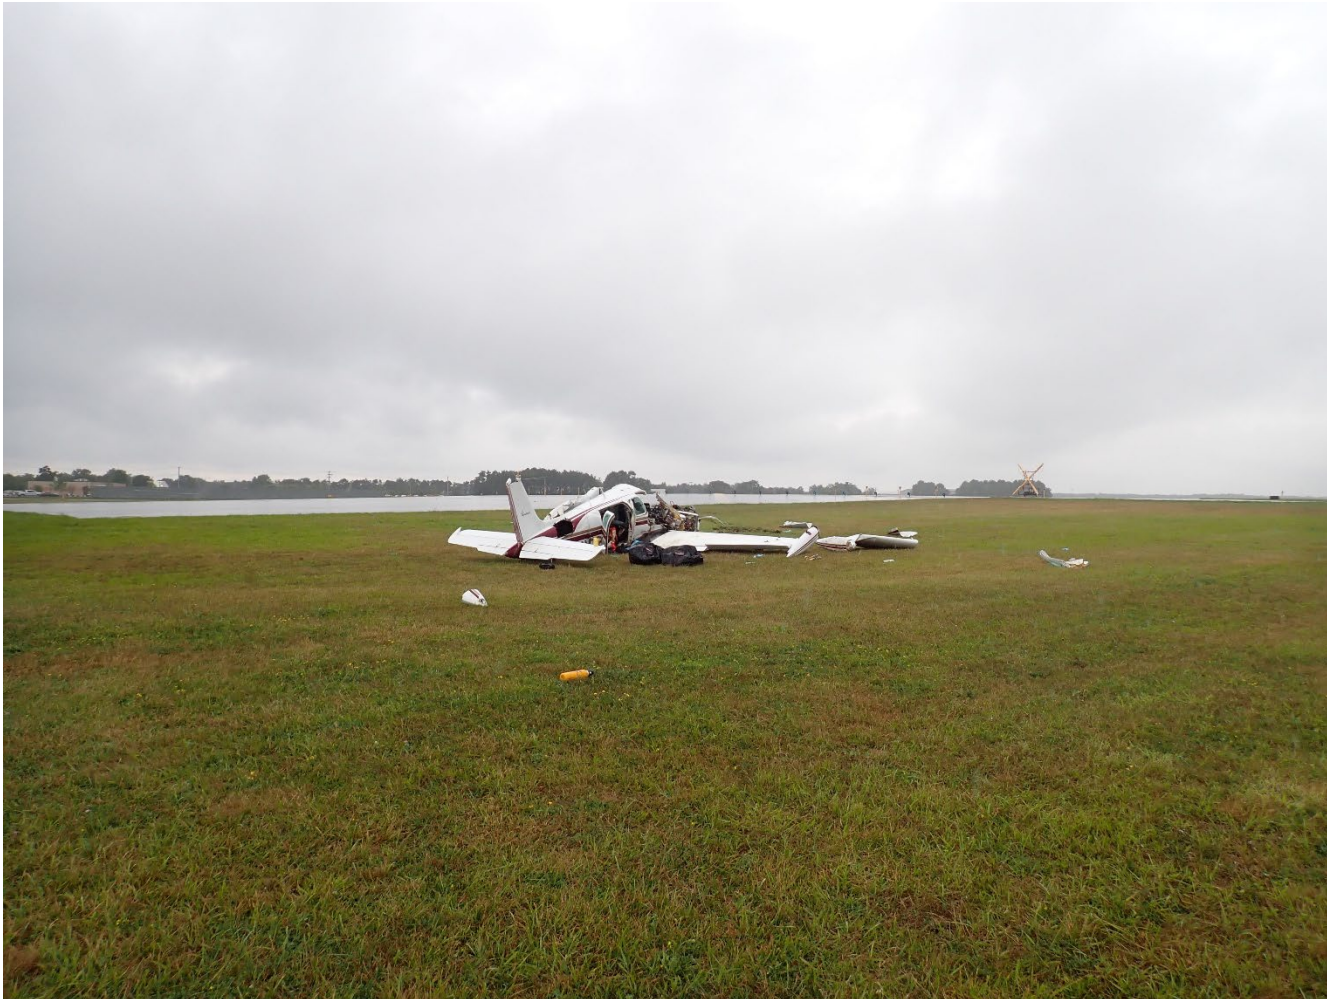
**Photograph 9 - Wide view of wreckage looking towards runway. (NTSB)**

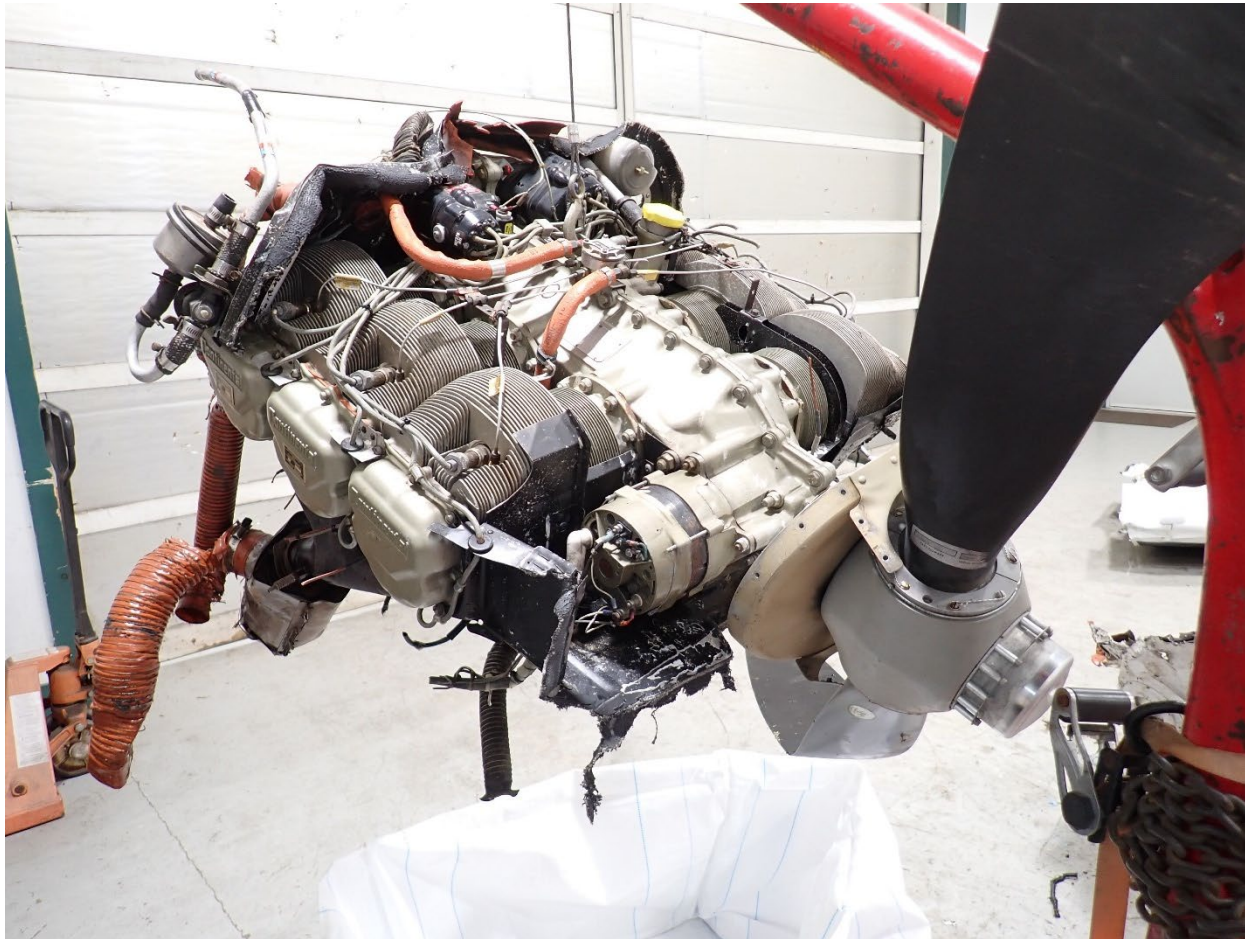
**Photograph 10 - View of engine and propeller on hoist prior to examination. (NTSB)**

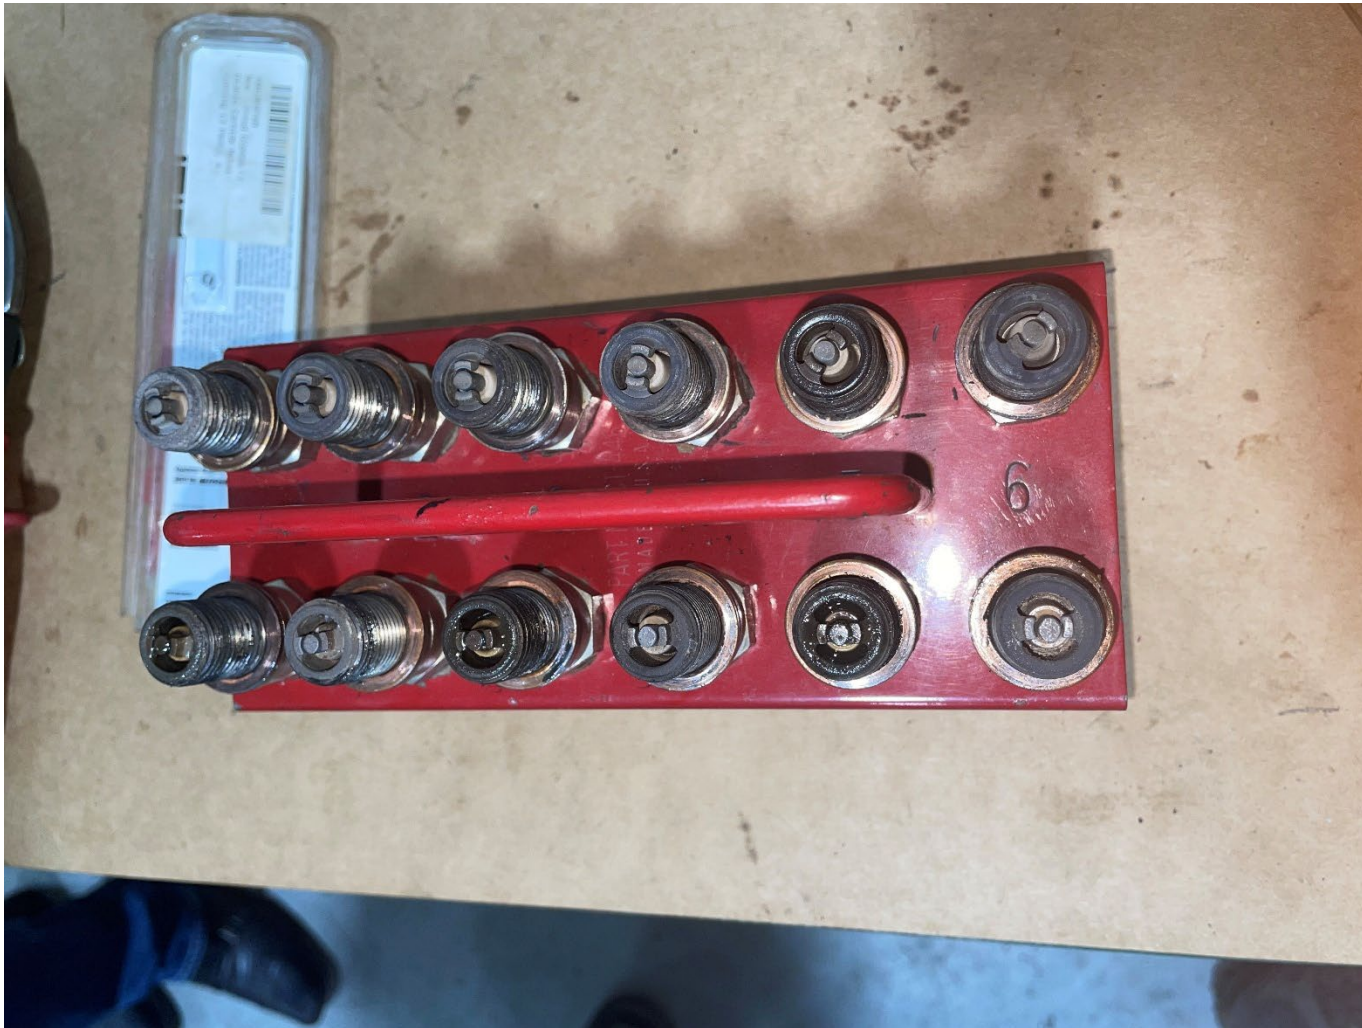
**Photograph 11 - View of spark plugs during engine examination. (NTSB)**

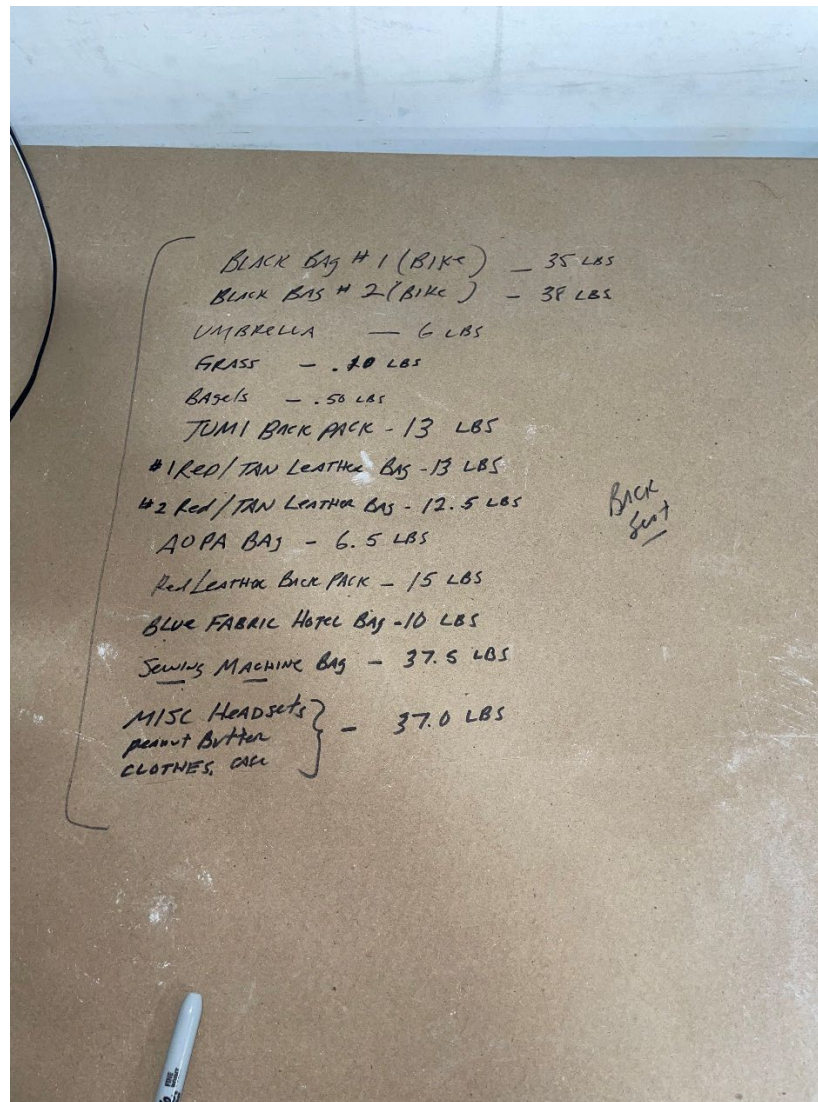
**Photograph 12 - Items removed from wreckage and their respective weights for weight and balance documentation. (NTSB)**

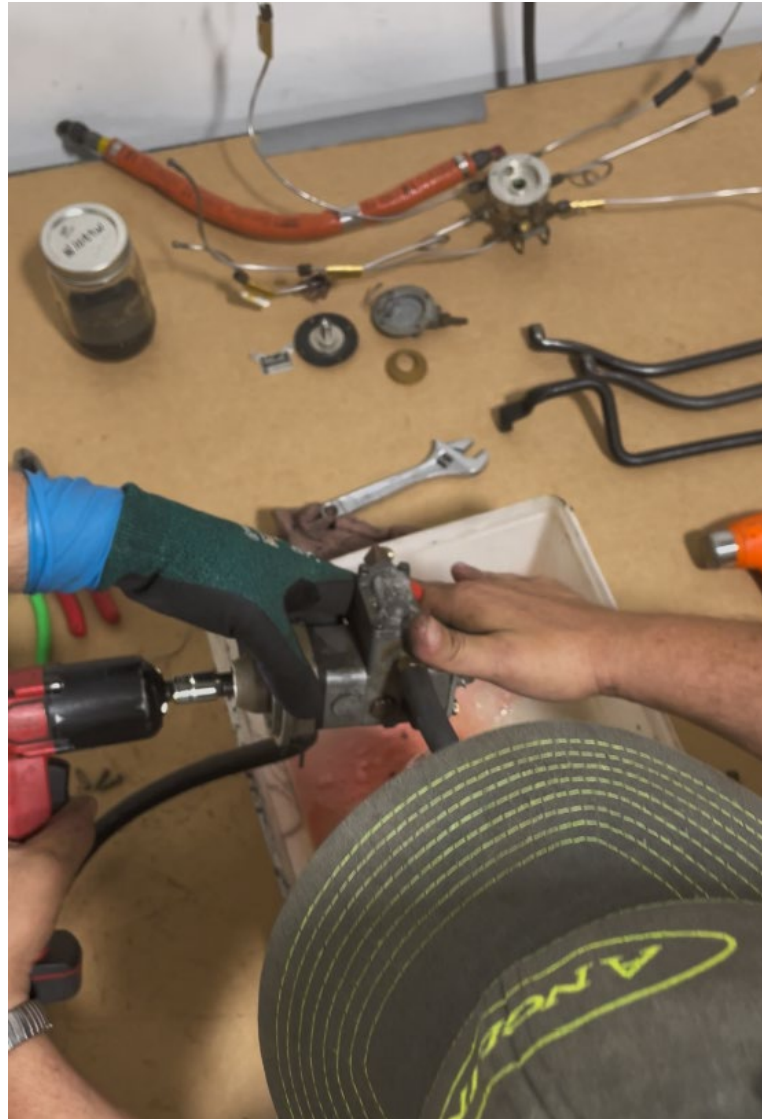
**Photograph 13 - View of engine components testing, specifically the engine driven fuel pump.  
(NTSB)**

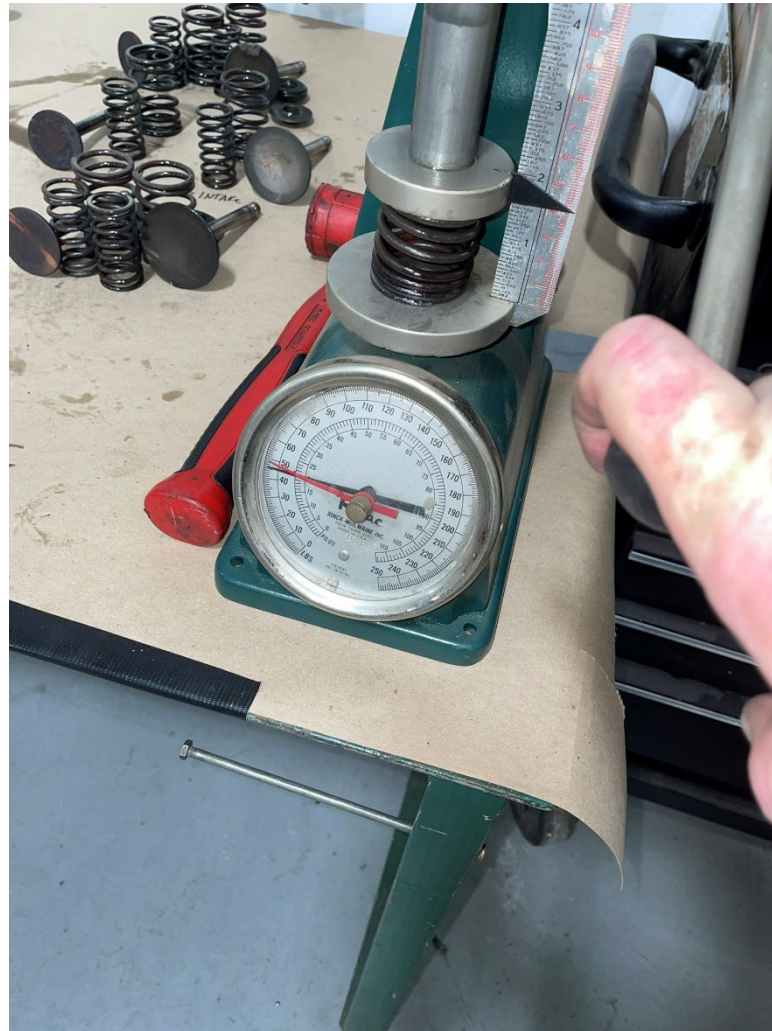
**Photograph 14 - View of valve spring testing. All six cylinders exhibited equivalent results.  
(NTSB)**

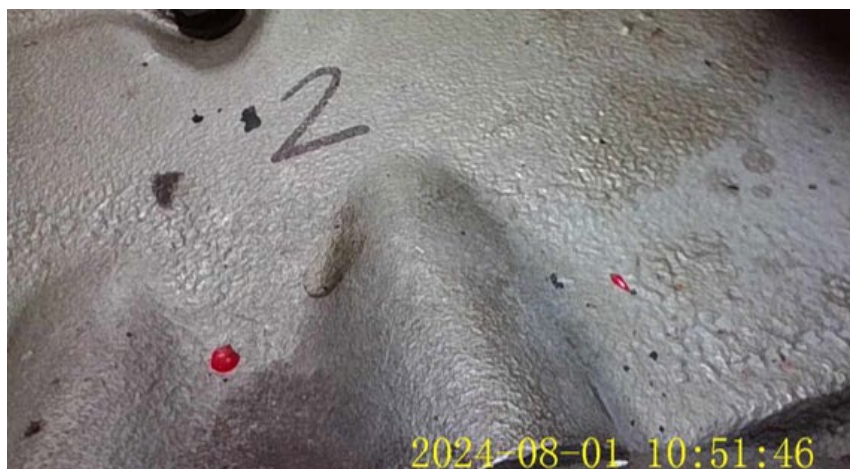
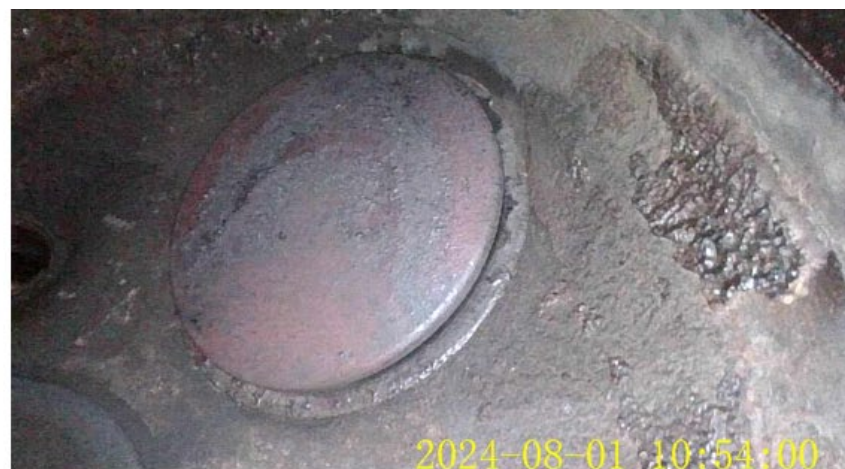
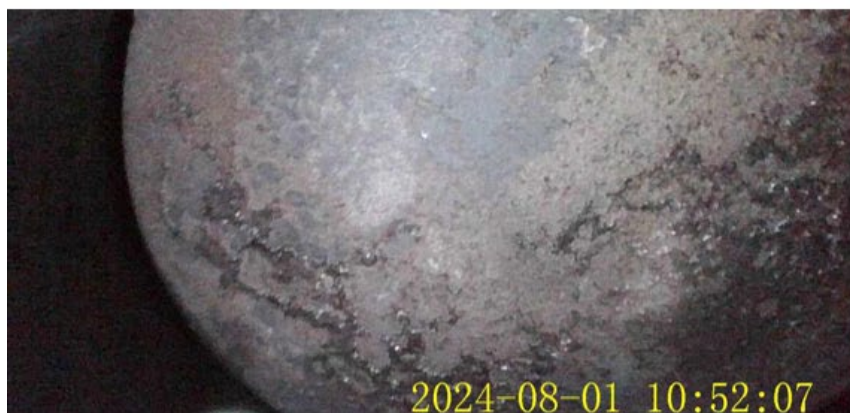
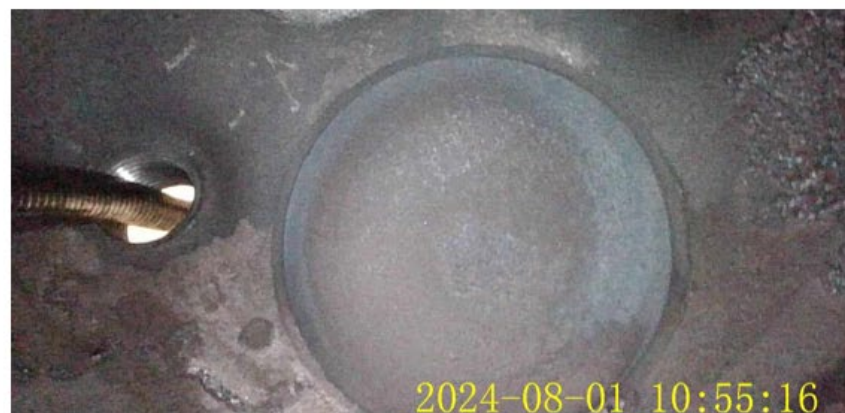
**Photograph 15 - Borescope of number 2 cylinder, valves, and piston. Equivalent results were observed on all 6. (NTSB)**
