# National Transportation Safety Board

ERA24FA318

## EXAMINATION

Location: Long Island Mac Arthur Airport (ISP)  
Date: July 22, 2024  
Time: 6:12 pm local EDT  
2212 (UTC)  
Airplane: BE-A36

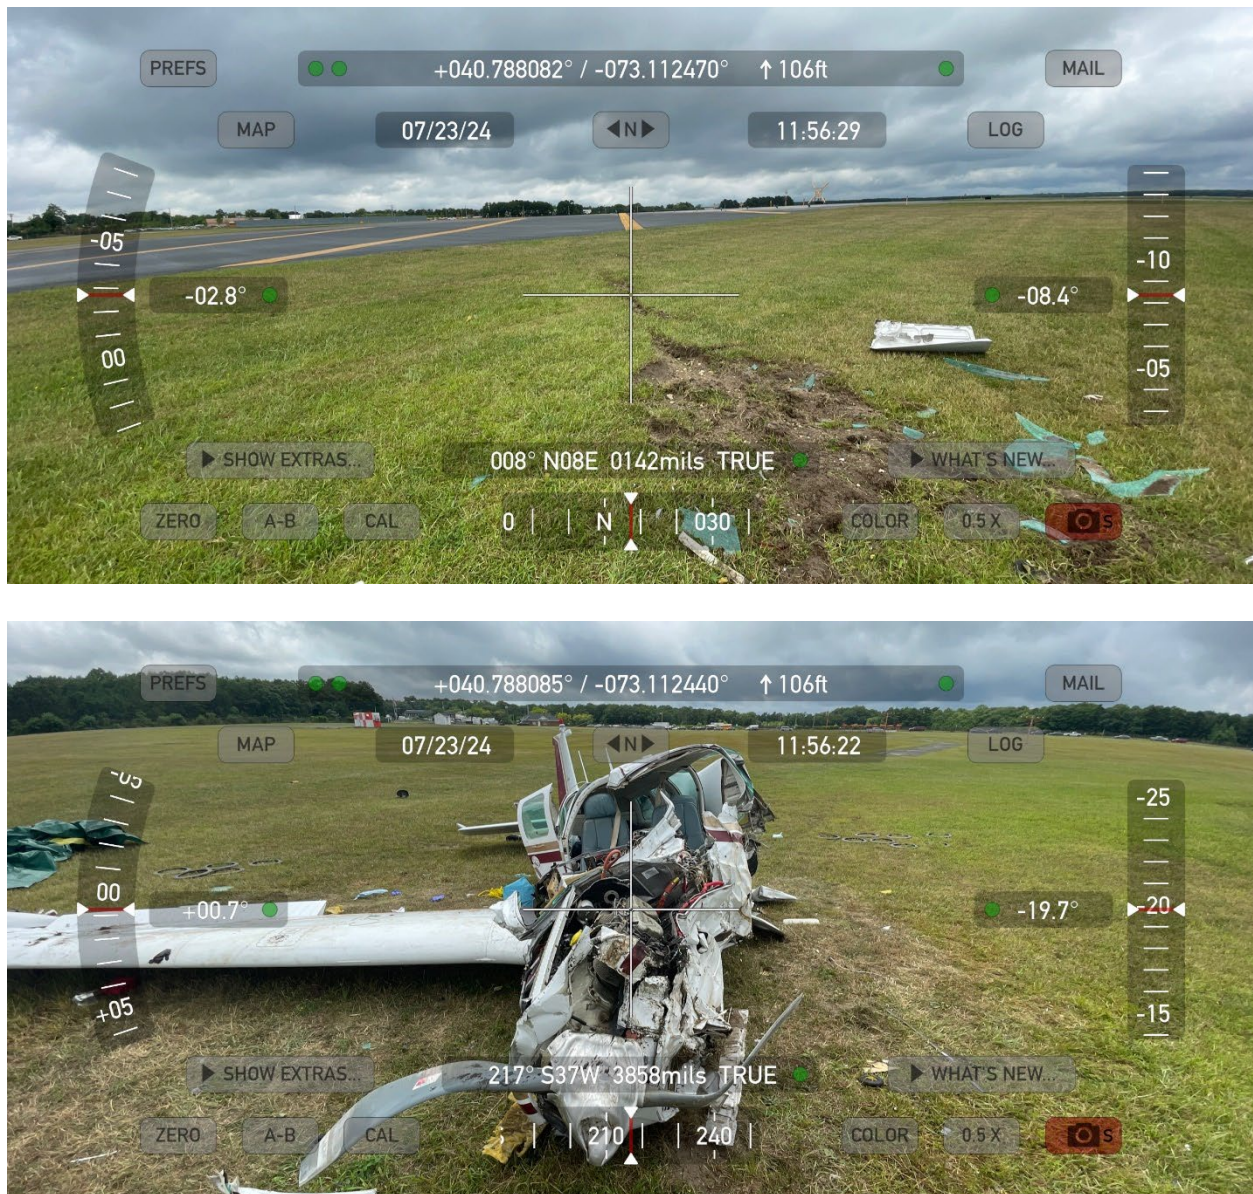
Accident site was relatively compact. The wreckage path consisting of the ground scars was about 40 feet long, but a majority of the wreckage was located in the immediate vicinity of the accident site. All components, flight control surfaces, wings, elevator & stabilizers were located.

**Figure 1: Accident site with location/ direction details.**

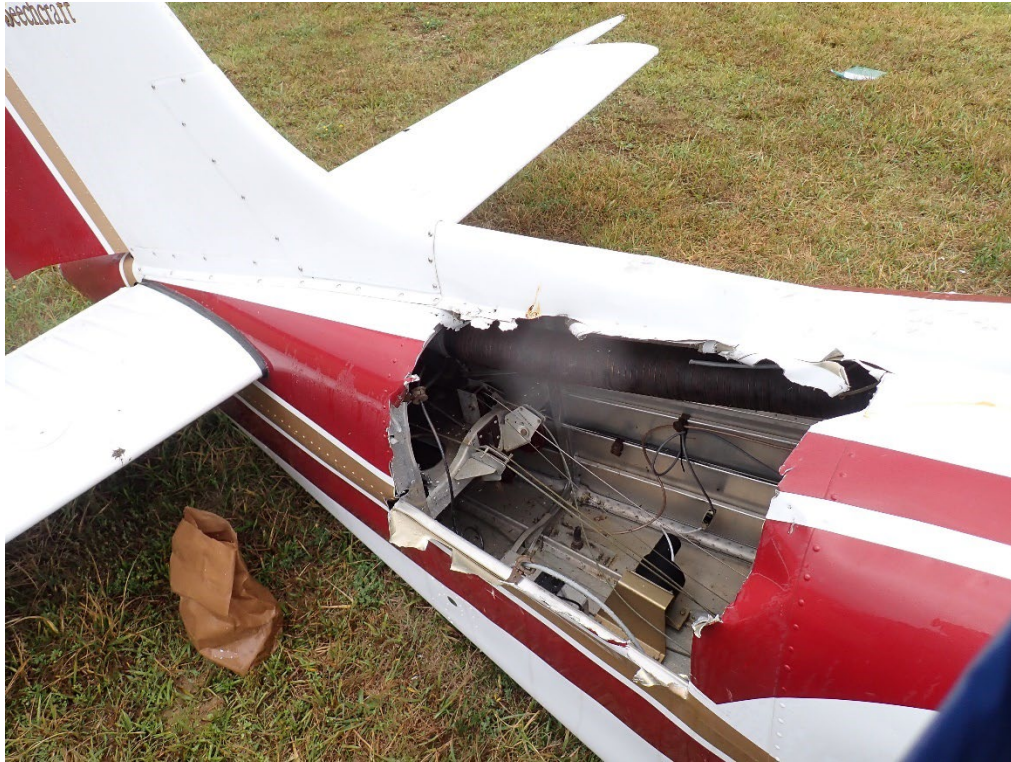
The empennage remained attached to the fuselage. The rudder and stabilizer remained attached to the empennage at their respective hinges. The stabilizer trim control surface remained attached. The rudder and stabilator control cables remained intact and continuous from the control column to their respective control attachments; the floorboards and underside of the fuselage pinched the cables and limited their movement but were visually traced and manipulated confirming continuity. The rudder cables remained attached to the rudder bar. The stabilizer control cables remained attached to the base of the control column. Rudder, stabilator and stabilator trim continuity was confirmed.

**Figure 2: Empennage with hole cut into interior to access the control cables and ELT.**

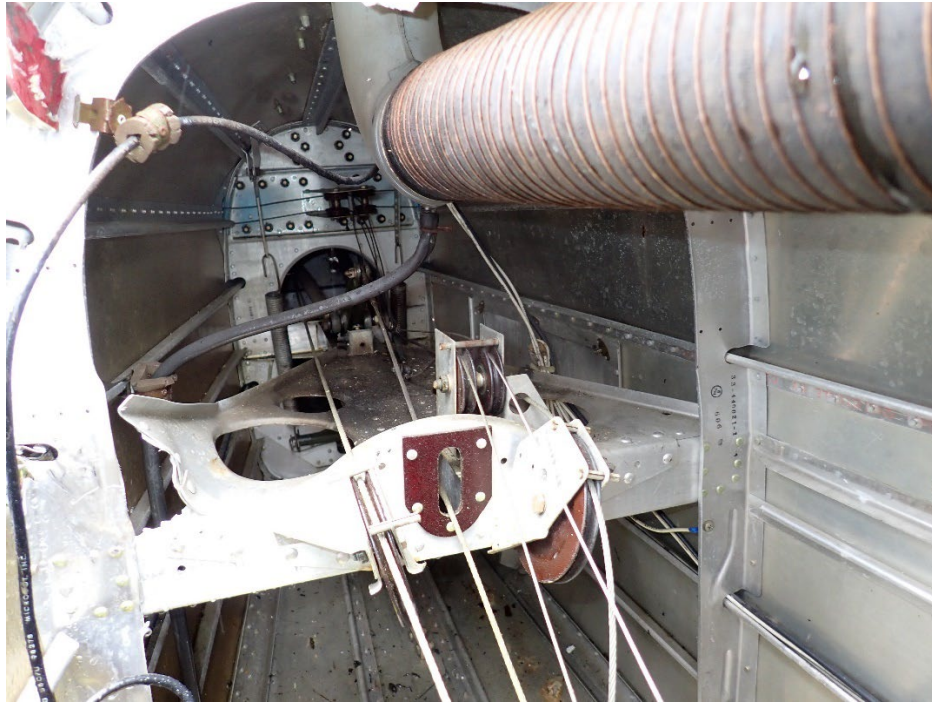
**Figure 3: View of inside of empennage looking aft showing control cables and their respective pulleys.**

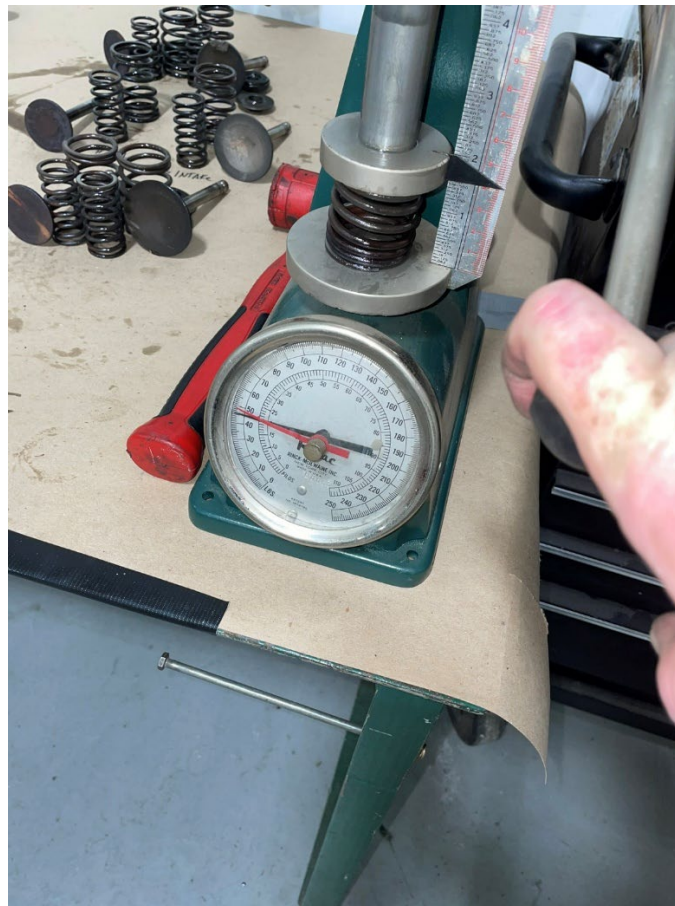
All six-cylinder assemblies were removed and disassembled down to their individual components, pistons, valves, pushrods, and springs. Each of the dual valve springs for intake and exhaust were visually examined and no defects were observed. The springs were placed on a RIMAC manual spring tester. All of the springs were free of defects, and each spring test yielded operating results between 32 and 50 lbs as shown below and in figure 4.

**Figure 4: Number 2 spring testing example.**

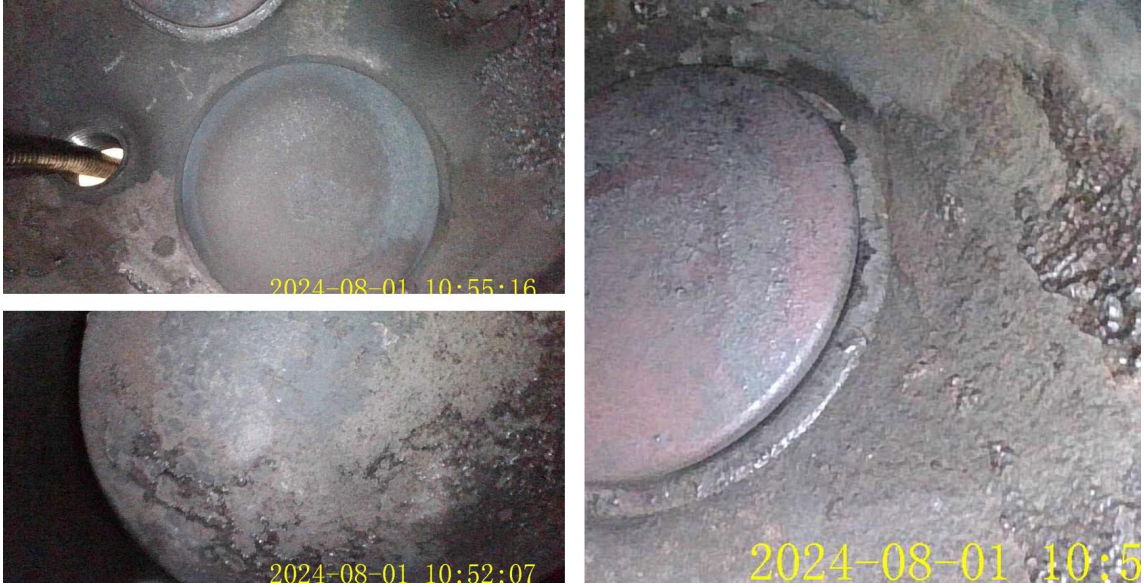
**Figure 5: Typical borescope view of the No 3 cylinder. Representative of all cylinder assys.**

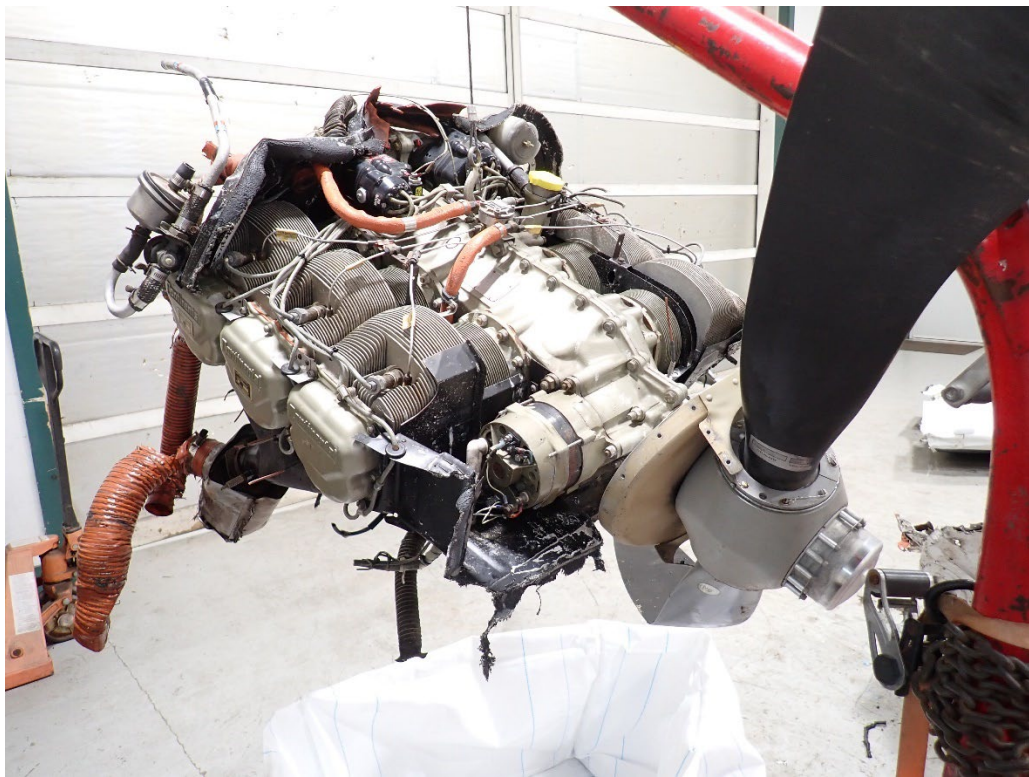
The powerplant, a Continental IO-520-BA (# 249555) is a six-cylinder, air cooled, direct drive, horizontally opposed, fuel injected, engine with a rating of 285HP @ 2700RPM. The engine was largely intact with very little impact damage with the exception of propeller impact damage to the left forward (No. 6) valve cover was damaged but otherwise remained intact. Impact damage was limited to several of the accessories.

**Figure 6: Engine prior to full examination.**

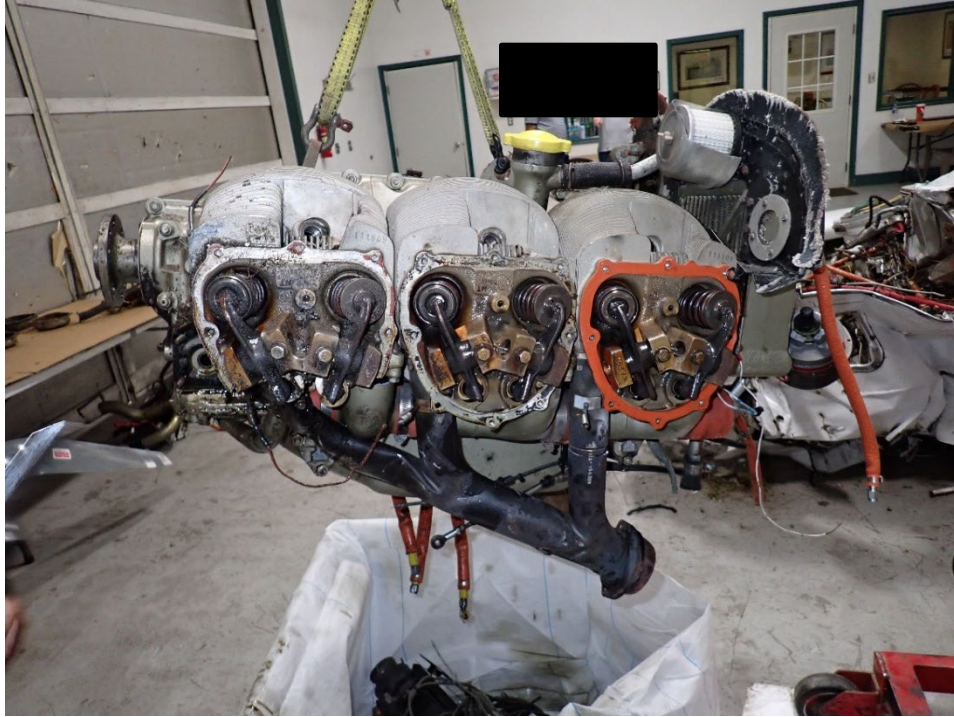
**Figure 7: View of left side (Nos 6, 4, 2) of engine with rocker covers off.**

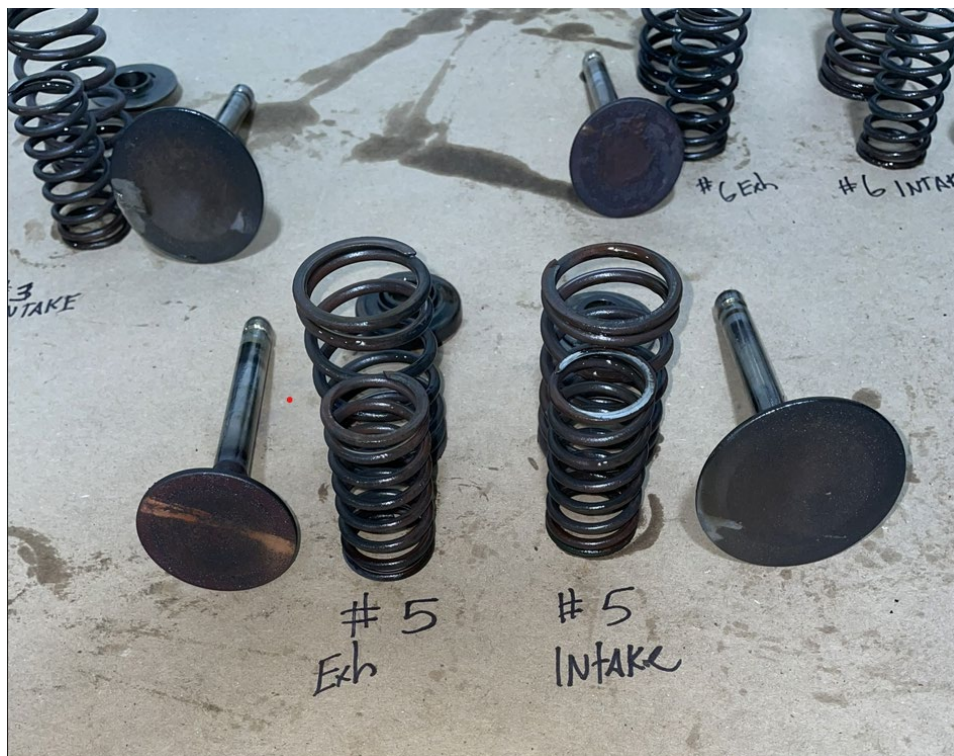
**Figure 8: View of the number 5 valve and spring assembly.**

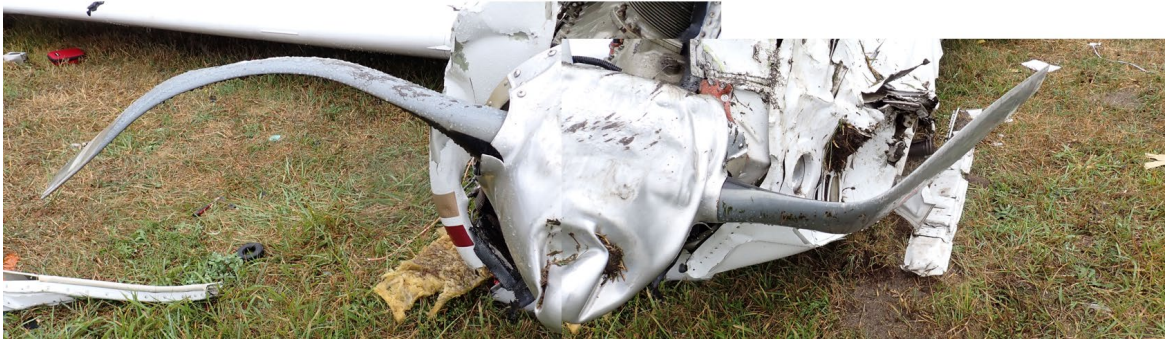
The propeller (McCauley) hub remained attached to the flange and crankshaft. The blades were designated as A & B. The A blade had a slight wave bend along its span and chordwise scrapes and polishing and was bent aft about 30°. The B blade was bent uniformly aft about 40 degrees and had minor chordwise scrapes and a tip gouge on the leading edge. The spinner was crushed inwards on one side and showed little rotational damage. The propeller governor and control linkage were destroyed due to impact.

**Figure 9: propeller on site.**
