# National Transportation Safety Board

ERA24FA371

## **FUEL SERVO EXAMINATION**

Location: Vergennes, VT  
Date: September 8, 2024  
Time: 12:25 EDT  
16:25 UTC  
Airplane: Piper PA28R-180 (N3757T)

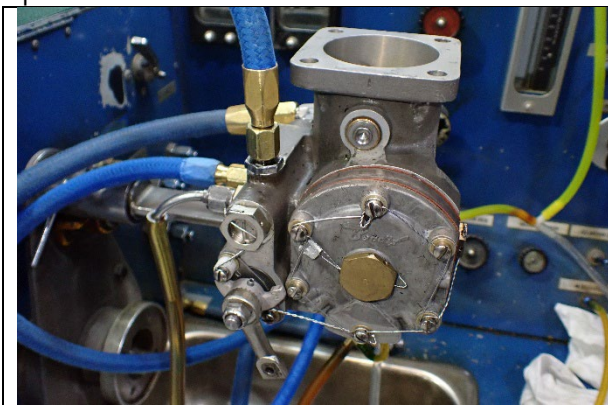
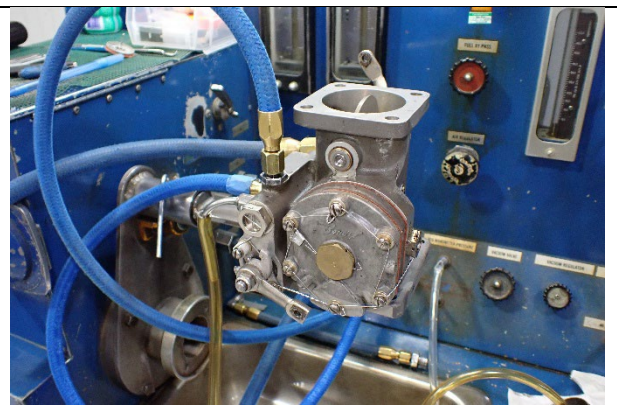
The servo fuel injector was placed on a production test bench and checked for proper fuel flow at multiple throttle settings. The servo fuel injector operated normally at all test points, and the observed fuel flow was within the service limits. There were no anomalies observed during the test that would have precluded normal operation.

Photograph 1: Servo on test bench

Photograph 2: Servo on test bench

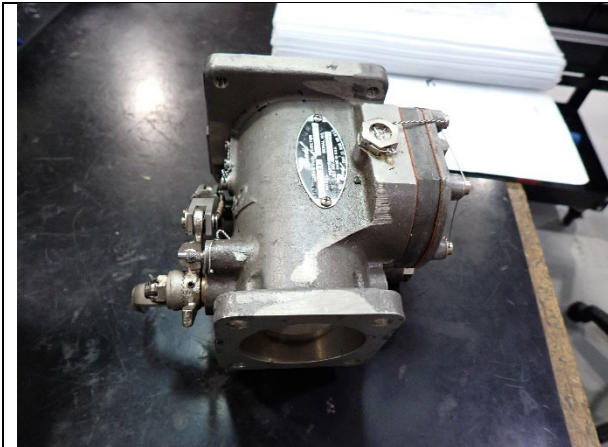
Photograph 3: Fuel servo prior to testing

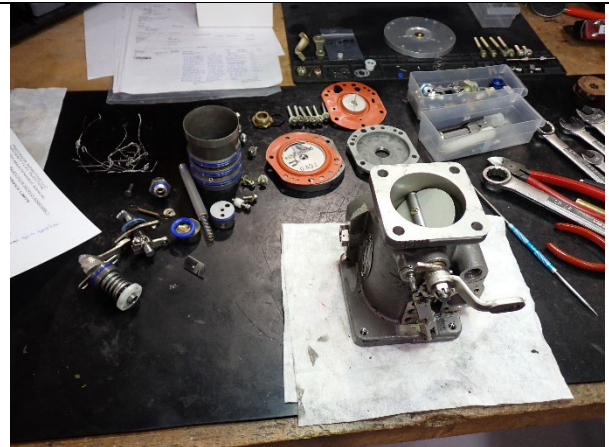
After completing the production test of the servo fuel injector, the servo was disassembled and examined. There was a small amount of oil consistent with preservative oil on the air side of the servo's regulator; however, the technician reported this would not have prevented normal operation of the regulator. The rest of the internal components displayed normal operating signatures. There were no anomalies observed that would have precluded normal operation of the servo.

Photograph 4: Fuel servo disassembled

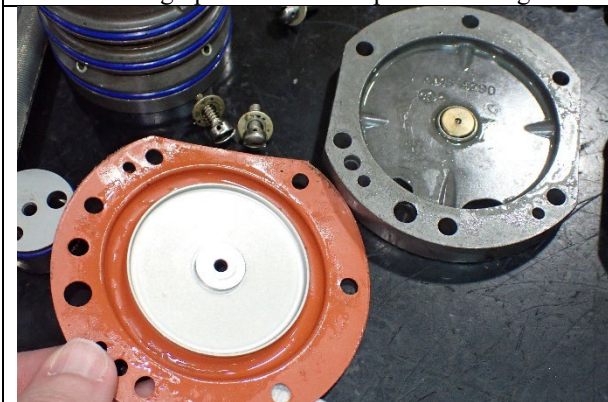
Photograph 5: Fuel servo regulator with oily substance

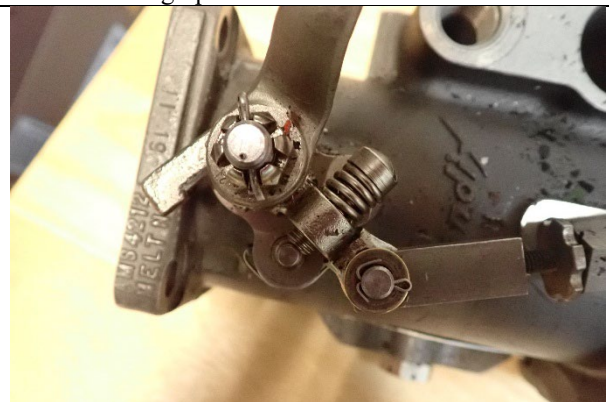
Photograph 6: Throttle control arm and linkage

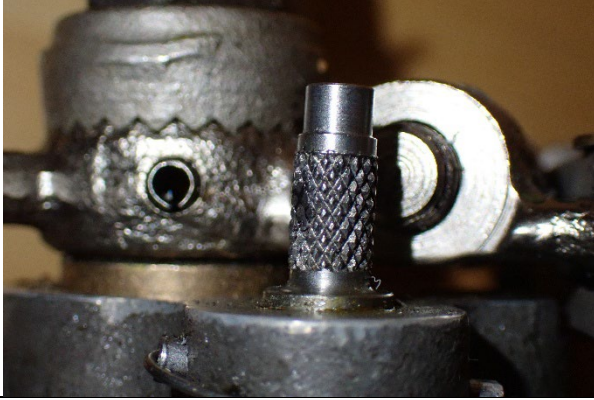
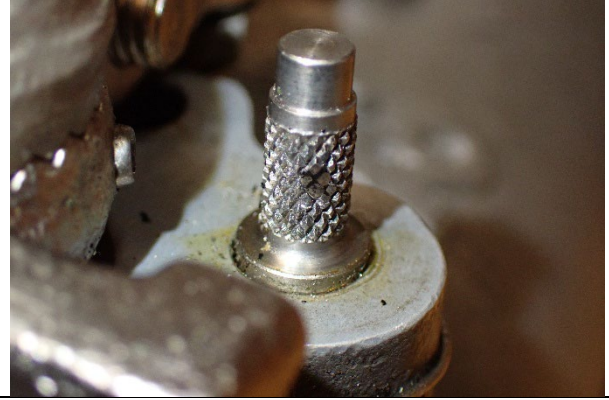
On March 25, 2025, the Bendix Servo Fuel Injector (P/N: 2524297-10, S/N: 16086 /4), was examined at AvStar Fuel Systems in Jupiter, FL. The examination revealed that the servo throttle stop was missing the plastic portion of the stop. The servo fuel injector was tested and examined, and it was found that the servo was still capable of normal operation despite missing the plastic portion of the throttle stop.

Photograph 7: Servo throttle stop with visible wear

Photograph 8: Servo throttle stop with visible wear
