ERA24FA371

## INVESTIGATION PHOTOGRAPHS

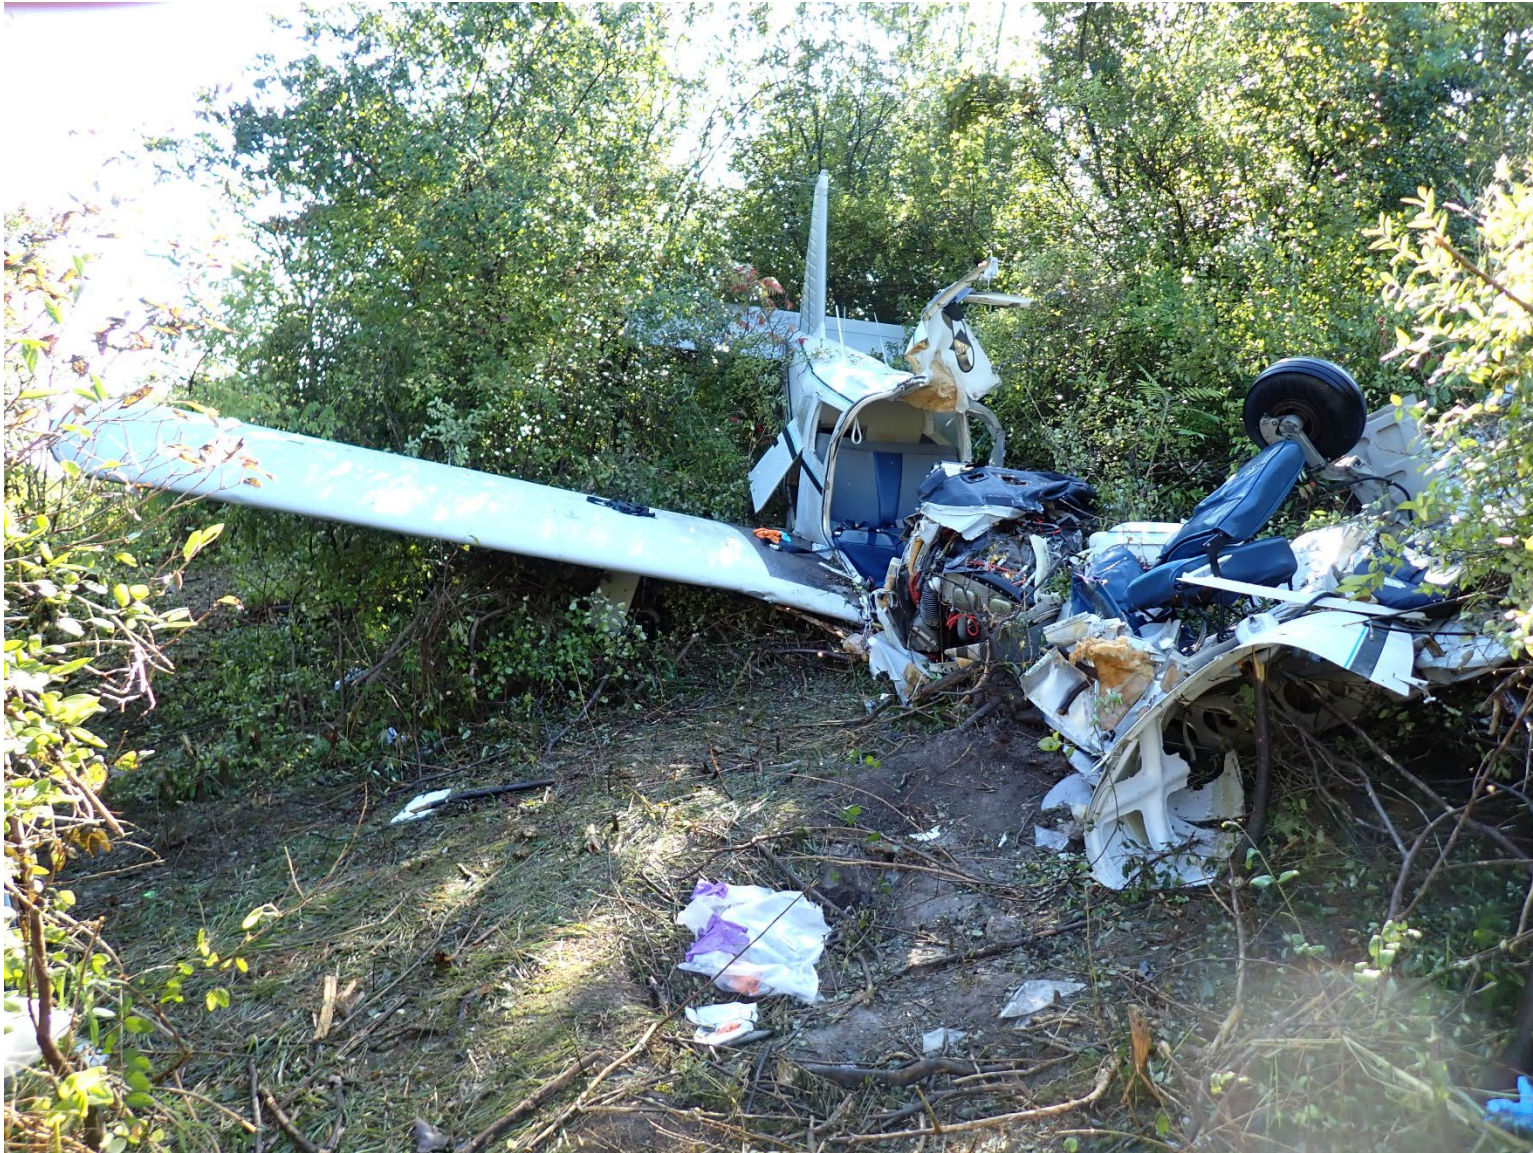
**Photograph 1 - Wreckage overview at the accident site**

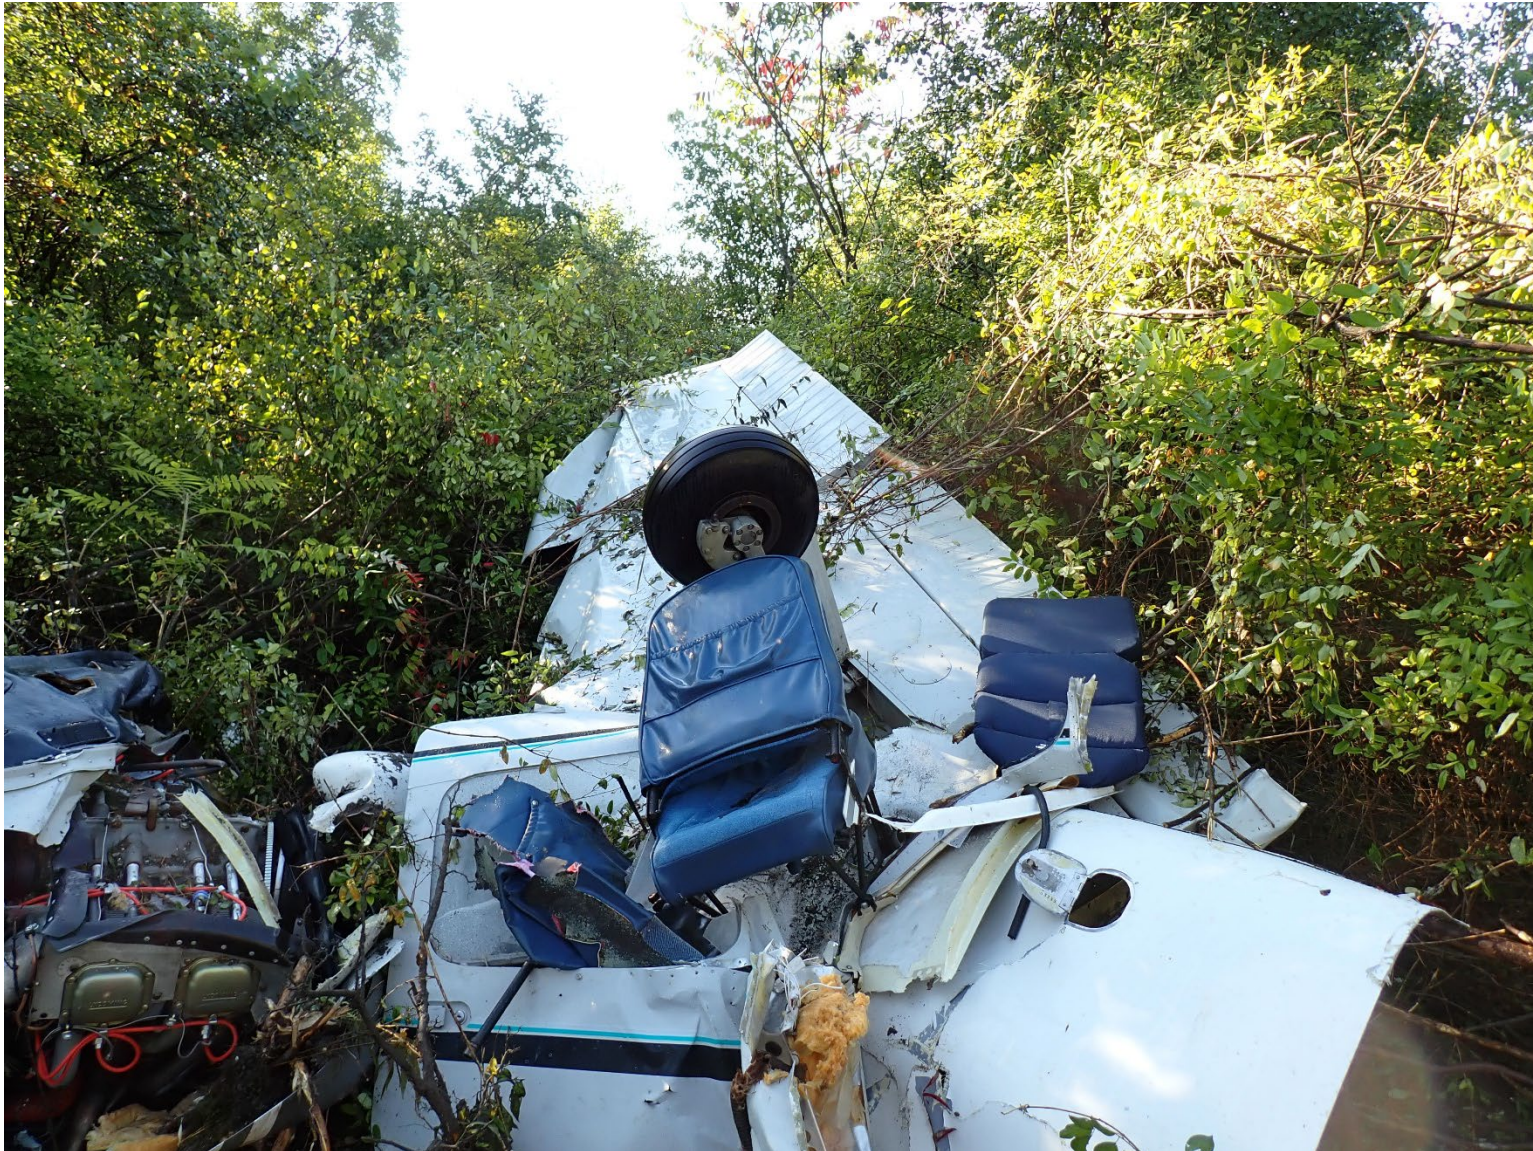
**Photograph 2 - Wreckage overview at the accident site**

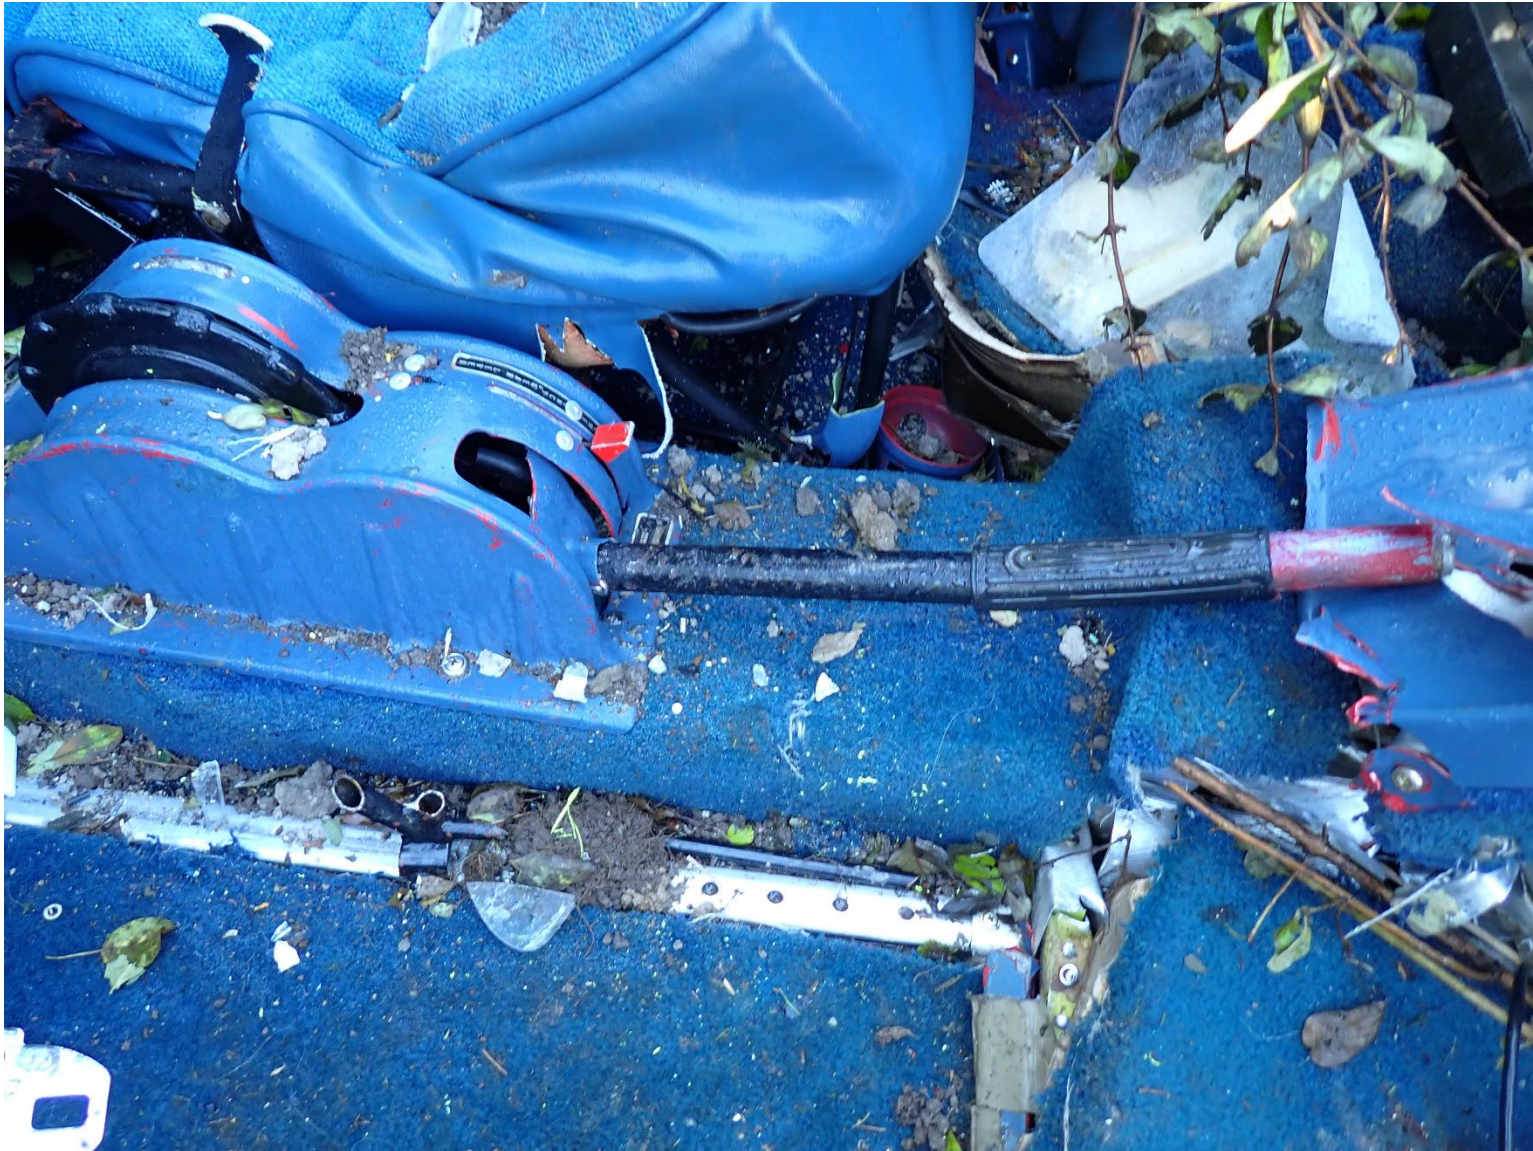
**Photograph 3 - Flap control bar**

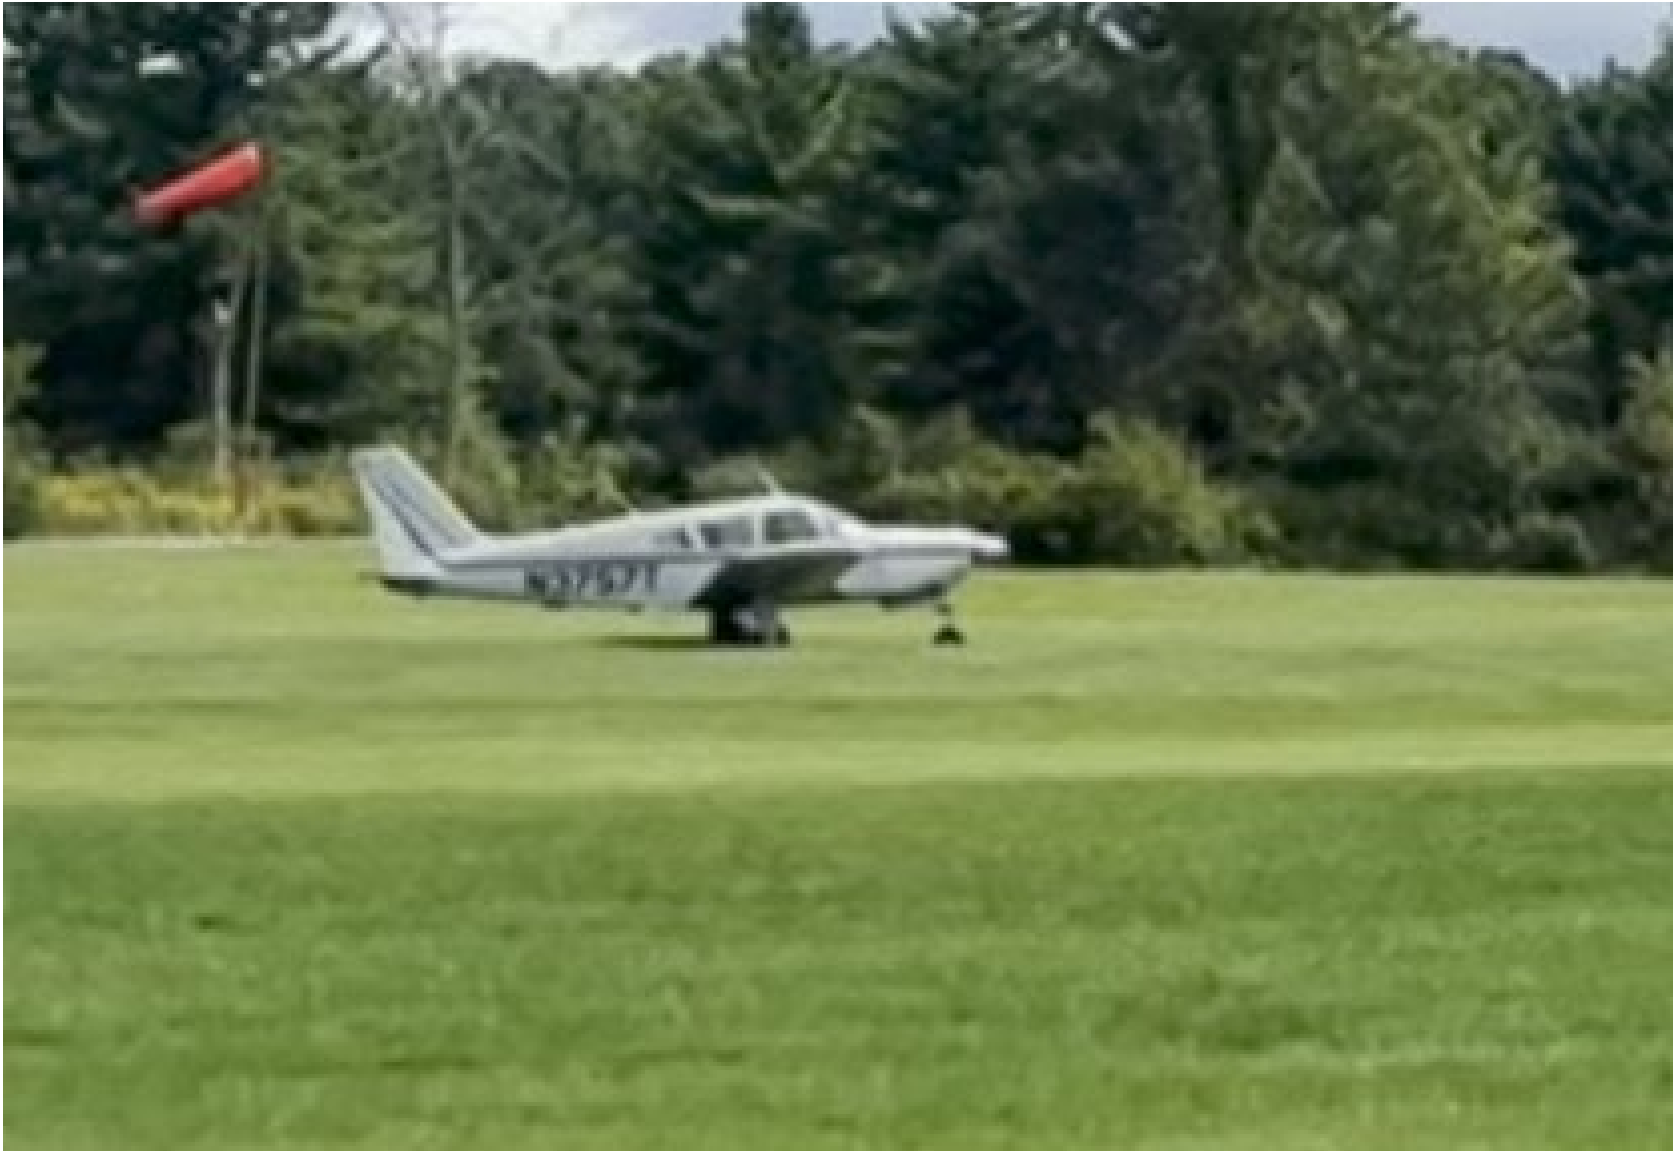
**Photograph 4 - Screenshot of accident takeoff (Courtesy of: Witness)**

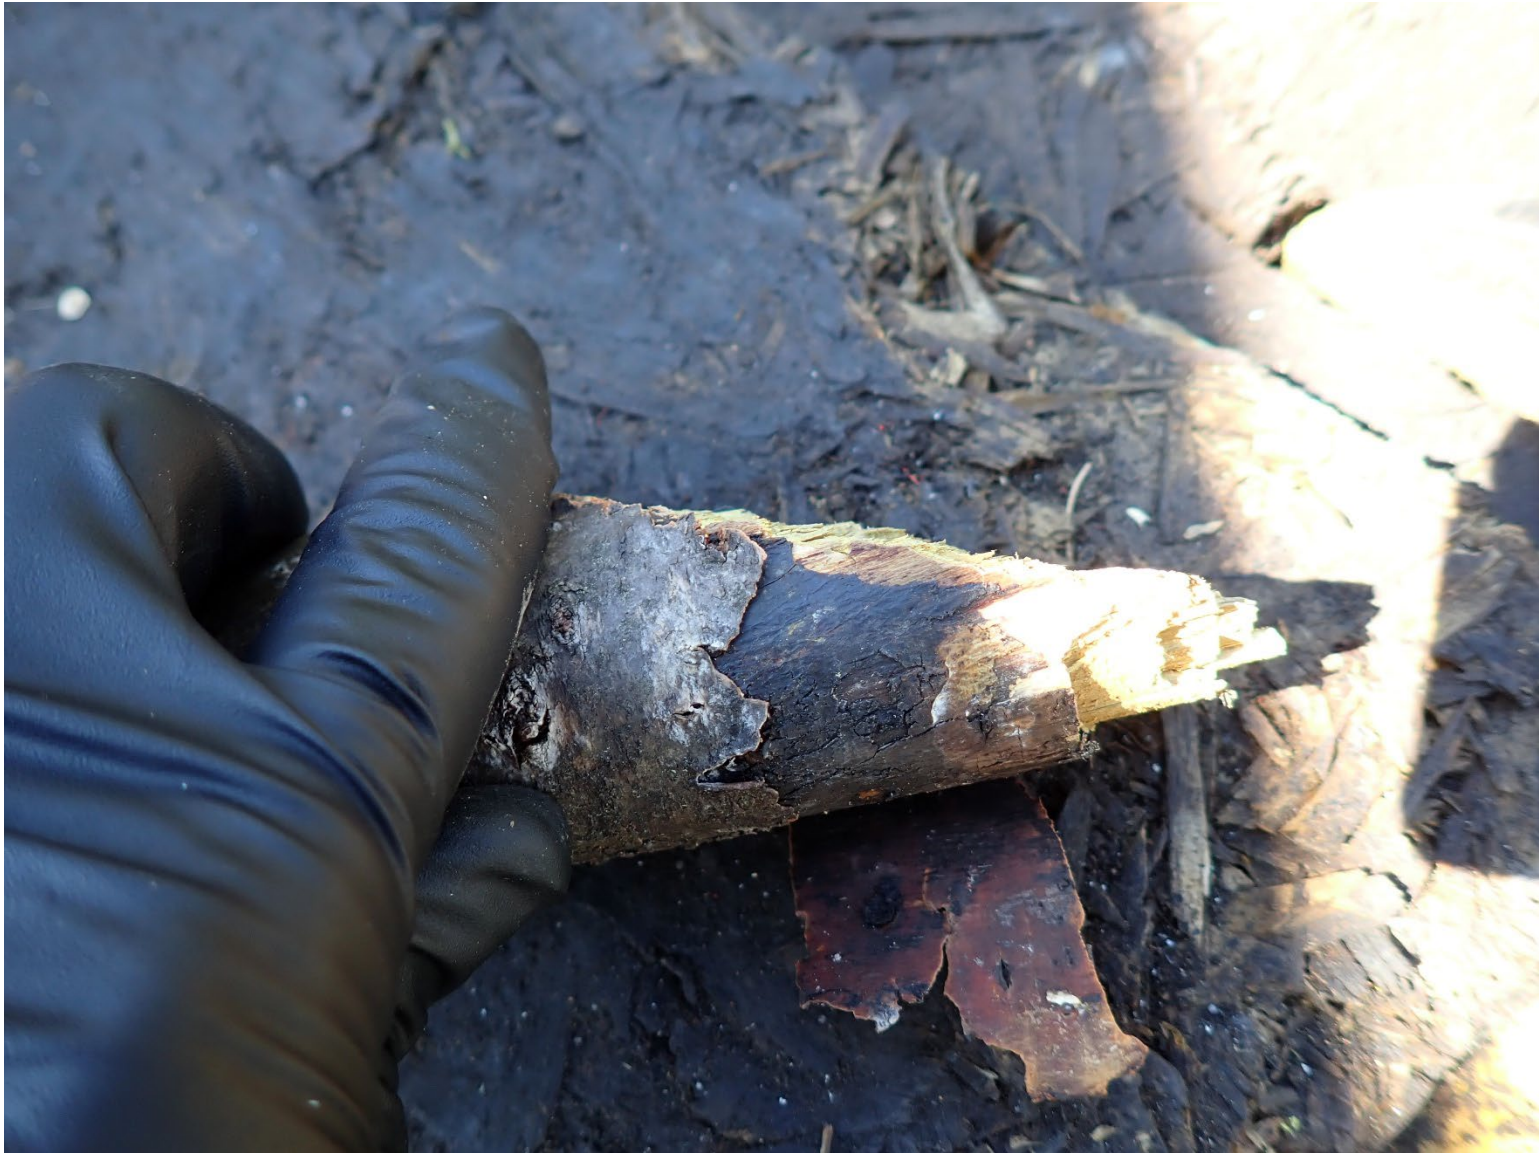
**Photograph 5 - Piece of wood at accident site with 45° cut**

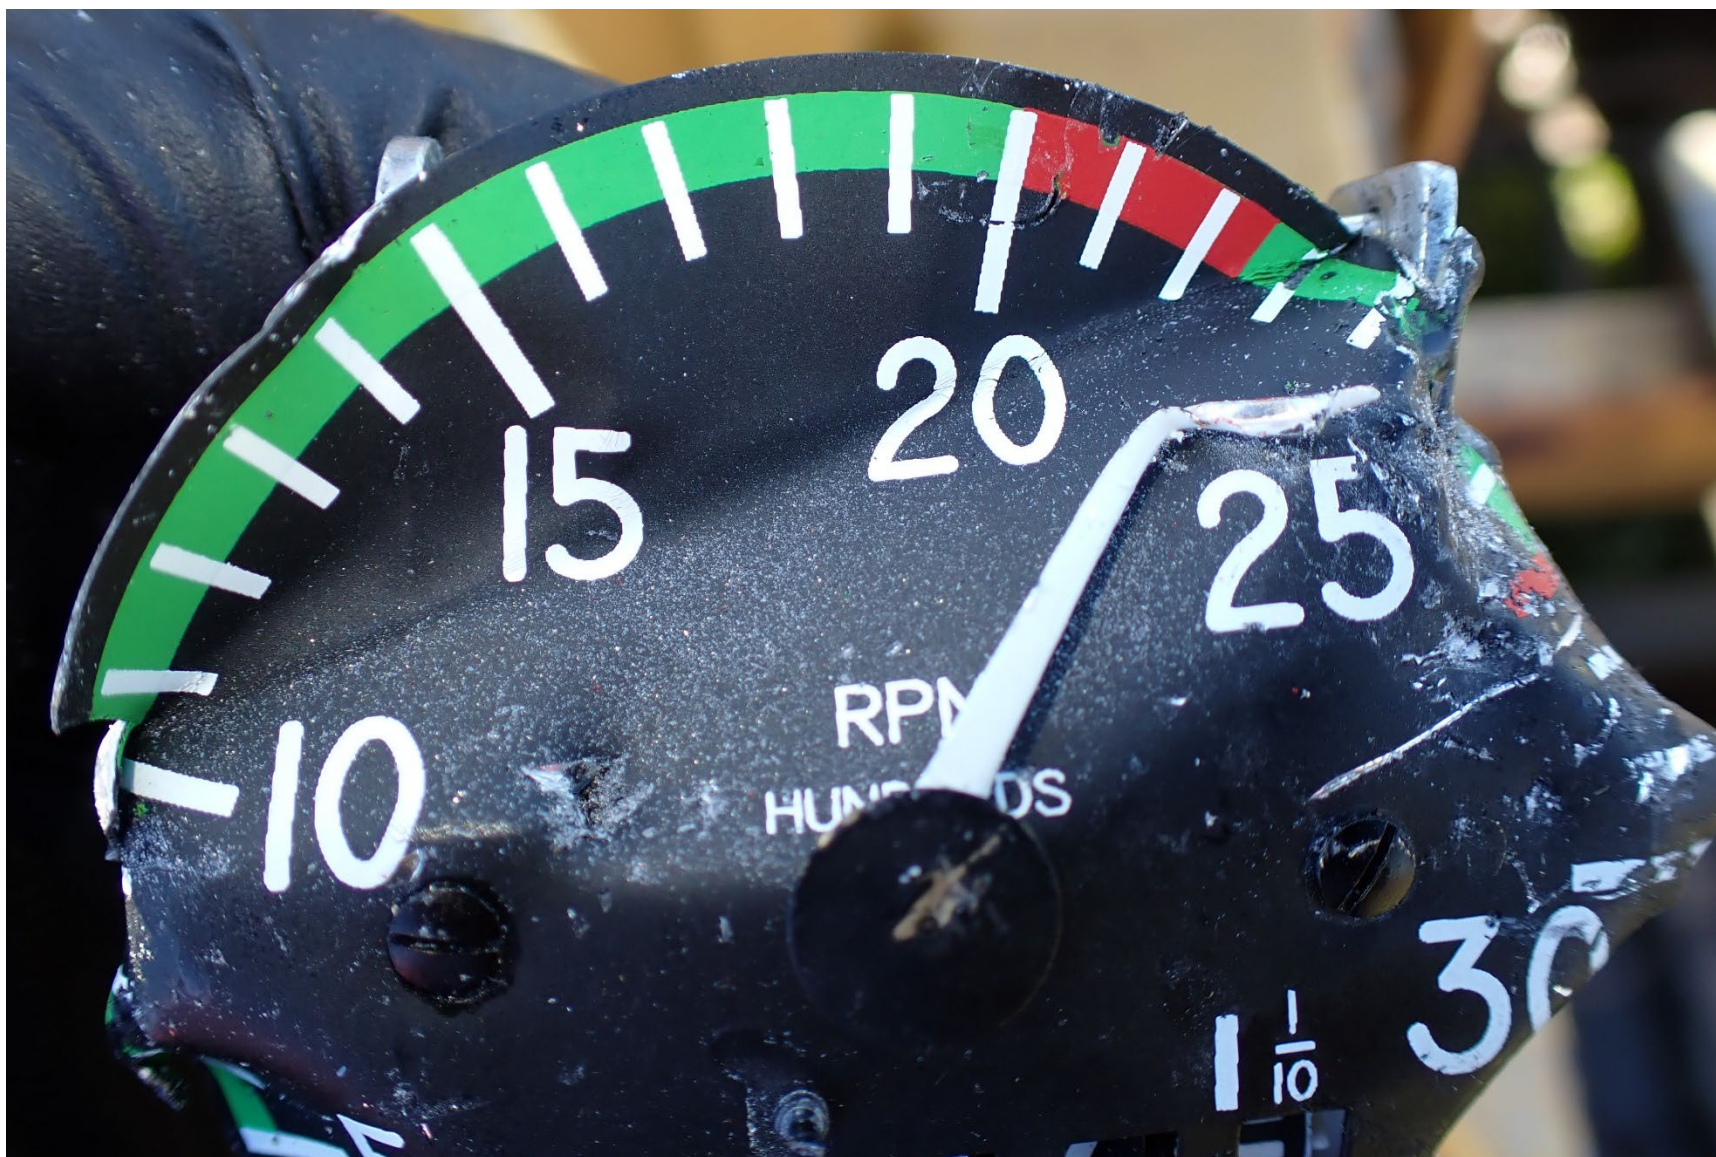
**Photograph 6 - Tachometer**

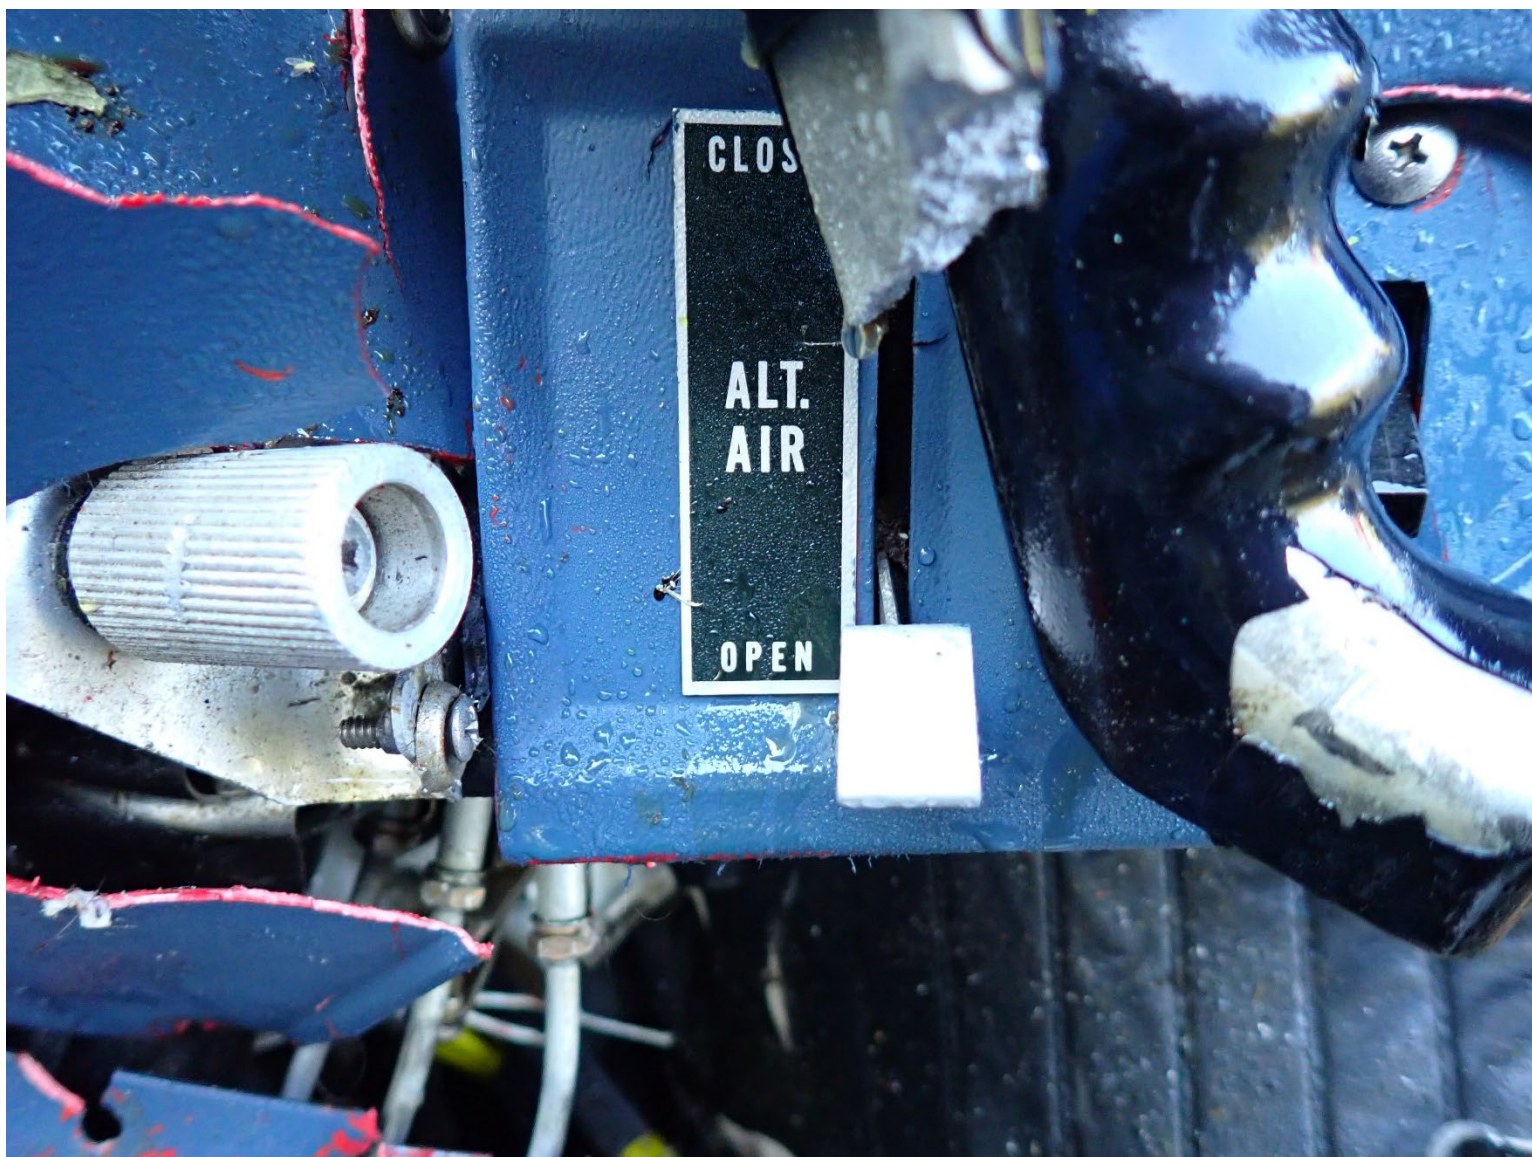
**Photograph 7 - Engine alternate air door control**

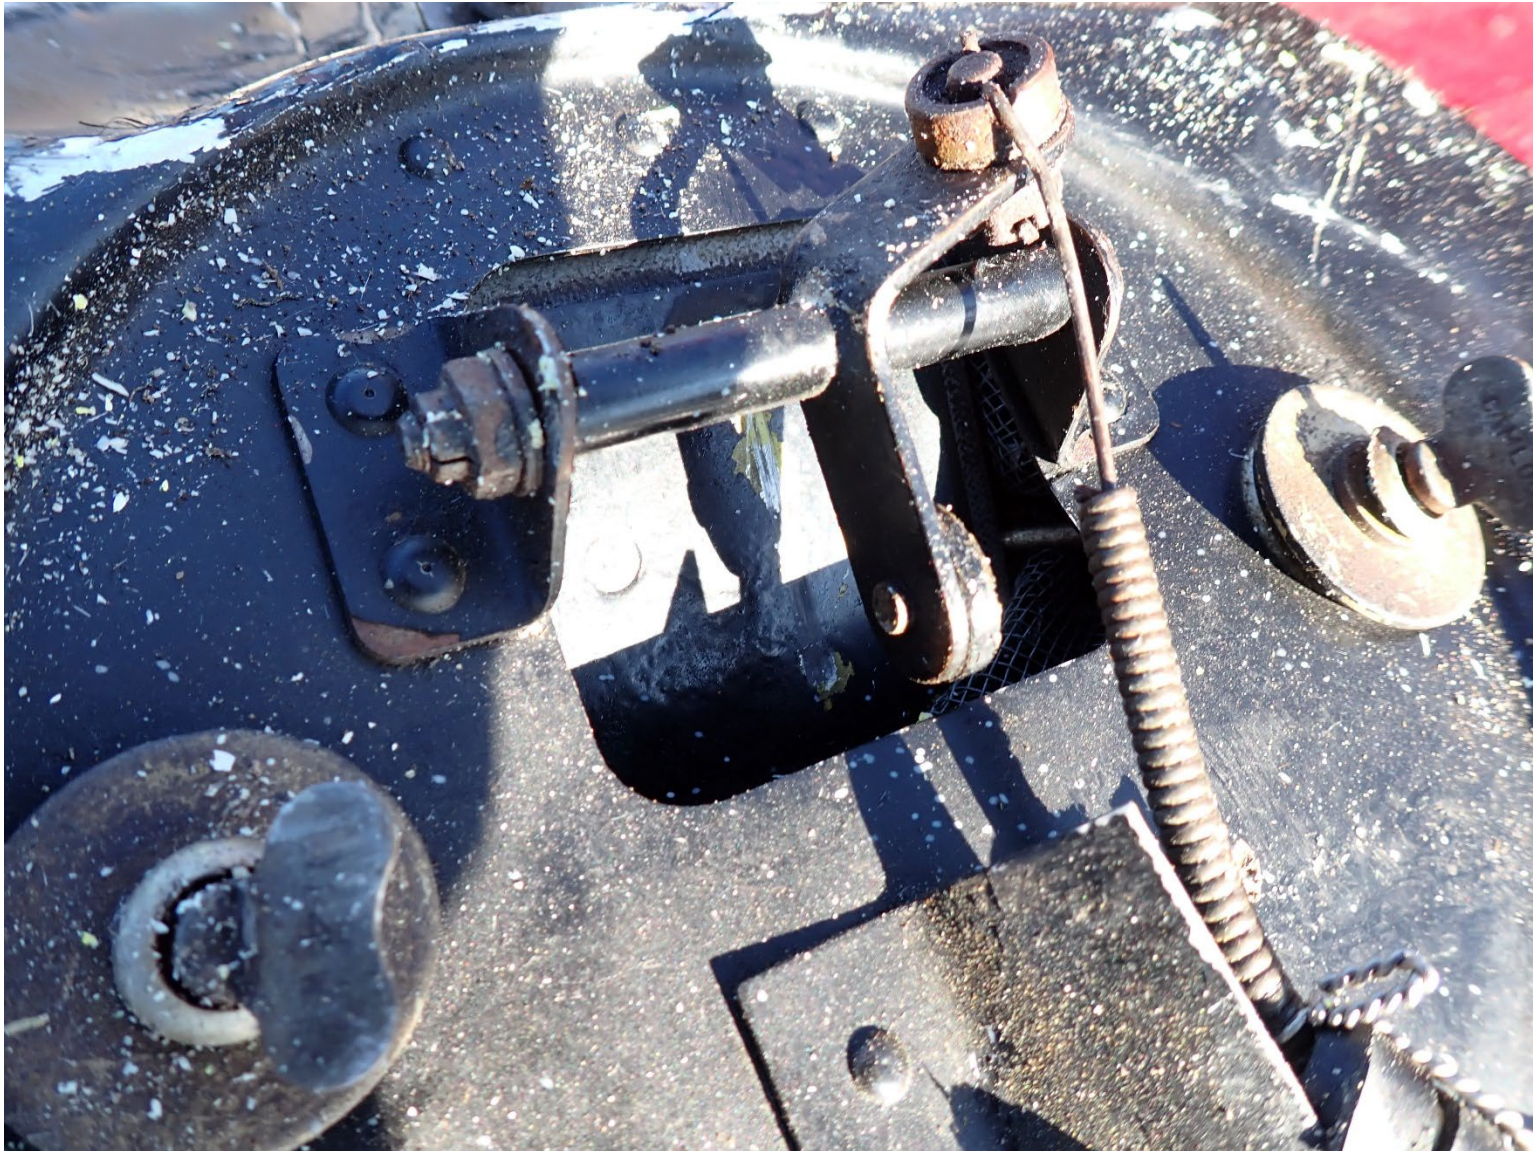
**Photograph 8 - Alternate air door**

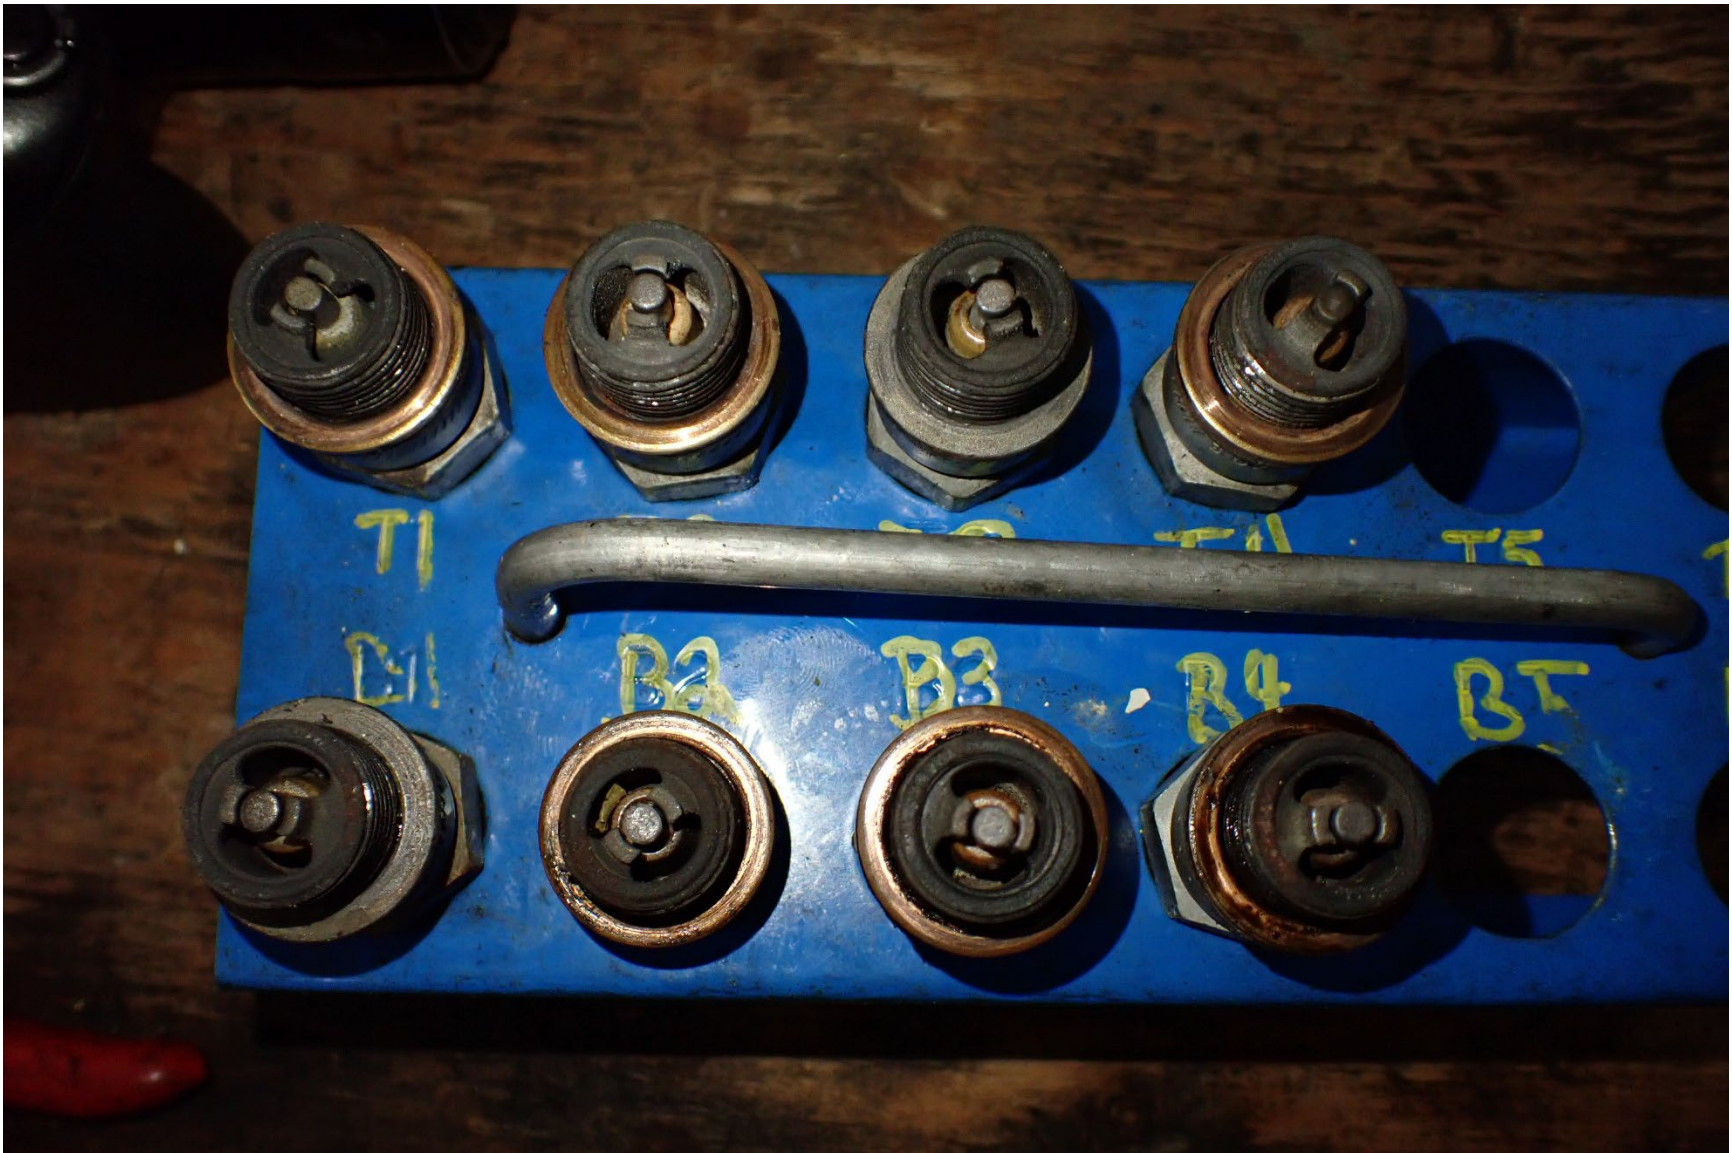
**Photograph 9 - Engine's spark plugs**

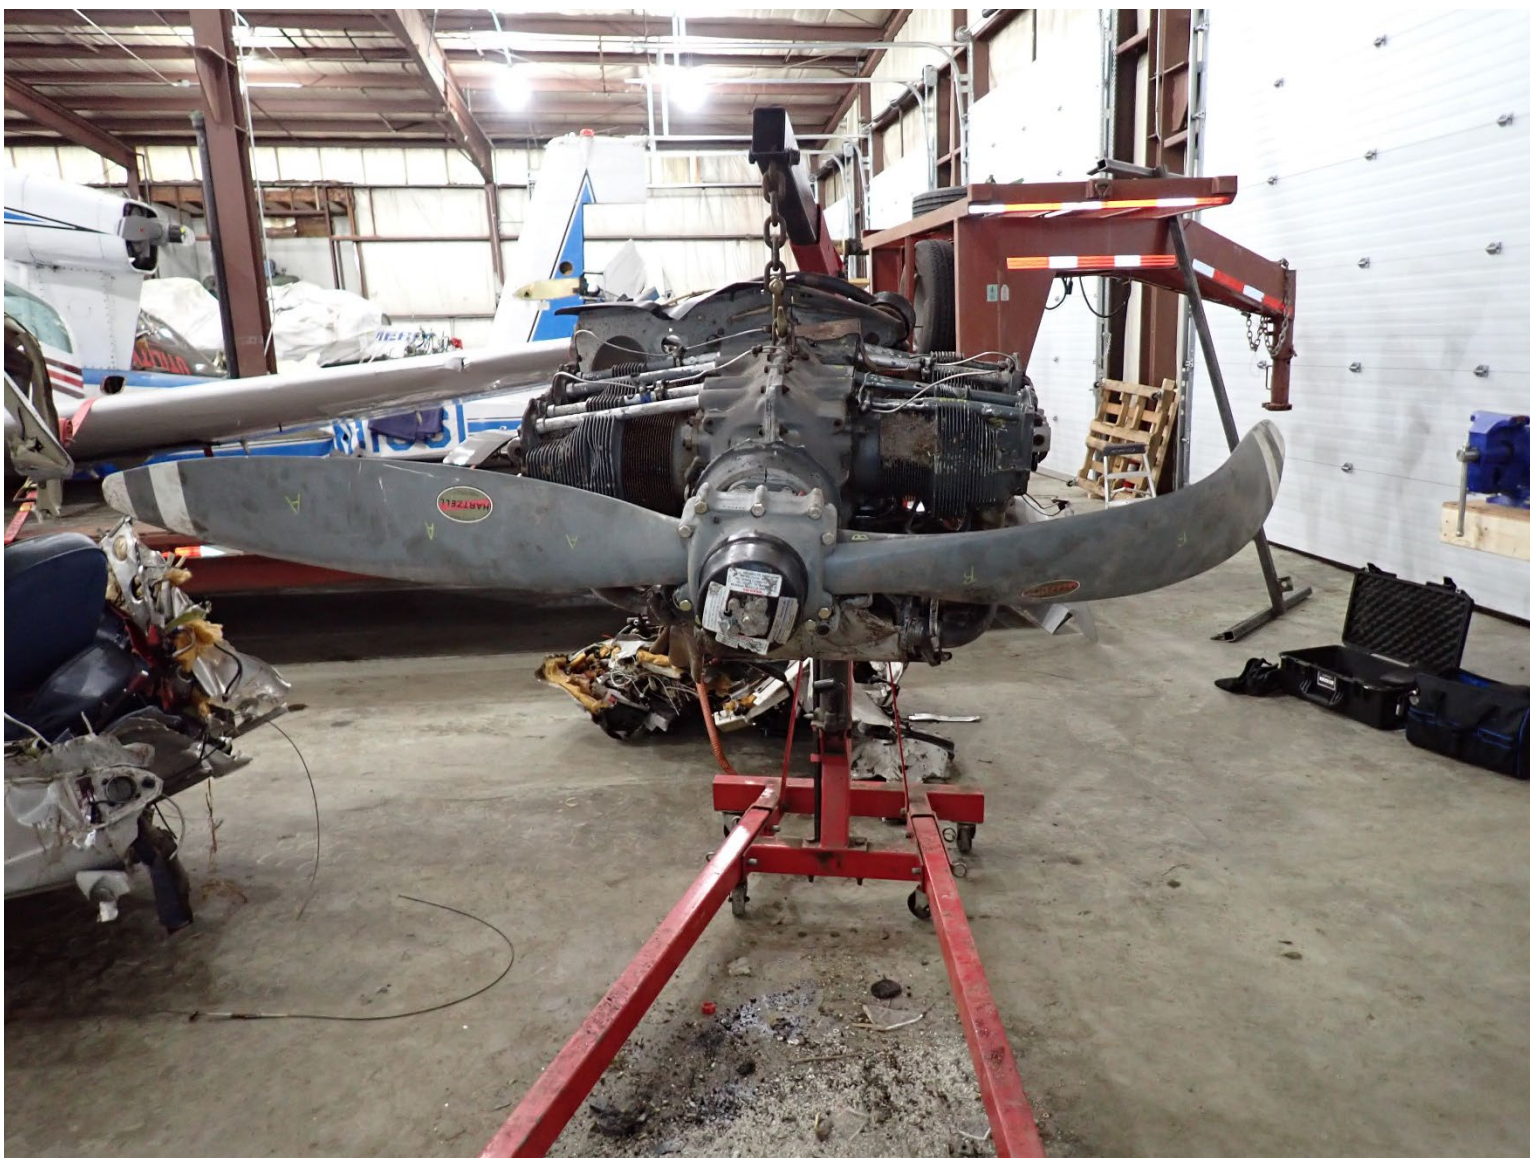
**Photograph 10 - Engine overview after recovery**

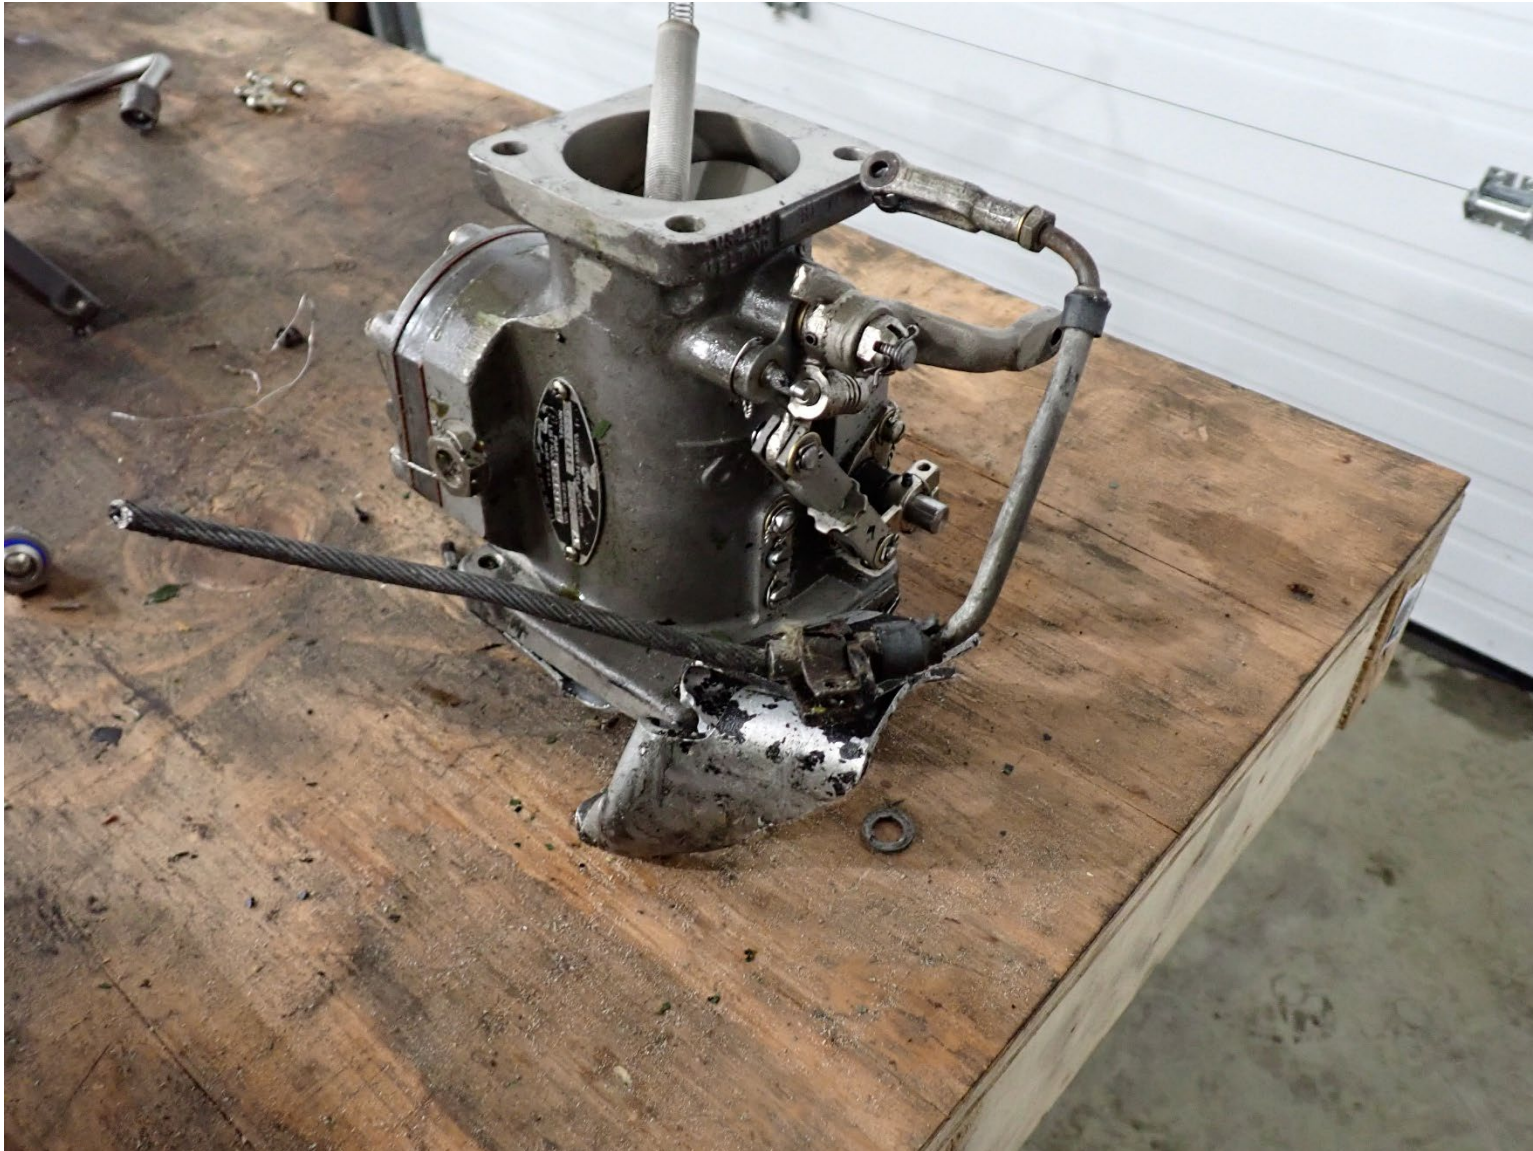
**Photograph 11 - Fuel injection servo**

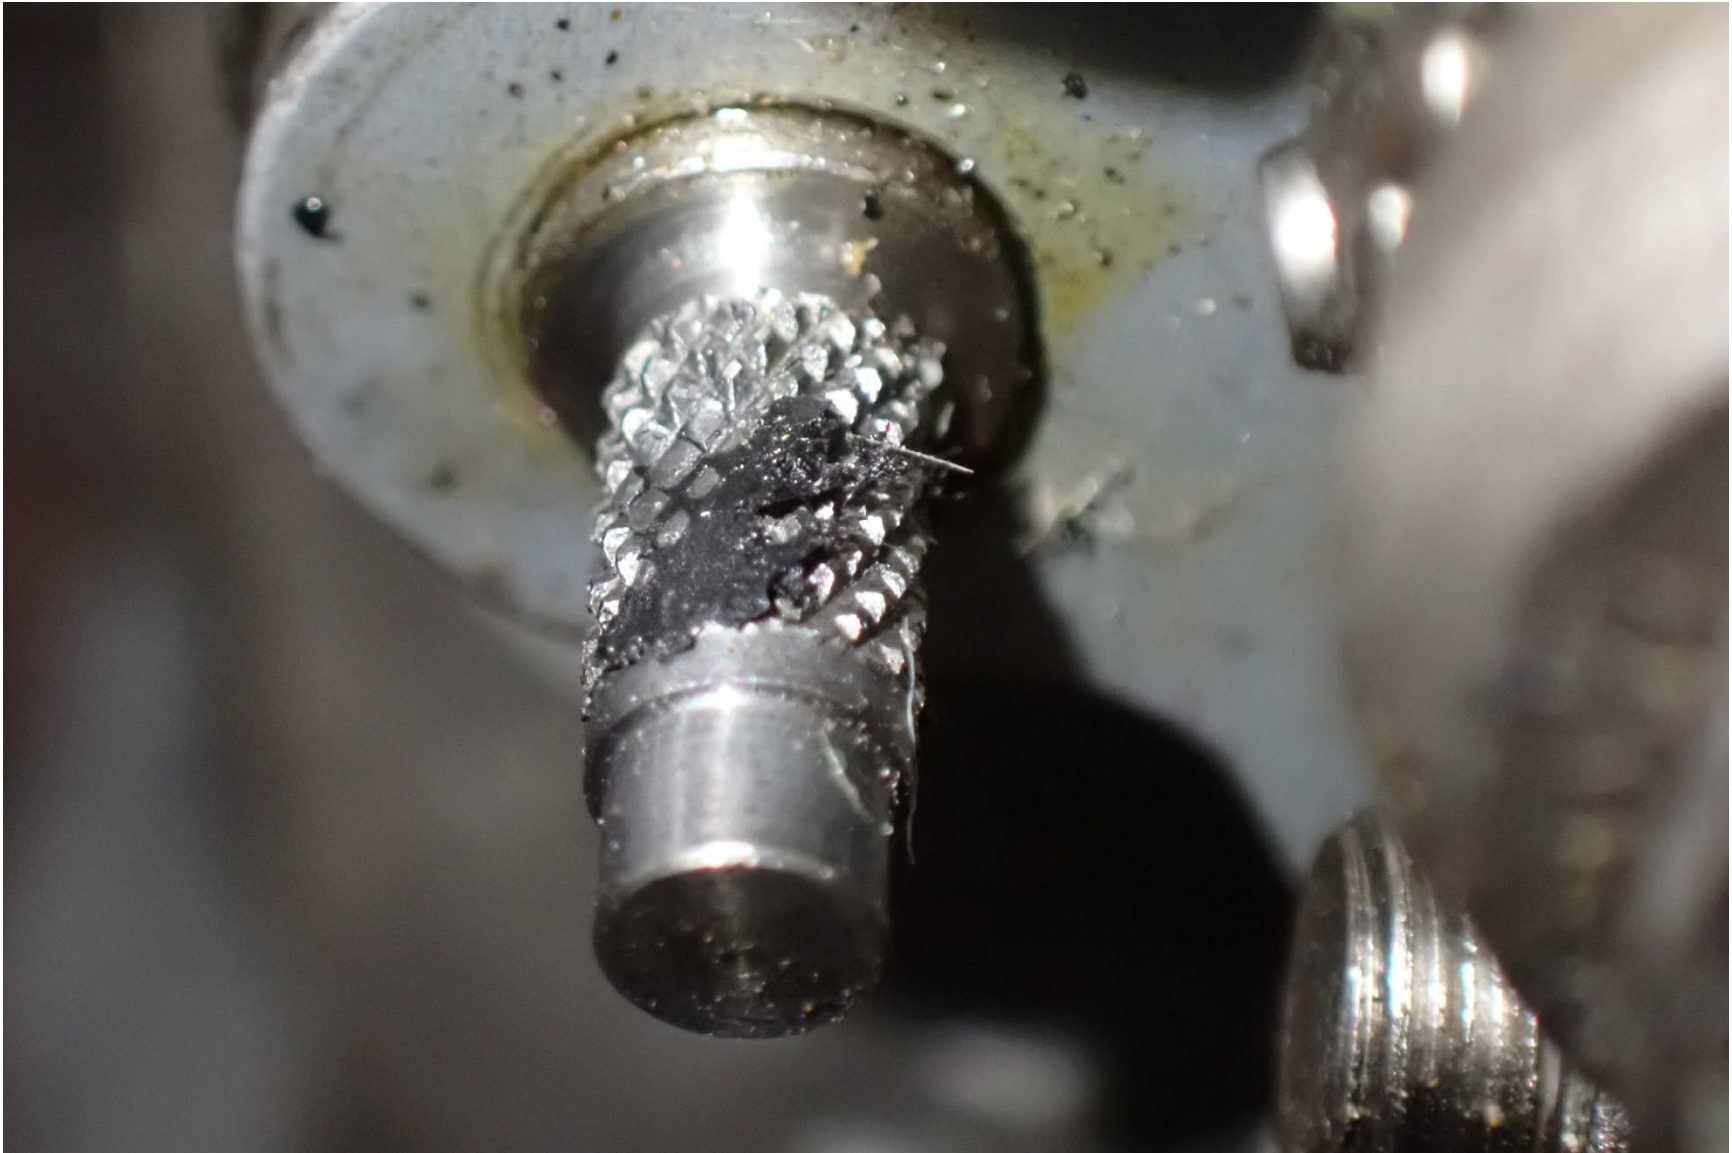
**Photograph 12 - Fuel injection throttle stop pin**
