# National Transportation Safety Board

ERA24FA371

## **WRECKAGE EXAMINATION SUMMARY**

Location: Vergennes, VT  
Date: September 8, 2024  
Time: 12:25 EDT  
16:25 UTC  
Airplane: Piper PA28R-180

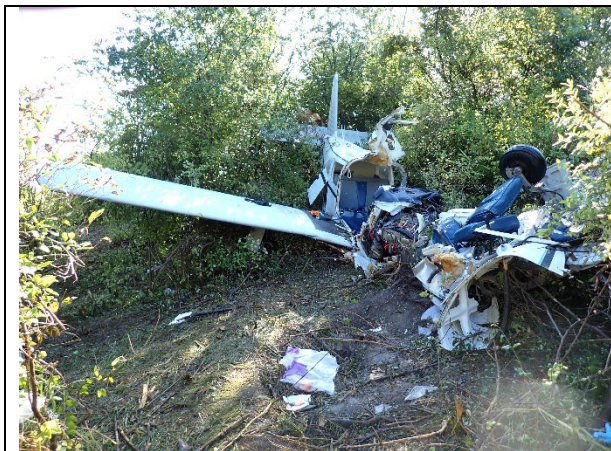
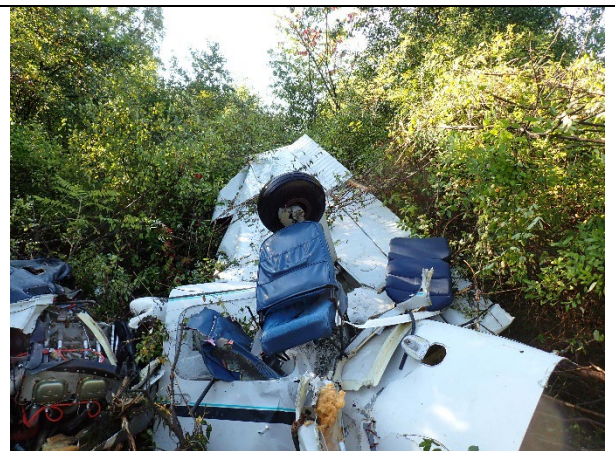
The airplane impacted terrain approximately 362 ft east of and near the departure end of runway 20 of the Basin Harbor Airport (B06), Vergennes, VT. The airplane impacted terrain in a steep, left wing low, nose low attitude. The airplane's left wing separated during the impact sequence and was located next to the primary wreckage. All the major airplane components were located at the accident site and there was no sign of fire. There were several cut branches with 45° cuts found at the accident site that were consistent with propeller strikes.

Figure 1: Airplane wreckage at accident site

Figure 2: Airplane wreckage at accident site

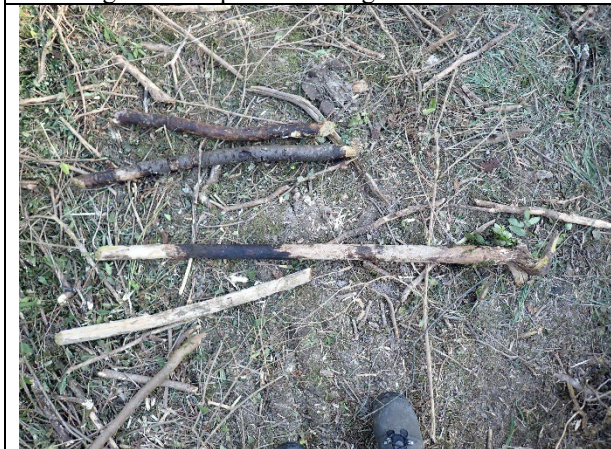
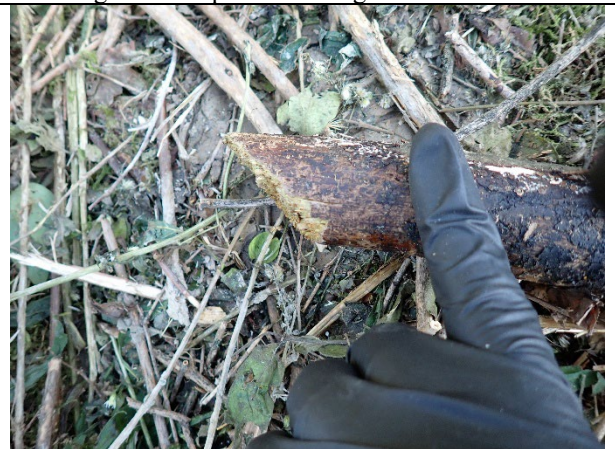
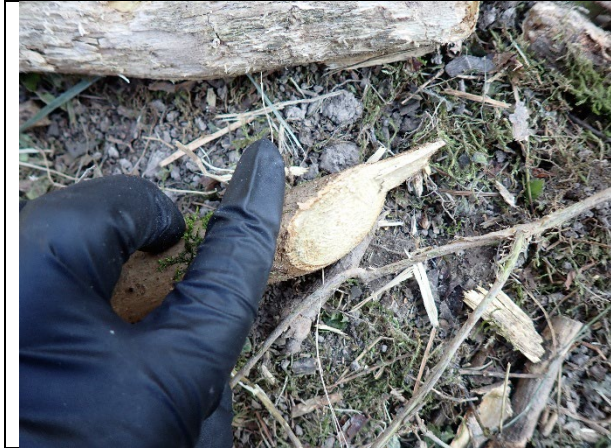
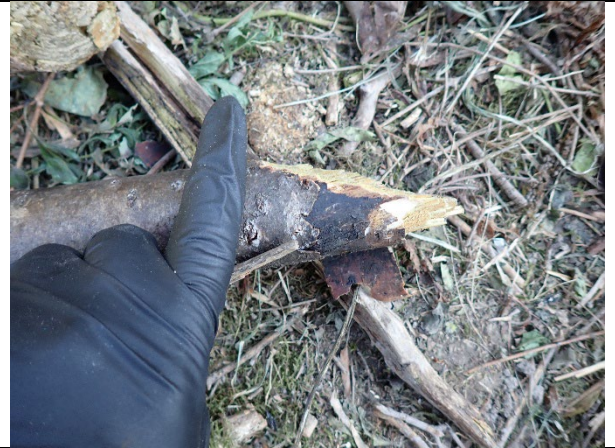
Figure 3: Branches with 45° cuts

Figure 4: Branch with 45° cut

Figure 5: Branch with 45° cut

Figure 6: Branch with 45° cut

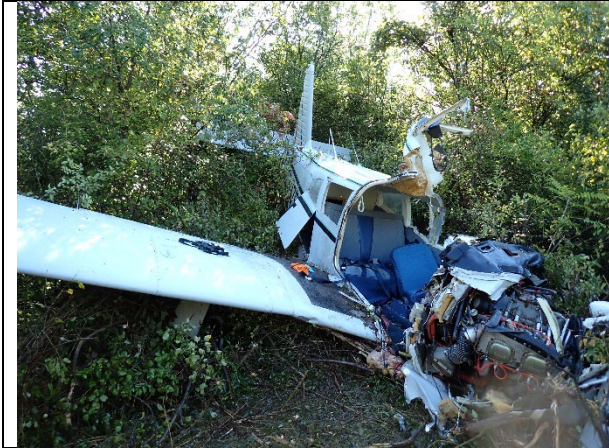
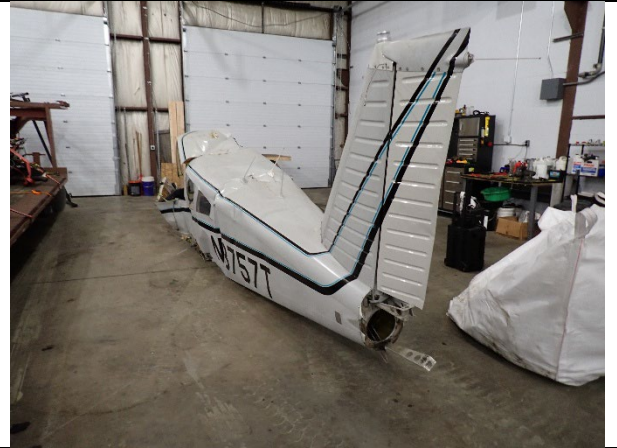
The fuselage sustained substantial damage with the majority of the damage occurring to the forward cabin area. A portion of the cabin had been cut open by first responders prior to the investigator's arrival.

Figure 7: Fuselage overview at accident site

Figure 8: Fuselage overview after recovery

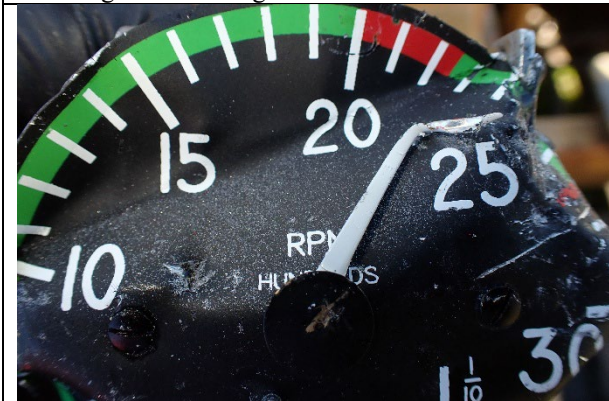
The instrument panel was impact damaged. A JPI 700 engine monitor was installed in the panel. The JPI engine monitor was removed and retained by the IIC and was sent to the NTSB Recorders Laboratory for data download. The tachometer instrument displayed impact damage signatures and the engine RPM needle was captured by a portion of the instrument face. The engine RPM needle was pointed to approximately 2300 RPM. The tachometer time was 2157.9. The hobbs meter displayed minor impact damage and the hobbs time was 27.7. Both the attitude indicator and the turn coordinator were indicating a steep left bank.

Figure 9: Tachometer

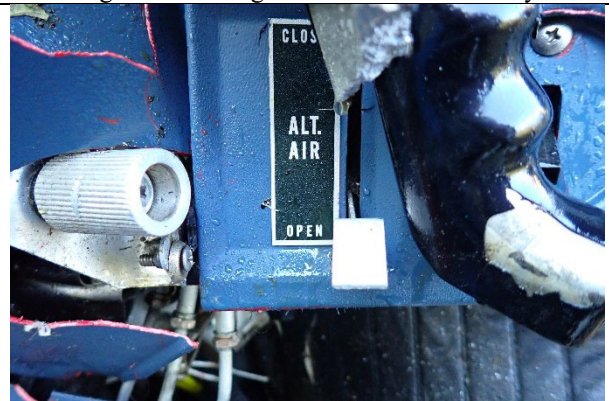
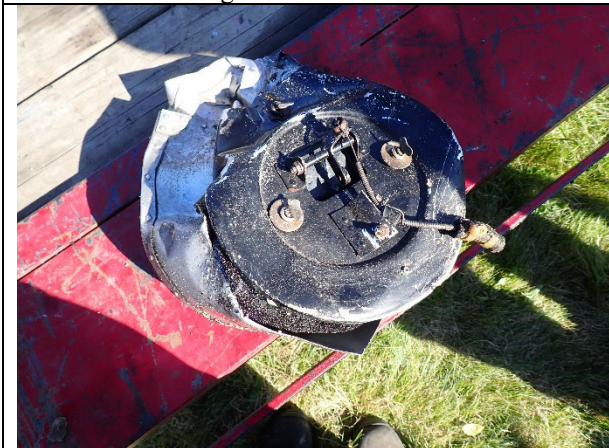
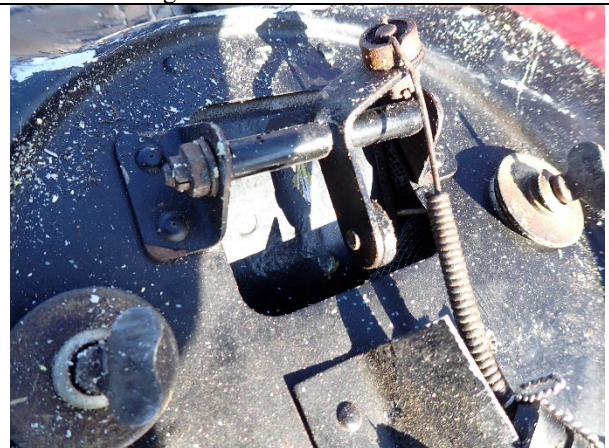
The magneto switch was found in the "BOTH" position. The throttle, propeller, and mixture controls were found in the full forward positions. The alternate air control was found in the "OPEN" position in the cockpit; the valve position at the air box was also found in the "OPEN" position.

Figure 10: Alternate air control

Figure 11: Induction air box assembly

Figure 12: Alternate air door

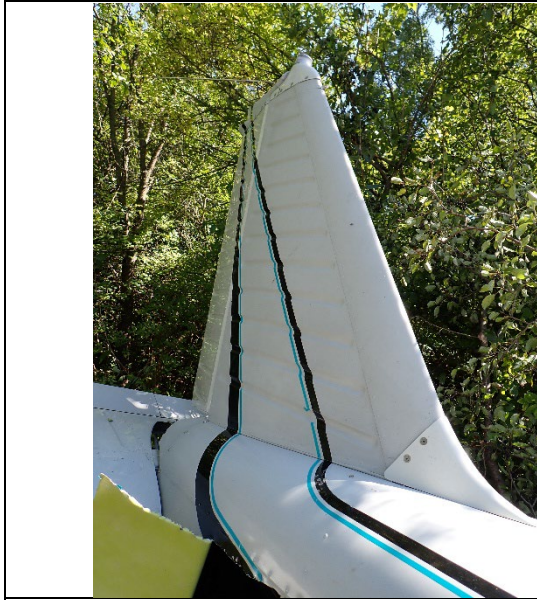
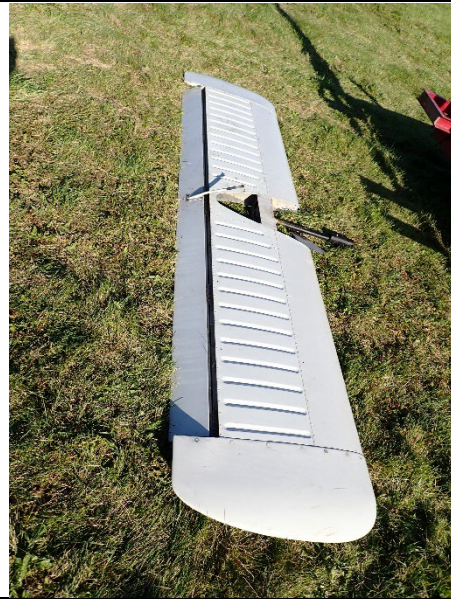
The empennage remained attached to the rest of the fuselage and displayed minor impact damage.

Figure 13: Vertical stabilizer and rudder

Figure 14: Stabilator after removal

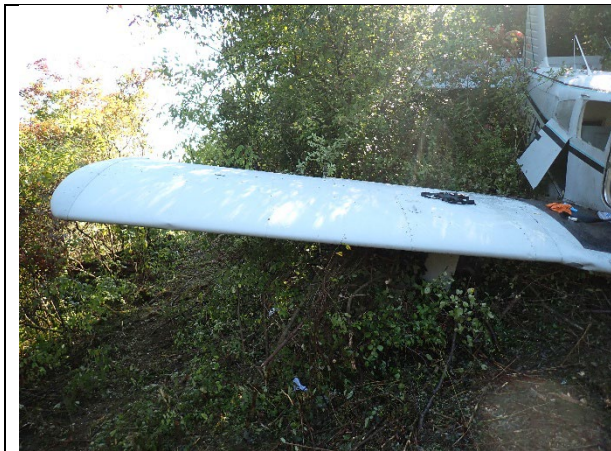
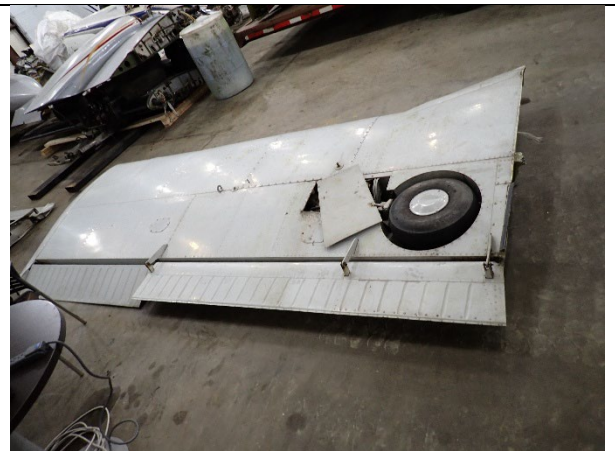
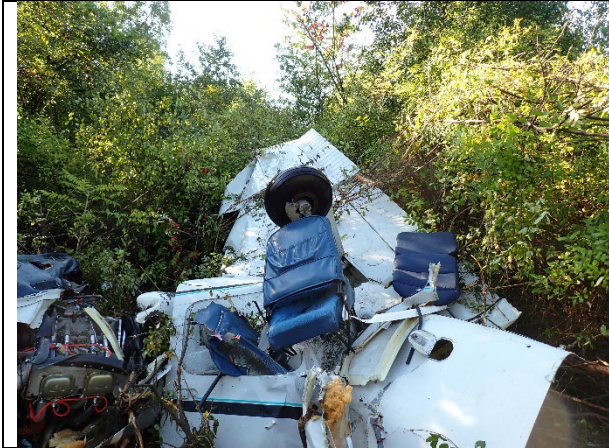
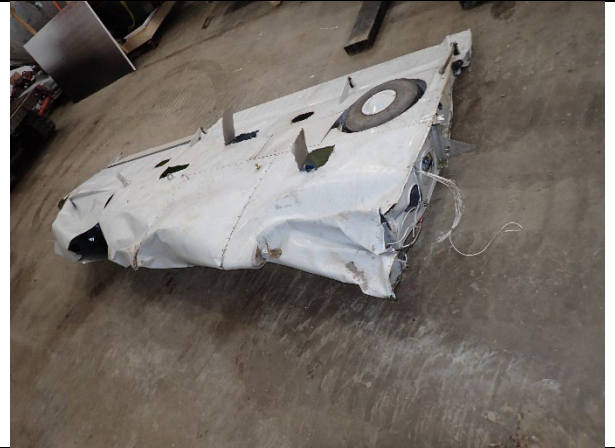
The left wing had impact separated from the rest of the airplane and was found adjacent to the primary wreckage site. A portion of the left wingtip was found in the initial impact point. The leading edge of the left wing displayed aft crushing in multiple locations. The right wing remained attached to the fuselage and displayed minor leading edge damage. The stall warning switch remained attached to its installation point and displayed impact damage signatures. The switch was tested for electrical continuity and the stall warning switched functioned normally while manually activating the switch.

Figure 15: Right wing overview at the accident site

Figure 16: Right wing overview after recovery

Figure 17: Left wing overview at the accident site

Figure 18: Left wing overview after recovery

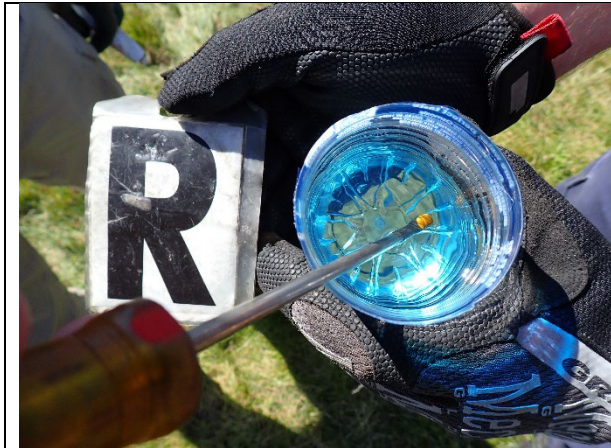
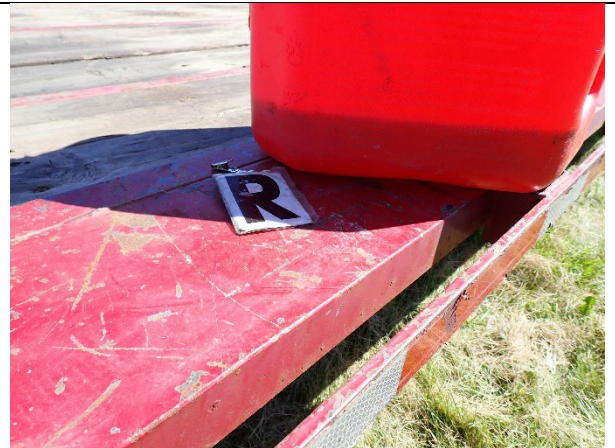
1.5 gallons of blue fuel was found in the right wing tank. This fuel was tested with water detecting paste. No water was found during this test. No fuel was found in the left wing tank, however, blue staining was observed near the left wing filler port. The fuel line from the left tank to the fuselage separated in the impact sequence. The fuel selector was found in the left tank selected position. Fuel was found in the fuel selector valve. Low pressure air was used to flow check the fuel lines and the fuel selector valve. All lines were found clear without restriction from the fuel selector valve to both wing tanks. The fuel selector valve was functionally checked for continuity. The valve operated normally in the "LEFT", "RIGHT" and "OFF" positions and produced a tactile detent for each position when the valve handle was operated. The fuel strainer bowl was displaced from its mounting location due to impact damage. The bowl contained some impact related debris. The fuel strainer screen was intact and was found clean. The electric fuel pump remained attached to the firewall and contained some blue fuel. The electric fuel pump was removed from the firewall and was tested using a 12-volt power source. The pump successfully ran smoothly during dry testing.

Figure 19: Fuel sample from right fuel tank (testing with water finding paste)

Figure 20: Recovered amount of fuel from the right fuel tank

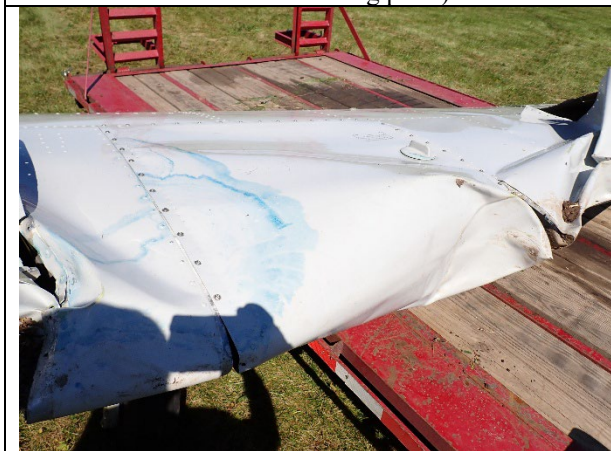
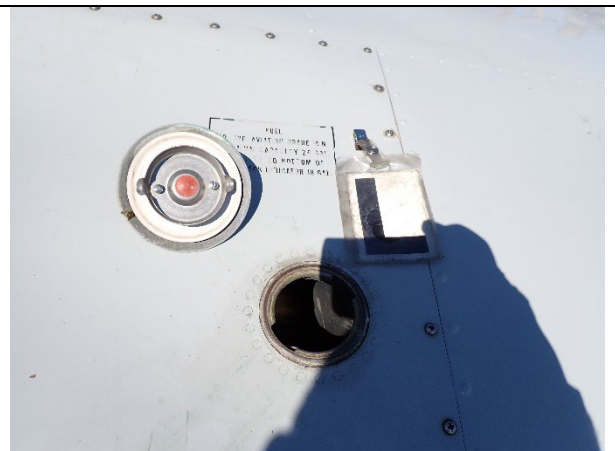
Figure 21: Left wing fuel tank with blue staining

Figure 22: Left fuel cap and filler port

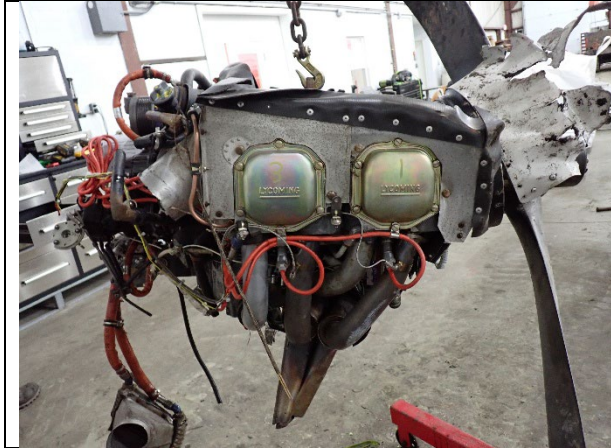
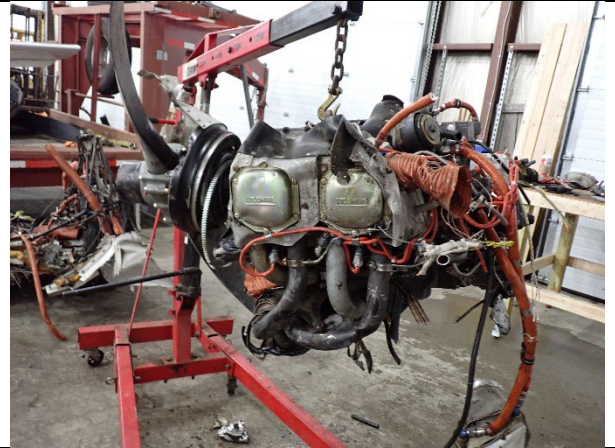
The crankcase remained intact, and there were no signs of a catastrophic engine failure. The crankshaft was rotated by hand a full 720°, and continuity was established between the crankshaft, camshaft, connecting rods, and associated components. During crankshaft rotation, all four cylinders displayed thumb compression and suction. All the rocker arms and valves operated normally during crankshaft rotation, with the No. 2 and No. 4 rocker arms having reduced movement, which was consistent with the impact damage observed to the push rods. The cylinders were inspected utilizing a lighted borescope; all of the piston faces exhibited normal operating and combustion signatures. The cylinder walls exhibited varying degrees of surface corrosion and scoring. All of the intake valve heads displayed normal operating and seating signatures. The #1 exhaust valve head displayed a slight greenish tint that was uniform around the outer diameter of the exhaust valve; however, the valve head was intact and was not deformed and displayed normal seating signatures. The rest of the exhaust valves displayed normal operating, combustion, and seating signatures. All of the overhead components (valve stems, springs, and rocker arms) displayed normal operating and lubrication signatures.

Figure 23: Engine overview

Figure 24: Engine overview

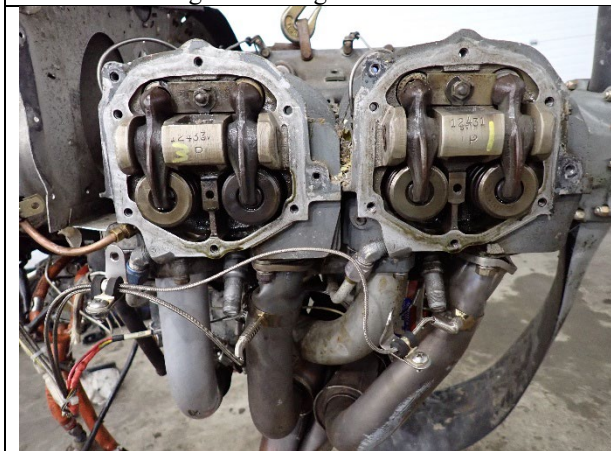
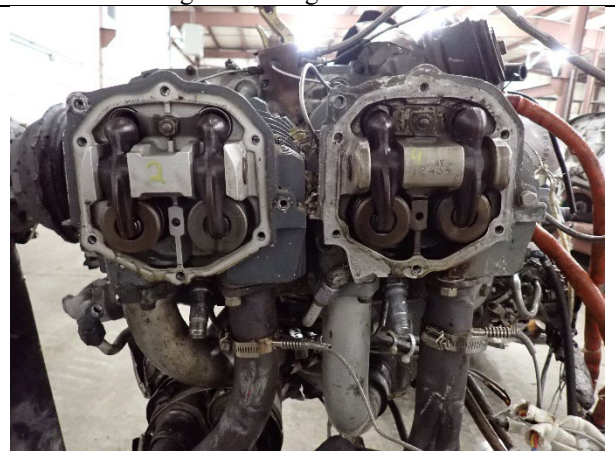
Figure 25: No. 1 and No. 3 cylinder overhead components

Figure 26: No. 2 and No. 4 cylinder overhead components

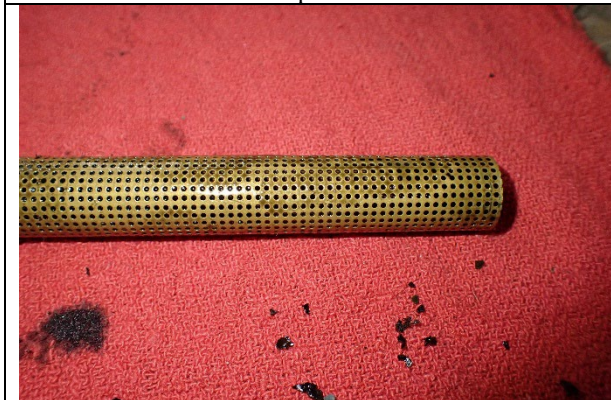
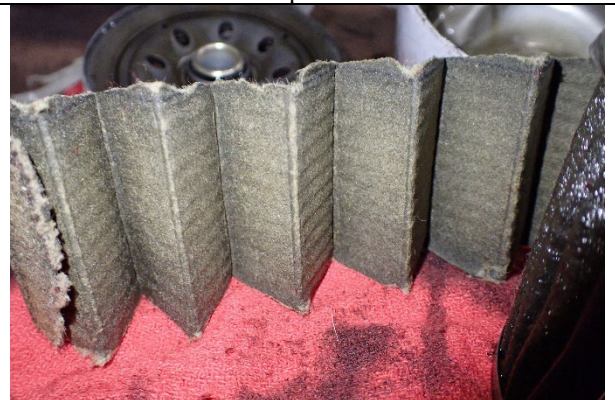
The oil suction screen was removed and found to contain particulates with the consistency of carbon; however, the screen was not obstructed. The oil pressure filter remained attached to the oil filter adapter and exhibited impact damage signatures. The oil filter was removed, and the filter housing was cut open. The filter pleats were visually inspected, and no anomalies were observed.

Figure 27: Oil suction screen

Figure 28: Oil filter pleats

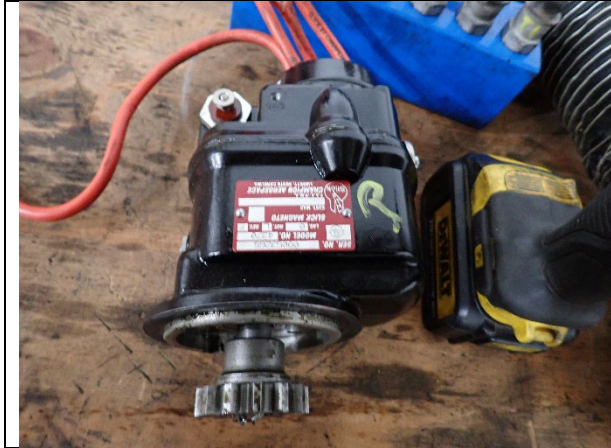
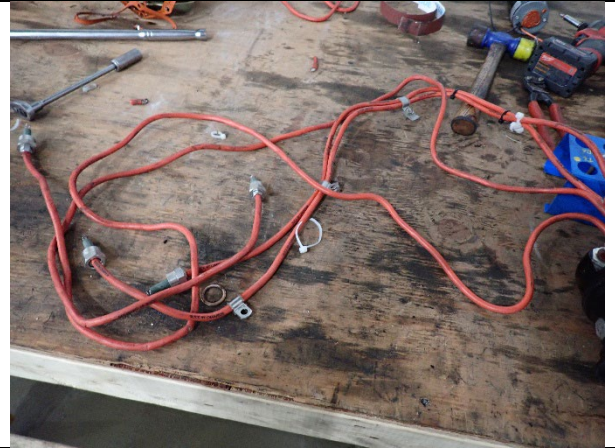
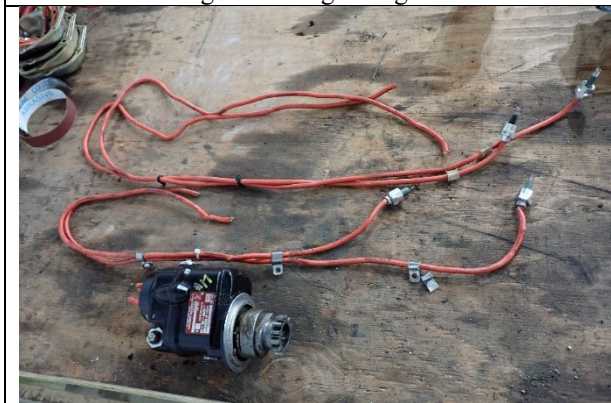
Both magnetos remained attached to their respective installation points and exhibited minor impact damage. Due to the impact damage to the starter gear and support, magneto timing could not be verified. Both magnetos were removed, and their drive shafts rotated normally. The left magneto impulse coupling remained intact and operated normally during rotation. During impulse coupling operation, the magneto was capable of producing a spark on all four towers. The right magneto drive was rotated using a drill, and the magneto was capable of producing a spark on all four towers. The left magneto ignition lead harness displayed significant impact

damage, and all four leads were either partially or completely severed; there were no signs of chafing or shorting of the ignition leads. The right magneto ignition leads displayed less impact damage; however, several of the leads were partially severed. The right ignition leads were capable of conducting a spark from the magneto to the ignition lead end or to the first section of impact damage. The spark plugs were removed and visually examined; the plugs were a mixture of Champion and Tempest spark plugs. All the spark plugs displayed normal wear and were dark grey in color when compared to Champion Aviation Service Manual AV6R and the Tempest Aviation Spark Plugs Installation and Maintenance Manual 1710A.

Figure 29: Right magneto

Figure 30: Right magneto ignition harness

Figure 31: Left magneto and ignition harness

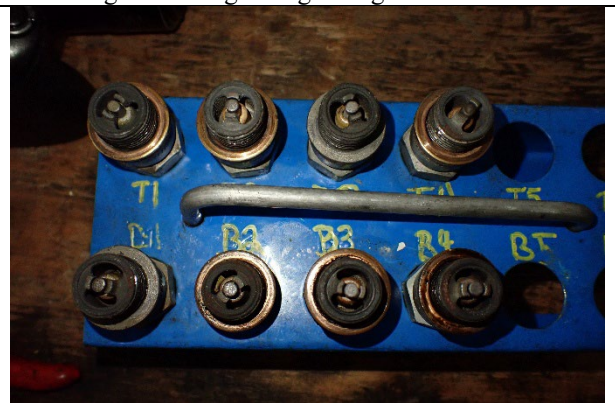
Figure 32: Spark plugs

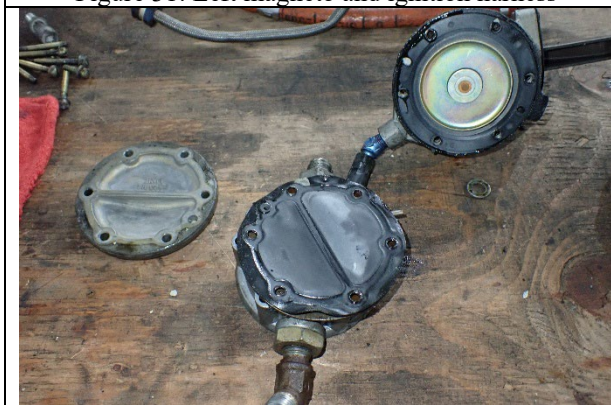
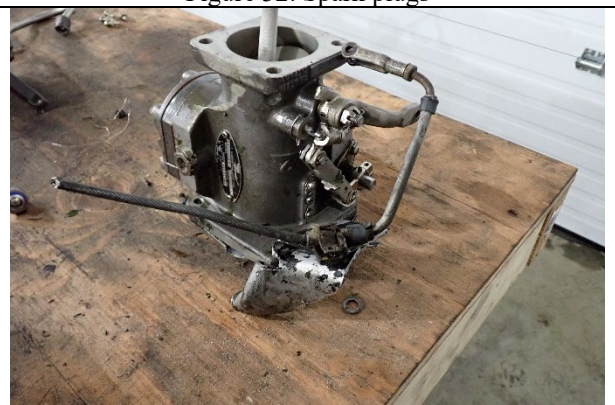
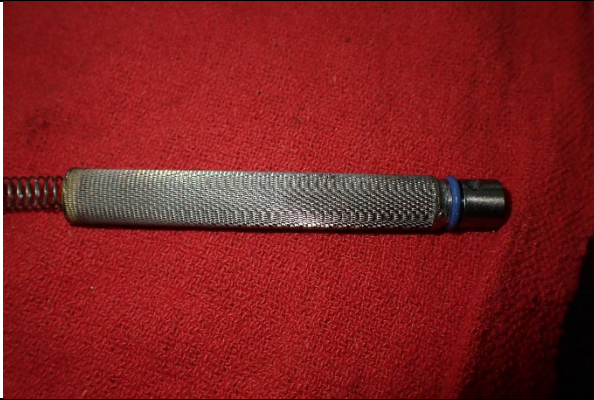
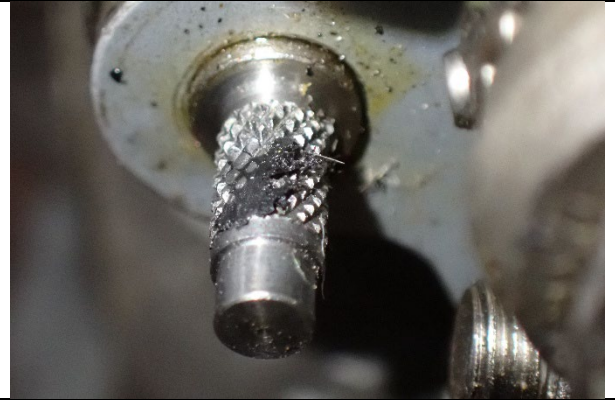
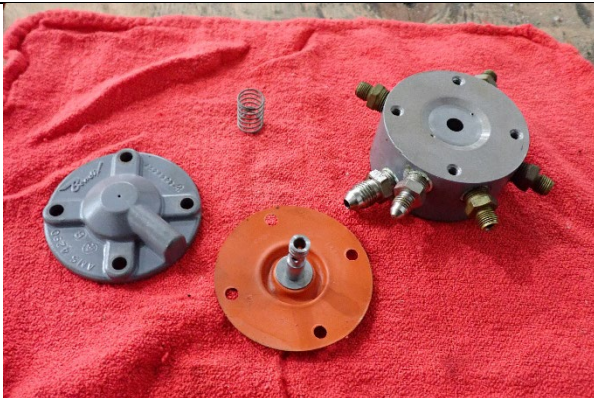
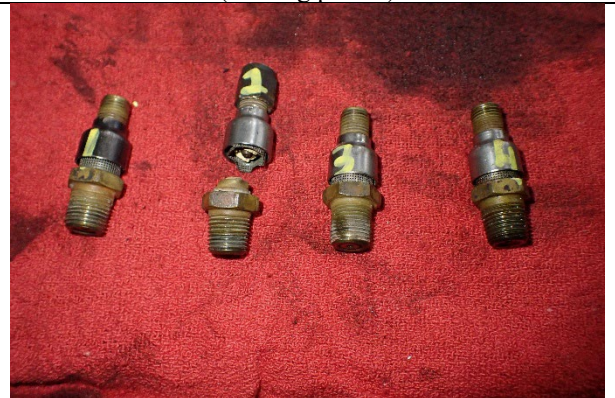
The fuel pump remained attached to its installation point and was undamaged and both the inlet and outlet fuel lines remained secured. The fuel pump was disassembled and displayed normal operating signatures. The fuel pump drive plunger was in place and operated normally during crankshaft rotation. The fuel injector servo remained attached to its installation point and displayed minor impact damage. The throttle and mixture control rod ends remained attached to their respective controls in the cockpit and the fuel injector servo. Both arms were capable of movement from stop to stop. The throttle control stop pin was noted to be missing the plastic portion of the throttle stop. The fuel inlet and outlet fuel lines remained secured, and there were no signs of fuel leaks. The fuel inlet screen was removed and was clear of any obstructions. The fuel flow divider remained attached to its installation point and was undamaged. The inlet fuel line and the fuel pressure indication line remained secured, and there were no signs of fuel leaks. The flow divider was removed and disassembled; the internal components displayed normal operating signatures, and there were no signs of obstructions. All four fuel nozzles remained installed in their cylinders and exhibited varying degrees of impact damage, with the No. 2 fuel nozzle showing the most damage. The fuel lines going to the nozzles were all secured to the nozzles and to the flow divider, and there were no signs of fuel leaks. All fuel nozzles were removed and found unobstructed.

Figure 33: Fuel pump after disassembly

Figure 34: Fuel injection servo after removal

Figure 35: Fuel injector servo inlet screen

Figure 36: Fuel injection servo throttle stop pin  
(missing plastic)

Figure 37: Fuel flow divider after disassembly

Figure 38: Fuel nozzles

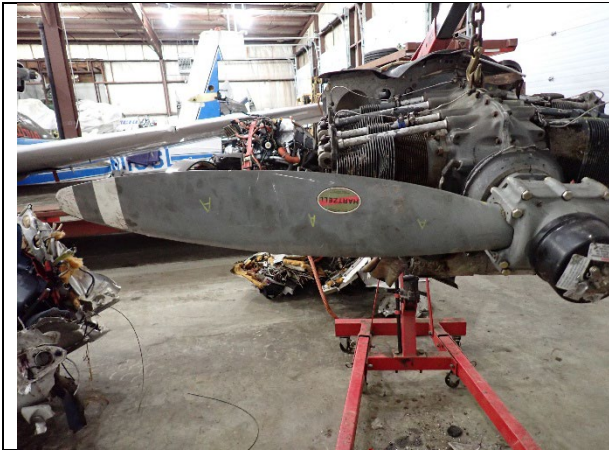
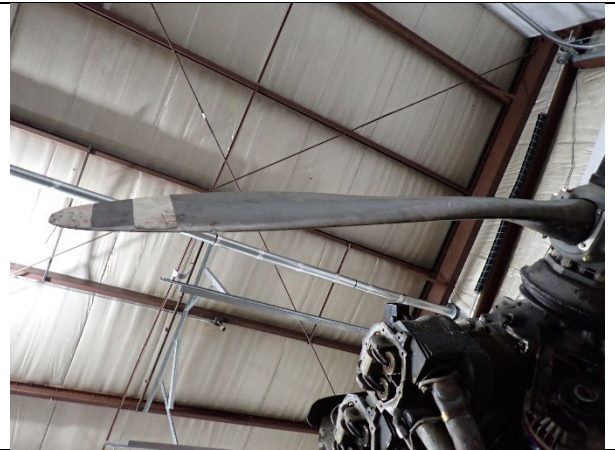
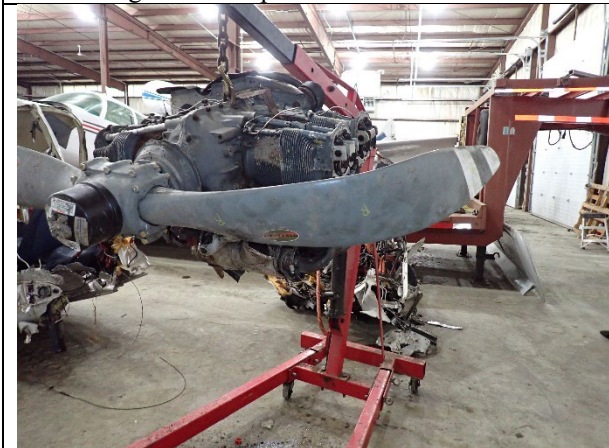
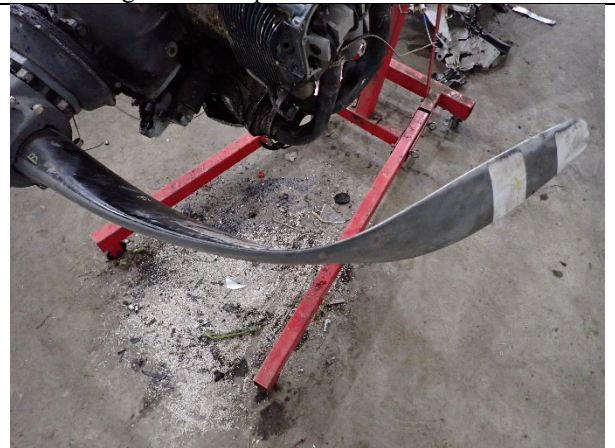
The two blade, constant speed propeller remained attached to the crankshaft, and both blades were secure in the propeller hub. The propeller blade marked "A" displayed minor impact damage signatures; the blade had minor aft bending deformation, minor leading edge polishing, and there was a gouge in the leading edge. The propeller blade marked "B" displayed aft bending and twisting deformation, leading edge polishing, and minor gouges near the blade tip.

Figure 39: Propeller blade marked "A"

Figure 40: Propeller blade marked "A"

Figure 41: Propeller blade marked "B"

Figure 42: Propeller blade marked "B"
