# National Transportation Safety Board

ERA24FA397

## **WRECKAGE EXAMINATION**

Location: Kill Devil Hills, North Carolina  
Date: September 28, 2024  
Time: 17:18 Local  
21:18 Z  
Airplane: N1281F, Cirrus SR22, S/N 9379

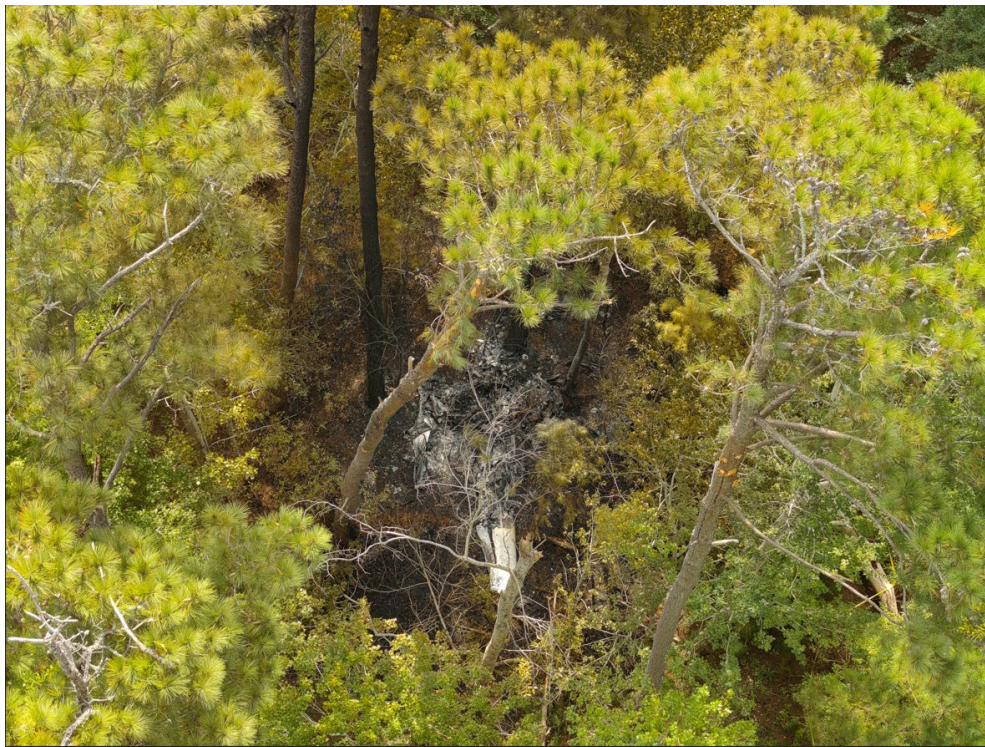
The main wreckage was located within heavily wooded terrain adjacent to Runway 21. The left wing of the airplane initially contacted tall trees on the edge of the wooded terrain on the left side of Runway 21 before the airplane contacted the ground approximately 135 ft from that initial contact point in the wooded terrain. The airplane came to rest on an approximate 222° heading. The left wing tip remained in a tree at the edge of the runway at the initial contact point. The left aileron was located on the ground approximately 95 ft from the initial contact point between the wing tip and the main wreckage. Several trees around the main wreckage were burned as a result of the postaccident fire.

**Aerial View of the Main Wreckage (Courtesy of National Park Service)**

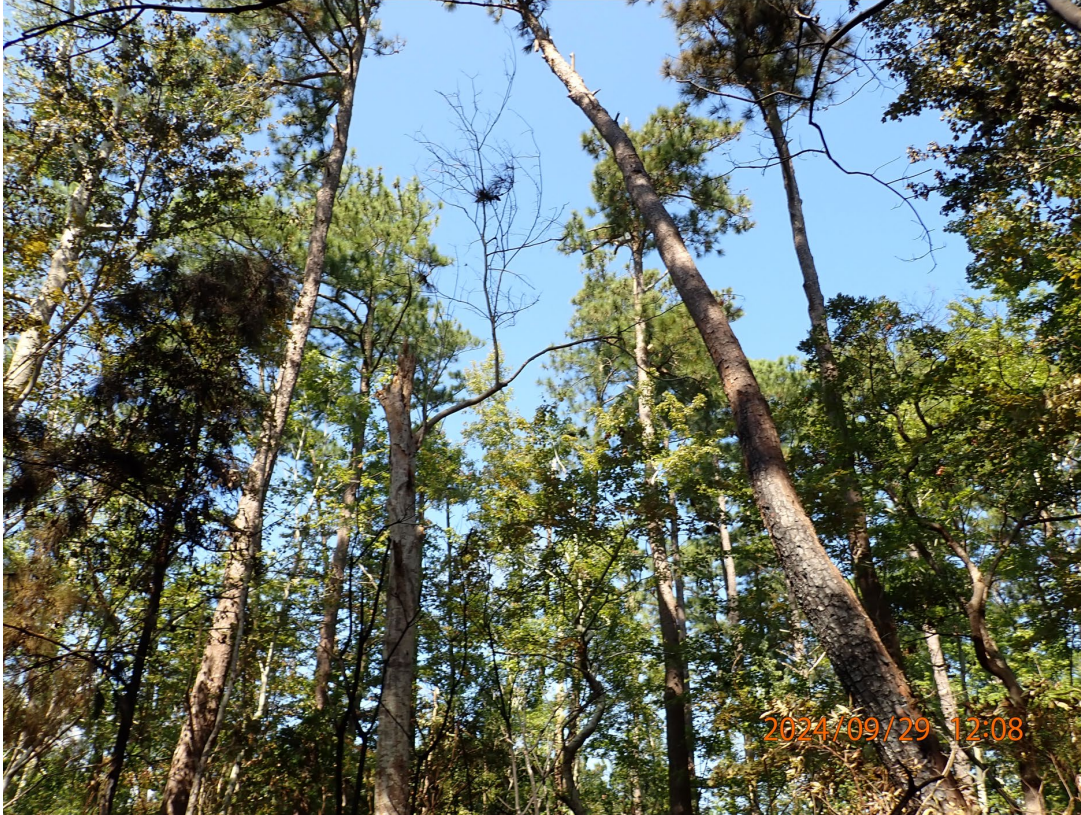
**Airplane Path of Travel Through Trees**

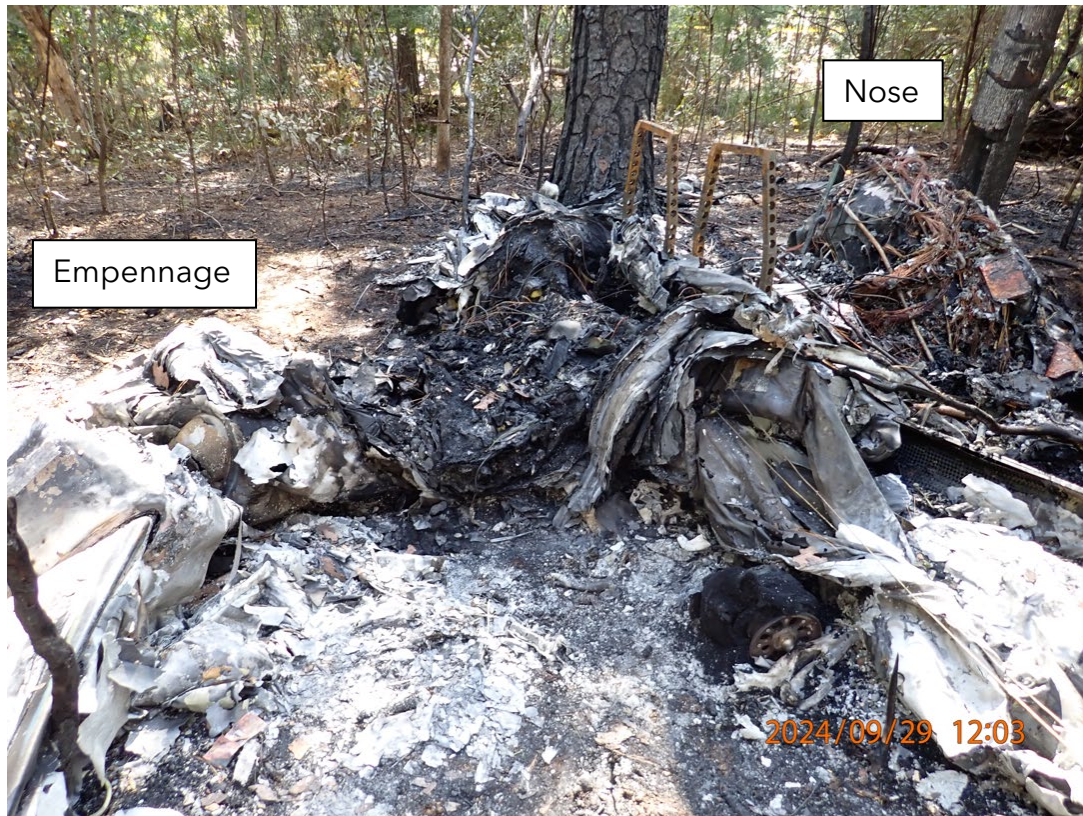
A representative from Cirrus Aircraft was present for the on-scene examination of the airplane. The airplane was mostly consumed by post impact thermal forces. The fuselage, engine, empennage, right wing, and majority of the left wing were located confined to the main wreckage location within the wooded terrain.

**Main Wreckage Overview**

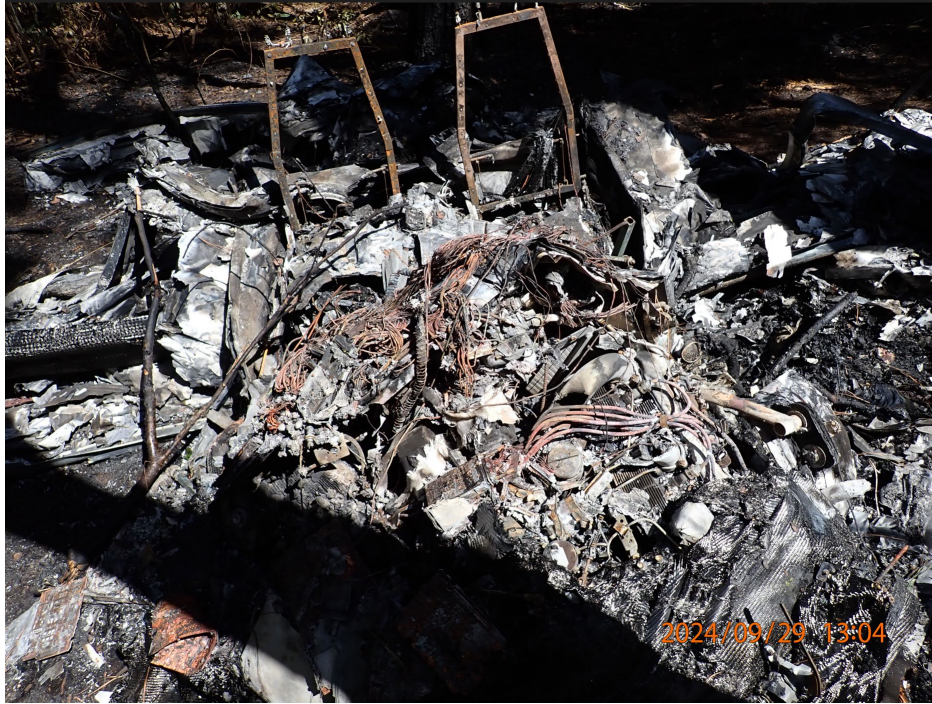
The fuselage was mostly consumed by post impact thermal forces. The left and right crew seat structures remained in place.

**Cockpit and Front Seats as Viewed from Forward to Aft**

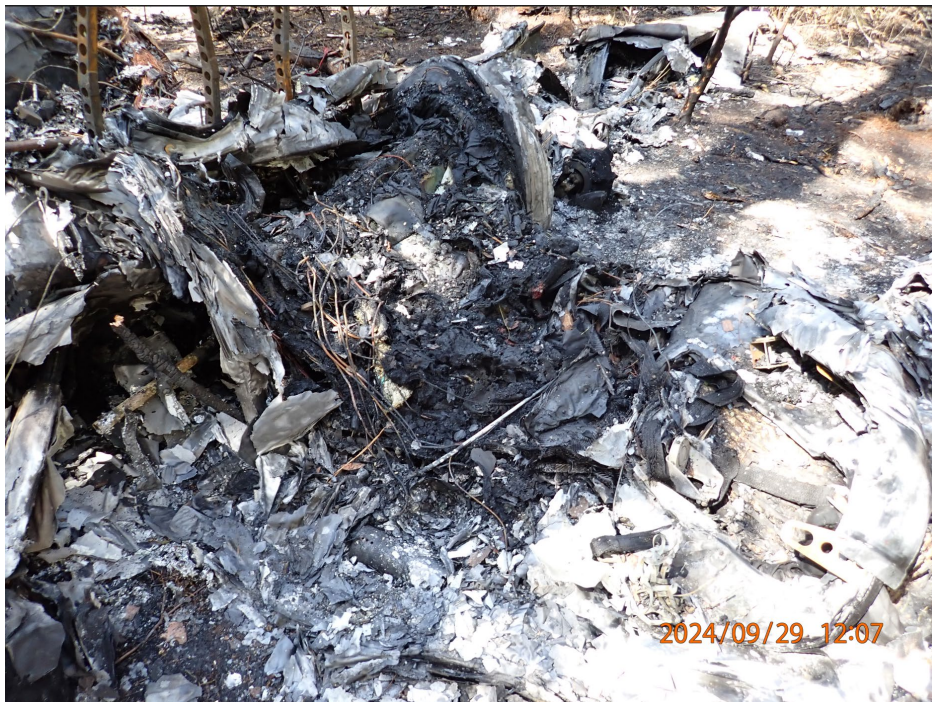
**Aft Cabin**

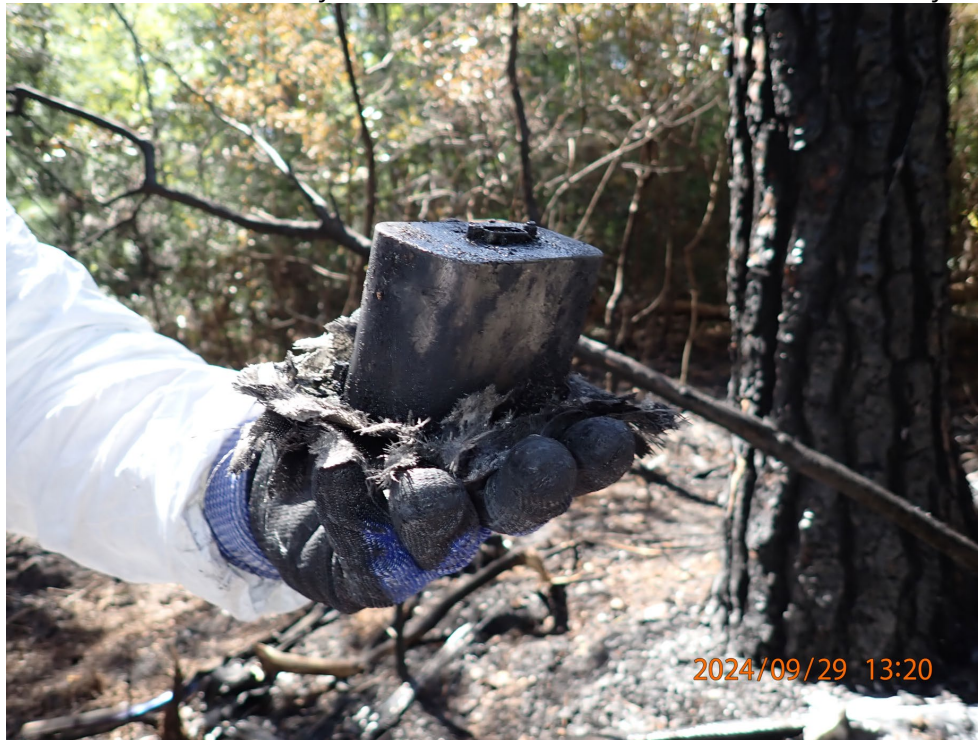
180°. Rudder and elevator control cable continuity was established to the cockpit. The Cirrus RDM-300 was located within the empennage and removed. The RDM was sent to the recorders laboratory for further examination and data recovery.

**Cirrus RDM-300 as Removed from Empennage**

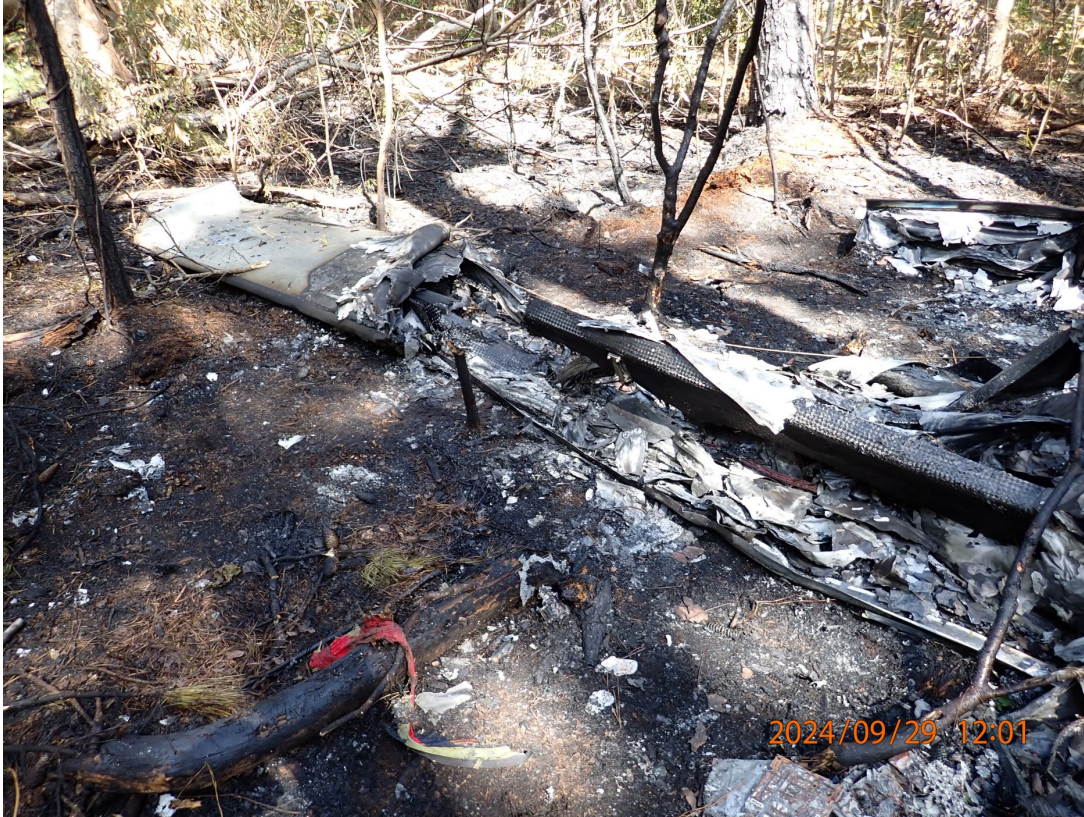
The right wing remained with the fuselage structure. The inboard portion of the wing was mostly consumed by thermal forces. The outboard portion and wing tip were intact and displayed thermal damage.

**Right Wing as Viewed from the Front**

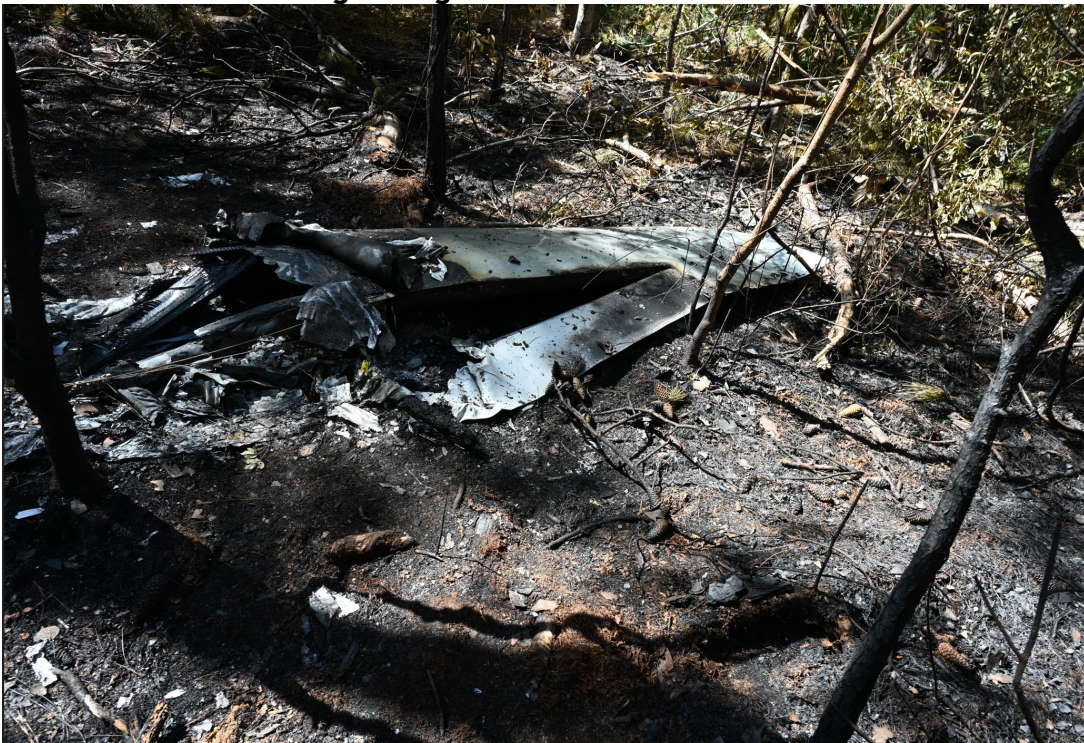
**Right Wing as Viewed from the Back (Courtesy of Cirrus)**

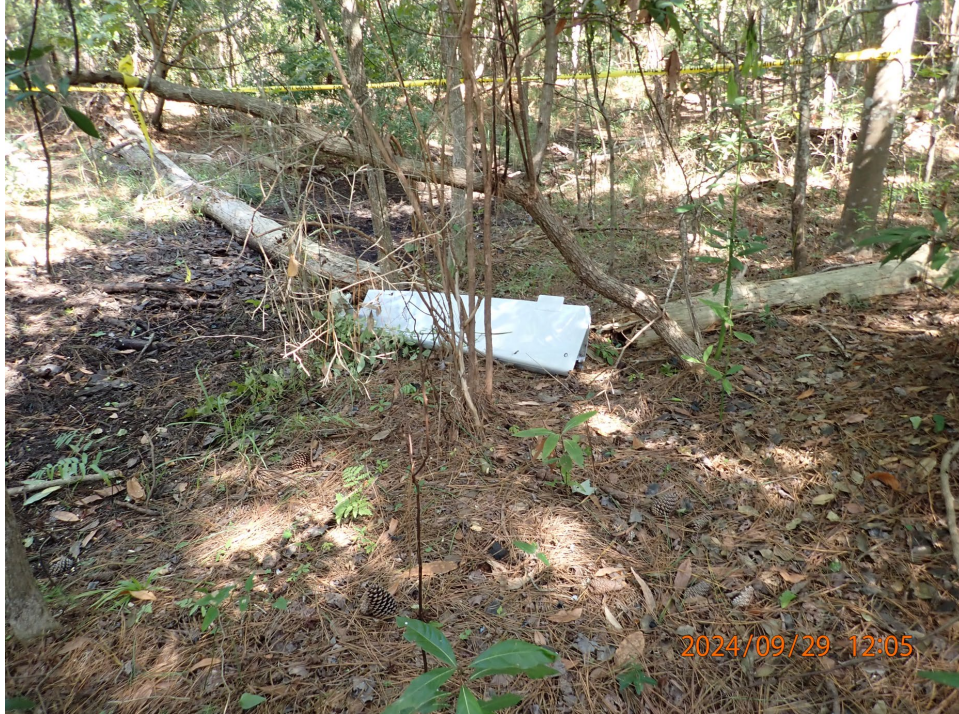
The left wing tip was separated from the main wreckage and was found in a tall tree at the initial contact point. The navigation lighting wiring remained with the wing tip and was wrapped around the tree, holding the wing tip in place. The left aileron and other miscellaneous portions of the left wing were found approximately half way from the initial contact point and the main wreckage. The remainder of the left wing remained with the fuselage and was consumed by thermal forces. The flaps were consumed by thermal forces. The flap actuator was found within the fuselage debris and indicated that the flaps were at the 100% position.

**Left Aileron as Found**

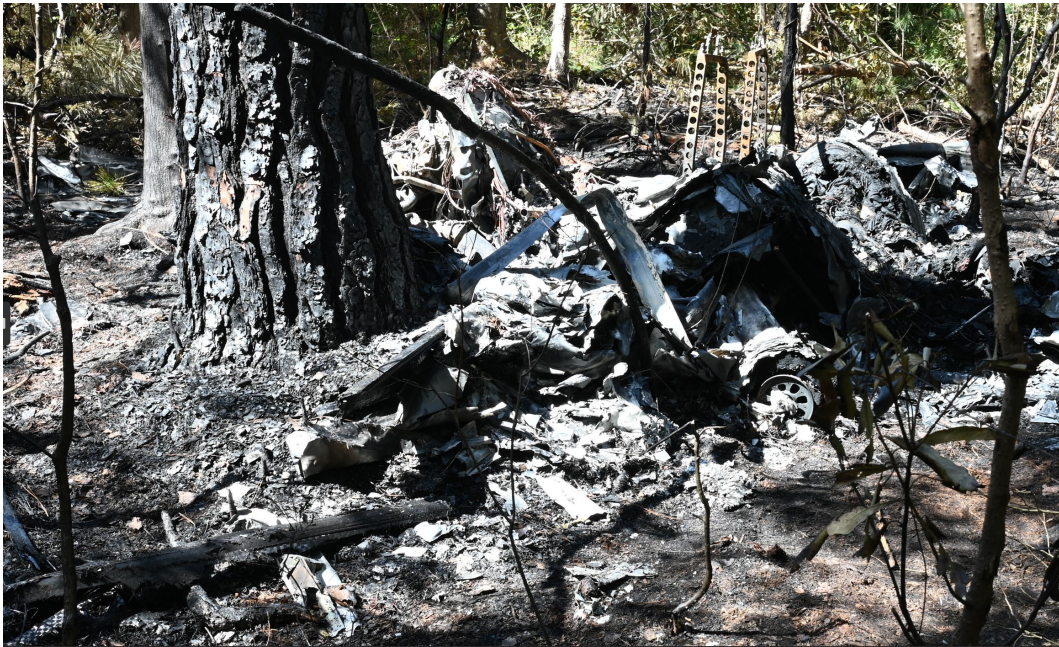
**Remaining Left Wing (Courtesy of Cirrus)**

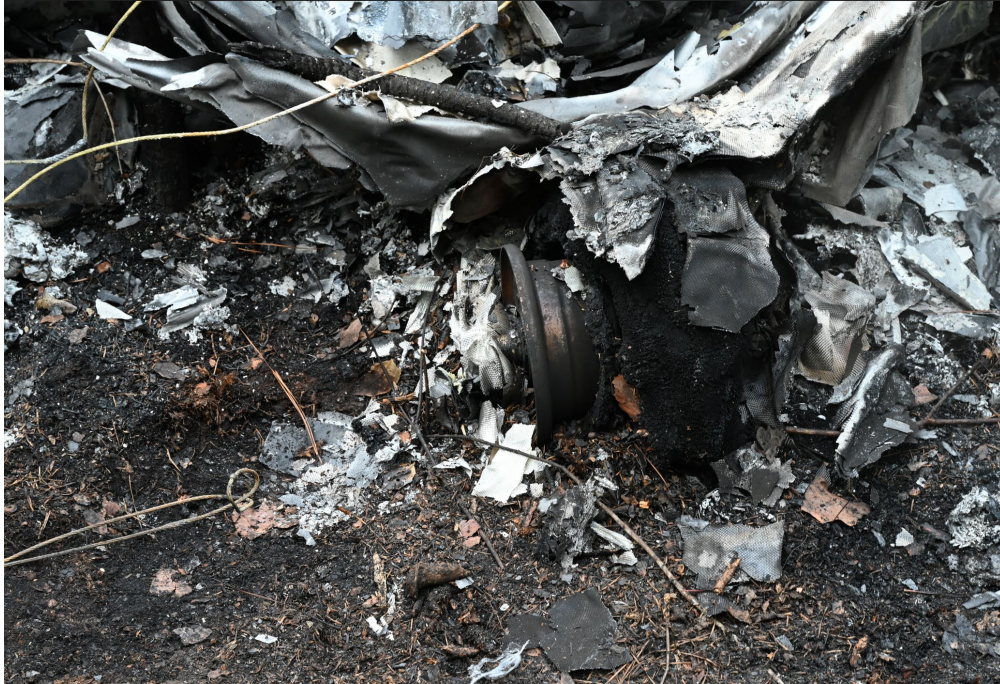
The airplane was equipped with tricycle style, fixed, landing gear. The main landing gear were found in place but were extensively damaged by the post impact fire. The nose landing gear was separated and damage by impact and thermal forces.

**Left Main Landing Gear (Courtesy of Cirrus)**

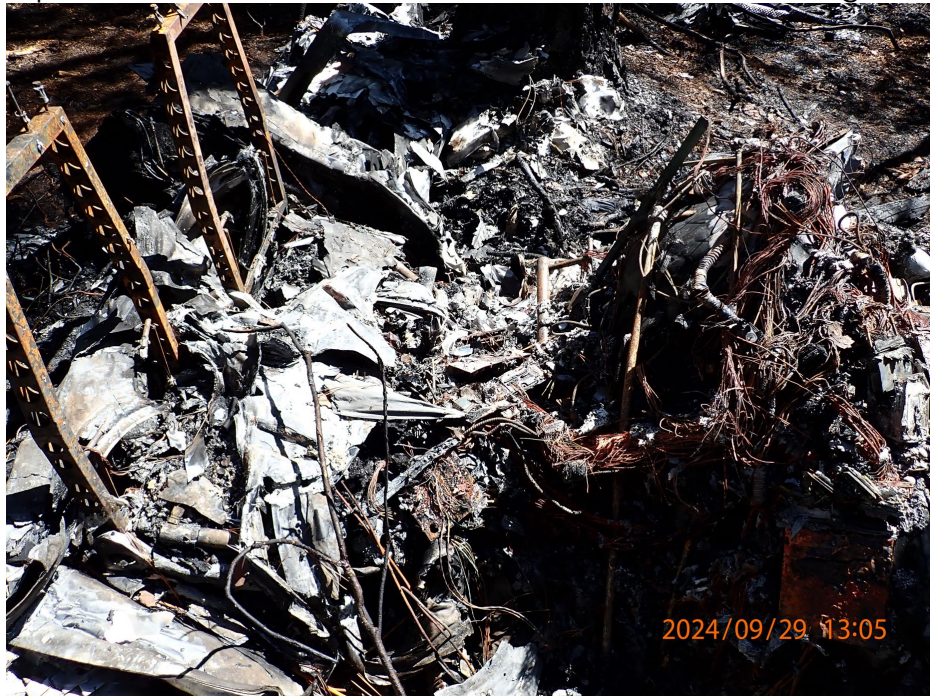
The cockpit was consumed by post impact fire. The Garmin G1000 displays were destroyed. The SD cards for the G1000 system were found in their respective card slots but were melted in place. The engine control levers were destroyed. The fuel selector position could not be determined due to thermal damage.

**Cockpit View**

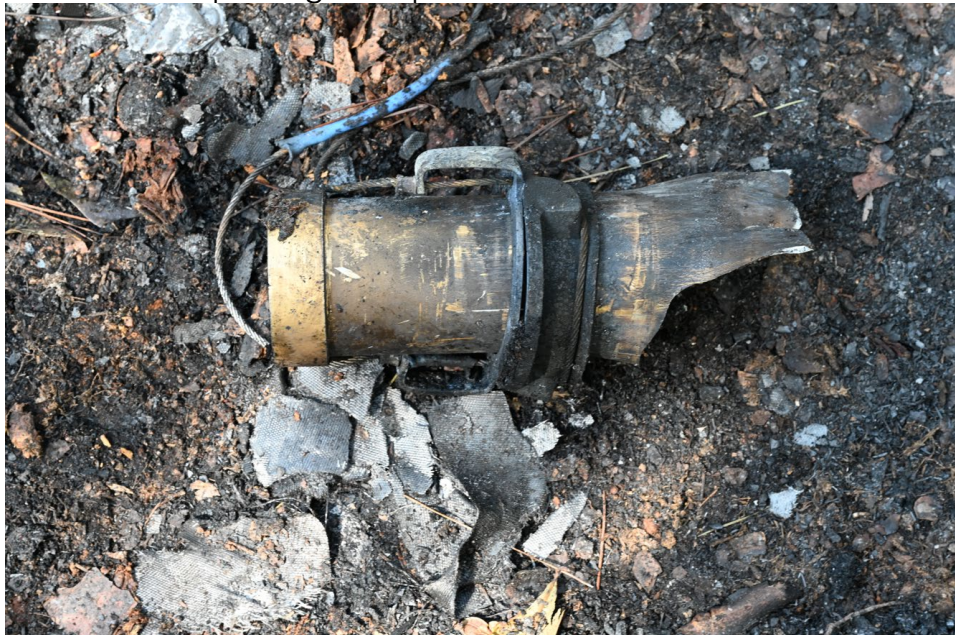
The airplane was equipped with a Cirrus Airframe Parachute System, also known as CAPS. A portion of the rocket motor was found adjacent to the empennage structure and likely exploded during the postcrash fire after becoming heat soaked. A rocket motor fuel grain was found approximately 110 feet away in the wooded terrain which had ignited a small auxiliary brush fire. The harness, suspension lines, and canopy were all contained within the Deployment Bag or D-Bag, and remained restrained within the empennage in a packed state.

**Damaged Portion of the CAPS System (Courtesy of Cirrus)**

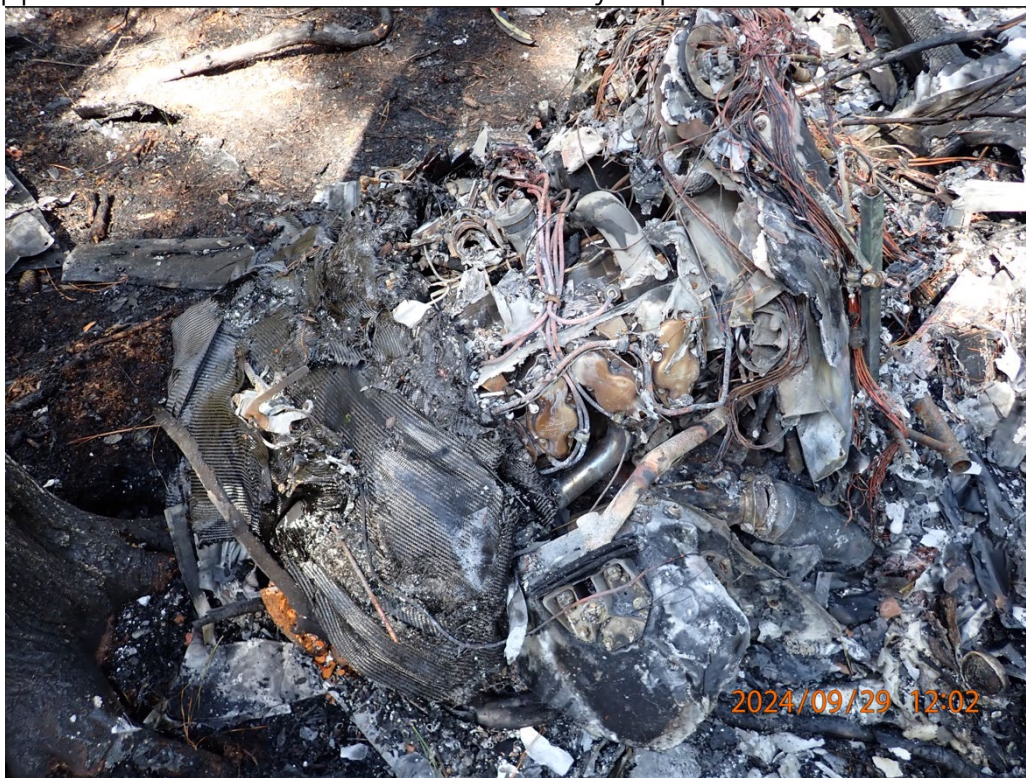
The engine remained attached to the airplane firewall. The powerplant is a Continental IO-550-N. The engine and its accessories were exposed to the post-crash fire. Two representatives from Continental Aerospace Technologies arrived on scene to assist with engine examination. A preliminary inspection was conducted near the accident site. While the engine was suspended from the recovery equipment, the engine truss mount, nose gear assembly, exhaust and firewall were removed. The fuel pump was removed for inspection and drive coupling condition. The drive coupling shaft was found intact. At this time, the top spark plugs were removed. The removed spark plugs were checked with the Champion Check-A-Plug Chart and were found to be within a normal operational condition. The engine was rotated in the direction of normal operational condition and thumb compression was found on all six cylinders. The crankshaft and camshaft continuity were confirmed throughout. The magnetos could not be tested at this time due to thermal damage. The engine was shipped to the manufacturer for disassembly inspection.

**Engine As Viewed from the Left Side**

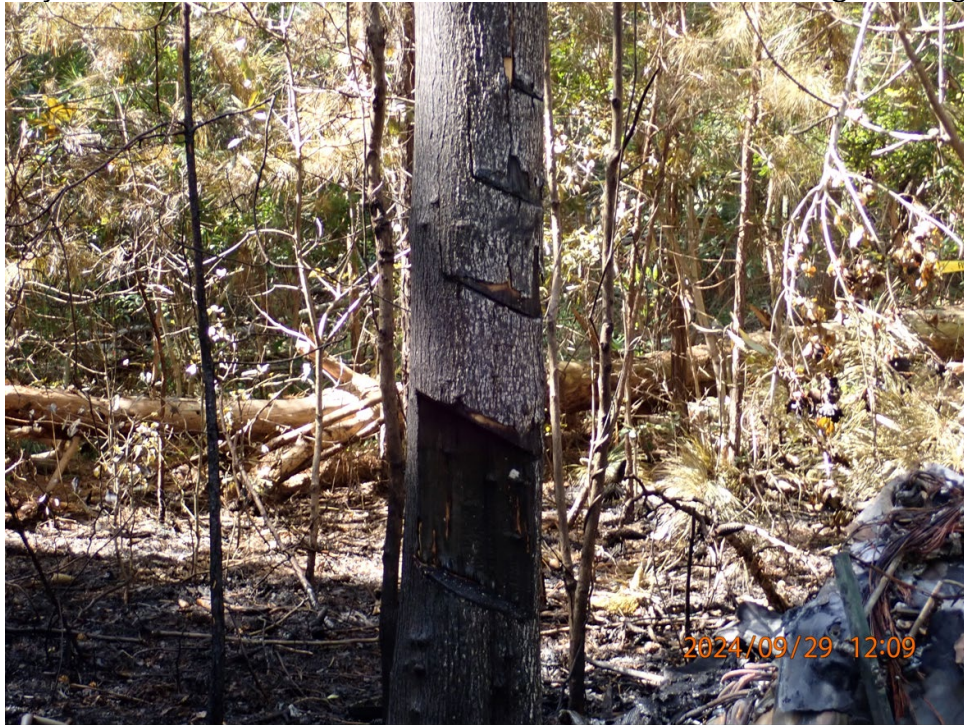
The airplane was equipped with a 3-bladed Hartzell propeller. Propeller strike marks were observed on a large diameter tree directly in front of the engine with slashes measuring approximately 8 to 12" apart down the tree trunk. A large 12" section of the tree trunk was dislodged from the propeller strikes. The three,

**Propeller Strike Signatures in Tree**

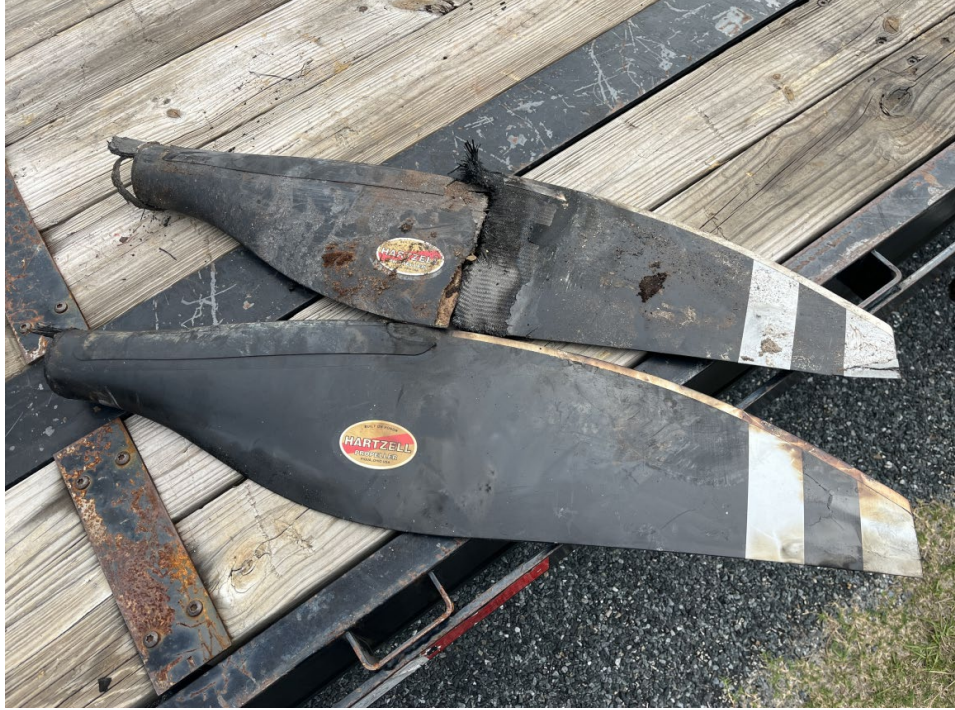
composite material propeller blades were liberated from the propeller hub assembly. One blade was found approximately 10 feet, forward, right of center from the hub assembly in one piece. A second blade was found below the hub assembly in the soil but was fractured in half from impact forces. The third propeller blade was recovered on January 29, 2025, near the main wreckage location. The third blade was recovered by the National Park Service and was sent to the wreckage storage facility.

**Propeller Blade Damage**
