ERA24LA004

## INVESTIGATION PHOTOGRAPHS

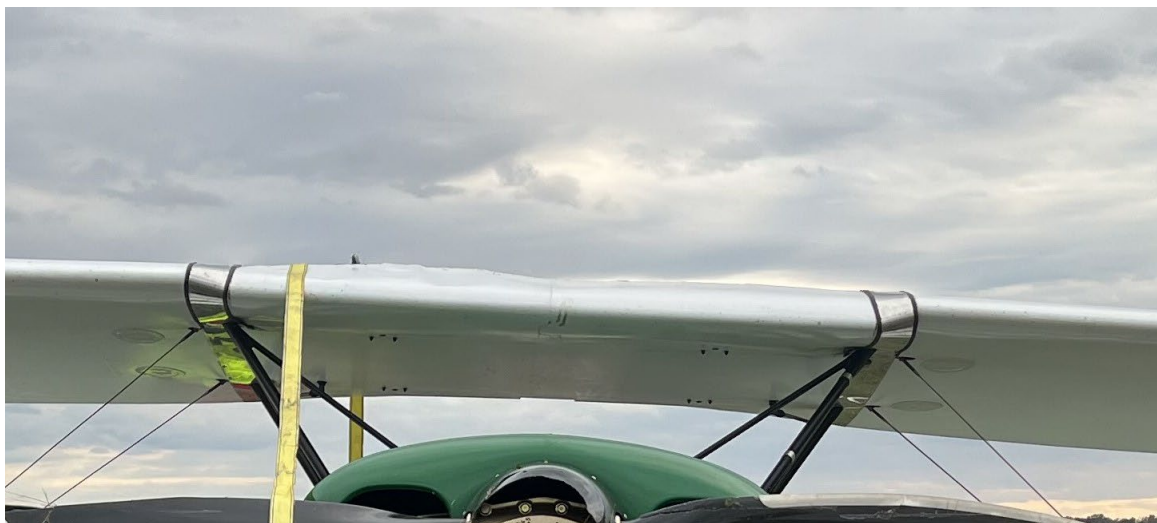
**Photograph 1 - Upper Wing Damage (Courtesy of FAA)**

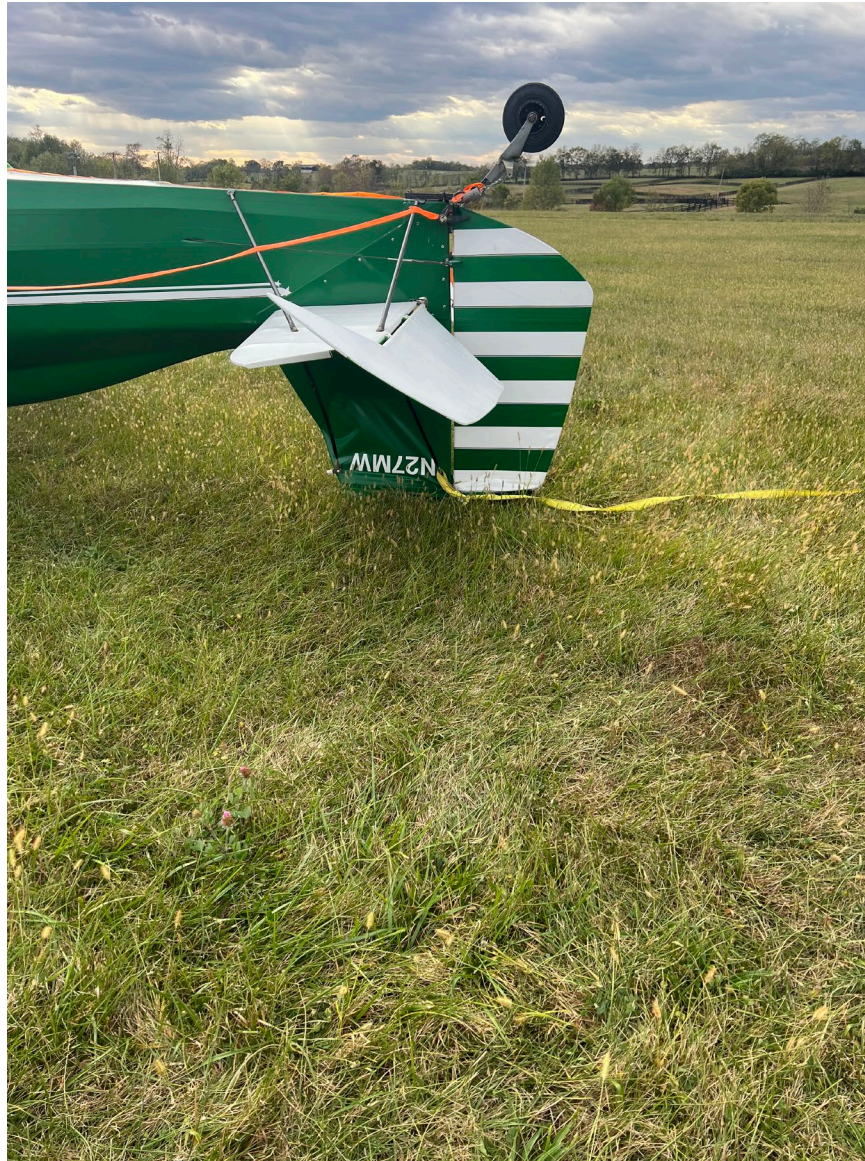
**Photograph 2 - Vertical Stabilizer and Rudder Damage (Courtesy of FAA)**
