# National Transportation Safety Board

**ERA24LA007**

## **AIRCRAFT SYSTEMS**

Specialist's Factual Report

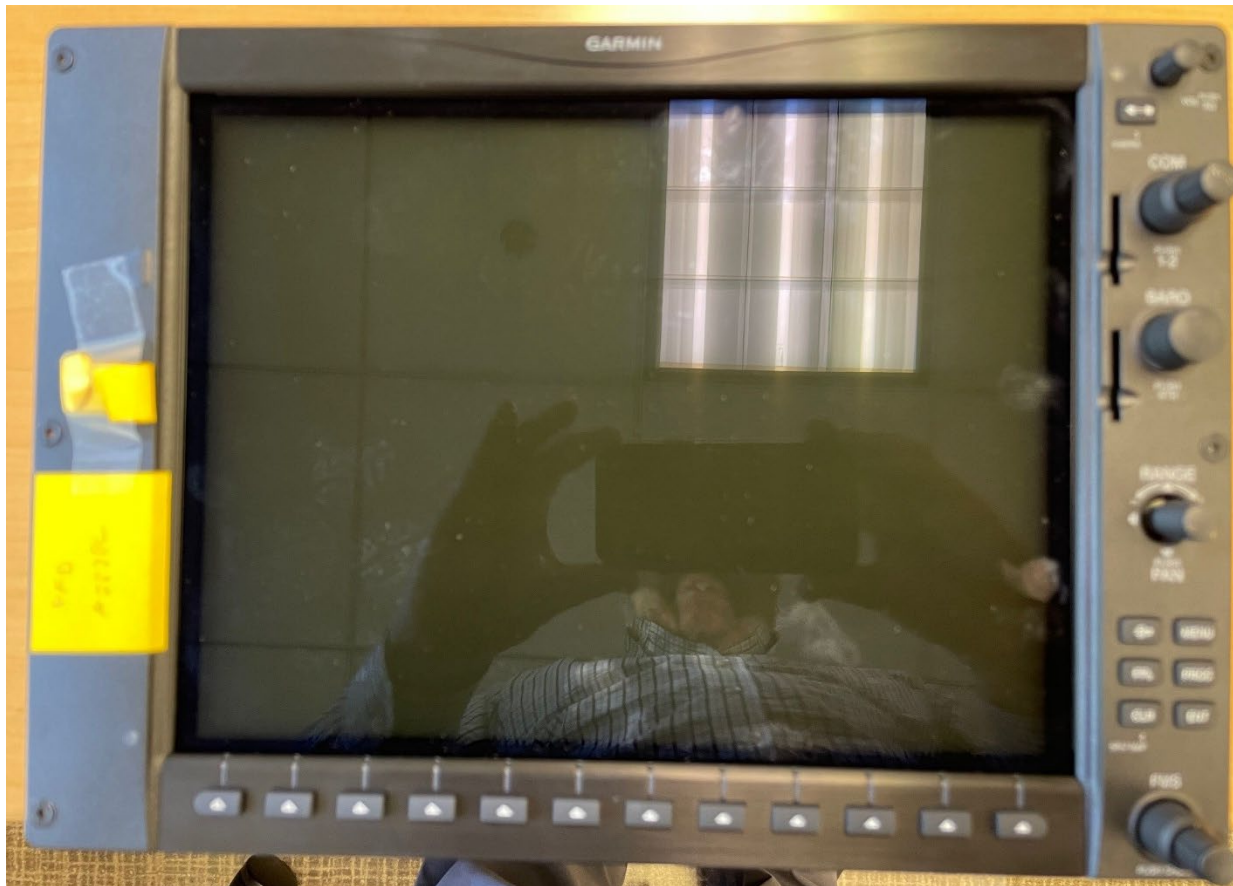
**Figure 1.** The airplane's PFD, as marked by investigators, removed from the airplane.

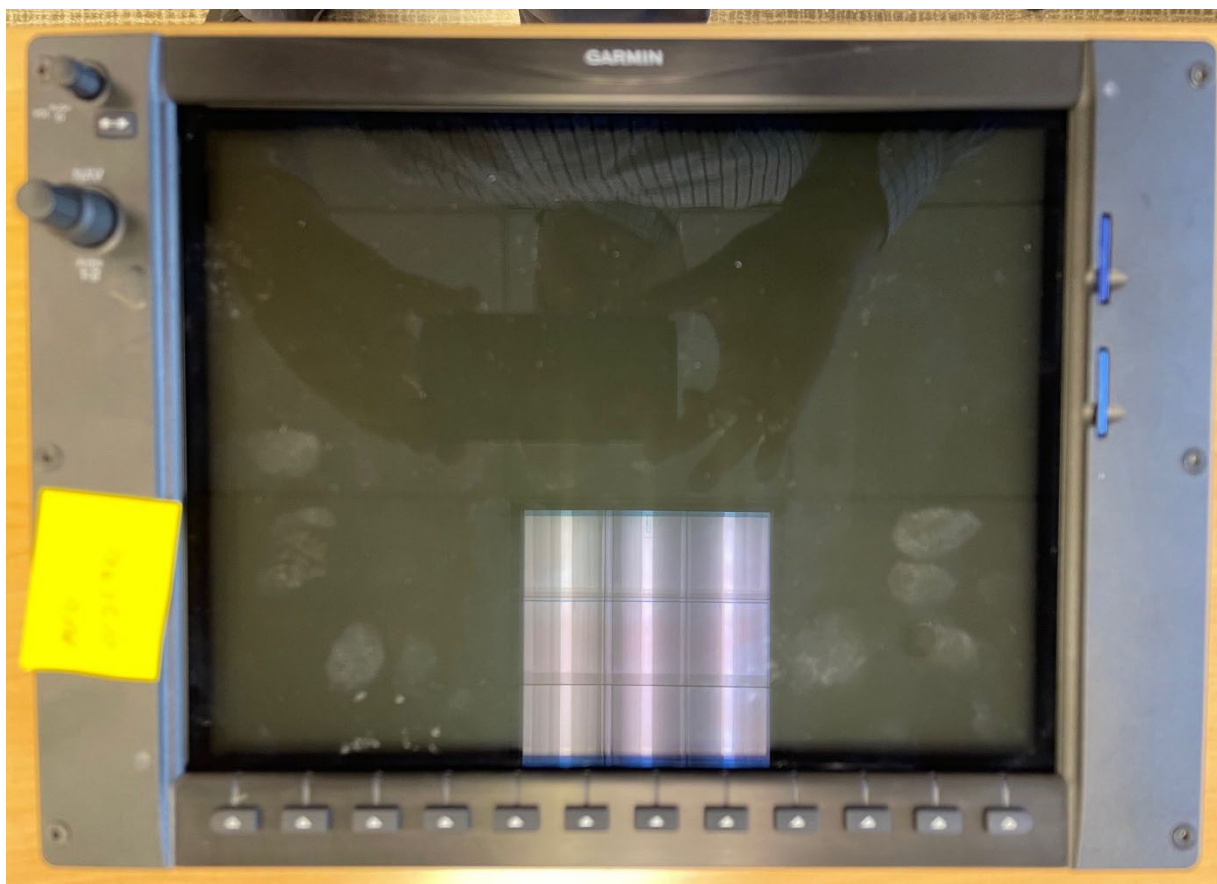
**Figure 2.** The airplane's MFD, as marked by investigators, removed from the airplane.
